# Long-Term Effects of Electrochemical Chloride Extraction on Laboratory Specimens and Concrete Bridge Components

PUBLICATION NO. FHWA-HRT-10-069

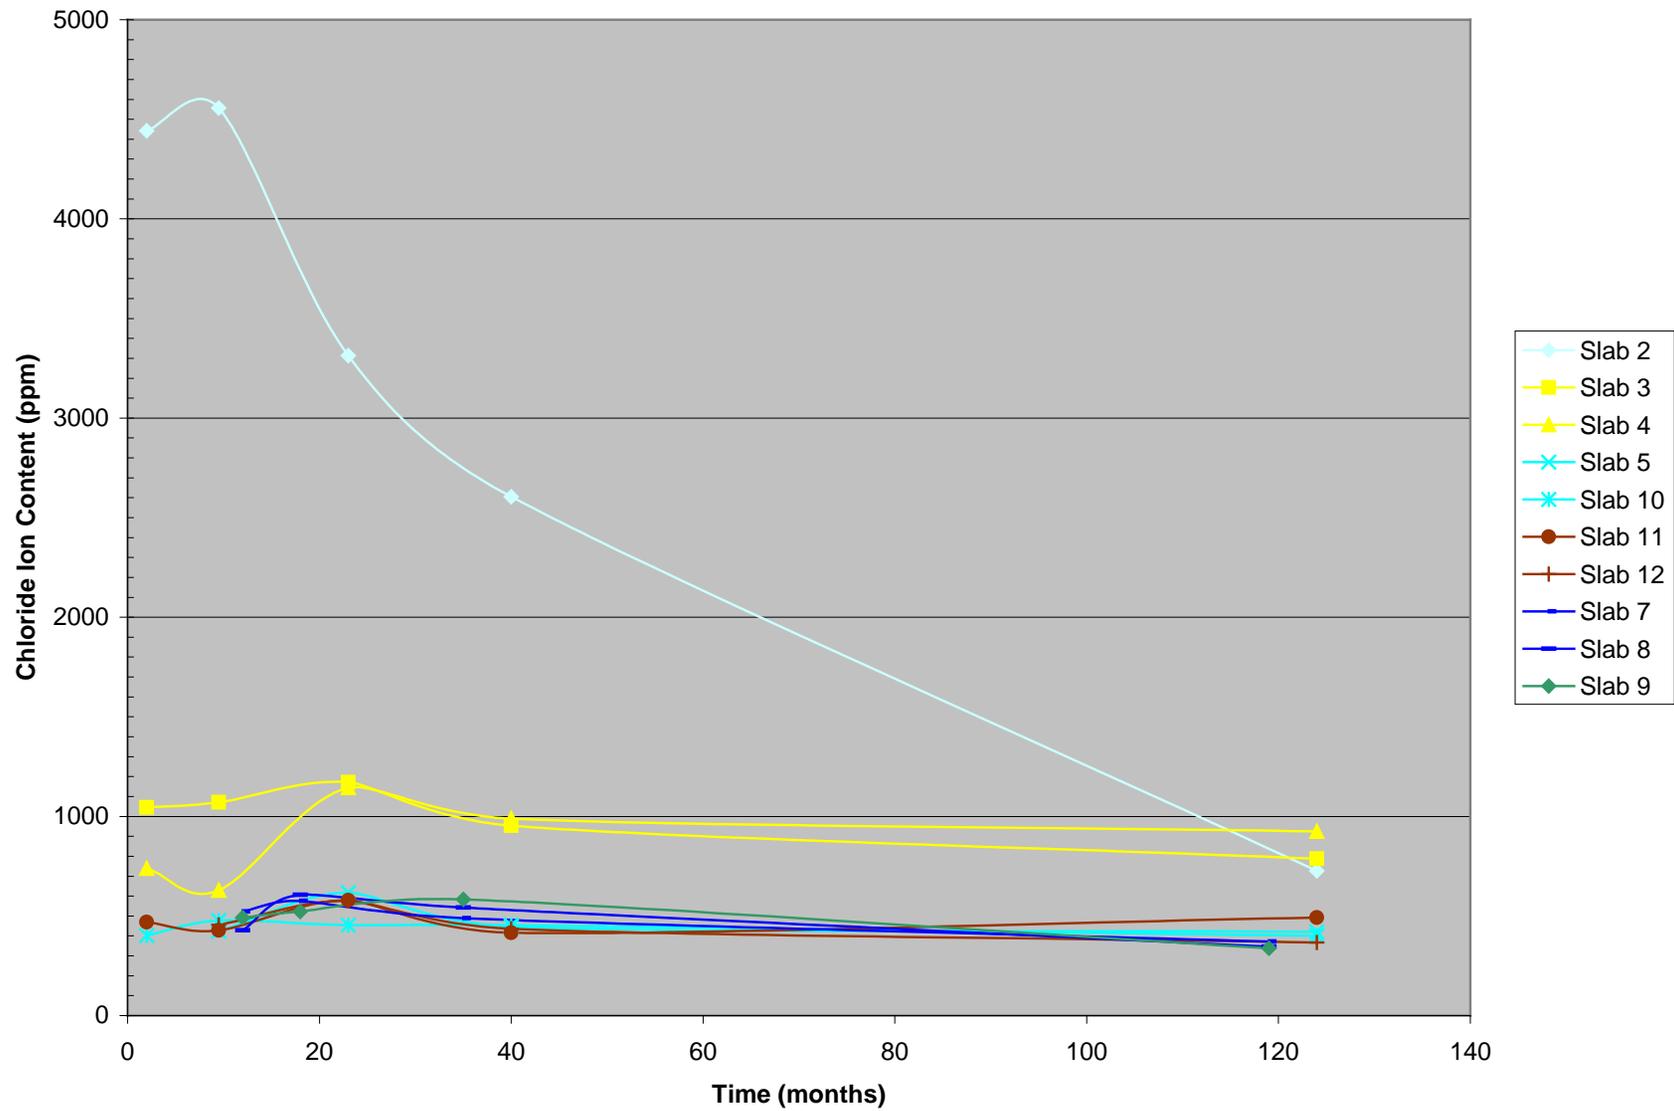
Figure 3. Graph. Chloride content versus time.

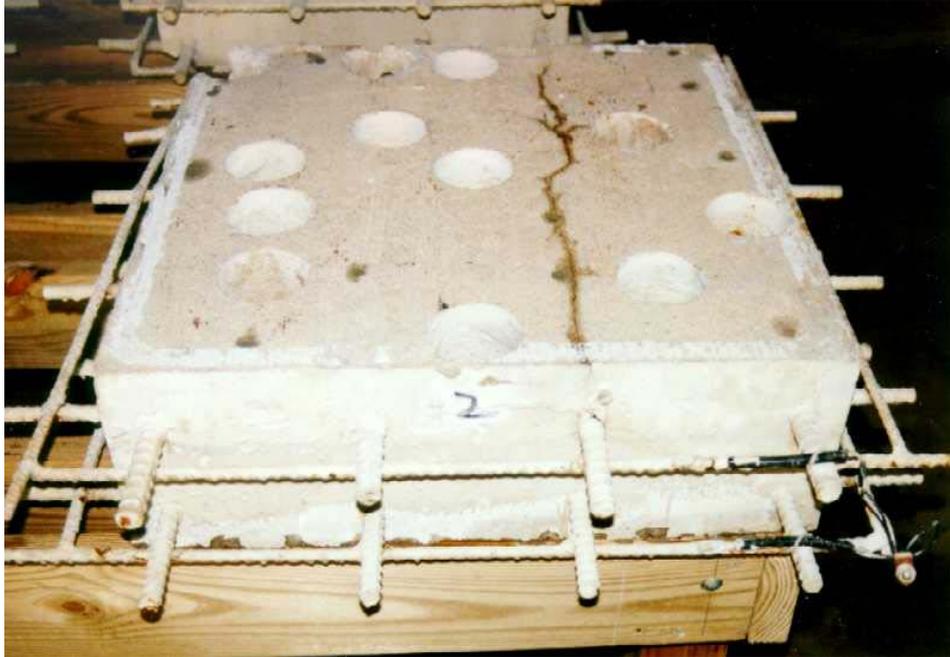
**Figure 4. Photo. Condition of crack on the top surface of slab 2 in August 1994.**

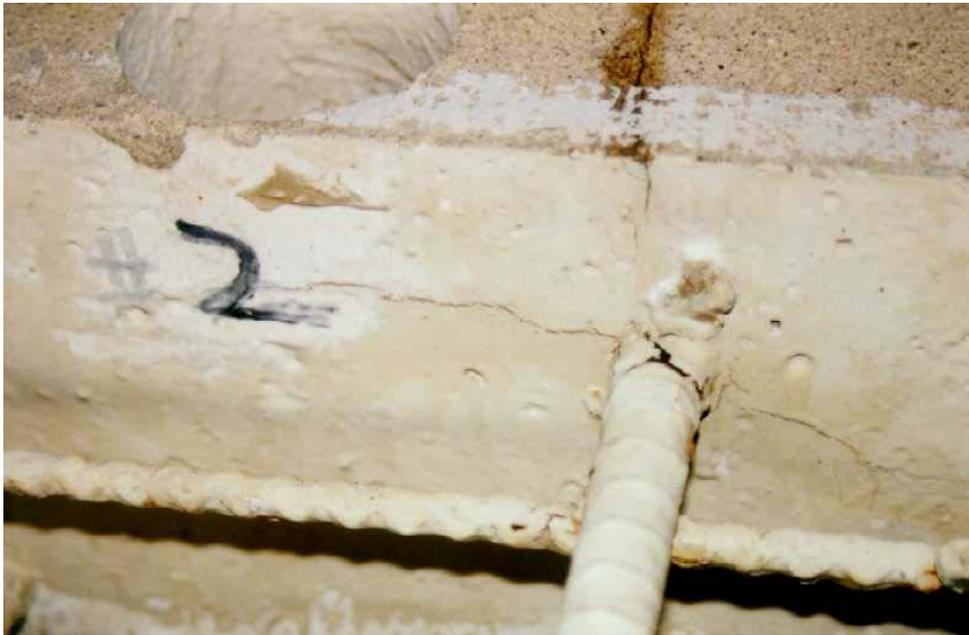
**Figure 5. Photo. Termination of the top crack and other cracks on the front side of slab 2 in August 1994.**

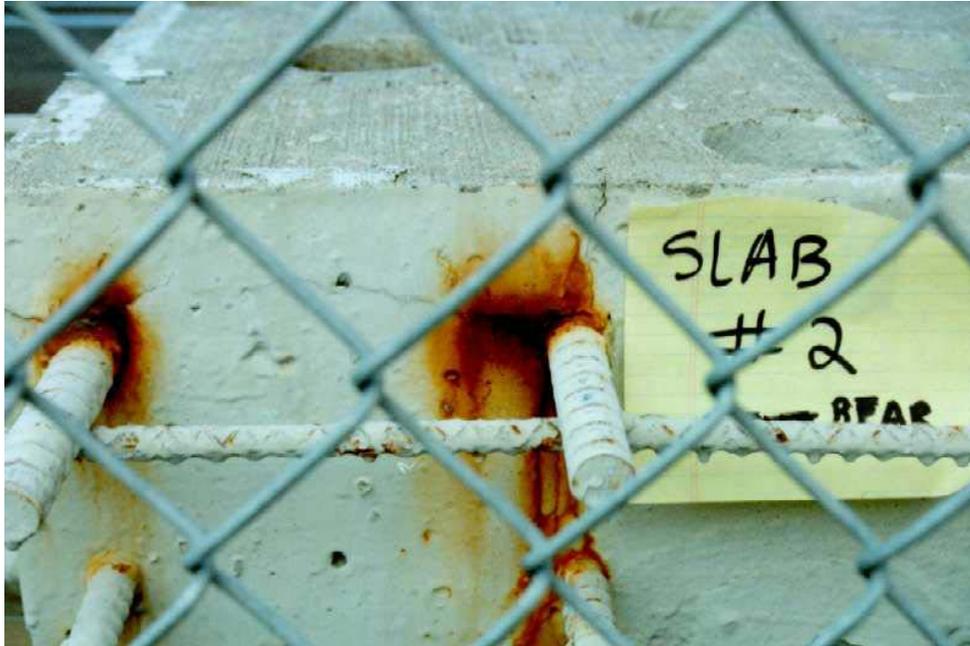
**Figure 6. Photo. Cracks and corrosion products on the rear side of slab 2 in August 1998.**

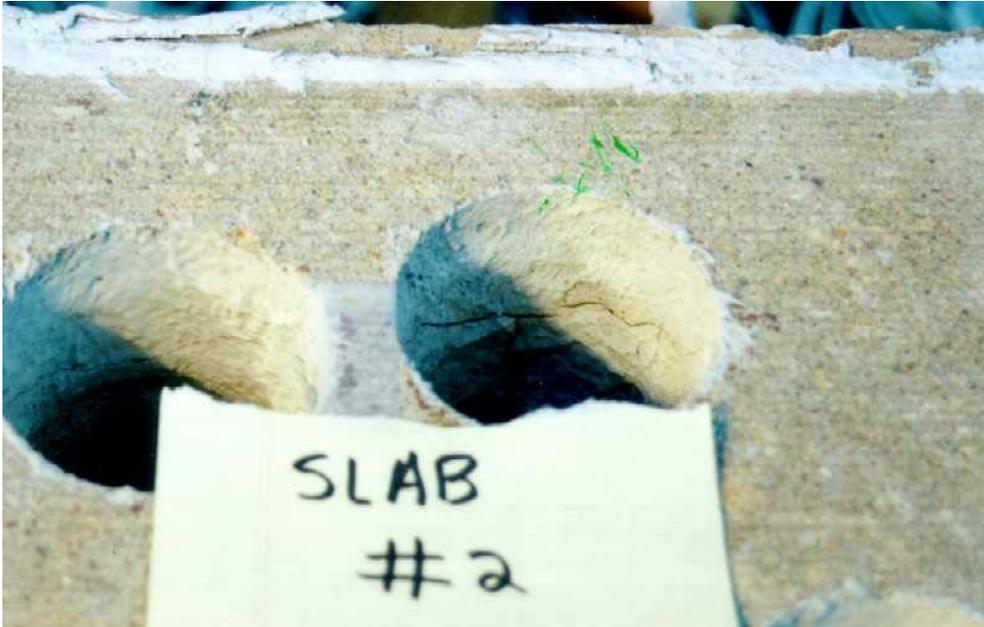
**Figure 7. Photo. Cracking and rust staining at the level of reinforcing steel in core holes of slab 2.**

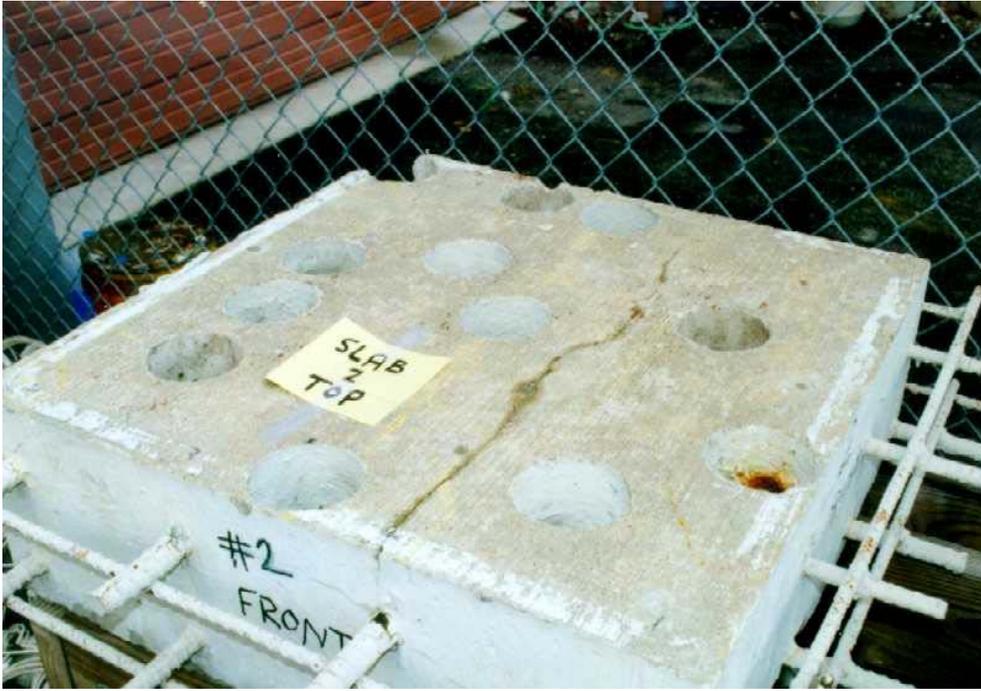
**Figure 8. Photo. Corrosion on the ends of rebar exposed in core holes of slab 2.**

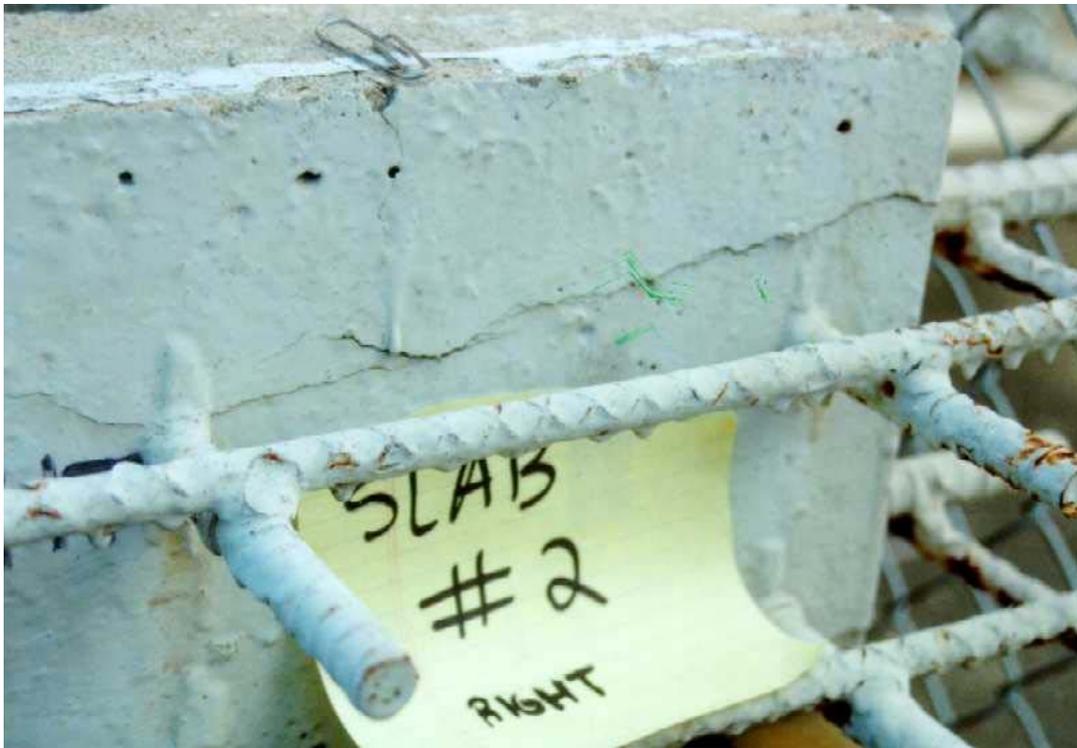
Figure 9. Photo. Crack on the right side of slab 2.

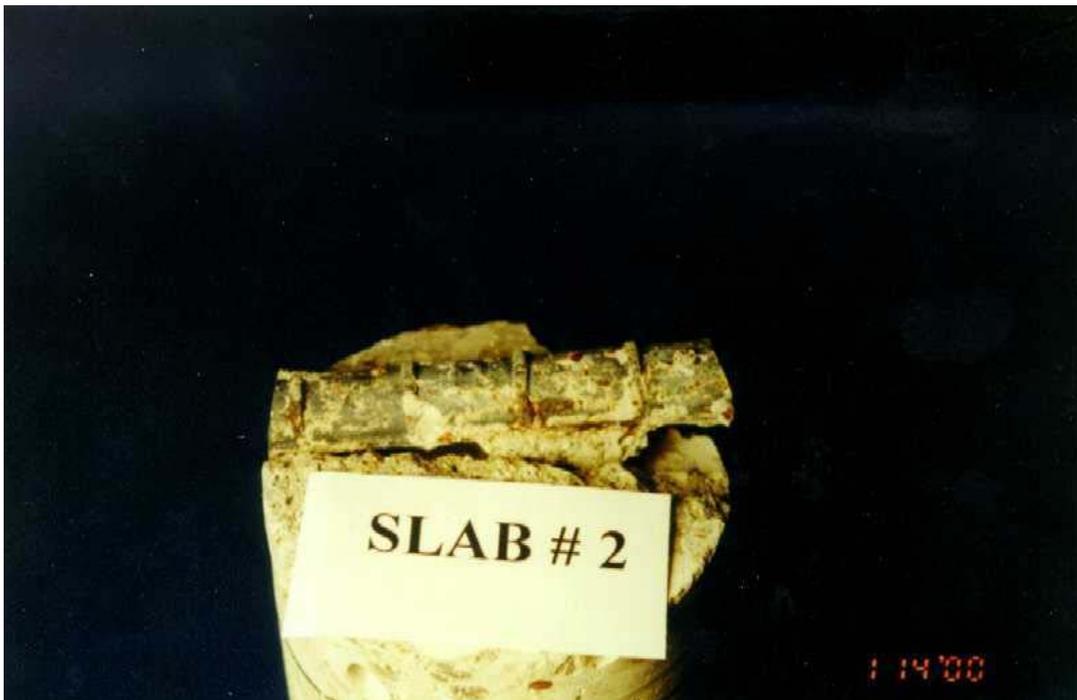
Figure 10. Photo. Autopsy of core extracted from slab 2 in December 1999.

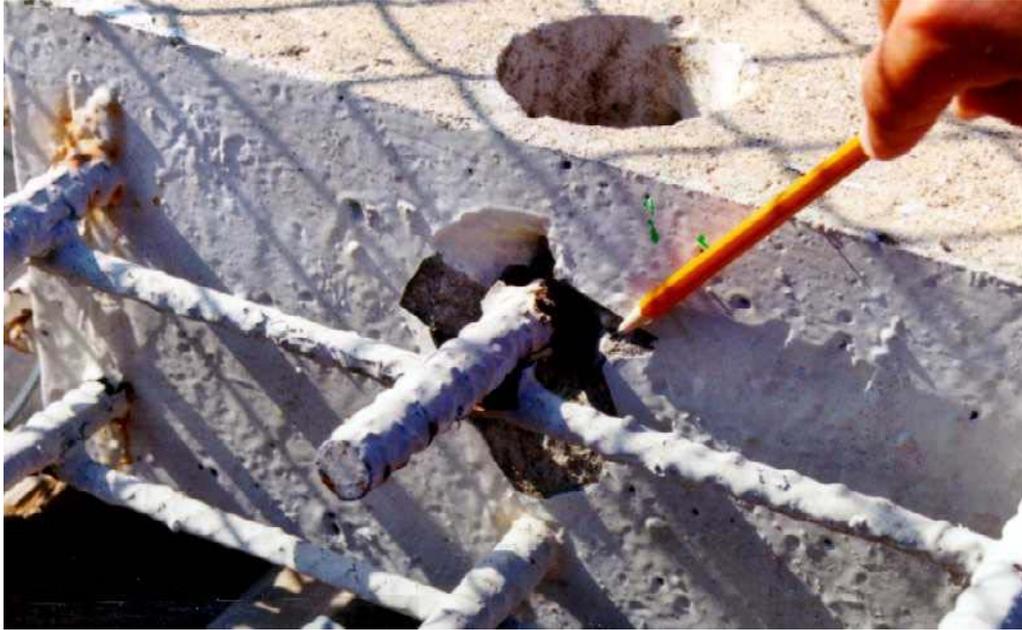
**Figure 11. Photo. Corrosion and spalling on one rebar at the concrete-air interface on the side of slab 3 in September 1997.**

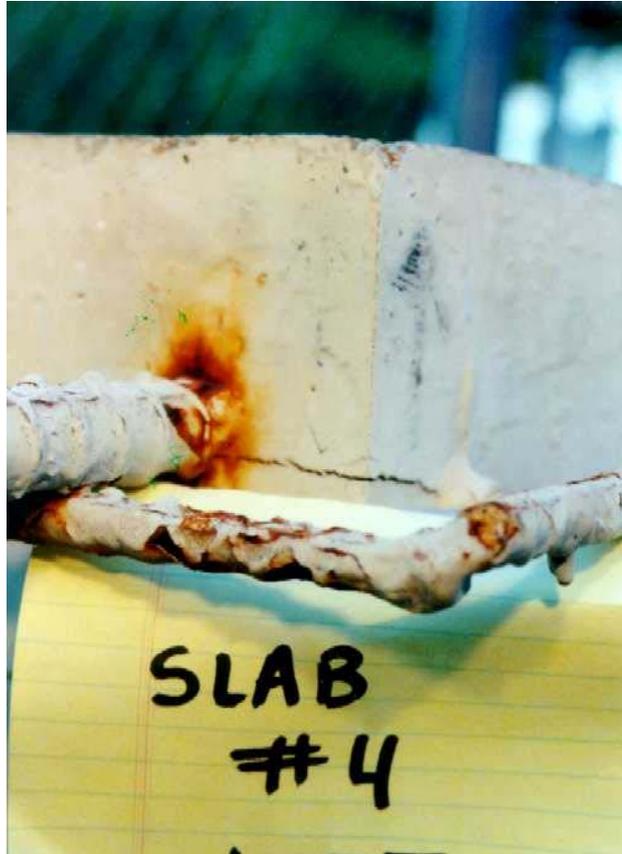
**Figure 12. Photo. Rust staining and cracking on the side of slab 4.**

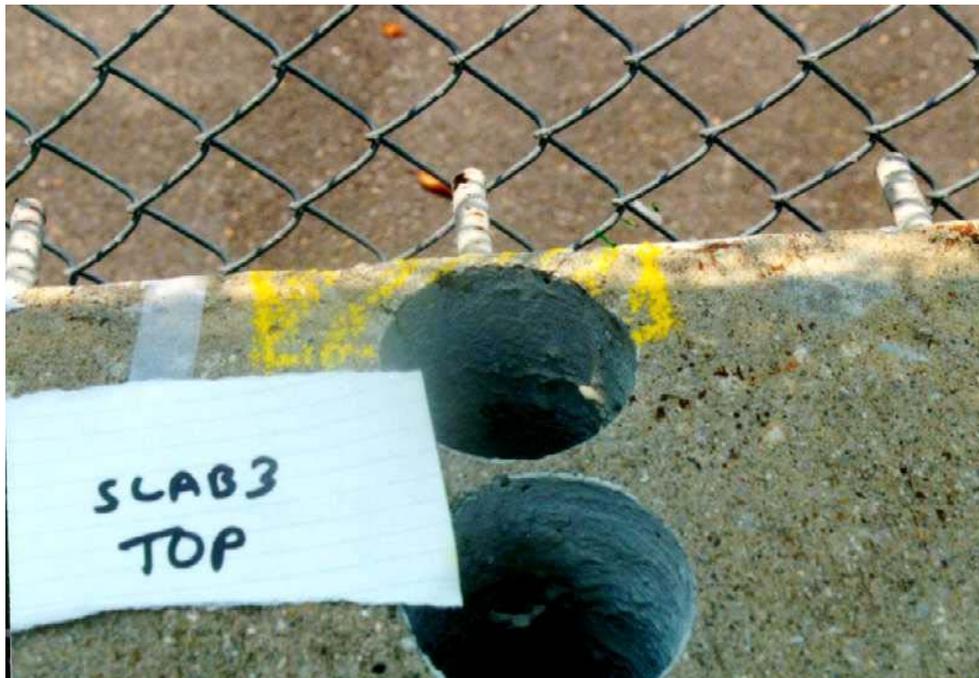
**Figure 13. Photo. Delamination (marked in yellow) found on the top surface of slab 3.**

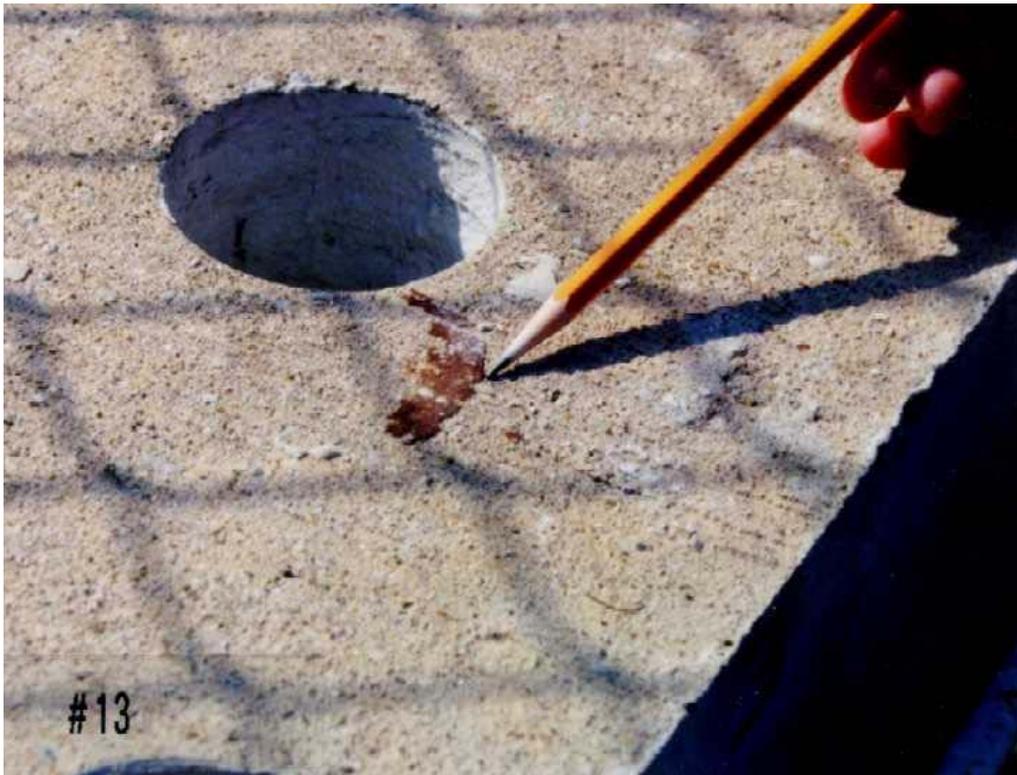
**Figure 14. Photo. Rust staining on the top surface of slabs 3 and 4.**

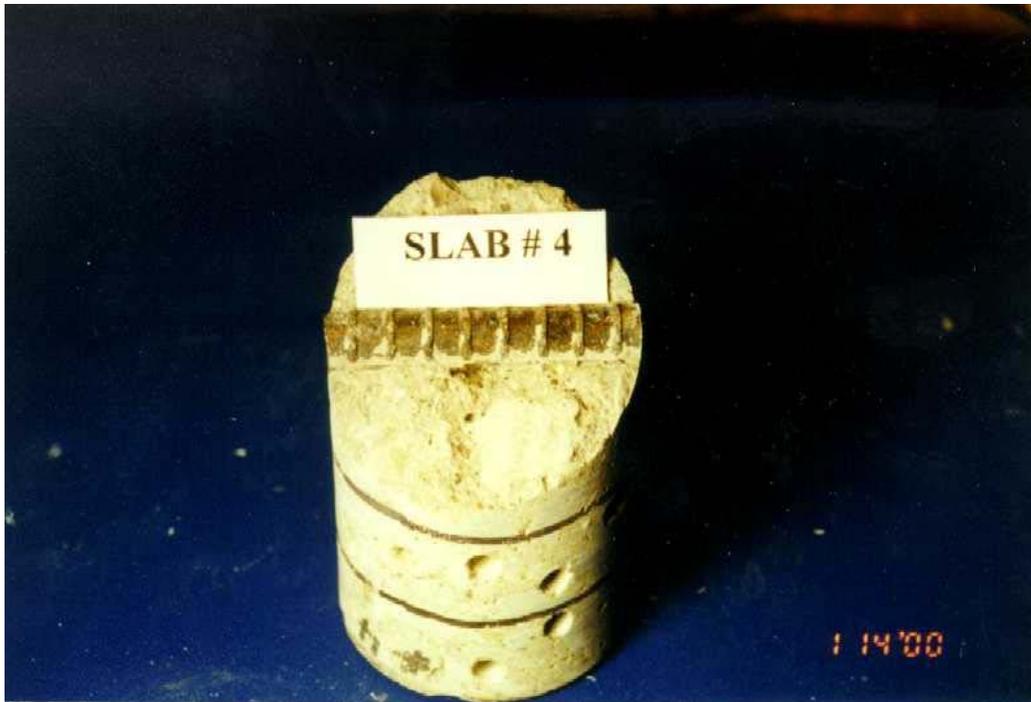
**Figure 15. Photo. Autopsy of core extracted from slab 4 in December 1999.**

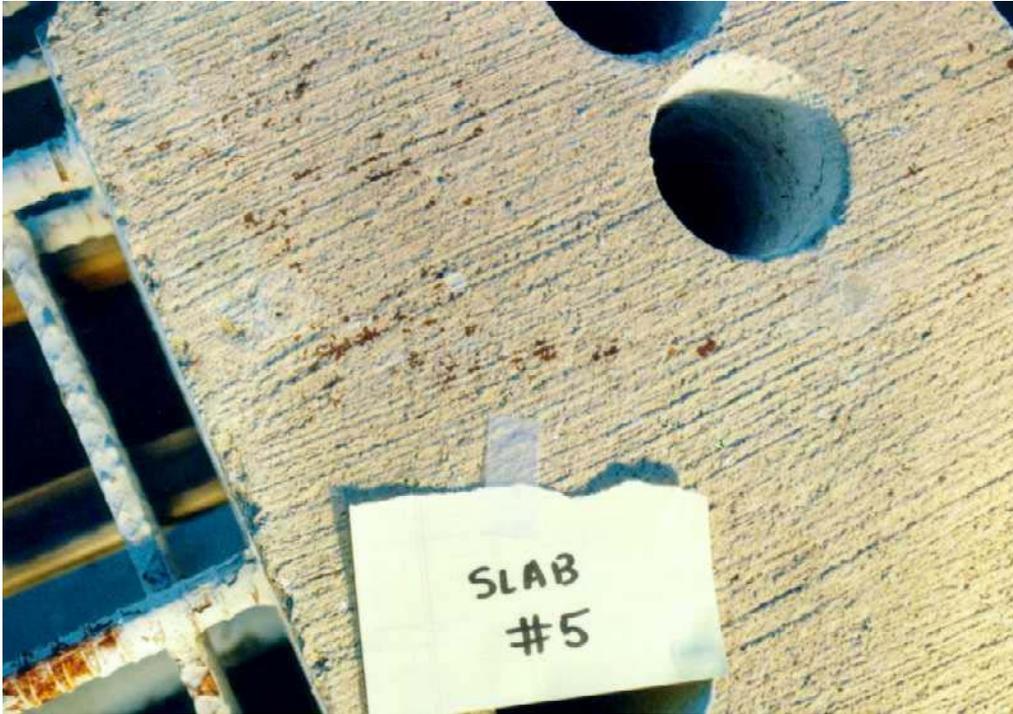
Figure 16. Photo. Rust stains on the top surface of slab 5.

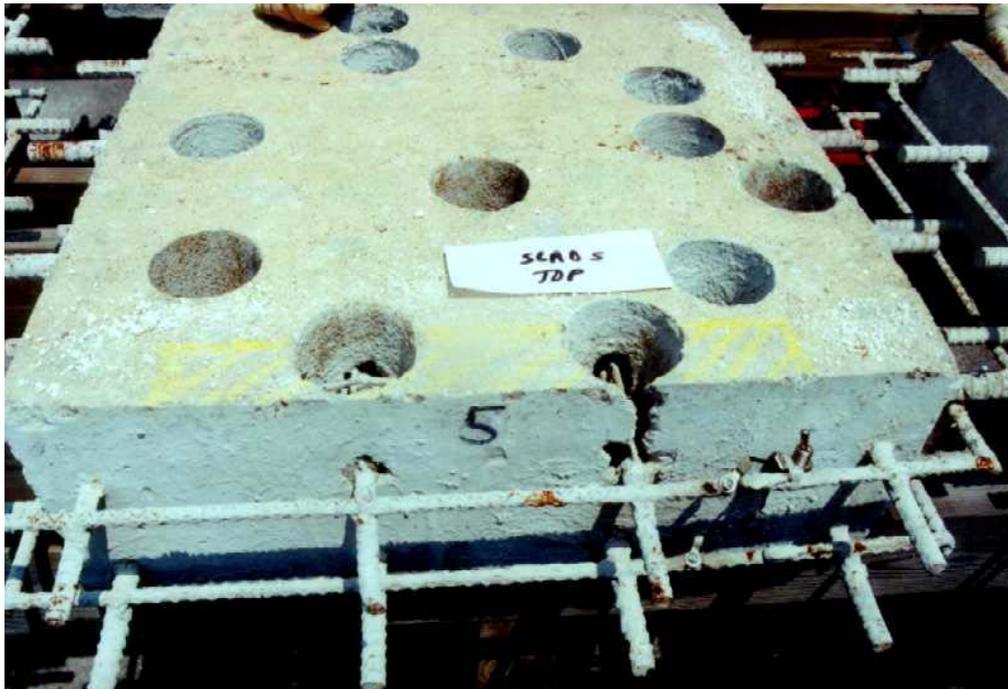
Figure 17. Photo. Delaminations (marked in yellow) and concrete failure near a core hole on slab 5.

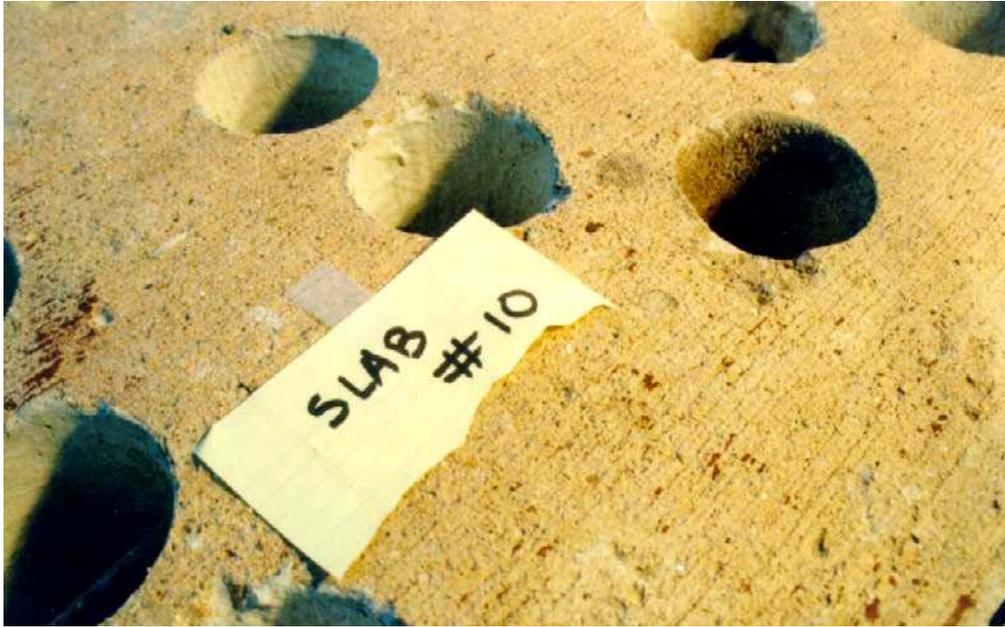
**Figure 18. Photo. Rust stains on the top surface of slab 10.**

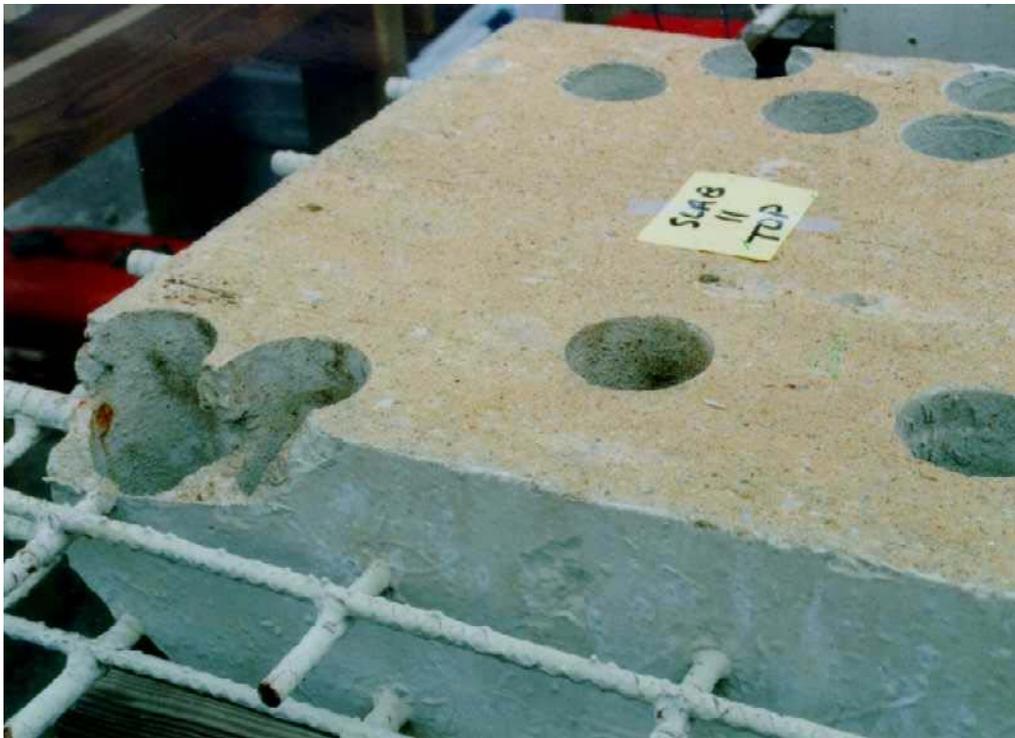
**Figure 19. Photo. Noncorrosion-related concrete failure adjacent to core holes on one corner of slab 11 in spring 1997.**

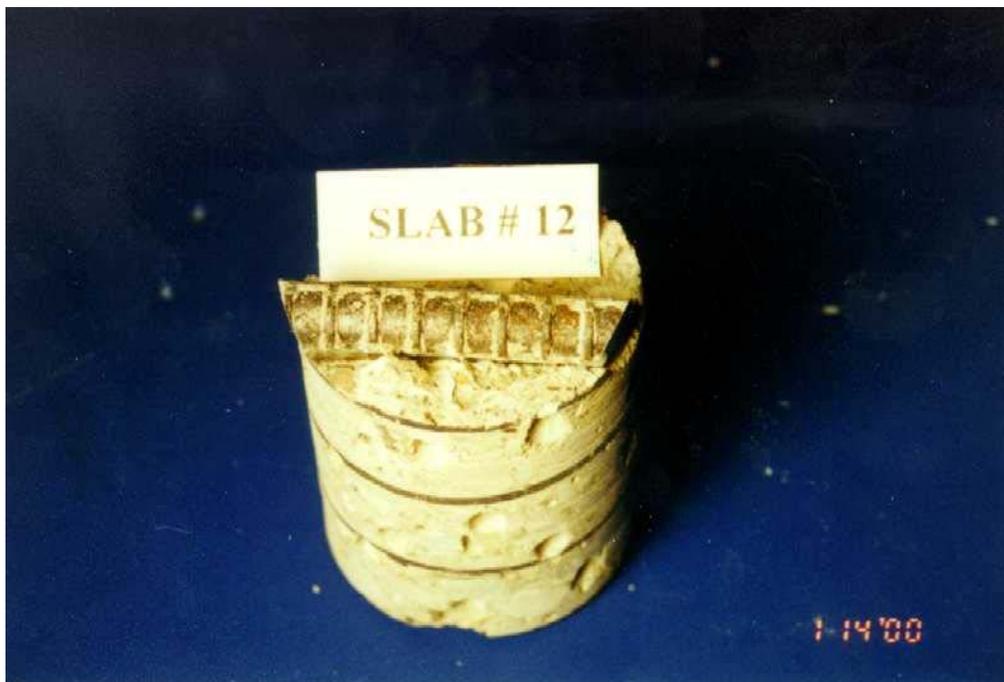
**Figure 20. Photo. Autopsy of core extracted from slab 12 in December 1999.**

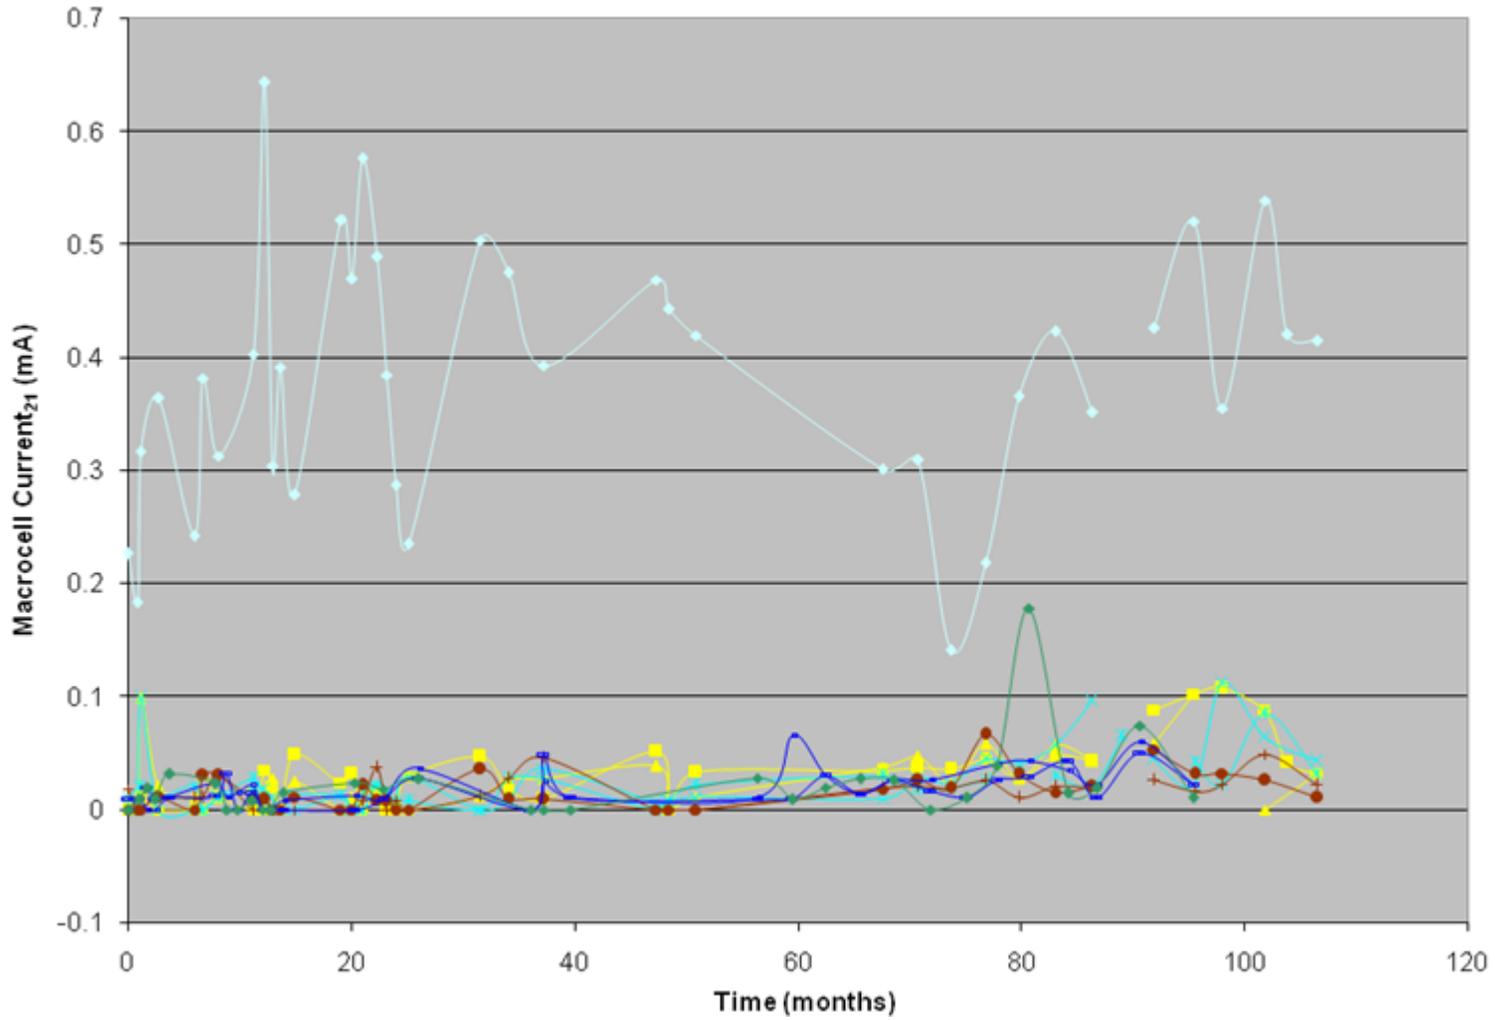
Figure 21. Graph. Macrocell current at 69.8 °F (21 °C) versus time.

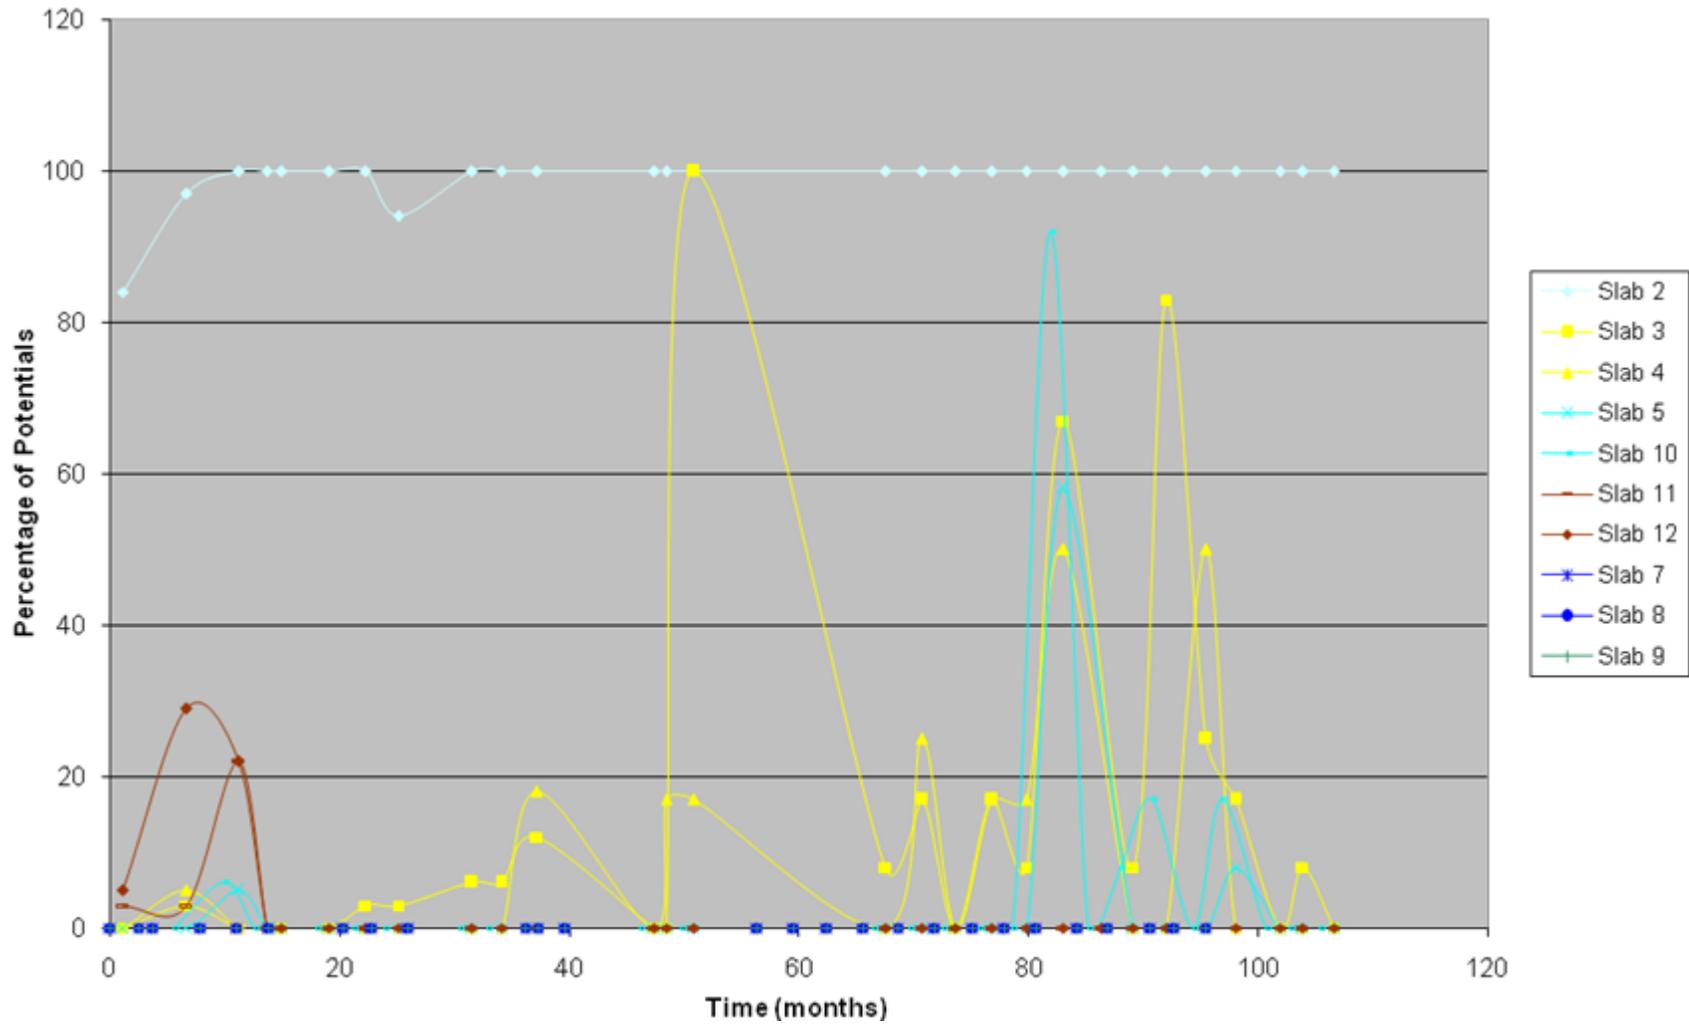
Figure 24. Graph. Percentage of active potentials versus time.

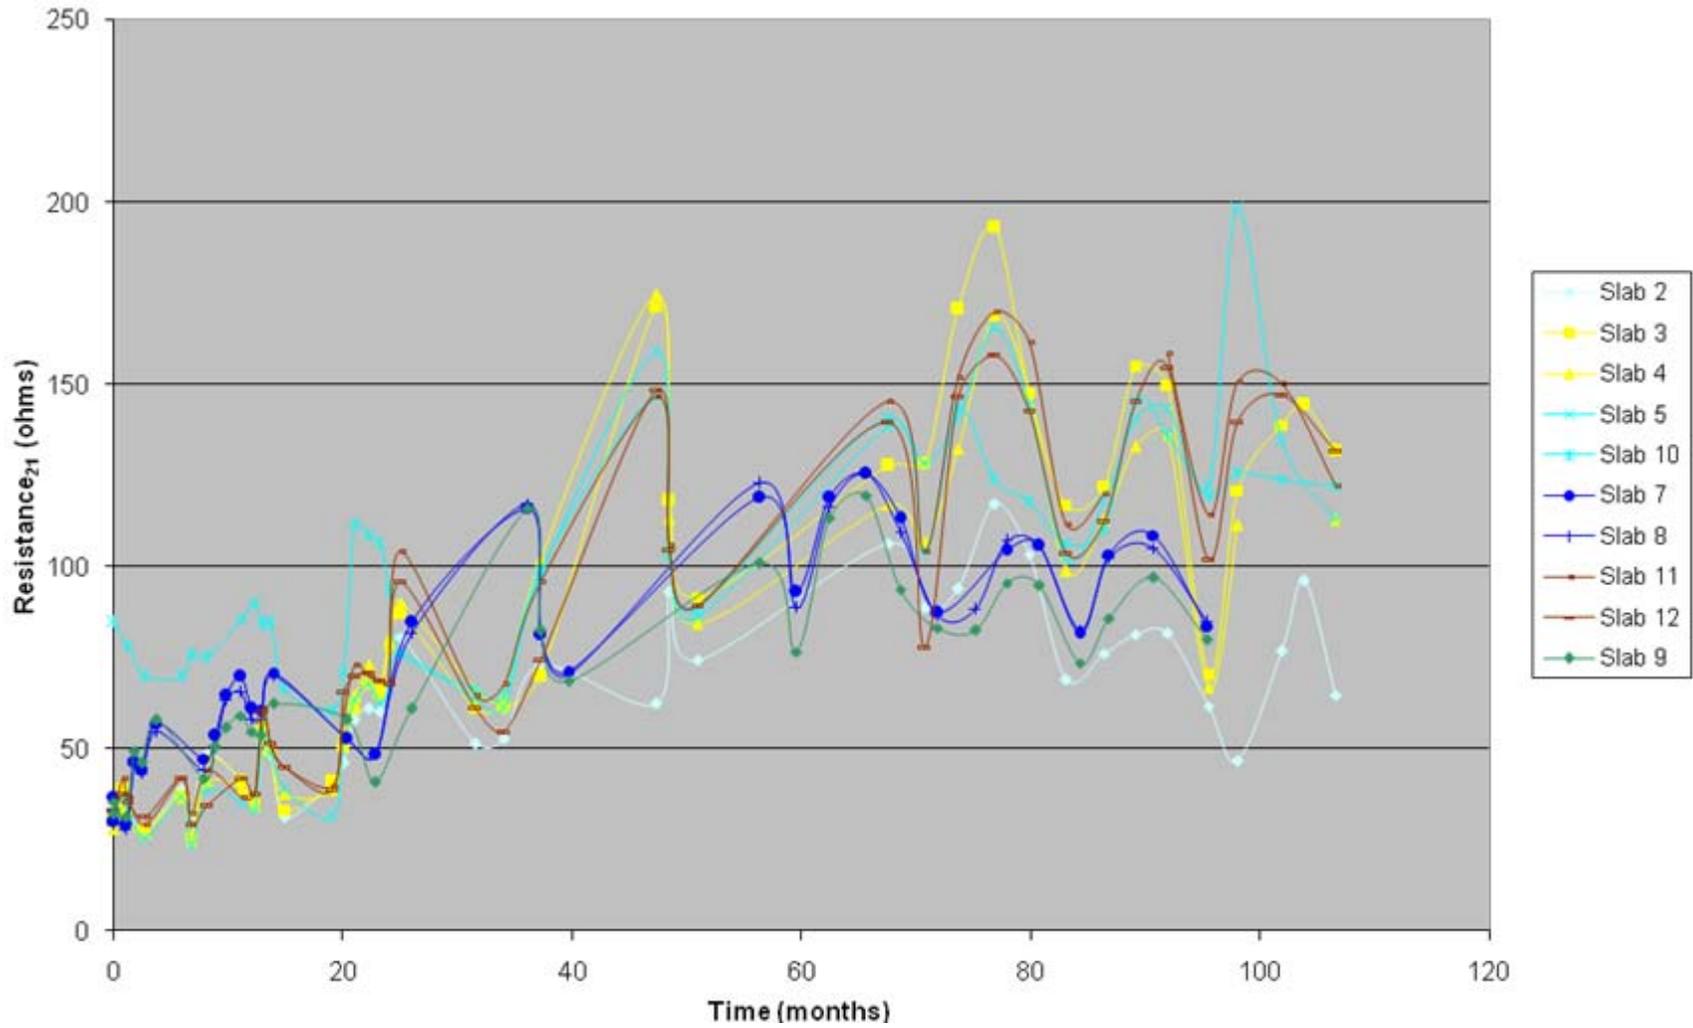
Figure 26. Graph. Resistance rate at 69.8 °F (21 °C) versus time.

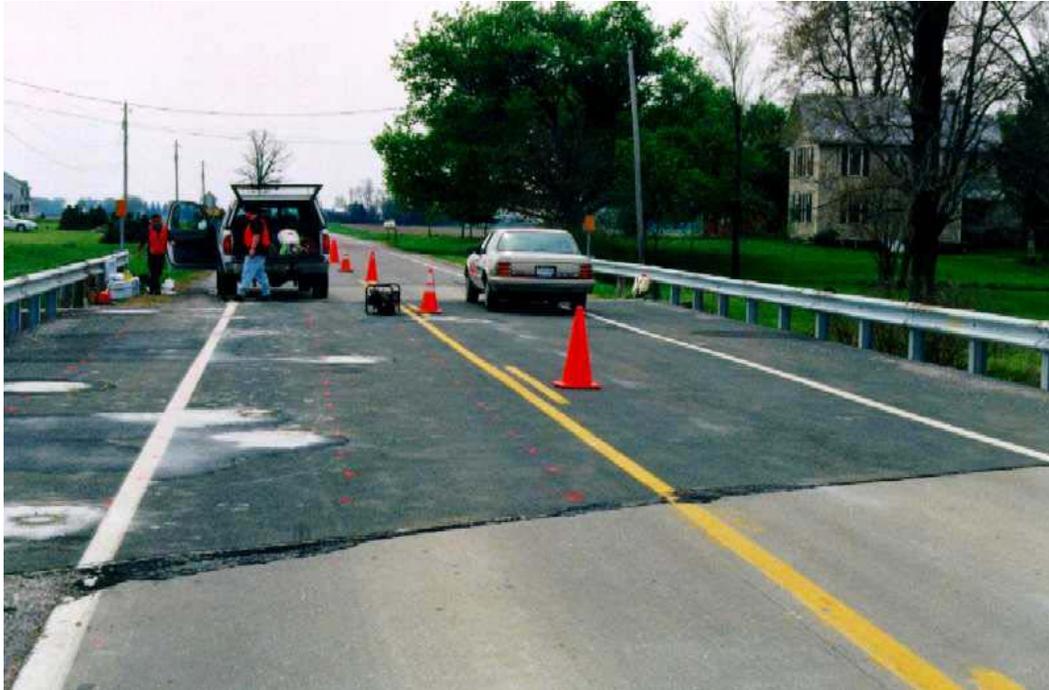
**Figure 27. Photo. Deck surface of bridge carrying SR-295 over Blue Creek in Lucas County, OH.**

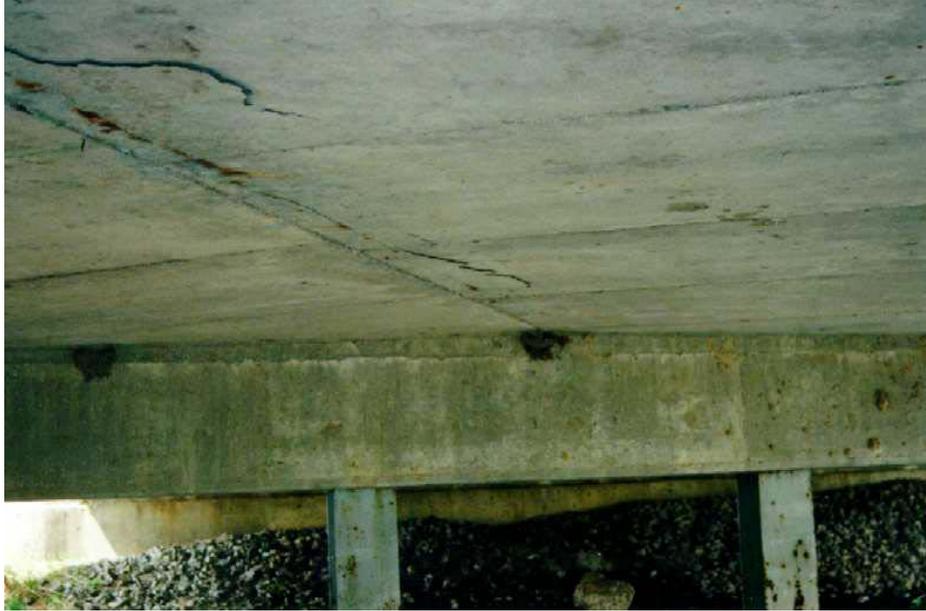
**Figure 28. Photo. Cracking, rust staining, and spalling on the soffit of the bridge.**

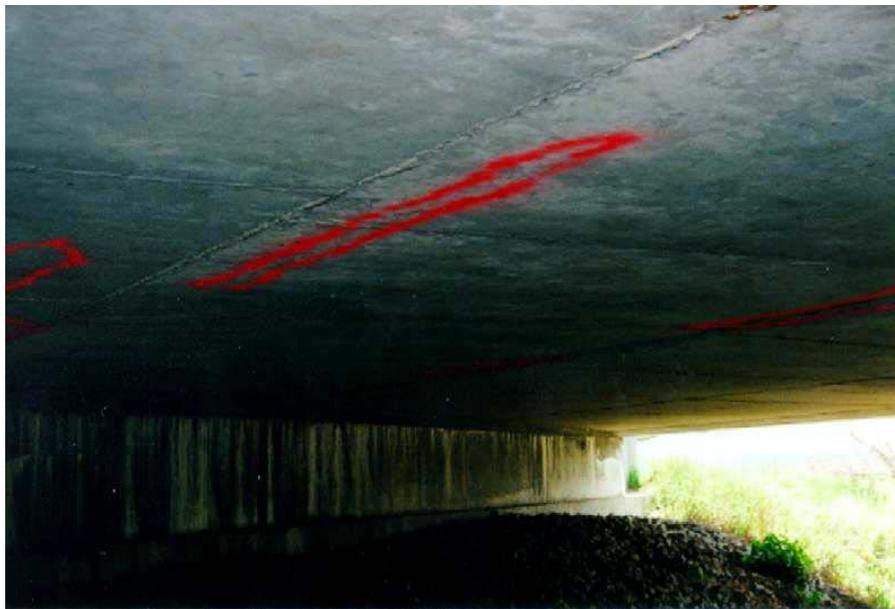
**Figure 29. Photo. Delaminated areas (marked in red) on the soffit of the bridge.**

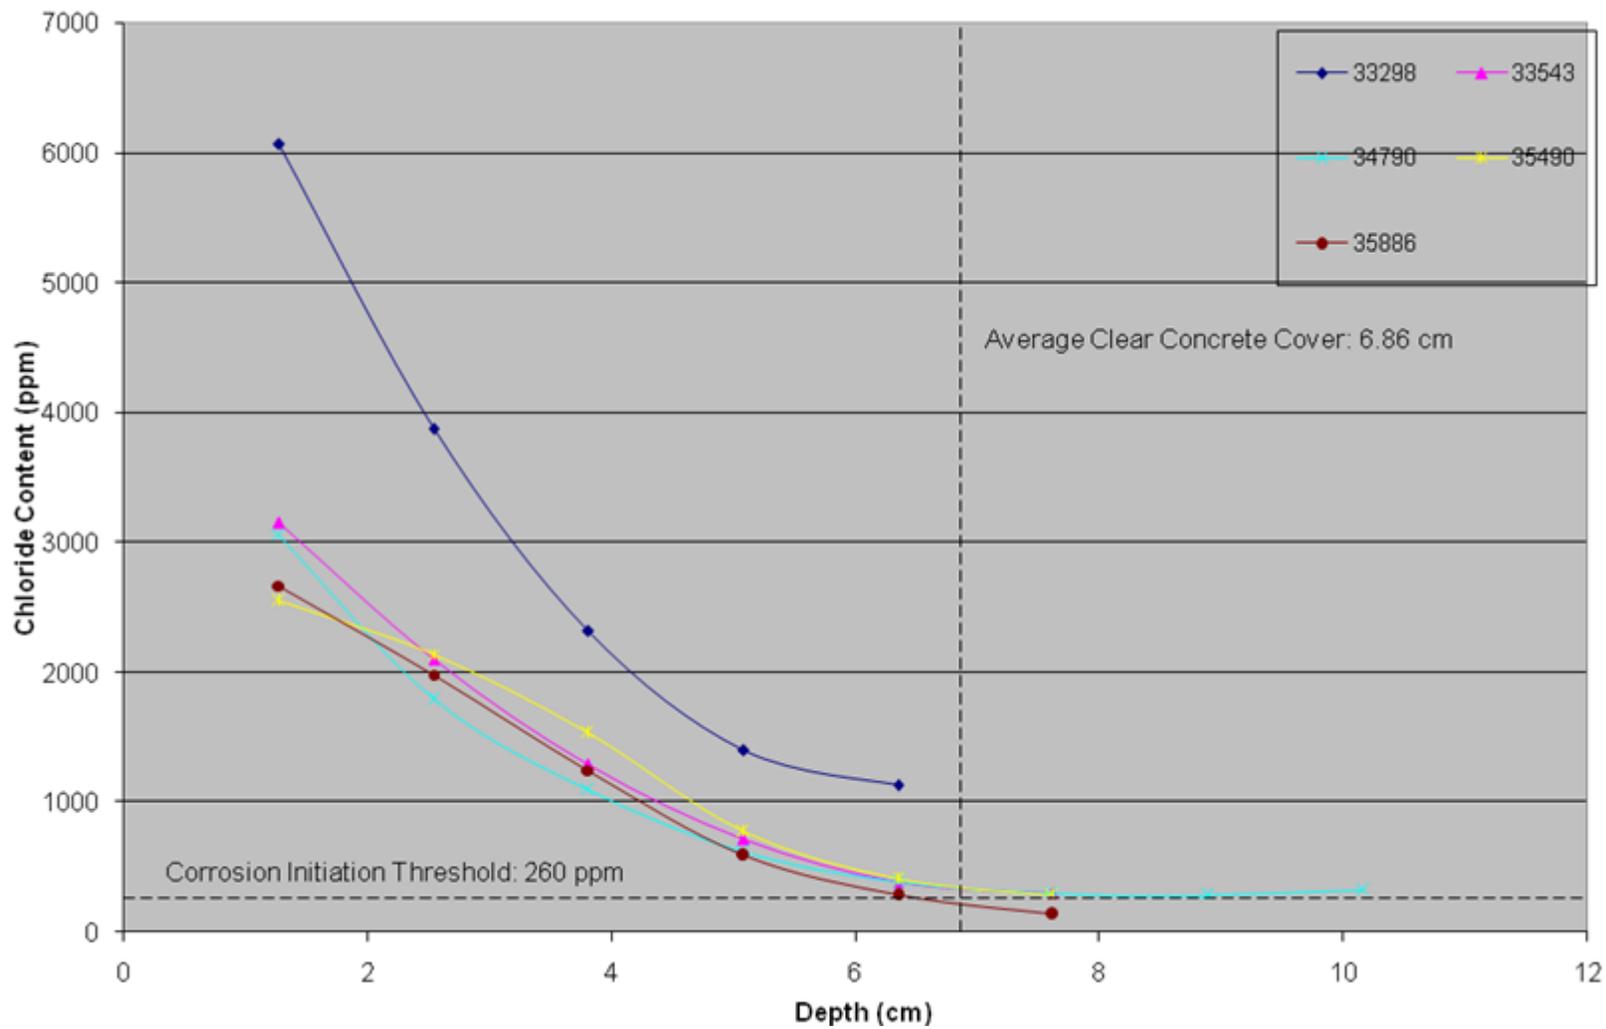
**Figure 30. Graph. Chloride profiles of ECE treated area versus time.**
