# Long-Term Effects of Electrochemical Chloride Extraction on Laboratory Specimens and Concrete Bridge Components

PUBLICATION NO. FHWA-HRT-10-069

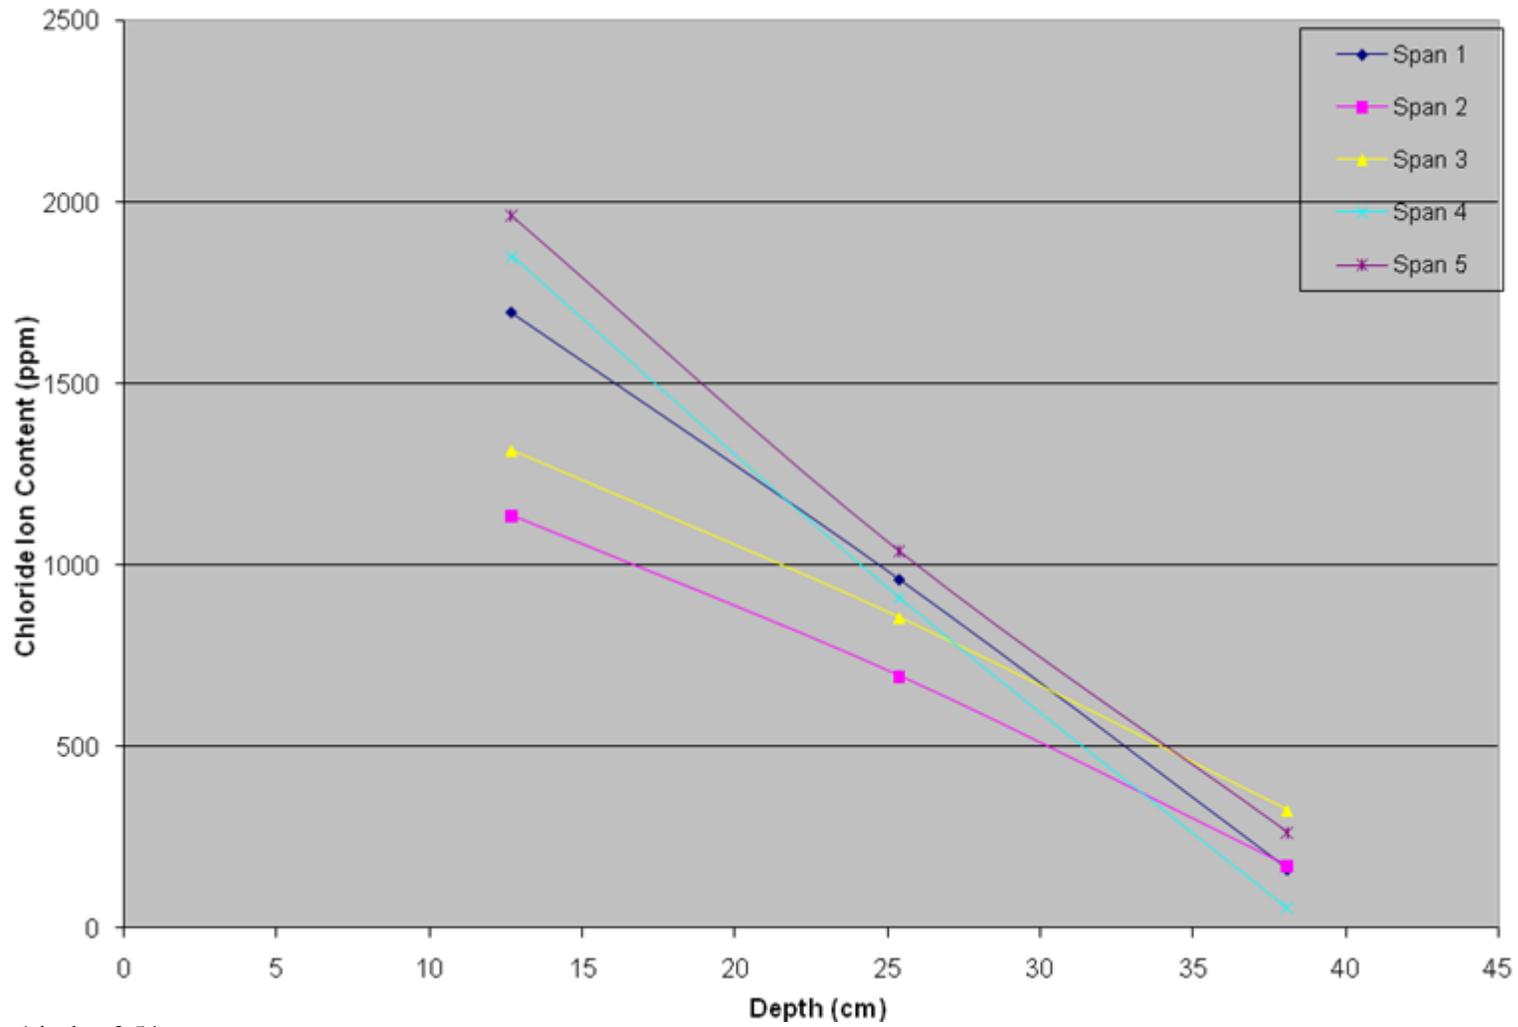
**Figure 32. Graph. Pretreatment chloride profiles.**

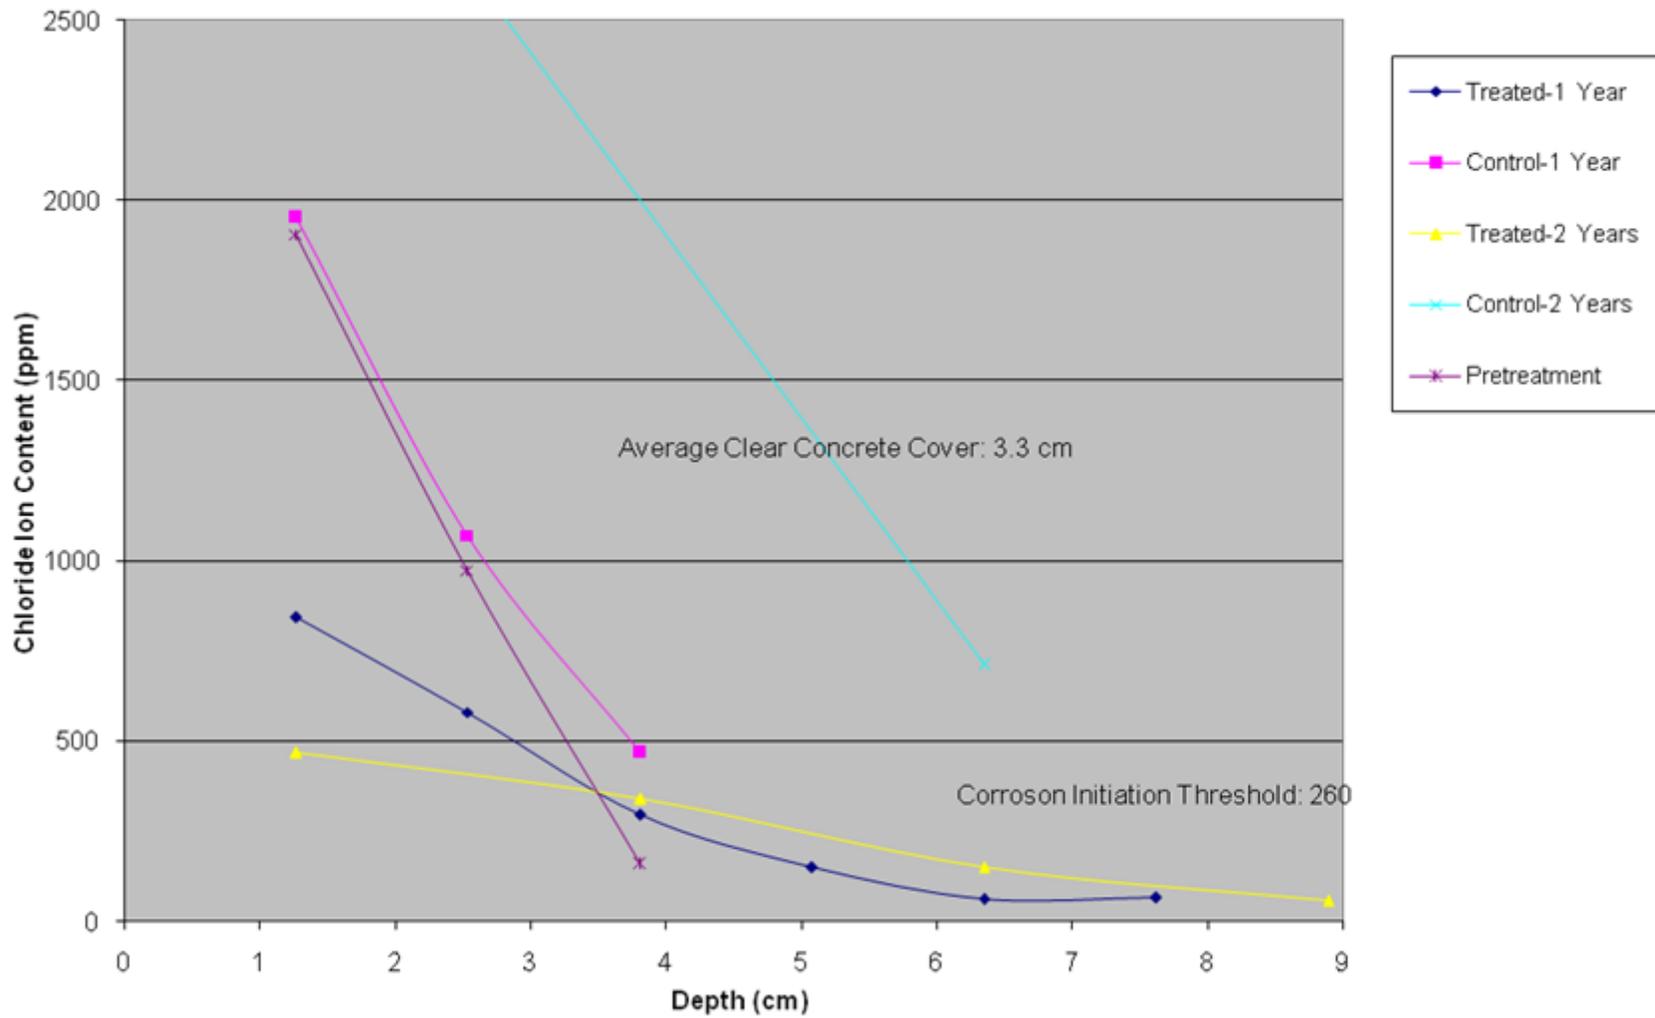
Chloride profile data presented in figure 34 indicate that the chloride ion content in span 3 was similar to conditions before 1995, while chloride content in the treated areas was much lower and diffusion of chloride ions occurred over time. The average chloride ion content at the average steel depth of 1.29 inches (33 mm) was in excess of the threshold of 260 ppm required to initiate corrosion.

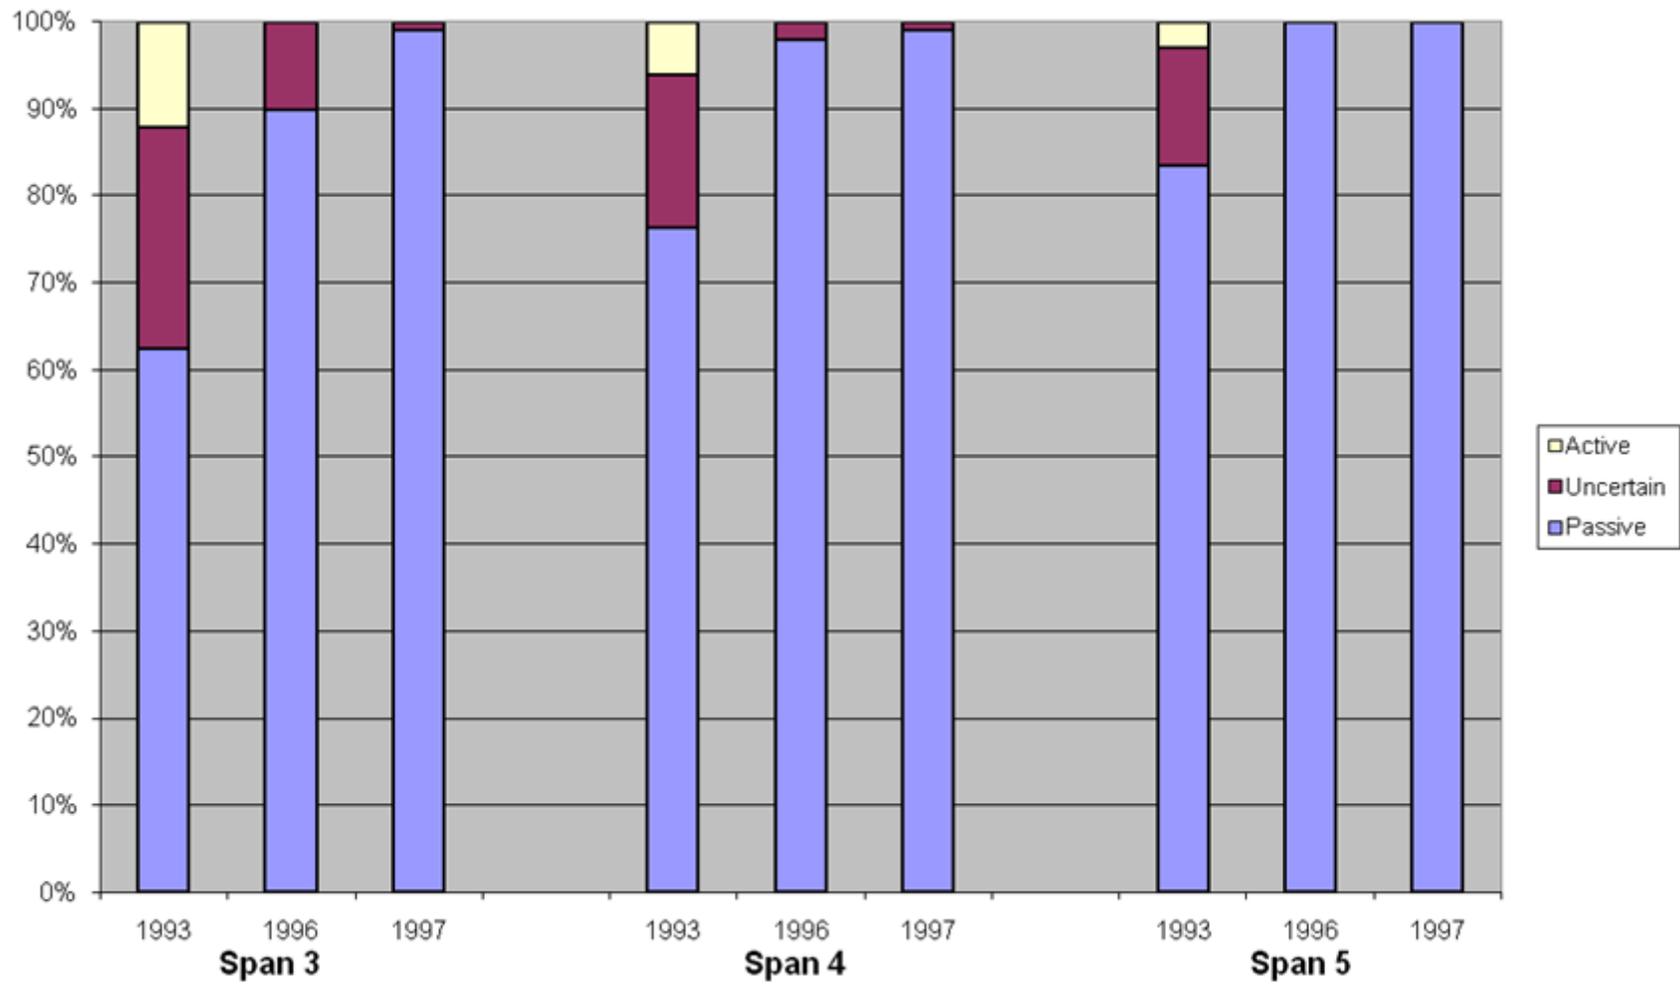
Figure 35. Graph. Half-cell potential distribution versus time.

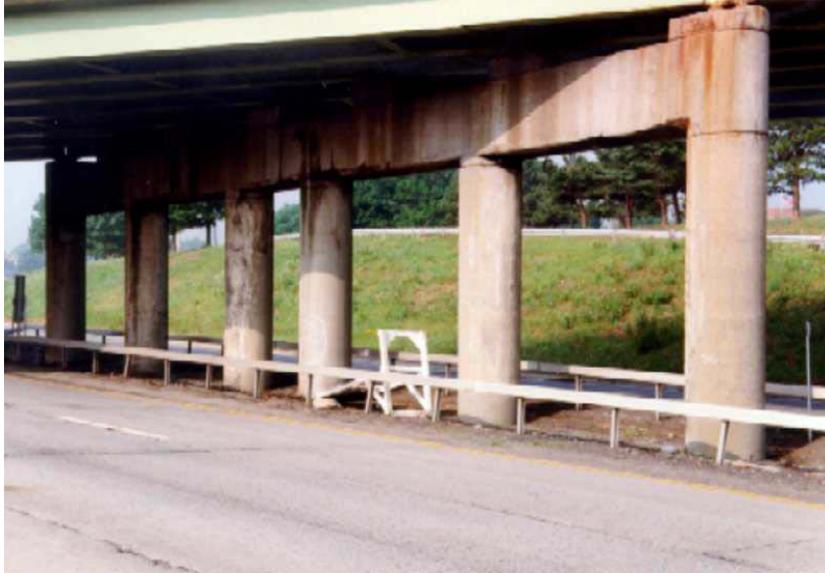
**Figure 36. Photo. Pier 2 of the Campus Loop Bridge in Albany, NY.**

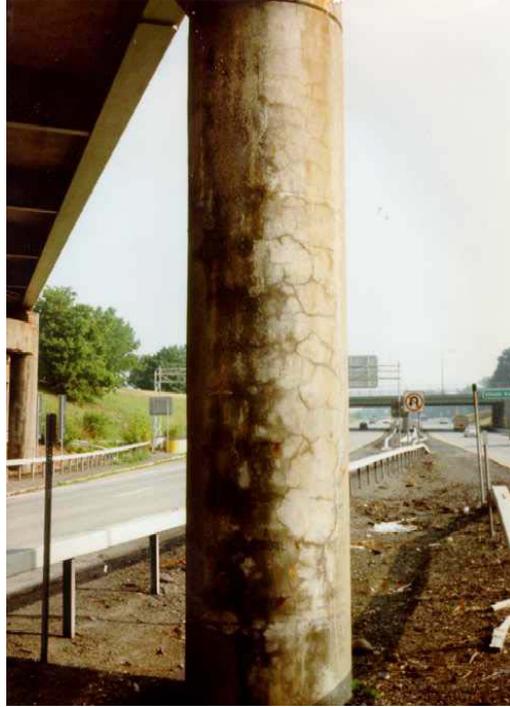
**Figure 37. Photo. Cracking on the patched areas on one of the columns of the Campus Loop Bridge in Albany, NY, during the first evaluation in 1995.**

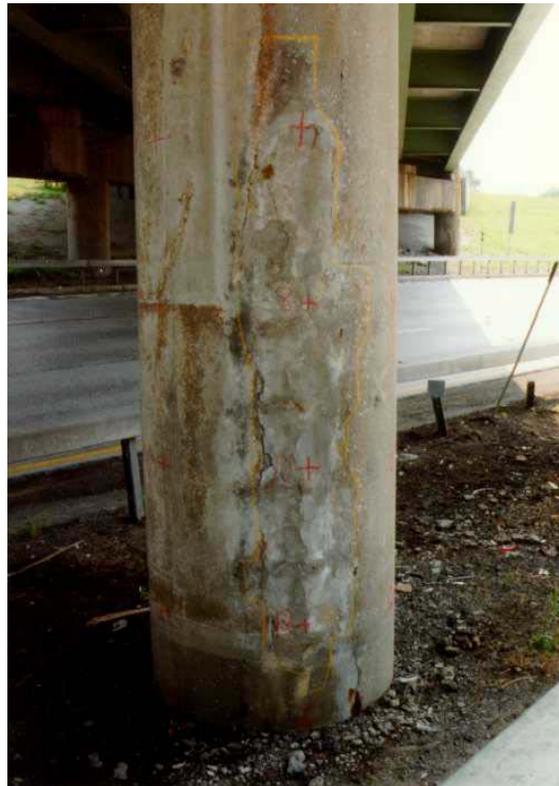
**Figure 38. Photo. First view of cracks and rust staining in patched and nonpatched areas of the columns of the Campus Loop Bridge in Albany, NY, during the second visit in 1996.**

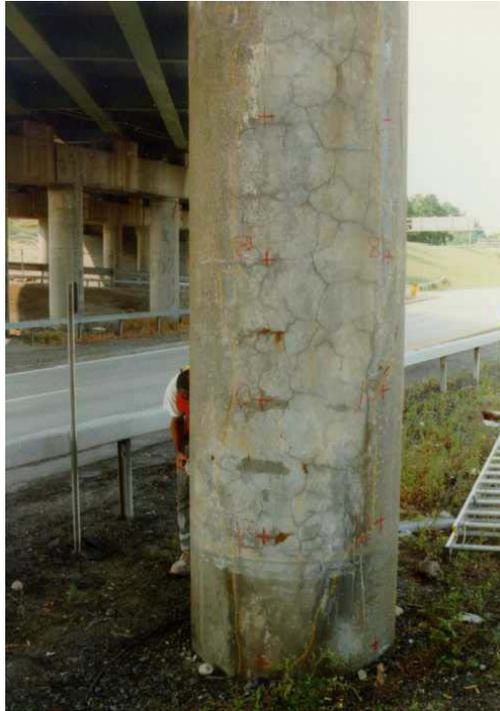
**Figure 39. Photo. Second view of cracks and rust staining in patched and nonpatched areas of the columns of the Campus Loop Bridge in Albany, NY, during the second visit in 1996.**

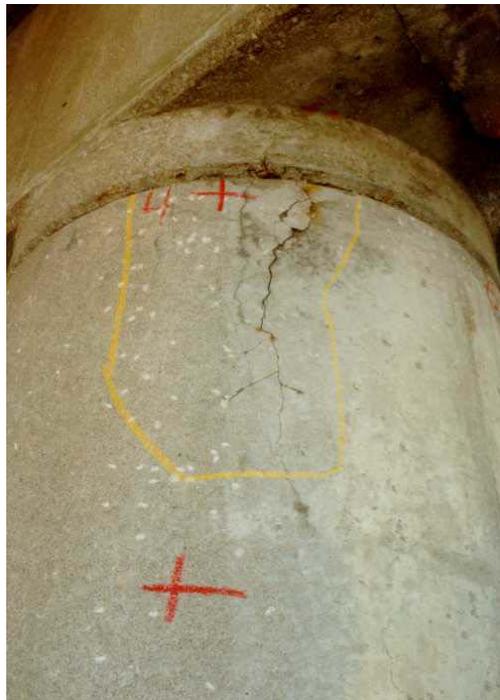
**Figure 40. Photo. Cracks and rust staining in a nonpatched area of a column of the Campus Loop Bridge in Albany, NY, during the second visit in 1996.**

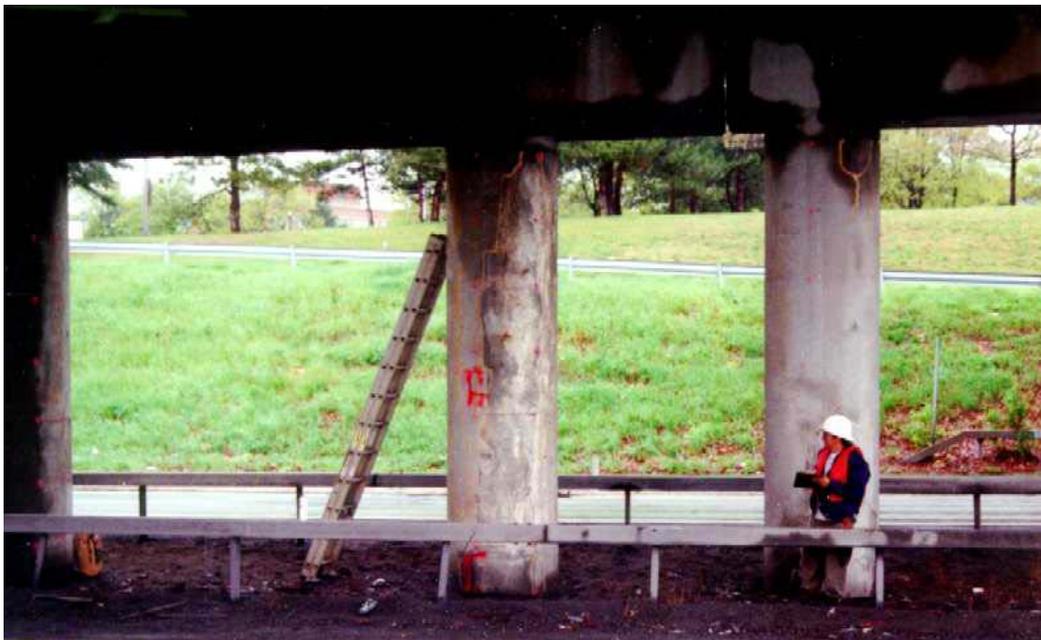
**Figure 41. Photo. Water flowing down the pier caps and columns through leaking joints.**

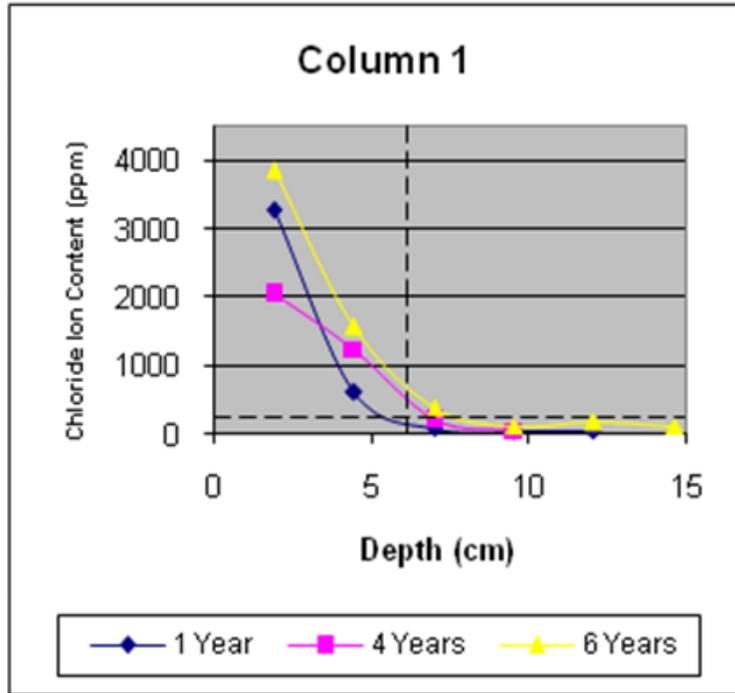
occurred in patched areas with cracks and occurred adjacent to cracks in other areas where chloride ions had direct access to the steel.

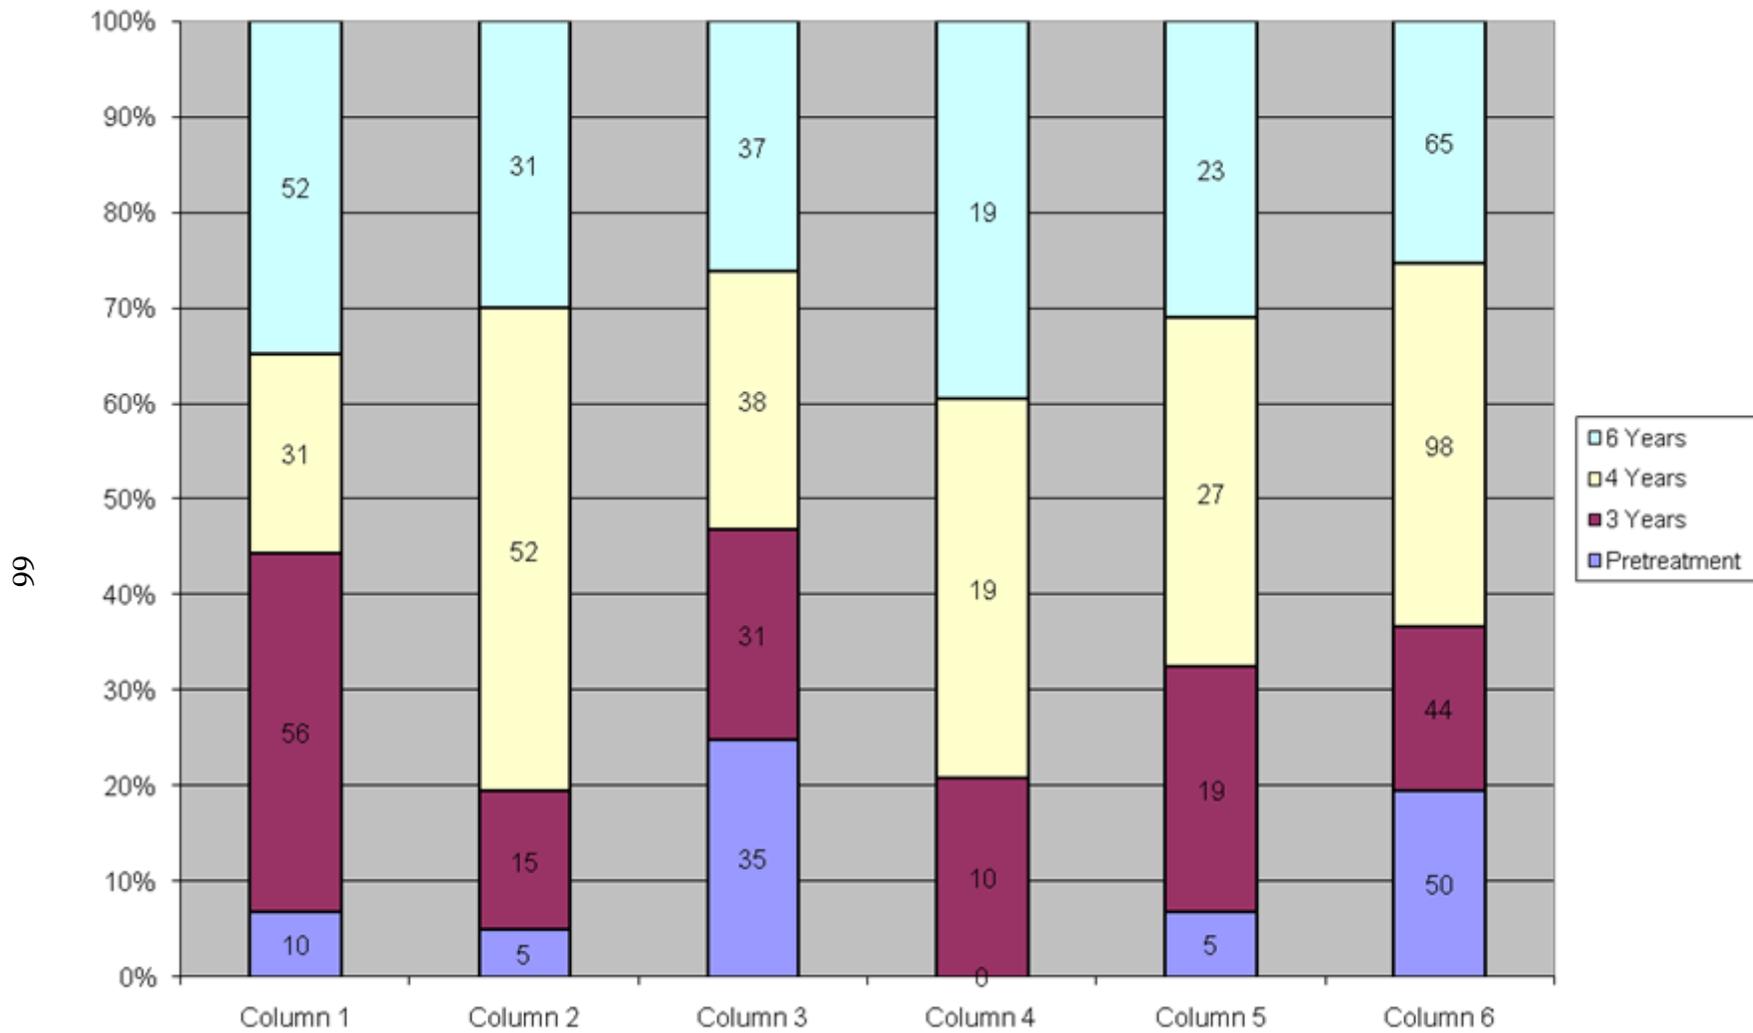
**Figure 51. Graph. Distribution of active potentials versus time.**
