Case Study:

Utilization of Cathodic Protection to Extend the Service Life of Reinforced Concrete Bridges – An Overview of the Installation and Maintenance of the Cathodic Protection Systems Protecting the Howard Frankland and Crescent Beach Bridges

FHWA-HIF-22-004

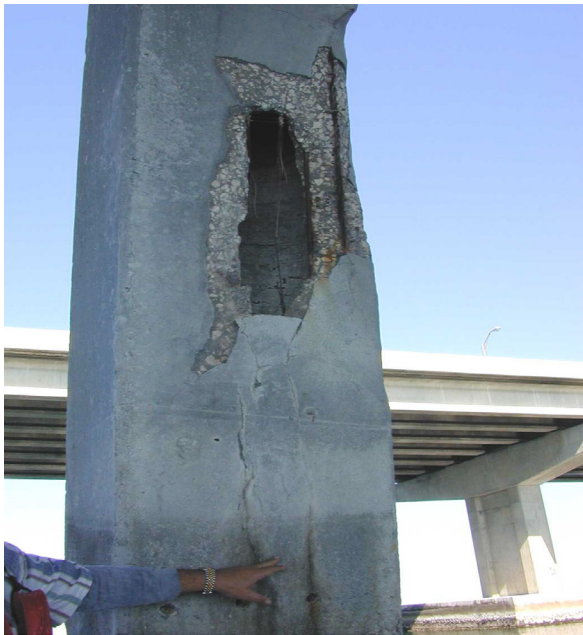
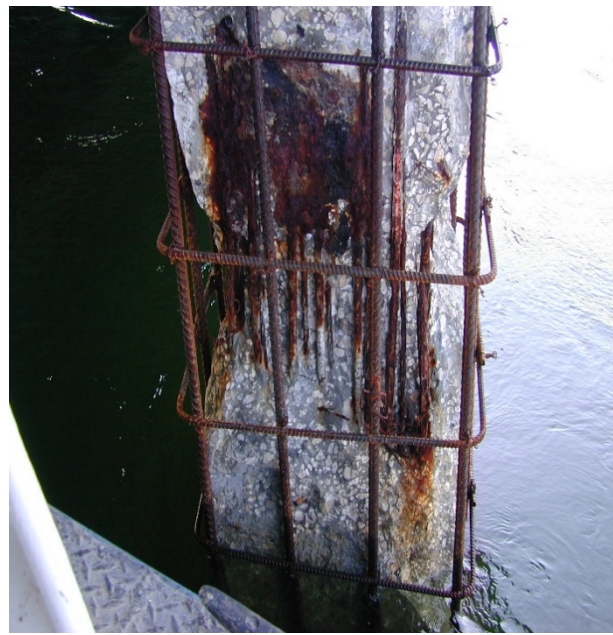
Figure 1. Photos. Howard Franklin prestressed hollow core bridge piles, circa 1988 (left). Fitted with additional reinforcement (right).

Corrosion is a natural process in which a metal alloy is oxidized (loses electrons) and converted into another form that is more electrochemically stable, such as steel to iron-oxide. The Association for Materials Performance and Preservation (AMPP), formerly known as the National Association of Corrosion Engineers (NACE), estimates the cost of corrosion in bridges of the United States at \$13.6 billion annually and indirect costs (traffic delays, lost productivity, etc.) may be substantially higher. Examples of spalled concrete and corroded reinforcing elements are presented in Figure 1.

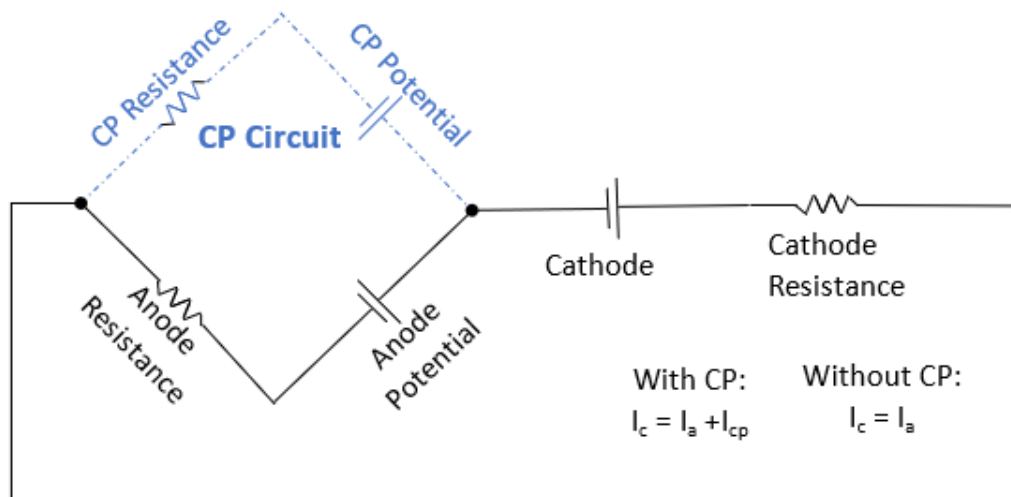
Figure 4. Schematic. Electrical Model of a Corrosion Cell with Applied Cathodic Protection.

Identical to a battery, a corrosion cell is composed of a cell cathode, cell anode, electrolyte (ionic path), and metallic path. When implementing cathodic protection, a circuit is installed parallel to the corroding anode within the corrosion cell. The wiring diagram in Figure 4 models this arrangement electrically.

Without cathodic protection, in an unaltered corrosion cell, the current flowing through the anode is the same as the current flowing through the cathode (i.e., $I_a = I_c$). However, when CP is installed into the corrosion cell circuit, as shown above, the cell must reach a new steady state, in which the current to the cell anode ($I_a =$ anode current = corrosion current) is reduced by the amount of the applied cathodic protection current. Cathodic protection current is supplied by either a DC power source, or a galvanic anode. By installing a suitable CP current the corrosion current is reduced, and corrosion is mitigated.

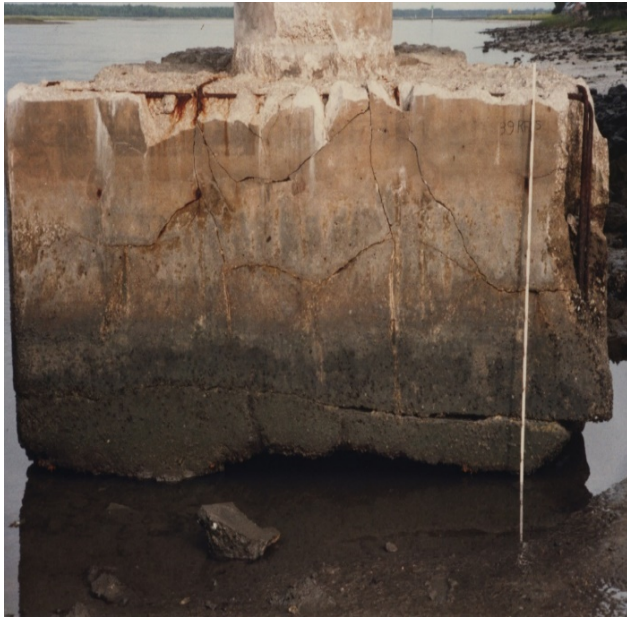
Figure 7. Photo. Crescent Beach pier footing prior to rehabilitation, circa 1986.

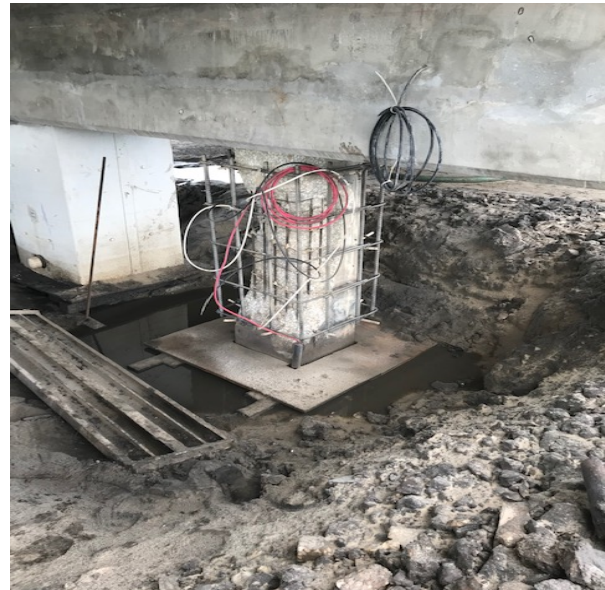
Figure 10. Photo. Crescent Beach pile jackets under construction. ICCP bent cap complete and ready for wiring.

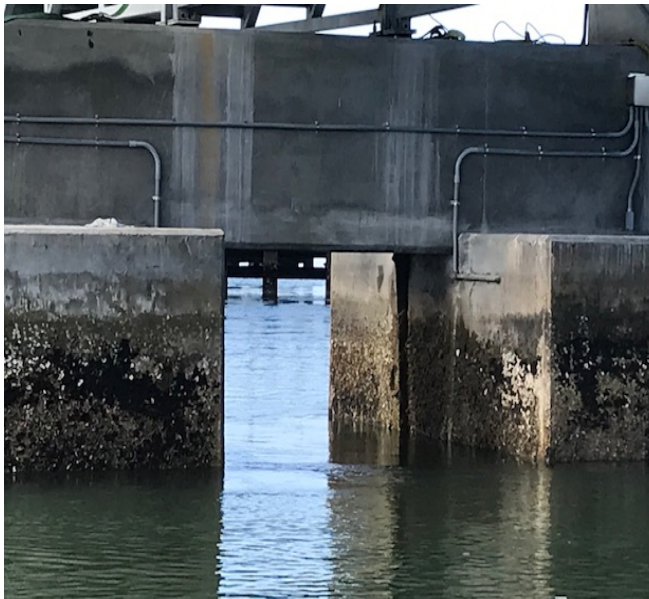
Figure 11. Photo. Crescent Beach ICCP: Finished pier footings.

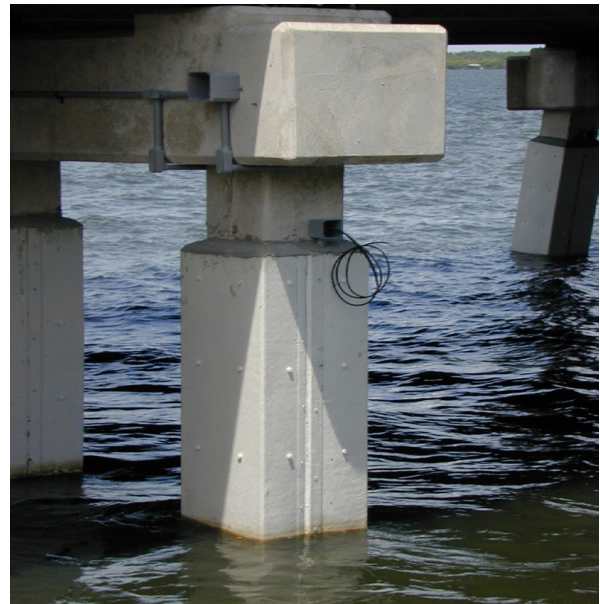
Figure 12. Photo. Howard Frankland CP pile jacket ready for connection. ICCP bent cap also ready for wiring.

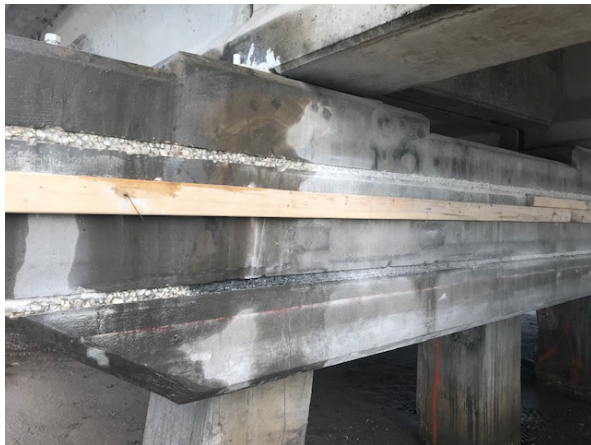
Figure 15. Photo. Crescent Beach excavation for titanium ribbon installation.

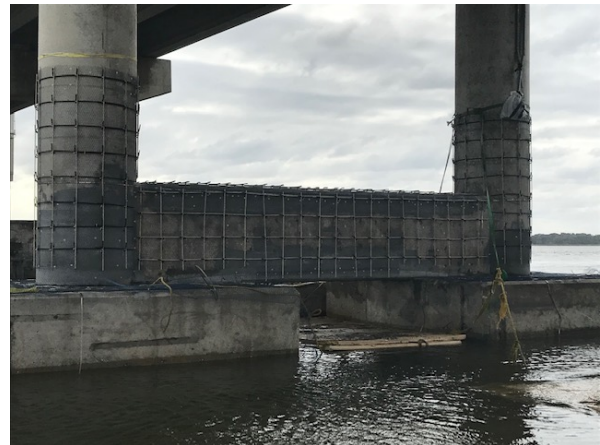
Figure 16. Photo. Crescent Beach concrete repairs completed, titanium mesh and reinforcement in-place, prior to forming and concrete placement.

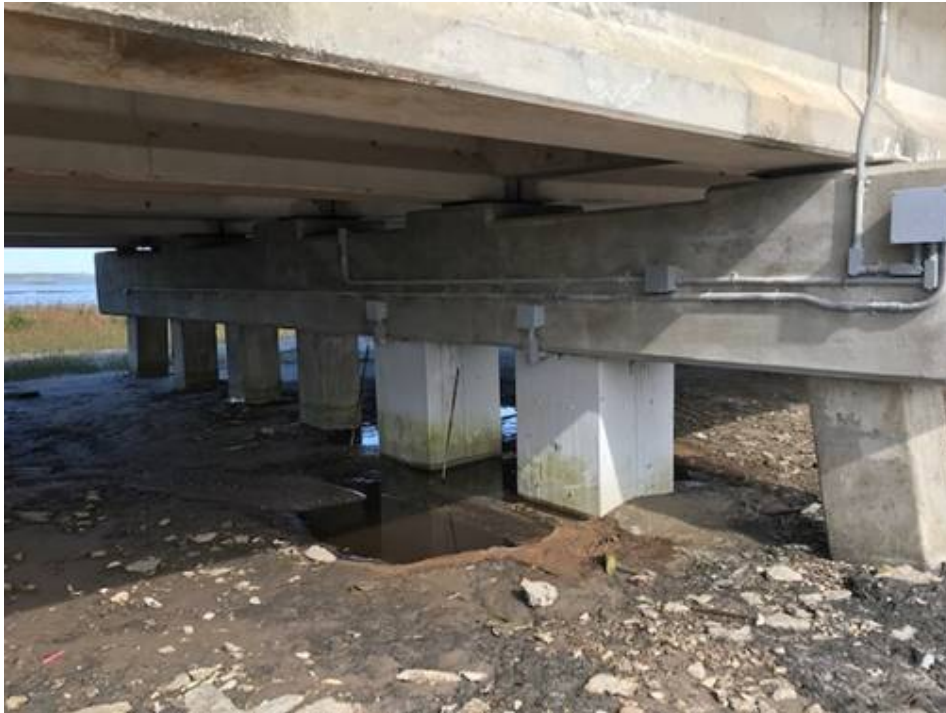
Figure 17. Photo. Crescent Beach two galvanic pile jackets and an impressed current pile bent cap.
