Impact of Environmental Factors on Pavement Performance in the Absence of Heavy Loads

PUBLICATION NO. FHWA-HRT-16-084

MARCH 2019

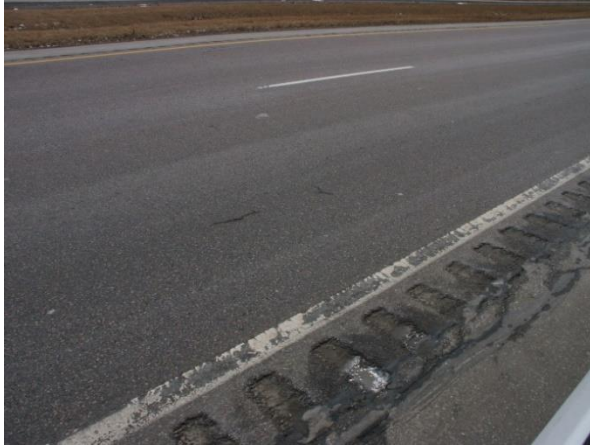
Figure 54 shows different stages of longitudinal cracking distress and how this distress can be confused with alligator cracking. Note the similarity of this distress to bottom-up fatigue alligator cracking.

A. View of first stage—occurrence of short longitudinal cracks in and/or adjacent to the wheel path.

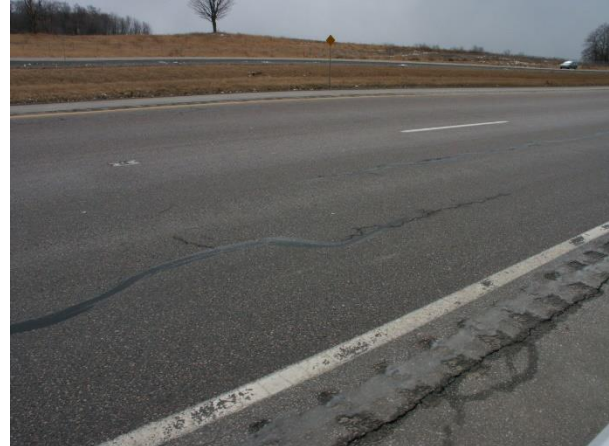
C. Second view of first stage—occurrence of short longitudinal cracks in and/or adjacent to the wheel path.

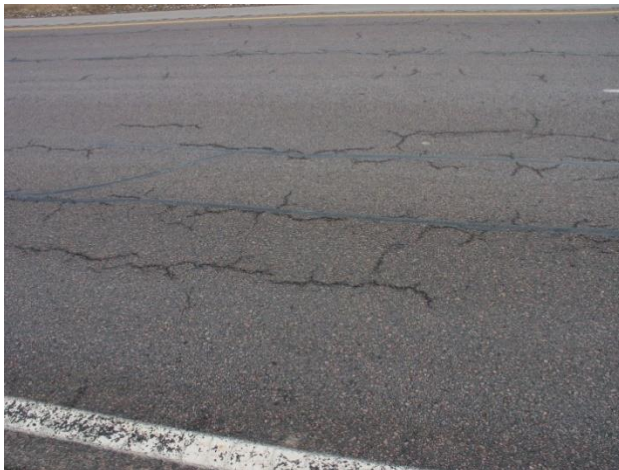
B. Second stage—occurrence of parallel longitudinal cracks.
