# Guidelines for Sampling, Assessing, and Restoring Defective Grout in Prestressed Concrete Bridge Post-Tensioning Ducts

PUBLICATION NO. FHWA-HRT-13-028

OCTOBER 2013

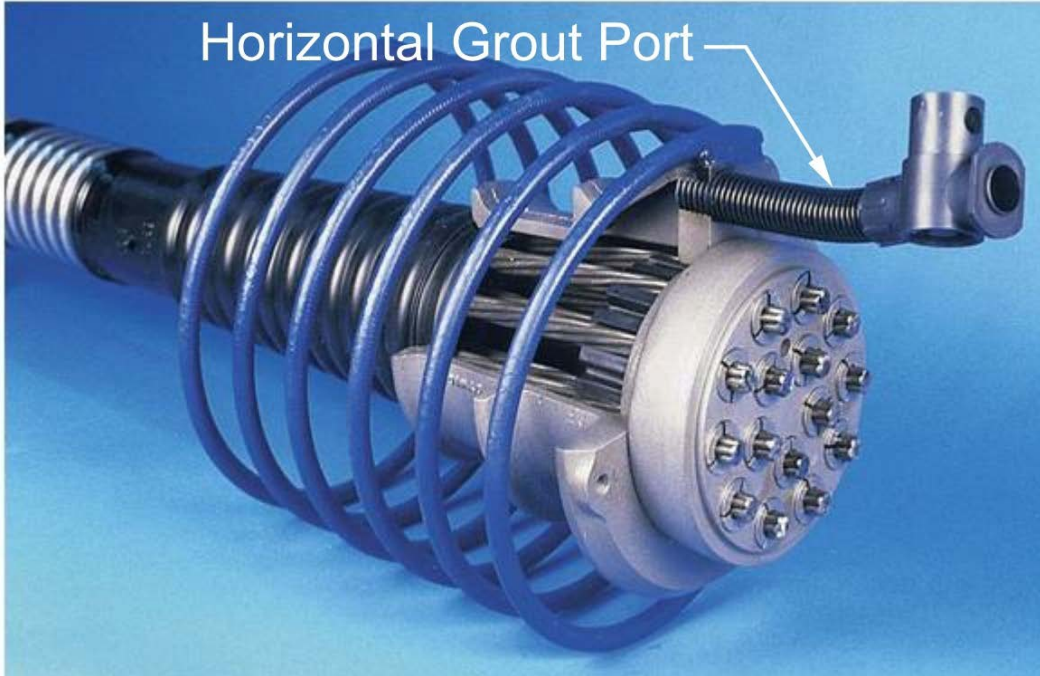
**Figure 2. Photo. Old generation of PT anchorage system.**

In 2003, the Florida Department of Transportation (FDOT) required an additional vertical grout port/vent located above the trumpet to facilitate post-grouting inspection and permanent grout cap in its PT specifications. The differences between the older and newer generations of PT anchorages systems are shown in figure 2 and figure 3. Many other State transportation departments have adopted PT anchorages with requirements similar to the FDOT requirements. For the new anchorages, the inspection access into the trumpet interior is much simpler through the vertical grout port.

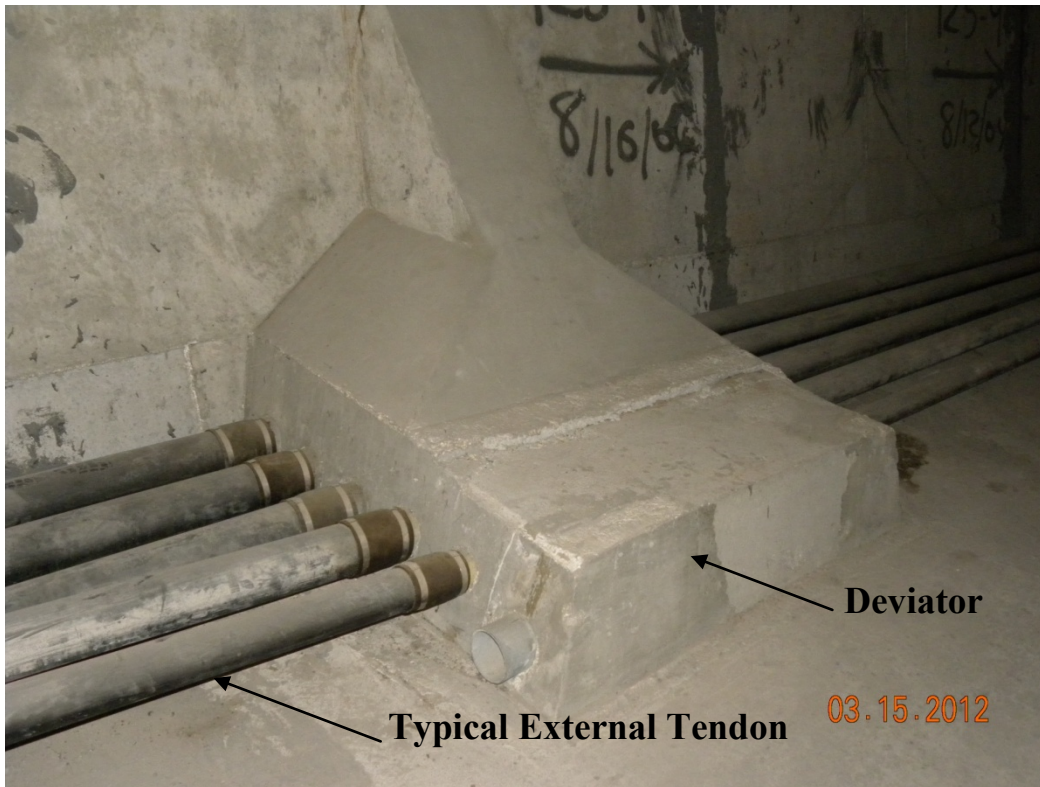
**Figure 6. Photo. External tendons at deviator.**

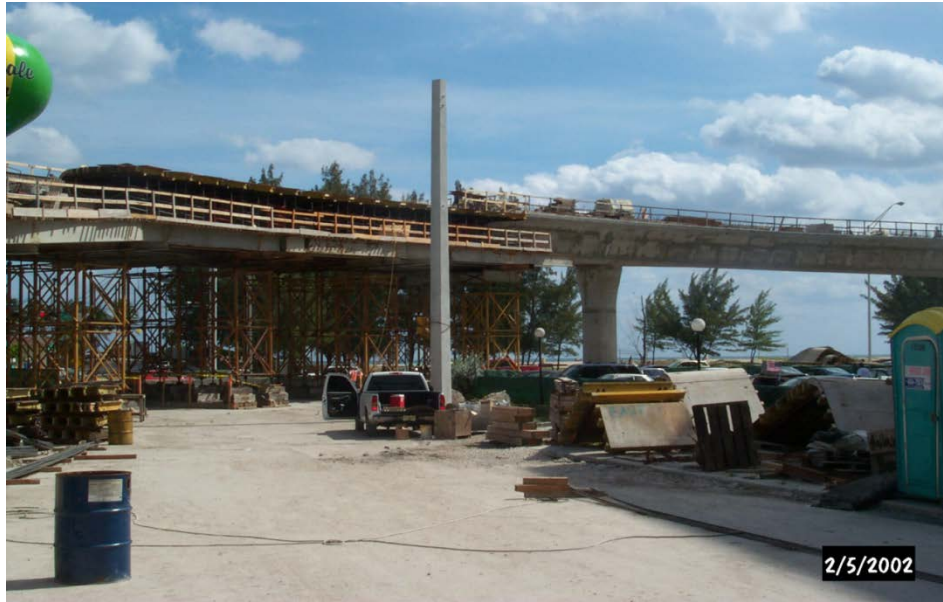
**Figure 7. Photo. CIP concrete box girder bridge on false works.**

CIP concrete box girder bridges built on false works consist of single- to multi-cell box girders, as shown in figure 7. Typically, these types of bridges have an internally draped tendon in the webs. In a continuous multispan structure, the PT anchors are anchored in the end diaphragms, and some tendons may be anchored in the intermediate diaphragms. For long-span bridges, additional internal tendons are also provided in the top and bottom flanges and anchored in blisters (see figure 8 and figure 9). The top deck could be either transversely PT or reinforced concrete using mild reinforcement.

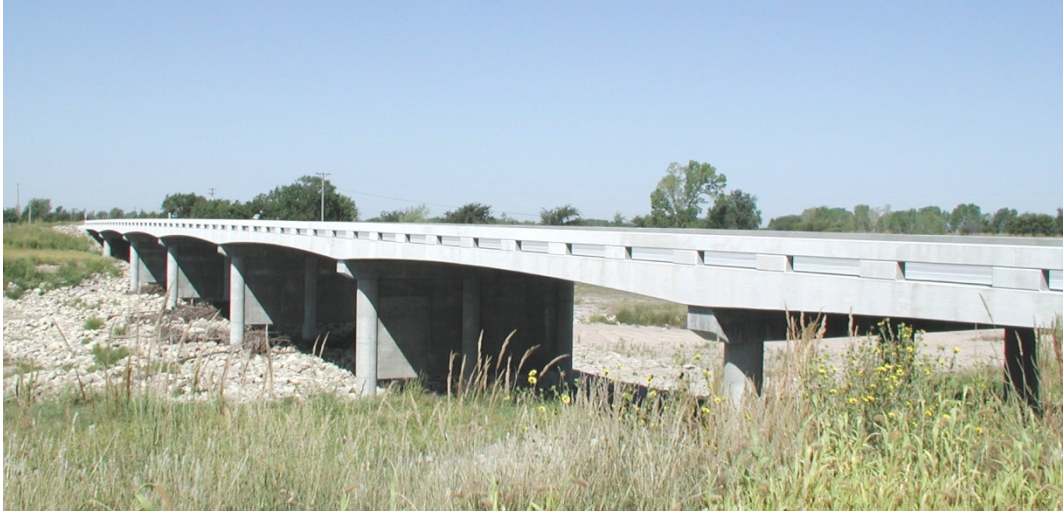
**Figure 11. Photo. CIP PT concrete slab bridge.**

CIP concrete slab bridges (see figure 11) are very popular for short-span bridges. The CIP PT slab and T-girder bridges are also constructed on false works. Typically, this type of structure has shallow draped longitudinal internal tendons in the deck (see figure 12). In most cases, transverse internal tendons in the deck are also provided. The superstructure may be a single-span or multispan continuous structure from abutment to abutment.

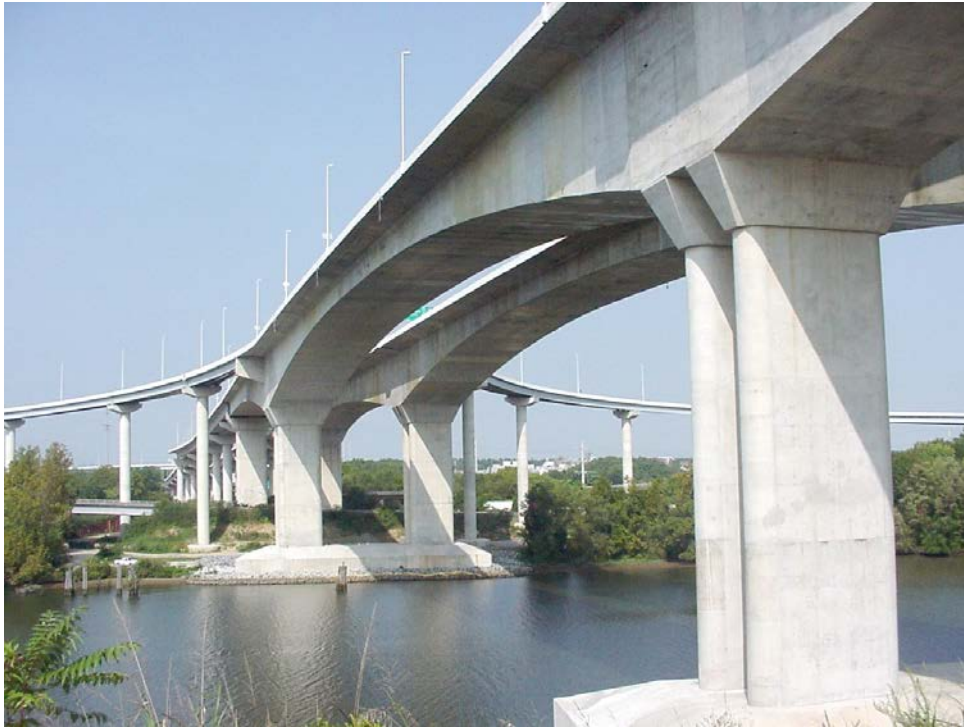
**Figure 13. Photo. CIP segmental balanced cantilever bridge.**

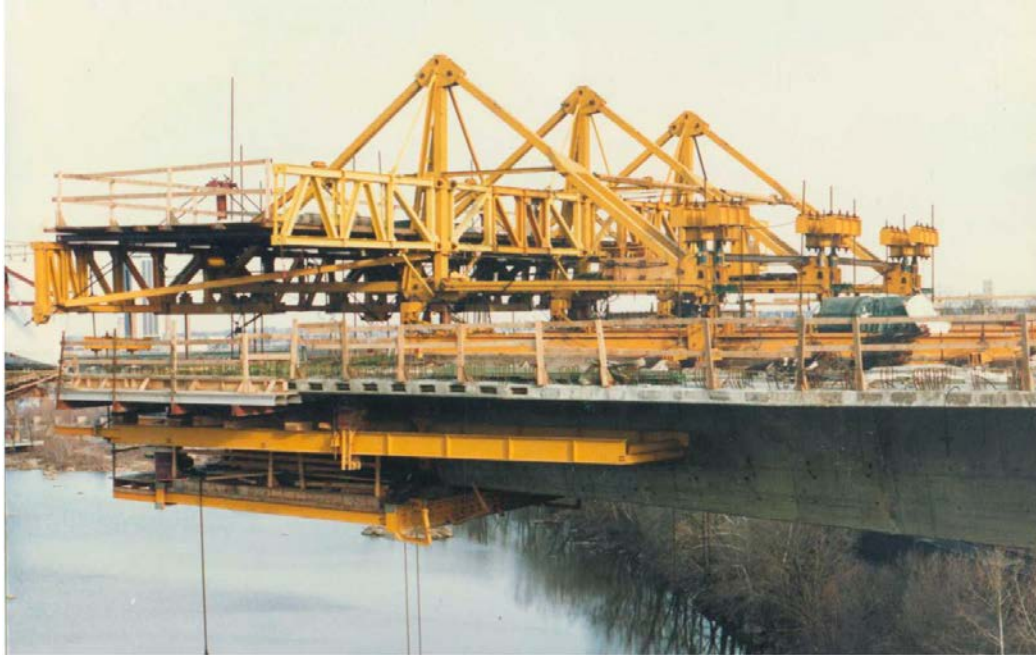
**Figure 14. Photo. CIP balanced cantilever bridge during construction using form traveler.**

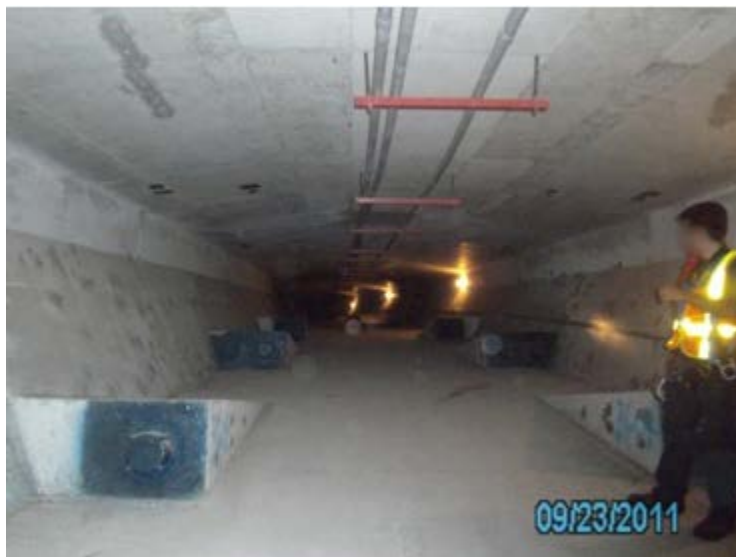
**Figure 15. Photo. Typical bottom flange blister.**

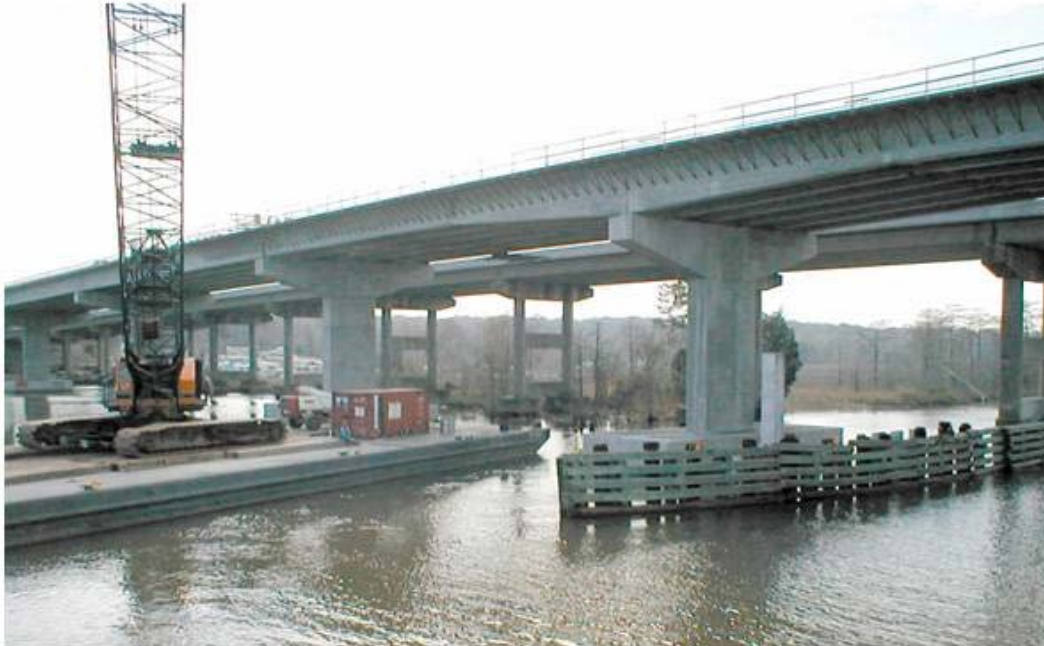
**Figure 18. Photo. Precast spliced girder bridge.**

Precast spliced girder bridges have been gaining popularity within the last decade for medium-span bridges (see figure 18 and figure 19). Several long pieces of pretensioned American Association of State Highway and Transportation Officials (AASHTO) I-girders or bulb-tee girders are PT using draped internal tendons in the web to form a continuous multispan girder from end to end. The joints between the girders are CIP concrete. The diaphragms are typically cast at the splice locations and are reinforced concrete or PT transversely. A temporary support is provided at the CIP joint locations to stabilize the structure until the girders are made continuous. The deck slab is CIP after the first PT stage is applied. The final PT is applied after the CIP deck slab reaches minimum concrete strength.

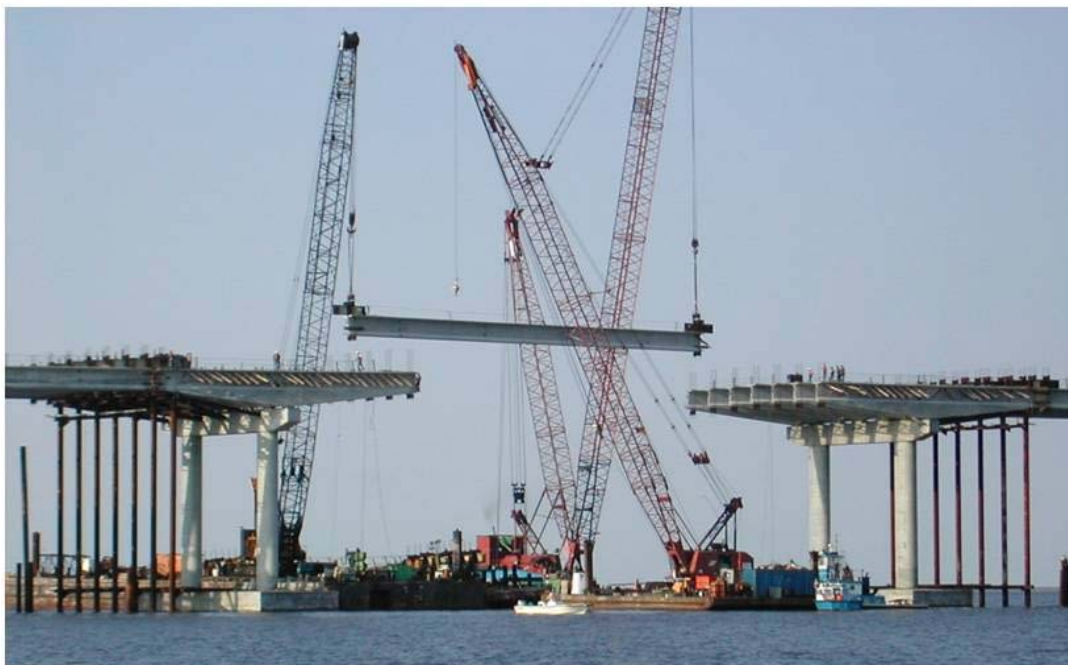
**Figure 19. Photo. Precast spliced girder bridge during erection.**

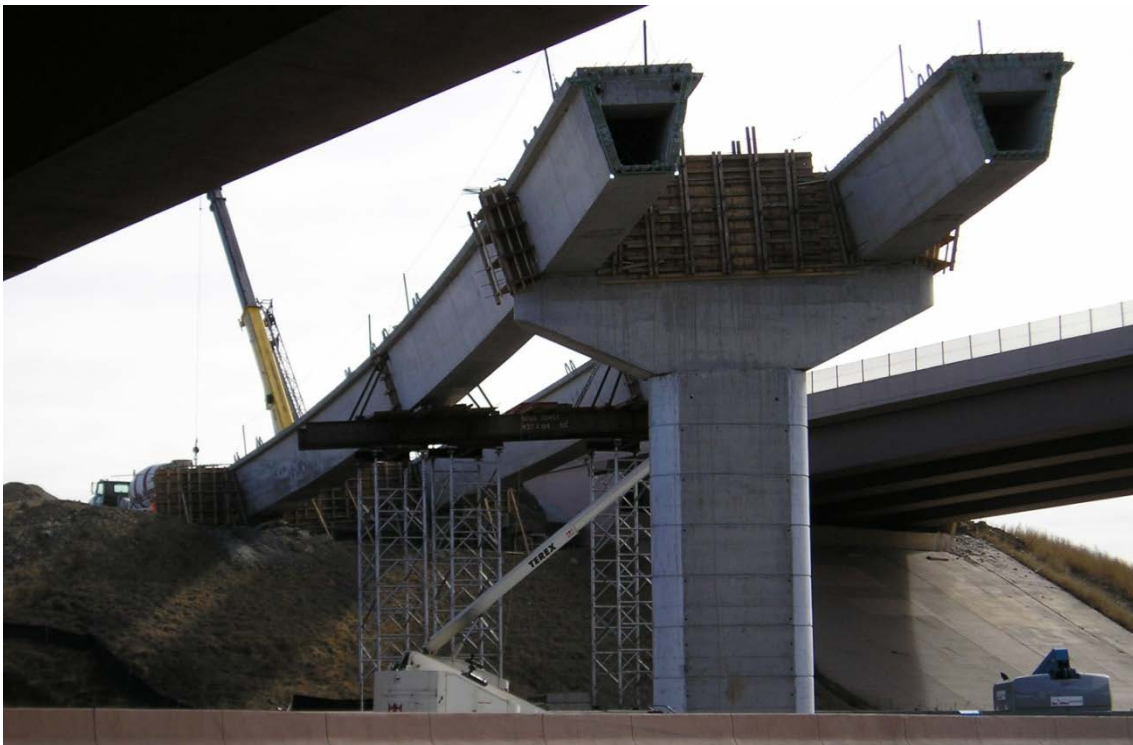
**Figure 20. Photo. Precast spliced U-girder bridge during erection.**

(see figure 20 and figure 21). Several long segments of pretensioned or PT U-girders are PT using draped internal tendons in the web to form a continuous multispan girder from end to end. The joints between the girders are CIP concrete. The diaphragms are typically cast at the splice locations and are reinforced concrete or PT transversely. A temporary support is provided at the CIP joint locations to stabilize the structure until the girders are made continuous. The CIP deck slab is placed after the first stage PT is applied and the rest of the PTs are stressed after the CIP deck is hardened.

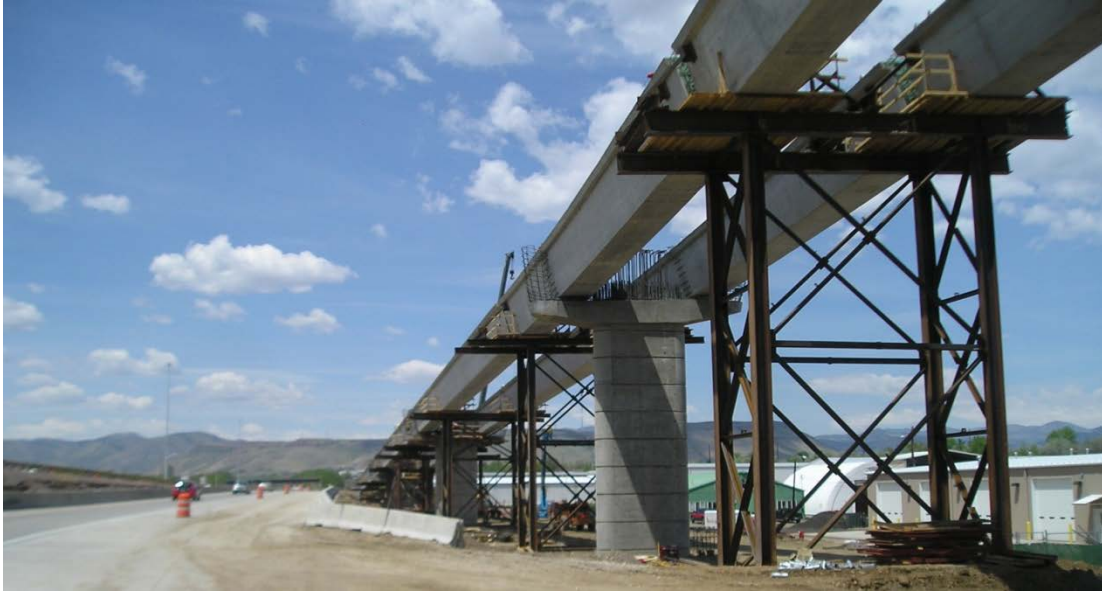
**Figure 21. Photo. Precast U-girder supported on temporary false work.**

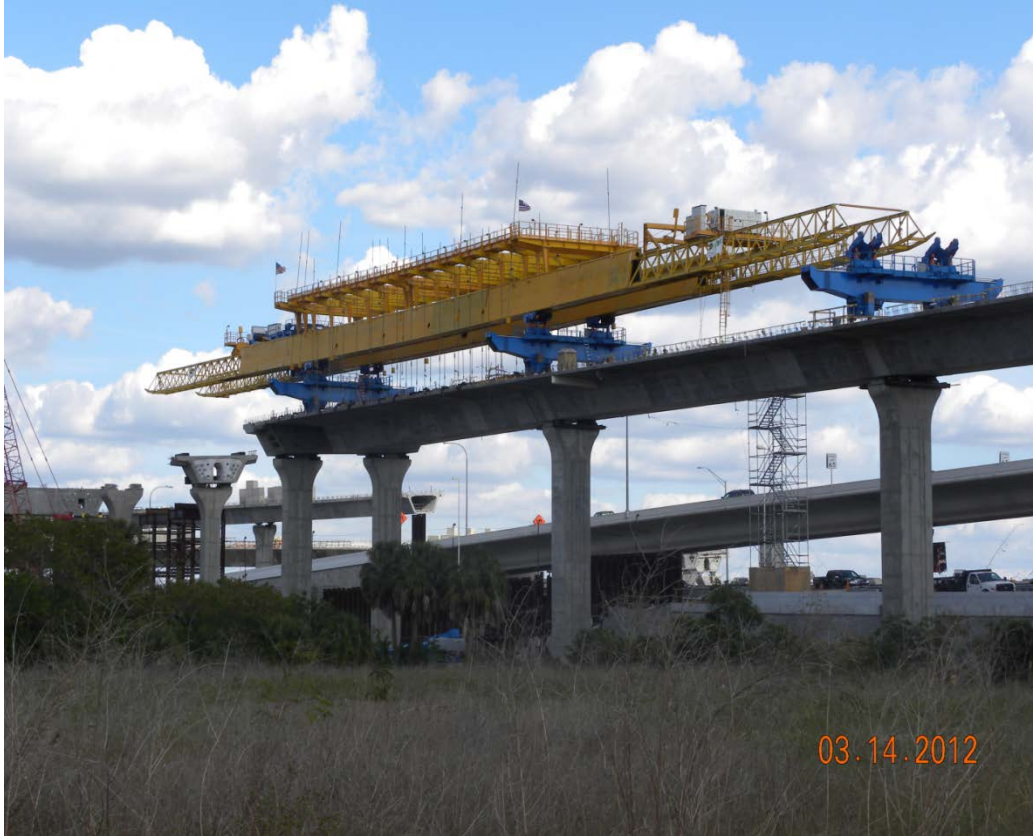
**Figure 23. Photo. Precast segmental span-by-span erection using an overhead gantry.**

Precast span-by-span bridges consist of precast match cast segments that are 10 to 12 ft long and erected using an under-slung gantry or an overhead gantry as shown in figure 23. The entire span is temporarily supported by overhead or under-slung gantry stressed together using PT bars after epoxy is applied on the match cast joint. The CIP joints are cast between precast segments and the diaphragm segments. Permanent longitudinal external tendons are PT from both diaphragms to complete the span construction. The process is repeated at the next adjacent span.

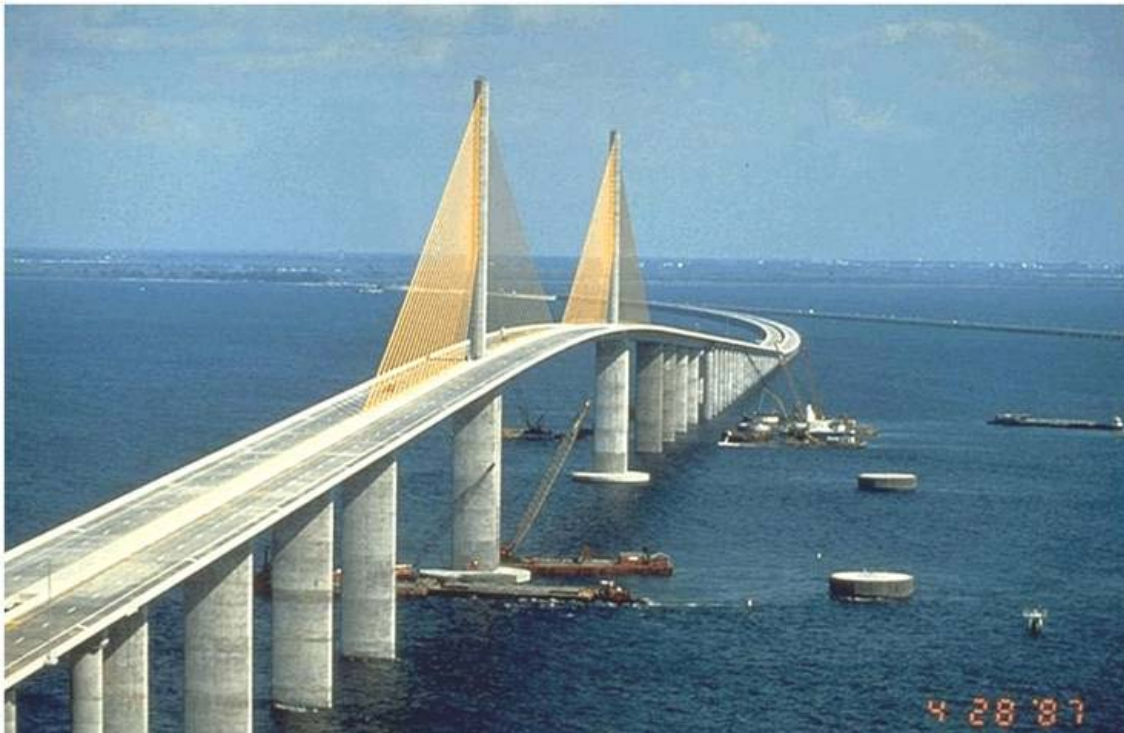
**Figure 25. Photo. Precast segmental cable stayed bridge.**

- CIP cable-stayed bridge.
- Precast segmental cable-stayed bridge (see figure 25).
- Extradosed segmental bridge.

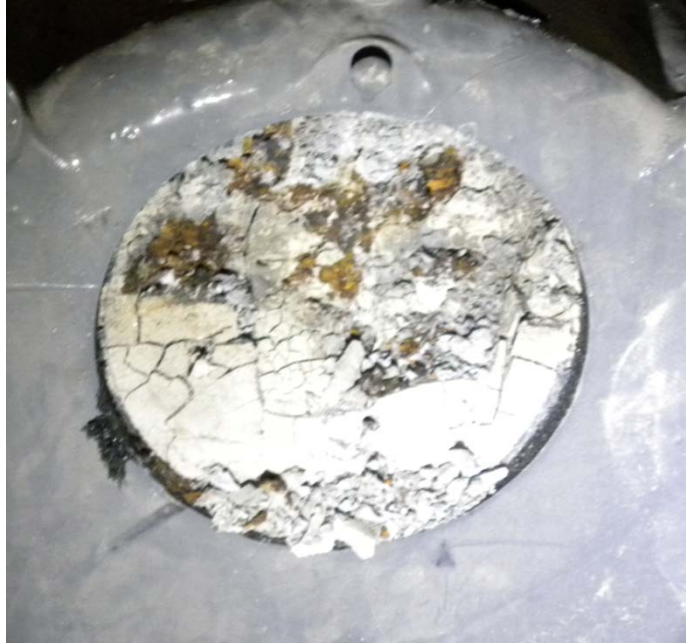
**Figure 30. Photo. Opened tendon end showing predominantly type 3 grout and strand corrosion products.**

Figure 30 and figure 31 show opened tendon anchorages. In these cases, there was no grout contamination by  $Cl^-$ , and grout filling of the duct was complete. However, regions of varied grout quality and strand corrosion products are apparent. For example, the grout in figure 30 consists predominantly of type 3 grout with an interconnecting network of cracking. Corrosion products at some of the strand ends are also visible. Figure 31 illustrates much the same but with type 1 grout in the central region. Figure 32 is similar to figure 31 but with type 4 grout in the bottom region. Thus, poor grout quality for these ducts is pervasive.

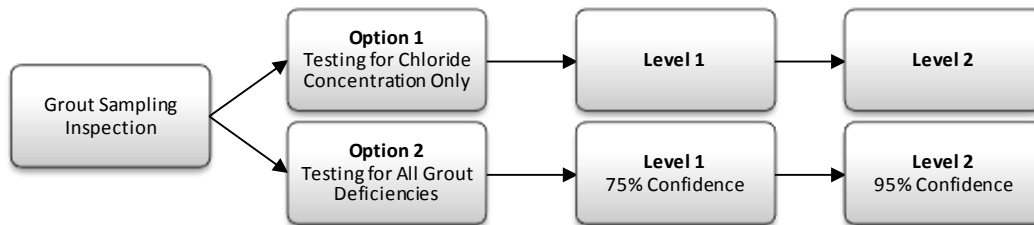
**Figure 35. Flowchart. Inspection options.**

For owners who are only concerned with the grout  $\text{Cl}^-$  contamination, the sampling procedure for option 1 should be followed. Otherwise, the sampling procedure for option 2 is followed, as shown in figure 35.

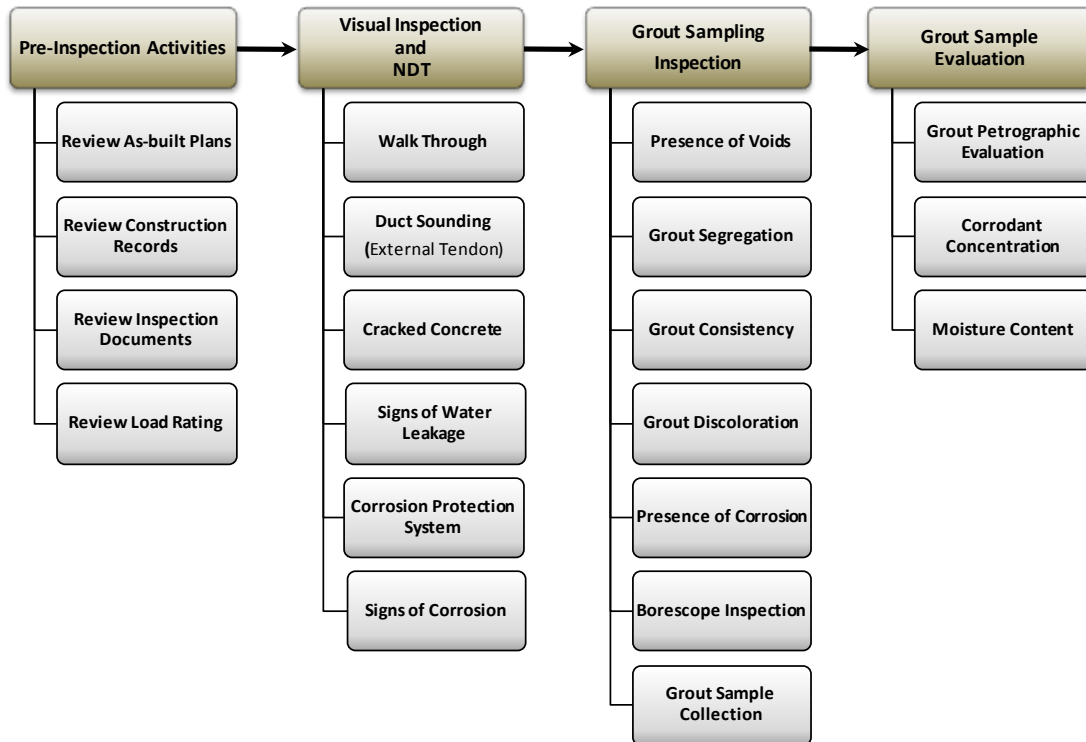
**Figure 36. Flowchart. Grout inspection processes.**

Depending on the type of structure/tendon, some specialized equipment/tools might be necessary. At this point, the possibility of causing a “weak spot” or distress in the element (e.g., tendon damage during drilling) and rendering it prone to corrosion in the future if not properly repaired becomes an important factor in selecting the number of tendons for sampling. Therefore, it is important to minimize the number of sampled tendons while still providing an acceptable level of accuracy in representation of the grout chemical composition and condition. Chapter 7 of this report discusses the strategy that should be used to identify and preselect test locations within a tendon that are most likely to have deficient grout.

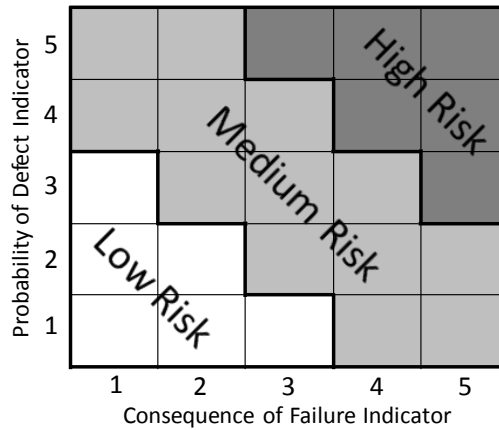
**Figure 37. Graph. Risk matrix.**

The risk is expressed as a product of a probability of defect indicator and a consequence of failure indicator, as shown in figure 37. The critical factors influencing risk are defined in terms of a series of tables with designated categories. Numerical values from 1 to 5 are assigned to each category, with 1 being the least probable or lowest consequence, 3 being intermediate, and 5 being most probable with very high catastrophic consequence.

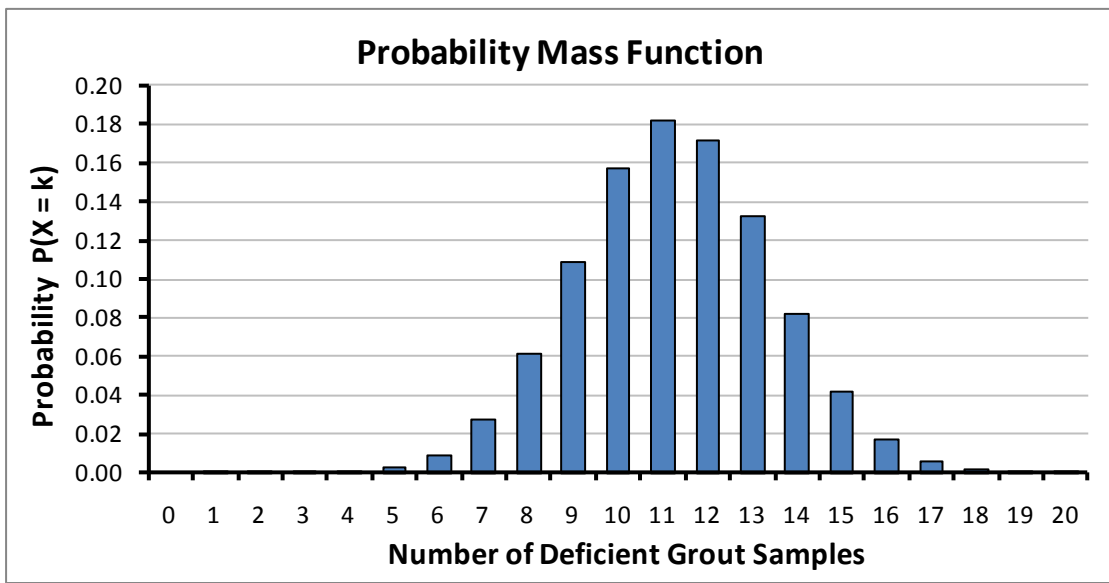
**Figure 42. Graph. Example of PMF for hypergeometric distribution.**

Where  $P(k)$  is the probability of observing  $k$  number of deficiencies when selecting without replacement  $n$  samples from the population of size  $N$ .<sup>(39)</sup> Figure 42 presents an example of PMF of the fraction of samples with defective grout calculated for  $N = 100$ ,  $m = 25$ ,  $n = 45$ , and  $k = 1 \dots 20$ . Each bar represents the probability that when 45 tendons are randomly inspected from a total population of 100 tendons,  $k$  tendons will have a defect. Since in this example 25 percent of tendons have defective grout, the expected and most probable number of successes (detection of tendon with defect) is 25 percent of 45, or 11 tendons.

Figure 44 shows CDF for PMF for the example PMF presented in figure 42. Based on the properties of CDF, it can be determined that there is  $(1 - P_d) = 10$  percent probability of discovering not more than eight defective tendons and a  $P_d = 90$  percent chance of discovering eight or more defective tendons where  $P_d$  is defined as the probability of detecting more than  $i$  number of defective tendons in the population of  $N$  with  $m$  tendons being defective.

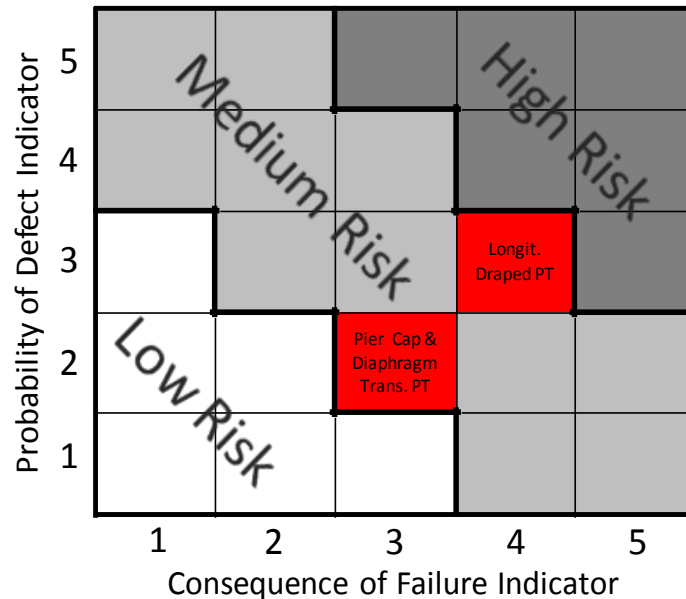
**Figure 50. Graph. Spliced girder bridge—tendon risk categories.**

5. Assign tendon groups to appropriate risk categories (see figure 50).

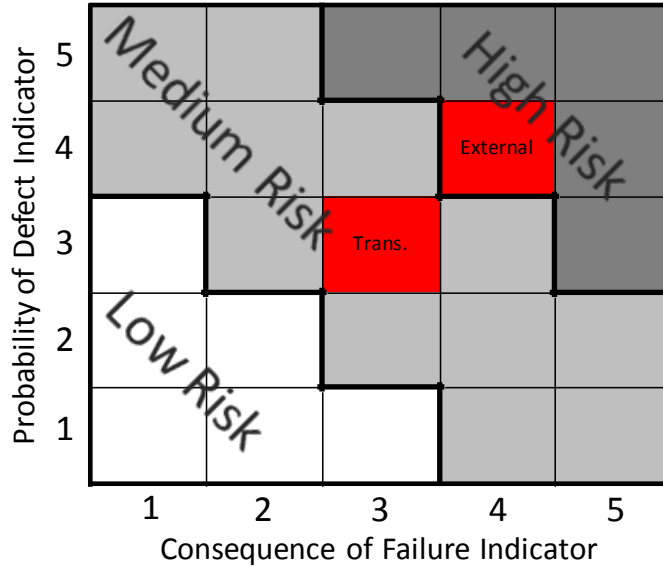
**Figure 51. Graph. Span-by-span segmental bridge—tendon risk categories.**

5. Assign tendon groups to appropriate risk categories (see figure 51).

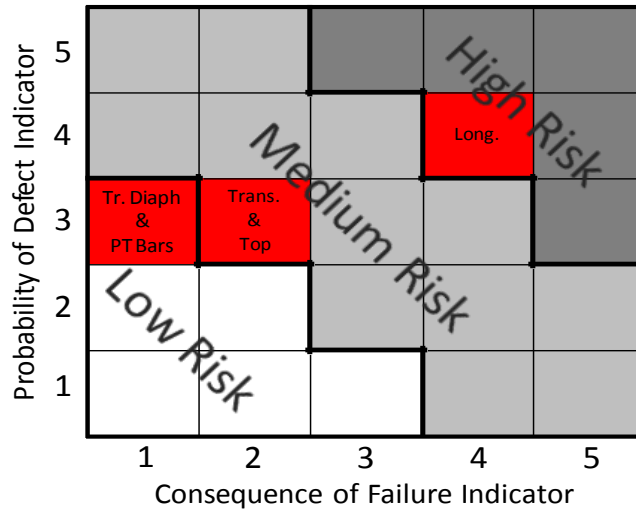
**Figure 52. Graph. PT bridge—tendon risk categories.**

5. Assign tendon groups to appropriate risk categories (see figure 52).

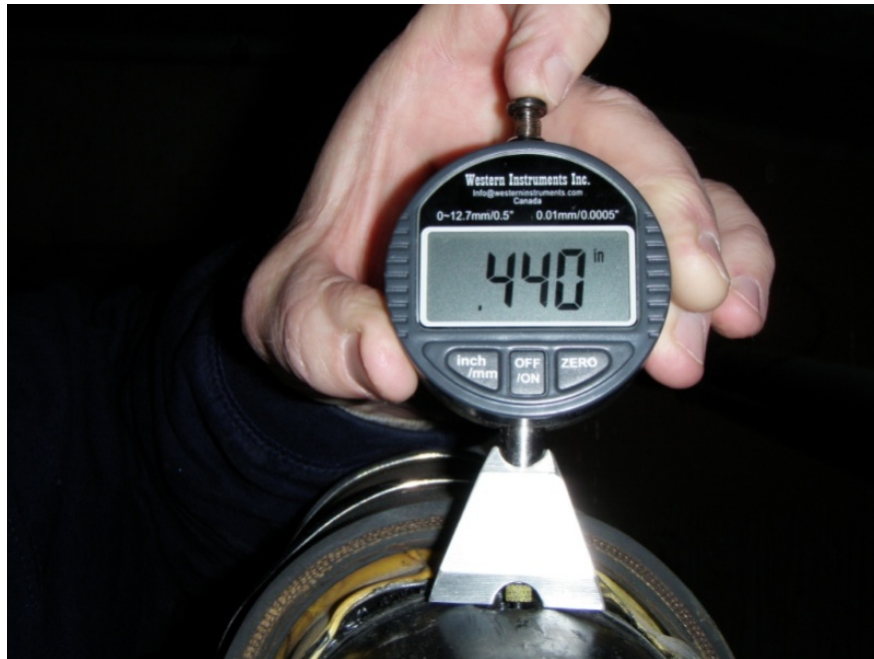
**Figure 53. Photo. Dial gauge used to determine the depth of a grout air void.**

As an initial step in the case of external tendons, the general appearance of the tendon should be documented. The duct should be inspected for any cracks or connections that could serve as conduits for corrosives from an external source. Access to grout and strands can be accomplished either by end cap removal or by sectioning away duct at an intermediate location along the tendon. In the latter case, duct wall thickness is determined from construction documents, and duct sectioning can be performed using either a plastic cutting wheel or a depth guard that limits grinding depth to that of the duct wall thickness. Caution should be used in duct sectioning so that strands are not impacted. It is important to recognize that these strands may press against the interior duct wall at some circumferential orientation. Upon exposing the grout, its visual appearance and presence of any strand corrosion (or lack thereof) should be documented. Direct access to strands may require removal of some grout cover, which is described later in this chapter. Alternatively, potential measurements can be made to assess the corrosion state of embedded strand. Figure 53 shows a dial depth gauge being used to measure the size of a grout air void at the top of a tendon at a location where access to the underlying grout was made on an external tendon.

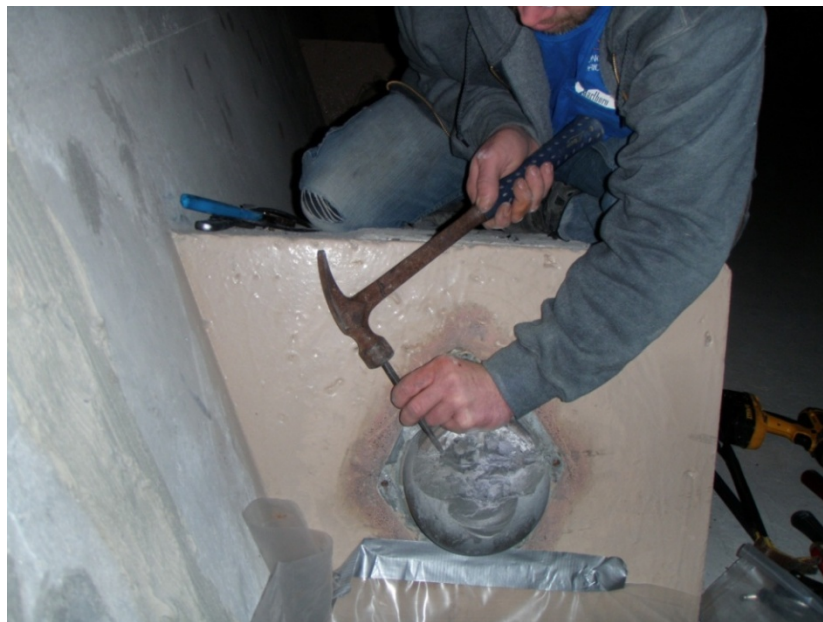
**Figure 54. Photo. Grout sample acquisition at an opened internal tendon end cap by light chipping.**

Internal tendons represent special challenges because intermediate locations along the length require concrete excavation, and there is greater potential that damage to the tendon may occur compared to external tendons. Similar to external tendons, the investigation should document the initial general appearance of internal tendon end caps. An appropriate number of these end caps (see chapter 5) should be opened, and their condition should be assessed. Figure 54 shows a grout sample being taken at an opened internal tendon end by chipping after the cap was removed. Note the plastic sheet beneath the anchorage to ensure no sample contamination. If the grout condition within these is good and grout  $\text{Cl}^-$  analysis results determine that concentration of this species is within acceptable limits, then no further sampling at intermediate locations should be required. However, if the grout appearance is problematic (i.e., undesirable grout types are encountered, see chapter 4),  $\text{Cl}^-$  contaminated, or otherwise defective, then consideration must be given to inspect and sample additional end caps, intermediate locations, or both. This access should be performed by standard concrete excavation methods but with due diligence being taken to ensure that reinforcement is not cut or otherwise compromised and the tendon itself is not damaged. Figure 55 shows concrete excavation to access an internal tendon subsequent to its being located using ground penetrating radar (GPR). Once the tendon is exposed, then inspection and analysis can be performed the same as for external tendons.

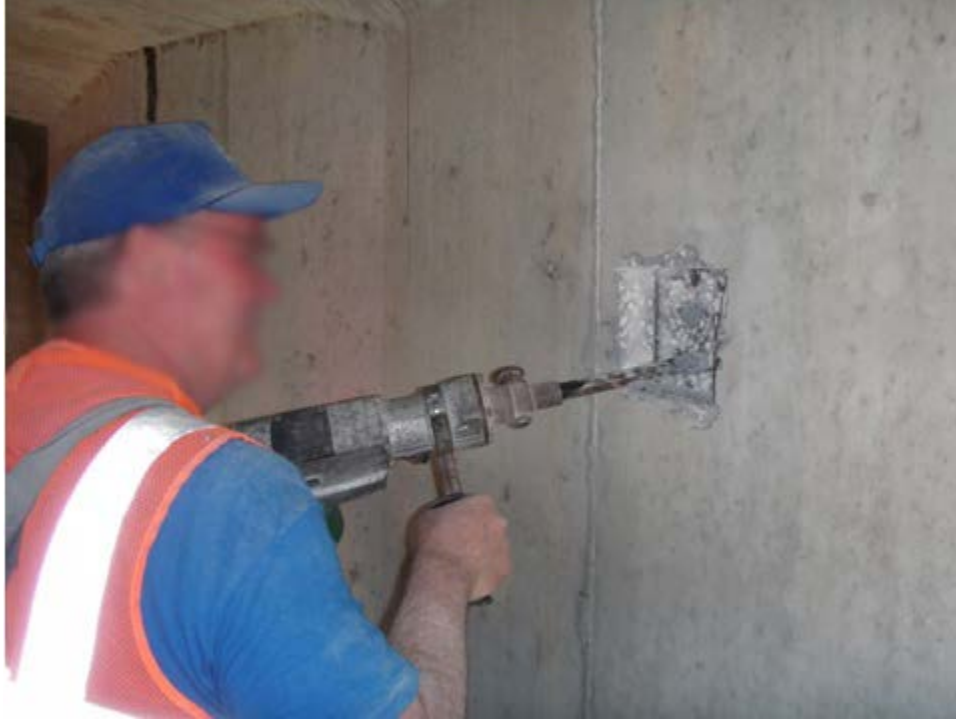
**Figure 55. Photo. Concrete excavation to expose an internal tendon.**

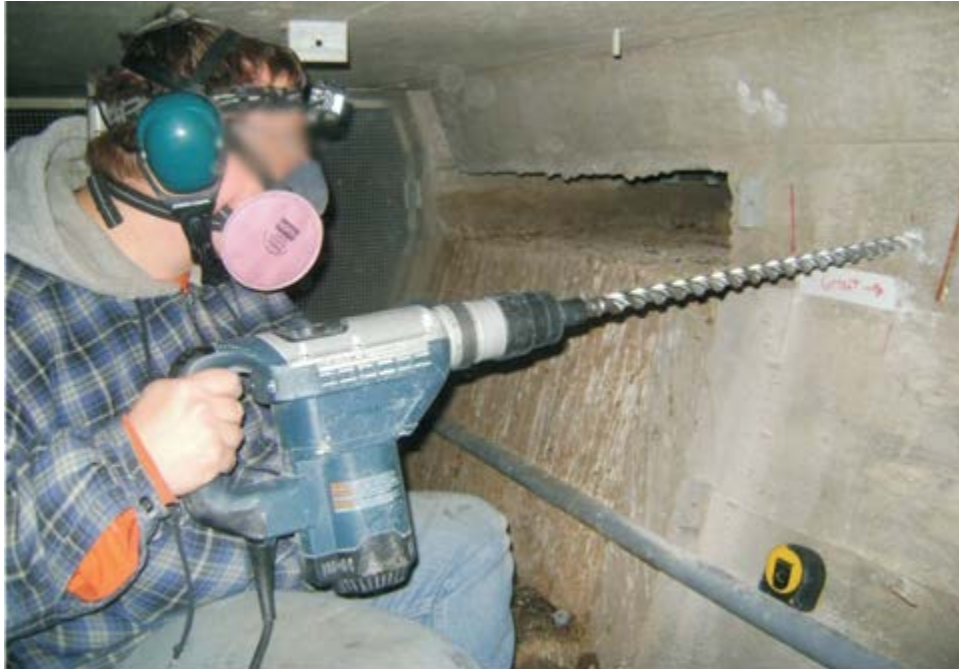
**Figure 56. Photo. Internal tendon access at an intermediate location by drilling.**

If a grout sample has been acquired from an end cap, then it is probably not necessary to acquire additional samples from the same tendon. However, it may be appropriate to determine the grout quality at intermediate locations, particularly the presence of any air pockets at high points. This can be done for internal tendons with minimal concrete and tendon disruption by drilling with a 1-inch-diameter bit, as shown in figure 56. There are noticeable changes in the drill noise and vibration when a tendon is contacted, which helps ensure that there is no strand damage. If an air pocket is disclosed, it can be inspected using a borescope.

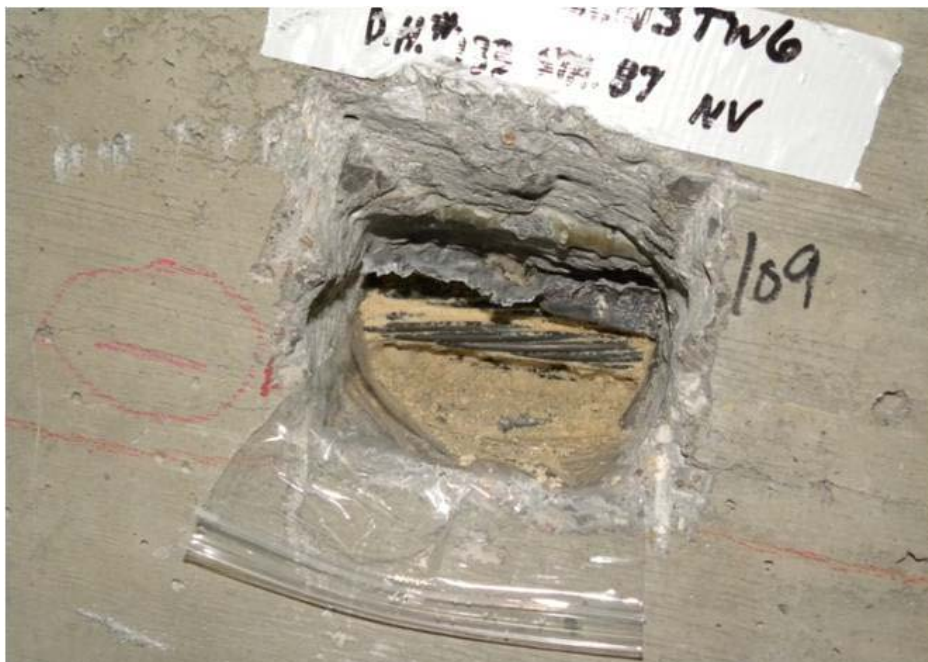
If it is necessary to acquire grout samples at intermediate locations on internal tendons, relatively small excavations can be used, as shown in figure 57. In the figure, an approximately 6-inch-diameter access was created to reveal the exposed strand and grout.

**Figure 57. Photo. Access hole in an internal tendon at an intermediate location revealing strand and grout.**

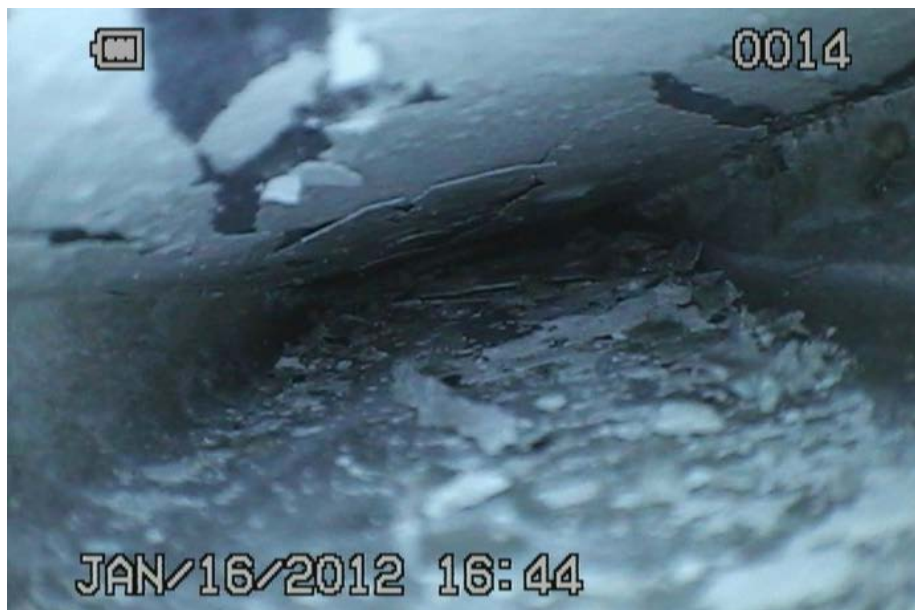
**Figure 58. Photo. View of a duct interior revealing a channel air void.**

- Presence of any air pocket or void space along the top of the duct. Figure 58 shows an interior tendon void space. If defects are present, then components in the air space (the duct internal surface if access is at an intermediate location along the tendon or anchorage end plate and strand ends) should be inspected to determine if grout residue is present. Absence of residue is an indication of incomplete grout filling at the time of construction, while presence of residue may indicate grout subsidence.
- Presence of free water.
- Presence and extent of any corrosion on strands and anchorage.
- Differences in grout color, consistency, or segregation (or a combination of these).
- Presence of voids in the grout (this should be documented for each type of grout appearance).

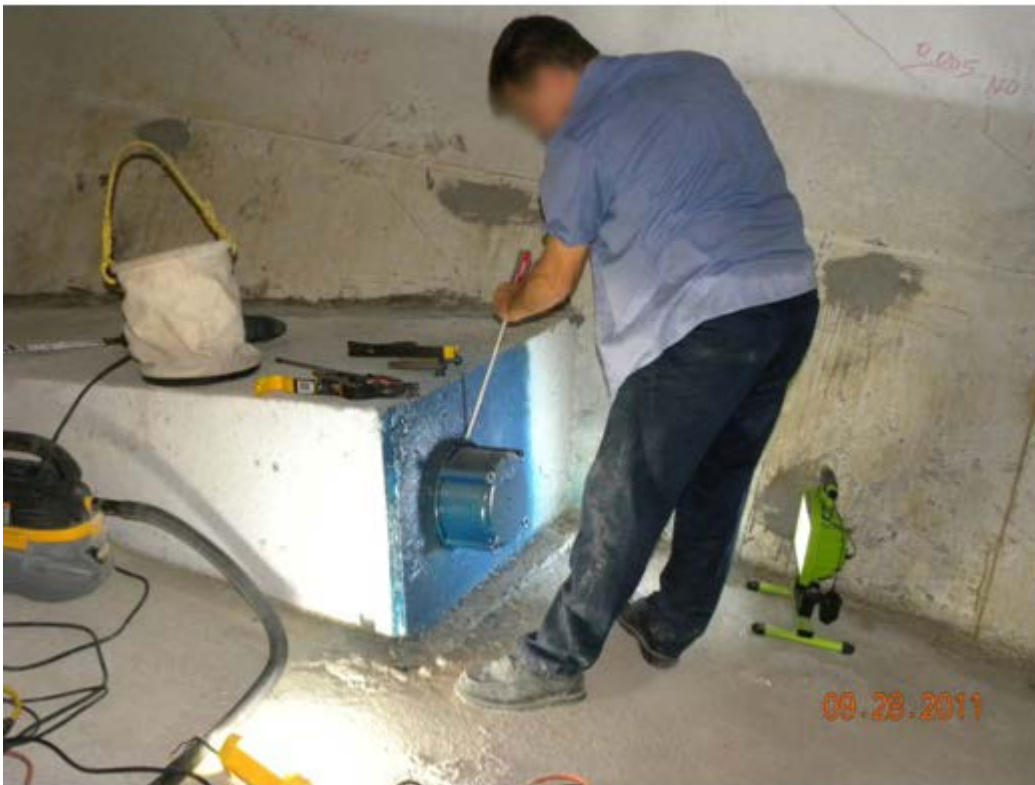
**Figure 62. Photo. Removing a permanent grout cap.**

After the number of sampled tendons are determined based on the methodology presented in chapter 5, it is important to strategically locate the sampling areas in a certain type of tendon after the target tendons are selected. The target tendons should be randomly selected from the bridge being inspected. It is not always possible to remove grout samples from a cut window in the duct away from the anchorages of an internal tendon due to the strand configuration in the duct. If the tendon has a permanent grout cap over the anchor head, the simplest way to collect grout samples is from the cap internal area as shown in figure 62 and figure 63. Extracting grout samples from the grout cap should be used as the first option.

If a permanent grout cap is accessible or exists, the cap should be removed from the blister (see figure 62 and figure 63). Alternatively, the cap can be partially removed using a core drill about 3–4 inches in diameter toward the upper location, as shown in figure 65. The cored section should be saved for later for grout cap repair. The grout sample should be removed as required in chapter 6 for further testing, and its physical condition should be inspected, including the exposed strands in the anchor head and the presence of voids. If the grout cap is not available/accessible or if a void is present in the grout cap, the trumpet interior should be inspected by drilling through a grout port over the trumpet area. This drilling has to be done with extreme care to avoid damage to any strand in the trumpet. If a void is present, a videoscope should be used to inspect the condition of the internal void area. For each continuity tendon selected randomly, both ends of the anchorage should be inspected as shown in figure 66 and figure 67. If severe corrosion is discovered, the entire grout cap and grout over the anchor head should be removed for further investigation.

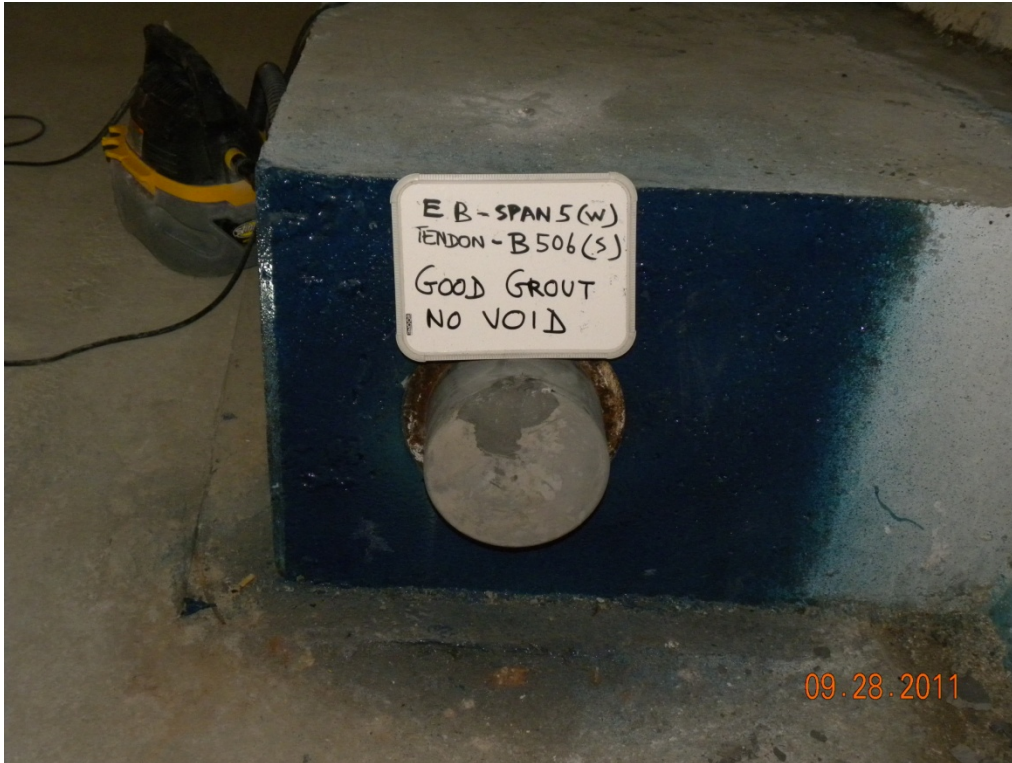
**Figure 63. Photo. Exposed anchor head after grout sampling.**
