# Guidelines for Sampling, Assessing, and Restoring Defective Grout in Prestressed Concrete Bridge Post-Tensioning Ducts

PUBLICATION NO. FHWA-HRT-13-028

OCTOBER 2013

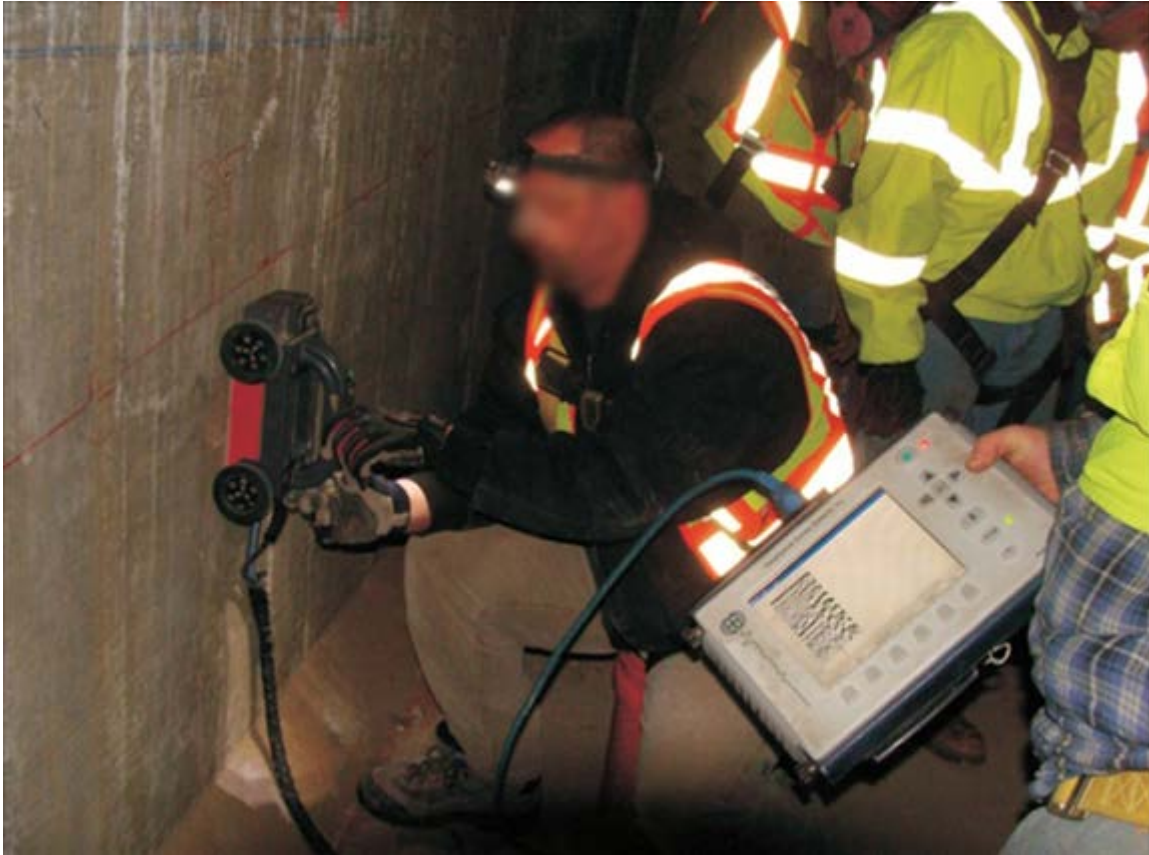
This chapter provides a guideline on locating the strategic locations along each type of tendon, also known as the inspection point. In terms of internal tendons, prior to opening a hole in the tendon, the tendon should be located using GPR as shown in figure 64. It is not recommended to use as-built plans to locate internal tendons because tendon locations might change during construction.

**Figure 64. Photo. Locating internal tendons in the web wall using GPR.**

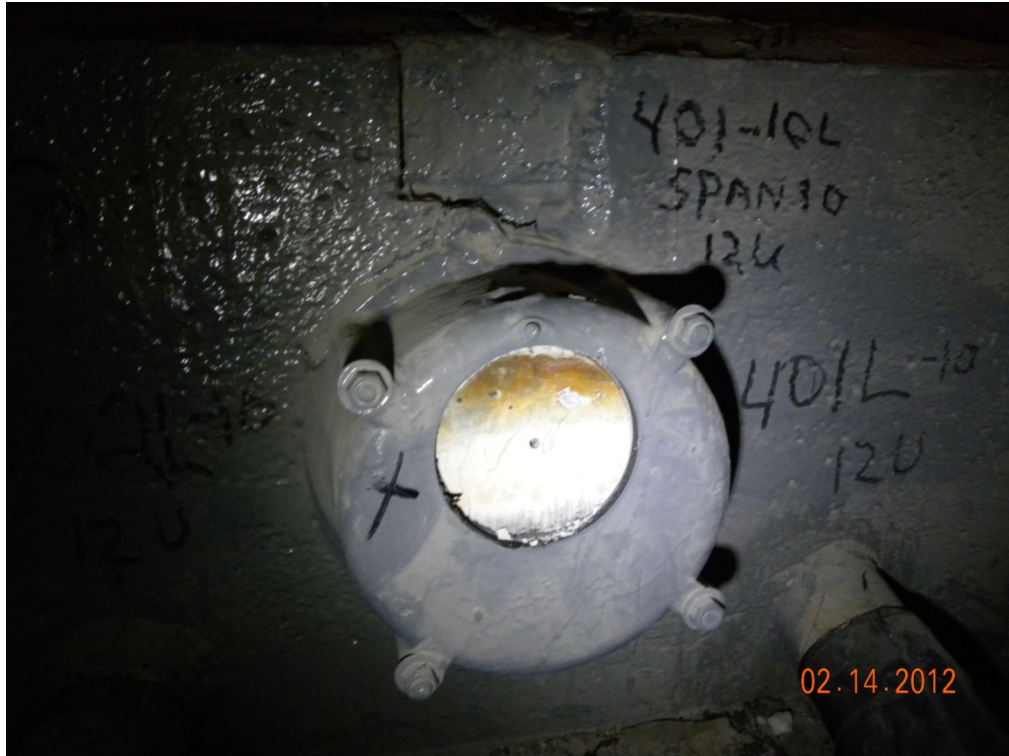
If a permanent grout cap is accessible or exists, the cap should be removed from the blister (see figure 62 and figure 63). Alternatively, the cap can be partially removed using a core drill about 3–4 inches in diameter toward the upper location, as shown in figure 65. The cored section should be saved for later for grout cap repair. The grout sample should be removed as required in chapter 6 for further testing, and its physical condition should be inspected, including the exposed strands in the anchor head and the presence of voids. If the grout cap is not available/accessible or if a void is present in the grout cap, the trumpet interior should be inspected by drilling through a grout port over the trumpet area. This drilling has to be done with extreme care to avoid damage to any strand in the trumpet. If a void is present, a videoscope should be used to inspect the condition of the internal void area. For each continuity tendon selected randomly, both ends of the anchorage should be inspected as shown in figure 66 and figure 67. If severe corrosion is discovered, the entire grout cap and grout over the anchor head should be removed for further investigation.

**Figure 65. Photo. Partial removal of a grout cap.**

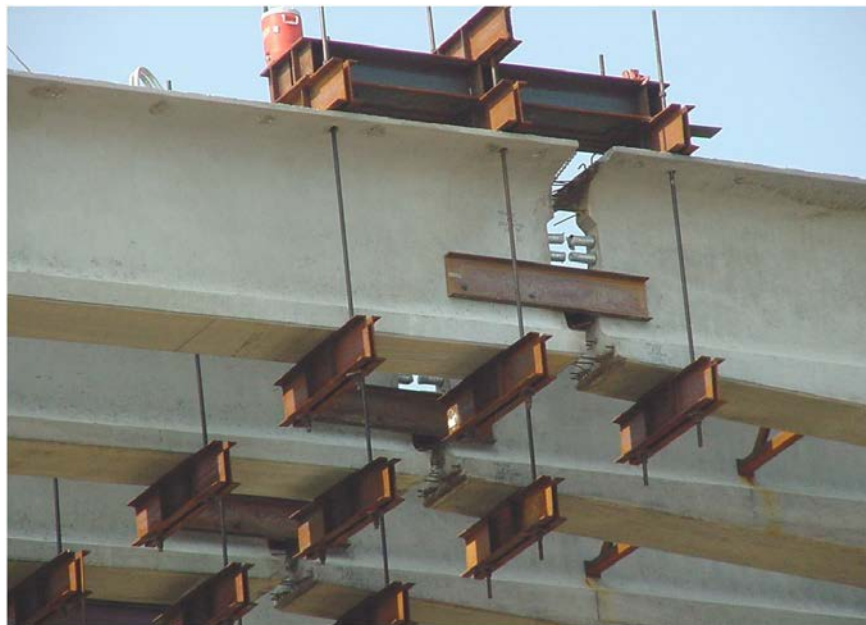
**Figure 71. Photo. Spliced bulb-tee girder bridge CIP joint detail.**

A PT spliced girder bridge typically has three to four internal tendons from end to end of a multispan continuous unit as shown in figure 70, figure 71 for bulb-tee girders, and figure 72 for a U-girder bridge. Similar to a CIP PT bridge, it is almost impossible to access the anchorage area due to a lack of sufficient clearance at the bridge ends. For a three-span continuous bridge, it is recommended to have a minimum of three inspection points—the first adjacent to the anchorages, the second at the CIP closure joint near the pier, and the third at the highest area over the pier (see figure 70 and figure 72).

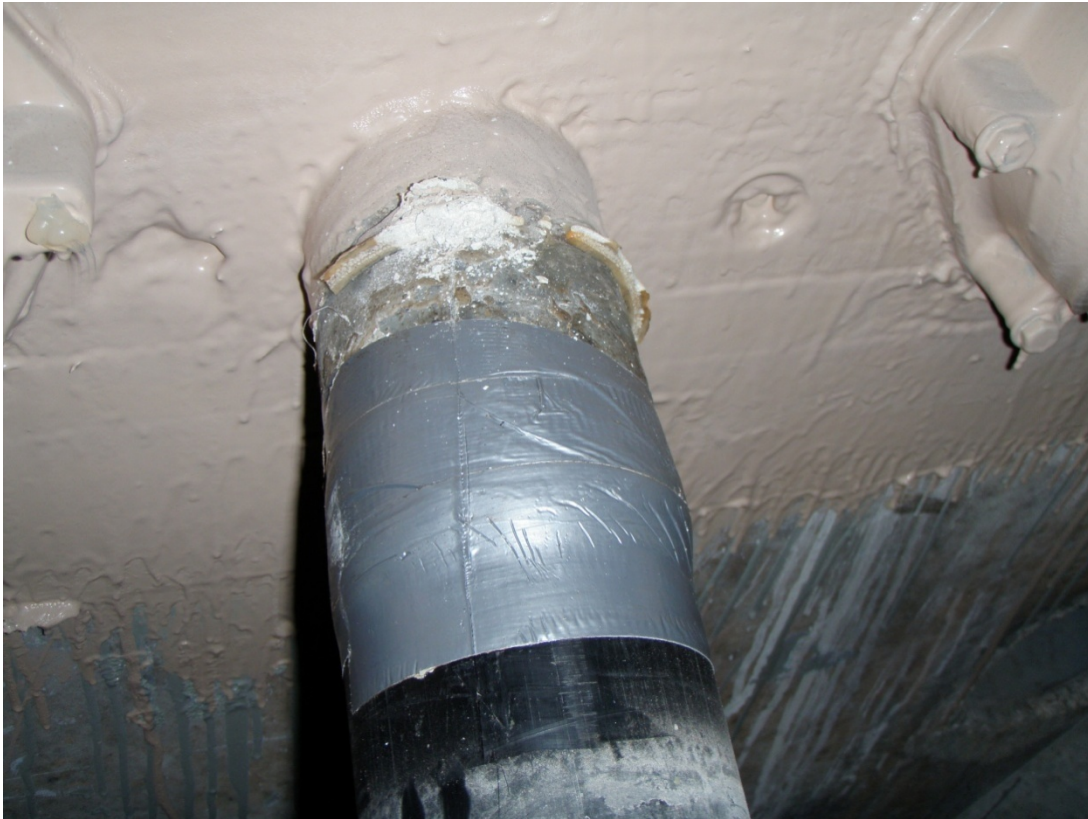
1. Properly clean any dust and soft material in the restoration area using vacuum cleaner or dry air blower.
2. Apply an approved hydraulic cement grout mortar over any exposed strands.
3. Reattach the original two half pieces of polyethylene (PE) ducts (two half duct).
4. Seal the cut lines with sealant.
5. Wrap the restoration area with a minimum 4 inches of high-performance waterproof tapes at each end (see figure 73).

**Figure 73. Photo. Temporary restoration of an external tendon.**

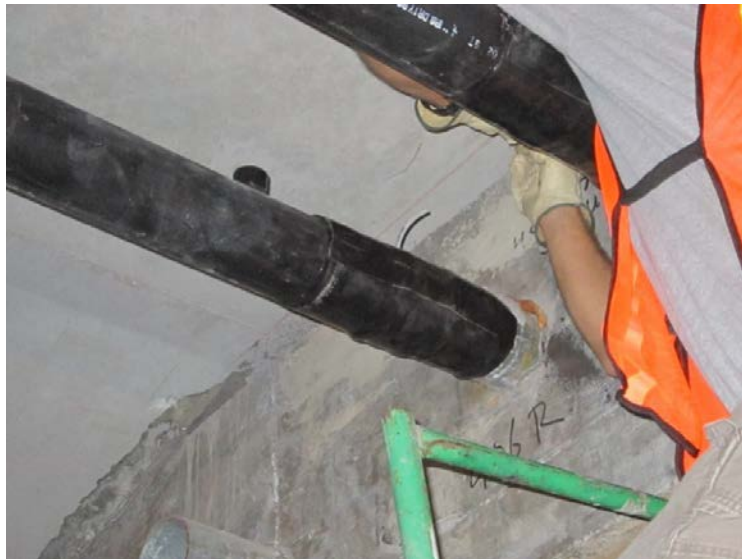
1. Properly clean any dust and soft material in the restoration area by vacuum cleaner or dry air blower.
2. Apply an approved hydraulic cement grout mortar over any exposed strands.
3. Reattach the original two half pieces of PE ducts.
4. Seal the cut lines with sealant.
5. Wrap the restoration area with a minimum of 4 inches of heat shrink wrap at each end (see figure 74).

**Figure 74. Photo. Permanent restoration of an external tendon using heat shrink sleeve.**

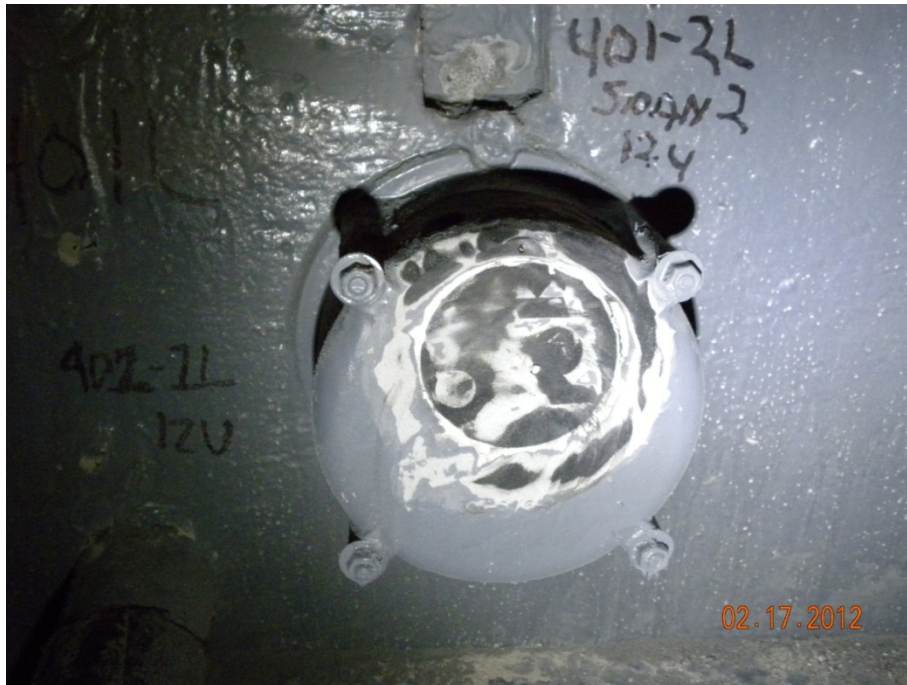
**Figure 76. Photo. Completed restoration of a partially cut grout cap prior to coating.**

Figure 76 through figure 78 show the permanent restoration process of a grout cap, including elastomeric coat application.

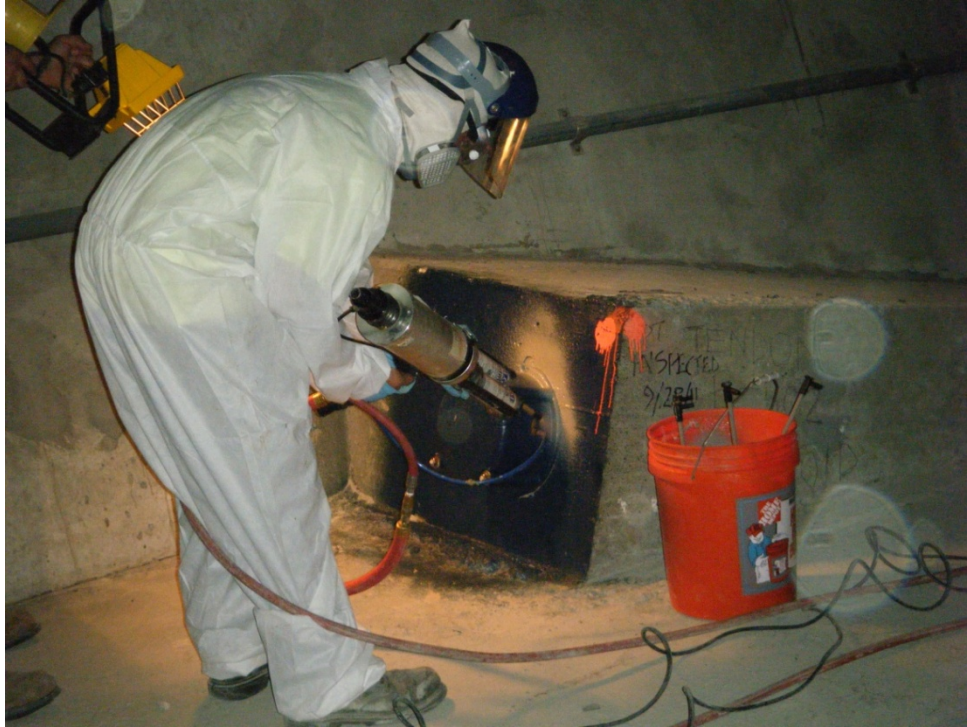
**Figure 77. Photo. Applying elastomeric coating over a grout cap.**

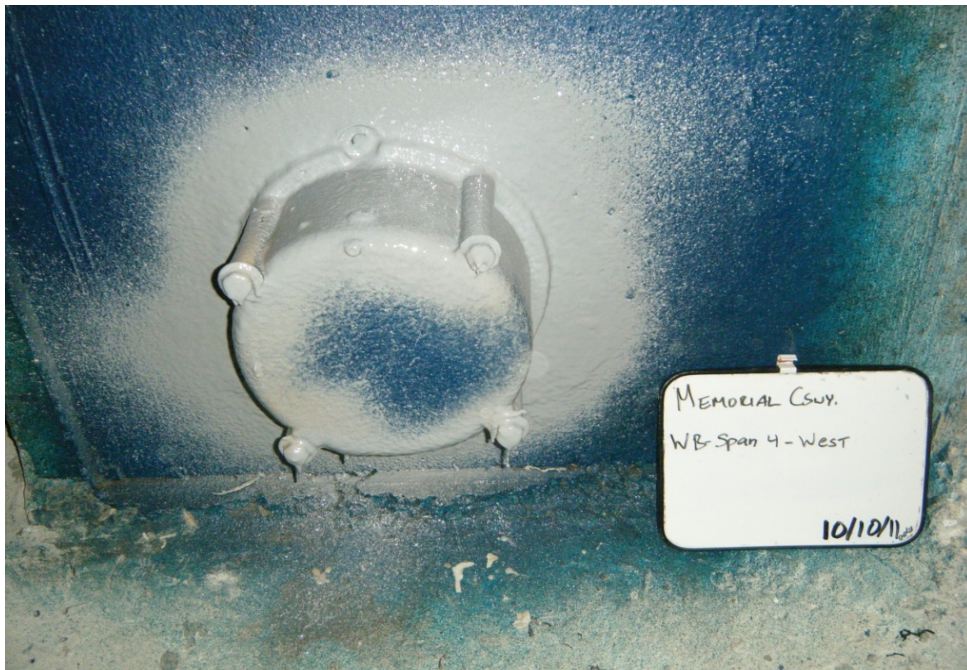
**Figure 78. Photo. Completed permanent restoration of a grout cap.**
