# Laboratory Evaluation of Corrosion Resistance of Various Metallic Dowel Bars

PUBLICATION NO. FHWA-HRT-15-079

JUNE 2018

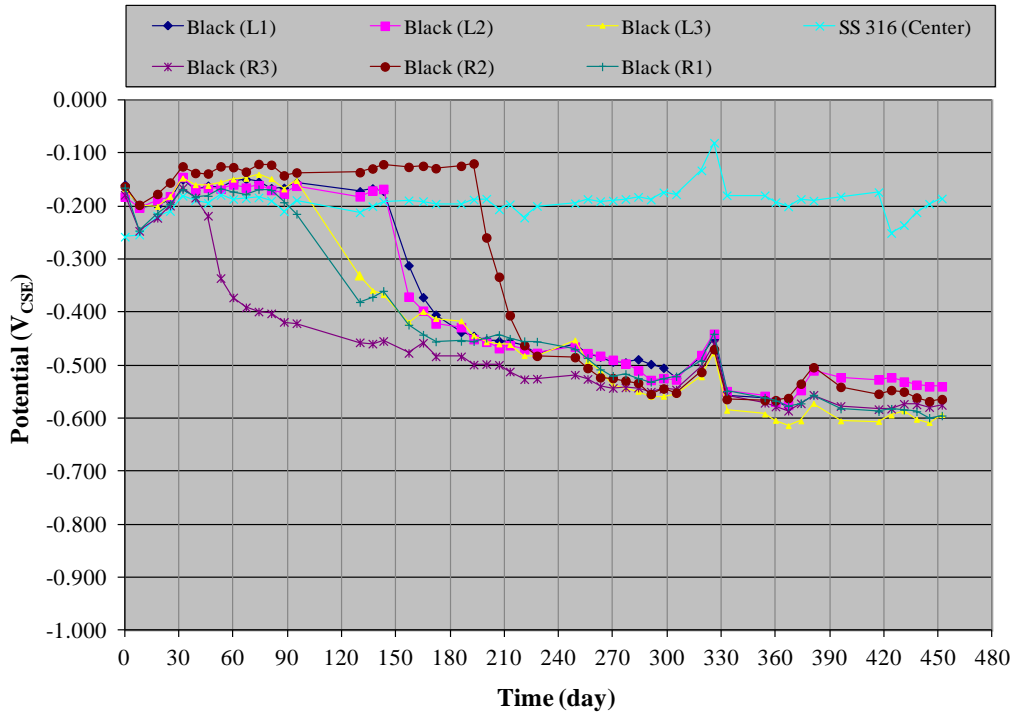
**Figure 26. Graph. Corrosion potentials versus time plot for black bar slab.**

As the black bars initiated corrosion one by one, the corresponding  $i_{macro-cell}$  increased gradually toward a relatively low level of  $0.1 \mu\text{A}/\text{cm}^2$  until the testing was over (note that  $1 \mu\text{A}/\text{cm}^2 = 6.45 \mu\text{A}/\text{inch}^2$ ). If only the actively corroding area beneath the joint is taken into consideration,  $i_{macro-cell}$  could be at least 10 times higher than what was calculated based on the entire bar surface area.

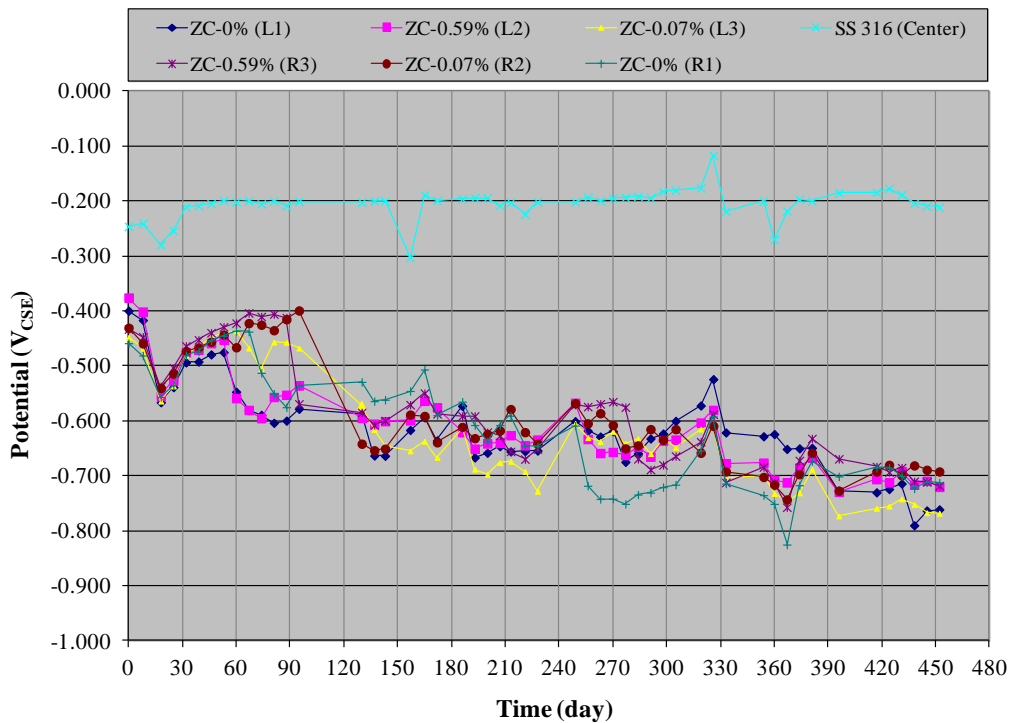
**Figure 32. Graph. Corrosion potentials versus time plot for ZC bar slab.**

The  $i_{macro-cell}$  data show a steadily increasing trend with time in association with the gradually decreased corrosion potential, but there was a large variation of  $i_{macro-cell}$  data accompanied by four distinctive current surges. The maximum  $i_{macro-cell}$  observed at the peak of the surges was about 15 percent higher than that observed at the single peak of the HDG  $i_{macro-cell}$  data. The  $i_{macro-cell}$  data indicate that the ZC produced the largest corrosion current among the entire bar materials tested in this study.

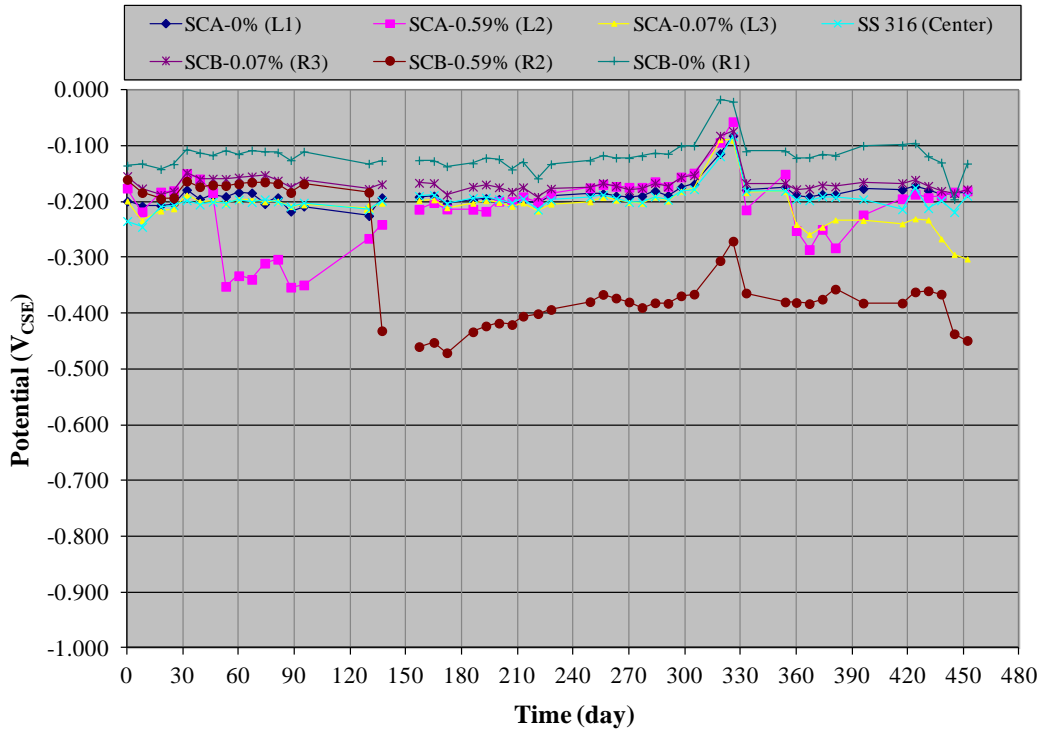
**Figure 34. Graph. Corrosion potentials versus time plot for SCA/SCB bar slab.**

The  $i_{macro-cell}$  data indicate virtually zero activity, regardless of cladding type and defect size. The negligible  $i_{macro-cell}$  must be due to small potential differences that are the driving force between each of the SCA/SCB bars (macro-anode) and type 316L solid SS bar (macro-cathode).

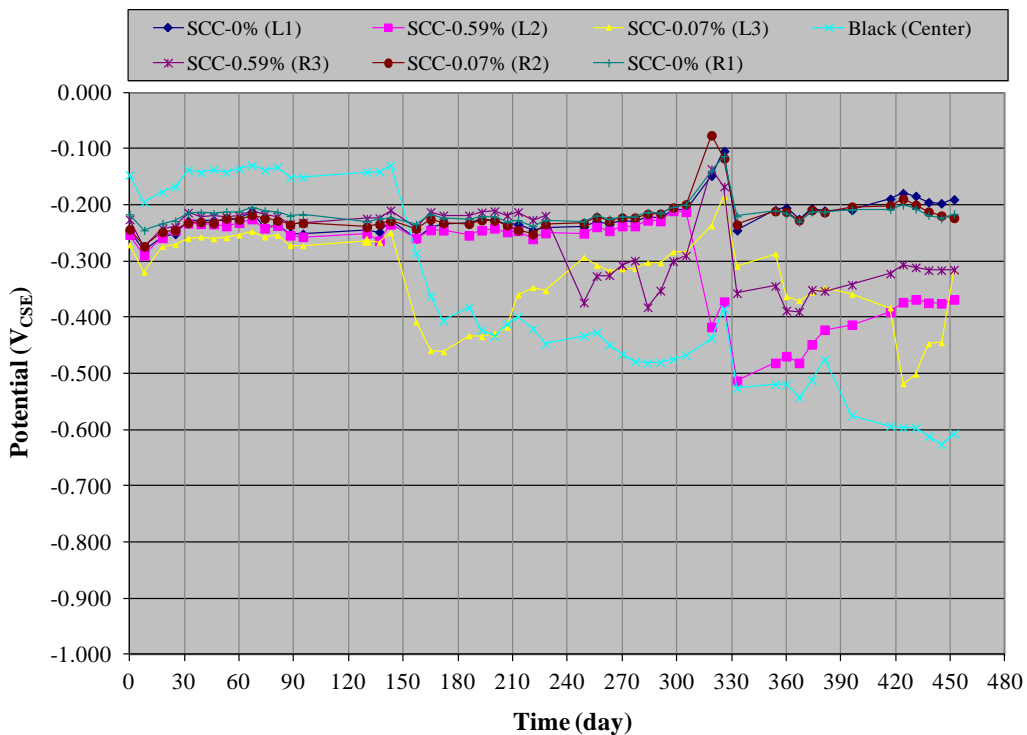
**Figure 36. Graph. Corrosion potentials versus time plot for SCC bar slab.**

Because the black bar was the macro-anode and each of the SCC bars was the macro-cathode, the  $i_{macro-cell}$  data presented in figure 37 is macro-cell corrosion current density of the black bar when it was coupled to individual SCC bars. The  $i_{macro-cell}$  data exhibited increasingly higher  $i_{macro-cell}$  with time. This means that the black bar was corroding more due to increasingly accumulated chloride ions over time. The highest  $i_{macro-cell}$  was about  $0.4 \mu A/cm^2$ , which is nearly four times higher than the black bar slab case presented in figure 27. One possible reason for much higher  $i_{macro-cell}$  may be due to the black bar's prolonged time being the single macro-anode. Although each of the black bars in the black bar slab also served as the macro-anode, they were connected to the solid SS bar only for a relatively short duration whenever the macro-cell corrosion current was measured.

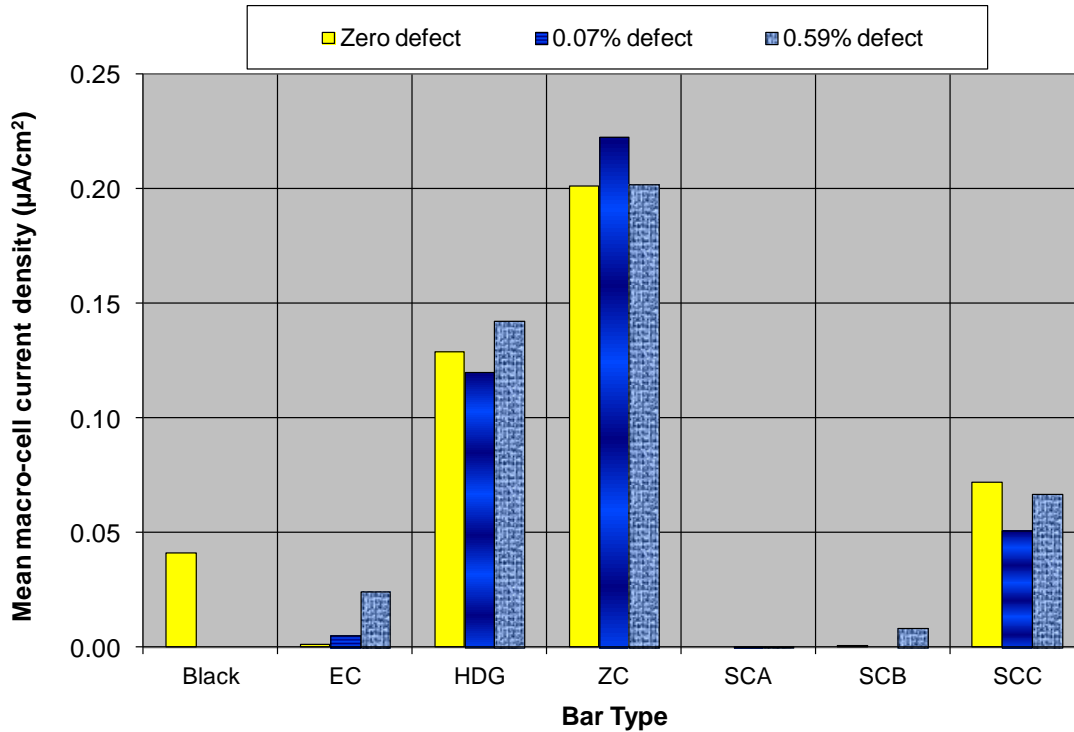
Figure 40 summarizes mean  $i_{macro-cell}$  values based on individual  $i_{macro-cell}$  data points grouped by bar type and defect size over the entire testing period of 452 d. The ZC bar showed the highest mean  $i_{macro-cell}$ , followed by the HDG and the SCC. As mentioned earlier regarding the SCC data, their mean  $i_{macro-cell}$  values actually represented those of the black bar in connection with the individual SCC bars. The effect of defect size was not apparent on these SCC bars. The other bar materials (EC, SCA, and SCB) exhibited very low mean  $i_{macro-cell}$  values. The EC and the SCB bars containing the large defect show slightly higher mean  $i_{macro-cell}$  than those bars with small or no defects.

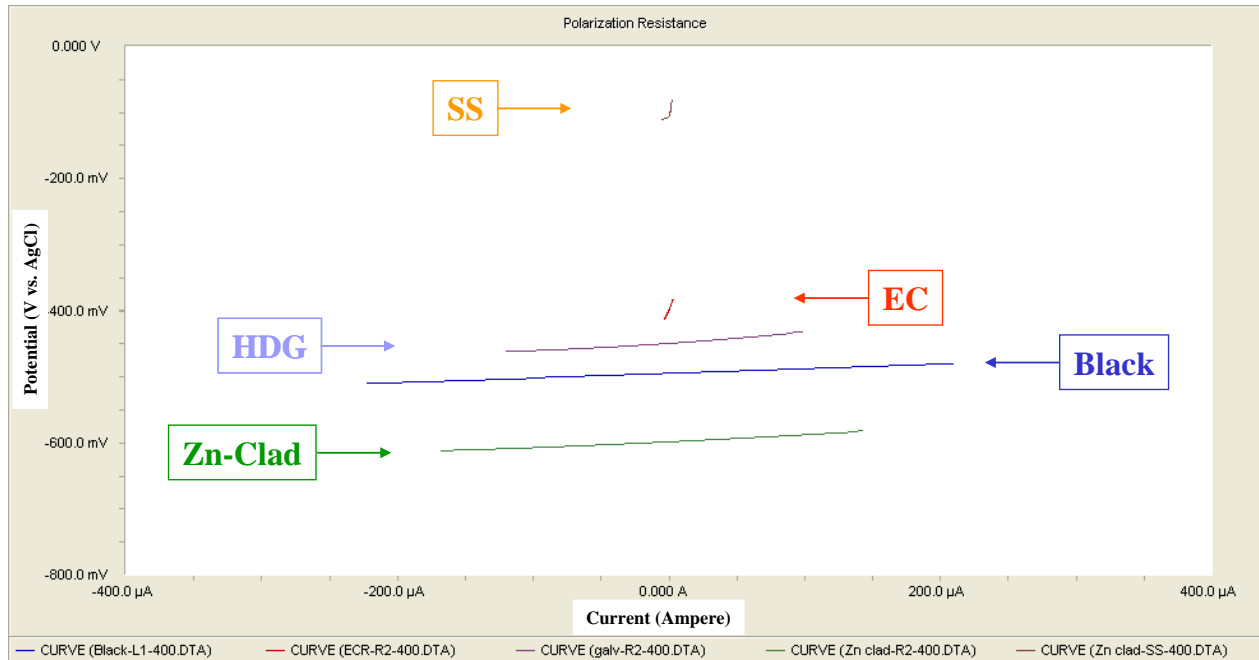
Figure 48 shows typical experimental LPR data of individual bar materials. (Figure 21 presented a schematic of the LPR data; all of the solid SS and SC bars can be related to SS.) This figure illustrates how the relative position of the potential and the relative magnitude of the current range in the LPR plots can vary depending on different bar materials: more corrosion-resistant materials show more positive corrosion potential and smaller current magnitude in association with a larger slope. For example, two more corrosion-resistant bars, labeled SS and EC, exhibit more positive corrosion potential and much smaller current range associated with steeper slopes than the less corrosion resistant bars, labeled HDG, black, and Zn-clad.

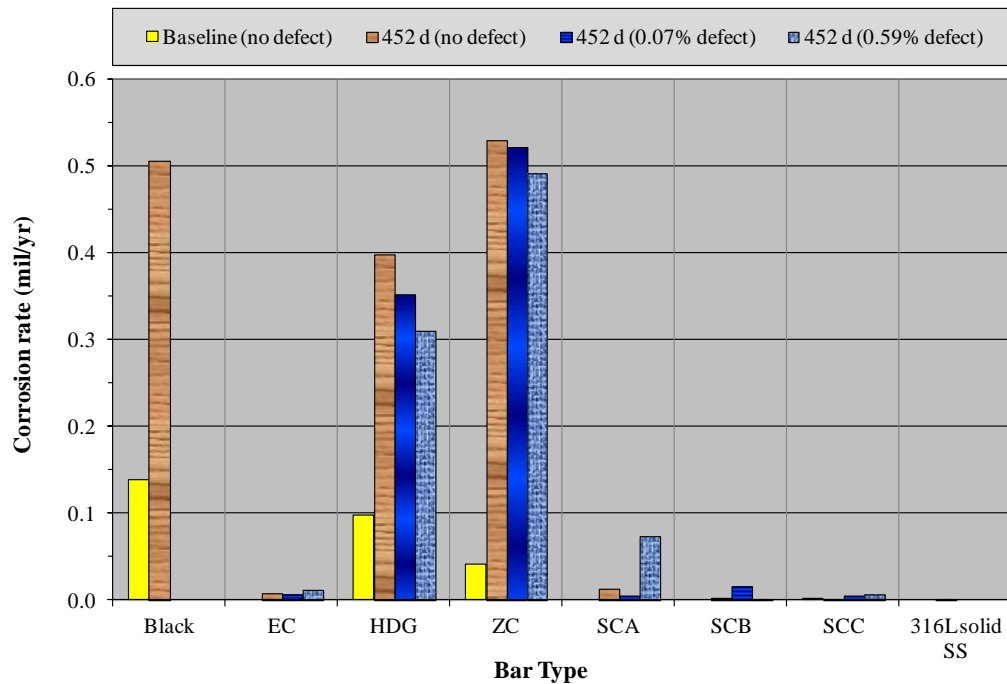
Figure 49 summarizes the mean corrosion rate values of each bar material that are grouped by time of measurement (baseline versus final at 452 d) and defect size (0, 0.07, and 0.59 percent). When the bars were exposed to chloride-free concrete, baseline corrosion rate was very low. The highest mean corrosion rate of 0.15 mil/yr was observed with black bars, followed by 0.1 and 0.05 mil/yr for HDG and ZC bars, respectively. The others exhibited negligible corrosion rates. After excessive chloride ions were accumulated at the bar/concrete interface near the end of the testing, the same bars showed 4 to 10 times higher corrosion rates compared with their baseline data. The most significant increase was made by the ZC bars, which had shown the most active corrosion behavior in terms of corrosion potential and  $i_{macro-cell}$  data (which is to be expected, since the zinc coating acts as a large, exposed anode). At the end of the accelerated corrosion testing, the ZC and black bars yielded the highest mean corrosion rate. As observed in the  $i_{macro-cell}$  data, the HDG bar exhibited the second highest mean corrosion rate. The other bars did not produce recognizable corrosion rates. Even though ZC and HDG showed a trend of decreased mean corrosion rate as artificial defect size increased, especially HDG, the significance of this observation is not clear. The other bars did not show such a trend.

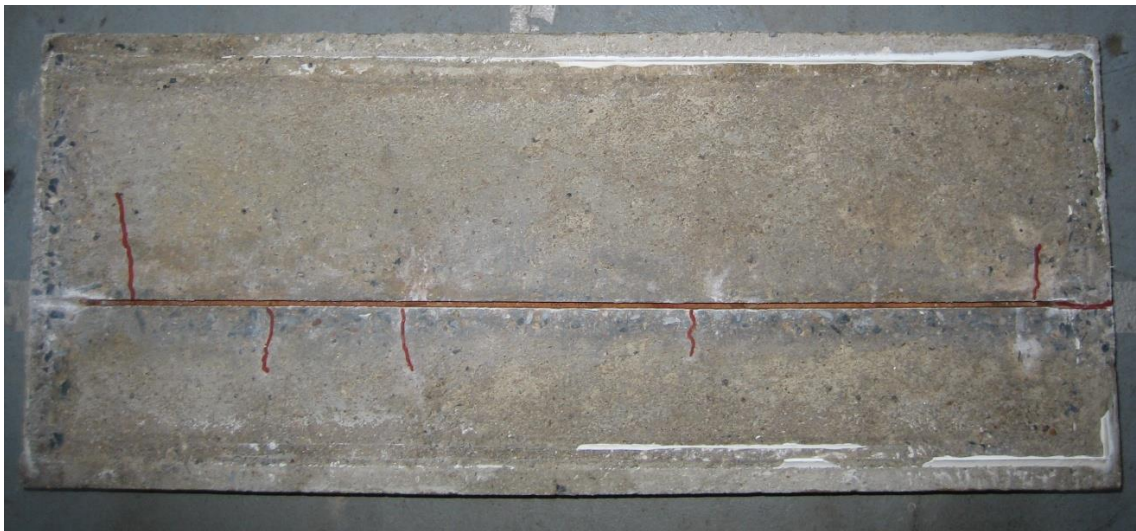
**Figure 51. Photo. Top surface condition of black bar slab before autopsy.**

Figure 51 shows the top surface of the black bar slab that contained five visible cracks. The cracks were formed directly above five out of six black bars. Figure 52 shows physical condition of the as-extracted black bars in the same position and orientation as they were in the slab. As expected, all of the black bars exhibited more or less severe corrosion while a type 316L solid SS bar was clean without signs of corrosion.

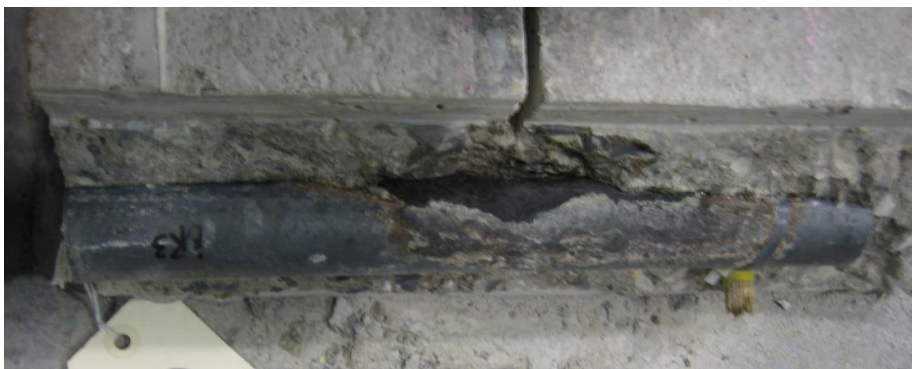
Figure 53 shows a representative condition of the black bars when they were exposed during the slab demolition process. Figure 54 and figure 55 show appearance of top and bottom sides of an as-extracted bar. The top side suffered from heavy corrosion damage as it faced the joint, but the bottom side was still in good condition. Figure 56 shows another freshly exposed black bar that exhibited greenish and black corrosion products, suggesting very intensive corrosion through a chloride-inducing acidification process in a less oxygen-available environment. Figure 57 shows a cleaned black bar segment that revealed the deepest pit (48 mil) surrounded by numerous shallow pits. The intensity of the corrosive environment created during the accelerated corrosion testing can be inferred by this corrosion morphology.

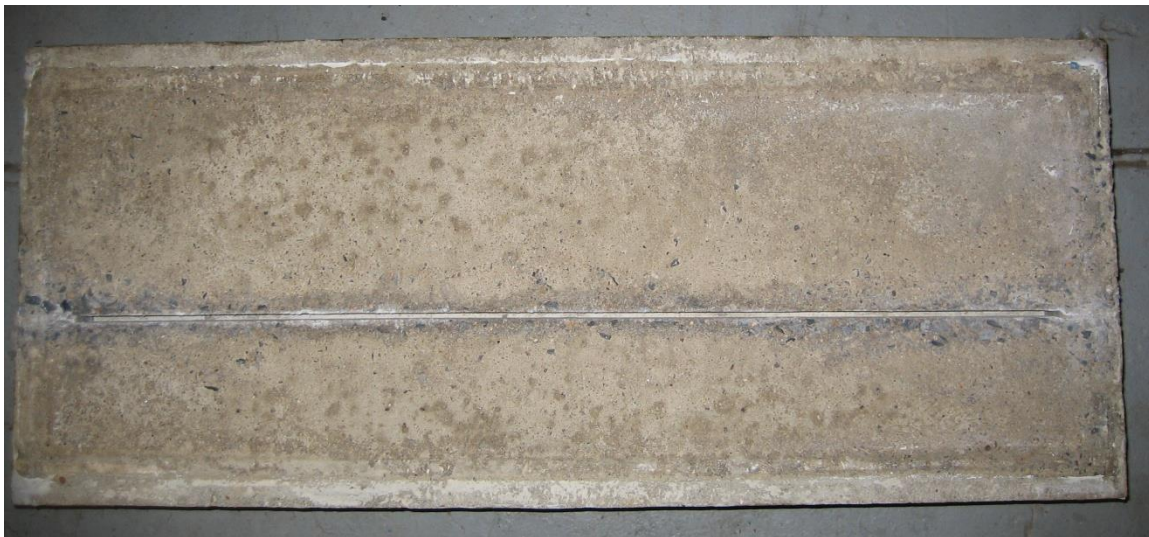
**Figure 58. Photo. Top surface condition of EC bar slab before autopsy.**

Figure 58 shows the top surface of the EC bar slab that contained no visible cracks. Figure 59 shows the physical condition of the as-extracted EC bars in the same position and orientation as they were in the slab. All of the EC bars exhibited some localized corrosion. Again, the type 316L SS bar was clean without signs of corrosion.

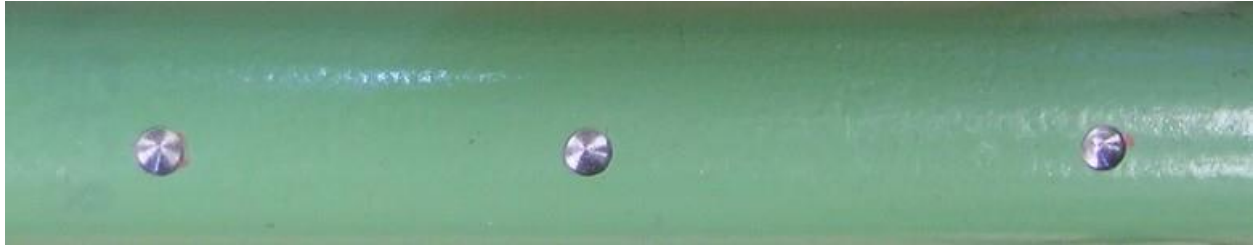
**Figure 60. Photo. Initial condition of an EC bar (EL2).**

Figure 60 through figure 62 show the initial condition, final condition right after extraction, and autopsied condition of an EC bar, respectively. It contained three holes of the large coating defect. The bar developed a localized corrosion near the middle defect, as shown in the small red square in figure 61. Upon removal of the rust-stained coating surface, severely corroded substrate was exposed (inset of figure 61). All of the loose coating on the same bar was removed using a knife as part of the autopsy work. The excessive coating disbondment that had occurred during the corrosion testing is revealed in figure 62. The disbonded areas that originated from the left and right defects exhibited fairly shiny surfaces, indicating that they were caused by a cathodic delamination process that produced hydroxyl ions. The extensive disbonded area around the middle defect was covered with red corrosion product, indicating that this area was one stage more advanced than the other defect areas; water, chloride ions, and oxygen reached the delaminated substrate and initiated corrosion there. The localized corrosion shown in figure 61 was associated with the substrate corrosion in question. As a coating disbonded area grew independently from the middle and the right defects, they eventually merged together to create one extensive coating delaminated area, as shown in figure 62.

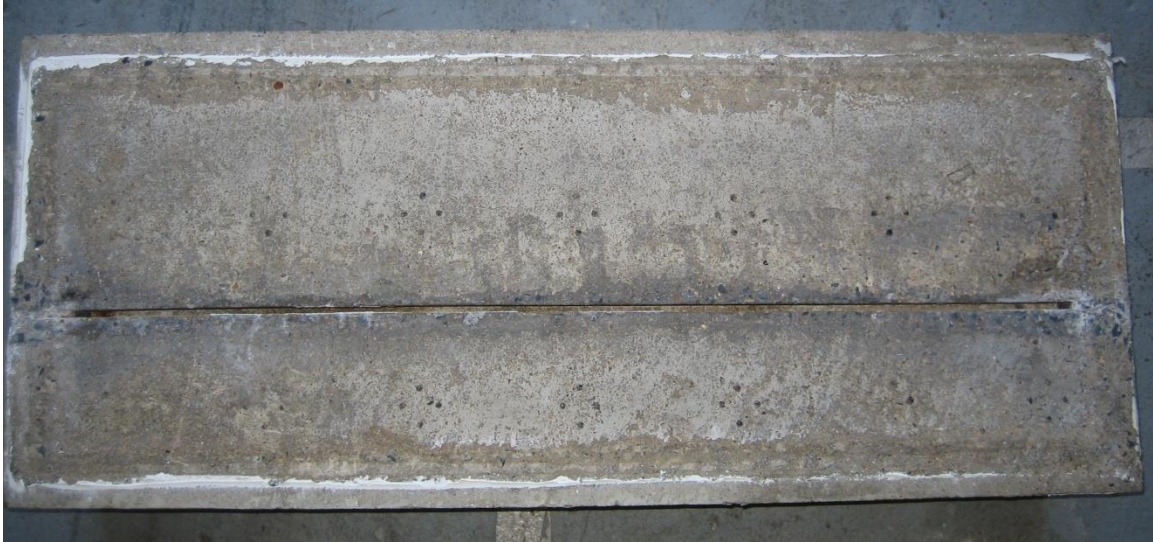
**Figure 67. Photo. Top surface condition of HDG bar slab before autopsy.**

Figure 67 shows the top surface of the HDG bar slab that contained no apparent visible cracks. Figure 68 shows the physical conditions of the as-extracted HDG bars in the same position and orientation as they were in the slab. All of the HDG bars exhibited white zinc oxide corrosion product and reddish steel corrosion product. The type 316L SS bar was clean without signs of corrosion.

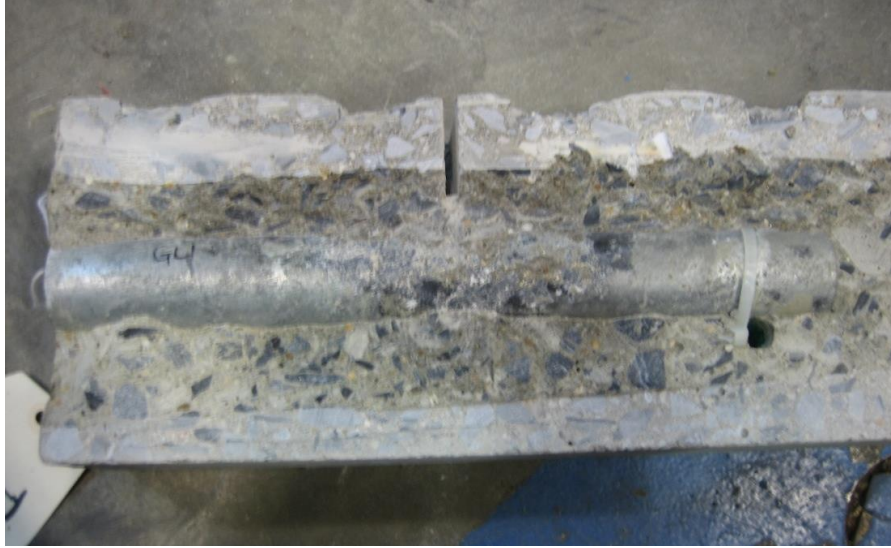
**Figure 69. Photo. Condition of an exposed HDG bar (GL1).**

Figure 69 shows the typical condition of an as-exposed HDG bar when the concrete was removed. Figure 70 shows the top side of the same bar upon its extraction. It shows intensive corrosion covered with black and reddish corrosion products near the simulated joint. A close-up view of such a condition is shown in figure 71. The bottom side of the bar shows mainly white zinc oxide corrosion product, as shown in figure 72. This condition indicates limited corrosion activity there.

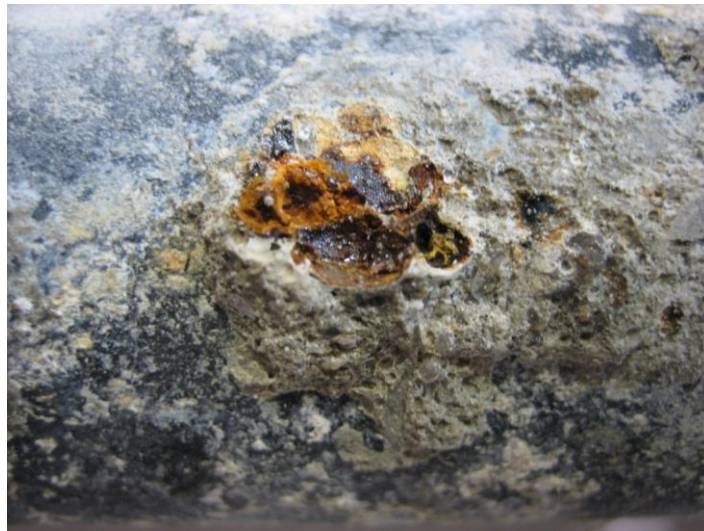
Figure 73 and figure 74 show another actively corroding spot covered with red corrosion product and no corrosion at an artificial large defect along the same bar (GL2), respectively. The absence of corrosion at the defect might be due to sacrificial cathodic protection offered by the zinc coating. Figure 75 shows a cleaned HDG bar piece that contained a 15-mil-deep pit surrounded by shallower pits. Since the galvanized zinc layer was completely penetrated, the red corrosion product of the steel substrate can be seen in the bottom of the deep pit.

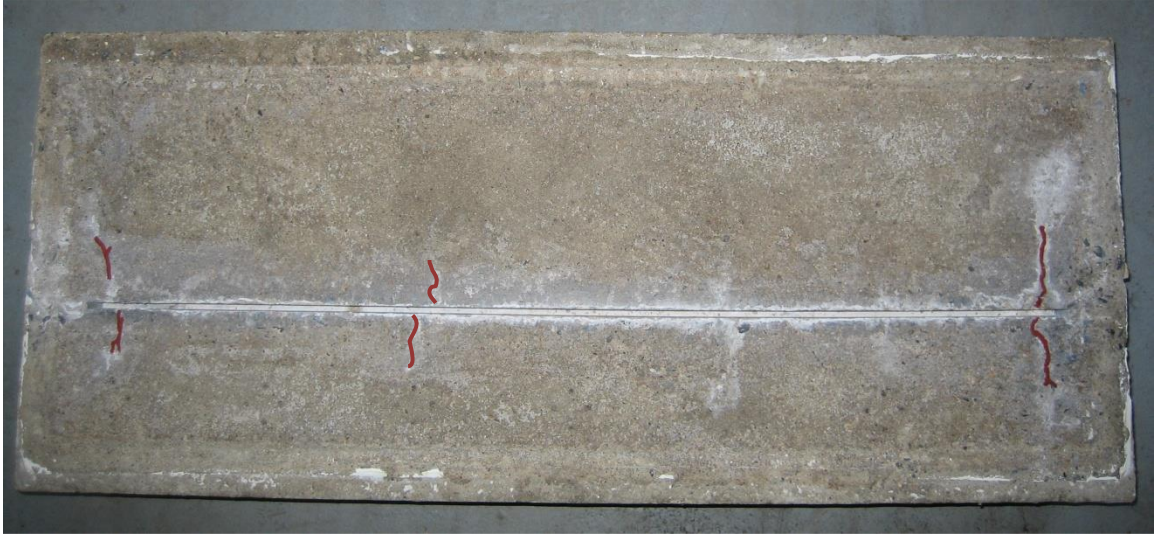
**Figure 76. Photo. Top surface condition of ZC bar slab before autopsy.**

Figure 76 shows the top surface of the ZC bar slab that contained three small cracks. In addition, there was a weak white line that might be another young, small crack being developed. Figure 77 shows physical condition of the as-extracted ZC bars in the same position and orientation as they were in the slab. All of the ZC bars exhibited white zinc oxide and black corrosion products. The type 316L SS bar was clean with no corrosion.

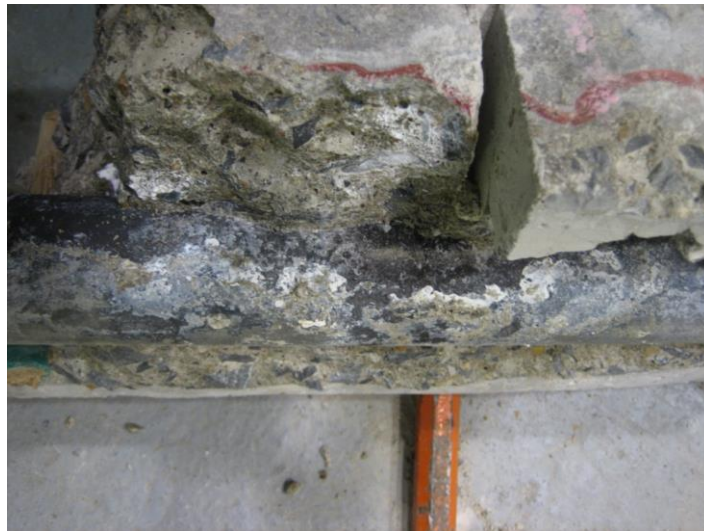
**Figure 78. Photo. Condition of an exposed ZC bar (ZR1).**

and figure 81 show top and bottom sides of the as-extracted ZC bar shown in figure 78, respectively. Its top side shows intensive corrosion covered with black and white corrosion products, and the bottom side shows limited white corrosion product.

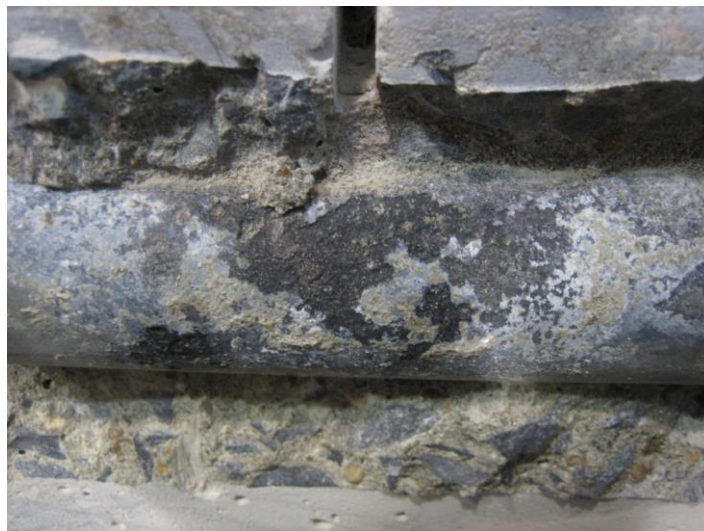
**Figure 82. Photo. Condition of another exposed ZC bar (ZL1).**

Figure 82 and figure 83 show another ZC bar (ZL1) exhibiting worse condition than the previous one on the ZR1 bar. Figure 82 reveals several noticeable pits in the black corrosion product covered area, and figure 83 shows a uniform white zinc corrosion product upon bar extraction that covered the entire bar/concrete interface with a mixture of white and black corrosion products beneath the joint. After viewing the physical condition of the extracted ZC bars and the bar/concrete interface, it is likely that the concrete cracks observed on the top surface are due to excessive corrosion products formed on the interface beneath the cracks.

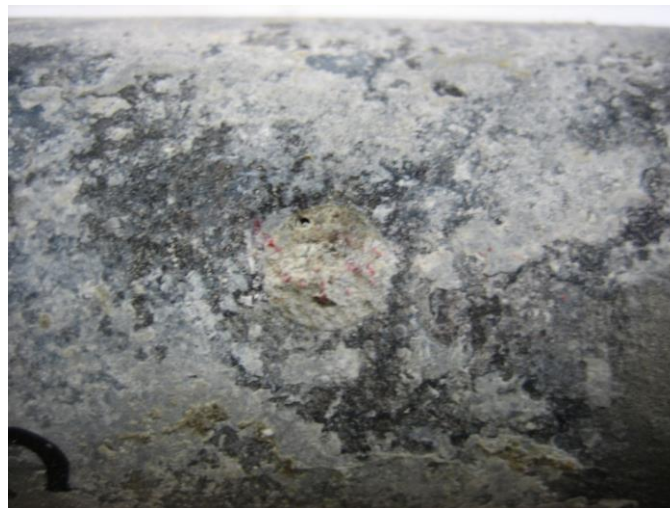
**Figure 84. Photo. Condition of a large defect.**

Figure 84 and figure 85 show close-up views of a large defect and a small defect, respectively. Thanks to the sacrificial cathodic protection of the zinc cladding, none of the defects on the extracted ZC bars showed corrosion. However, figure 86 shows a representative pit that was found in the actively corroding zinc-cladding layer. There were many pits with various sizes and depths. Figure 87 shows a cross-section view of a severely corroded ZC bar. It can be seen that localized corrosion resulted in the compromised zinc-cladding layer with varying pit depths, and the deepest pit in the microphotograph almost reached the steel substrate.

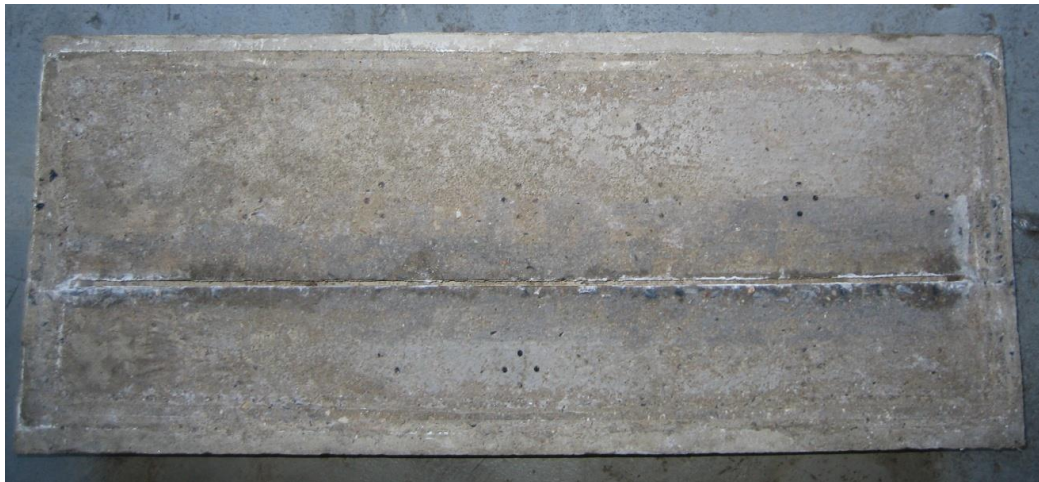
**Figure 88. Photo. Top surface condition of an SCA/SCB bar slab before autopsy.**

Figure 88 shows the top surface of the SCA and SCB bar slab that contained no apparent concrete cracks. Figure 89 shows the physical condition of the as-extracted SCA and SCB bars in the same position and orientation as they were in the slab. All of them exhibited superficial rust stains in some areas. The type 316L SS bar was clean without signs of corrosion.
