Strength and Fatigue Resistance of Clustered Shear Stud Connectors in Composite Steel Girders

PUBLICATION NO. FHWA-HRT-20-005

NOVEMBER 2019

U.S. Department of Transportation
Federal Highway Administration

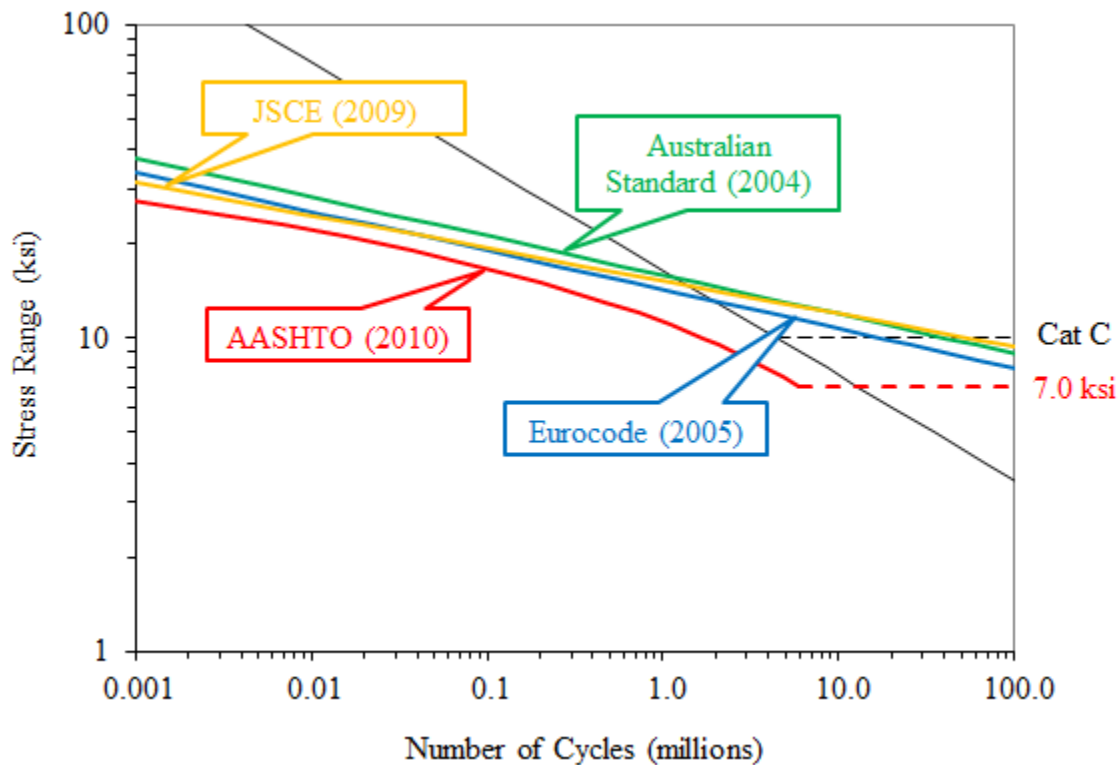
When compared to some international shear stud–fatigue design provisions, the AASHTO equations are quite different. Figure 4 shows the shear stud–fatigue design curves according to AASHTO, the Eurocode 4, the Australian Standard, and the Japan Society of Civil Engineers (JSCE).^(1,8–10) The AASHTO category C fatigue detail is included in the figure for reference. The JSCE design equation depends on various geometric and material properties, so the following were assumed: shear stud diameter of 7/8 inch, shear stud height of 6 inches, and concrete compressive design strength of 4.0 ksi.

As shown in figure 4, the AASHTO fatigue design curve follows a semi-log format (i.e., it is curved in the log-log space). The other international provisions follow a log-log format, with slopes ranging from -8 to -9.5 .⁽⁸⁻¹⁰⁾ These slopes are much shallower than the -3 slope for the other AASHTO fatigue details. This difference in slope is because of the difference in mode of cracking. Shear studs develop fatigue cracks because of shear stresses, whereas the other AASHTO details develop cracks because of tensile stresses. Since the AASHTO shear stud–fatigue design curve is semi-log, the design stress range reduces more drastically as the number of design cycles increases. This is especially evident at approximately 6.0 million cycles, where the infinite fatigue life equation begins to govern. At this point, the AASHTO design stress range is approximately 1.6–1.8 times less than the international provisions shown, requiring a greater number of shear studs. The AASHTO shear stud CAFT of 7.0 ksi also appears somewhat conservative since the international provisions do not include CAFTs.

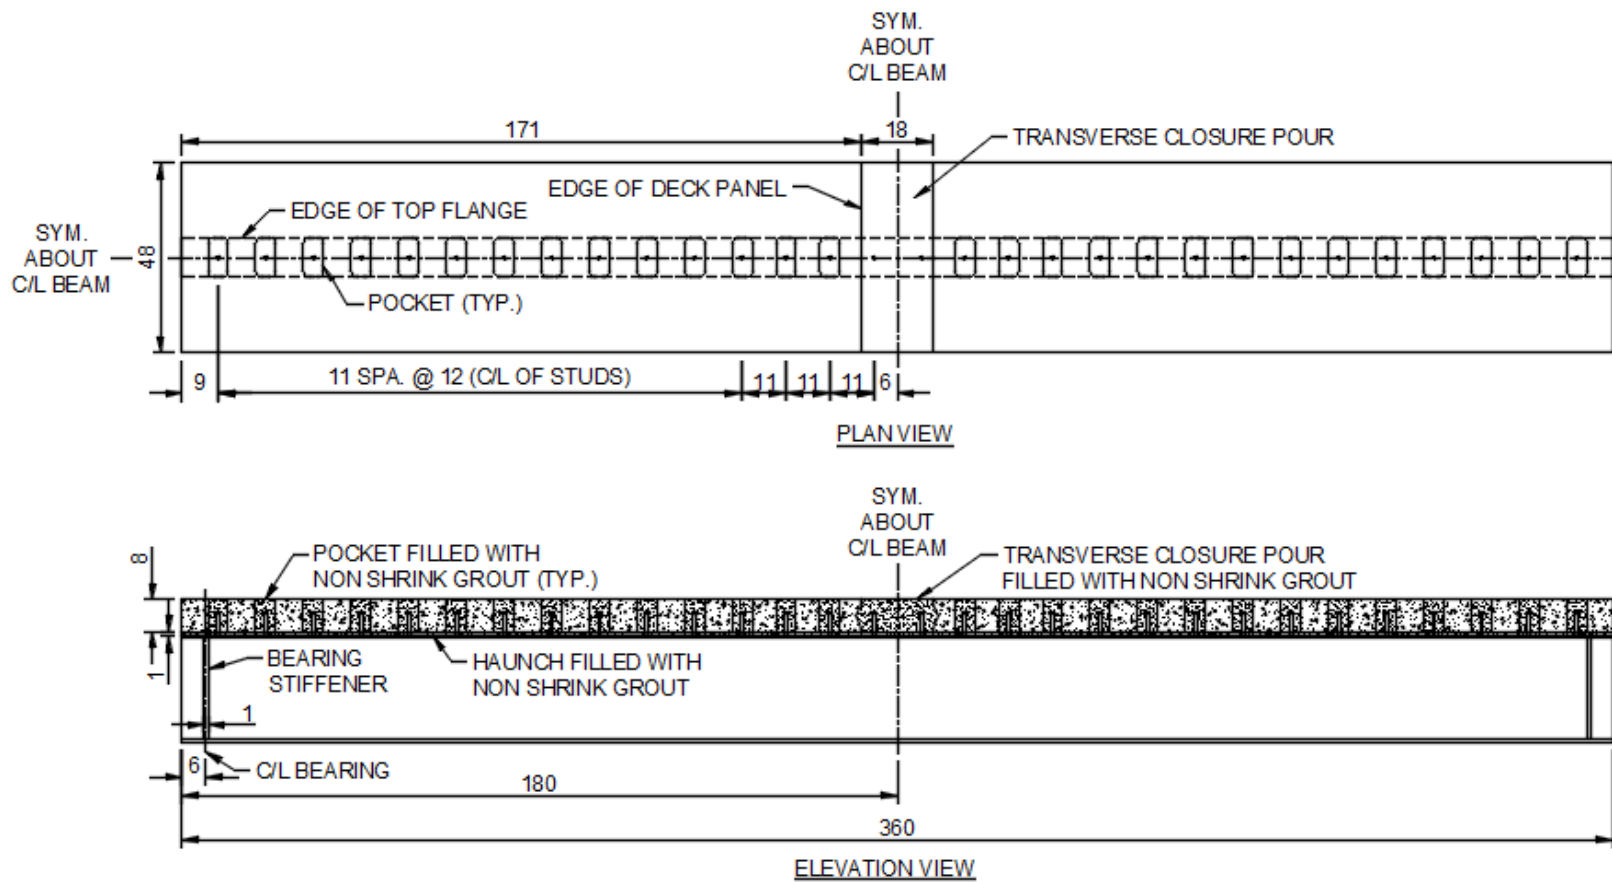
Figure 7. Schematic. Plan and elevation view for all 12-inch spacing beams except 1S2.

Figure 7 through figure 12 show plan and elevation views for each of the large-scale beams tested in this study. Typical sections for each of the beams, except for beam 2S1, are also shown in figure 12. Beam 2S1 has the same sections, except rather than a single shear stud across the width of the flange, there are two shear studs spaced at $4\frac{3}{8}$ inches apart, symmetrically located about the center of the beam web, as shown in figure 8.

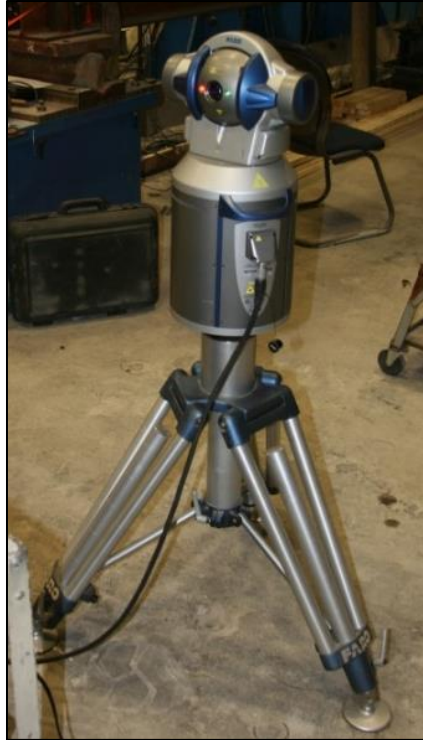
Figure 30. Photo. Laser tracker system head unit.

One unique instrumentation technique used on these tests was taking slip and uplift measurements using a laser tracker. This system uses a centralized head unit on a tripod. The head has two encoders to measure horizontal and vertical angles and an absolute distance measurement laser, which, together, are able to provide highly accurate three-dimensional coordinates of a spherically mounted reflector moved through space by the user. Slip and uplift measurements were recorded by first mounting aluminum spacers, which acted as reference points, to the edges of the haunch and top flange every 6 inches along the entire length of the beam. All of the spacers were mounted to the north side of the beam using hot glue so that the instrumentation cables would not be disturbed when laser tracker measurements were taken. Measurements were recorded by stopping the fatigue tests at predetermined cyclic intervals, depending on the expected life of the fatigue tests, and applying a static load equal to the maximum fatigue load. The spherically mounted reflector was nested into each aluminum spacer, and the team recorded the measurements. Using these measurements, researchers calculated relative slip and uplift between the haunch and the top flange from the baseline measurement. Figure 30 shows a photo of the laser tracker head unit, and figure 31 shows a photo of the method of nesting the prism into the aluminum spacers to record data.

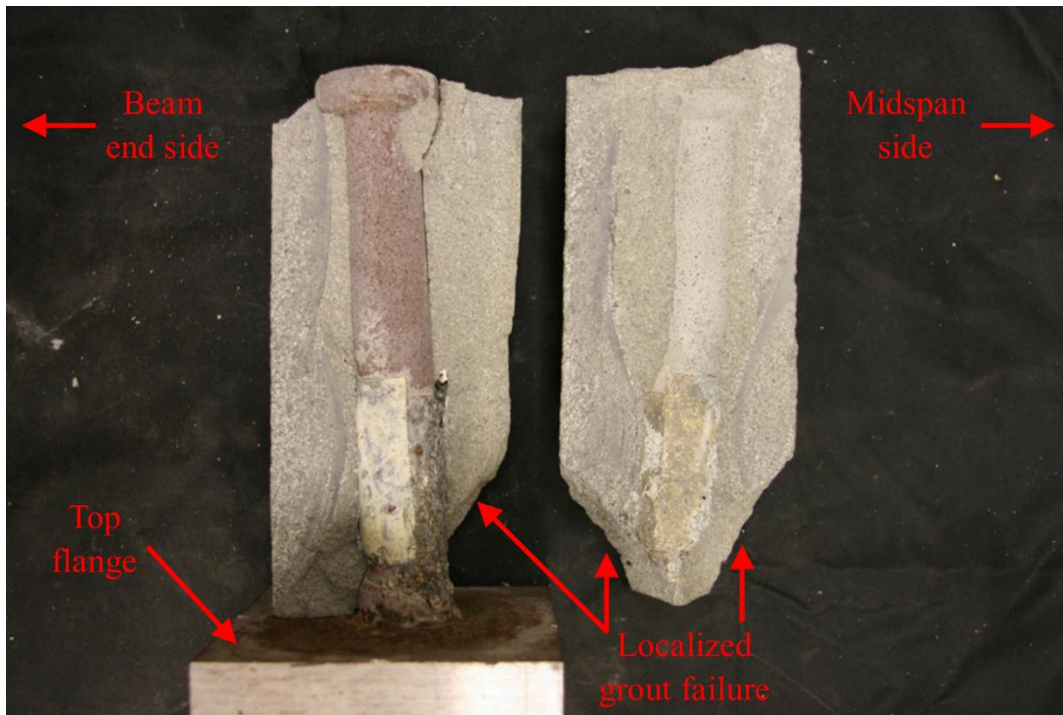
Figure 41. Photo. Typical large-scale fatigue test core showing shear failure in grout.

figure 41 shows a typical photo. This specific grout core was taken from the sixth easternmost shear stud in beam 4F3. Note that this shear stud had a strain gauge installed on it; the protective coating system applied to this strain gauge is seen on the shear stud.

In figure 41, it is clear that the grout crushed locally near the base of the shear stud since no large pieces were retained in that area. This is evident by the diagonal fracture plane on both the midspan and beam-end side of the shear stud. These localized grout failures were common among the intact shear studs. In some cases, the localized grout failures occurred only on the beam-end side, only on the midspan side, or, as shown in the photo, on both sides of the shear stud. The beam-end side and the midspan side of the same grout core are shown in figure 42 and figure 43, respectively. For both of these photos, the two halves of the grout core were placed together to clearly show the entire core.

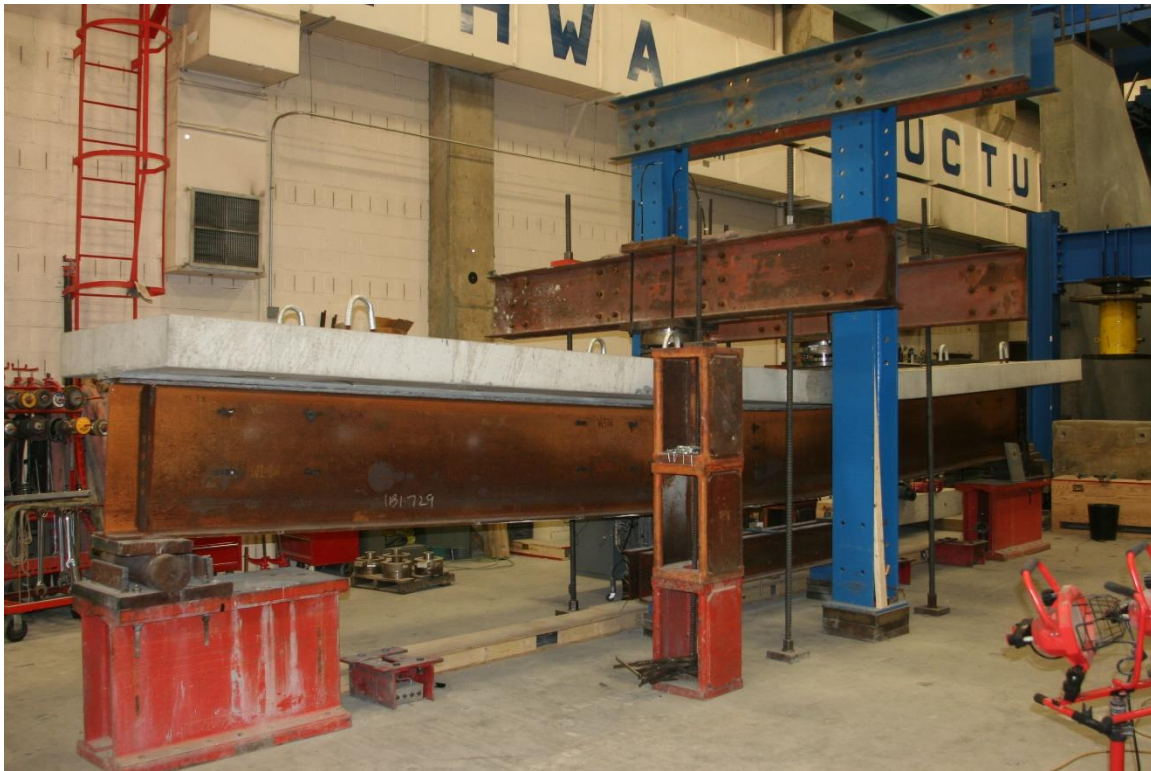
Figure 62. Photo. Overall view of beam 3S1 after completion of large-scale static test.

After the large-scale static tests were complete, researchers visually examined the beams in their damaged states. This included examining the steel beam and identifying the failure mechanism. Figure 62 shows an overall photo of beam 3S1 after completion of the static test. Figure 63 shows a closeup view of the opposite side of beam 3S1. This view shows the grout and concrete crushing on one side of the grouted transverse joint and also shows the yield lines visible in the whitewash that was applied to the steel beam. Both photos represent typical observations seen in the large-scale static tests.

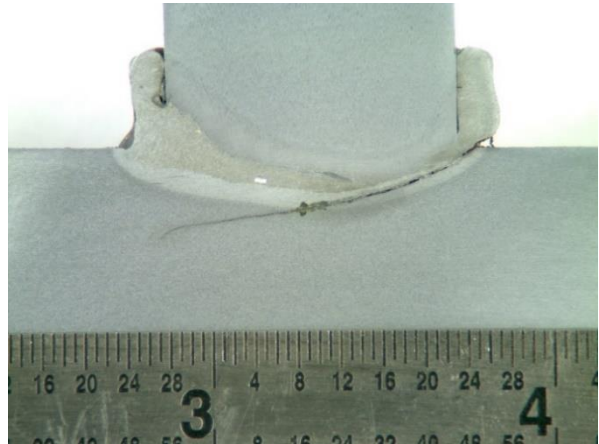
Figure 293. Photo. POF6_2 cross section.

Figure 290 through figure 293 show the photos of the fatigue specimen PO-F6. These specimens had only one stud welded to each side of the beam; the studs were numbered arbitrarily.
