FHWA Workshop

Alkali-Aggregate Reaction

Session 07: Diagnosis and Prognosis of Alkali-Aggregate Reaction

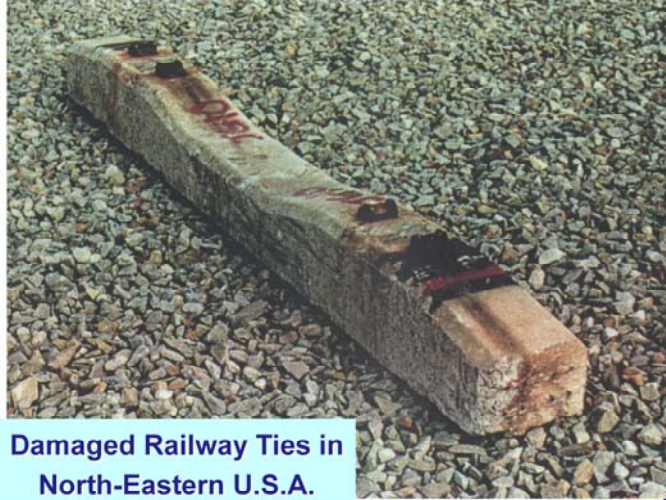
Damaged Railway Ties in North-Eastern U.S.A.

It is particularly a challenge for concrete structures that may be affected by more than one deleterious mechanism. This is the case of a number of railway ties manufactured in the 1990's in the Northeastern USA. Other than the legal case that went on to determine the group responsible for the deterioration, it is critical to identify the source of the problem to apply the proper remediation strategy.

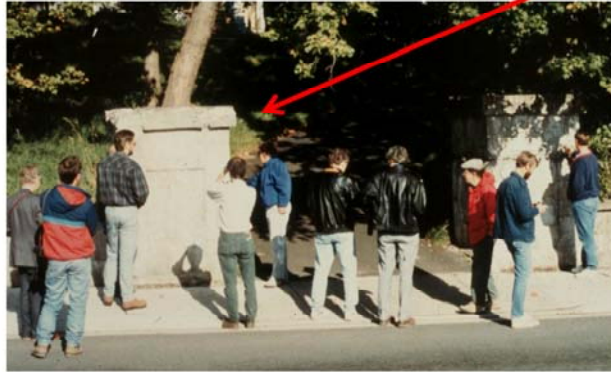
Combined deterioration mechanisms (AAR + FT) !?

The situation can be particularly critical in Northern states or countries where the effects of cracking initiated by ASR are exacerbated by freeze-thaw cycles, which will largely accelerate the progress of deterioration.

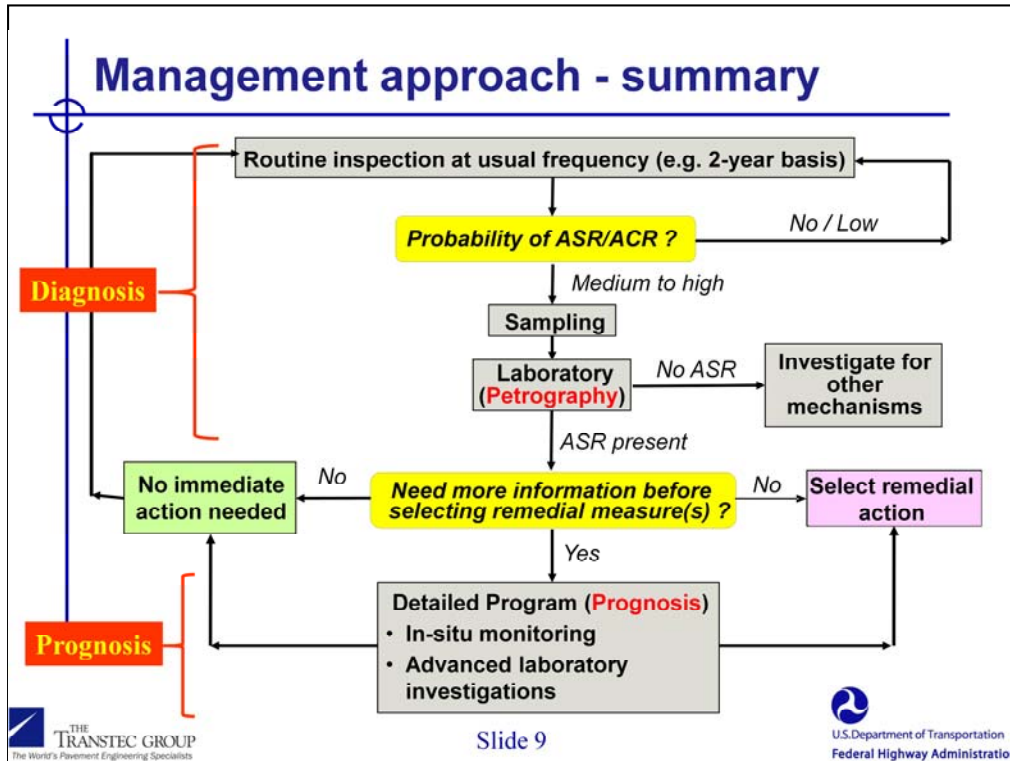
Slide 9

This flowchart presents a step-by-step approach aiming at evaluating the cause of concrete distress (**diagnosis**) and the potential for future expansion/damage (**prognosis**), both elements providing information for the selection of appropriate mitigation measures for ASR-affected structures.

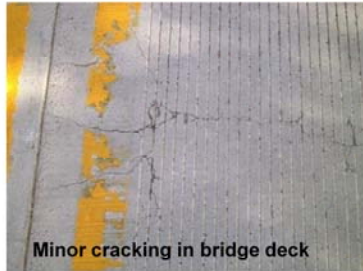
Minor cracking in bridge deck

For instance, examples are given here of minor and moderate cracking in bridge decks, moderate to severe cracking in abutment walls of bridge structures.

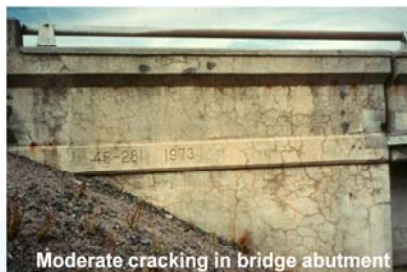
Moderate cracking in bridge abutment

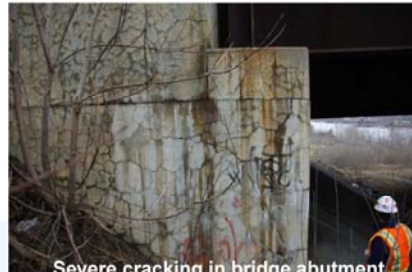
Severe cracking in bridge abutment

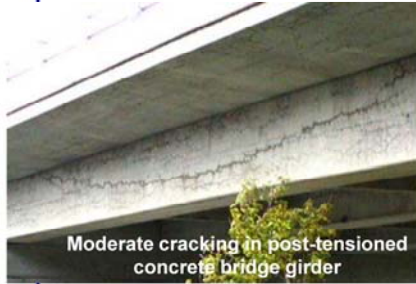
Moderate cracking in post-tensioned concrete bridge girder

Other examples are given in this slide, i.e. moderate cracking in post-tensioned concrete bridge girder, severe cracking in the top chord of a reinforced concrete arch bridge, very severe cracking in the foundation block of columns in a bridge structure, and moderate cracking in a reinforced concrete column.

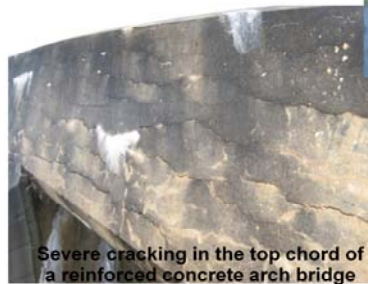
Severe cracking in the top chord of a reinforced concrete arch bridge

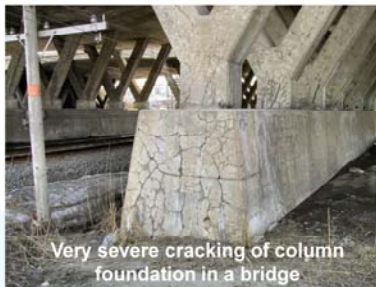
Very severe cracking of column foundation in a bridge

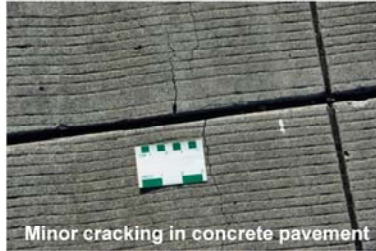
Minor cracking in concrete pavement

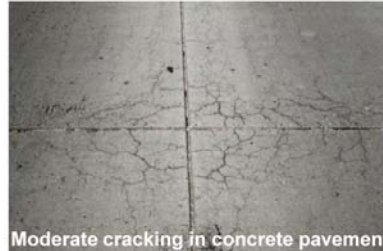
Moderate cracking in concrete pavement

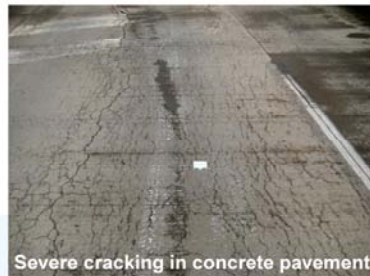
Severe cracking in concrete pavement

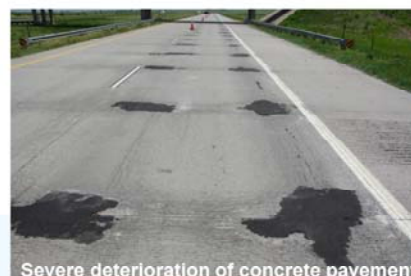
Severe deterioration of concrete pavement

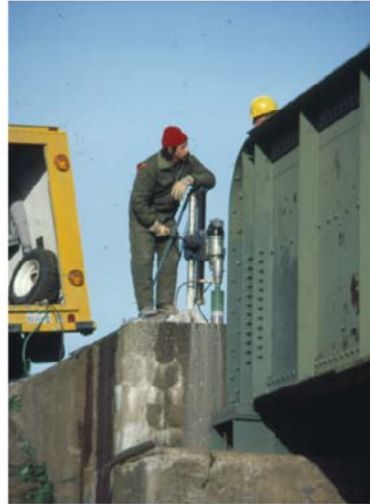
Sampling for Diagnosis

- Look for petrographic evidence of ASR
- Cores from components showing typical / more severe signs suggestive of ASR
- Cores from less deteriorated / exposed components (optional but good for comparison purposes)

At this stage of the program, sampling is carried out on component(s) of the structures showing typical defects suggestive of ASR, which most often correspond to structural components exposed to a constant or renewable supply of moisture.

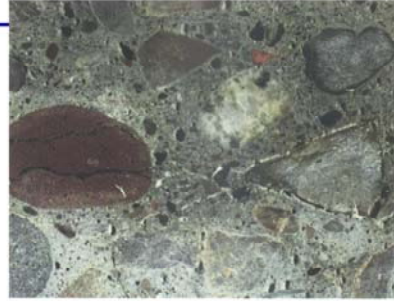
Polished concrete samples

Uranyl acetate staining can be used on polished samples to help identify deposits in cracks or around aggregates.

The confirmation of the presence and of the nature of reaction products is not necessarily easy. Staining techniques have been proposed to help identifying the reaction product gel in concrete affected by ASR.

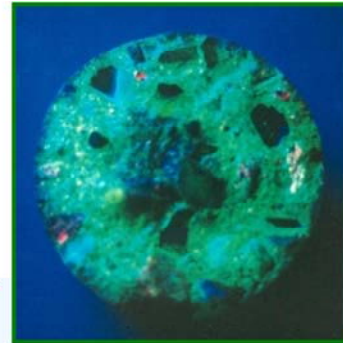
Concrete with no ASR →

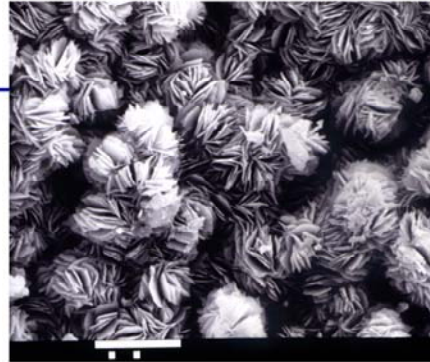
Alkali-rich gel on crack surfaces of the aggregate particles but close to the cement paste

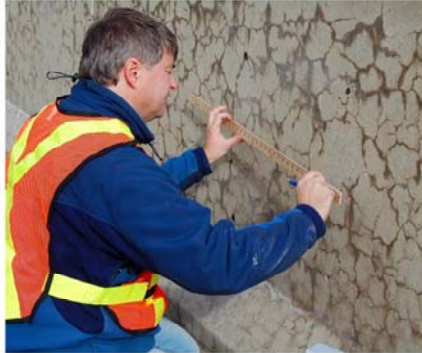
Slide 46

- Measurement and summation of crack widths along a set of lines
- Lines on the most severely cracked structural components (moisture and severe conditions)

The extent of surface cracking on severely exposed/cracked sections of concrete elements is somewhat related to the overall amount of expansion reached by the affected member. The *Cracking Index* method consists in the measurement and summation of crack widths along a set of lines drawn perpendicularly on the surface of the concrete element investigated.

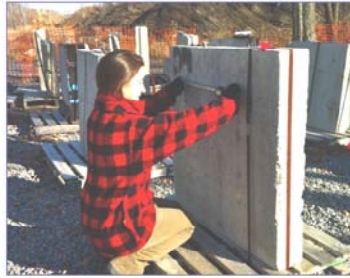
In-situ Investigations - Cracking Index

For example, Francoeur and co-workers, recently used the Cracking Index method to study the progress of expansion and cracking in metric size concrete blocks exposed outdoors and suffering from deleterious aggregate's reactions. The graphs show a good correlation between the expansion of the concrete blocks and the progress of surface cracking measured through the Cracking Index method.

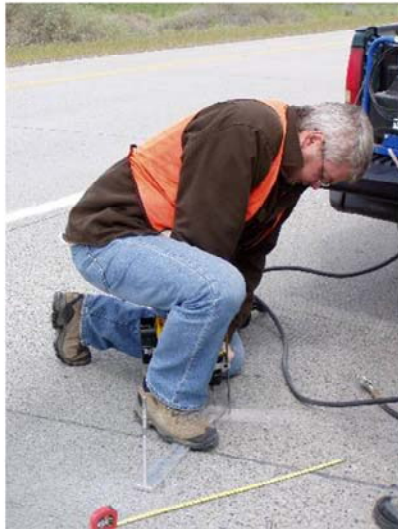
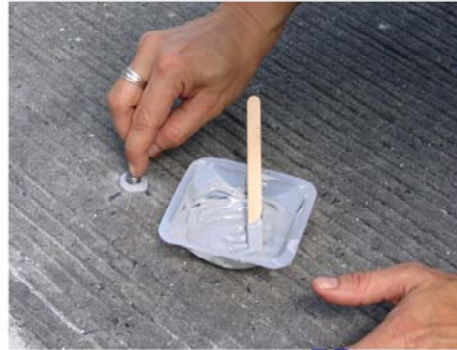
Deformation Measurements

Measurements of expansion/deformation can be performed using demec points or metallic references drilled into the surface of selected structural members and extensometers. As part of the *Federal Highway's ASR Development and Deployment program*, grid systems with demec points were installed on selected ASR-affected and non-deteriorated concrete members, which served for both Cracking Index and expansion measurements.

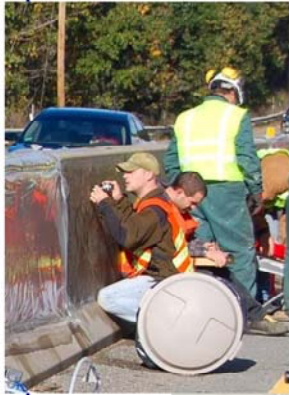
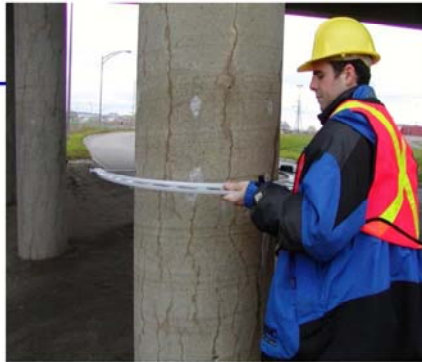
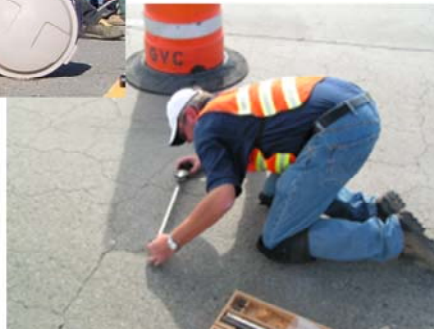
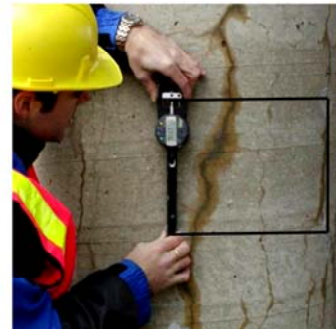
Deformation Measurements

Such a set-up is versatile and can be used on various types of concrete members, such as pavements, barrier walls, abutment walls in bridges, columns, etc.

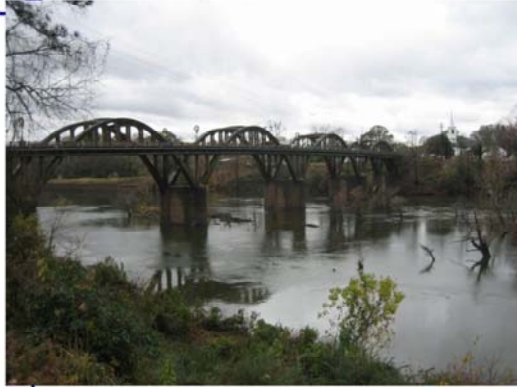
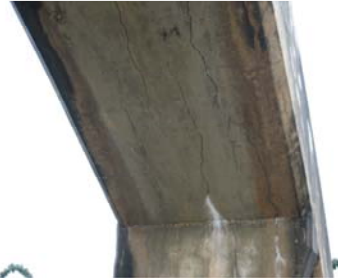
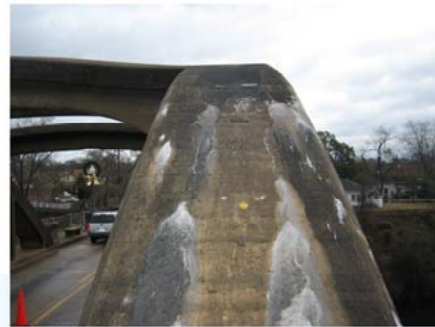
Alabama: Bibb Graves Bridge (Wetumpka)

One arch exhibiting symptoms of ASR; other arches constructed with same materials (same measured alkali content)

This slide shows an historical bridge structure located in Alabama, which has been selected as part of *Federal Highway's ASR Development and Deployment program*. The structure, constructed in 1930 and 1931, is composed of ten concrete arches, with one of them exhibiting significant deterioration. Other arches were constructed with the same materials (same measured alkali content) but are in good condition.

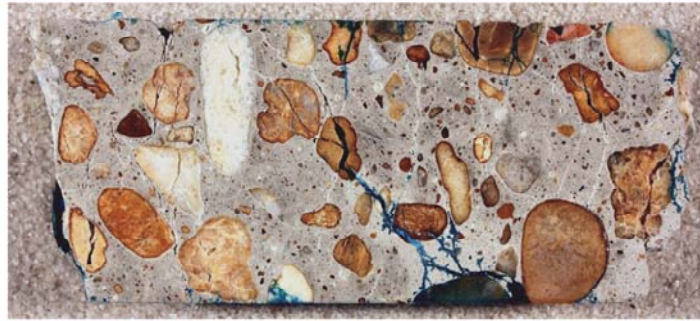
Bibb Graves Bridge

Petrographic symptoms of deterioration included extensive cracking both in the aggregate particles and in the cement paste. Cracks were found to be filled by alkali-silica gel along with large amounts of ettringite in cracks of the cement paste.

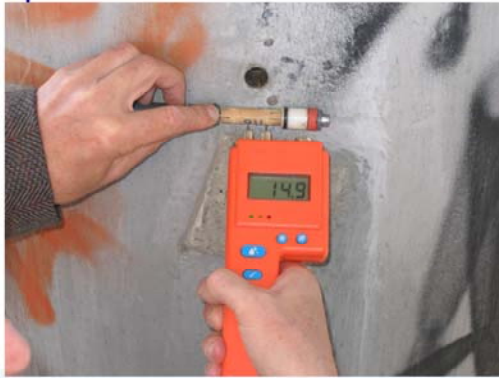
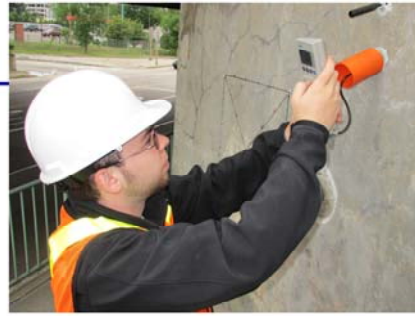
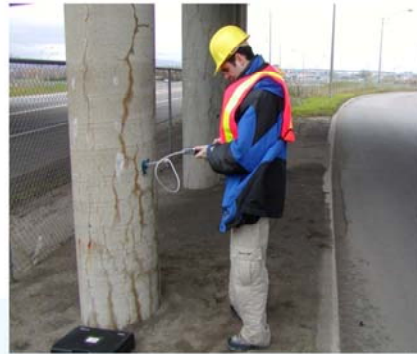
Expansion rate due to ASR is a function of temperature and humidity

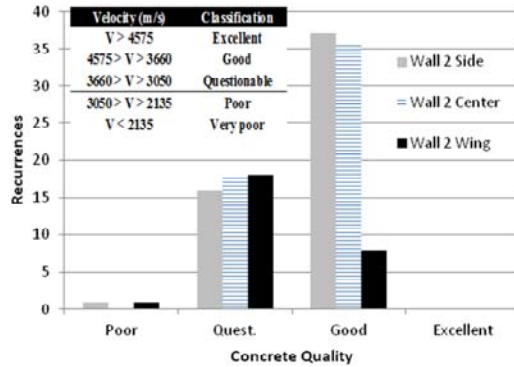
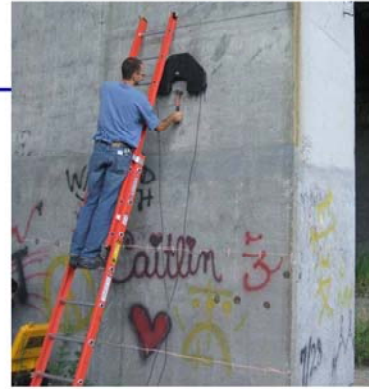
Condition rating of concrete for three walls according to indirect velocities measured in the impact-echo test.

The chart on the left shows an example of a condition rating based on impact echo results obtained on three walls (abutment, side and center; wing wall). It is clear that the wing wall, which is exposed to moisture and displays higher visual damage, has a much lower number of measurement spots classified as "good concrete" compared to the other walls. The center (unexposed) wall has no spots classified as "poor concrete", while the other areas exhibit some. None of the three walls fell in the "excellent" category for concrete quality.

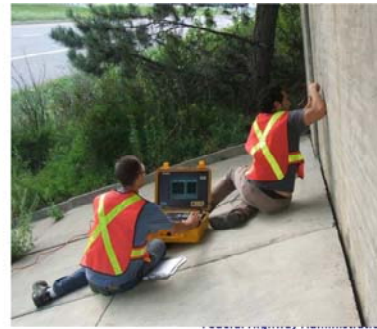
As part of *Federal Highway's ASR Development and Deployment program*, advances are being made to evaluate the reliability of various non-destructive techniques, such as pulse velocity, impact echo (illustrated on the slide), and acoustic methods, for evaluating the progress of ASR in ASR-affected structure treated or not with surface sealers.

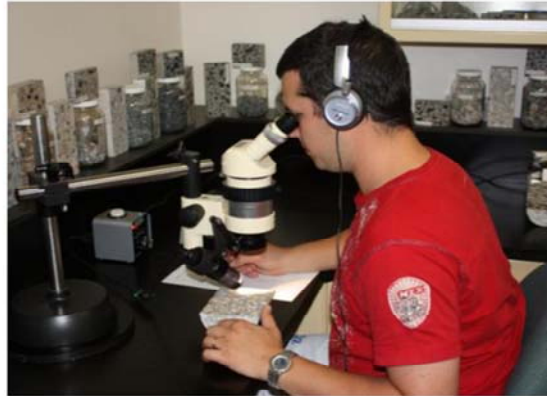
Damage Rating Index (Grattan-Bellew & Danay, 1992)

- Quantitative petrographic procedure
- Polished concrete sections examined under stereobinocular microscope (16x)

The *Damage Rating Index* is a semi-quantitative petrographic technique that evaluates the condition of polished sections of concrete under the stereomicroscope, at about 16x magnification.

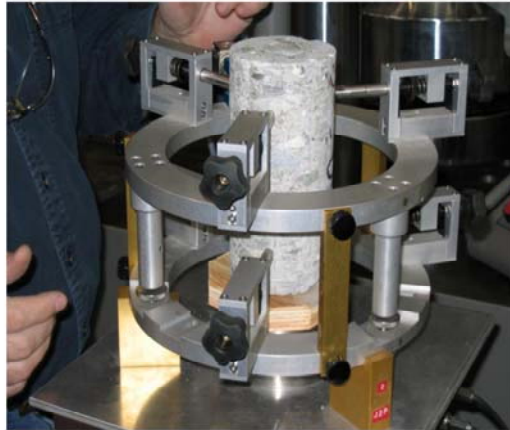
Slide 66

- 5 cycles of loading/unloading up to 10 MPa

The *Stiffness Damage Test (SDT)*, which consists in subjecting concrete cores to 5 cycles of uniaxial loading/unloading can be used for assessing the effect of ASR on the mechanical properties of concrete.

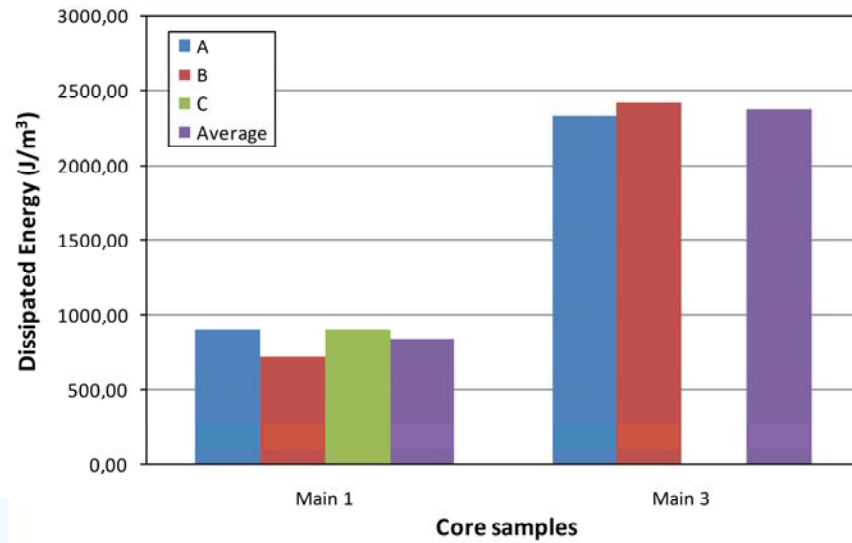
First Cycle hysteresis

This graph shows the Dissipated Energy results obtained for cores extracted from the sites mentioned before. Once again, a good correlation was obtained between the visual condition of the concrete and the SDT results, the highest dissipated energy values (J/m^3) corresponding to the core samples extracted from severely exposed structural elements, i.e. Main 3.

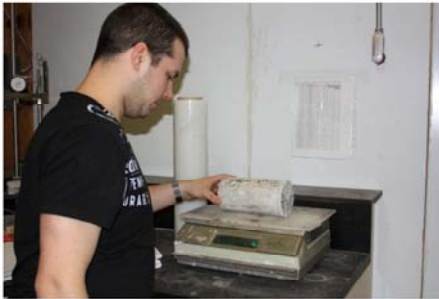
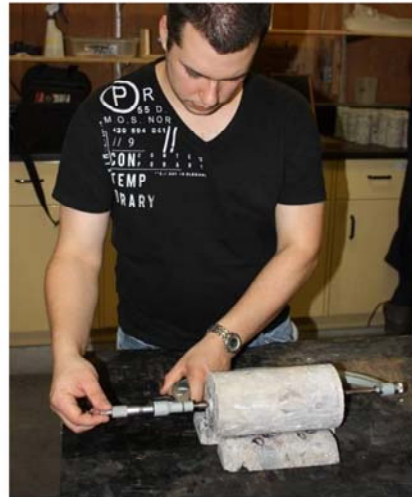
- Install demec points on the cores
- Test a minimum of two cores (minimum 4 inches in Φ)
- Larger cores are recommended (reduce effect of leaching)

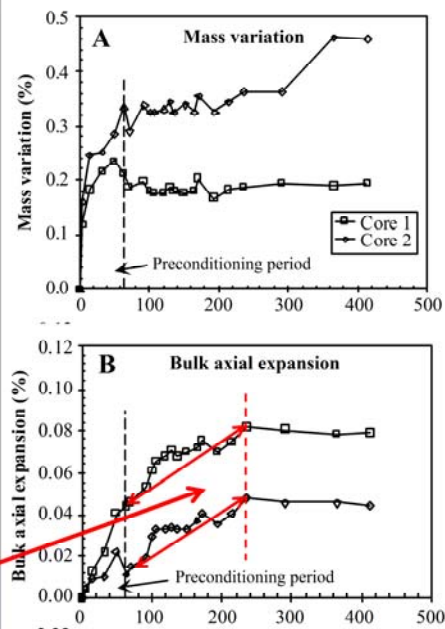
Average residual expansion rate

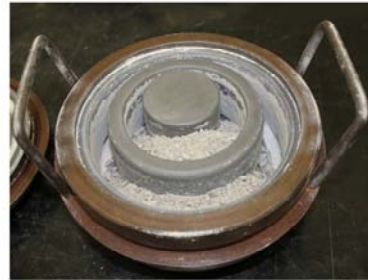
Prognosis – Water soluble alkalis

- 10g ground (< #100 sieve) concrete samples in 100ml of boiling water for 10 minutes
- Solution left to stand overnight
- Solution filtered, completed to 100 ml and [Na, K] determined through chemical analysis

The measurement of the “available/residual” alkali content in concrete can yield interesting information in assessing whether the concrete tested contains sufficient alkalis to sustain this reaction (*prognosis*).
