PT Grout with Elevated Chlorides

2014 TRB Annual Meeting

Long-Term Bridge Performance Program

Reggie Holt, P.E.

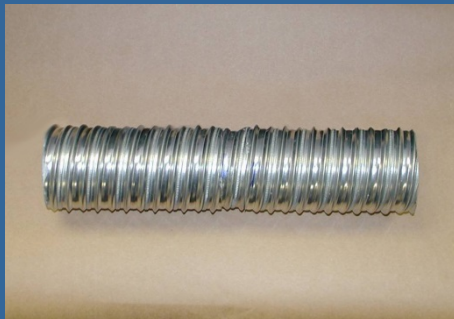
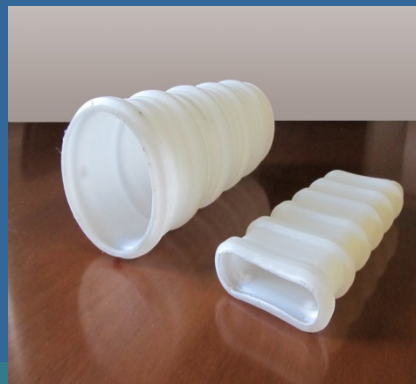
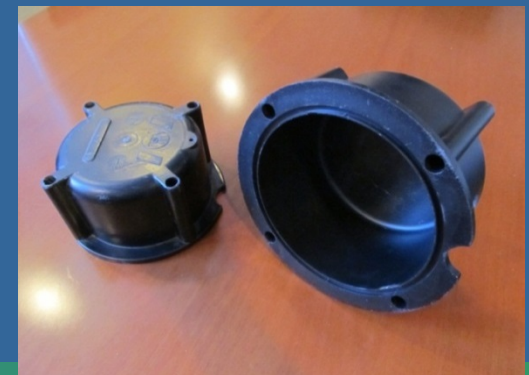
Step 2 - Determine PT Tendon Robustness

- Review Bridge Drawings to Identify PT Details and Components
- Compare Details & Components to Protection Level Requirements in PTI / ASBI *Guide Specification for Grouted Post-Tensioning (June 2012)*
 - PL1A, PL1B, PL2 & PL3

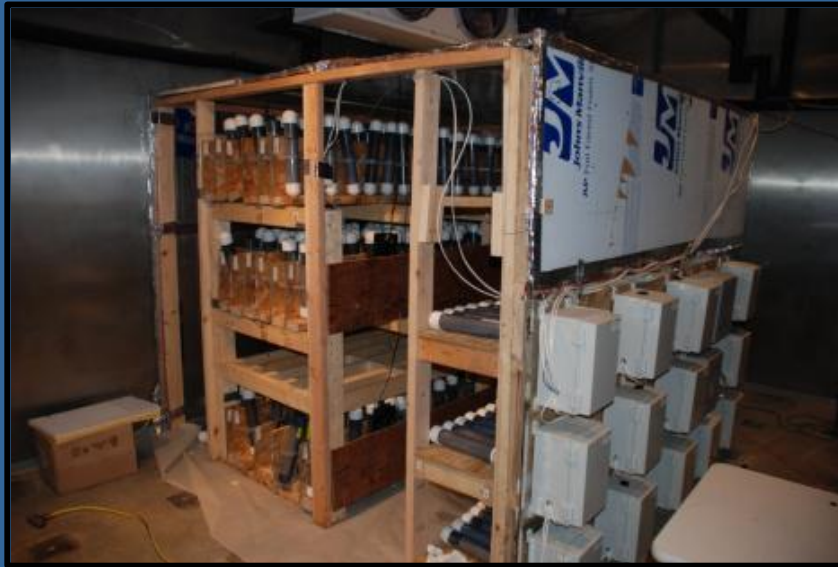
Sika Research

- Research was needed to provide basis on which tolerable chloride concentrations could be identified.

- Research findings
 - Both research teams agreed that sustained corrosion was definitively observed at chloride concentrations above 0.75%.
 - One researcher observed minor and possibly sustained corrosion at 0.40% and suggested that additional research should be directed at understanding the long term importance of this observation.
