# Evaluation of Pine Bluff Bypass Concrete Pavement in Pine Bluff, Arkansas

## *Petrographic Evaluation*

ASR Development and Deployment Program  
Field Application and Demonstration Projects

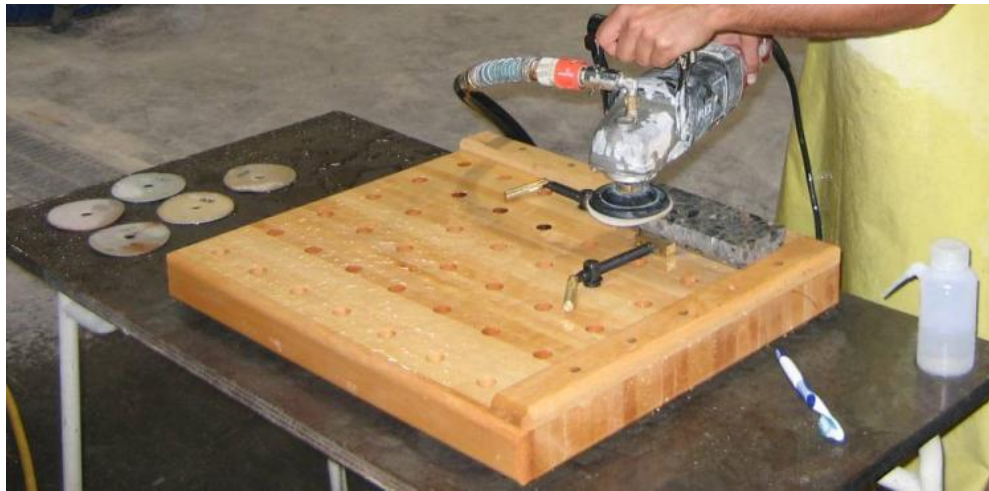
The portable hand-polishing device (Figure 1) uses a series of diamond-coated rubber disks to ensure progressive polishing from coarser to finer sizes [i.e. from disks no. 50 (coarse), 100, 400, 800, 1500 to 3000 (very fine)]. The polished sections are then photographed and a grid is drawn on the section, which includes a minimum of 200 grid squares, 1 cm by 1 cm (0.4 by 0.4 in) in size (Figure 2).

Figure 1: Polishing process of the concrete specimens for the Gel Pat Test.

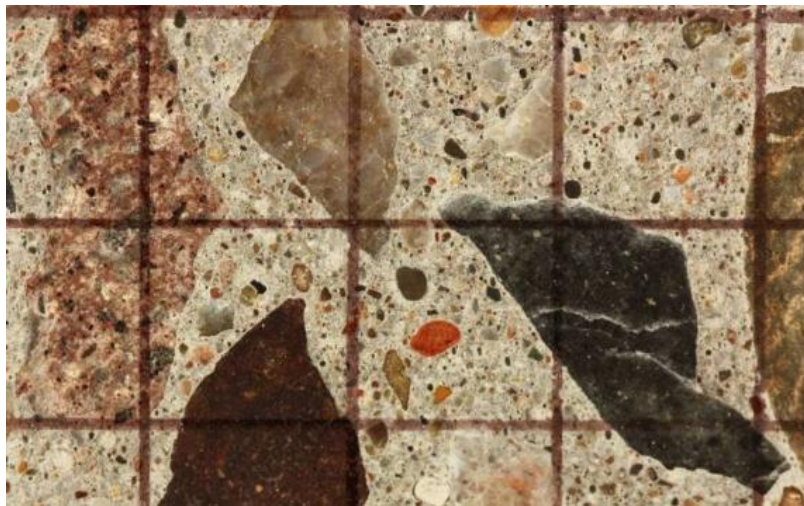
Figure 2: One cm by one cm (0.4 in. by 0.4 in.) grid drawn at the surface of the polished concrete section for petrographic examination using the DRI method.

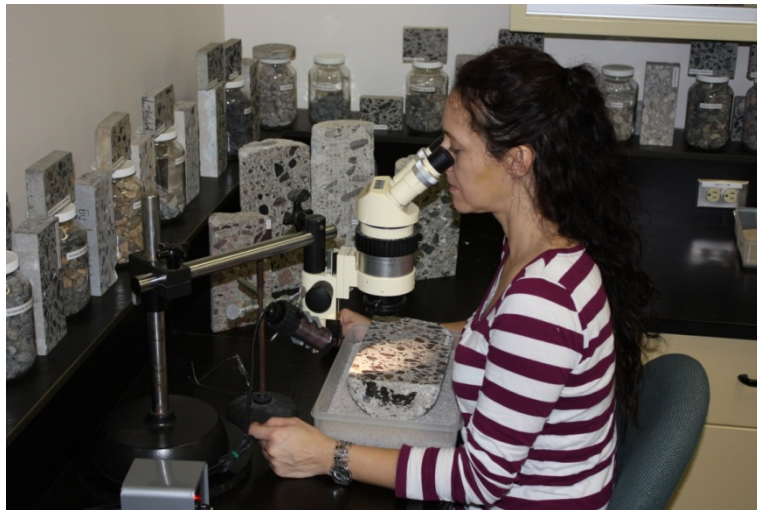
Each grid square is then examined under the stereomicroscope to determine the *Damage Rating Index* (DRI) (Figure 3). Grattan-Bellew (1992) and Dunbar and Grattan-Bellew (1995) indeed described a method to evaluate the condition of concrete by counting the number of typical petrographic features of ASR on polished concrete sections (15x magnification) (Table 2). The *Damage Rating Index* represents the normalized value [to 100 cm<sup>2</sup> (16 in<sup>2</sup>)] of the presence of the above petrographic features after the count of their abundance over the surface examined has been multiplied by weighing factors representing their relative importance in the overall deterioration process. Table 2 also gives the weighing factors originally proposed by Dr. Grattan-Bellew from the National Research Council of Canada and used in this study.

Figure 3: Examination of the polished concrete section under the stereomicroscope for the determination of the *Damage Rating Index*.

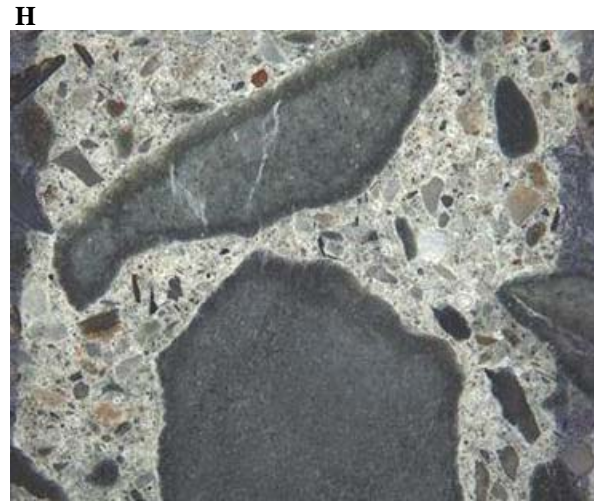
Figure 4 gives examples of the petrographic features that are quantified as part of the process. The DRI was originally developed to quantify the damage in concrete affected by ASR in the coarse aggregate particles. We have thus adopted a procedure that consists in evaluating the presence of petrographic features of ASR in aggregate particles of minimum 2 mm (0.08 in) in size. However, in the case of the Arkansas cores, the preliminary examination of the polished sections revealed that signs of ASR were actually present in the coarser fraction of the fine aggregate (sand) of the concrete (chert particles). For that reason, we modified slightly the DRI procedure to allow the identification of the petrographic signs of deterioration in aggregate particles down to 1 mm (0.04 in) in size.

Figure 4: Examples of typical petrographic features of deterioration due to ASR identified on polished concrete sections as part of the *Damage Rating Index* (DRI). A&B: Cracks in coarse aggregate particles (A- tight cracks; B- open cracks); C&D: Cracks with reaction products in the coarse aggregate particles; E&F: Cracks with reaction products in fine aggregate particles.

Figure 4 (cont'd): G: Debonded coarse aggregate particle; H: Reaction rims around reactive coarse aggregate particles; I: Cracks in the cement paste; J-L: Cracks with reaction products in the cement paste; L: Whitish and glassy alkali-silica reaction products in air voids of the cement paste.

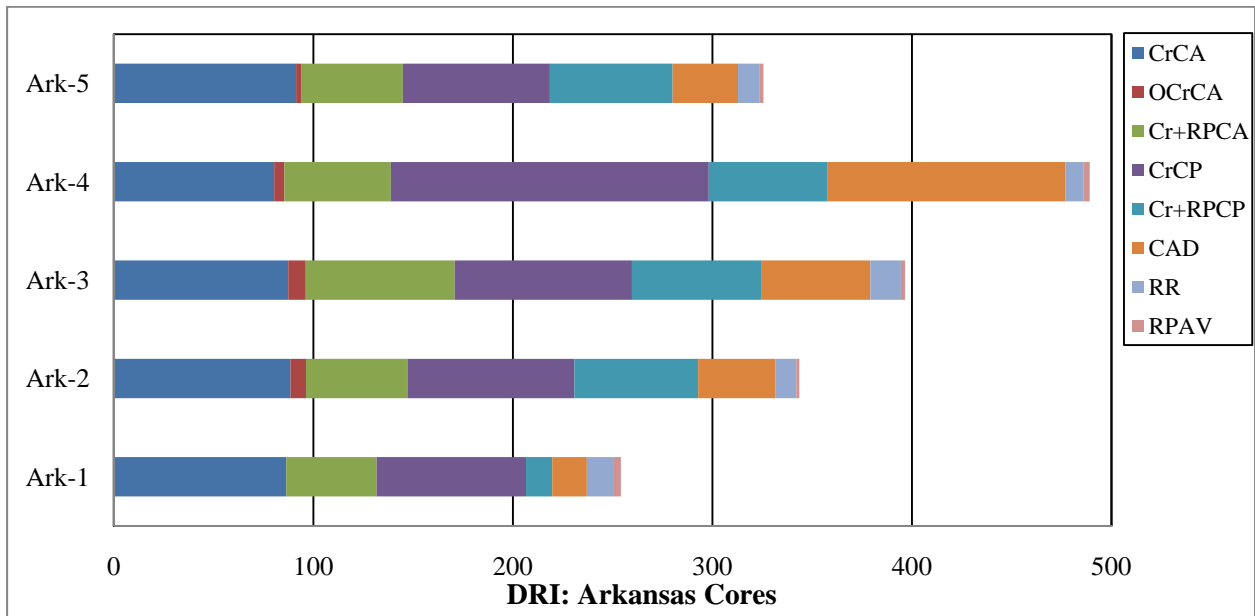
Figure 6: Results of the *Damage Rating Index* (DRI) for the Arkansas DOT cores. The colored cells give the proportions (or contribution in %) of each petrographic feature to the DRI value.

As illustrated in the Figures 5 to 7, the polished concrete sections of the Arkansas cores show *Damage Rating Indices* ranging from 254 to 489, suggesting low to moderate degree of deterioration/damage due to ASR. As indicated in the Figure 6, the highest contributor to the DRI corresponds to *Cracks in the cement paste with or without reaction product (CrCP - Cr+RPCP)* (total of 35 to 45% of the DRI values). Widths of the cracks in the cement paste vary from 0.1 mm (0.004 in) in core Ark-1 to 2 mm (0.08 in) in core Ark-4. Those cracks are not always filled with ASR reaction product and show some signs of carbonation.

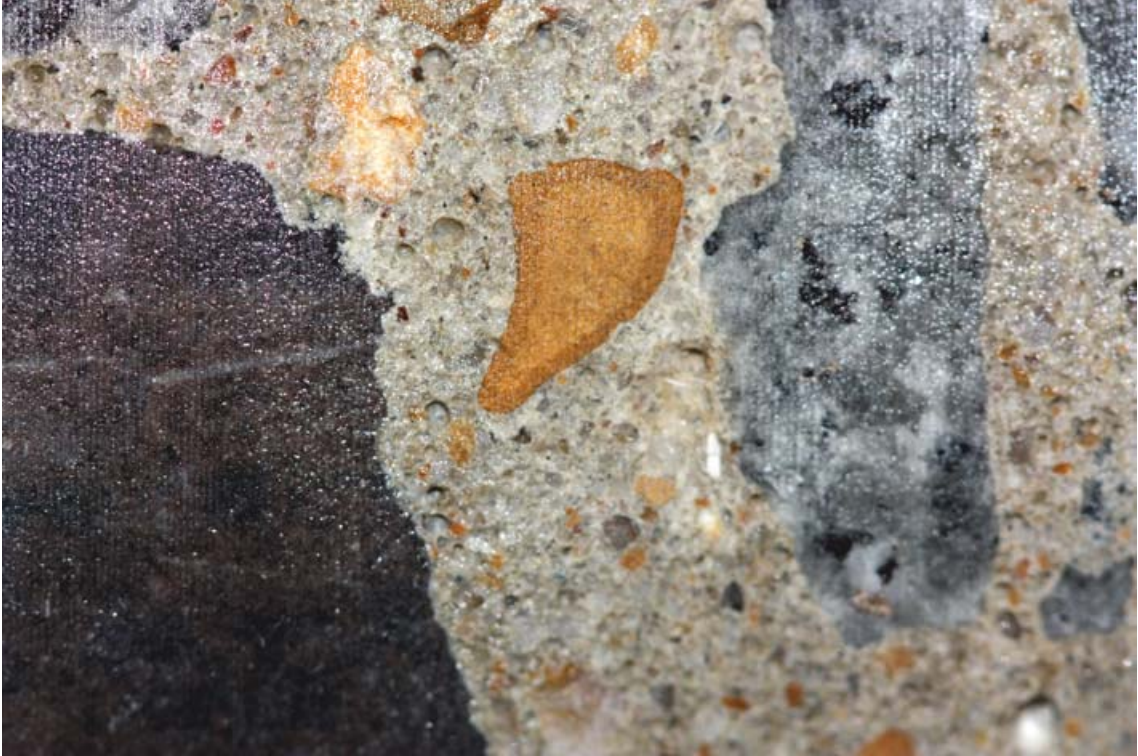
Figure A2: Details on the core Ark-1; reaction rim on a reactive particle of the fine aggregate.

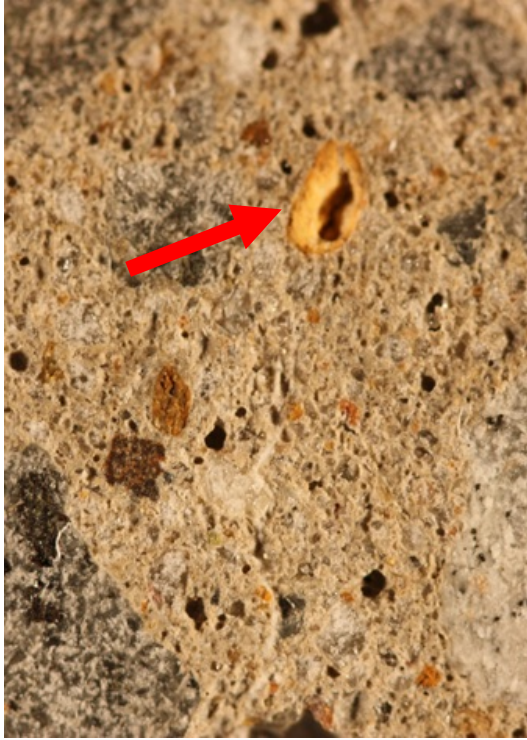
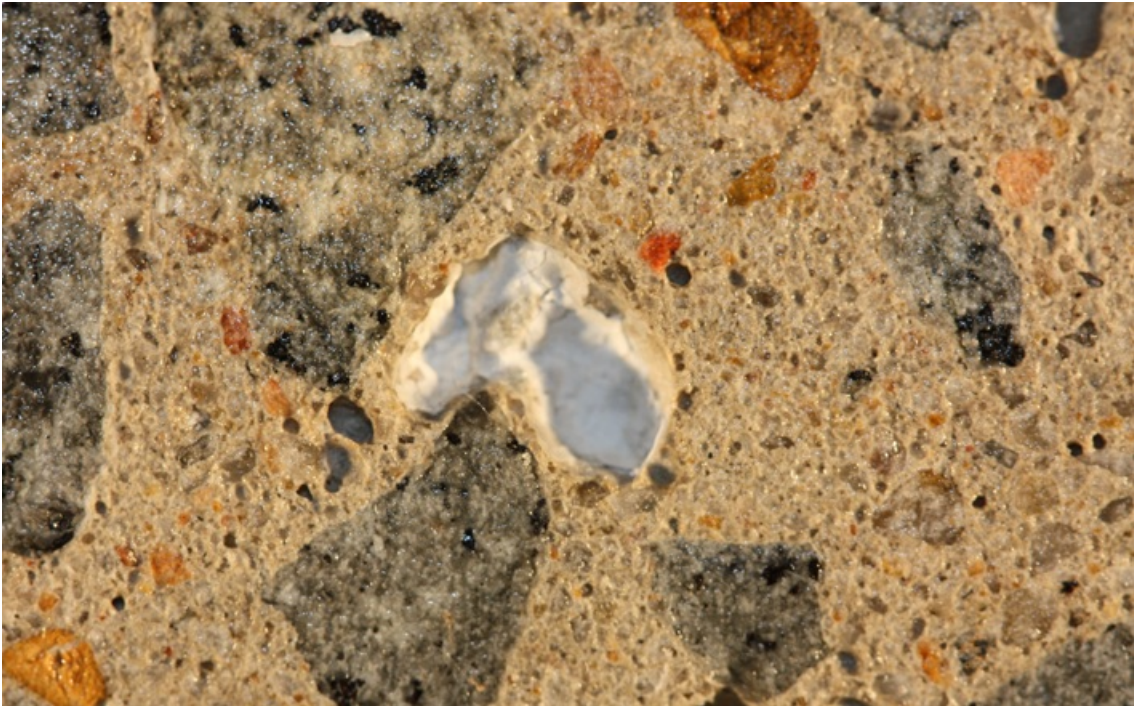
Figure A4: Details on core Ark-2. A: disaggregated/reacted aggregate particle; B: crack in the cement paste running through a reactive sand particle; C: air void filled with alkali-silica reaction product.

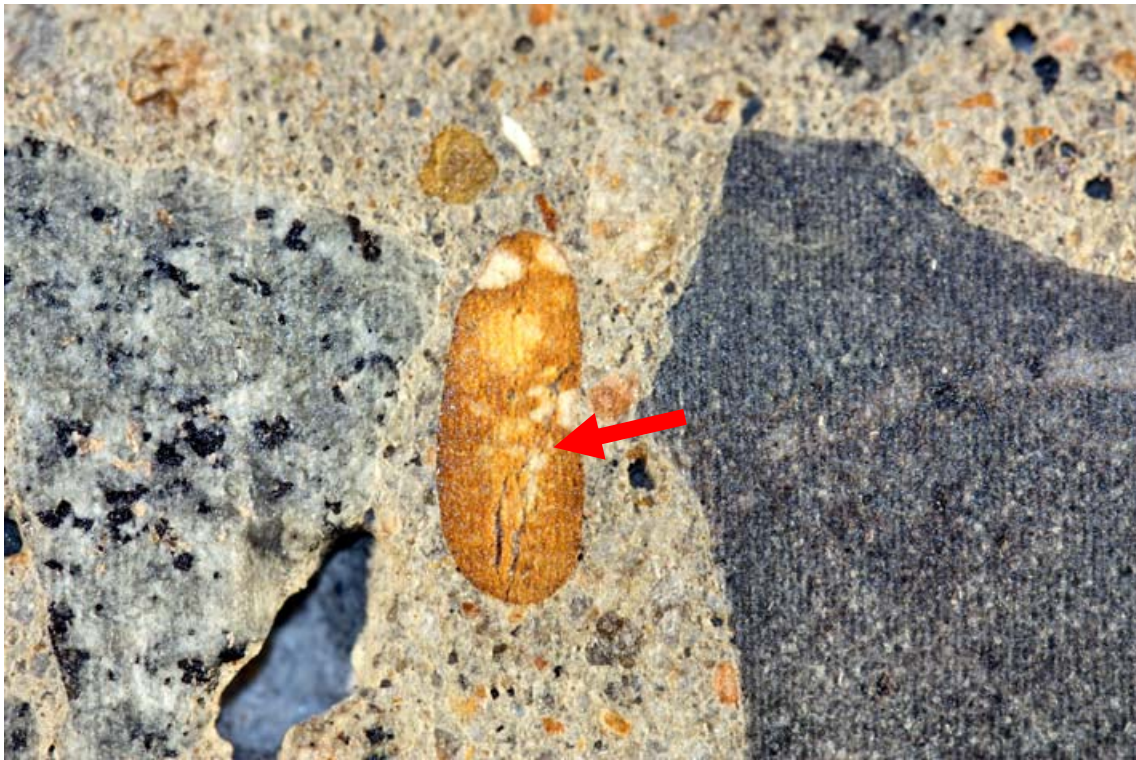
Figure A6: Details on core Ark-3. A: reaction rim around reacted sand particle and air void filled with alkali-silica reaction product; B: cracks with alkali-silica reaction product in a reactive particle of the fine aggregate.

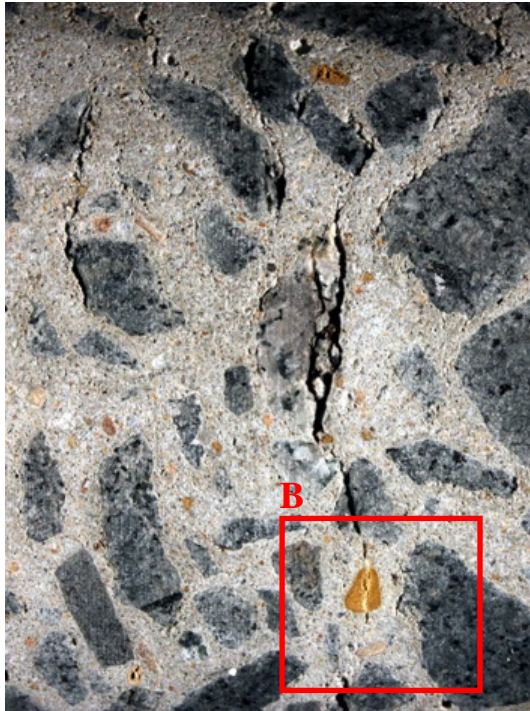
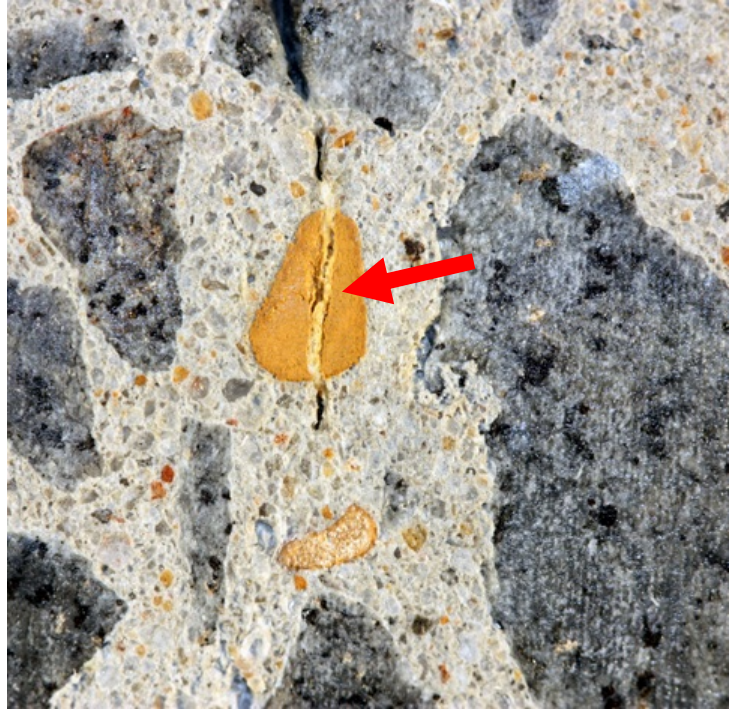
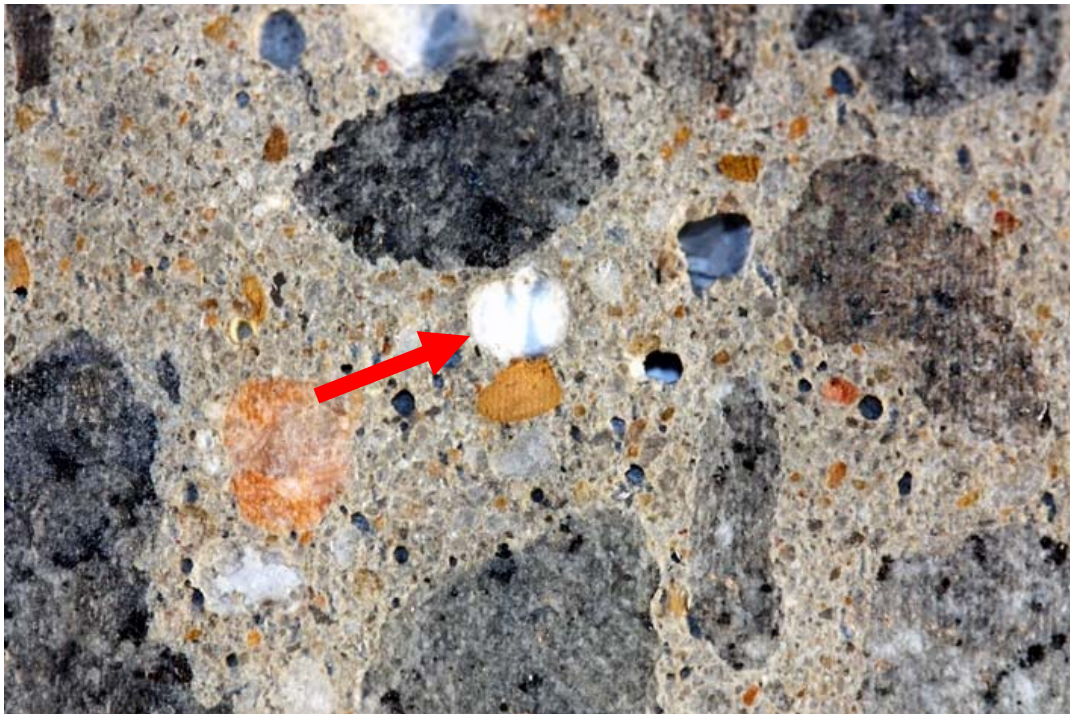
Figure A8: Details on core Ark-4. A: cracks in the cement paste running through a reactive sand particle; B: crack with alkali-silica reaction product in a reactive particle of the fine aggregate; C: air void filled with alkali-silica reaction product.

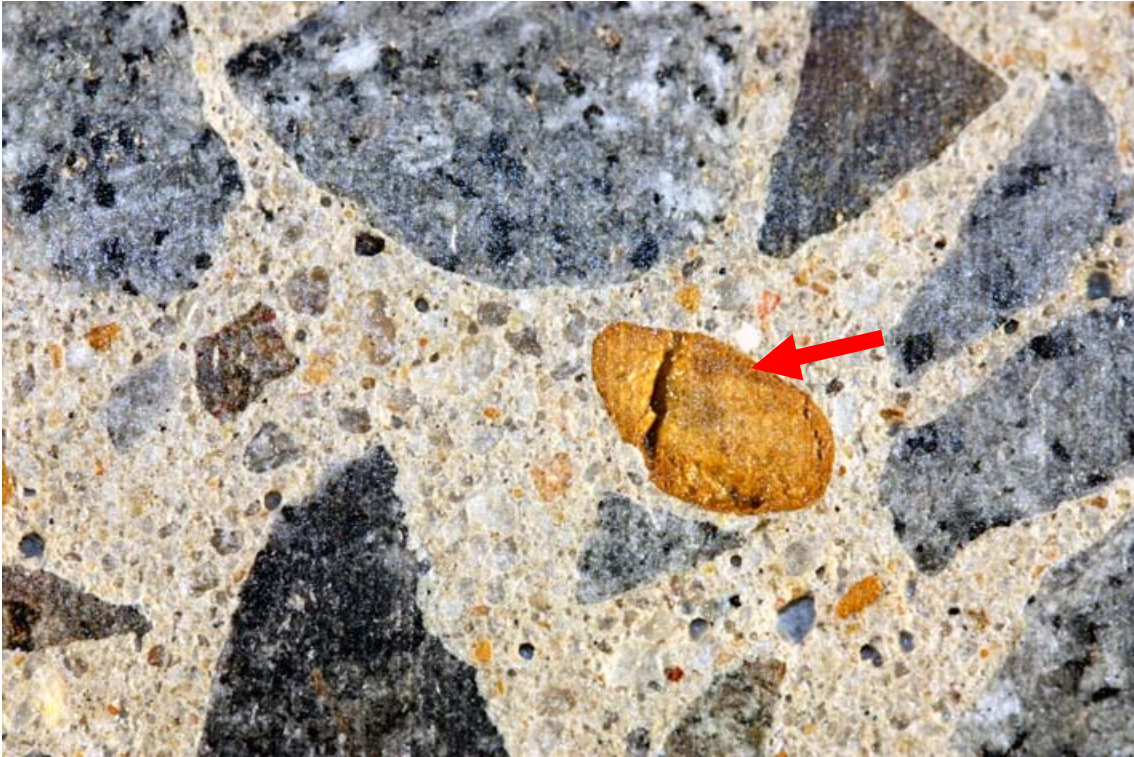
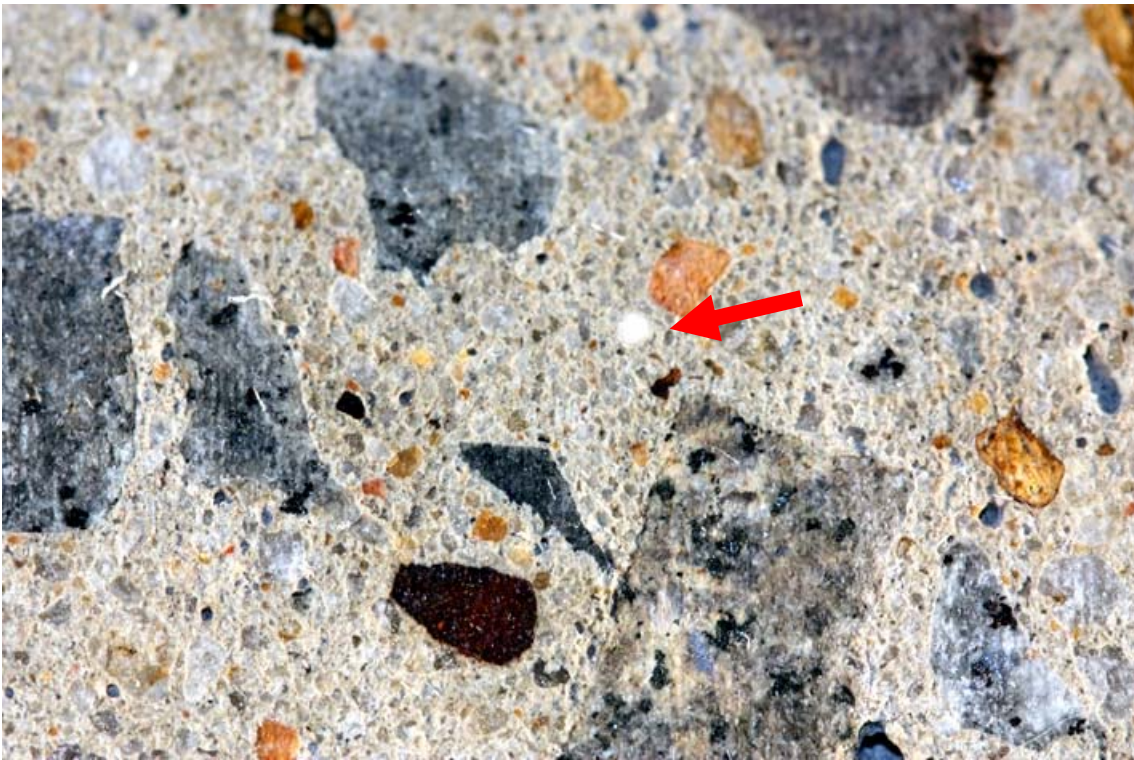
Figure A10: Details on core Ark-5. A: reaction rim and cracks with alkali-silica reaction product in a reacted particle of the fine aggregate; B: air void filled with alkali-silica reaction product.

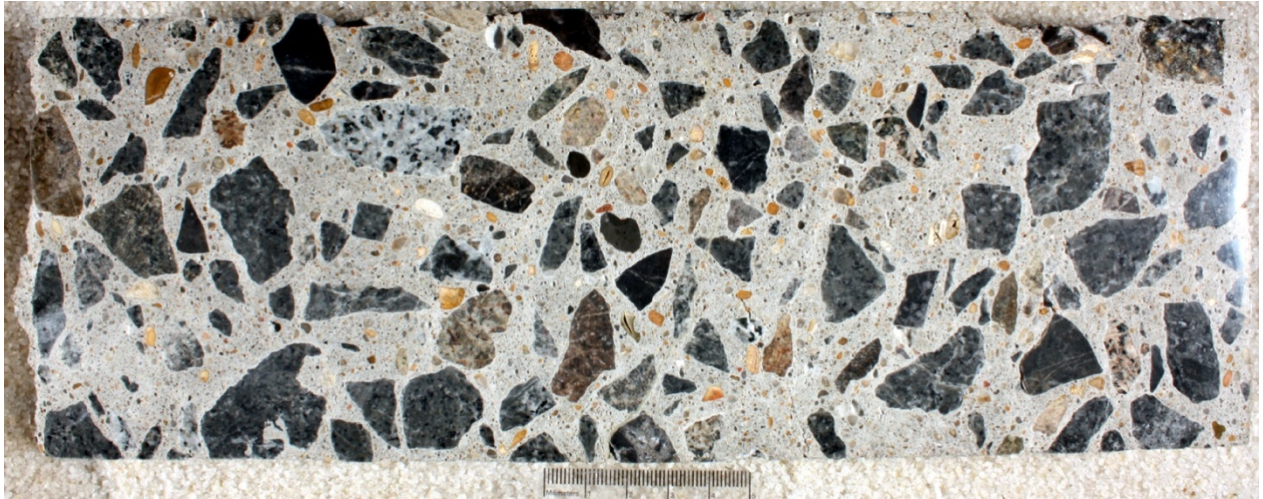
Figure B1: Polished core section Ark-1 and DRI results

Sample	CrCA	OCrCA	Cr+RPCA	CrCP	Cr+RPCP	CAD	RR	RPAV	DRI
Ark-1	86	0	45	75	13	17	13	4	<b>254</b>

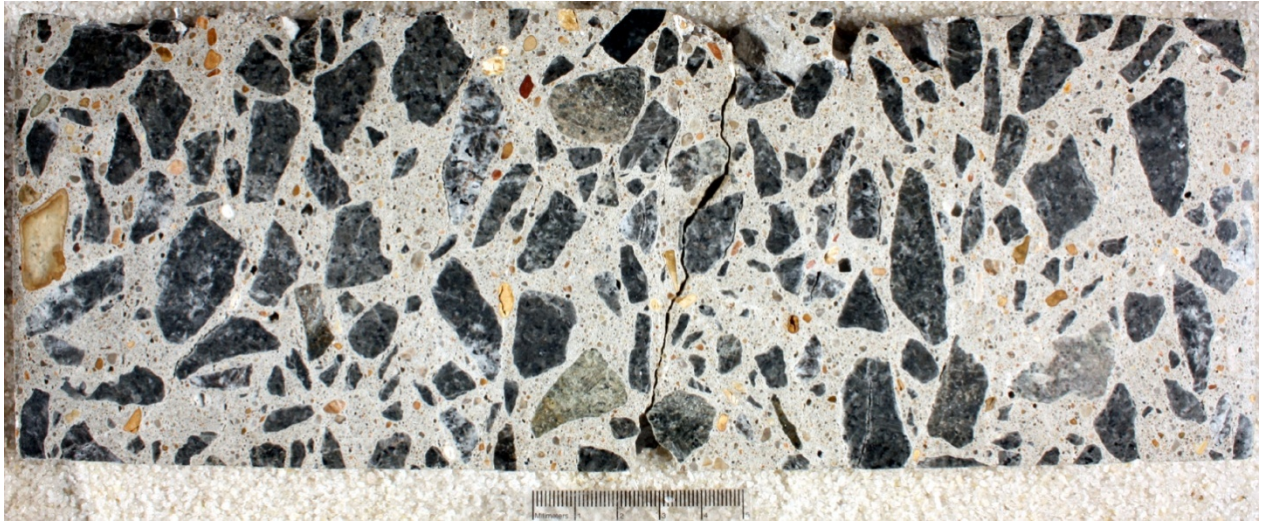
Figure B3: Polished core section Ark-2 and DRI results

Sample	CrCA	OCrCA	Cr+RPCA	CrCP	Cr+RPCP	CAD	RR	RPAV	DRI
Ark-2	89	8	51	84	62	39	10	2	<b>344</b>

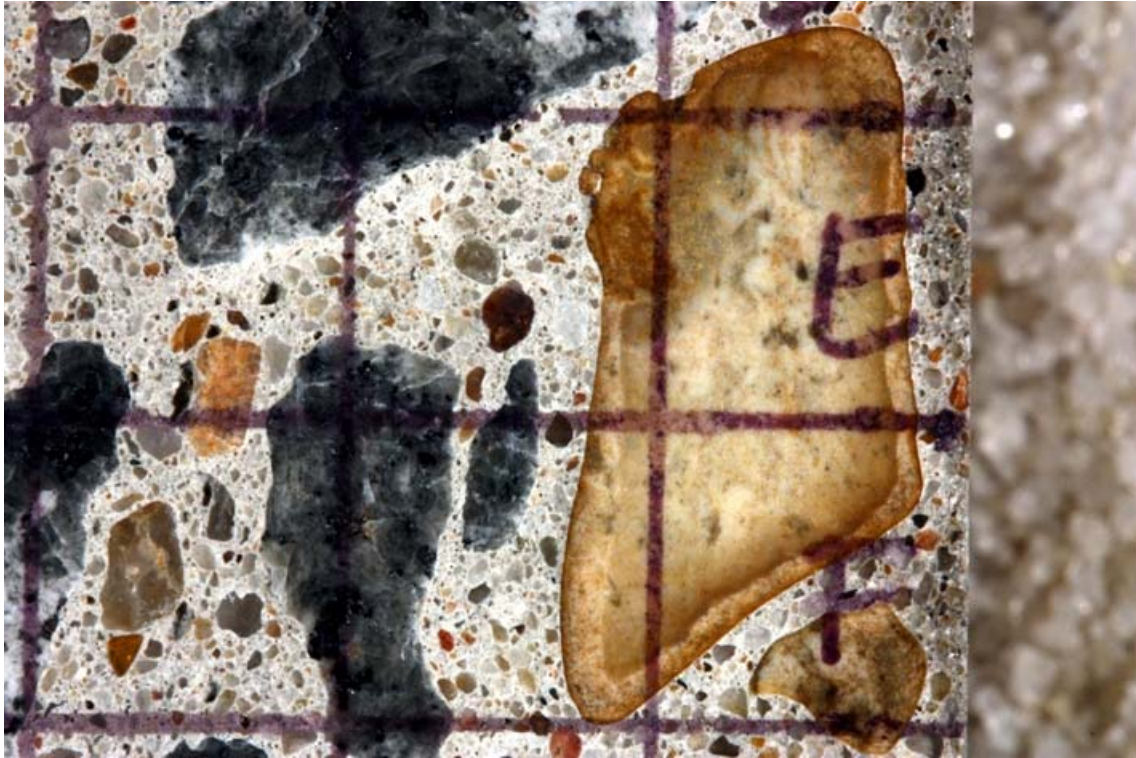
Figure B4: Micrographs of the polished section Ark-2 [distance between vertical lines = 1 cm (0.4 in.)] showing reaction rims around a coarse particle of chert (same nature as fine aggregate particles).

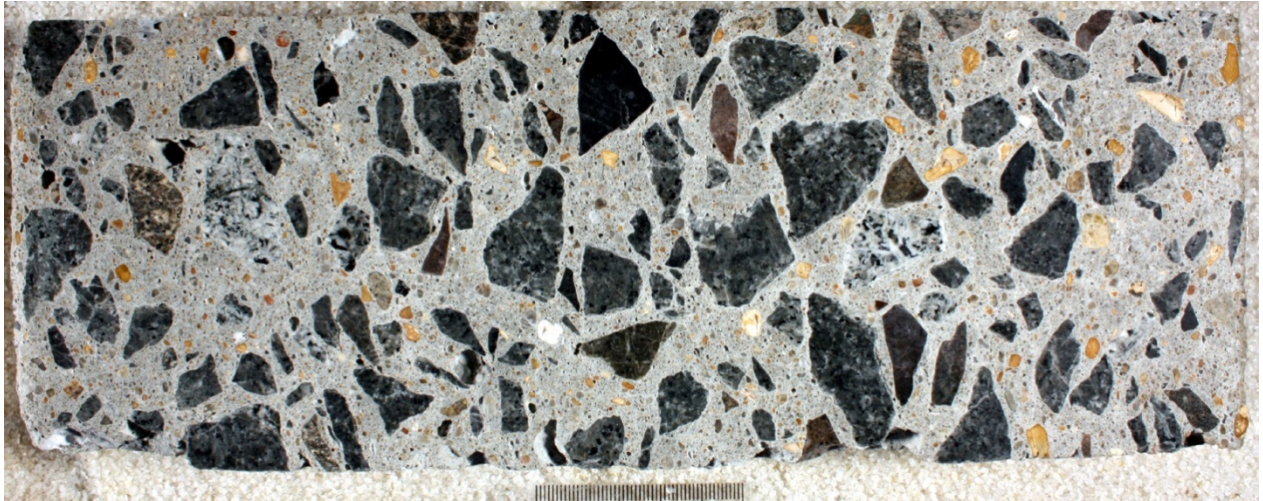
Figure B6: Polished core section Ark-3 and DRI results

Sample	CrCA	OCrCA	Cr+RPCA	CrCP	Cr+RPCP	CAD	RR	RPAV	DRI
Ark-3	87	9	75	89	65	55	15	2	<b>397</b>

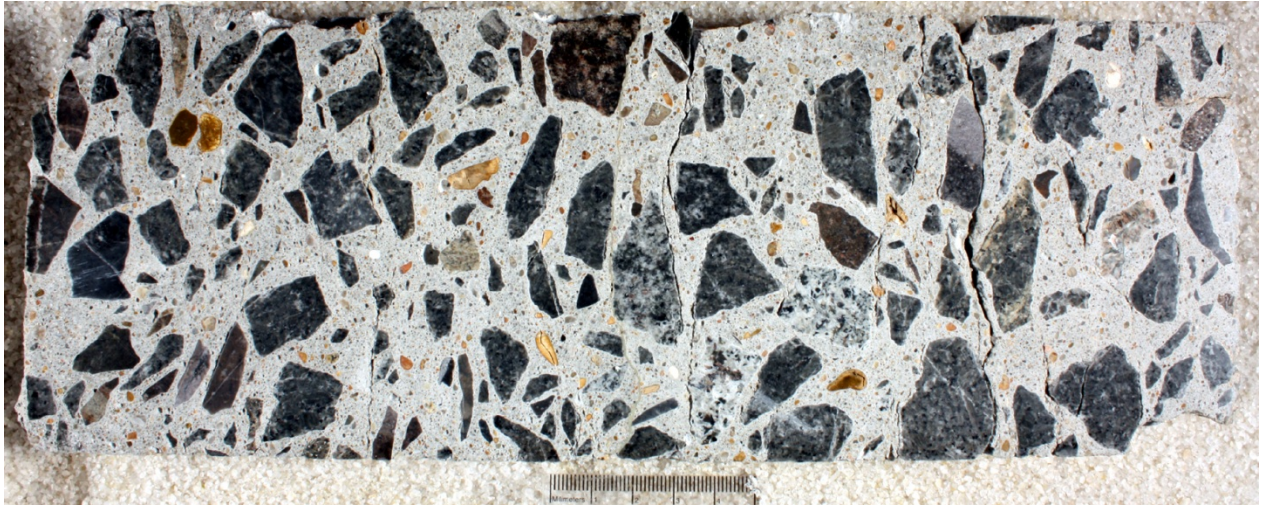
Figure B8: Polished core section Ark-4 and DRI results

Sample	CrCA	OCrCA	Cr+RPCA	CrCP	Cr+RPCP	CAD	RR	RPAV	DRI
Ark-4	80	5	53	159	59	119	9	3	<b>489</b>

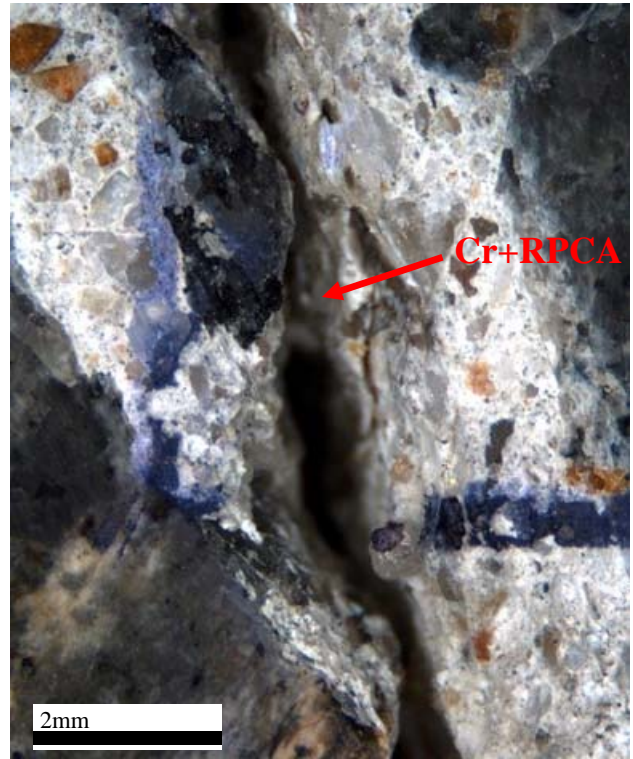
Figure B9: Micrographs showing petrographic features observed on the concrete polished section of core Ark-4. A to C: cracks with alkali-silica reaction product in the fine aggregate (Cr+RPCA) and in the cement paste (Cr+RPCP); D: cracking in the cement paste (CrCP) and a debonded coarse aggregate (CAD).

Figure B9 (cont'd): Micrographs showing petrographic features observed on the concrete polished section of core Ark-4. E: debonded coarse aggregate (CAD) and an open crack in the cement paste (CrCP).

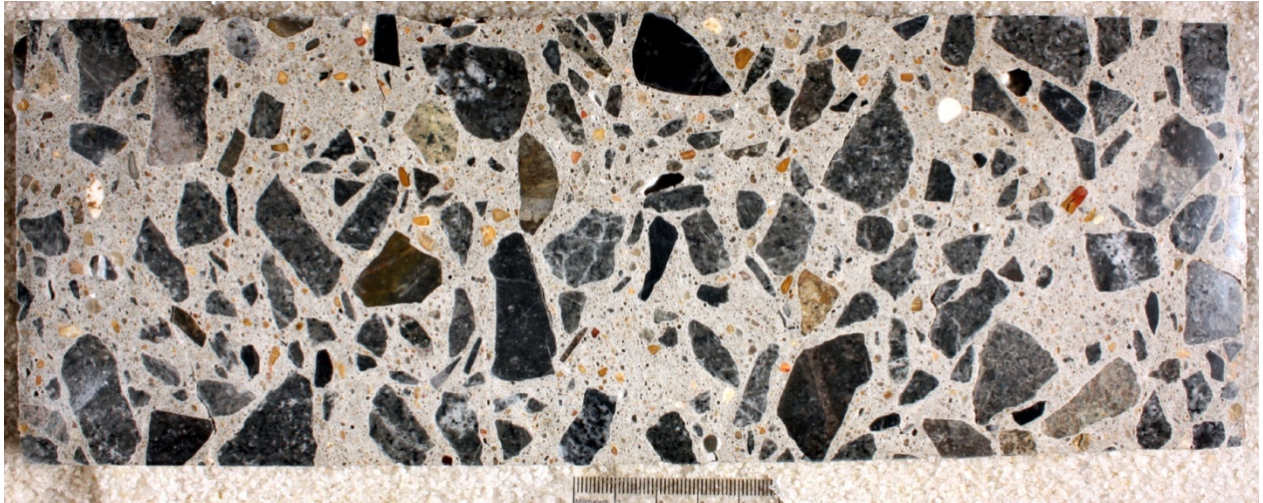
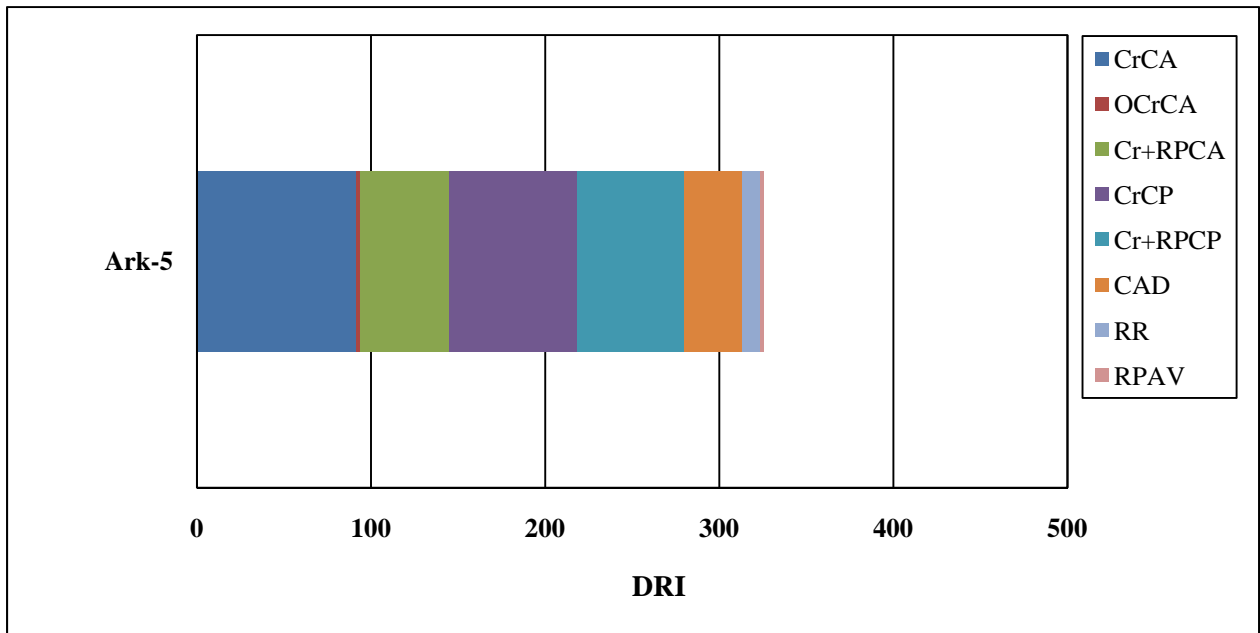
Figure B10: Polished core section Ark-5 and DRI results

Sample	CrCA	OCrCA	Cr+RPCA	CrCP	Cr+RPCP	CAD	RR	RPAV	DRI
Ark-5	91	2	51	74	62	33	11	2	326
