Evaluation of Concrete Pavement on US Route 113, Delaware

Field Site and Petrographic Evaluation

ASR Development and Deployment Program
Field Application and Demonstration Projects

1. Report No. FHWA-HIF-13-065		2. Government Accession No.		3. Recipient's Catalog No.	
4. Title and Subtitle Evaluation of Concrete Pavement on US Route 113, Delaware: Field Site and Petrographic Evaluation				5. Report Date January 2009

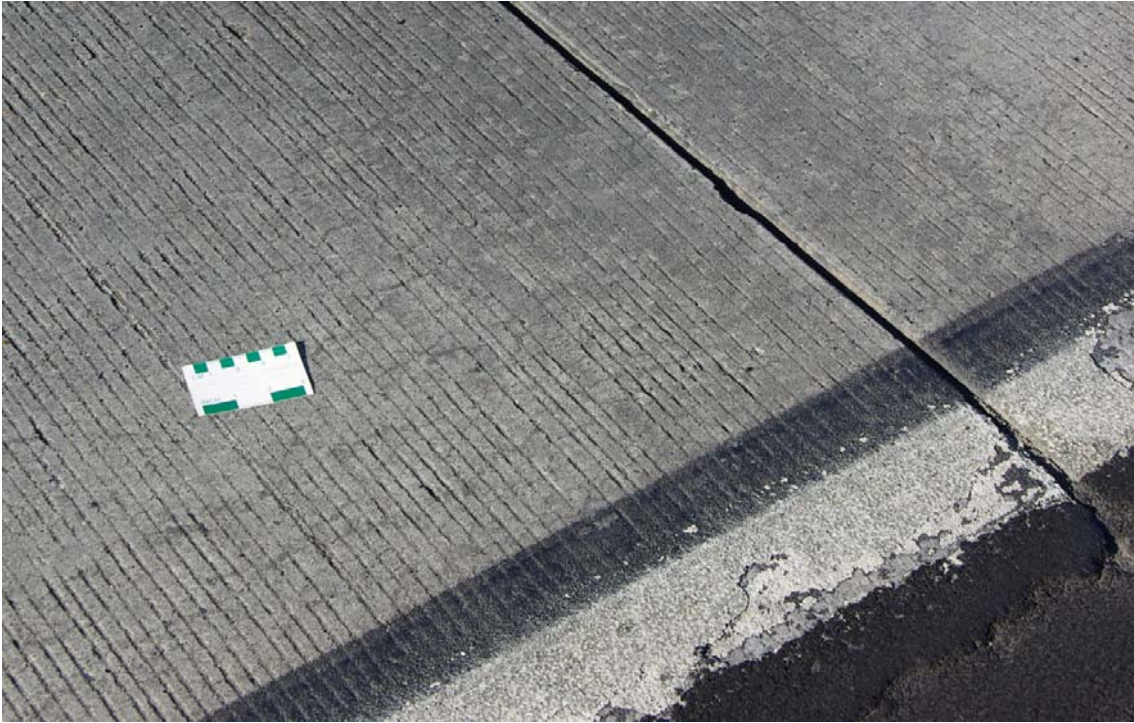
Figure A1 Staining around pavement joints

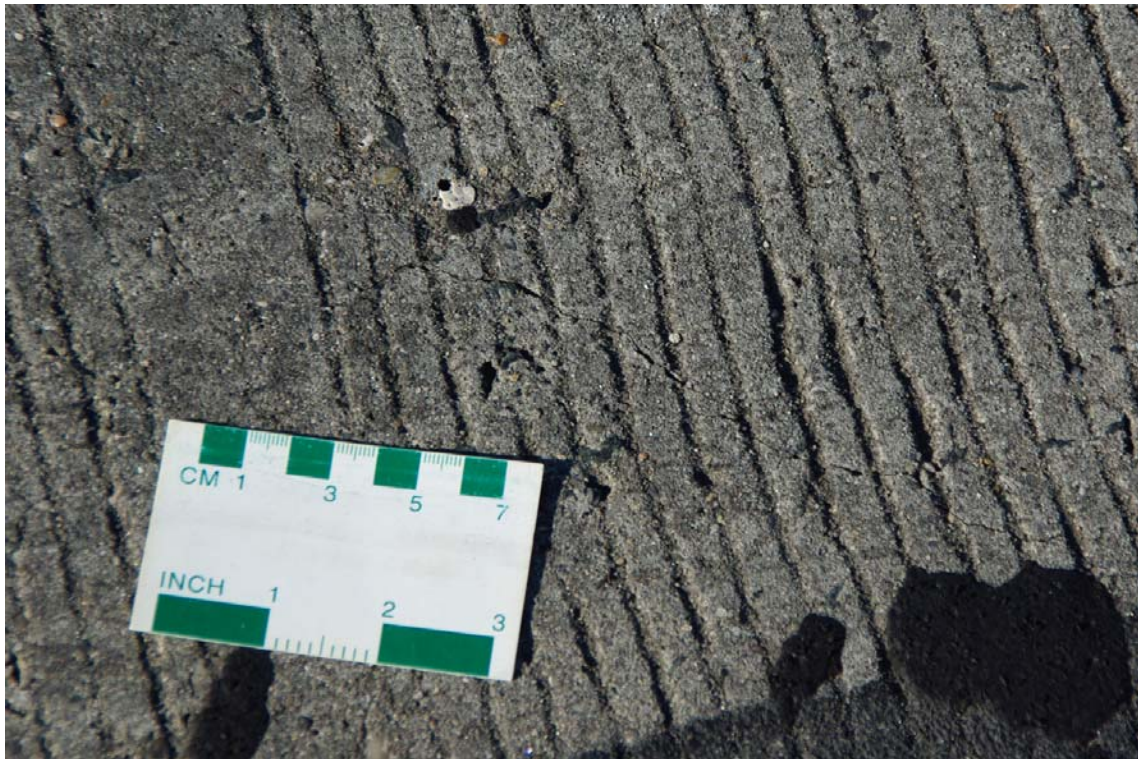
Figure A2 Hairline cracking (< 0.015-in) in panel where Core #3 is located

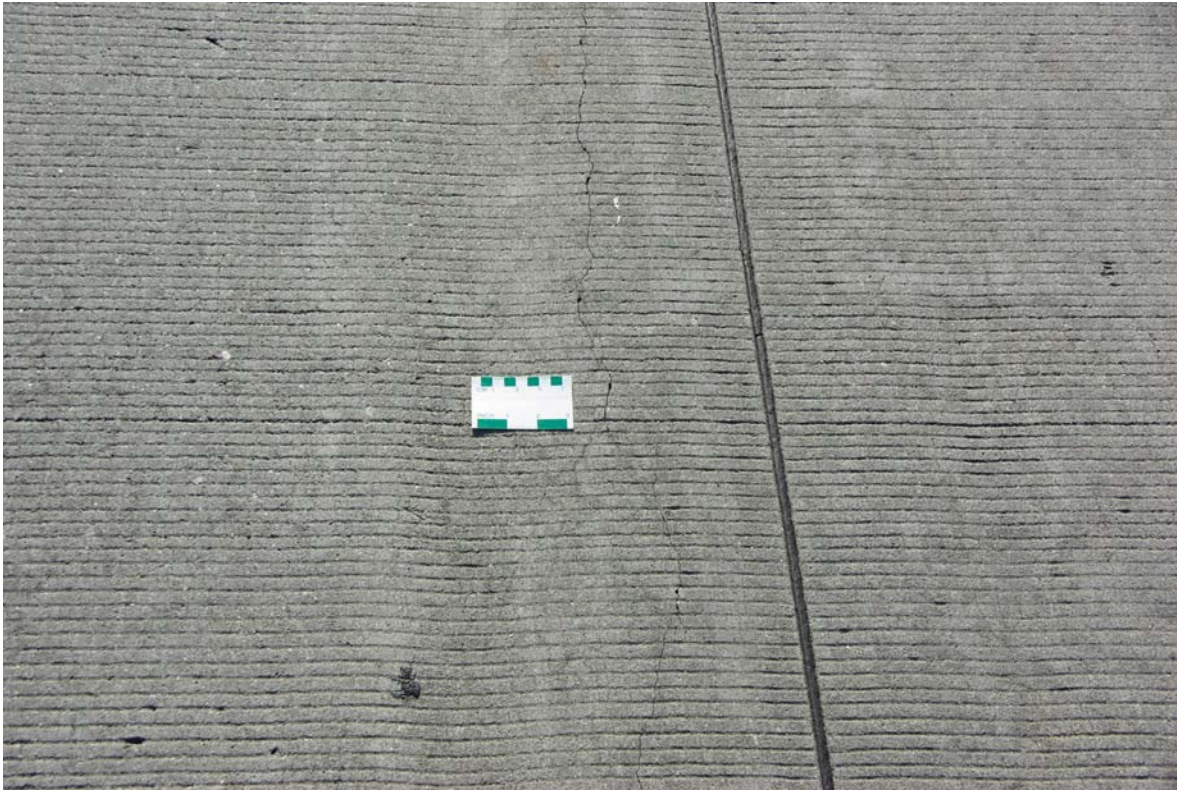
Dr. Michael Thomas of C&CS Atlantic Inc. visited the pavement on November 10, 2008, in the company of Mr. James Pappas and other representatives of DelDOT, and Mr. David Stokes of the FMC Corp. Approximately 0.5 miles of the right-hand lane of the northbound lanes was examined; photographs are shown in Appendix A). Visible cracking was not present for much of the pavement and the “damage” was restricted to dark stained lines in the vicinity of transverse and longitudinal joints (see Fig. A1). Hairline cracks (with < 0.015 in) were visible on close inspection in some of these locations (Fig. A2). A small number of panels did show visible cracking with cracks (widths 0.020 – 0.60 in) generally oriented in the longitudinal direction (Figs. A3 and A4).

Figure A3 Cracking (0.03 – 0.06-in.) in panels where Cores #5 & #6 are located

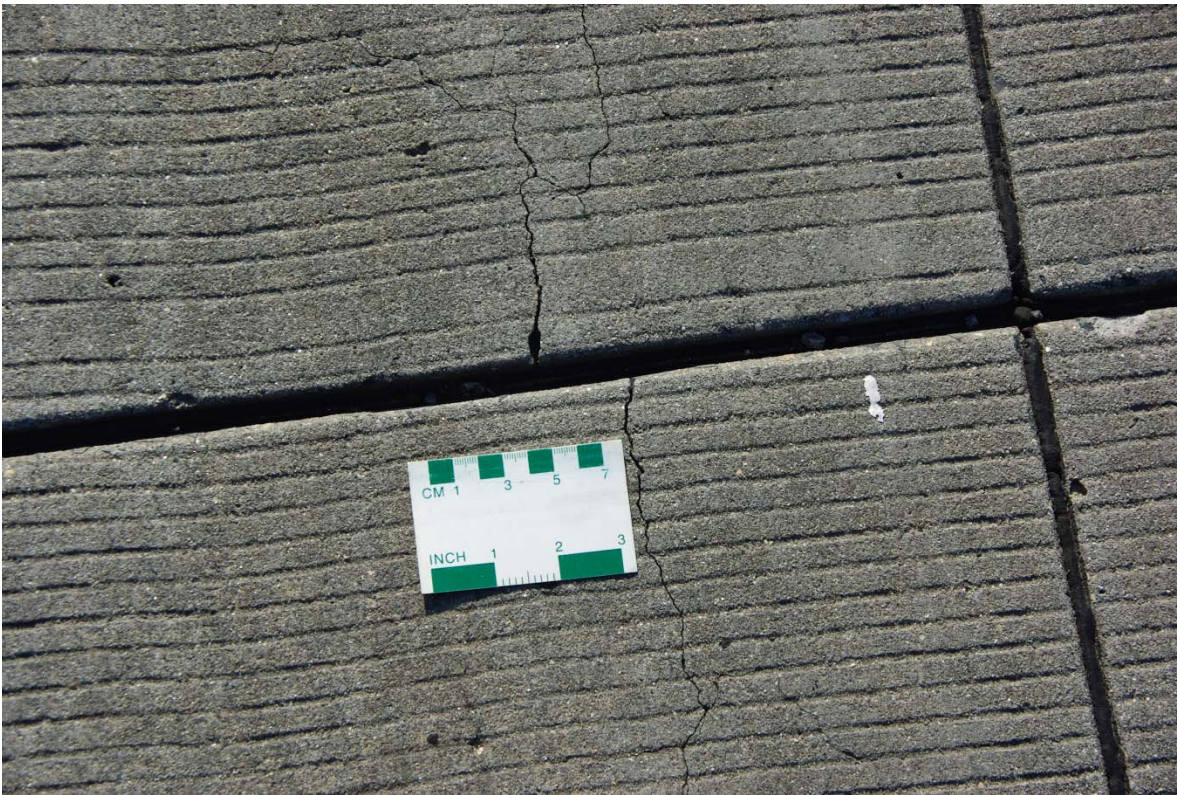
Figure A4 Close-up of Cracking (0.03 – 0.06-in.) in panels where Cores #5 & #6 are located

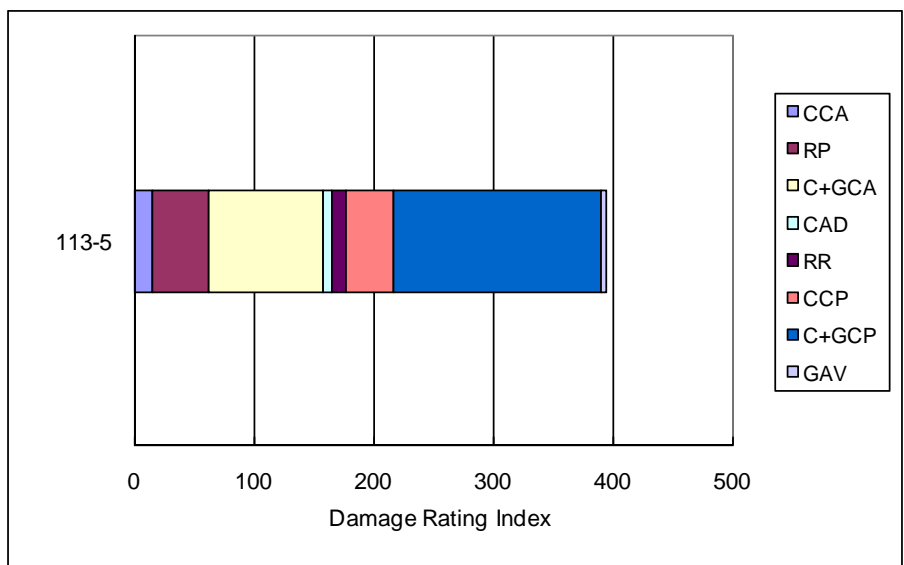
The results of the DRI for the two cores examined (113-5 and 113-7) are illustrated in Figures 2 and 3. There is currently no “absolute” number for the DRI that indicates whether a concrete is not affected, or mildly, moderately or severely deteriorated due to ASR. However, values below 50 to 100 are generally indicative of a low degree of reaction / deterioration. Also, the method is under review to try improving the process and thus reduce the variability between the operators.

The two cores examined show fairly different degrees of deterioration, as illustrated by the DRI values of 395 and 65.

Figure 2 : Results of the Damage Rating Index for the core 113-5. The DRI for this core is 395.

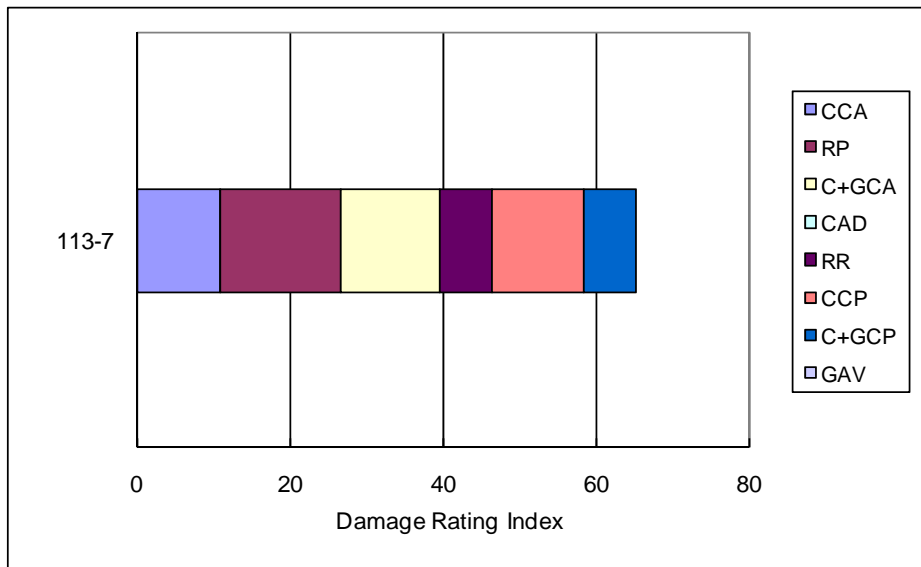
Figure 3 : Results of the Damage Rating Index for the core 113-7. The DRI for this core is 65.

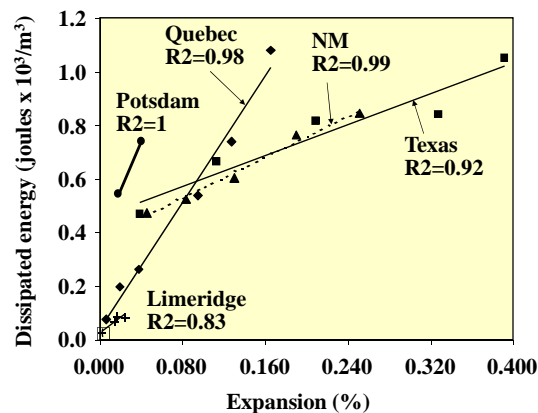
The results of the SDT obtained on three cores (113-1, 113-2 and 113-6) are given in Table 1 and illustrated in Figure 7. There is currently no "absolute" number for the SDT that indicates that a concrete is not affected, or mildly, moderately or severely deteriorated due to ASR. Smaoui et al. (2004a) tested a number of different aggregates subjected to the Concrete Prism Test (ASTM C 1293) and carried out the SDT at different concrete prism expansion levels. The results of Samoui et al. (2004a) are illustrated in Figure 8.

The results in Figure 8 show that the results of the SDT can be significantly affected by the type of reactive aggregate. For this reason, the curves proposed in Figure 8 are not directly applicable to the testing carried out on the cores tested in this study. However, Figure 8 provide an "order of magnitude" of the results obtained in the SDT for a number of reactive aggregates. Based on Figure 8, the results of the SDT obtained on the cores 113-01, 113-02 and 113-06 (from Delaware) "could" correspond to a concrete that would have suffered from a relatively low to moderate expansion/deterioration. Once again, this is an approximation; confirmation of the correspondance between the internal damage due to ASR and the SDT values would be best obtained by establishing a calibration curve with the aggregate used in the Delaware structure. This would be obtained by performing expansion testing under controlled conditions in the laboratory and mechanical testing of specimens obtained from the deteriorating concrete at specific expansion levels (or internal degrees of deterioration).

Figure 8 : Relationship between the Dissipated Energy (areas under the first hysteresis) and the expansion of concrete dues to ASR (Samoui et al. 2004).
