Evaluation of I-89/Dog River Bridge Barrier Walls near Montpelier, Vermont

Petrographic Evaluation and Recommendations

1. Report No. FHWA-HIF-13-068		2. Government Accession No.		3. Recipient's Catalog No.	
4. Title and Subtitle Evaluation of I-89/Dog River Bridge Barrier Walls near Montpelier, Vermont: Petrographic Evaluation and Recommendations				5. Report Date July 2010

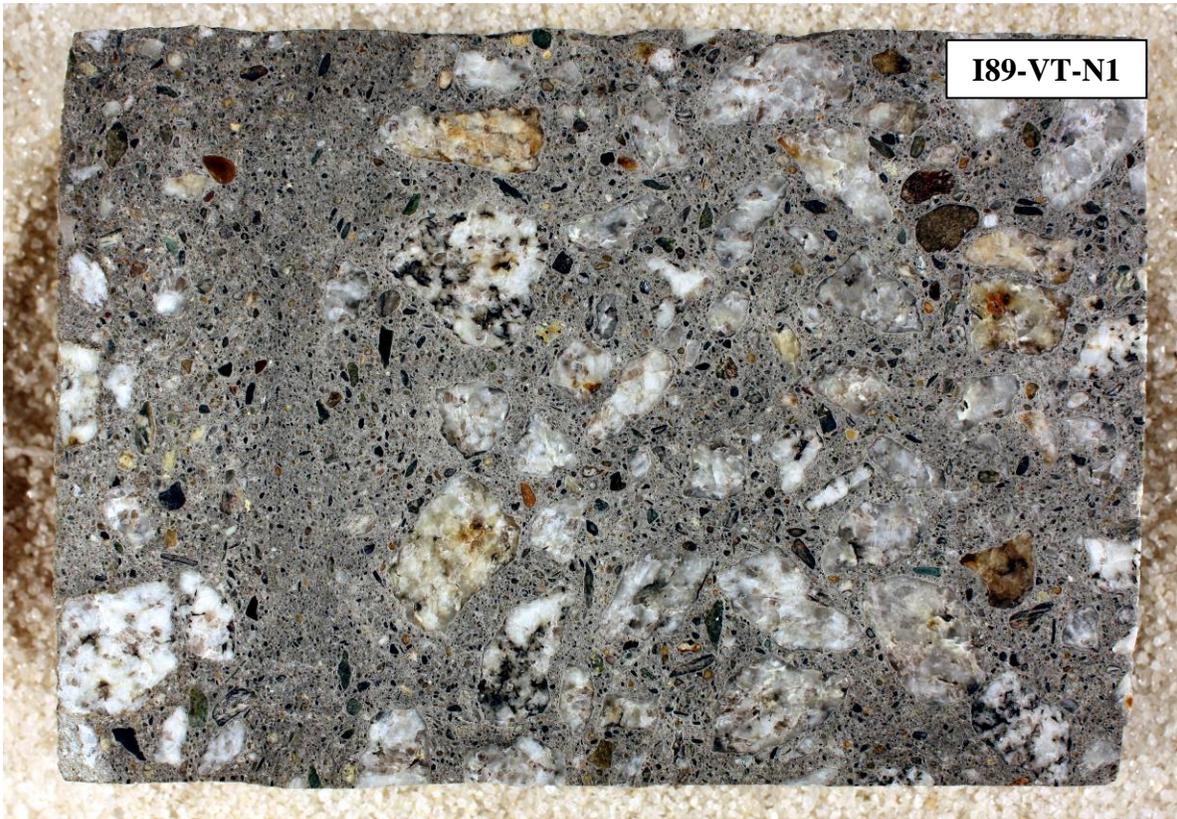
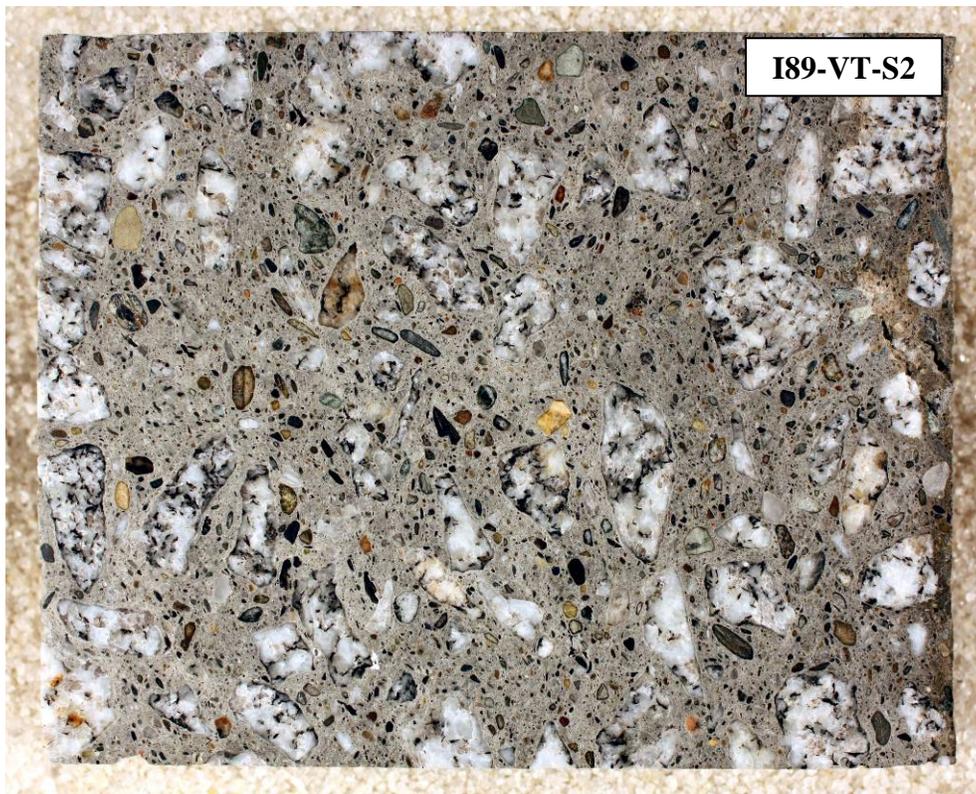
Figure 1. Polished concrete sections from the I89 structure in Vermont.

Figure 2. Polished concrete sections from the I89 structure in Vermont (cont'd).

Figure 3. Polished concrete sections from the I89 structure in Vermont (cont'd).

As illustrated in Figures 1 through 4, the polished concrete sections I89 N1 to N3 and I89 S1 show limited overall deterioration. Damage Rating Indices ranging from 53 to 202 were obtained for those cores, thus indicating low to very low degree of deterioration/damage due to ASR. Details of the DRIs and micrographs of the polished sections can be seen in the Appendix A, figures A1 to A8.

As illustrated in Figures 1 through 4, the polished concrete sections I89 S2 and S3 show a moderate degree of deterioration due to ASR. Damage Rating Indices of 647 and 568 were obtained for cores S2 and S3, respectively. Details of the DRIs and micrographs of the polished sections can be seen in the Appendix A, figures A9 to A12. It is important to mention that the deterioration essentially appears at the microscale since the reactivity is observed within the fine aggregate.

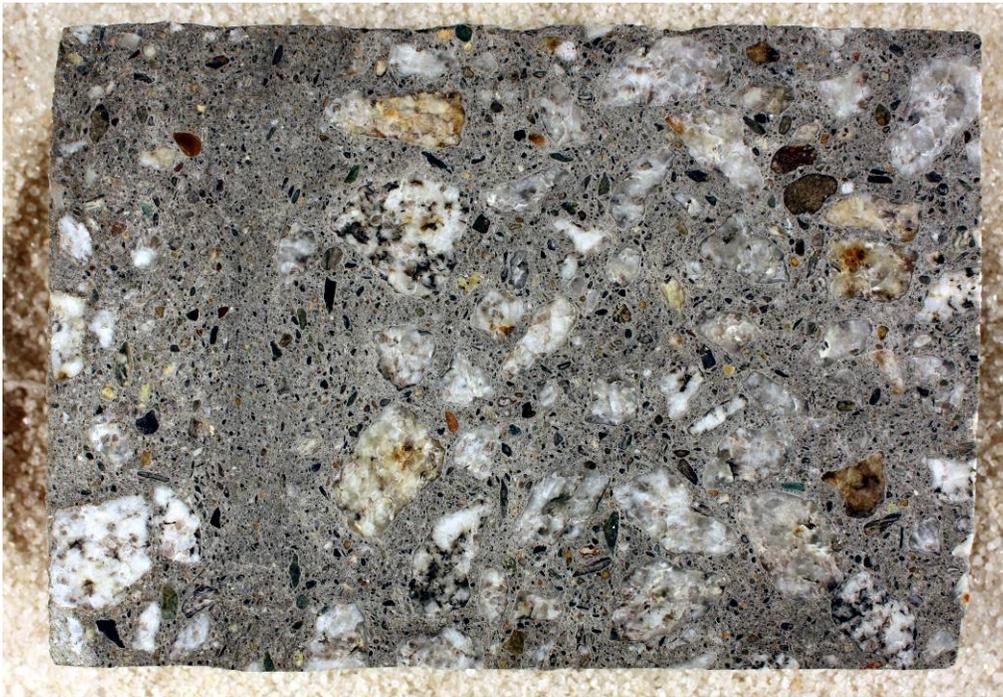
Figure A1. Polished core section I89-VT-N1 and DRI results

Sample	CrCA	OCrCA	Cr+RPCA	CrCP	Cr+RPCP	CAD	RR	RPAV	DRI
I89-VT-N1	45	2	8	10	0	0	39	0	104

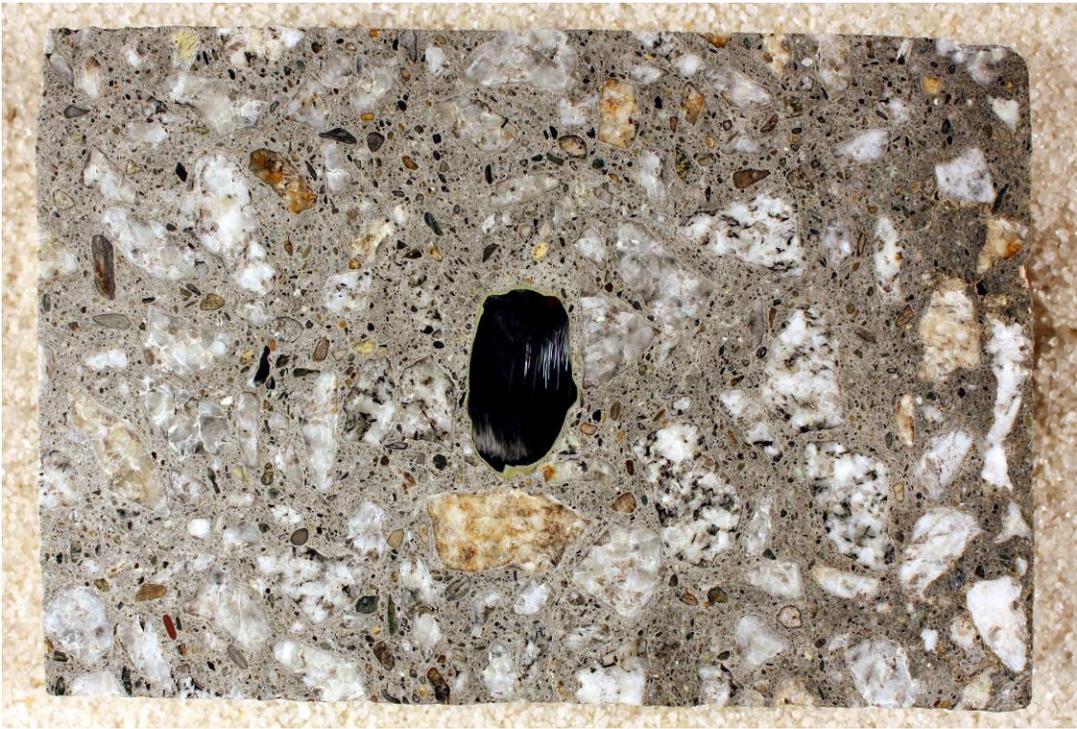
Figure A3. Polished core section I89-VT-N2 and DRI results

The polished concrete core I89-N2 shows slightly more signs of deterioration, including surface cracking penetrating into the concrete (about 1 inch) with associated carbonation, mild cracking in the cement paste with sometimes secondary reaction products (ASR gel), and a fair number of voids in the cement paste lined or filled with secondary reaction products, mostly ettringite.

Sample	CrCA	OCrCA	Cr+RPCA	CrCP	Cr+RPCP	CAD	RR	RPAV	DRI
I89-VT-N2	64	12	8	38	6	2	39	33	202

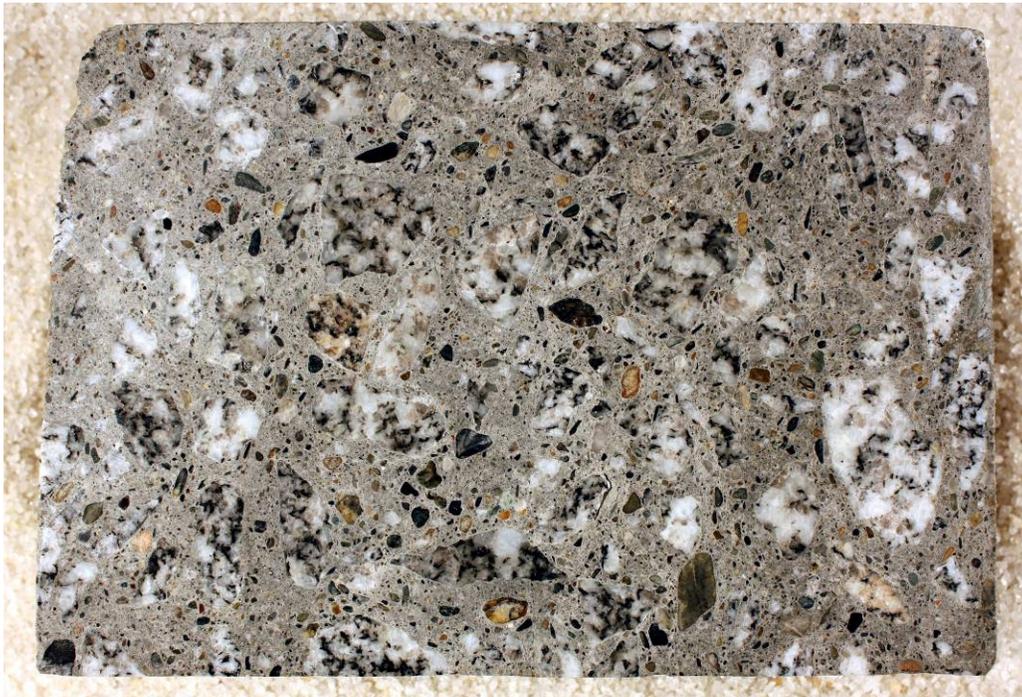
Figure A7. Polished I89-VT-S1 core section and DRI results

Sample	CrCA	OCrCA	Cr+RPCA	CrCP	Cr+RPCP	CAD	RR	RPAV	DRI
I89-VT-S1	33	2	11	17	0	12	28	0	104

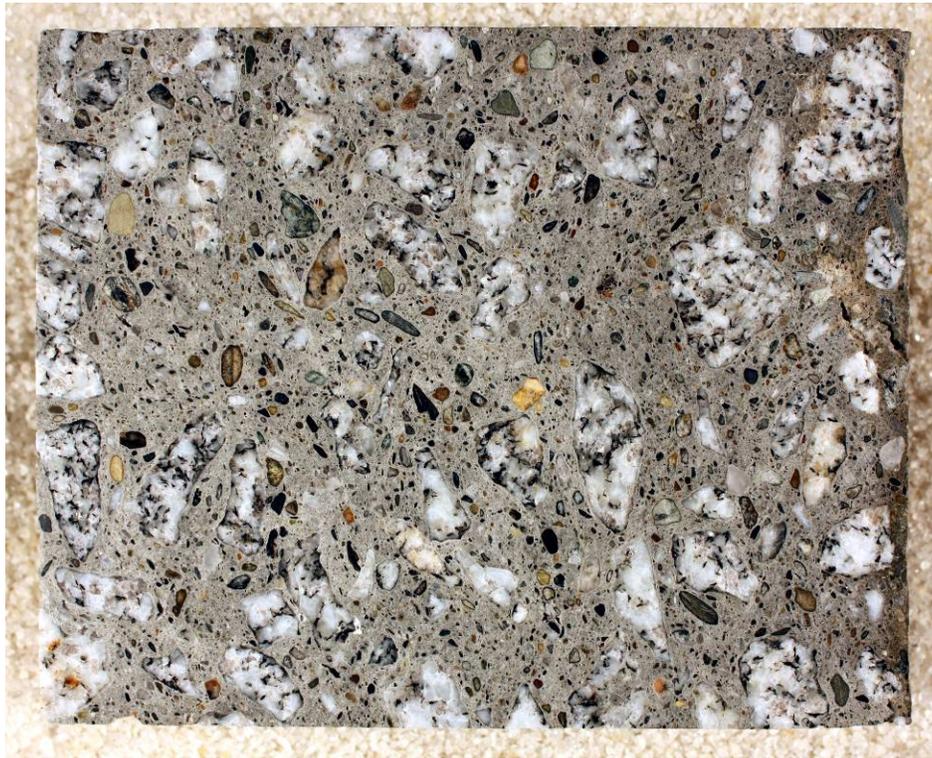
Figure A9. Polished I89-VT-S2 core section and DRI results

The polished concrete core I89-S2 shows surface cracking penetrating into the concrete (about 0.5 inch) with associated carbonation.

Sample	CrCA	OCrCA	Cr+RPCA	CrCP	Cr+RPCP	CAD	RR	RPAV	DRI
I89-VT-S2	65	14	128	189	119	6	98	29	647

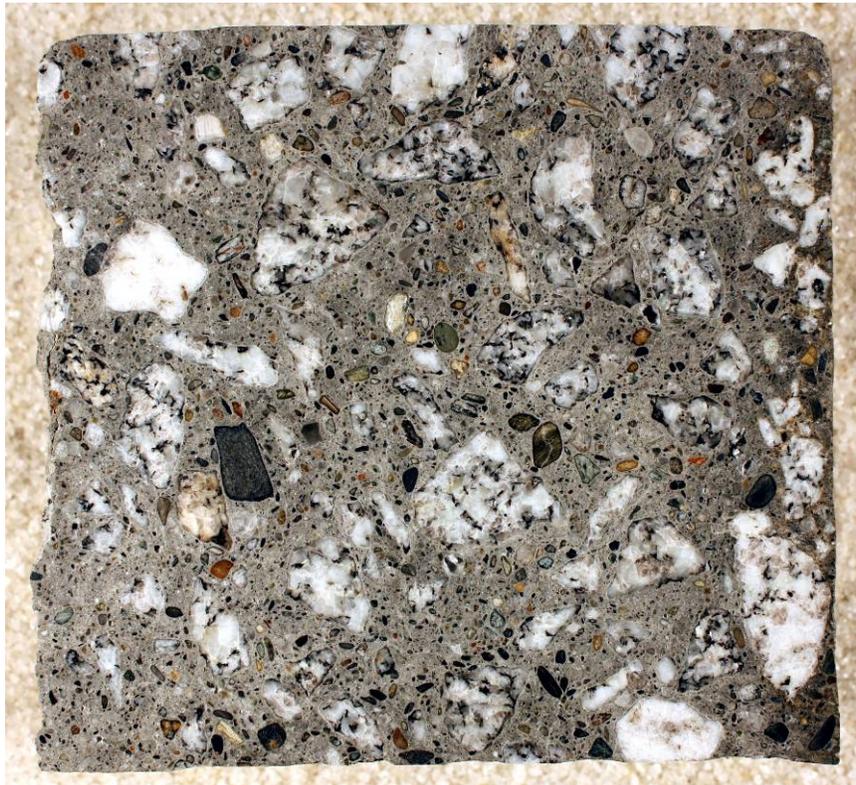
Figure A11. Polished I89-VT-S3 core section and DRI results

Sample	CrCA	OCrCA	Cr+RPCA	CrCP	Cr+RPCP	CAD	RR	RPAV	DRI
I89-VT-S3	78	29	75	138	83	2	74	90	568

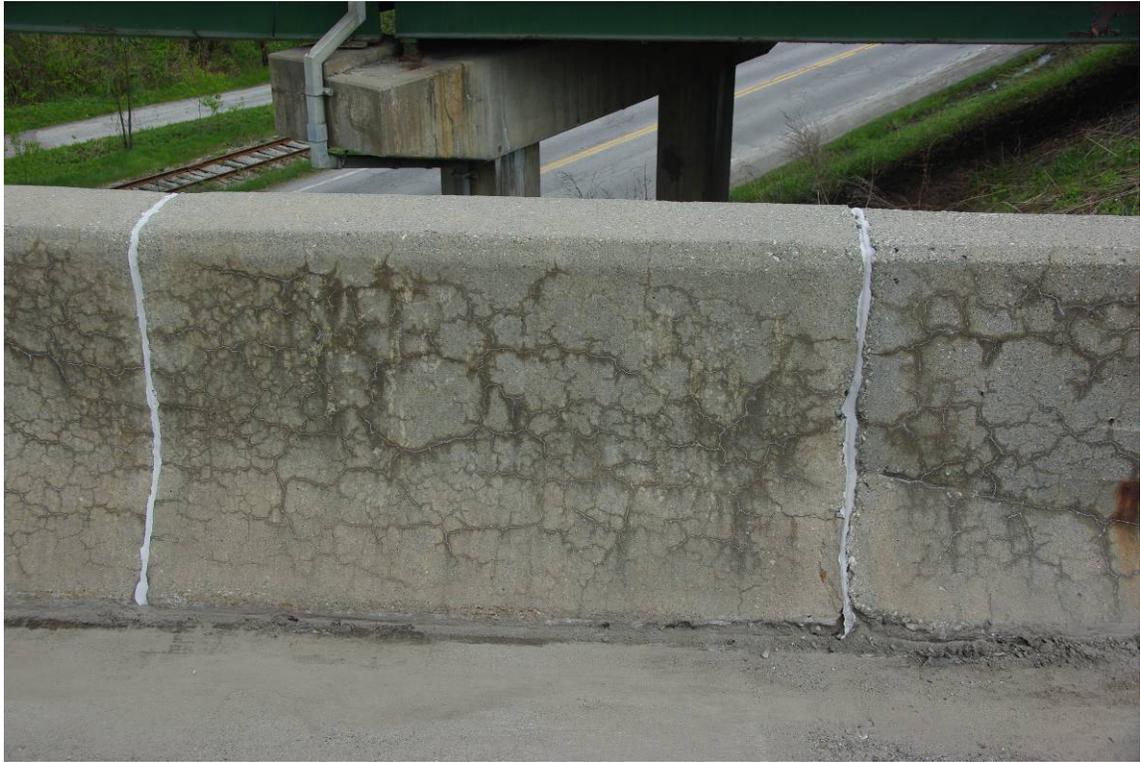
Details regarding the location of the bridges and photographs showing the condition of the concrete and locations of the cores are shown in Appendix B. Map cracking was evident on most of the barrier walls (see photos in Appendix B) and the nature of the cracking is consistent with alkali-silica reaction. There was no evidence of corrosion of embedded reinforcement or damage due to freeze-thaw.

Figure B3. Typical View of Map Cracking

It is recommended that the barrier walls be treated with suitable coating or sealant systems to retard the rate of further deterioration due to ASR. Breathable coatings or sealants, such as certain silanes, that are capable of preventing the ingress of liquid water (e.g. from rainfall) while allowing the passage of water vapor, have been found to be effective in reducing the internal relative humidity in concrete, especially in relatively slender elements such as barrier walls, and, thus, retarding the rate of future alkali-silica reaction.
