**FIELD TEST REPORT**

# **Tensile Bond Strength of a High Performance Concrete Bridge Deck Overlay**

**I-90, STURGIS, SOUTH DAKOTA  
SUMMER, 1999**

**FHWA MCL Project # 9904**

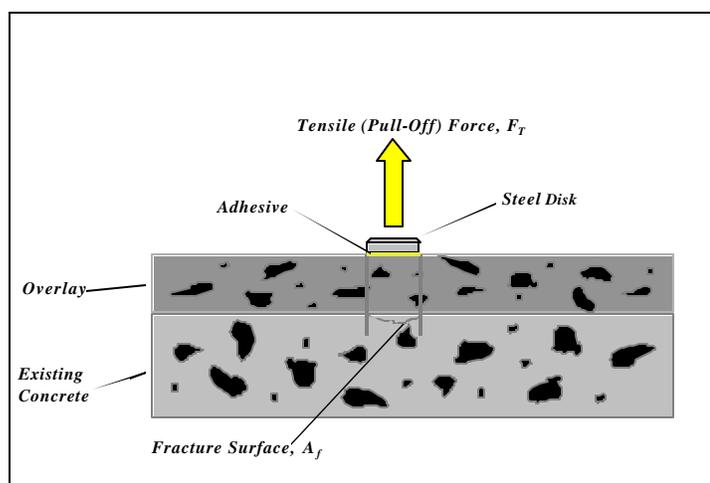
**Figure 1. Schematic of Pull-Off Test Principle**

As mentioned in the previous paragraph, the pull-off test involves applying a direct tensile load to a partial core advanced through the overlay material and into the underlying concrete until failure occurs. The tensile load is applied to the partial core through the use of a metal disk with a pull pin, bonded to the overlay with an epoxy. A loading device with a reaction frame applies the load to the pull pin. The load is applied at a constant rate, and the ultimate load is recorded. Figure 1 illustrates the principle of the pull-off test.

There are essentially four different modes of failure when applying load in this manner. These different failure modes provide valuable information about the overlay system. The magnitude and location of the fracture surface determines what conclusions may be drawn from the test. First, if the failure occurs at the bond surface, the pull-off strength is in fact the tensile bond strength. In this case, the ultimate load is a direct measure of the adhesion between the overlay and the substrate concrete. Second, when the failure occurs between the disk and the overlay surface, there is an adhesive failure. In this case, the tensile strength of the overlay system is greater than the failure load, and a stronger adhesive is needed. Third, if the failure occurs in the overlay material, the repair material (overlay) is the weakest portion of the system, and we know the bond strength exceeds the ultimate stress applied. This is also referred to in the literature as cohesive failure of the overlay.<sup>2,3,4</sup> Finally, if the failure occurs in the substrate, or underlying concrete, the overlay (repair) concrete and the bond are stronger than the existing concrete, and the repair can be considered successful. This is again often referred to as cohesive failure of the substrate. The illustration in Figure 1 is an example of such a failure mode. In this case, the failure stress is the tensile stress of the substrate concrete. When this occurs, the failed specimens can be taken to the laboratory for further testing (direct shear, laboratory direct tension, etc.) if the bond strength value is desired. In some cases the failure occurs partially along the bond surface and partially in either the overlay or substrate concrete, and the failure mode is a combination of two or more of the failures discussed above.

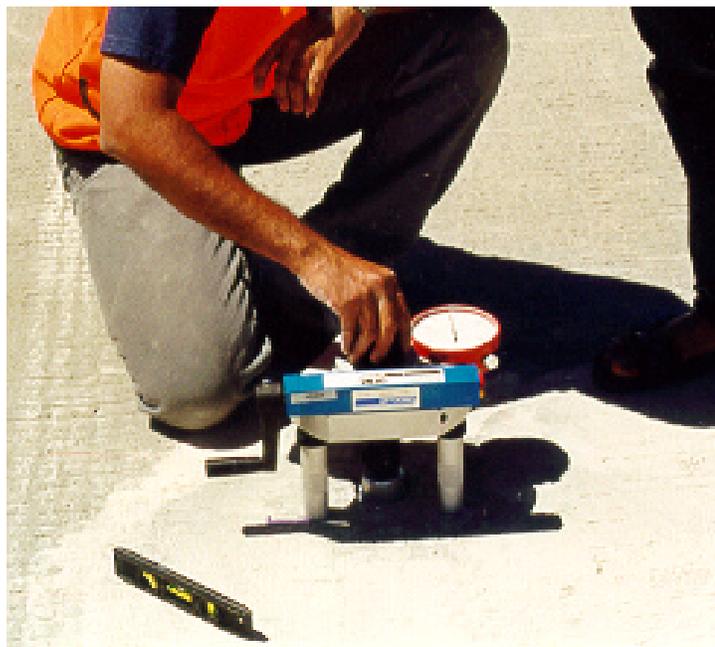
*Figure 2. Commercially Available Tensile Bond Strength Test Device*

Figure 2 shows the tensile bond test device used for this evaluation (Proceq DYNA Z15).

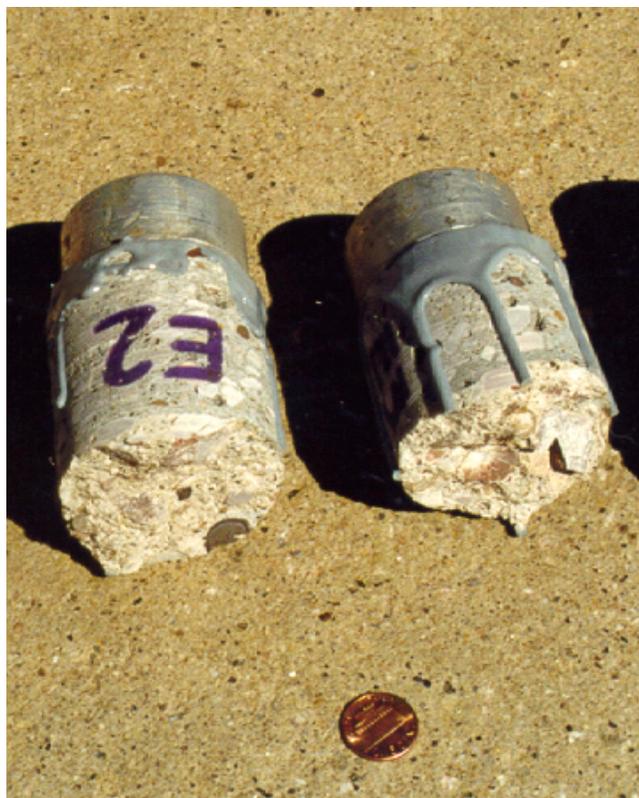
*Figure 3. View of Fracture Surface of Tensile Cores*

Visual examination of the fracture surface of the cores indicates that the failures are a combination of aggregate-paste bond failure, coarse aggregate failure and paste failure. Approximately 65% of the fractures appear to be due to failure in the bond between the aggregate and the paste fraction. The remaining 25% are due to a combination of coarse aggregate fractures and paste failures. Also evident from visual examination of the cores is a significant amount of entrapped air voids. This may be an indication that the low slump fiber reinforced HPC was not properly consolidated. Figure 3 gives a fracture surface view of pull-off cores E2 and E3.

1. The low slump dense non-metallic fiber-reinforced HPC overlay is bonding well to the substrate concrete, and the overlay's tensile strength exceeds that of the substrate concrete. Therefore, the bridge-deck rehabilitation overlay can be considered successful. Some evidence of excessive entrapped voids was evident in all the cores retrieved, suggesting that increased attention should be focused on consolidating the low slump dense HPC mixture.
