Precast Concrete Panel Systems for Full-Depth Pavement Repairs

Field Trials

PUBLICATION NO. FHWA-HIF-07-019

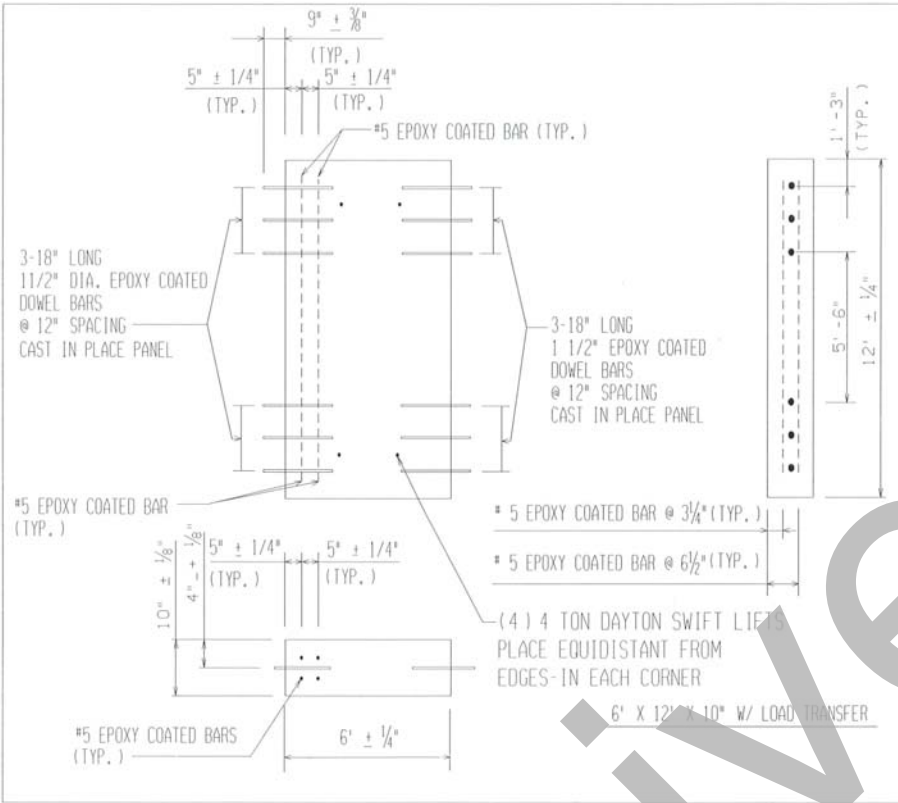
Figure 1. Structural details of the doweled precast panel.

diameter placed at 150-mm [6-in.] intervals and held together with 6-mm [0.25-in.] ties) was placed at the panel mid depth to resist the potential of early-age cracking. The panels were wet-cured for 7 days using wet burlap covers. The 20 precast panels were stockpiled at the ready-mix concrete supplier's yard. Eight panels were installed at the I-675 site, and 12 were installed at the M-25 site. The typical structural details are illustrated in Figure 1.

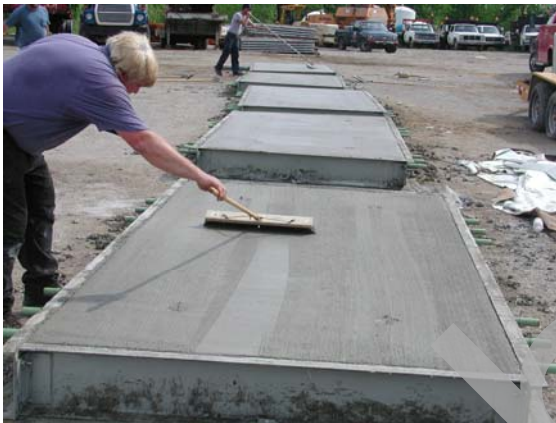
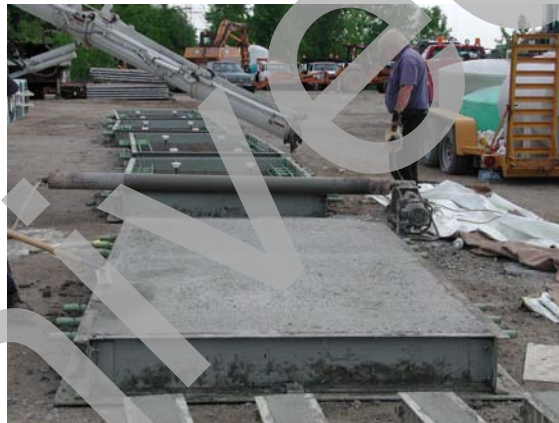
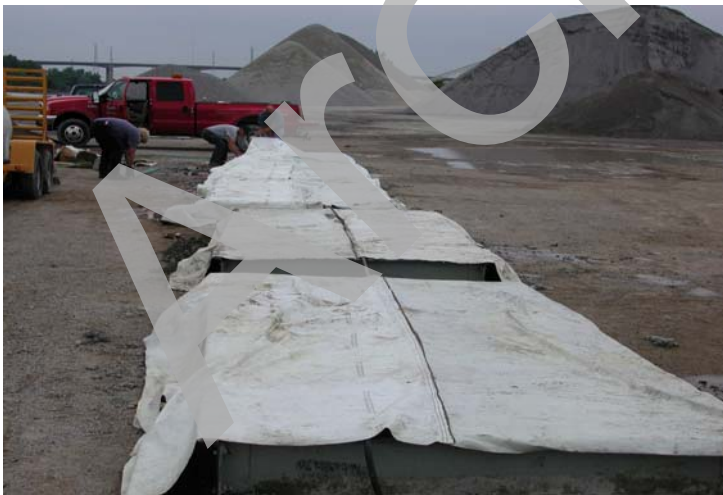
Figure 2. Fabrication of the doweled precast panels.

a) Reinforcement and dowel bar placement in the formwork.

b) Concrete placement for precast panels.

c) Texturing of fresh concrete.

d) Curing of precast slabs.

Descriptions of the activities listed above are presented in the following section of the report. (The types of distresses addressed by the repair strategy and the panel fabrication process, illustrated in Figure 2, are presented above and will not be discussed further).

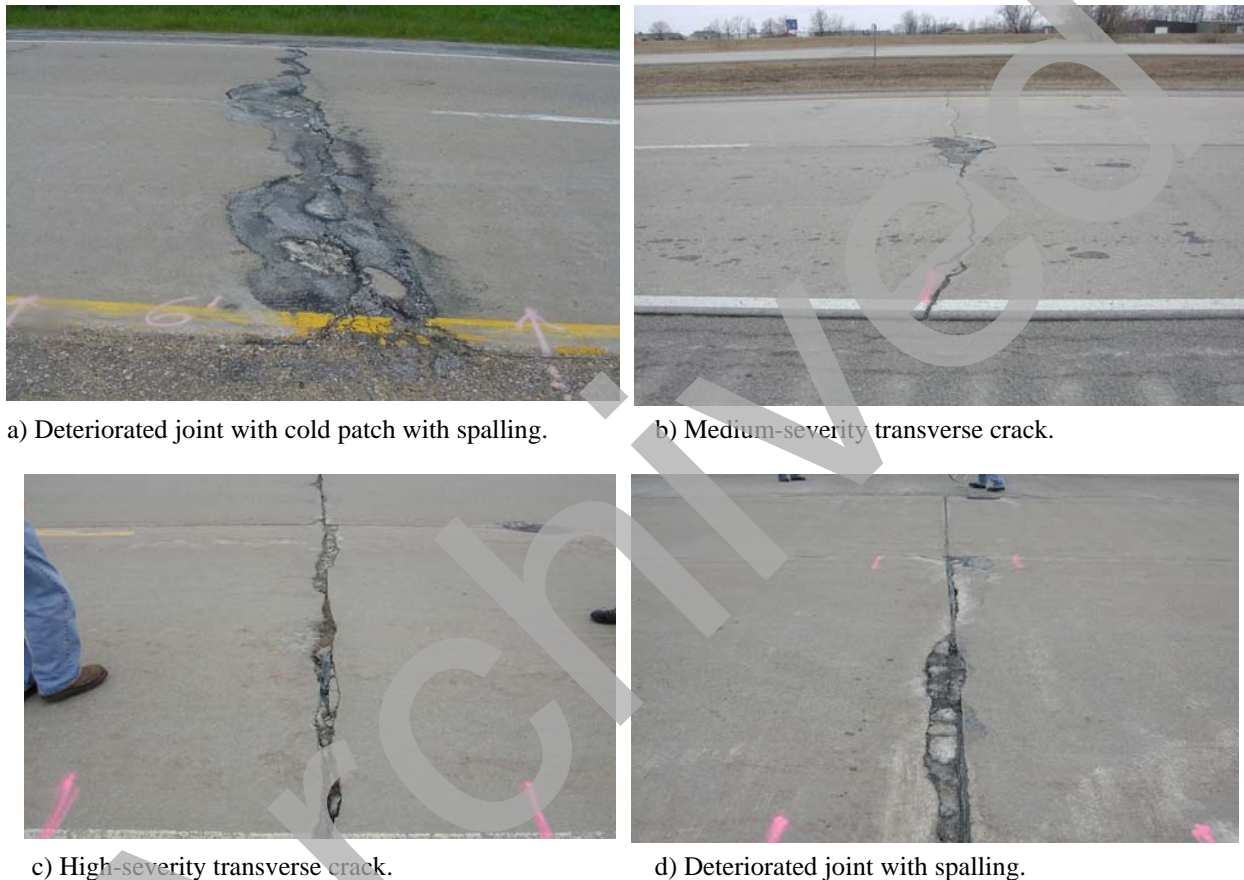
Figure 3. Typical distresses.

Prior to the removal of the candidate panels, a distress survey was conducted in accordance with the protocol laid out in the LTPP distress identification manual (FHWA 2003). Typical distresses observed during the survey included mid-panel transverse cracks with associated spalling and deteriorated joints with spalling and asphalt patch deterioration. Examples of the typical distresses are shown in Figure 3. During the field visit the distress information was recorded on a distress documentation form (a sample form is presented in Appendix A).

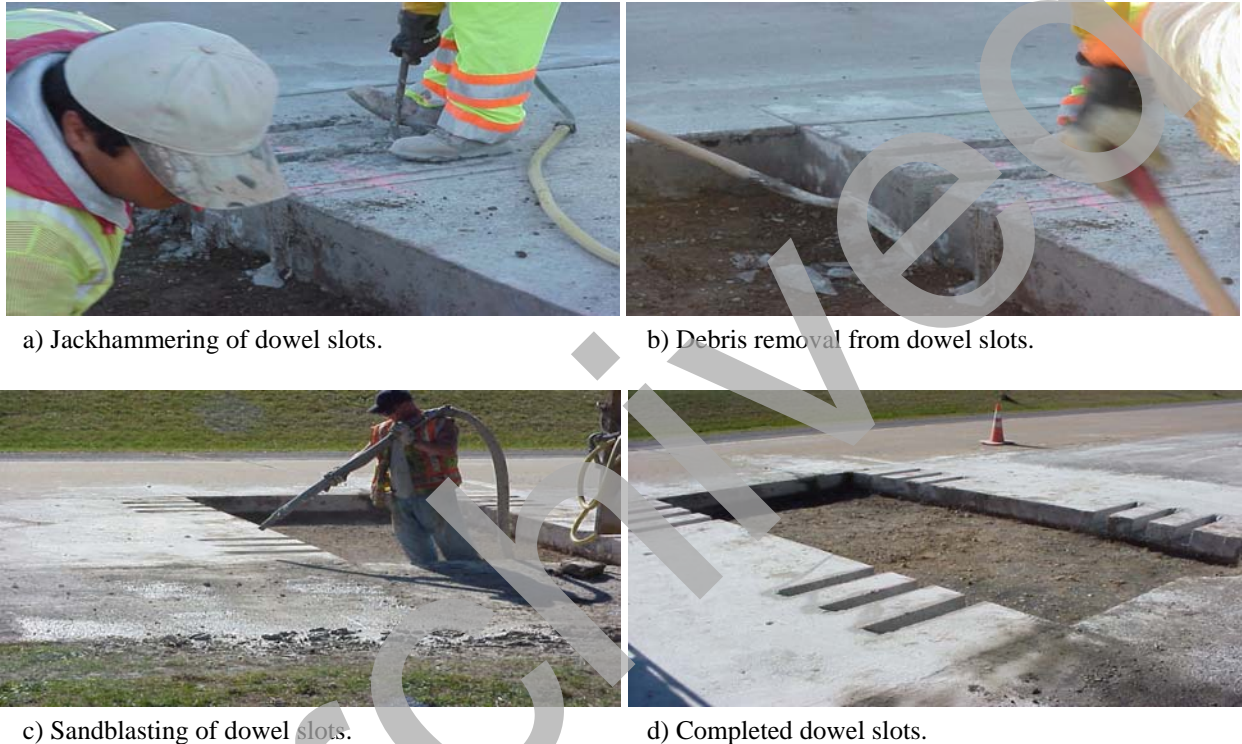
Figure 6. Preparation of the load transfer slots.

As shown in Figure 6, there are three dowel bars in each wheelpath. The dowel slot cutting and preparation include initial grooving to the required depth with a concrete saw; jackhammering of the concrete to carve out the dowel slot; air cleaning of dowel slot to remove debris and any loose concrete pieces; and sandblasting of the dowel slots. The dowel slots were approximately 100 mm (4 in.) wide and 133 mm (5.25 in.) deep (base of the slot cut). Figure 6 illustrates the slot cutting and preparation process.

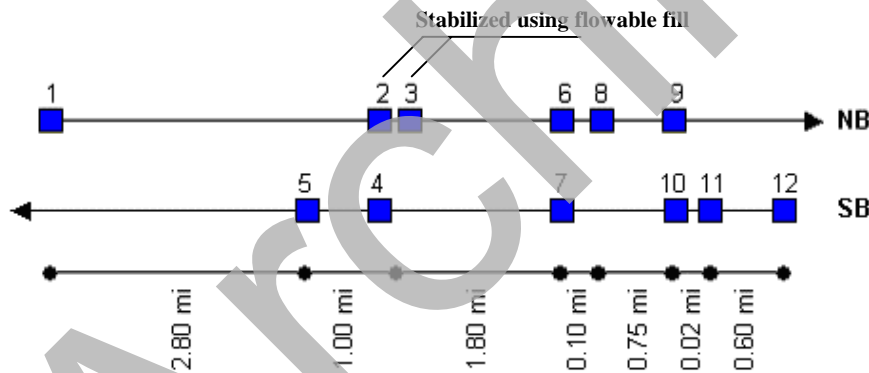
Figure 12. Relative distances of patches along the M-25 project.

At the M-25 project site, 12 precast panels were installed over a period of 3 days. Contributing to the longer installation time were the distances between some of the panels and the construction interruptions due to rain. Figure 12 illustrates the relative location of the precast panels.

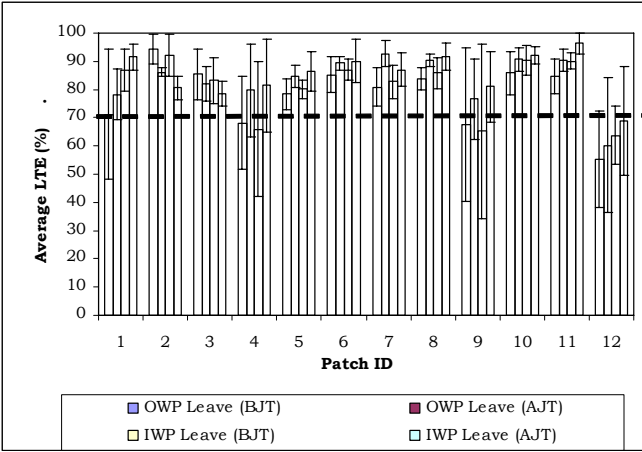
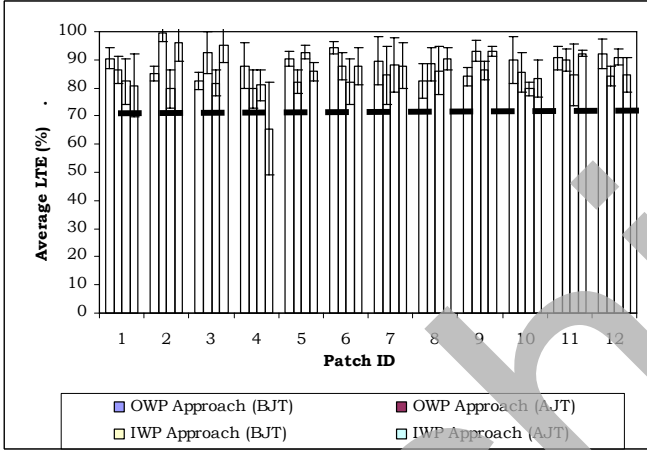
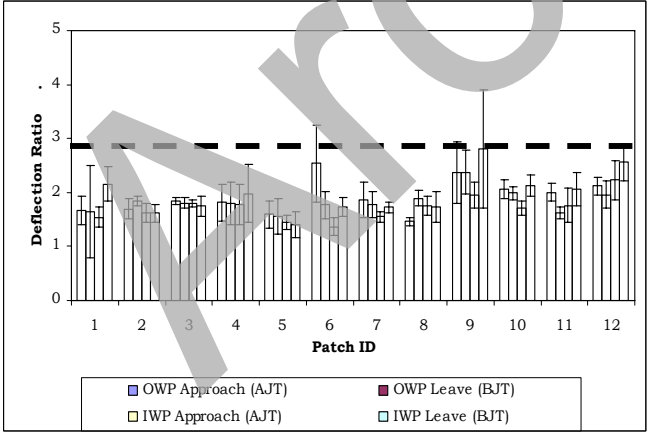
The FWD results are presented in Figure 16 (a) through (c). The dashed lines represent the minimum LTE threshold of 70 percent and a deflection ratio threshold of 3 for doweled joints. On average, the approach and leave LTEs are in excess of 70 percent (the average LTEs range from 72 percent to 90 percent) as shown in Figure 16 (a) and (b) and Table 8. Figure 16 (c) represents the relative deflections (peak) of the joint with respect to the mid-slab deflection (peak). The approach joint deflection ratios range from 1.2 to 2.3, whereas the leave joint ratios range from 1.0 to 3.0, indicating an acceptable support under the panel.

(a) Leave slab loading.

(b) Approach slab loading.

(c) Deflection ratio.

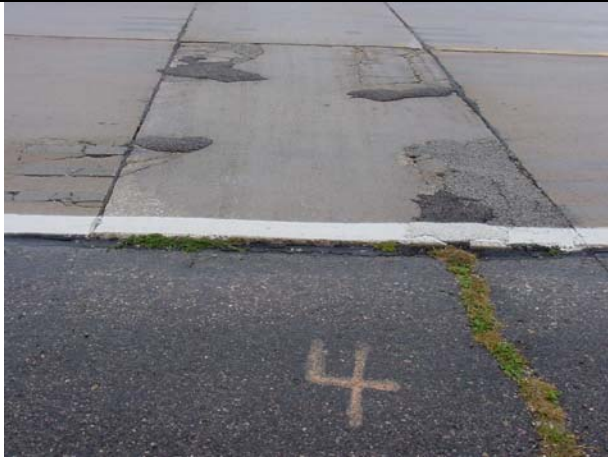
<p data-bbox="469 730 553 758">Panel 4</p>	<p data-bbox="846 443 1433 625">The repair is severely deteriorated. The cracking along the dowels was first observed during the summer of 2004. The cracking was observed along the approach and leave joint of the panel. The average joint LTE ranges from 73% to 78% and the deflection ratios are less than 2.</p>

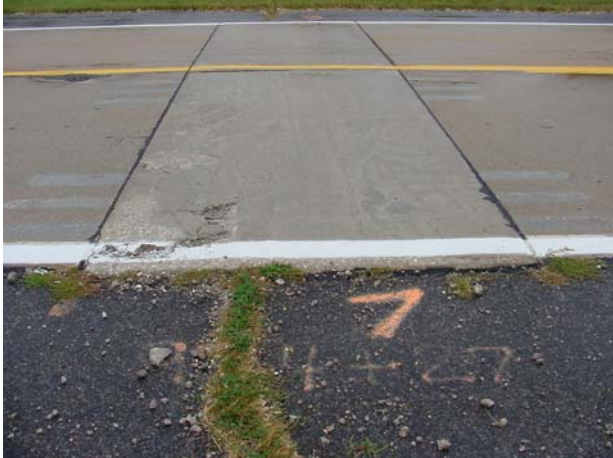
<p data-bbox="469 747 553 772">Panel 7</p>	<p data-bbox="846 470 1430 590">The panel is broken in one corner most probably due to snowplow damage, as there was a high spot along the approach joint. The average joint LTE ranges from 86% to 88% and the deflection ratios are less than 2.</p>

3. Diamond grinding of the panel, especially the joints, is recommended to remove high spots. These high spots have a potential to “break off” as a result of snowplowing operations.

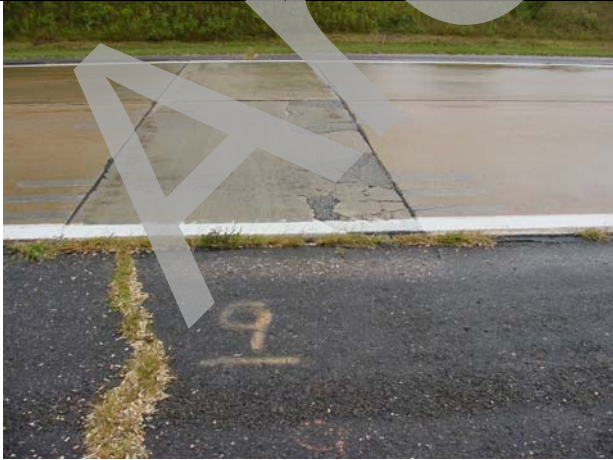
<p data-bbox="469 1778 553 1803">Panel 9</p>	<p data-bbox="846 1457 1430 1640">The repair is deteriorated. The cracking along the dowels was first observed during the summer of 2004. The cracking is along the leave joint of the panel. The average joint LTE ranges from 72% (leave joint of the panel) to 89% and the deflection ratios are approaching 3 along the leave joint of the panel.</p> <p data-bbox="1325 1761 1430 1787" style="text-align: right;"><i>continued</i></p>

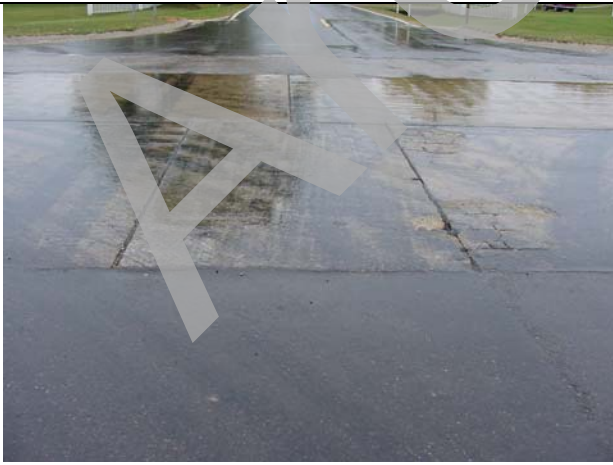
<p data-bbox="464 1766 558 1793">Panel 12</p>	<p data-bbox="846 1444 1419 1625">The panel is in acceptable condition. Trailing edge (leave joint of the panel) broken in the old concrete. The average joint LTE ranges from 62% (leave joint) to 88% and the deflection ratios are less than 2.5. However, the deflection ratio at the broken edge is approaching 3.</p>

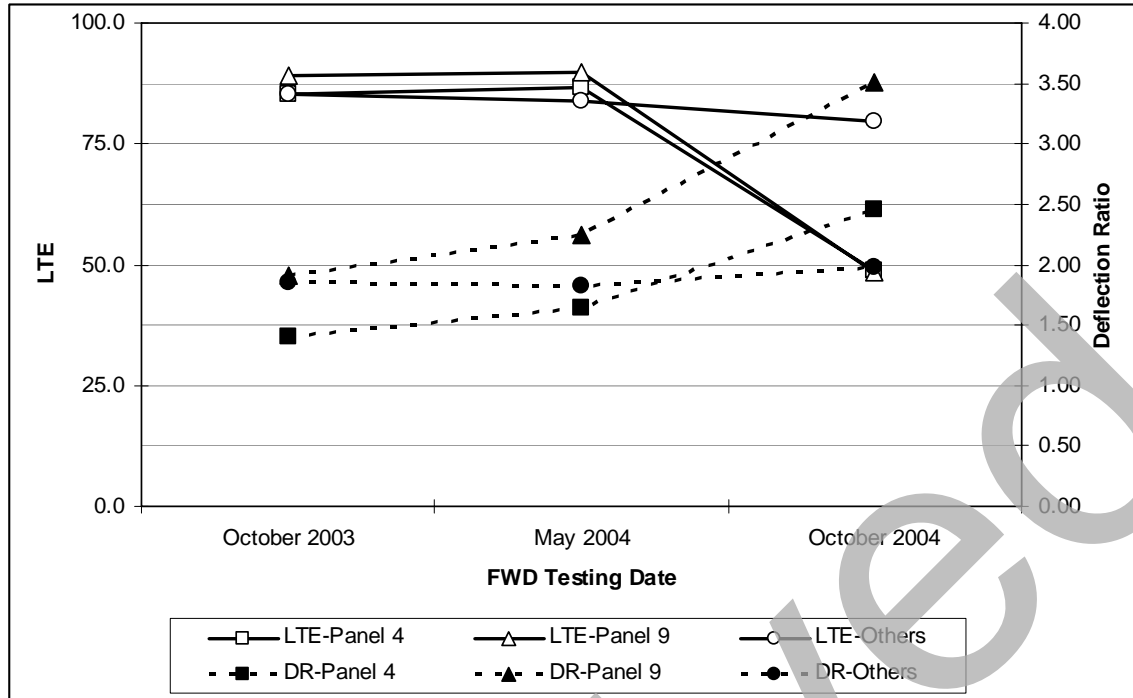
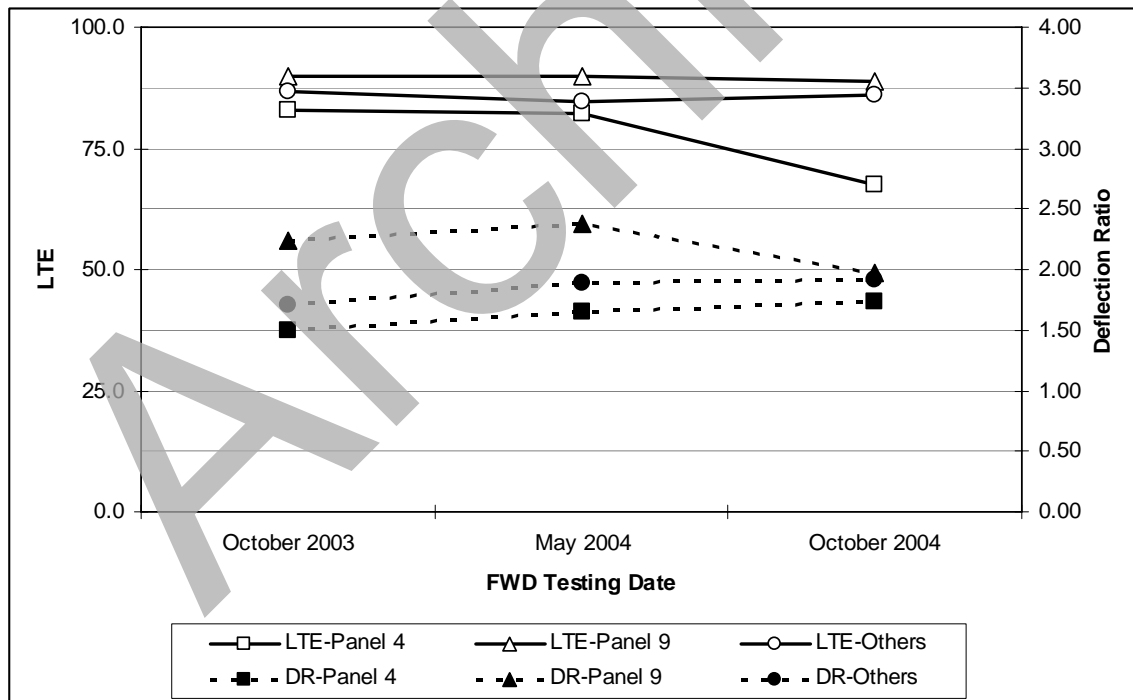
Figure 17. Structural response of panels 4 and 9.

(a) Leave Joint

(b) Approach Joint

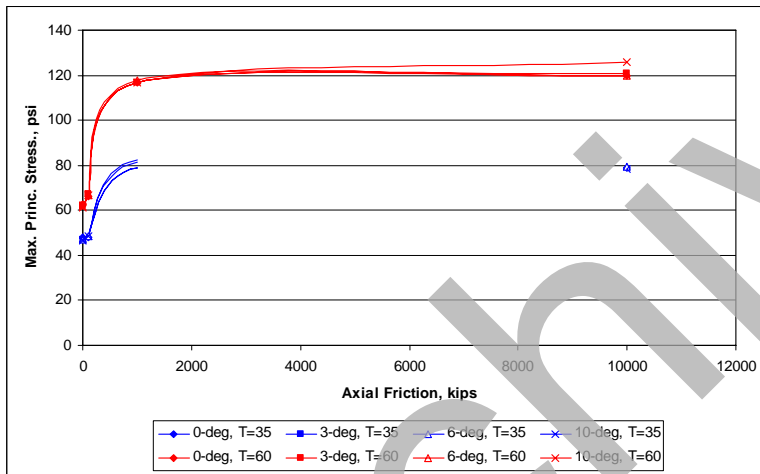
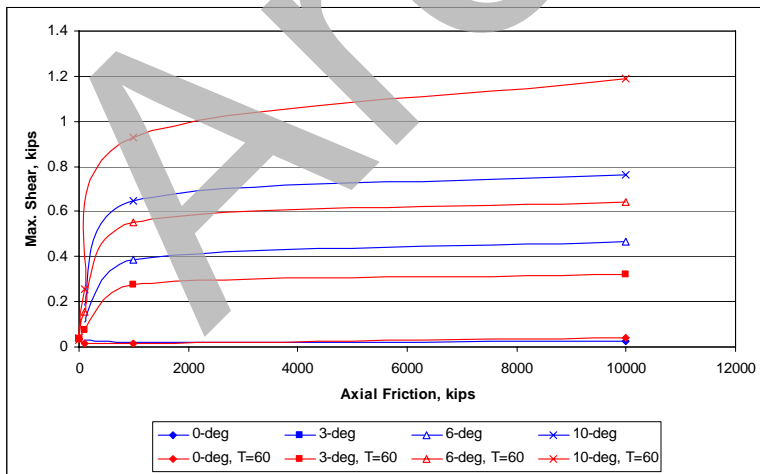
(a) Effect of temperature differential on concrete tensile stresses.

(b) Effect of horizontal dowel skewness on dowel vertical shear force.

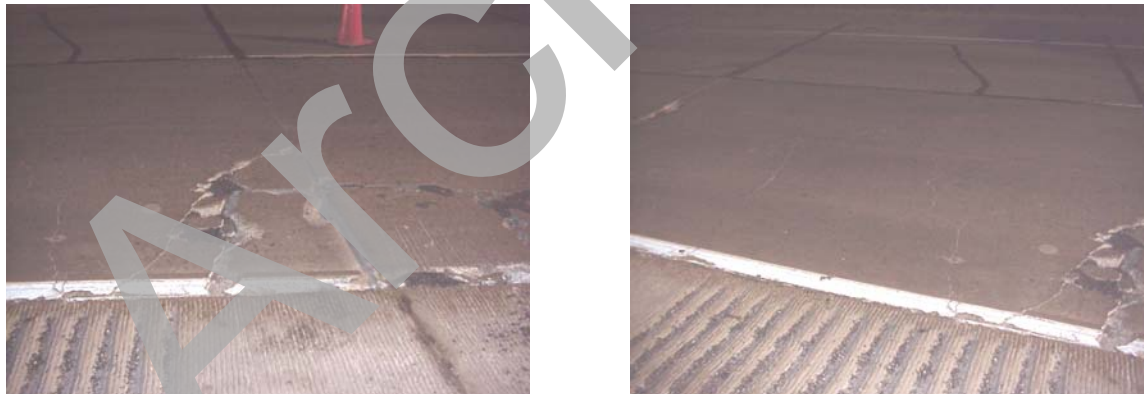
Figure 21. Examples of distresses.

Prior to the removal of the candidate panels a distress survey was conducted. Typical distresses observed during the survey included midpanel transverse cracks with associated spalling; joint sealant damage, spalling, and asphalt patch deterioration; and corner cracking. Some examples of distresses are shown in Figure 21.

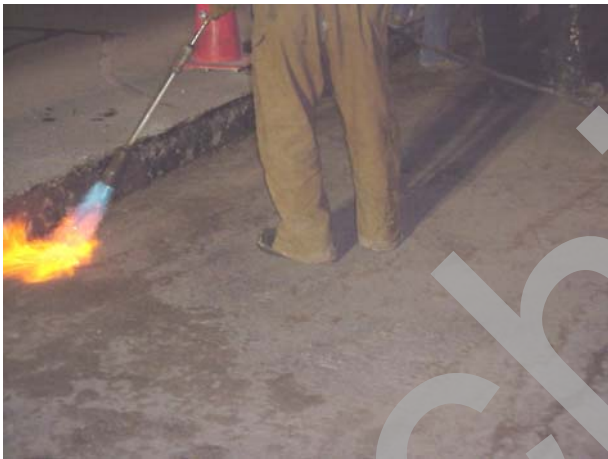
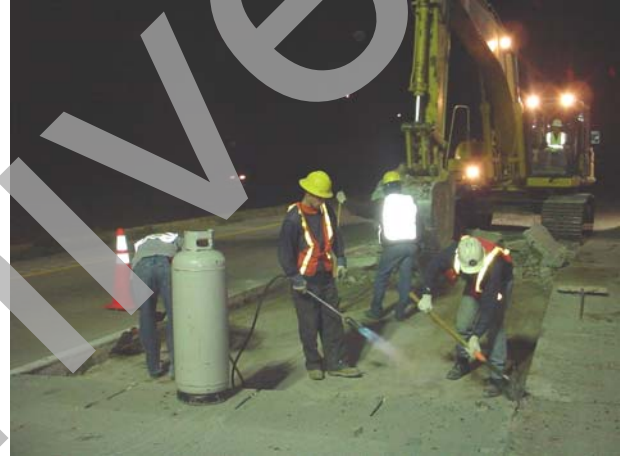
Figure 23. Base preparation activities.

The exposed base was swept and cleaned using compressed air. In addition to the cleaning, the base and joint edges were dried (to remove any traces of moisture) using a hot-air lance. A secondary effect of using the hot-air lance was to expedite the curing of the slab-jacking foam. Figure 23 illustrates the base preparation activities.

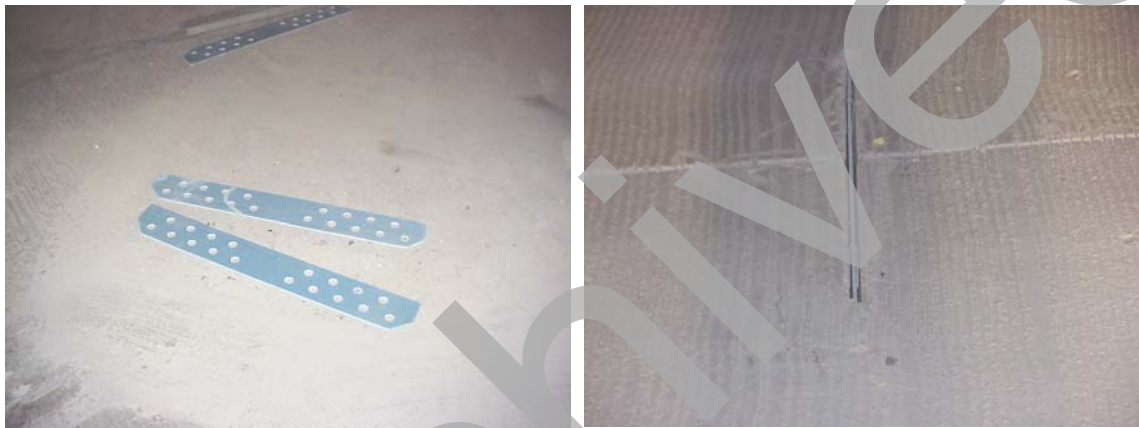
Figure 25. Fiberglass stitches.

The fiberglass stitches were placed into the 19-mm (0.75-in.) slot using two guide wire spacers, one at each end. The fiberglass ties are 0.9 m long, 127 mm wide, and 6 mm thick (36 in. long, 5 in. wide, and 0.25 in. thick). A picture of the tie bar is shown in Figure 25.

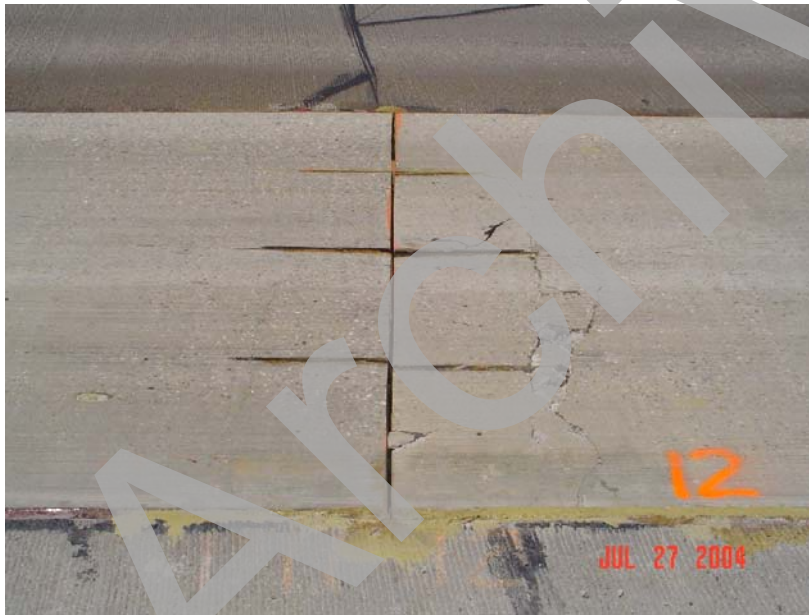
The majority of these cracks were in the vicinity of the fiberglass stitches. A typical crack pattern is illustrated in Figure 35.

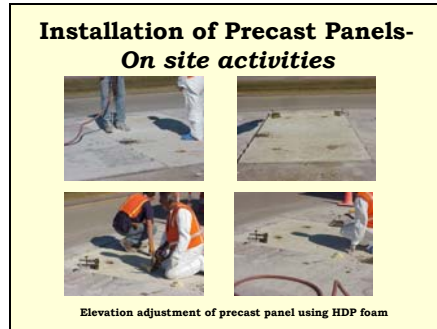
Slide 21

A series (approximately 4–6 holes/panel) of holes (5/8" in diameter) are drilled to inject the foam. The polyurethane foam is made from two liquid chemicals that combine under heat to form a strong, lightweight, foam-like substance. The chemical reaction between the two materials causes the foam to expand and fill the voids. According to the manufacturer's specification, the HDP foam sets in approximately 15 minutes (approximately 90% of full compressive strength), and the precast panel is ready to carry load. For the purpose of slab stabilization, the foam density is about 4 lbs/ft³ with a compressive strength range of 60 psi to 145 psi.
