## Tech Brief

# MATERIALS-RELATED DISTRESS: HARDENED CEMENT PASTE

## Best Practices for Jointed Concrete Pavements

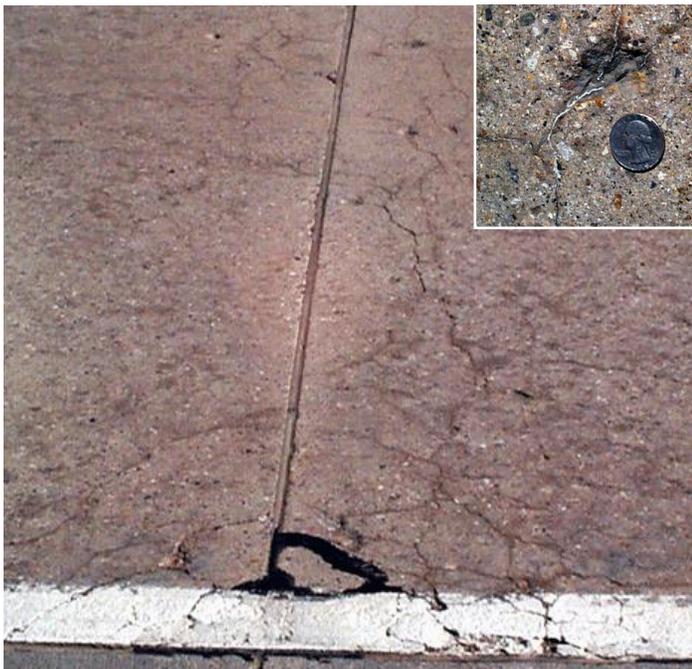
Map cracking commonly seen with freeze-thaw damage and exudate in map crack near the quarter (upper right inset)

Many of the MRD mechanisms affecting HCP, including paste FT, are expansive and manifest as widespread cracking, sometimes with exudate. This type of cracking is referred to as map cracking, as the pattern resembles lines on a road map.

In some cases, exudate will be present in the cracks. As discussed in the companion tech brief to this one (Taylor and Wang 2015), other MRDs, such as alkali-silica reactivity (ASR), can have exudate that looks very similar. In the case of paste FT, this exudate is typically calcium carbonate that results from calcium hydroxide (CH) that has leached from the concrete and carbonated in the presence of atmospheric carbon dioxide (CO<sub>2</sub>).

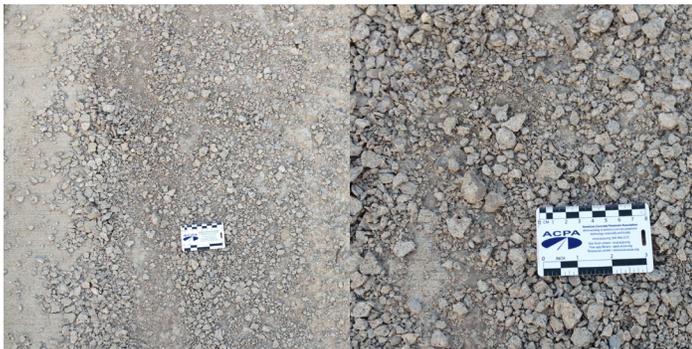
*Deicer scaling showing the intact surface on the far left side of the image (left) and close-up of the scaling (right)*

Deicer scaling is characterized by a disintegration of the outermost HCP layer on the surface of a concrete slab resulting in a remnant layer of powdered HCP, freed aggregates, or aggregates still in the concrete but clean of cement paste. In some cases, the detrital layer may be transported away by plowing or other activities and only the scaled concrete surface is seen.

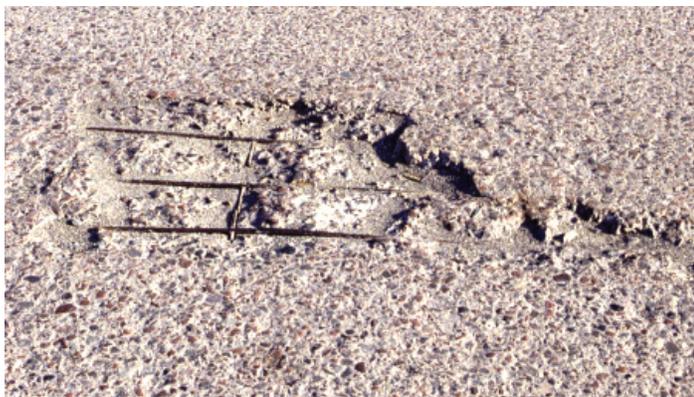
*Corrosion of embedded steel where cover layer has spalled*

The characteristic rust coloring of exudate from the concrete readily identifies corrosion. This should not be confused with superficial rust stains that may result from abrasion by plows or other means. Ultimately, the concrete cover over the steel will crack and spall, exposing the reinforcing steel.

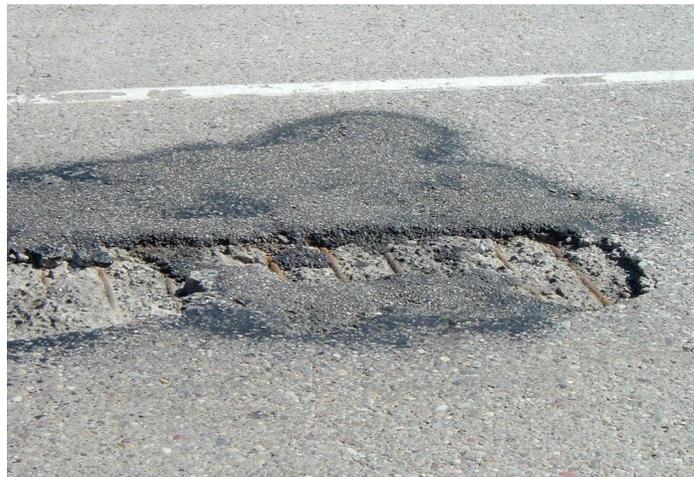
*Hot patch, which subsequently failed from other effects, applied over corrosion of embedded steel where cover layer had spalled*
