BRIDGE RAIL INSTALLATION PROCEDURE

Documentation Report
Replacement of Bridge #1
Over San Antonio Channel
San Juan, Puerto Rico

June 2002

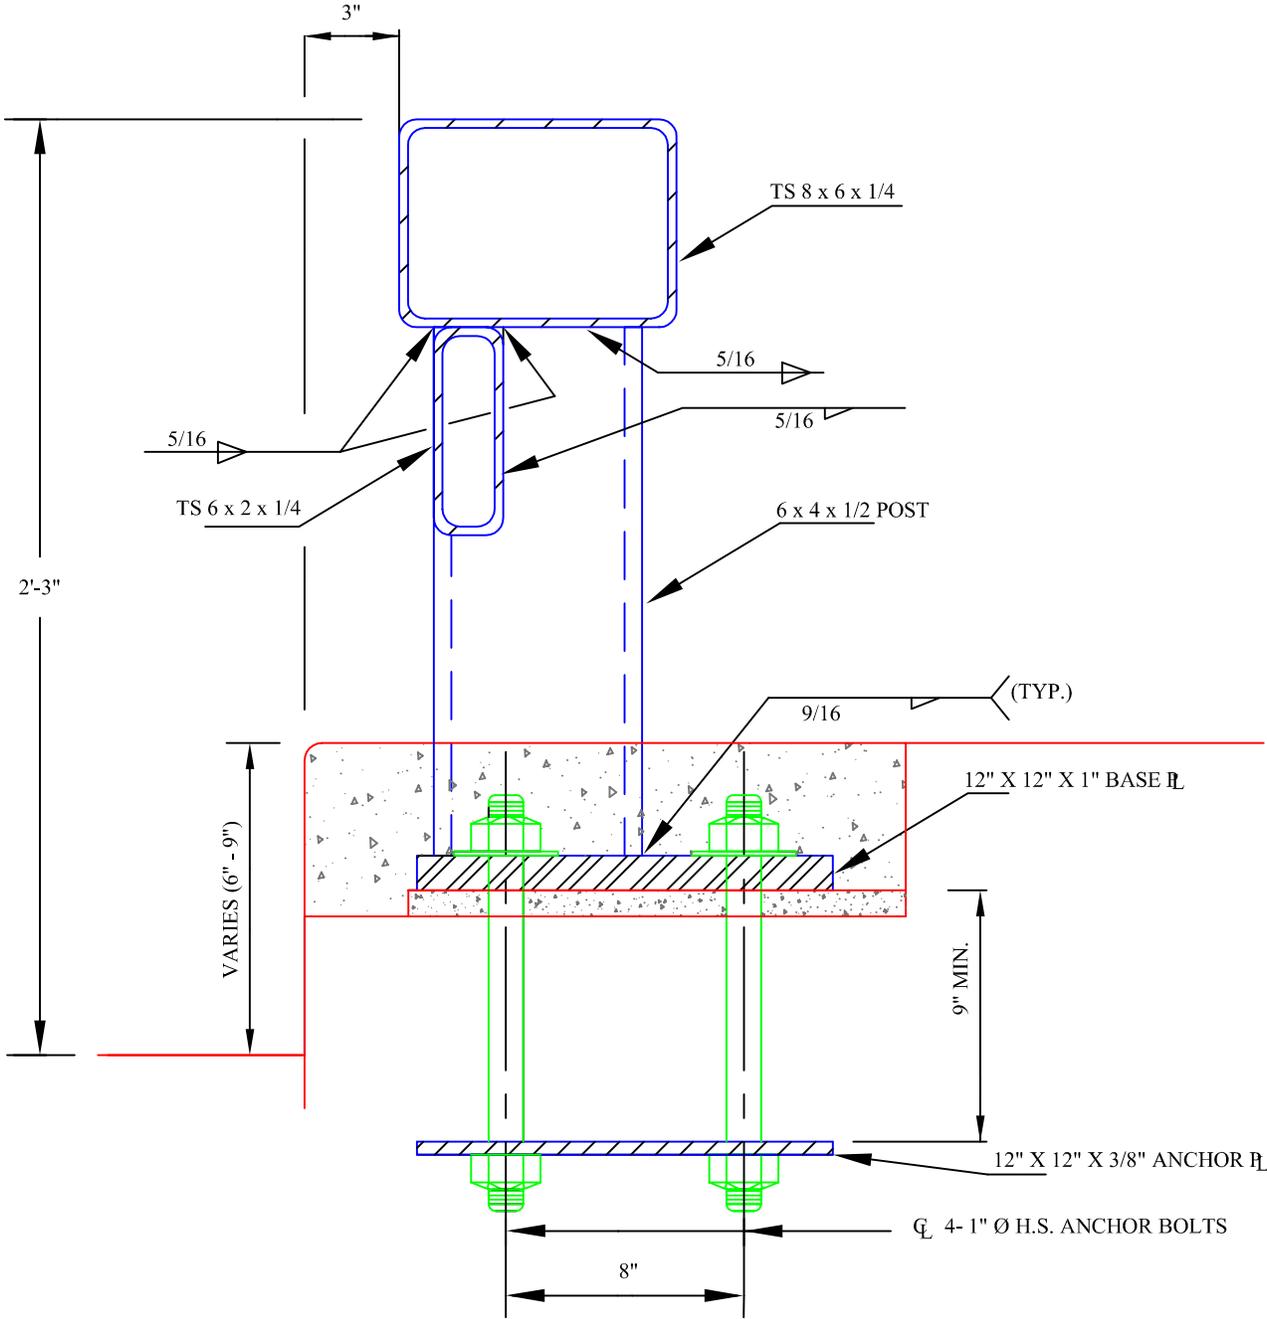
DRAWING 1.1. WASHINGTON DC HISTORIC BRIDGE RAIL
CURB MOUNTED RETROFIT

CROSS SECTION

The bridge rail standard drawing included on the construction plan (see Drawing 1.1), called for the sidewalk to be completed before the rail is installed; then partially demolished (chip out) to place the rail post; and finished again. The Contractor did not like the alternative of partially demolishing (just finished) sidewalks and decided for a different alternative.

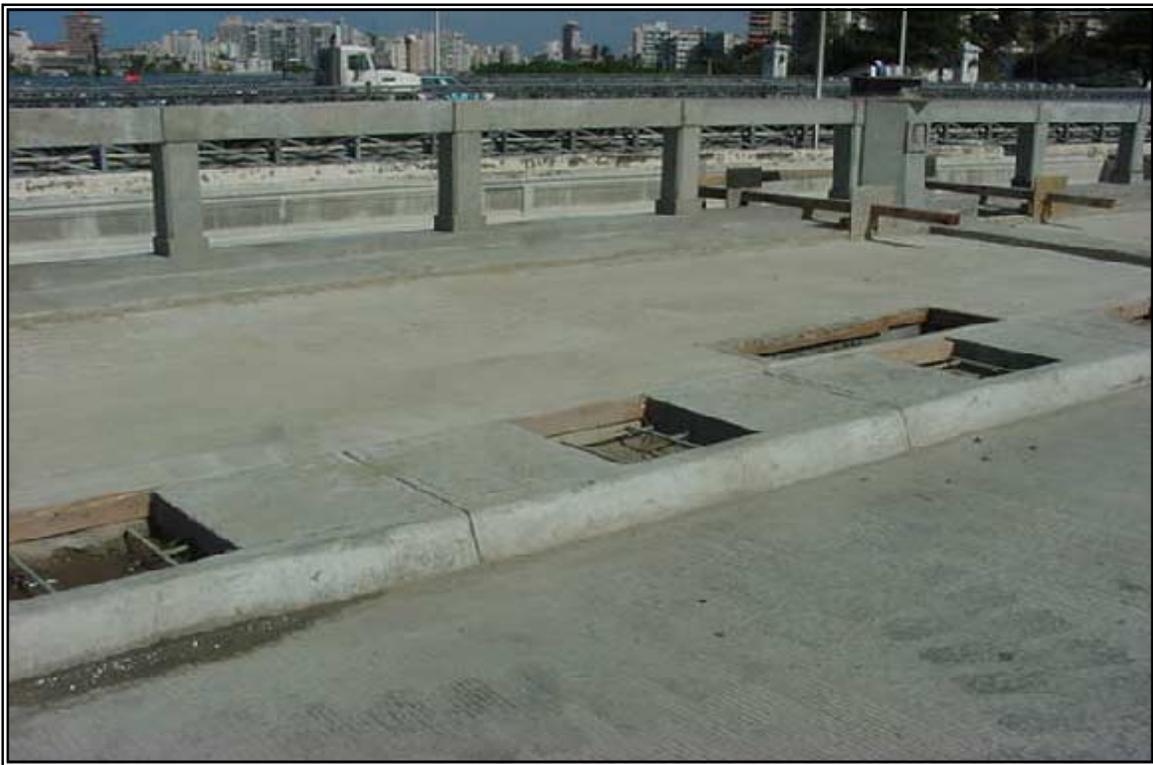
While the railing was under construction, the Contractor started the construction of the curbs and the concrete sidewalks (see Figure 1).

Figure 1. Concrete sidewalk and curb, Bridge #1 over San Antonio Channel

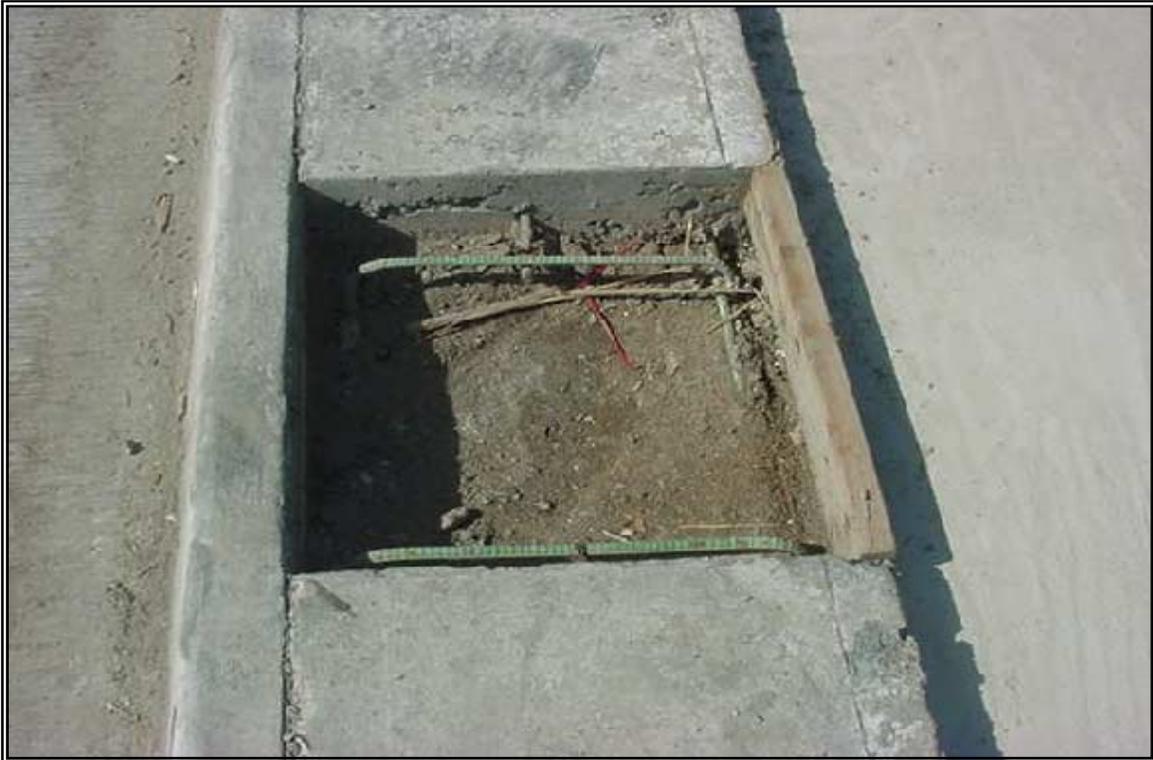
Rather than partially demolishing the sidewalk, he left open rectangular spaces for the anchorage of the base plates of the bridge rail sections. These spaces have dimension of 24 in x 24 in (see Figure 2). For a detail of the curb and sidewalk, see Drawing 4.1.

Figure 2. Open rectangular spaces left for the anchorage of the base plates

3. While building the portion of the sidewalk, the Contractor decided to leave some sidewalk areas without concrete. The purpose of these areas without concrete was to avoid the required chipping for the anchoring of the rail post.

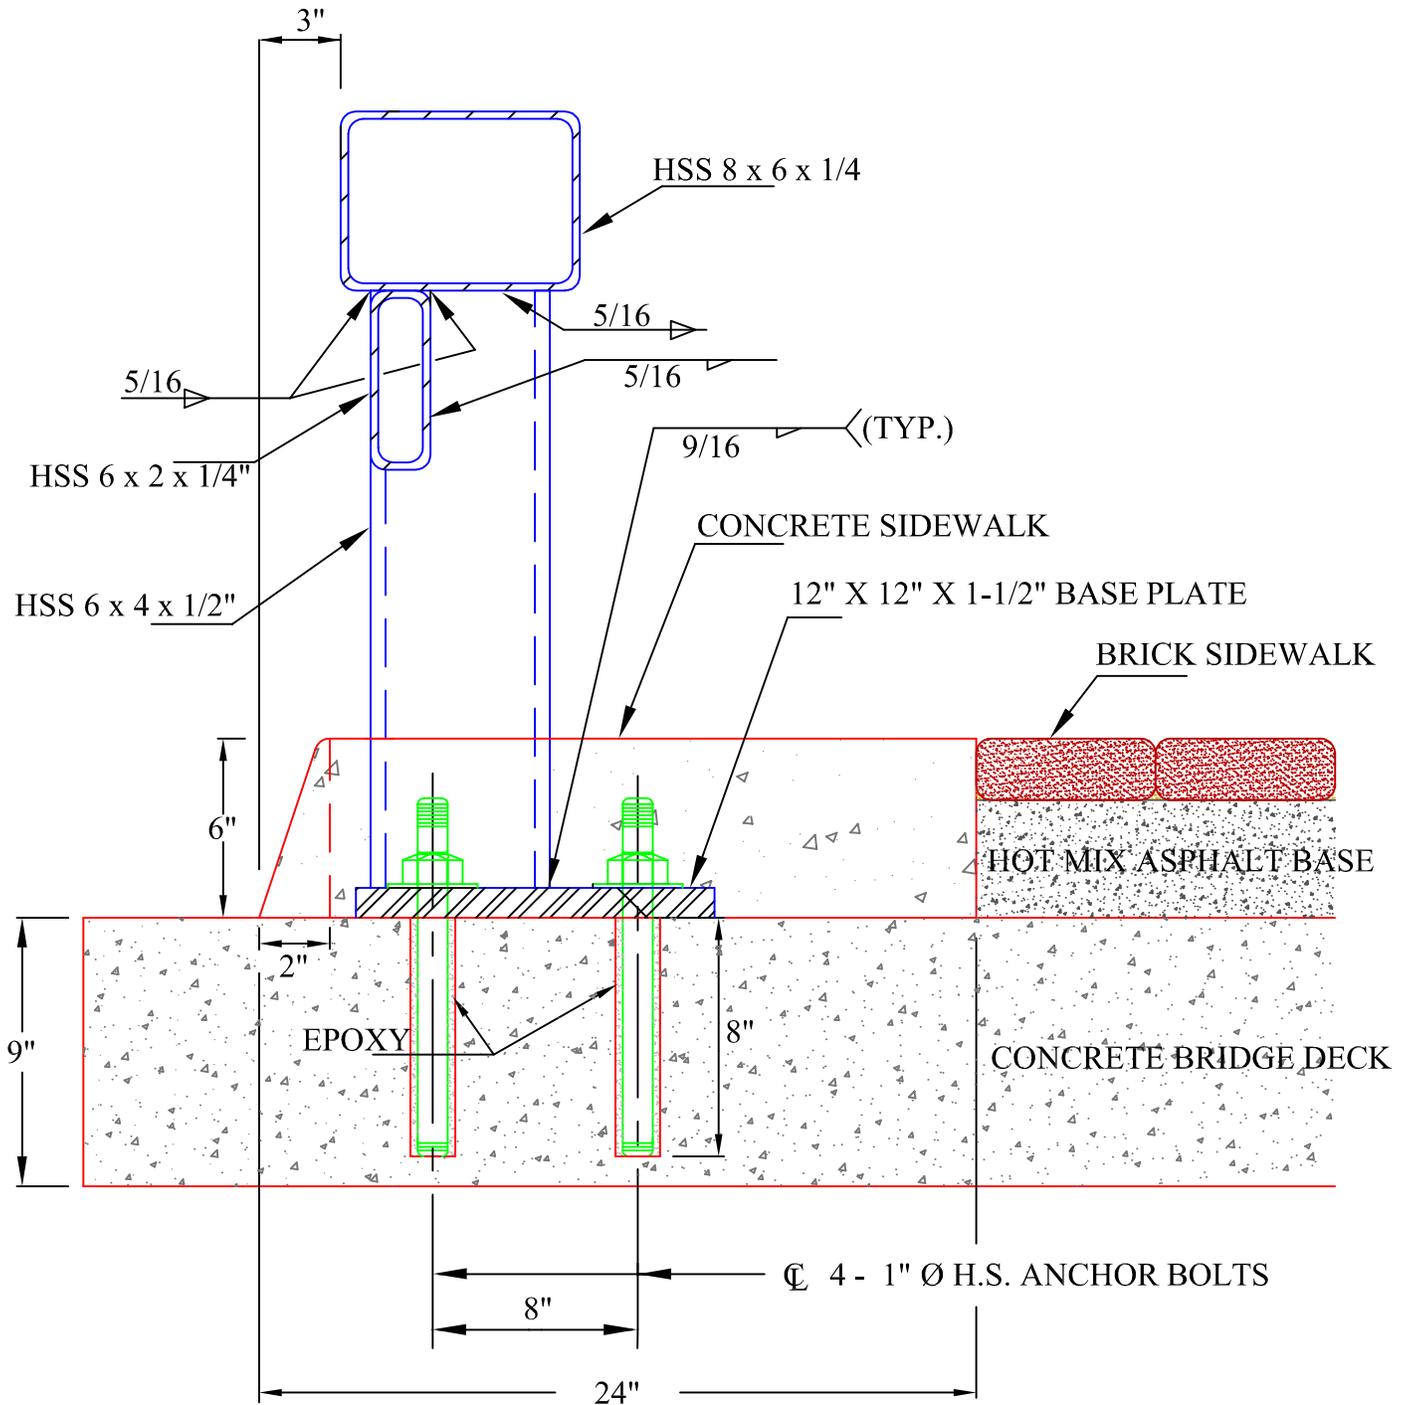
DRAWING 4.1. BRIDGE RAIL SECTION
 BRIDGE OVER SAN ANTONIO CHANNEL
 CURB MOUNTED RETROFIT

CROSS-SECTION

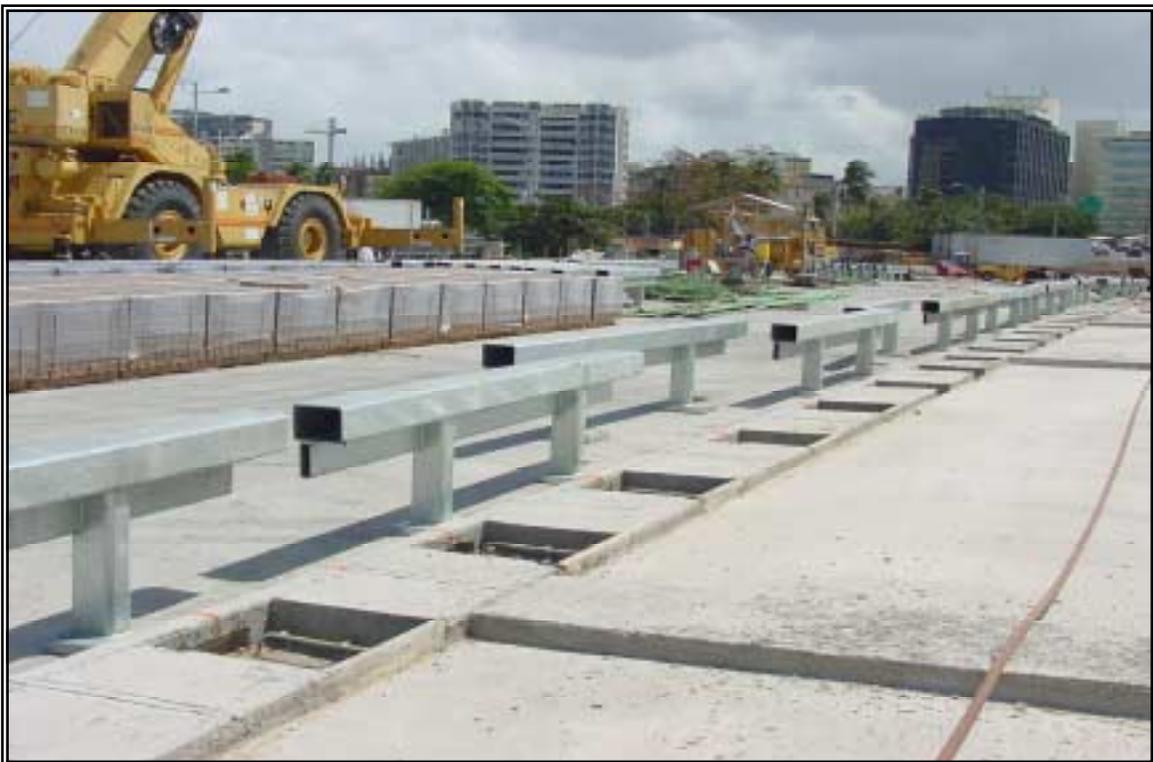
The bridge rail sections were placed near the open rectangular spaces for the preliminary location (see Figure 3). Every section had been identified in the shop drawings according to its corresponding position in the bridge. These identification codes have a nomenclature that shows the position and the section number from the beginning toward the center of the bridge. The identification codes were stamped at the base of each section. For example, the section identified as NW2 corresponds to the Northwest side of the bridge, and the section is the second one from the beginning of the bridge (see Figure 4). For the end sections, the bridge rail sections had been identified differently. For example, the section identified as ESW4 corresponds to the Southwest extension, and the section is the fourth one from the beginning of the transition part toward the beginning of the bridge (see Figure 5).

Figure 3. Back side view of the bridge rail preliminary location

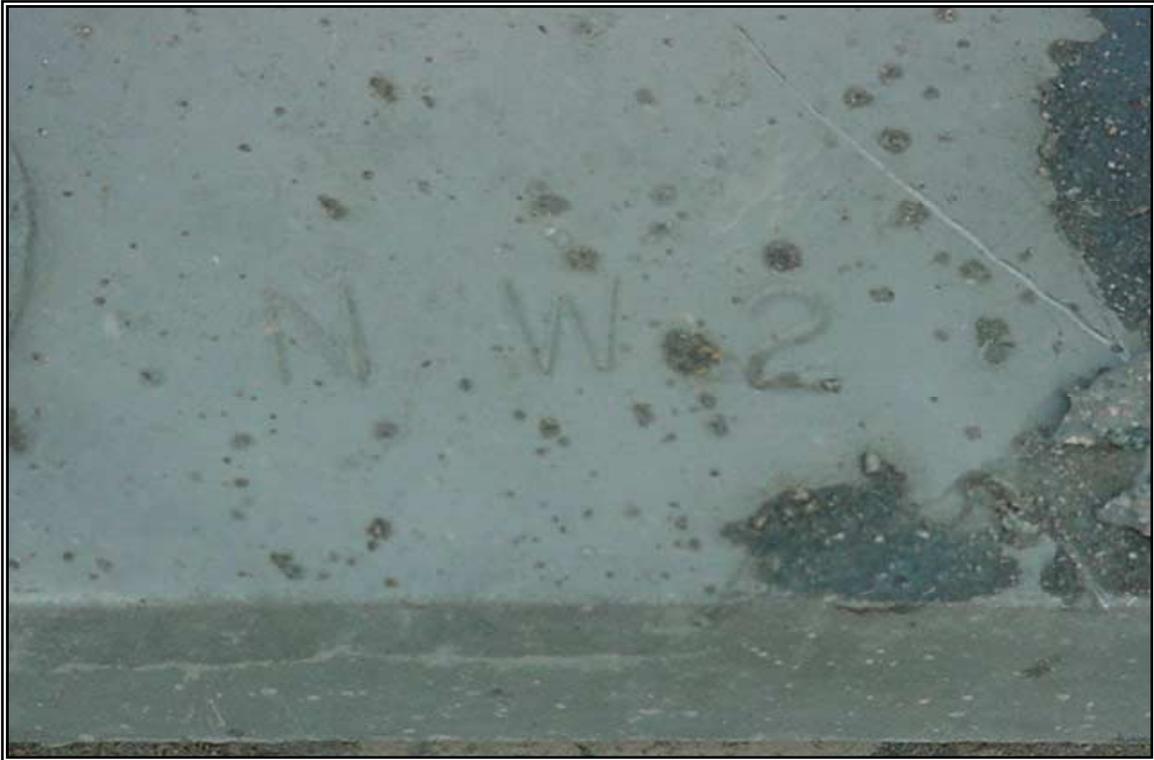
Figure 4. Bridge rail section that corresponds to the Northwest direction and position number 2

Finally, the sections were finished with a hot dipped galvanized treatment to protect them from corrosion. Each section had a unique identification number stamped at the base for identification purposes (see Figures 4-5). The shop drawings depicted the exact location of each section according to the position from the center of the bridge to the end of it. This identification ensures the correct position of the sections in the field assembly.

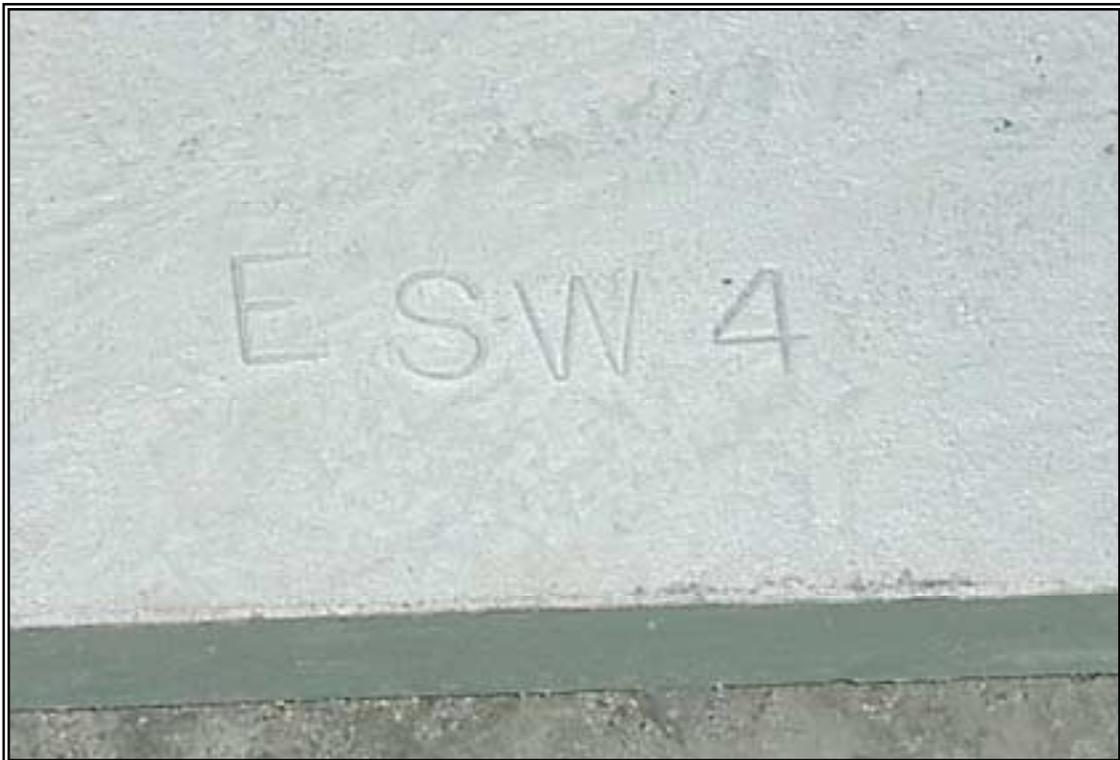
Figure 5. Extension section number 4 that corresponds to the Southwest part of the bridge

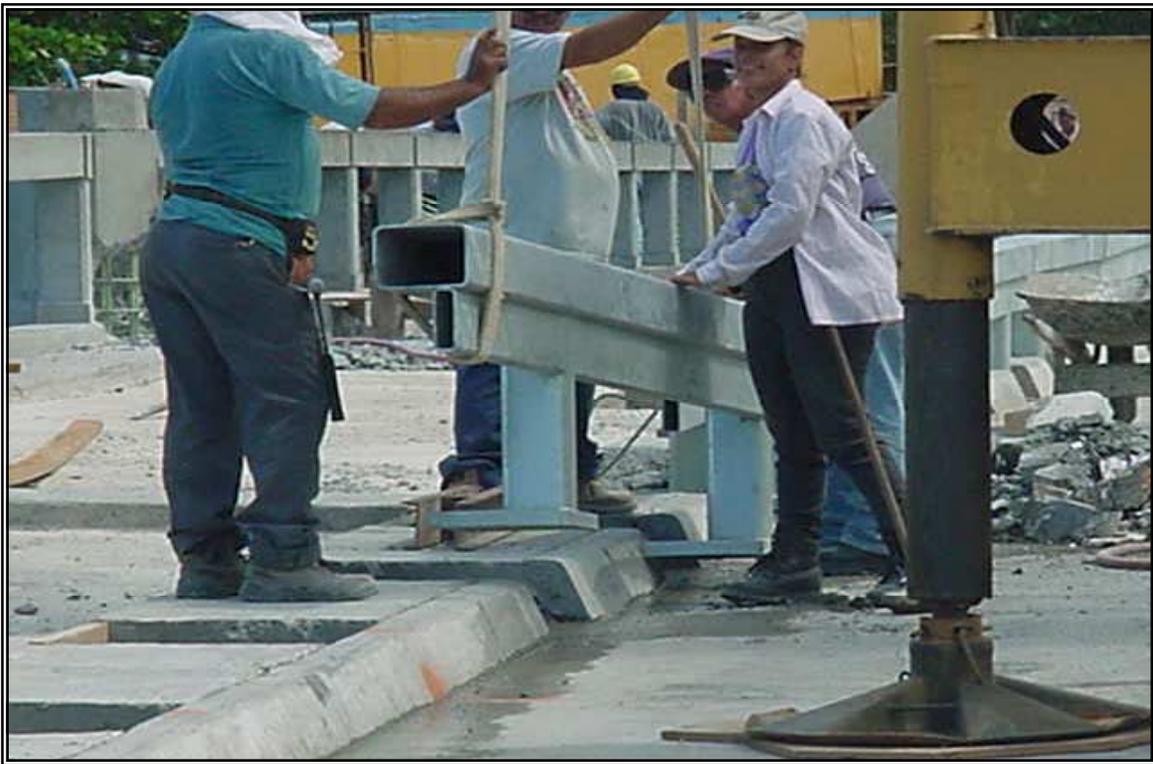
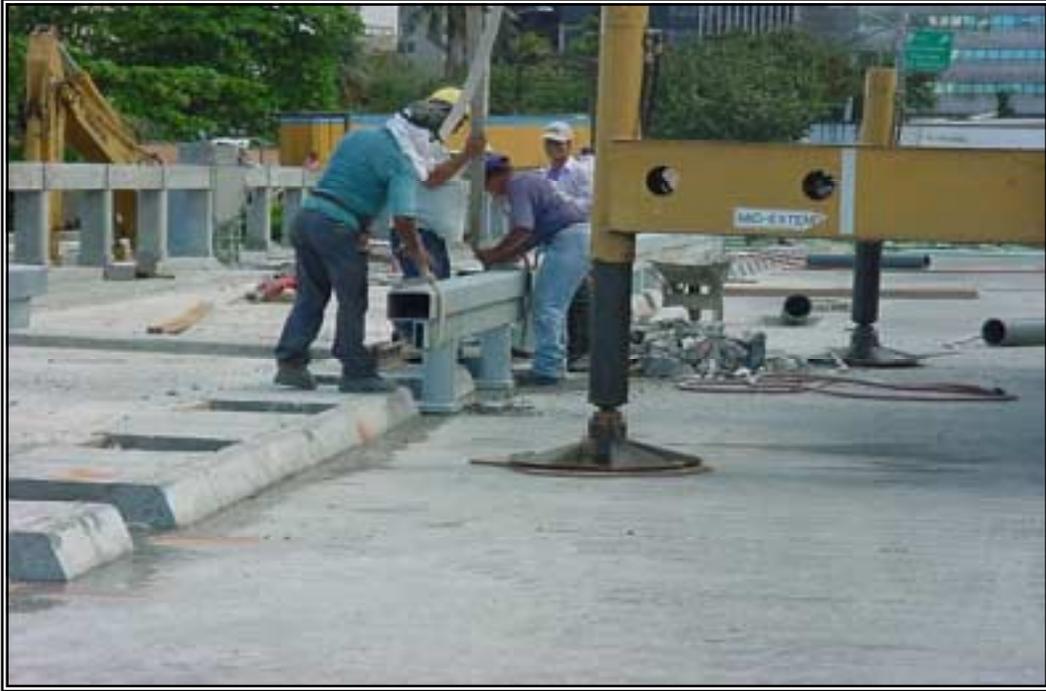
The bridge rail sections were set in place for the preliminary fitting using a crane. Each bridge rail section is connected to each other by inserting a joint sleeve. This joint sleeve is welded on one side only, and let free on the other. Due to this connection design, the Contractor was not able to install section by section easily. In order to fit just one section, the Contractor had to handle and fit adjacent sections at the same time. Consequently, the Contractor dry fitted the entire bridge rail on one side of the bridge in order to mark the pilot holes (see Figures 6-7).

Figure 6. The bridge rail section was dry fitted to mark the pilot holes

Figure 7. The bridge rail section was dry fitted to mark the pilot holes

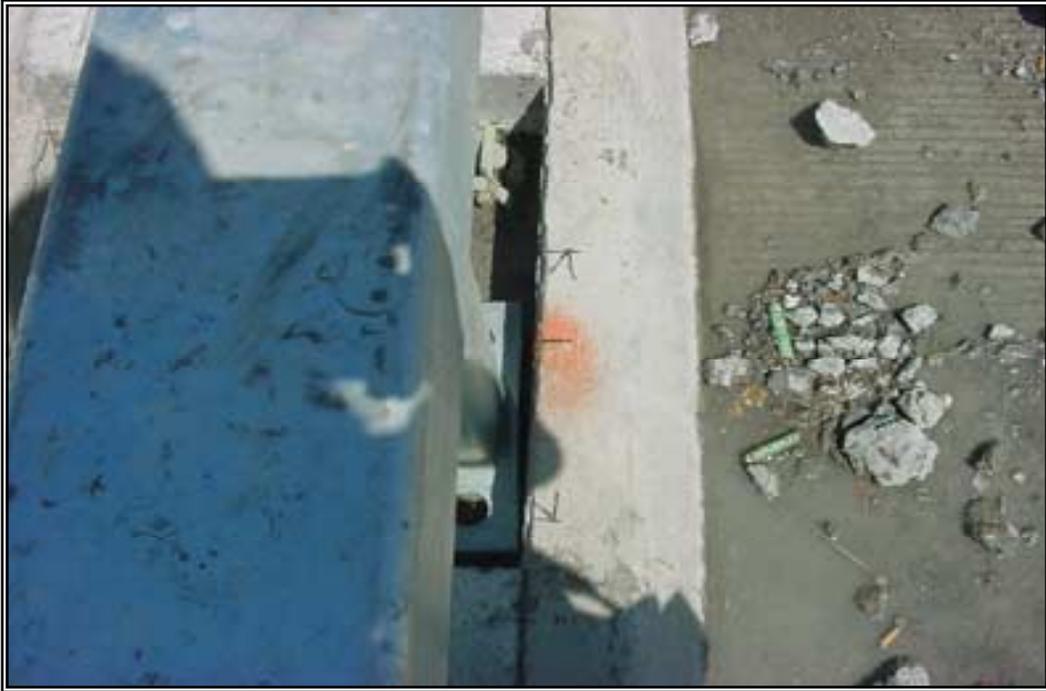
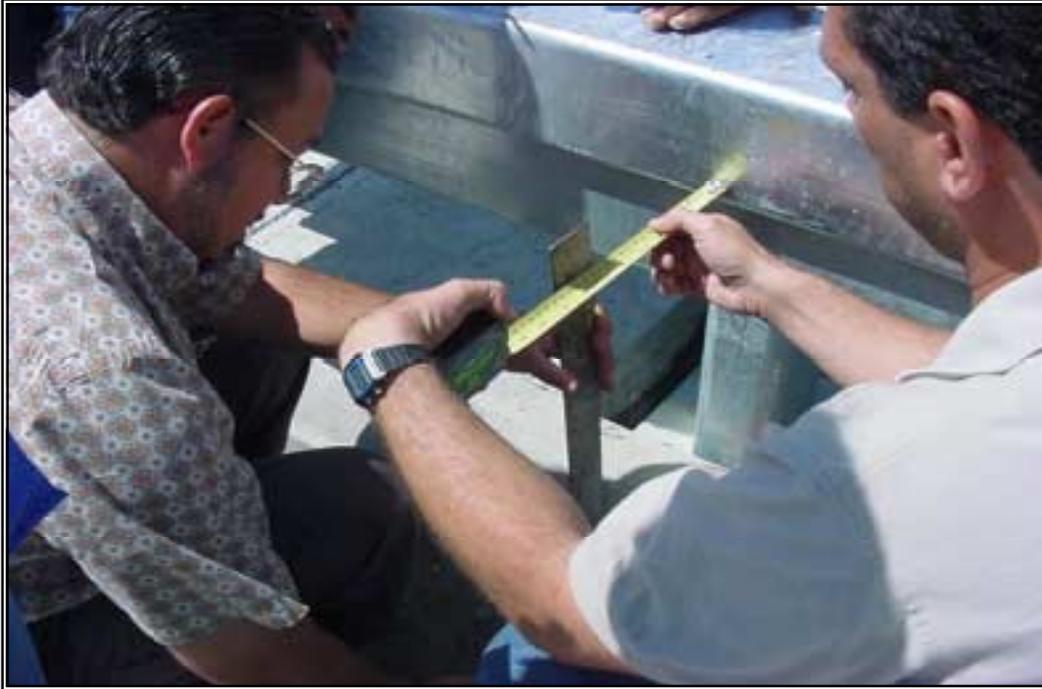
During the dry fitting, the Contractor realized that providing the 3 in offset from the curb’s bottom edge to the bridge rail face was not possible because the curb was in the way (see Figures 8-9).

Figure 8. Front side view of the bridge rail placement

Figure 9. The Contractor verified the distance between the bottom edge of the curb and the face of the bridge rail.

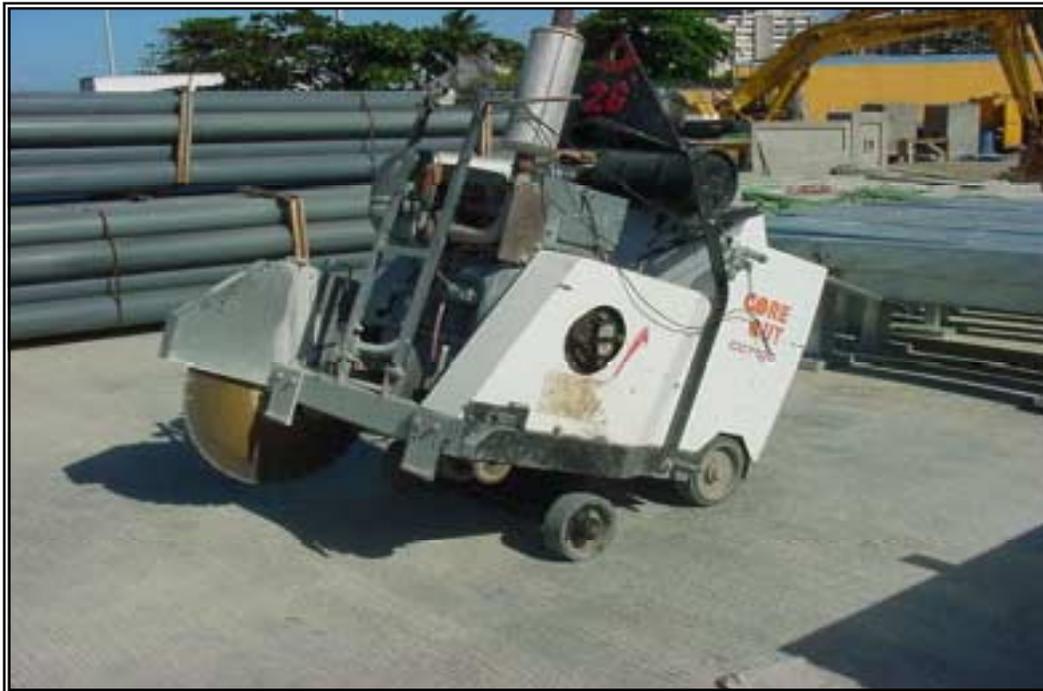
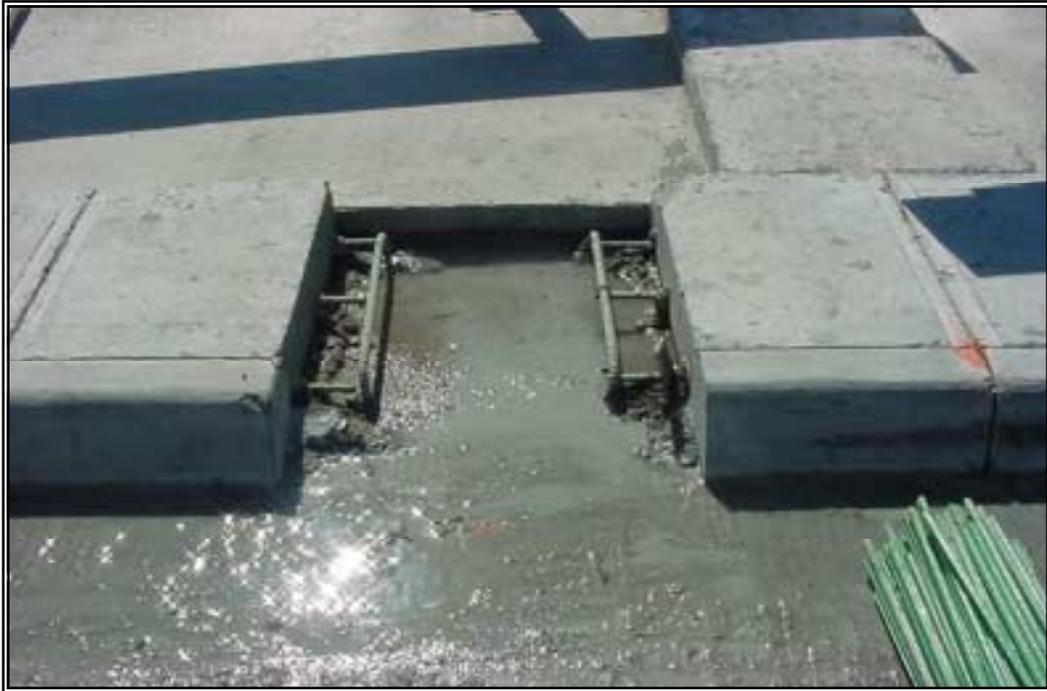
Consequently, the Contractor demolished the curbs. He used a saw cut machine (see Figures 10-11)

Figure 10. A saw cut machine was used to cut some parts of the curbs

Figure 11. Front view of the saw cut curb

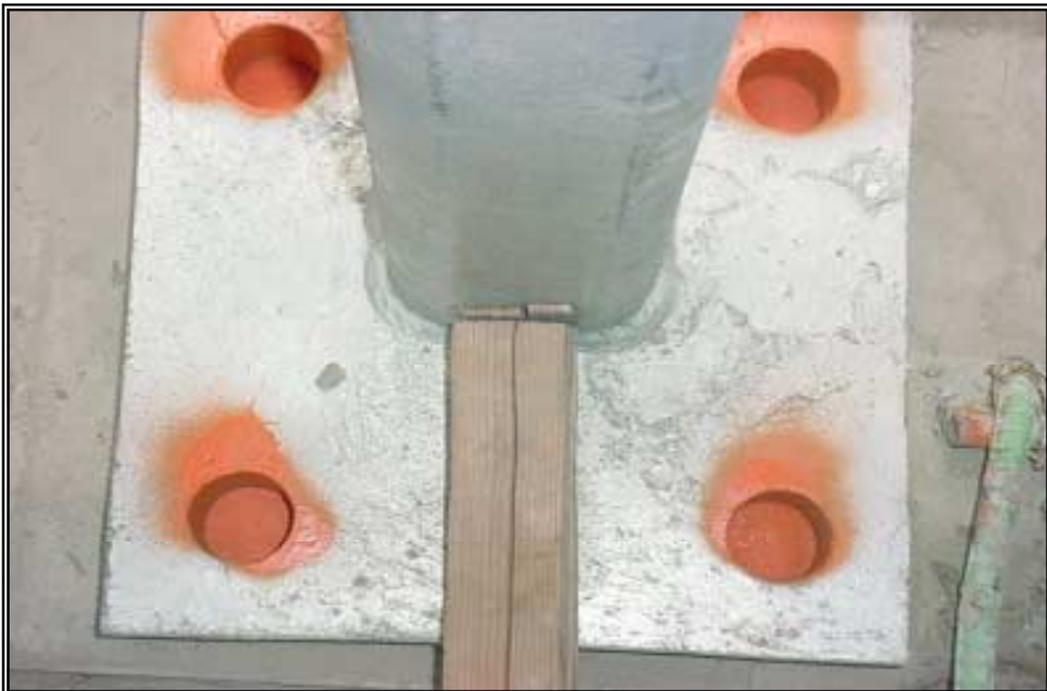
After the entire section of bridge rail was dry fitted correctly, the Contractor use spray paint to mark the pilot holes (see Figure 12).

Figure 12. The pilot holes were marked with spray paint

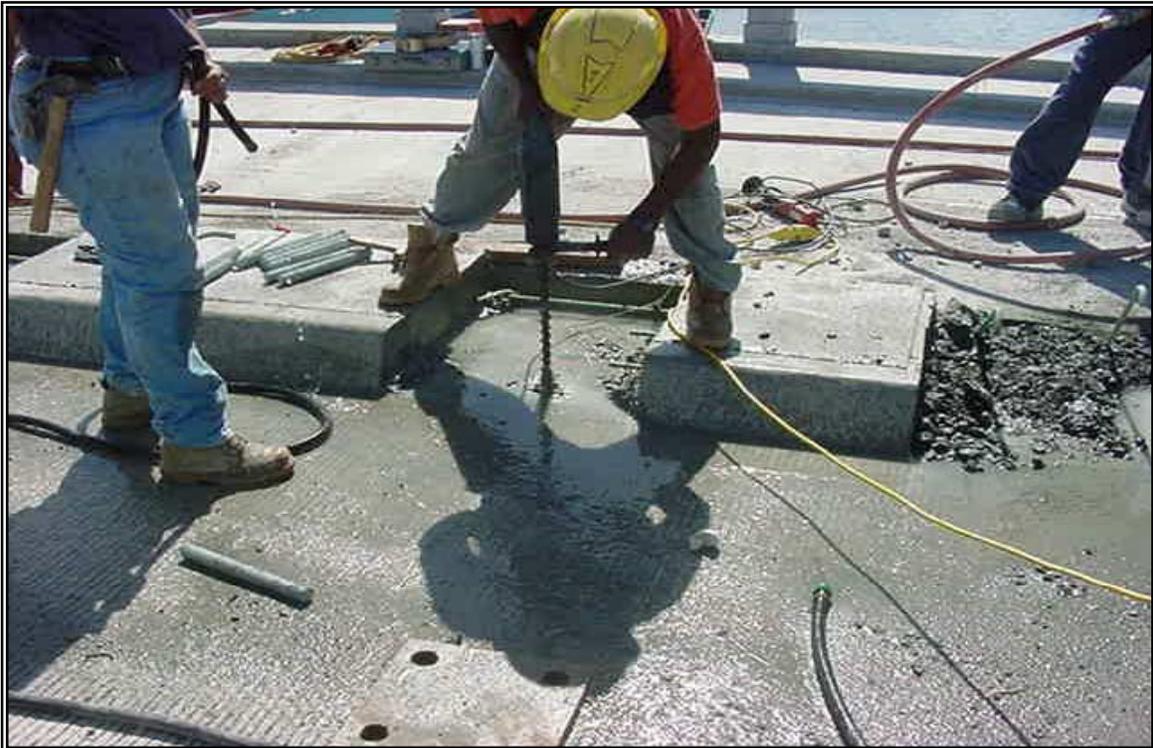
After all the pilot holes were marked, the bridge rail sections were removed to drill the pilot holes for the anchor bolts. Every hole was drilled using an impact hammer drill with carbide drill bit (see Figure 13). The depth required for the pilot holes was 8 in. The diameter of the pilot holes is 1/2 in bigger than the diameter of the anchor bolts. The anchor bolts were embedded with epoxy to maximize the anchorage.

Figure 13. The impact hammer drill with carbide drill bit was used to drill the pilot holes

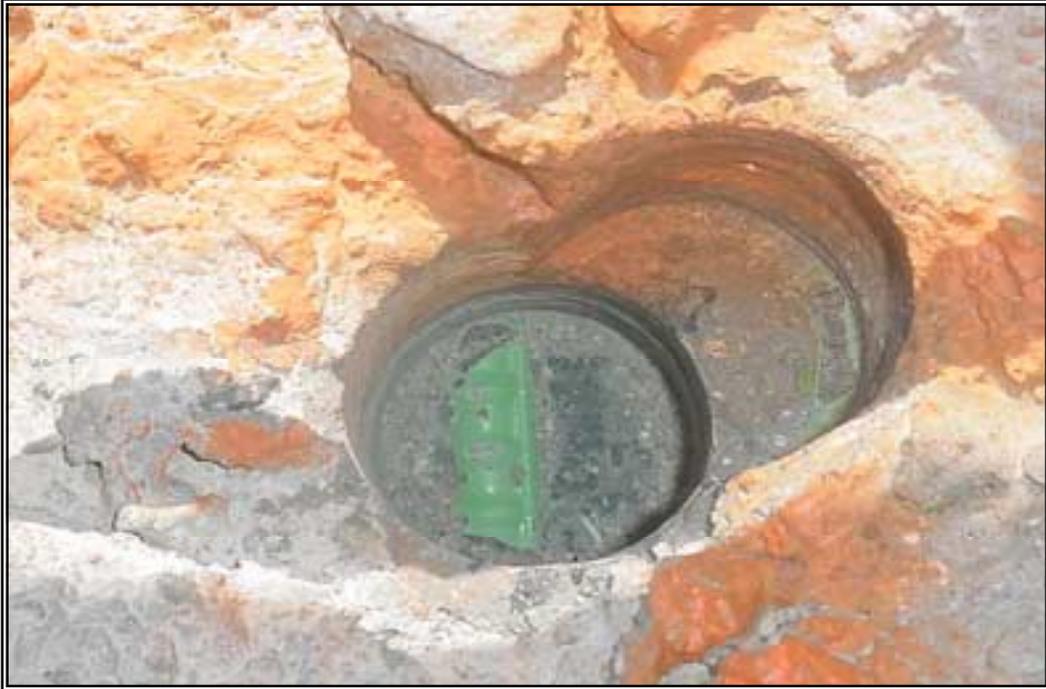
Sometimes, the workers hit reinforcing bars while they were drilling the pilot holes (see figure 14). The structural effect of cutting the reinforced bars is negligible. These bars are not subjected to direct loading and the removed sections are relatively small compared with the entire structure. When this happened, the workers had to change the drill. In order to cut through reinforcing bars, they used an industrial drill with a diamond core bit (see Figures 15-17). Figure 18 shows the pilot holes completed.

Figure 14. Steel bar of the deck found when drilling the 1 1/2 inch- diameter holes. The additional drill holes were covered with epoxy.

4. While drilling the pilot holes using an impact hammer drill with carbide drill bit, they hit the reinforcing steel bars of the bridge deck. At that moment the Contractor had to stop using the impact hammer drill and change to an industrial drill with a diamond core bit to finish the pilot holes. The problem of encountering steel bars delayed the drilling process considerably. The structural effect of cutting the bridge deck reinforcing steel (at the sidewalks) is negligible.

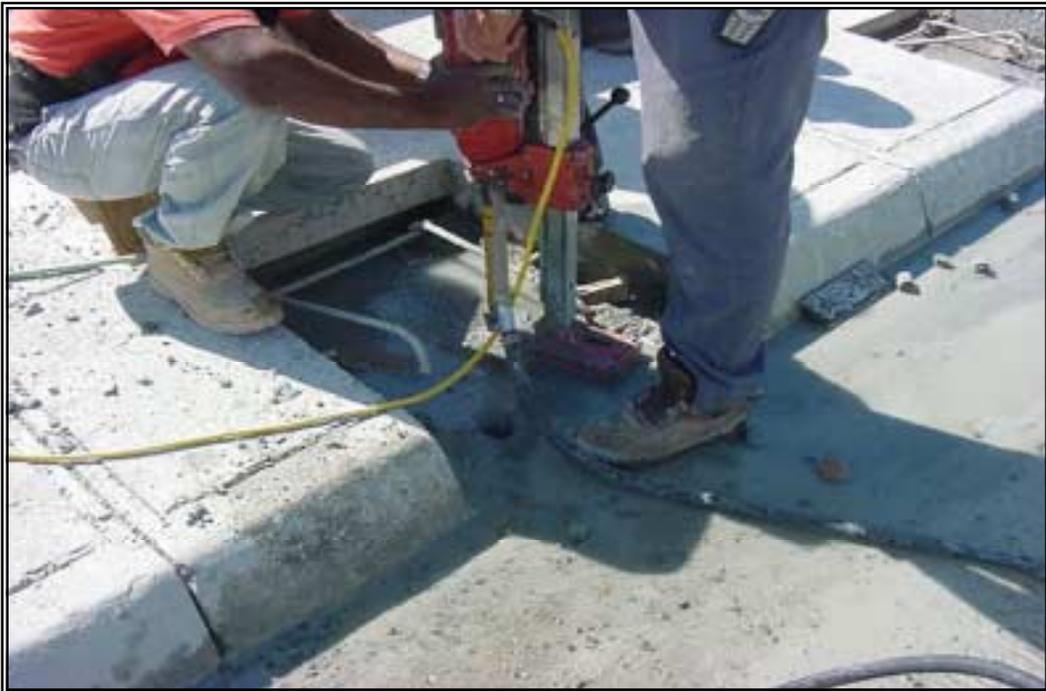
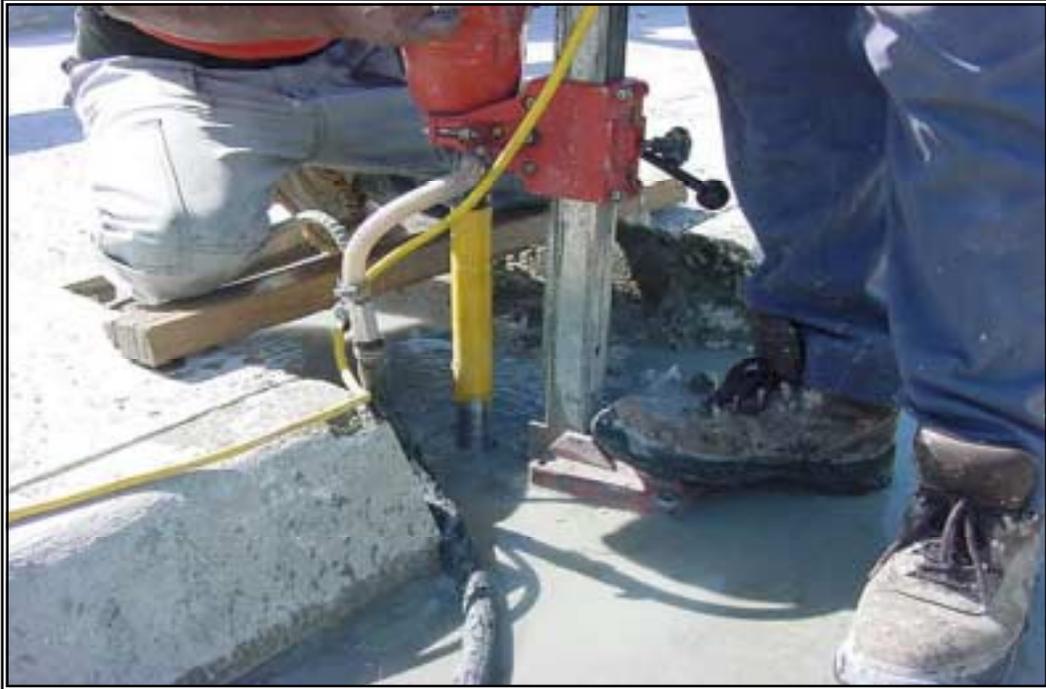
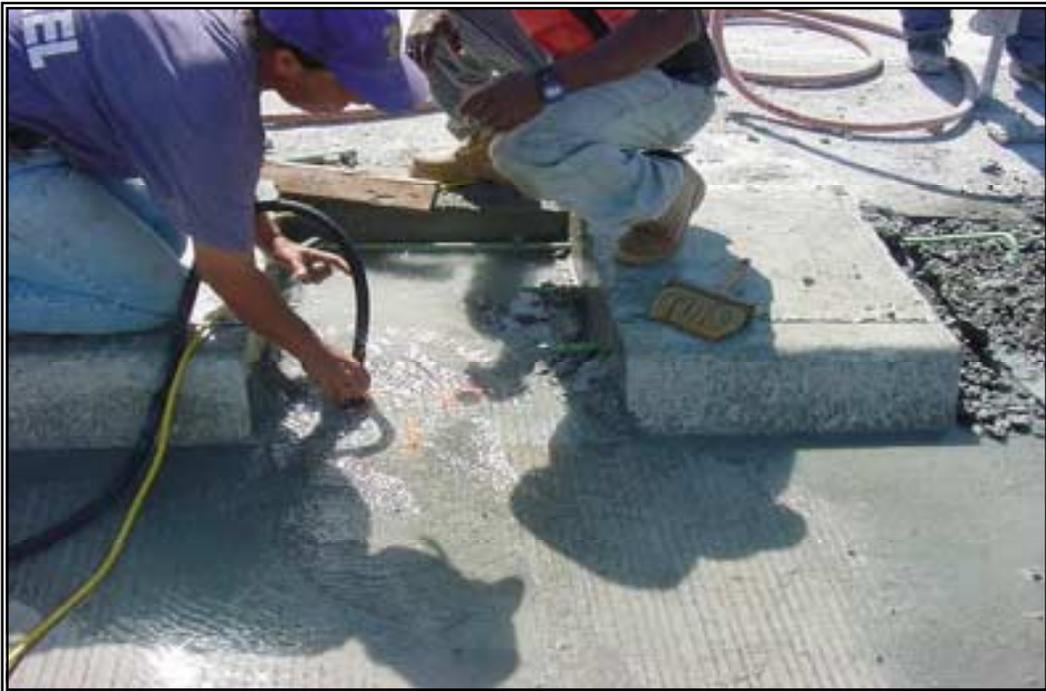
Figure 15. The diamond core bit was used to cut the steel bars found

Figure 16. They used water to clean the holes and avoid over heating of the driller.

Figure 17. Workers cleaned the holes to eliminate any debris

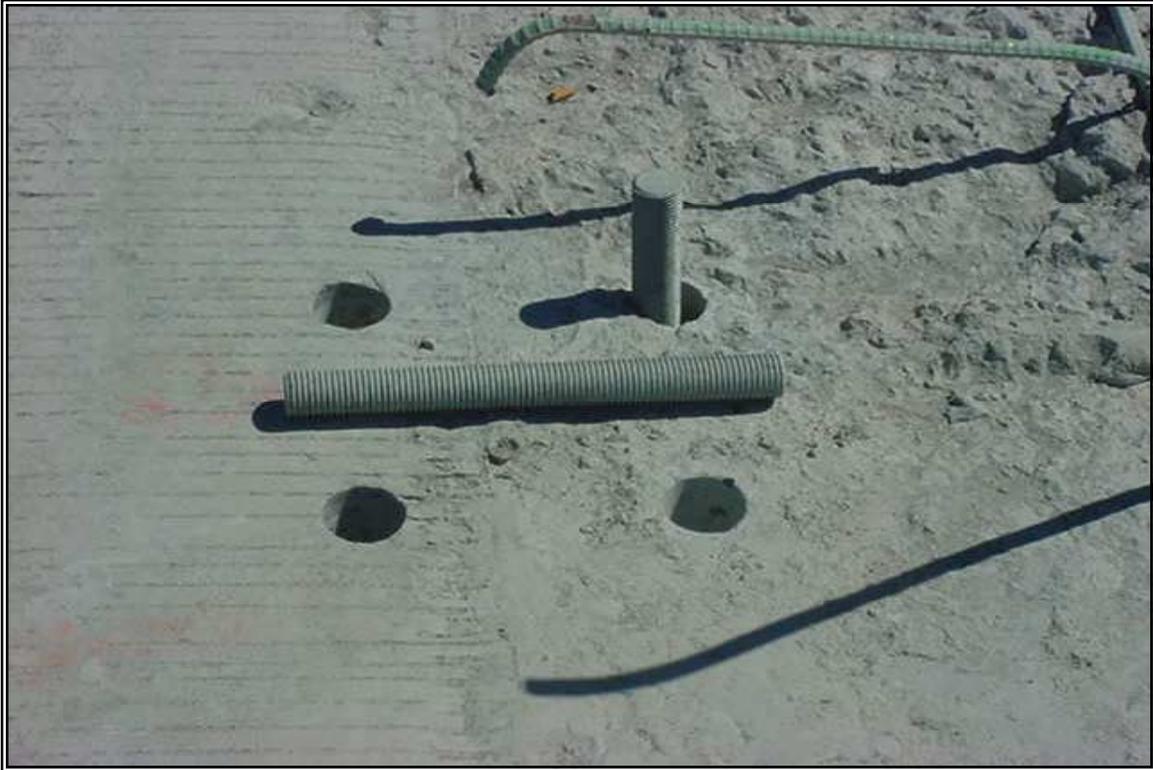
Figure 18 . The anchor bolts were placed in the holes already drilled

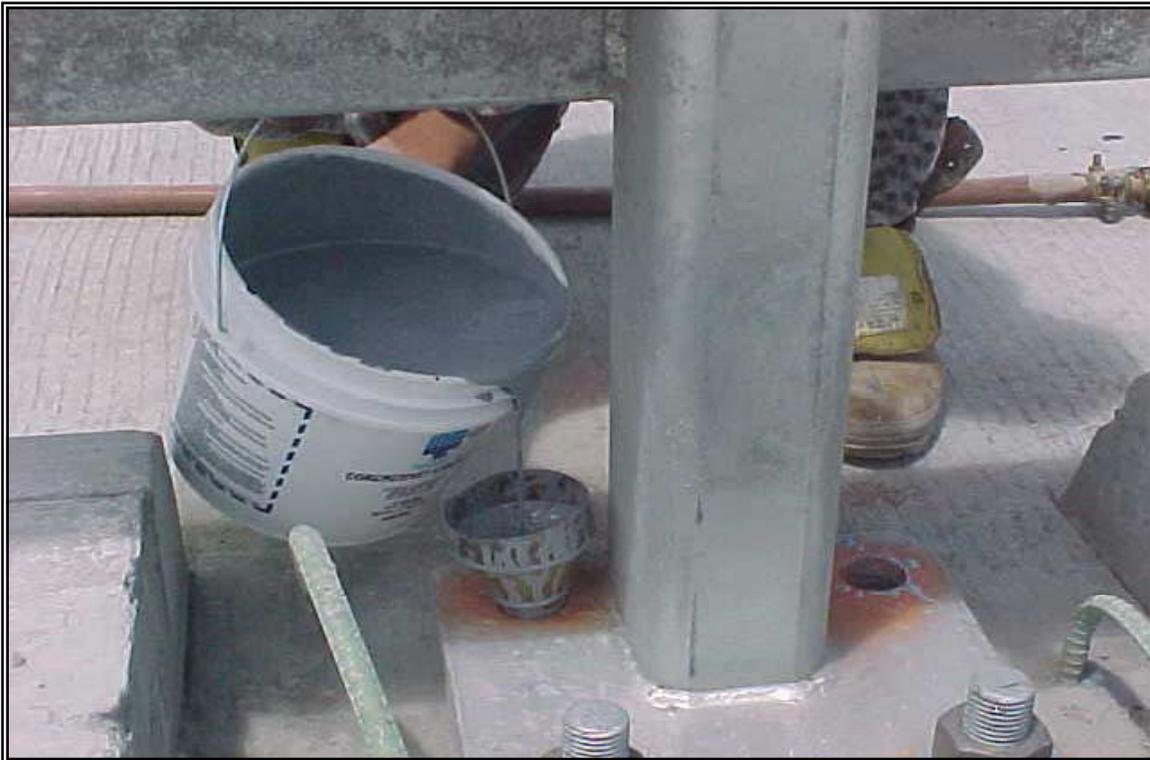
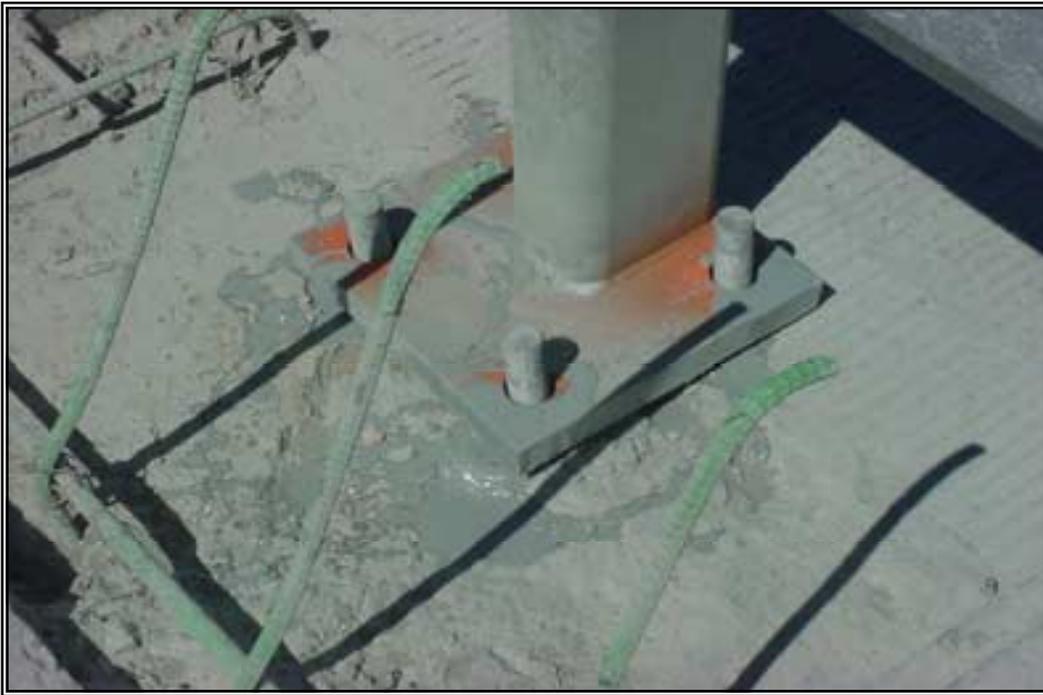
The bridge rail sections were placed in their final location (using the pilot holes as a guide). Construction grade epoxy was used to anchor the bolts into the bridge deck. The application of the epoxy was done with a funnel (see Figure 19). After the epoxy was poured, the anchor bolts were inserted in the pilot holes.

Figure 19. Epoxy Application

There was a little squeeze out of epoxy after inserting the bolts into the pilot holes (see Figure 20).

Figure 20. Epoxy Application

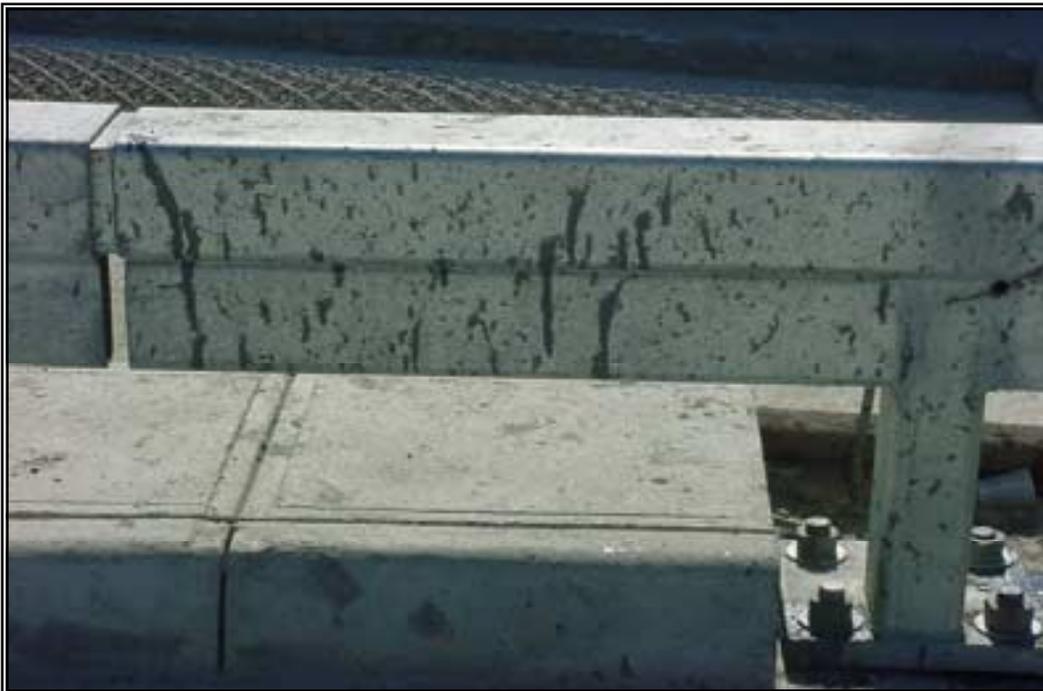
Unfortunately, some epoxy was splattered on the bridge rail. These stains were later cleaned up (see Figure 21).

Figure 21. Bridge Rail section with epoxy stains. They were removed with an anti-abrasive liquid.
