BRIDGE RAIL INSTALLATION PROCEDURE

Documentation Report
Replacement of Bridge #1
Over San Antonio Channel
San Juan, Puerto Rico

June 2002

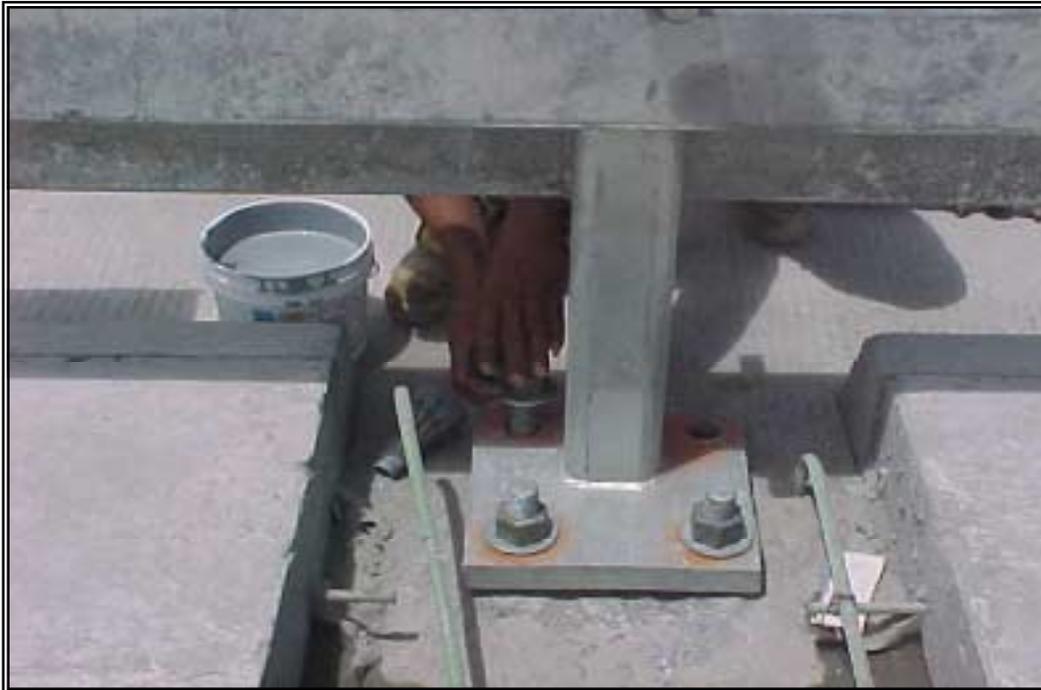
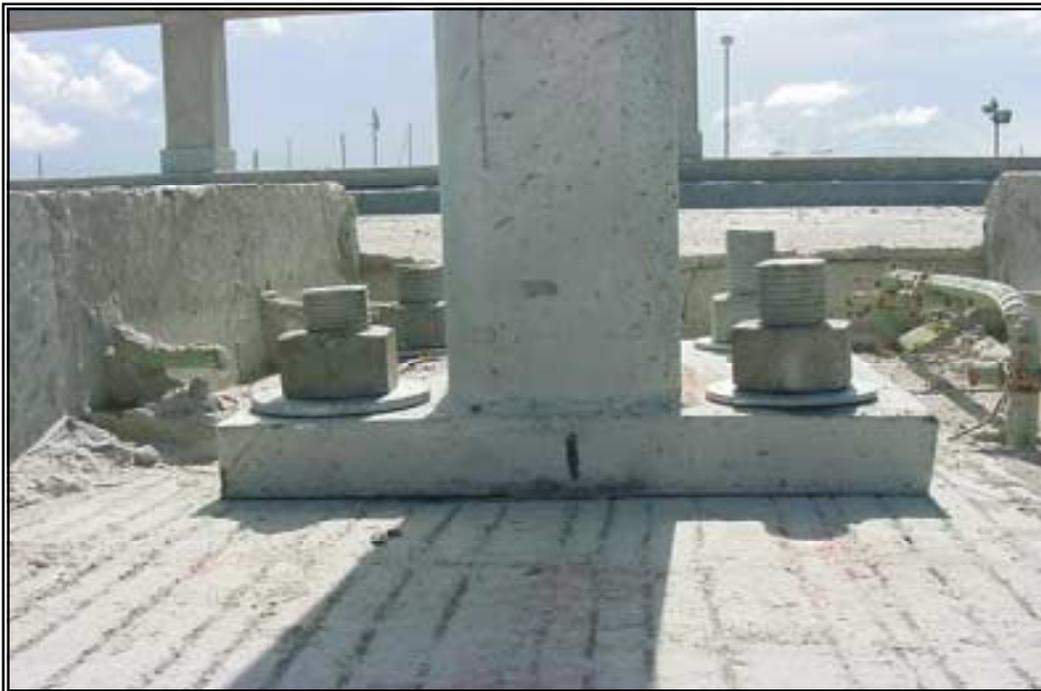
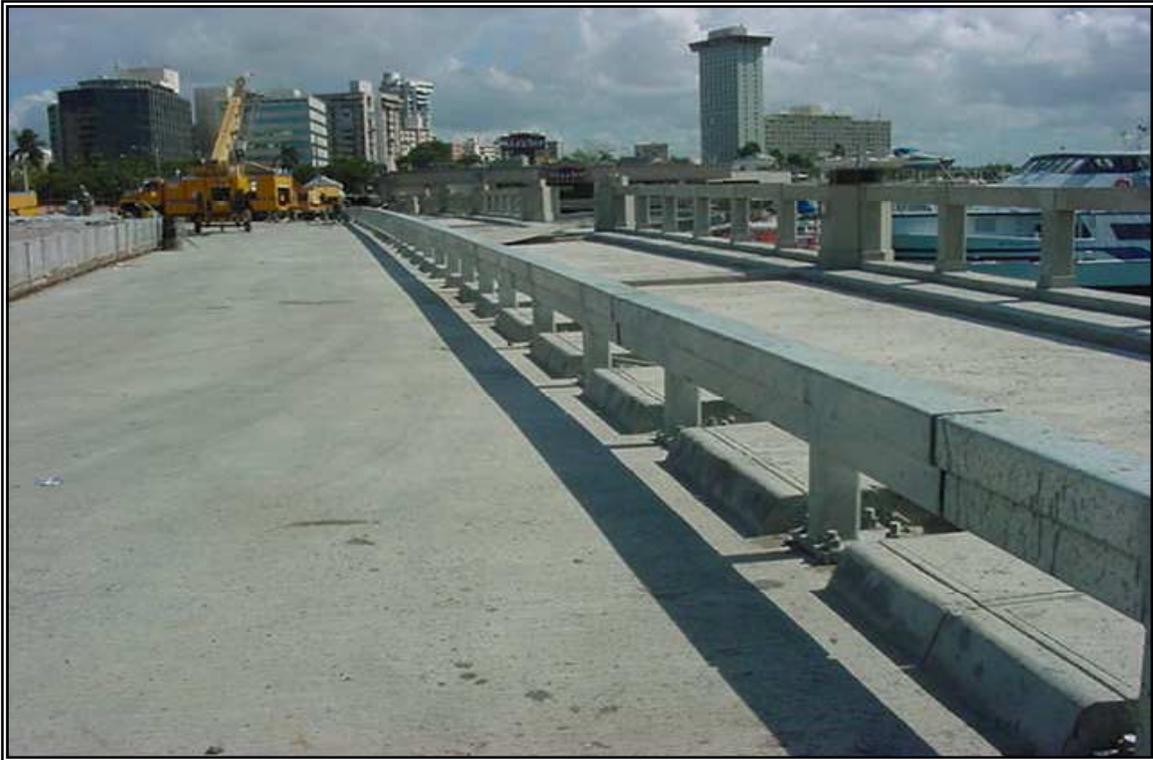
After the epoxy cured, washers and nuts were tightened, anchoring the bridge rail to the bridge deck (see Figures 22-24).

Figure 22. Placing of the washers and tightening of the nuts of the bridge rail sections

Figure 23. The nuts were tightened after the epoxy cured.

Figure 24. Partial assembly of the bridge rail sections

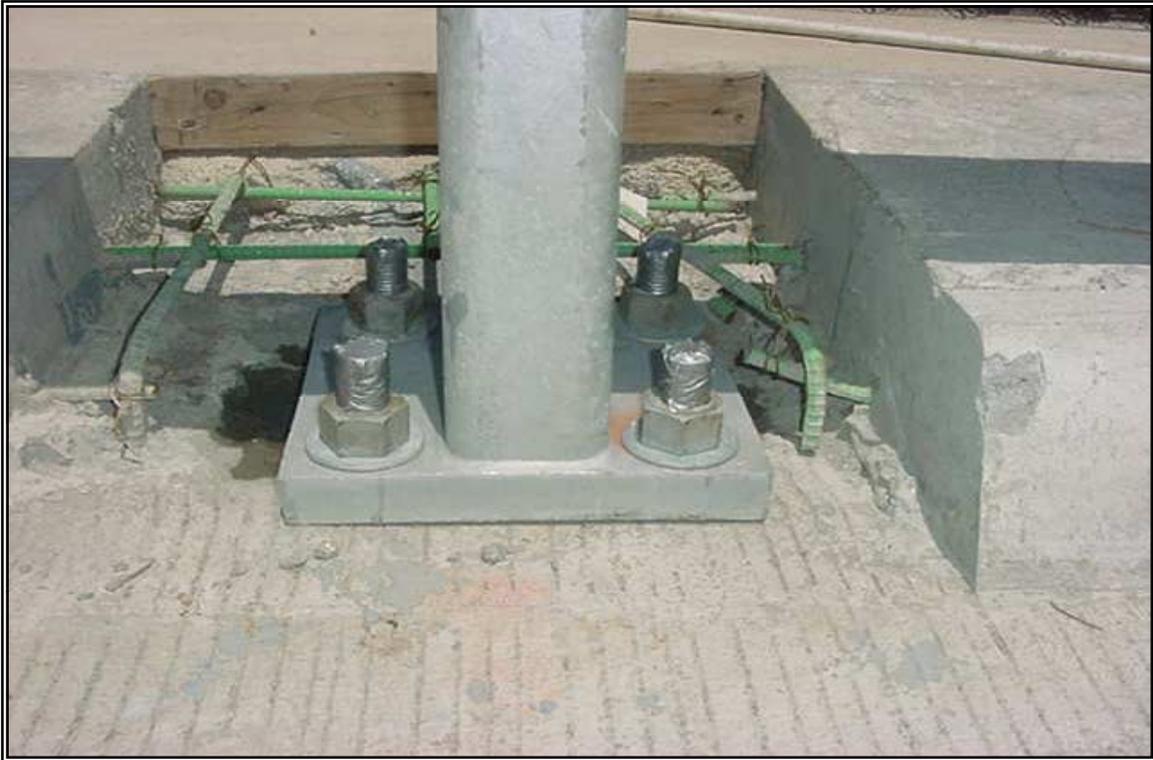
All the nuts were tightened after the epoxy application. Duct tape was placed at the free end of the anchor bolts (see Figure 25). The Contractor decided to do this to prevent future damage of the anchor bolts. This technique was used for future benefits, because if in the future the anchor bolts have to be removed, it will be easier to do it.

Figure 25. Duct tape application for prevent damage of the anchor bolts. The reinforced steel bars were left cut as shown.

deck are recessed into cutout or left spaces in the curb on the bridge deck. These spaces are then filled with concrete after the installation of the bridge rail. If the bridge rail was damaged to such an extent as to require replacement of a section of the rail, the concrete in these spaces will have to be manually chipped out before workers can get to the anchor bolts and nuts to remove the posts. Also, this increases the likelihood of the threads in the anchor bolts being damaged, which would further complicate the removal of the posts. To prevent damage to the bolts threads, the Contractor decided to cover the exposed anchor bolts with duct tape, so the concrete will not adhere, in order to make future repairs easier.

4. If the bridge rail is hit by a vehicle and damaged to such an extent as to require replacement of a section of the rail, the concrete around the post and base will have to be manually chipped out before workers can get to the anchor bolts and nuts to remove the posts. The Contractor used duct tape to protect the threads of the anchor bolts. However, we recommend the use of PVC pipe caps instead. These caps will protect the anchor bolts in case of chipping is required during maintenance.

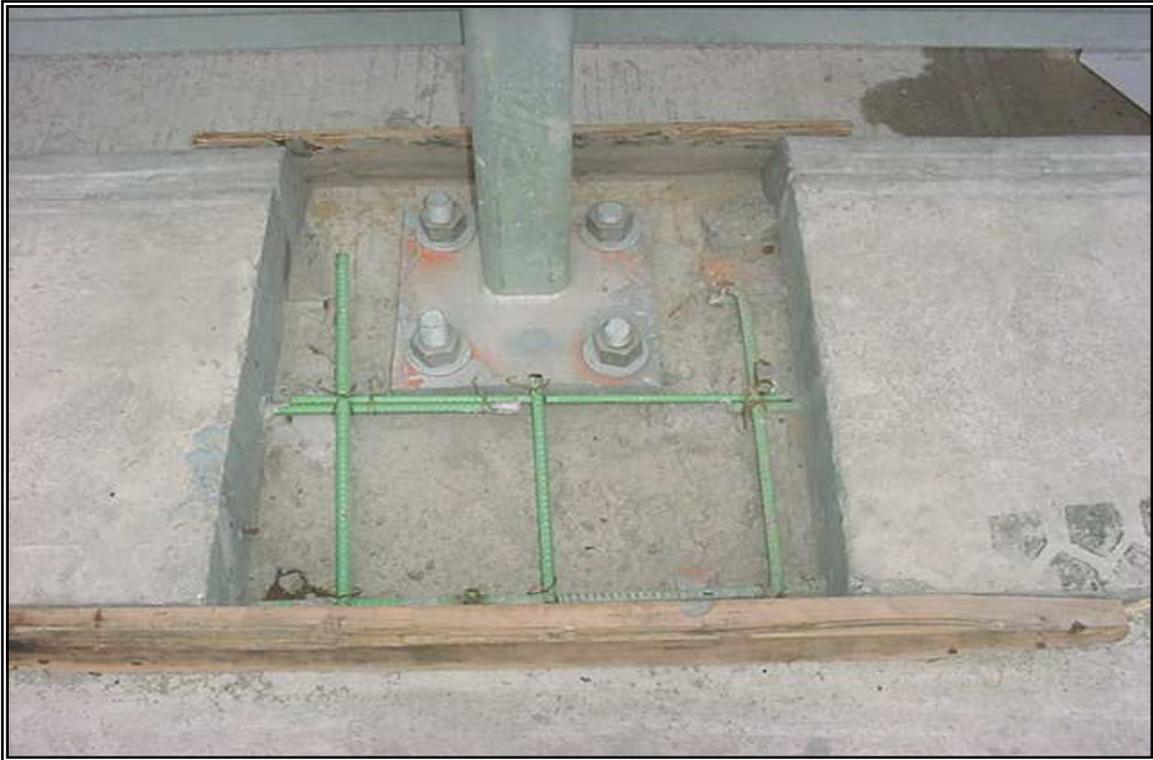
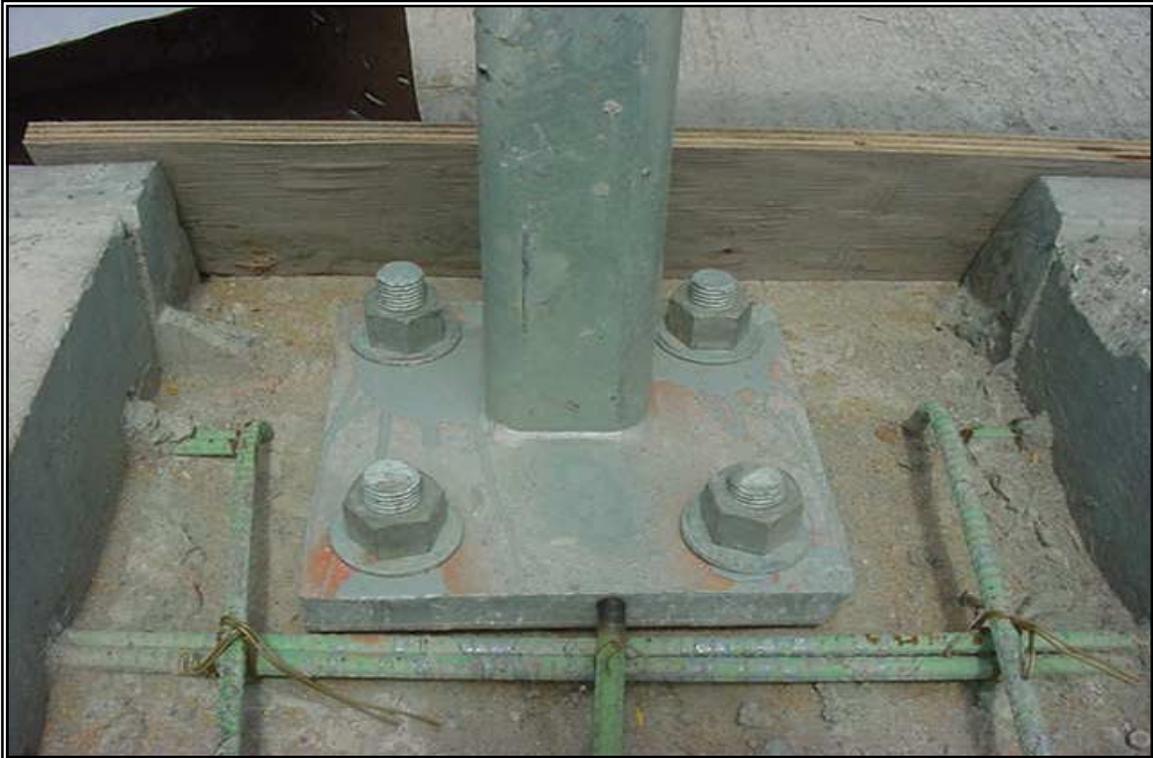
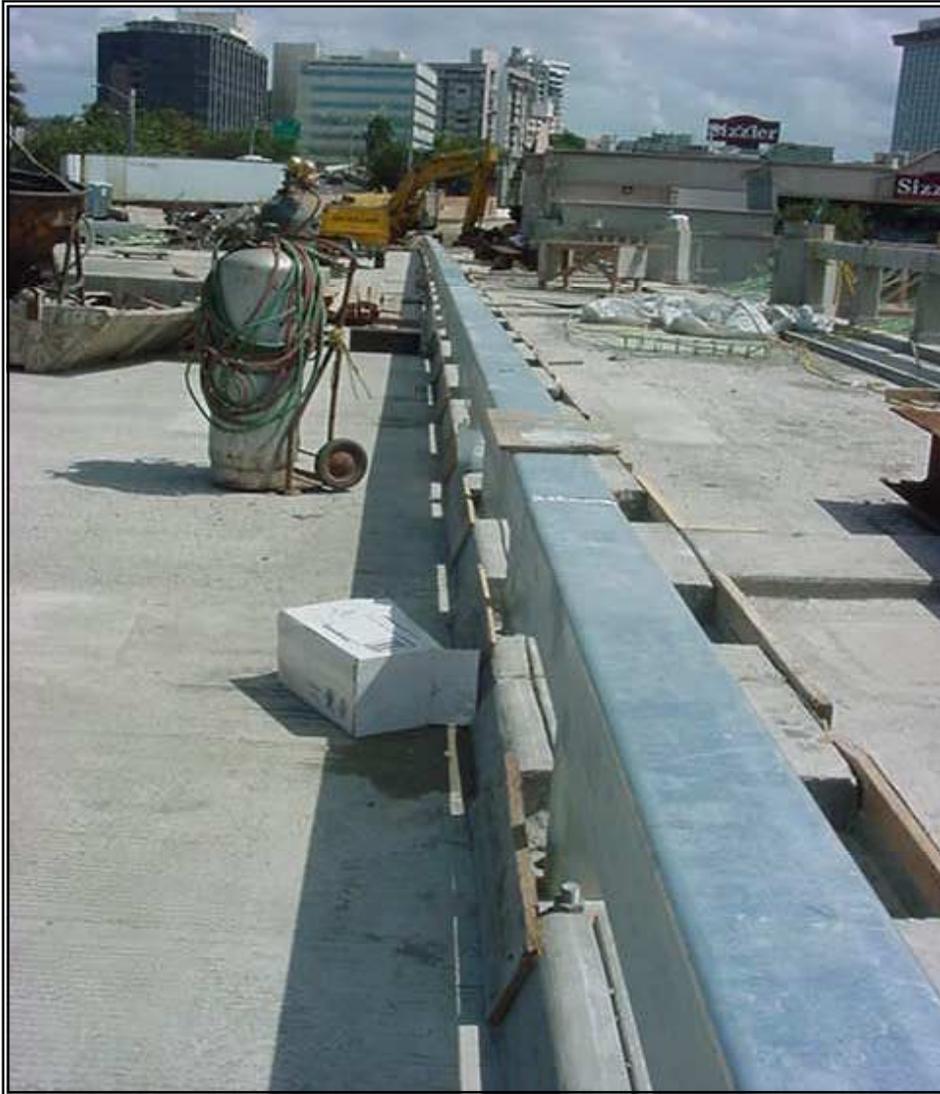
The formworks were installed after the tightening of the nuts to re-construct all the curbs that were demolished (see Figures 26-28). Also the open rectangular spaces, which were left for the bridge rail installation process, will be filled with concrete. Formworks were also installed at the other side of the concrete sidewalk (brick sidewalk side).

Figure 26. Formworks installation for the construction of the curbs and the concrete sidewalks

Figure 27. Formwork installation from the curb side

Figure 28. Complete installation of the formworks

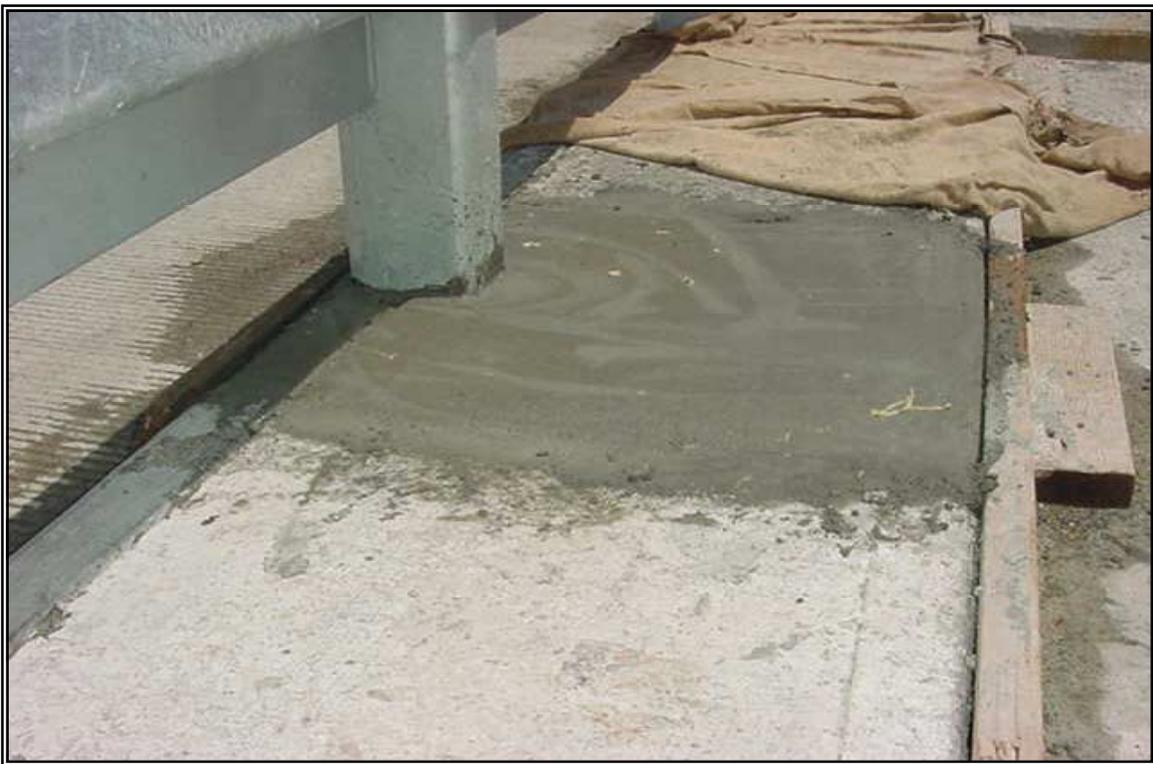
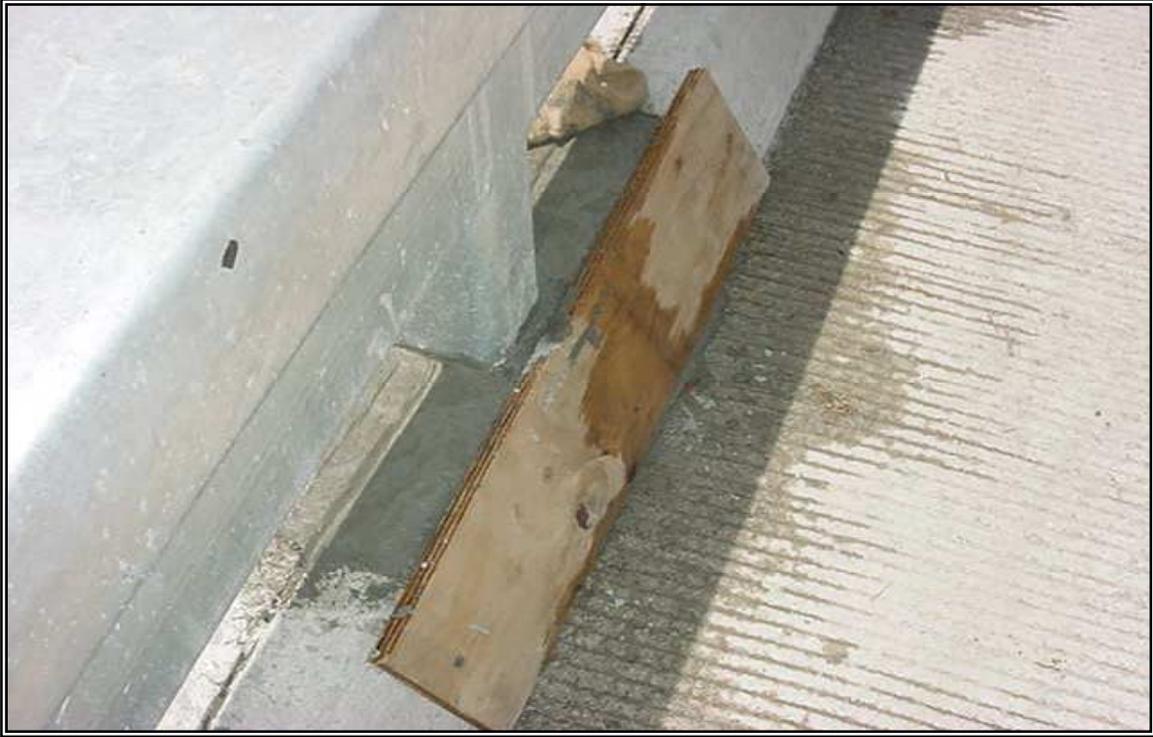
After the formworks were placed, the concrete was poured to fill the open rectangular spaces that were left for the bridge rail installation process and to re-construct all the curbs that were demolished (see Figures 29-30).

Figure 29. Type D concrete (5000 psi) concrete poured for the construction of the curbs and the concrete sidewalks

Figure 30. Concrete placement. Curb's side view

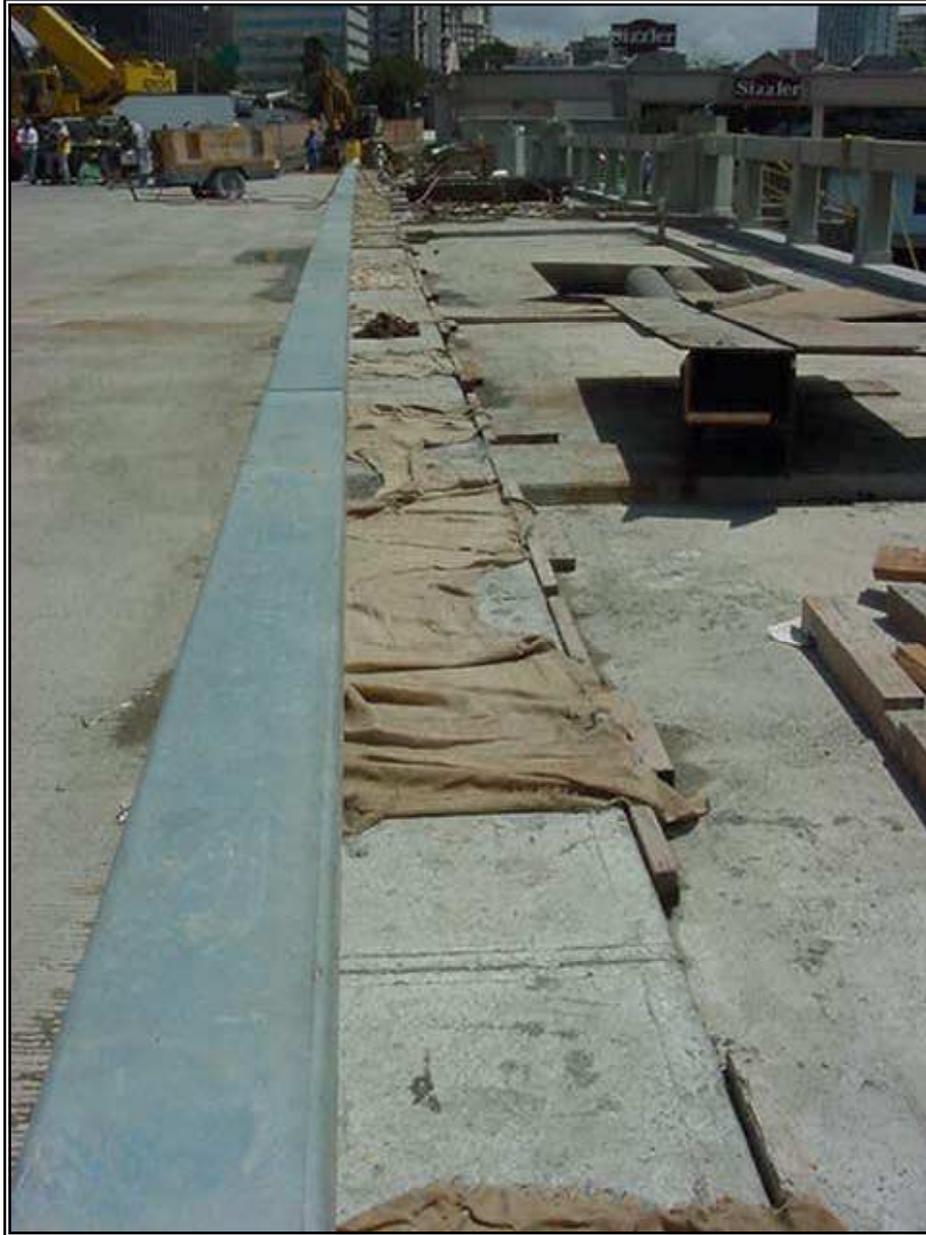
The Contractor utilized moist burlap for curing the concrete. Water was added every two hours to the moist burlap to maintain its humidity and obtain a good curing of the concrete (see Figure 31).

Figure 31. Moist burlap for curing the concrete

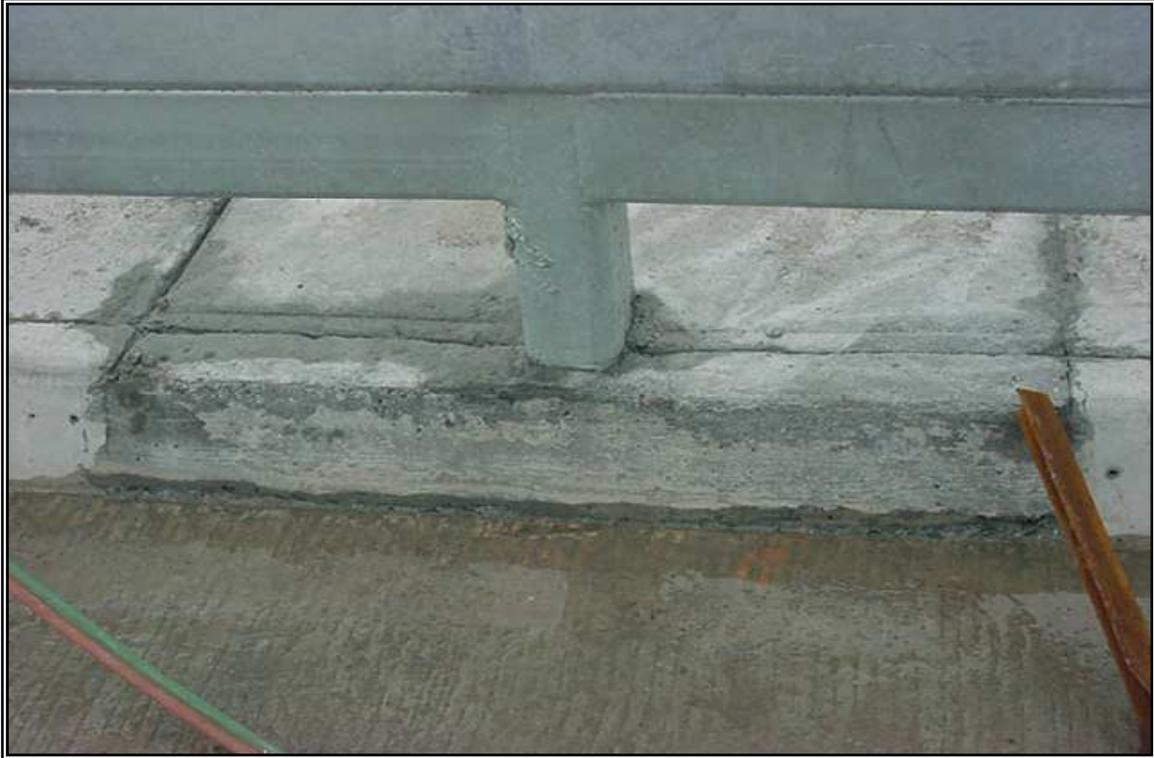
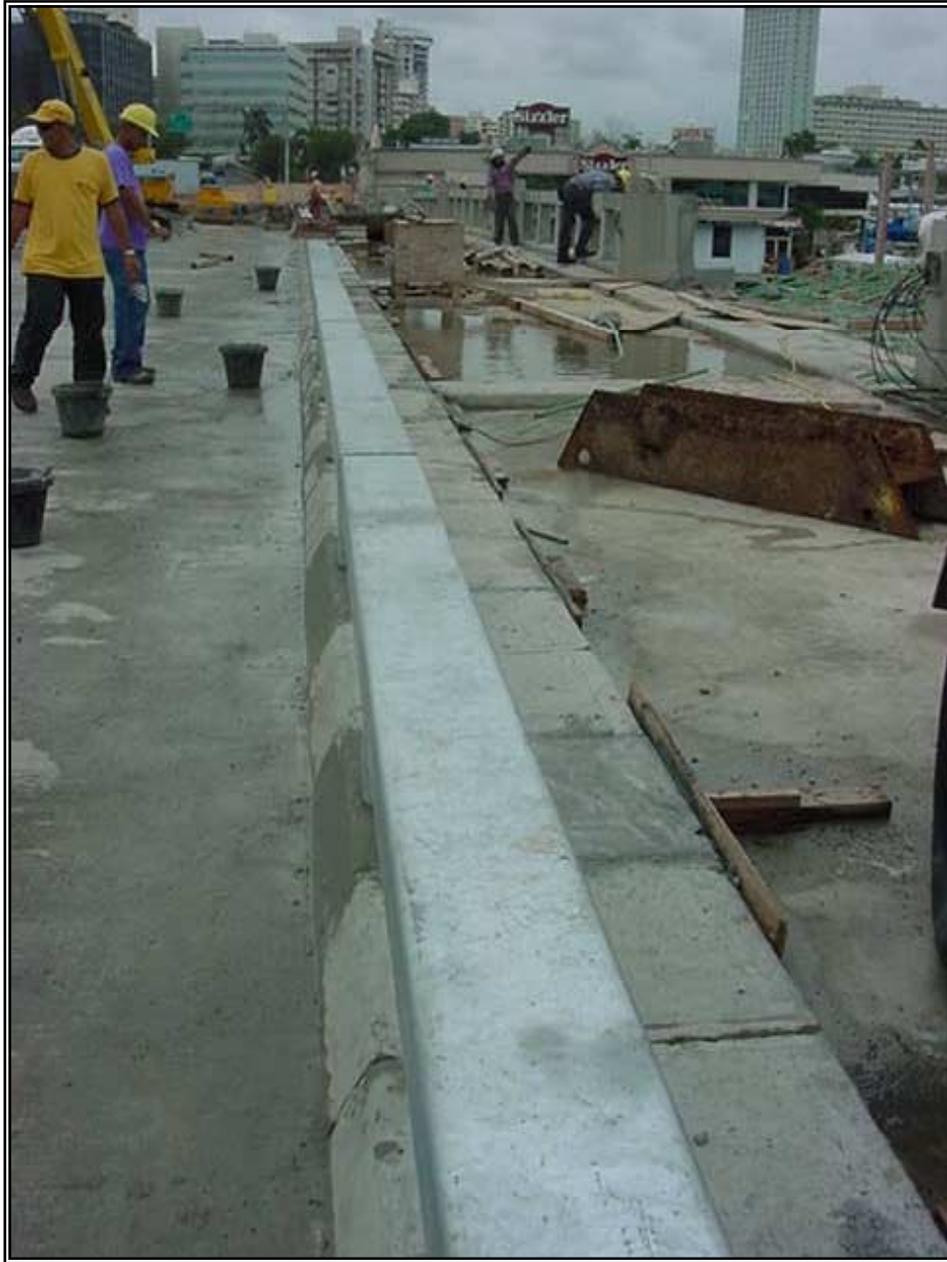
Figure 32: Front view of a finished curb

Figure 33: Finished concrete sidewalk and curb

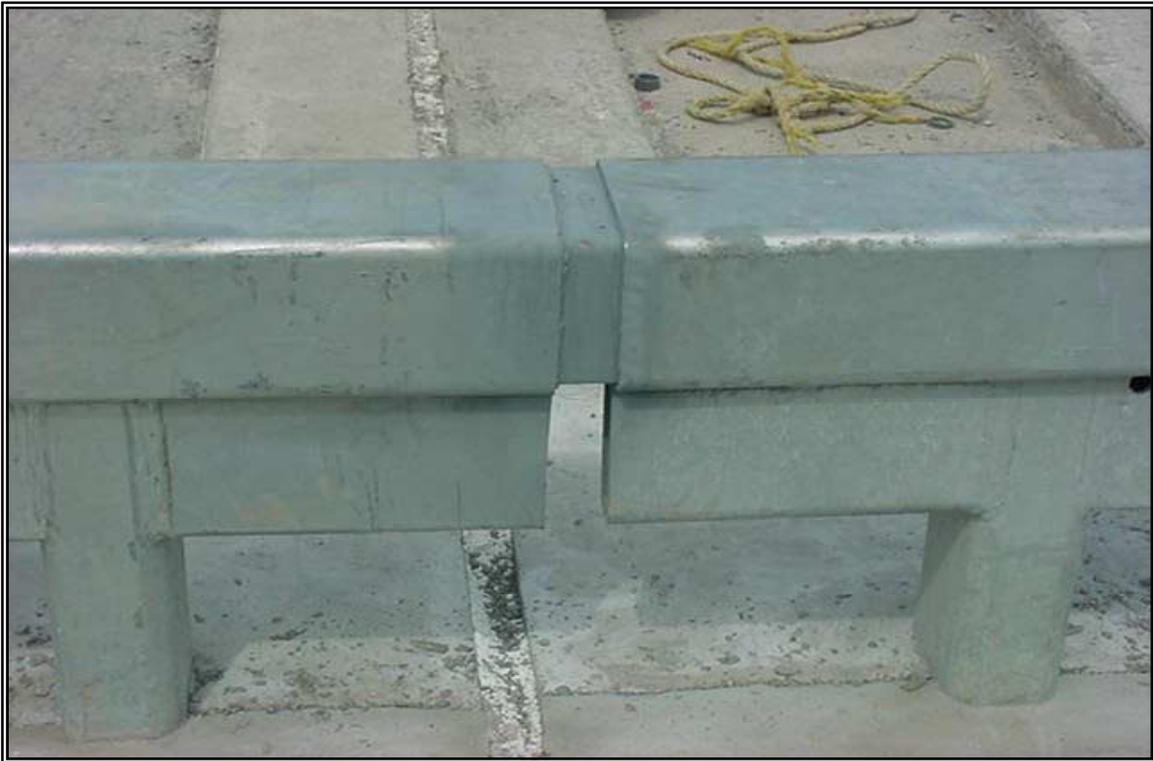
The bridge rail sections at the bridge deck expansion joint were adjusted. The bridge rail connection at this point coincided with the expansion joint. This connection was made with a separation of 2 in, the same separation at the expansion joint. Note that the joint sleeve was welded only to one section and free to move on the other section (see Figure 35).

Figure 34. Bridge rail connection at the bridge deck expansion joint

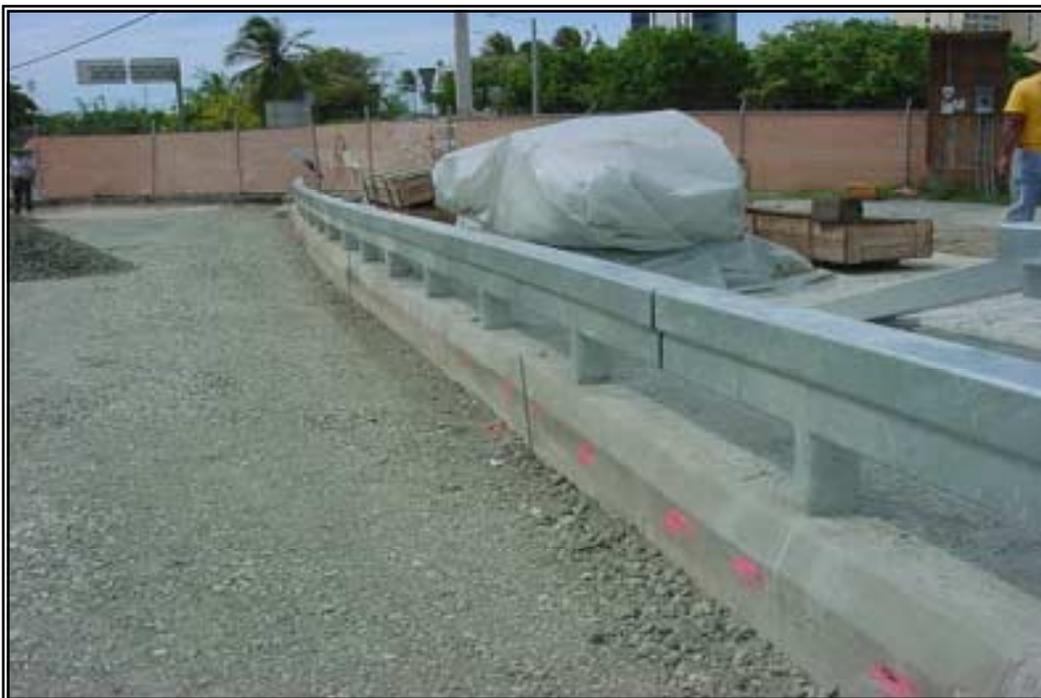
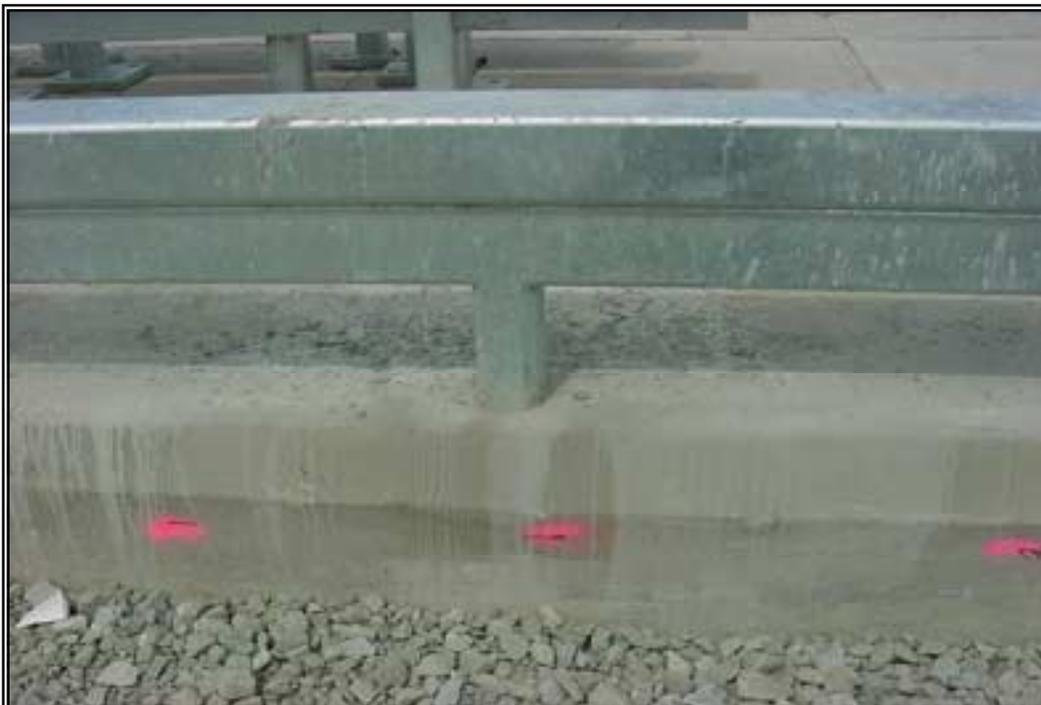
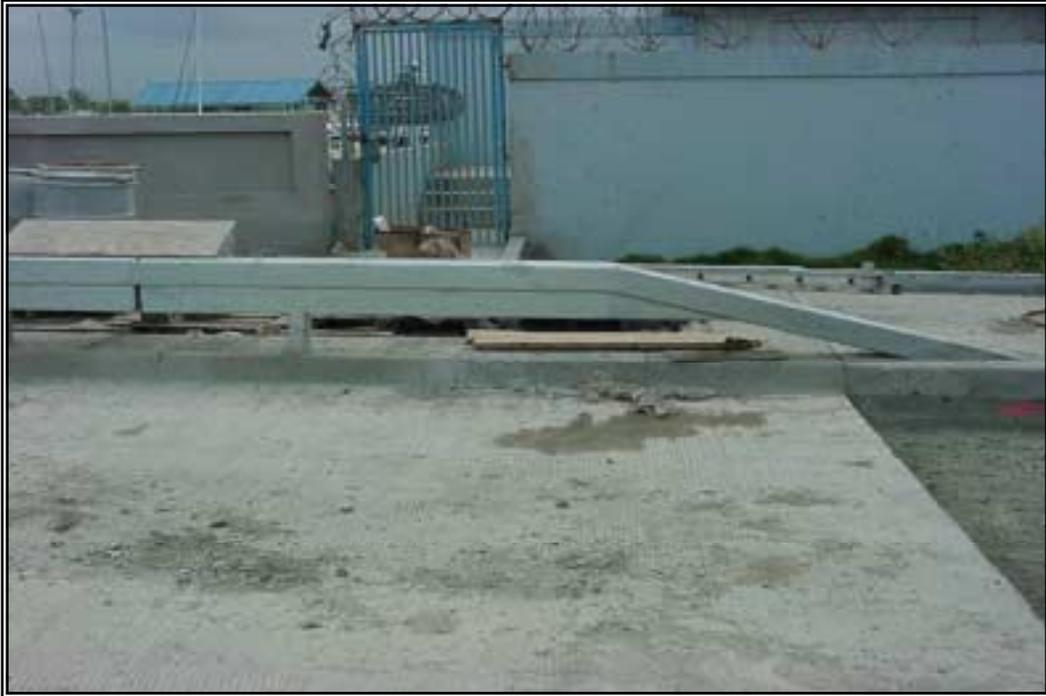
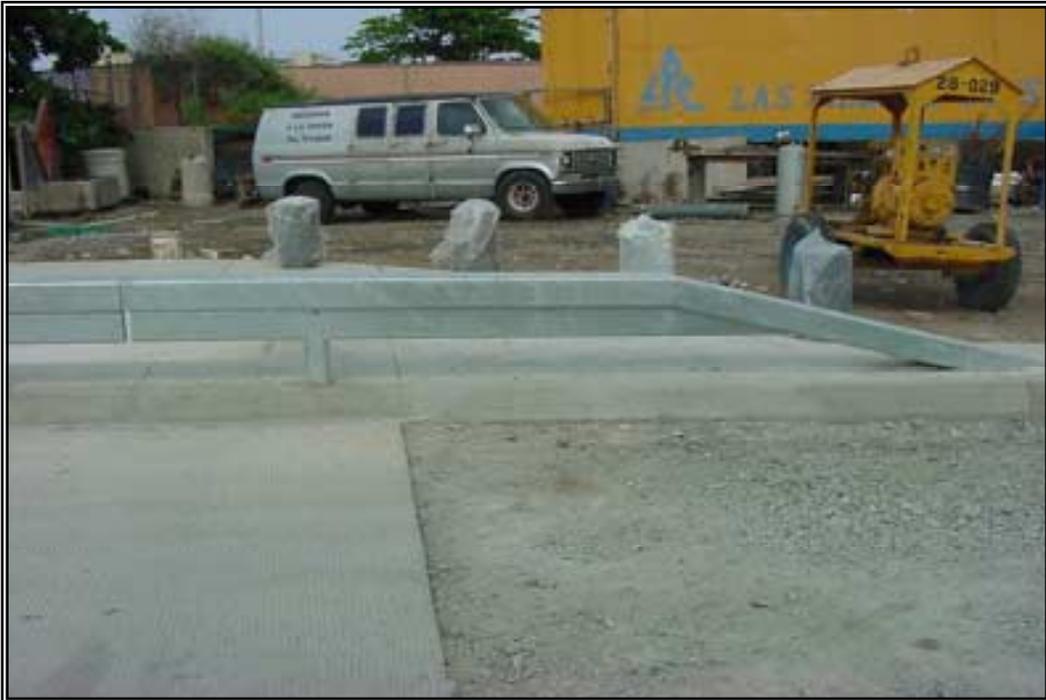
The bridge rail sections at the approach slab and the rail end sections were constructed in the same way as the bridge rail at the deck (see Figures 35-38).

Figure 35. Sections corresponding to the approach slab

Figure 36. Finished curb and concrete sidewalks for the sections of the approach slab

Figure 37. End section of the bridge rail system

Figure 38 . End section of the bridge rail system

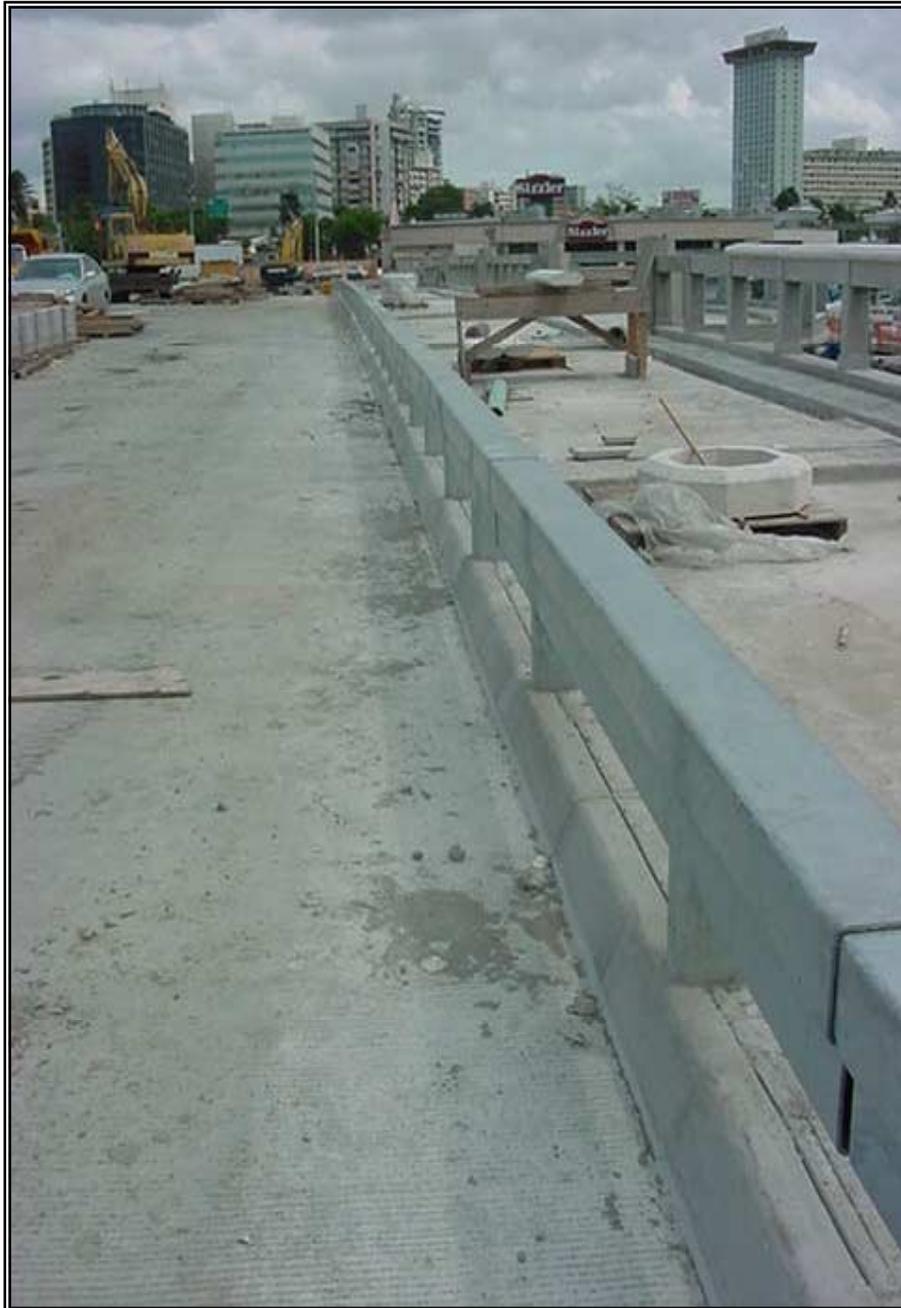
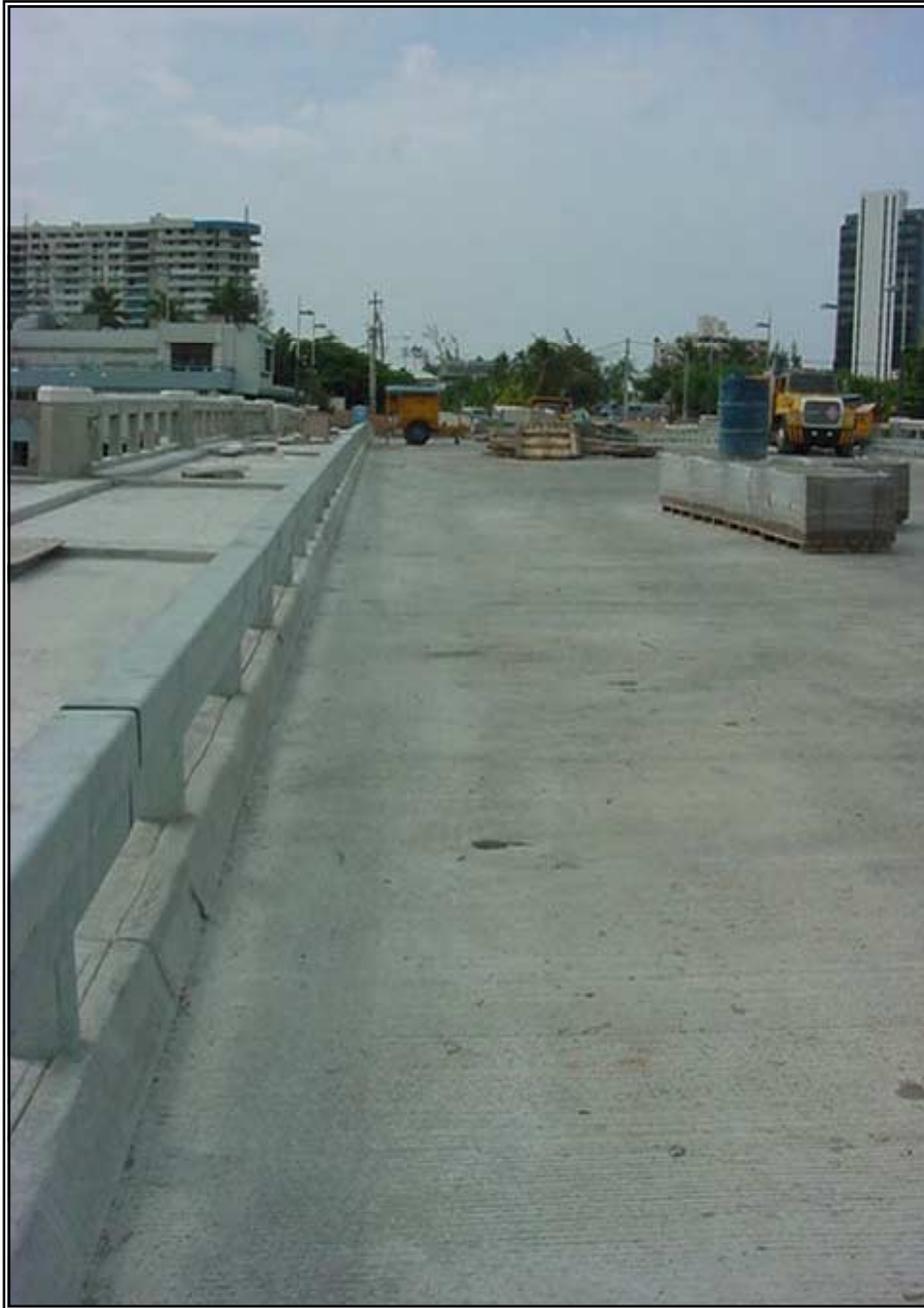
See Figures 39 and 40 for the complete view of the bridge rail finally installed as shown on the plans.

Figure 39. Final assembly of the bridge rail system

Figure 40. Final assembly of the bridge rail system
