# Emergency Relief Program

## Resilience Case Study – Arizona

### Adapting to Changes in Runoff Conditions and Implementing Long-Term Flood Mitigation Measures

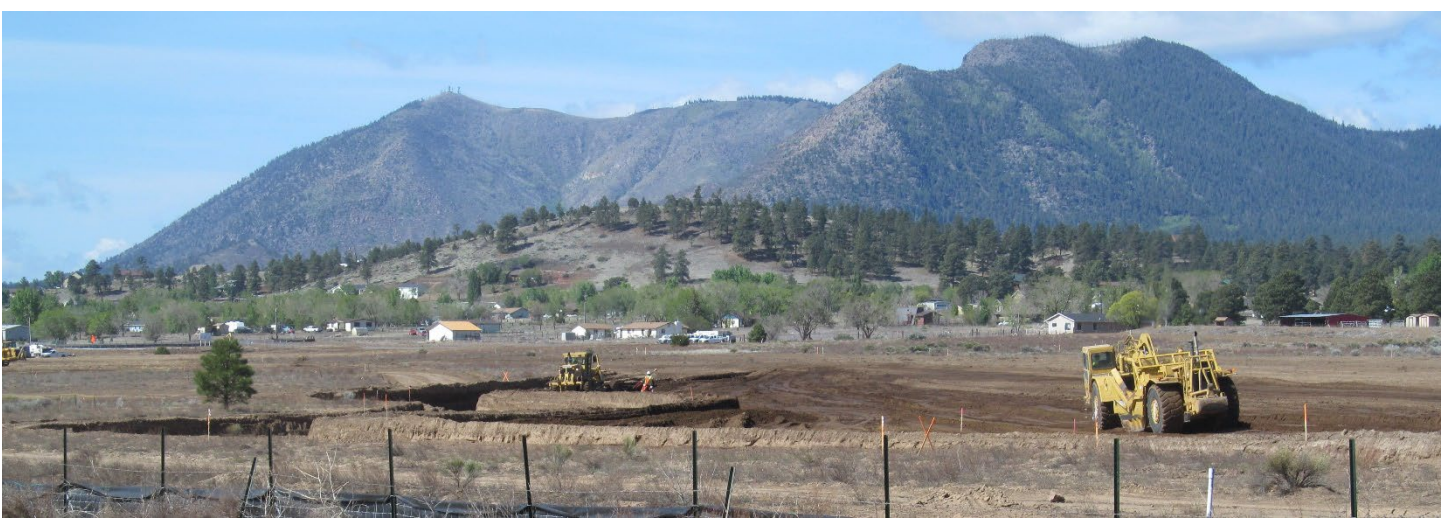
Figure 2: Construction of the detention basin. Source: FHWA

Following these repairs, ADOT and Coconino County constructed a downstream detention facility to capture water coming off the slopes and into the drainage channels and prevent it from reaching a landfill and housing development further downstream. The facility, which consists of three detention basins and three sediment traps, was located on a property that was purchased by the Coconino County Flood Control District prior to construction.

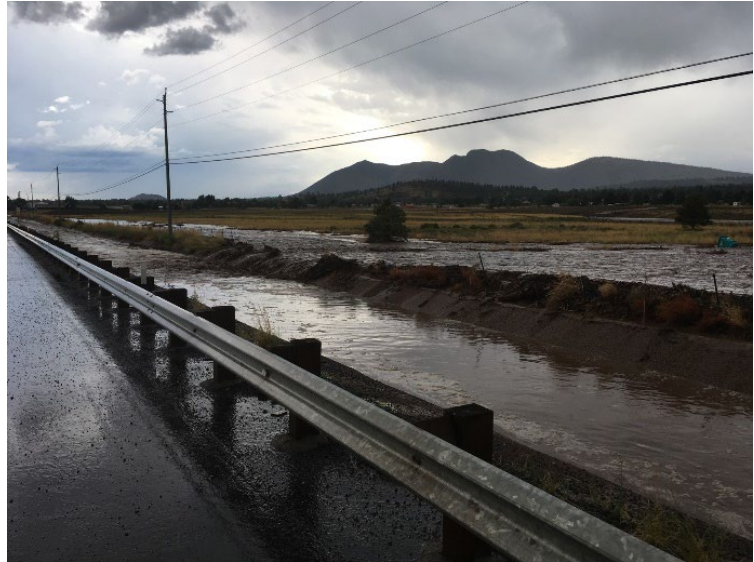
*Figure 3: In 2018, the new concrete lined channels along US 89 directed floodwaters to the detention basin and protected the roadway and surrounding homes from major damage. Source: FHWA*

In July 2018, the area experienced another historic rainfall event. Torrential rains fell on July 14, July 16, and July 18. The July 18 storm was the heaviest storm ever recorded in the region. In just three hours, over 5.9 inches of rain fell over the San Francisco Peaks. A storm of that magnitude is only expected once every thousand years in the area. While one of the inlets to the detention facility sustained minor flood damage, overall, the new protective measures held up to the floodwaters and protected the roadway and surrounding homes from major damage.
