Emergency Relief Program

Resilience Case Study – Hawai‘i

Incorporating Resilience through Bridge Replacement and Rehabilitation

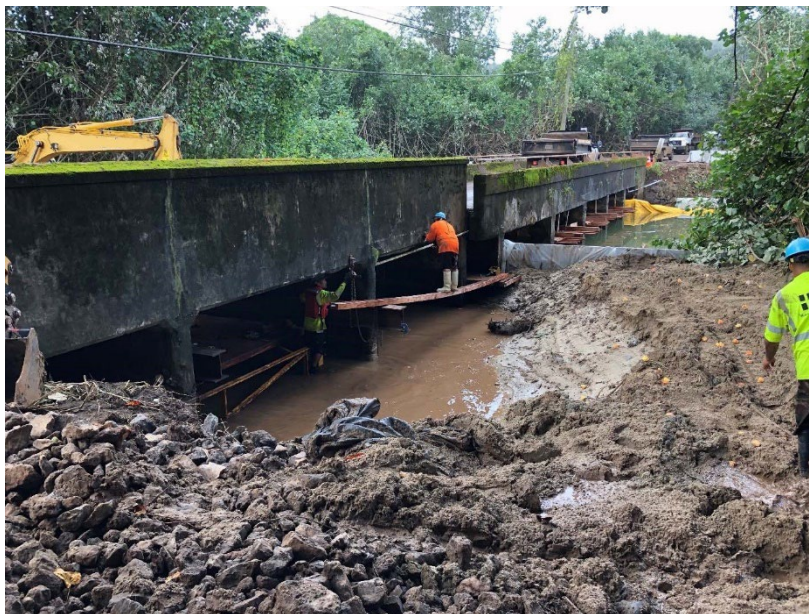
Between April 13 and April 15, 2018, the island of Kaua‘i in the State of Hawai‘i experienced a record amount of rainfall, nearly 50 inches total, causing severe flooding and landslides along Kūhiō Highway (State Route 56 and 560). Three historic one-lane, load-restricted bridges along Route 560, Wai‘oli, Waikoko, and Waipā, often referred to as the 3W bridges, were damaged. The bridges all experienced scour at the footings and abutments and damage due to debris buildup.

Figure 1: Side view of the historic Waipā Bridge illustrating the damage caused by the historic rainfall event in April 2018. Source: HDOT

- **Extent of the damage:** HDOT determined that the severity of the damage to the Waikoko and Waipā bridges and the ongoing deterioration of these bridges necessitated replacement. However, inspections and testing indicated that rehabilitating the Wai'oli bridge was feasible. For the Wai'oli bridge, HDOT removed and refurbished the existing unsound concrete and corroded rebar. The newly rehabilitated parts of the structure were then wrapped with fiberglass reinforced plastic (FRP) to strengthen the bridge.

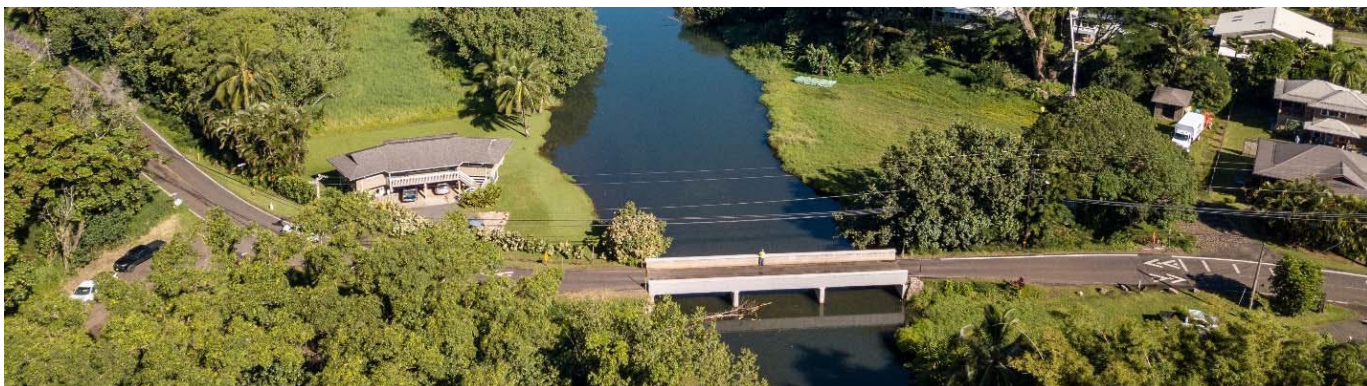
Figure 2: Aerial view of the rehabilitated Wai'oli bridge. Source: HDOT

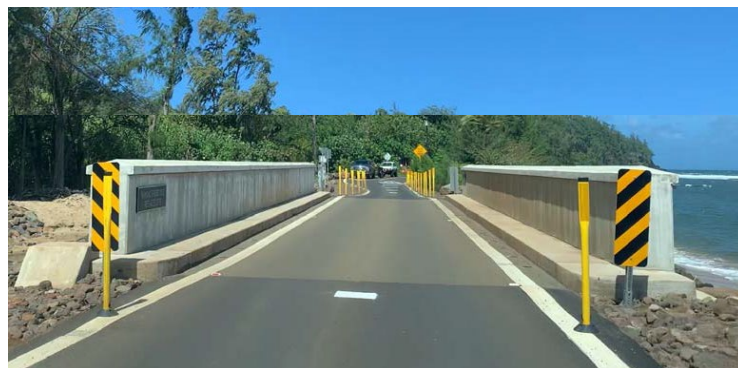
Figure 3: Completed Waikoko bridge with roadway striping and non-mountable curbs. Source: HDOT

- **Constructing the Waipā and Waikoko bridges to conform with current hydraulic design standards.** HDOT constructed the Waipā bridge to meet the State's current hydraulic design standards and in doing so, improved the performance and resilience of the bridge in addressing scour. The Waikoko bridge, known locally as the "broken bridge," had previously been damaged and partially repaired, resulting in reduced hydraulic capacity. By following current hydraulic design standards, the replacement of the Waikoko bridge allowed for larger stream flows.

Community members and local advocacy groups also expressed concern that replacing the historic, one-lane Waipā and Waikoko bridges and rehabilitating the Wai'oli bridge would affect the corridor's historically rural character. In accordance with section 106 of the National Historic Preservation Act of 1966, FHWA and HDOT conducted a consultation process with historic preservation organizations as well as community-based organizations regarding the impact on these historic properties. These organizations included Hanalei Roads Committee, Historic Hawai'i Foundation, Hanalei Watershed Hui, Waikoko 'Ohana, Hui Ho'omalu I Ka 'Āina, and the Konoiki Restoration Project. Stemming from this engagement, FHWA and HDOT developed a memorandum of agreement (MOA) to minimize and mitigate effects and lay out specific stipulations for the repair and cleanup work along the roadway, replacement of the Waipā and Waikoko bridges, and rehabilitation of the Wai'oli bridge. In particular, the design for the new Waipā and Waikoko bridges required that these low traffic volume facilities remain one lane (with a 12-foot roadway and one-foot shoulders on each side), retain the existing alignment and view sheds, and include railings similar to the old 3W bridges. The MOA also stated that the design for the new Waipā and Waikoko bridges would conform to the guidelines recommended by the Kūhiō Highway Historic Roadway Corridor Plan. An innovative feature that was negotiated between the parties was the inclusion of non-mountable curbs to act as a bridge girder, allow for pedestrian access, and improve roadway safety and traffic flow by providing additional space for emergency vehicle access.
