# NDEVC News

NONDESTRUCTIVE EVALUATION VALIDATION CENTER

Volume 1, Issue 1

January 2000

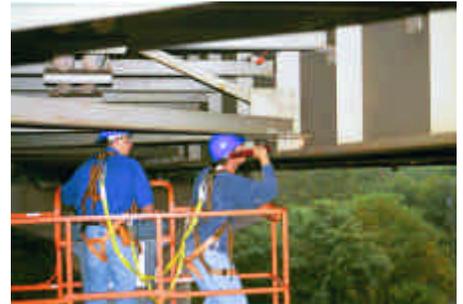
An inspector looks for defects in the superstructure of a bridge in Virginia.

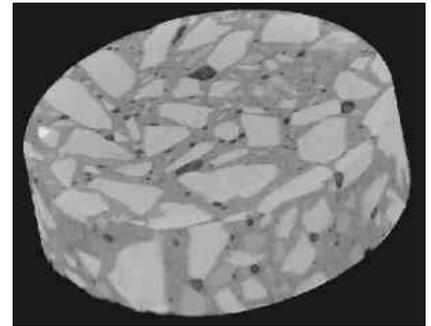
Three-dimensional tomographic image of a concrete core.

An x-ray computed tomography and digital radiography imaging system has been added to the NDEVC research facility. The advanced computed tomography imaging system ACTIS 600/420 was built by Bio-Imaging Research, Inc. according to specifications provided by researchers at the NDEVC. The system consists of dual-focus 420-kV and microfocus 160-kV continuous x-ray sources. It includes two digital detectors, with a 512-channel linear array detector for tomographic imaging and a tri-field image intensifier with a digital camera for both real-time radiography and microtomography. The system can benefit many industrial and scientific applications, including materials research, non-destructive testing, core sample characterization, weld inspection, failure analysis, and reverse engineering. It is suitable for x-ray inspection of metallic and non-metallic items over a wide range of densities. The system produces cross-sectional computed tomography (CT) images, in-motion real-time radiography (RTR) images, and digitized radiographed (DR) images. In addition to density mapping, CT provides complete 3D morphology of parts with highly accurate dimensioning capability. The CT data sets can be converted to line drawings and exported as splines for solid modeling and comparison to Computed-Aided Design (CAD) drawings. Computed tomography also provides superior flaw detection capability of extremely small cracks, porosities, and voids that are normally not visible with film radiography inspection. The system can provide spatial resolution of up to 20 lines per millimeter or 25-microns. In addition, sample sizes up to a weight of 200-kg and a length of 100-cm can be accommodated. The system has been used by researchers at the NDEVC to conduct projects such as determination of air void parameters, crack propagation, and internal structure characterization of portland cement concrete and asphalt concrete structures.

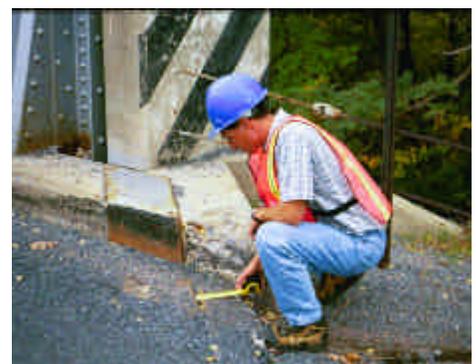
A bridge inspector measures the opening of an expansion joint.

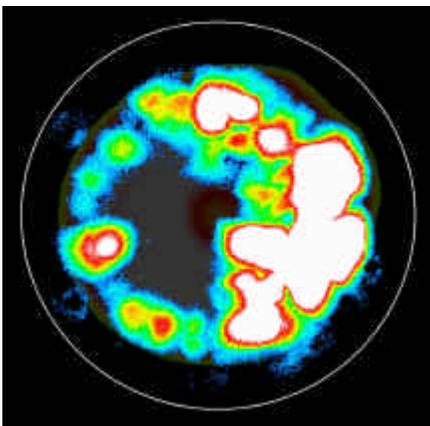
C-scan from the ultrasonic immersion tank testing of a hanger pin.

At the NDEVC, the pins were first studied using ultrasonics in an immersion tank. This is a non-contact automated technique that provides highly repeatable results. A C-scan image recorded during the immersion tank testing is shown below. For this pin in particular, the immersion tank testing showed that the pin cross-section at the level of one of the shear planes had decreased to approximately 25% of its original area. Overall, the immersion tank testing confirmed the results

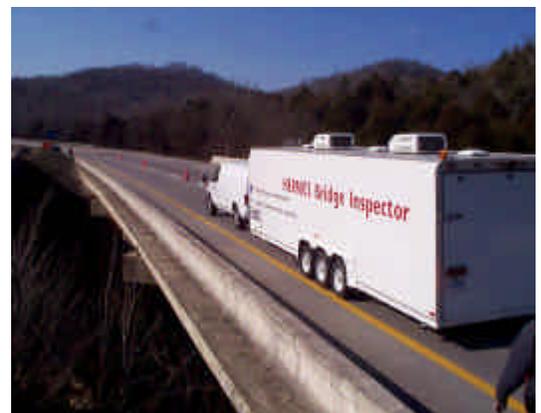
HERMES Bridge Inspector performing radar imaging of a bridge deck outside Nashville, TN.

Livermore National Laboratory under the sponsorship of FHWA. The HERMES (High-speed Electromagnetic Roadway Measurement and Evaluation System) bridge inspector is a GPR system built into a towable trailer. The design facilitates survey of the deck condition without the need to disrupt traffic flow. This system is based on a 64-channel antenna array covering 1.9-m in width with a sampling density of 3-cm.

The testing phase of these systems has commenced. To date, HERMES measurements have been recorded on in-service bridge decks in California, New Jersey, Tennessee, and Virginia. PERES has been tested using deck slabs that are part of the bridge component specimen collection held at the NDEVC, as well as in select field locations.
