# Achieving a High Level of Smoothness in Concrete Pavements Without Sacrificing Long-Term Performance

PUBLICATION NO. FHWA-HRT-05-068

OCTOBER 2005

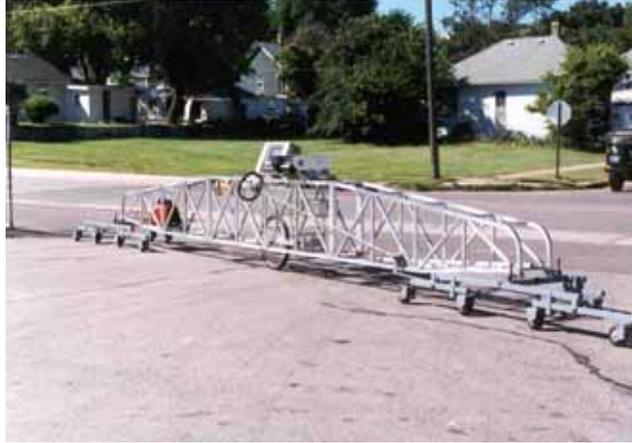
The most common profilograph used today is the truss-type California profilograph (see figure 1). The profilograph consists of a rigid frame with a system of support wheels at each end and a center wheel for profile measurement. The distance between the centers of the supporting wheel systems in the profilograph is 7.6 meters (m) (25 feet (ft)). The support wheels establish a datum from which the deviations of the center wheel can be evaluated. The center wheel is linked to a strip chart recorder or a computer that records the movement of the center wheel from the established datum. The profilograph is pushed along the pavement, and 3 to 5 kilometers (km) (1.9 to 3.1 miles (mi)) of the pavement can be measured in 1 hour.

Figure 1. Truss-type California profilograph.

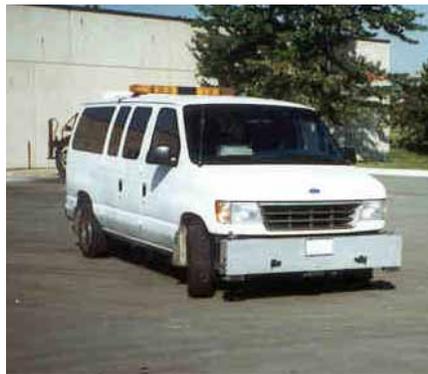
Inertial profilers are able to measure elevation features of the roadway that affect ride quality. The first high-speed inertial profiler was developed by Spangler and Kelley.<sup>(4)</sup> Most SHAs use high-speed profilers to collect roughness data on their highway networks. Figure 3 shows a photograph of a high-speed profiler. Currently, new PCC pavements usually are profiled immediately after they are paved; therefore, van-based high-speed profilers cannot be used to collect profile data on these pavements, because the pavement is not yet strong enough to support the weight of a van. Lightweight inertial profilers (see figure 4) based on a utility vehicle can be used to profile new PCC pavements several hours after the pavement is placed. The profiling system in a lightweight profiler is similar to the profiling system in a high-speed inertial profiler.

Figure 3. High-speed profiler.

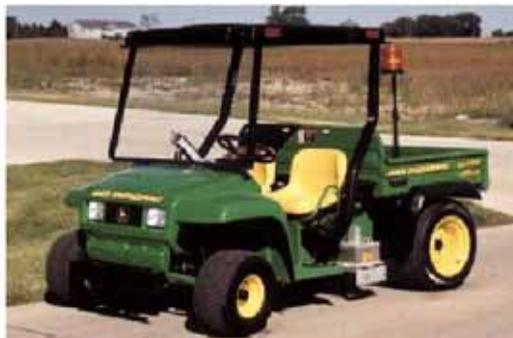
Figure 4. Lightweight profiler.

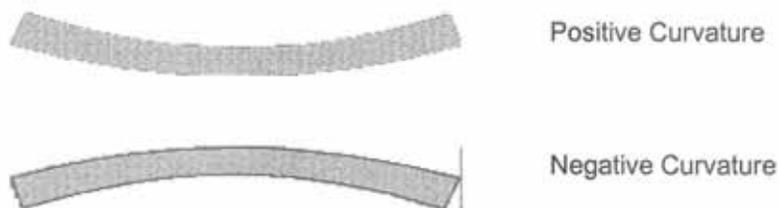
The shape of concrete slabs in a pavement can vary depending on the temperature and moisture gradient within the slab as well as the built-in curl in the slab. The concrete slab can take these shapes: (1) curled up, when the joints are at a higher elevation than the center of the slab, (2) curled down, when the center of the slab is at a higher elevation than the joints, or (3) flat. A procedure for determining the curvature of PCC slabs using data collected by inertial profilers was presented by Byrum.<sup>(10)</sup> In this procedure, a parameter called the Curvature Index (CI), which is calculated from profile data, is used to represent the amount of curvature in PCC slabs. This procedure was used in this analysis to evaluate the effect of slab curvature on roughness. This index not only captures slab curling or warping present on the slabs; it also captures any other curvature that will be present within a slab. A description of CI is presented in appendix A. The sign convention for CI is shown in figure 15; CI will have a positive value if the slabs are curled up and a negative value if the slabs are curled down.

Figure 15. Sign convention for slab curvature.

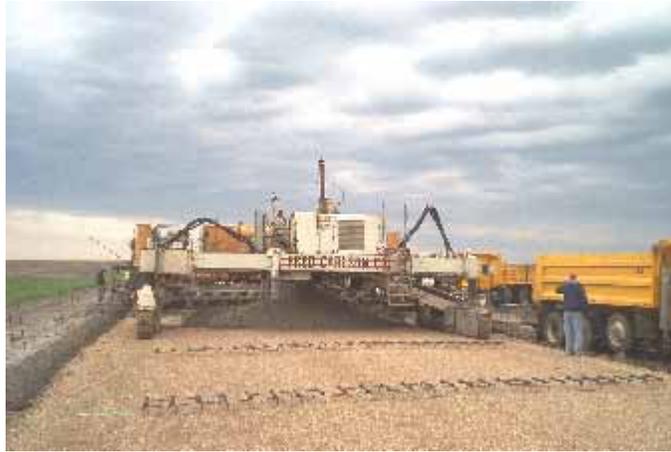
Table 36 presents the date and time when the test section was paved as well as other details about the paving process. The concrete was placed using a slipform paver. Figure 83 is a photograph of the paving operation. The paver had a super-smoother finishing attachment at the back of the paver for finishing the concrete. More than 25 mm (1 inch) of rain occurred after 8 p.m. on the day paving took place.

Figure 83. Paver in operation.

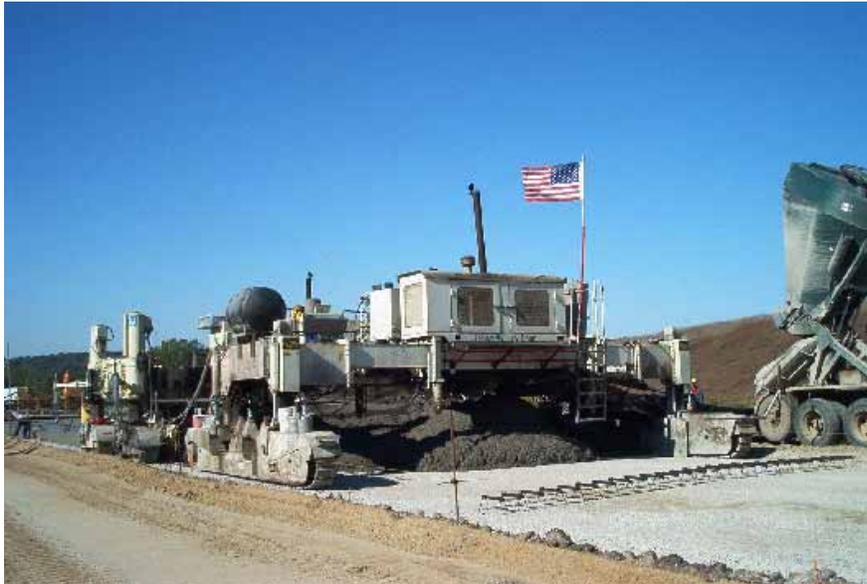
Table 46 presents the date and time the test section was paved and other details regarding the paving process. The concrete was placed using a slipform paver. Two photographs of the paving process are shown in figures 94 and 95.

Figure 94. Overall view of the paving train.

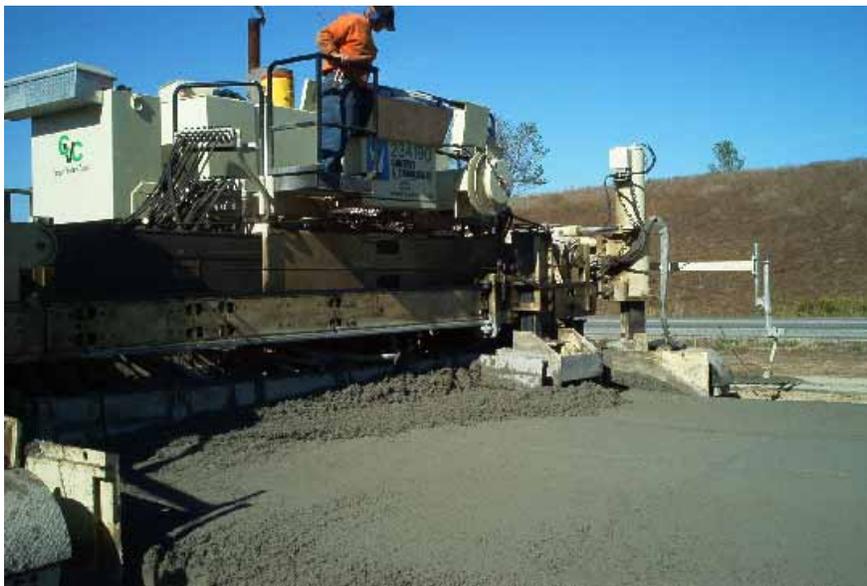
Figure 95. Slipform paver used for paving.

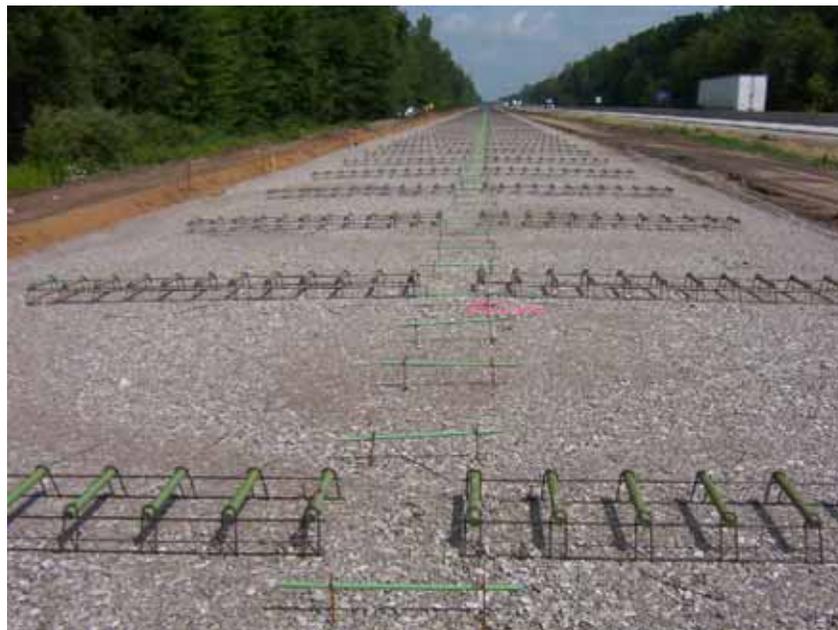
Figure 102. Tie bars and dowel basket placed on base.

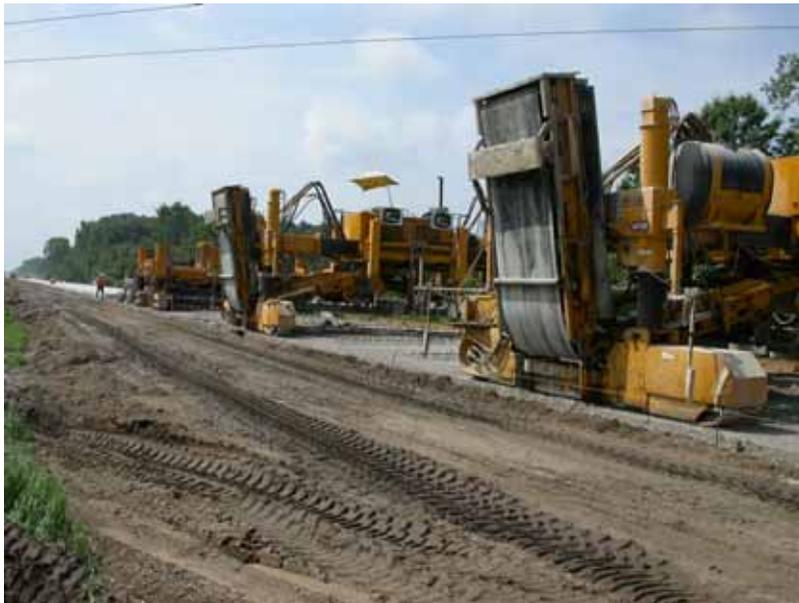
Figure 102 shows the view of the base course ahead of the paver and shows the tie bars and dowel baskets placed on the base. Figure 103 shows a view of the paving train used in the project, which consisted of a spreader, slipform paver, and the curing/texturing unit.

Figure 103. View of the paving train.

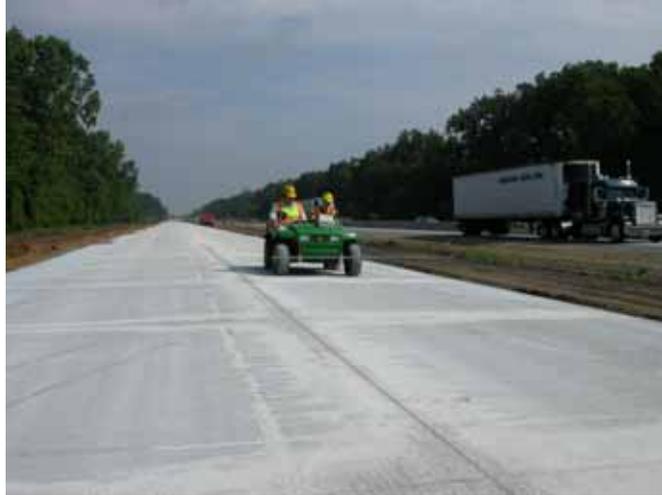
Five sets of profile data were collected at the test section in 2003 within a 10-day period. The profile data were collected using a lightweight profiler that was owned by MDOT, which was using software developed by Transology Association. Figure 104 shows a photograph of the lightweight profiler. This profiler is equipped with a laser height sensor and recorded profile data at 76-mm (3-inch) intervals.

Figure 104. Profile data collection using a lightweight inertial profiler.

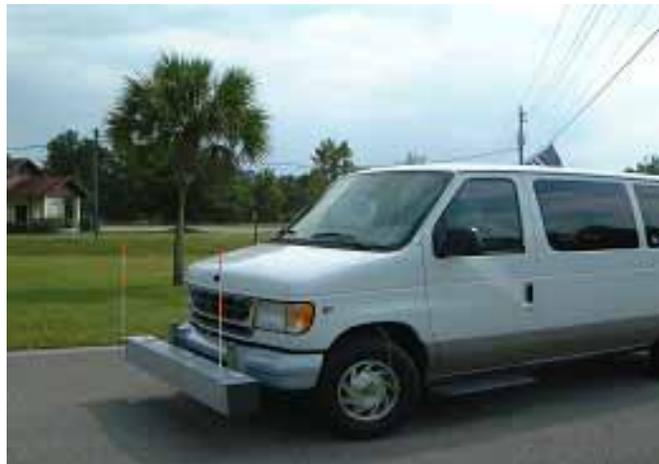
Approximately 1 year after paving, profile data were collected at the test section using a Dynatest<sup>®</sup> high-speed profiler. This profiler is equipped with laser height sensors and recorded profile data at 25-mm (1-inch) intervals. Figure 105 shows a photograph of the Dynatest high-speed profiler.

Figure 105. High-speed inertial profiler.

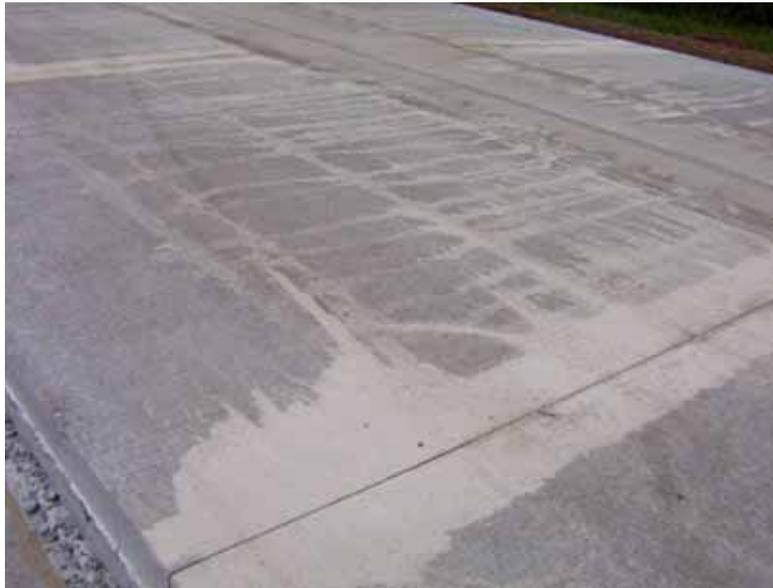
Figure 120. Residue from joint sawing operation adjacent to a joint.

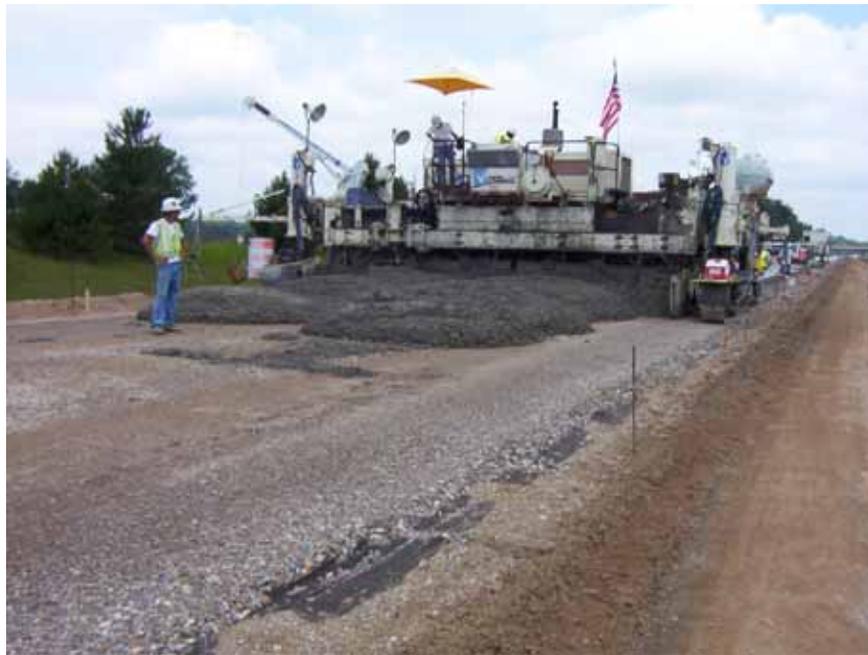
Table 67 presents the date and time the test sections were paved and other details about the paving process. The paving for that day began at 6 a.m. and stopped at noon because rain was predicted later for that day. It started to rain in the afternoon. The test section was observed to have had less than ideal (probably less than specified) tining depth, which was probably the result of the rain that occurred in the afternoon. Figure 121 shows a photograph of the front view of the paver and figure 122 shows a photograph of the finishing process behind the paver.

Figure 121. View from the front of the paver.

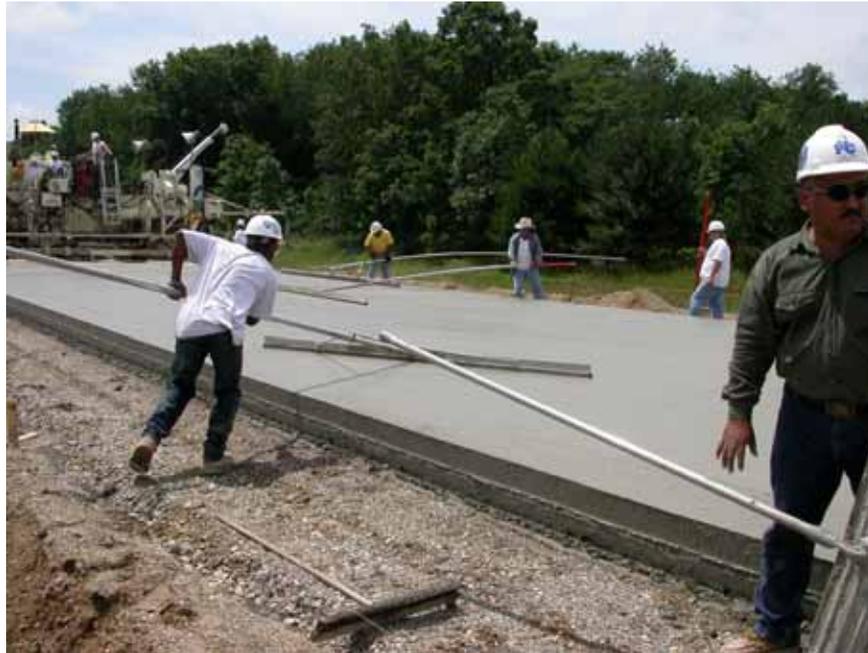
Figure 122. Finishing process behind the paver.
