Covered Bridge Manual

PUBLICATION NO. FHWA-HRT-04-098

APRIL 2005

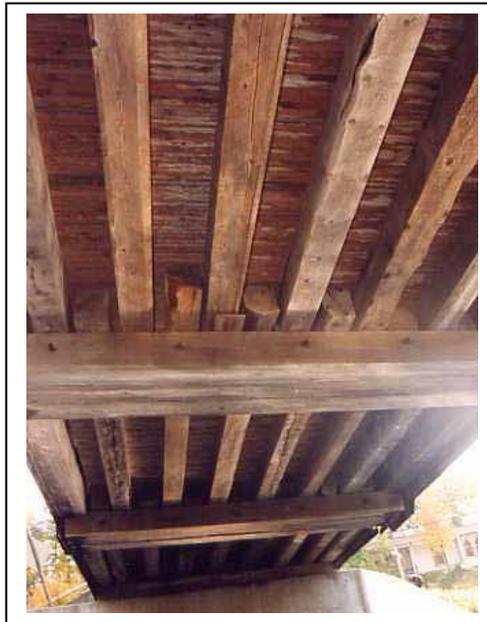
Figure 8. Floor system with stringers and floor beams—Warren Bridge, VT.

There is no clear separation between those bridges with stringers versus those without—virtually any type of truss configuration can support a floor beam and stringer system. Those with stringers have floor beams spaced farther apart—up to 3.0 to 3.7 m (10 to 12 ft). Figure 8 presents an example of a floor system with stringers supported by widely spaced floor beams. The floor beams in these types of bridges are, therefore, much heavier than those found in bridges with far more, but lighter, floor beams. An example of a floor system with closely spaced floor beams but without stringers is presented in figure 9.

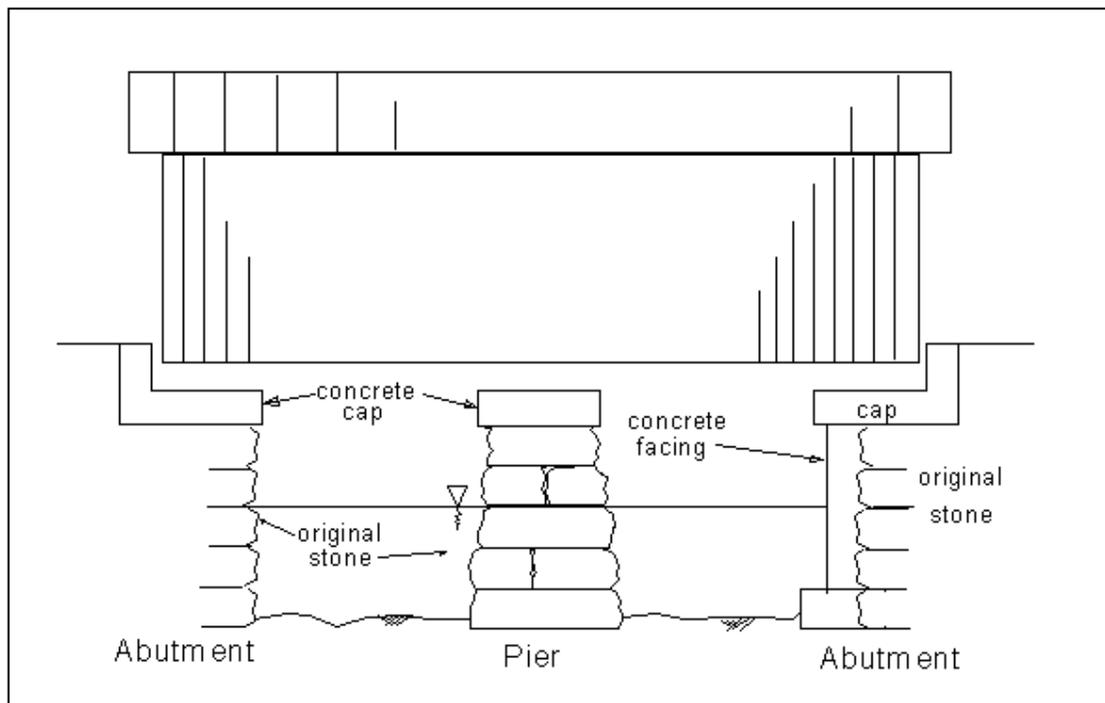
Figure 17. Foundations.

Following is a description of the bridge's foundations, those components that support the bridge—its foundations. The foundations at the end of the bridge are termed abutments. Any intermediate foundations are called piers. (Refer to figure 17 for terminology.) Most original multiple-span covered bridges were simple spans, framed separately but in line. Some Town lattices were originally continuous. Other covered bridges have intermediate piers (both permanent and long-term temporary) that were added to strengthen or to simply reinforce what had been a simple span. Some of these added piers are both well- intended and well- done. Others are just well- intended, albeit necessary. Most original foundations were constructed of stone, with or without mortar between the stones. More modern foundations, or in most cases, more recent rehabilitations, may have included reinforced concrete, cast either in front of the stone or in place of the original stone. The comparison of the economy and durability between concrete and stone is debatable; however, stone is often cited as much more aesthetically pleasing.

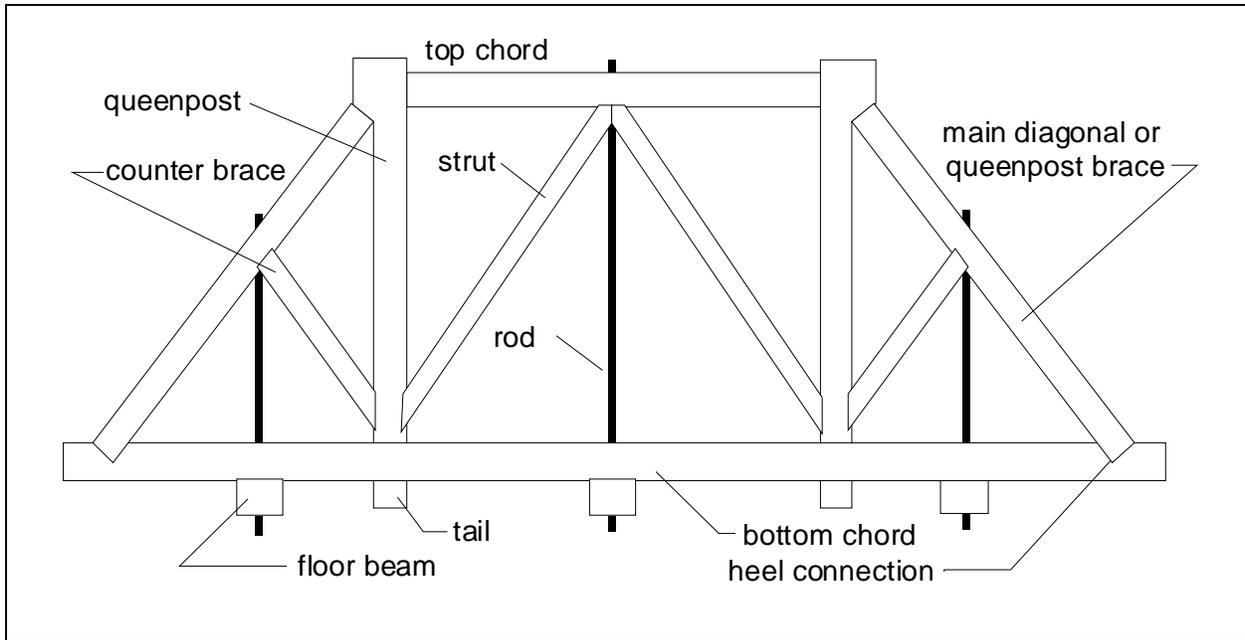
Figure 27. Diagram of queenpost truss.

accomplished by adding a central panel with extra horizontal top and bottom chords (see figure 27). Classic examples of queenpost trusses do not have any diagonal web members in the central rectangular web panel. Therefore, the most simple queenpost trusses are not true trusses at all,; but rather frames (although this distinction is not relevant to this discussion). The vertical members are termed queenposts. These trusses are considered to have three panels.

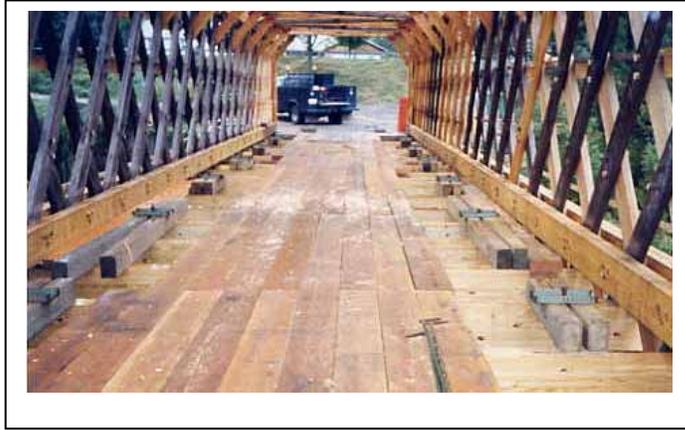
Figure 40. Transverse floor beams and longitudinal decking—Fitch's Bridge, Delaware County, NY.

Figures 40 and 41 depict two of the most common conventional floor systems. Figure 40 represents the basic floor system, a type most routinely found in Town lattice truss bridges. This floor system comprises transverse floor beams and longitudinal decking. Figure 41 represents the more complicated floor system, typically used in queenpost truss bridges, or more generically, all other truss types which have more distinct, separated panel points (unlike the uniform construction of the Town lattice truss). This system results in fewer, but heavier, transverse floor beams. An added element in this system is the longitudinal stringer that supports the transverse decking. The following sections discuss these individual components in more detail. The bulk of this chapter is devoted to the conventional timber floor components. The final subsection discusses some of the various replacement floor systems that have been installed in covered bridges.

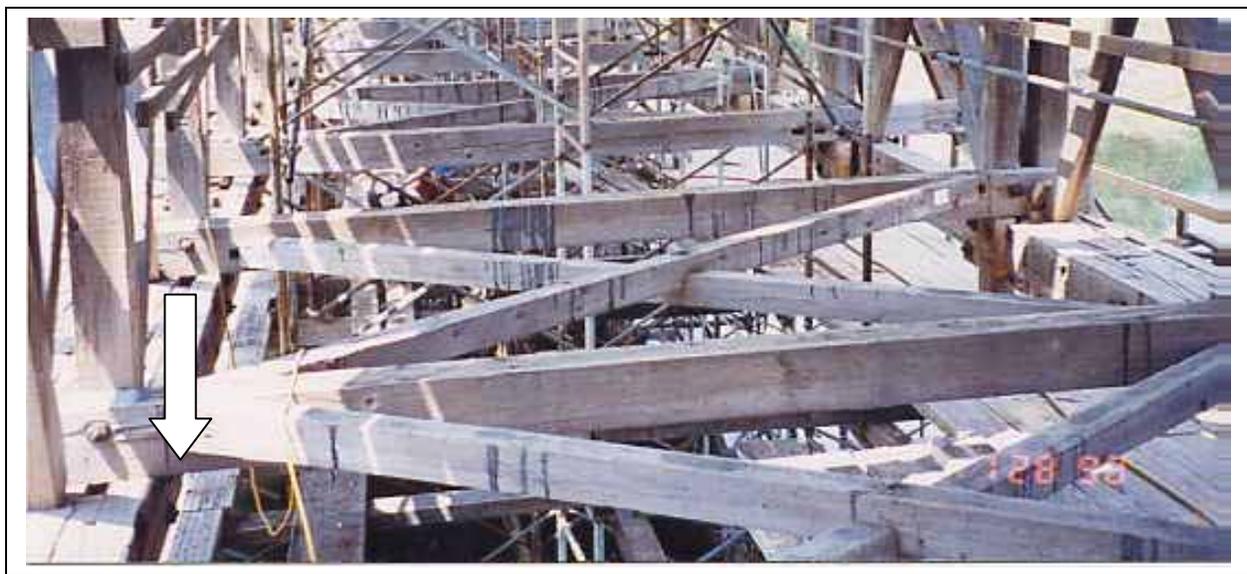
Figure 42. Mortise-and-tenon connection in floor beam—Downsville Bridge, Delaware County, NY.

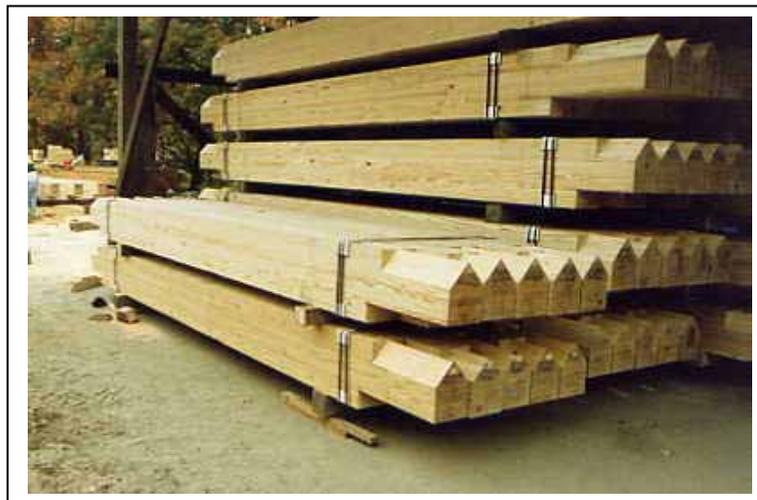
Figure 43. End notches of floor beams used in a Town lattice truss—West Dummerston Bridge, VT.

Local horizontal shear stresses in a timber beam increase where there is any cross-sectional defect. These defects could be natural, such as shrinkage checks resulting from the normal drying of the wood, or a knot. The defect could also result from the connection details used with the member, such as a notch cut to fit a floor beam into its support location along the truss. Figure 43 depicts the detail used at the ends of most floor beams in Town lattice trusses. Note that both the bottoms and tops are notched. The bottom notch provides a transverse and positive stop against the truss chord. The top is notched to allow the member to fit into the smaller and sloped top openings among the lattice truss members. The combination of these notches can increase the shear stresses in the floor beam sufficiently to require reinforcing the beam at its ends. This is commonly accomplished with vertical, large-diameter lag screws. This method of member reinforcement is not currently included in design specifications; however, the article, "Design of Notched Wood Beams" in the *Journal of Structural Engineering* discuss these issues.^[7]

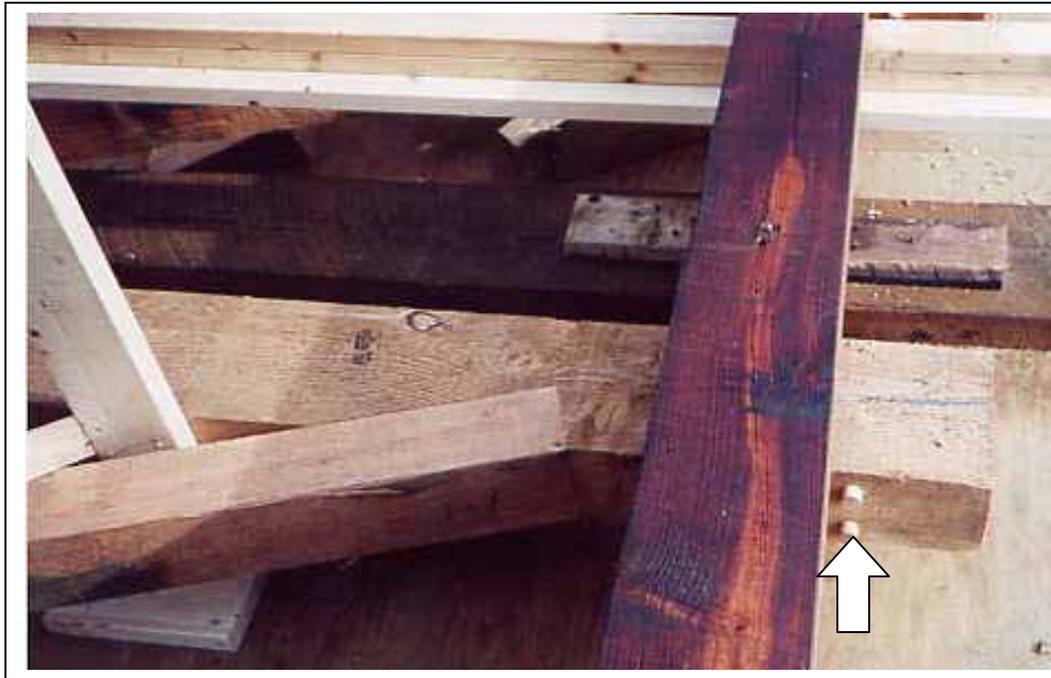
Figure 44. Timber dowel reinforcement of post-Mill Bridge, Tunbridge, VT.

Recently there has been some interest in using hardwood timber dowels as a substitute for the lag screw in reinforcing the critical shear planes in the floor beams. The lags tend to rust (even if originally galvanized), thereby becoming both unsightly and less effective. A hardwood dowel can also be less expensive than a galvanized lag screw. Wooden dowels are not mentioned in current design specifications, but various researchers are starting to discuss dowel behavior. Several bridge engineers have used dowels in lieu of lag screws in a few installations where there was confidence that the timber dowel could provide the improvement in shear resistance that analysis indicated to be necessary. Figure 44 depicts use of timber dowel reinforcement of a post against horizontal shear from the vertical component of load in the diagonal. The darker colored chord is pressure treated, while the lighter colored post and diagonal are not. Similar dowel reinforcement of the floor beam is possible. The truss is shown horizontal in this image as it was being constructed on falsework.

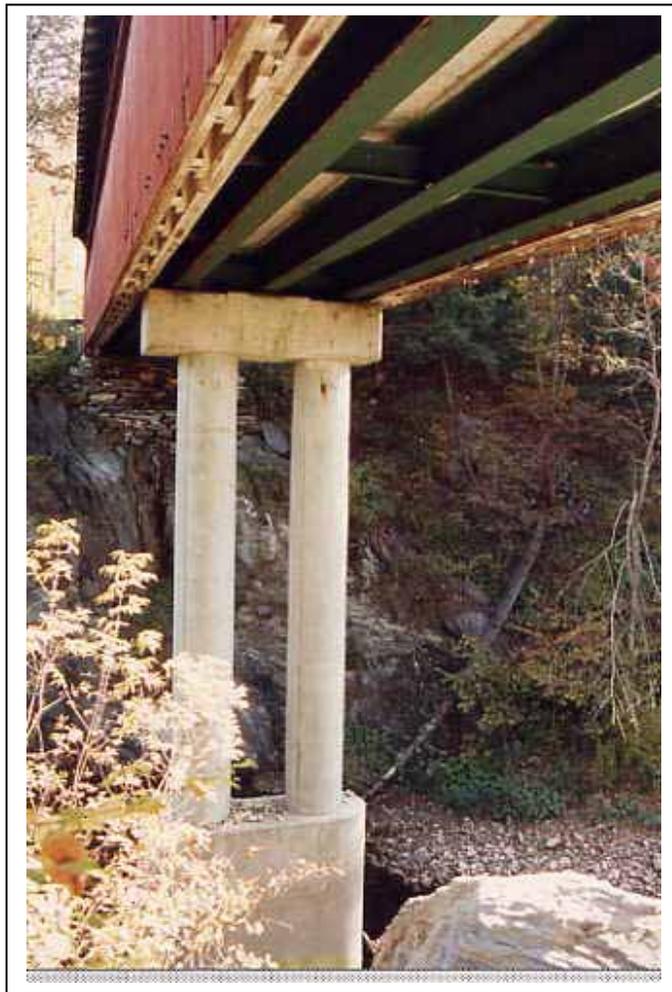
Figure 50. Independent floor system—Chiselville Bridge, VT. Note that the pier cap does not support the timber truss, which must still support the weight of the covering and snow.

In some instances, a deck is replaced in the course of installing a structurally independent bridge system within the shell of the original covered bridge. This can be accomplished by installing two or more steel beams within but below the original trusses with a timber, or even a concrete deck, supported on the longitudinal steel beams. The beams would be supported on independent bearing areas at the abutment, separate from the truss support area. Sometimes the beams are deep enough to show below the bottom of the original trusses. This means that either the roadway surface must be raised to maintain the same low point of the structure elevation (important when the hydraulic opening must not be reduced), or the beams project below the trusses (when there is ample hydraulic opening). Often, the beams are not readily visible and are not objectionable to the traveling public. Many consider this action an effective gutting of the bridge and, therefore, unacceptable. However, it may be the only way to keep the bridge in service. Figure 50 depicts an independent floor system.

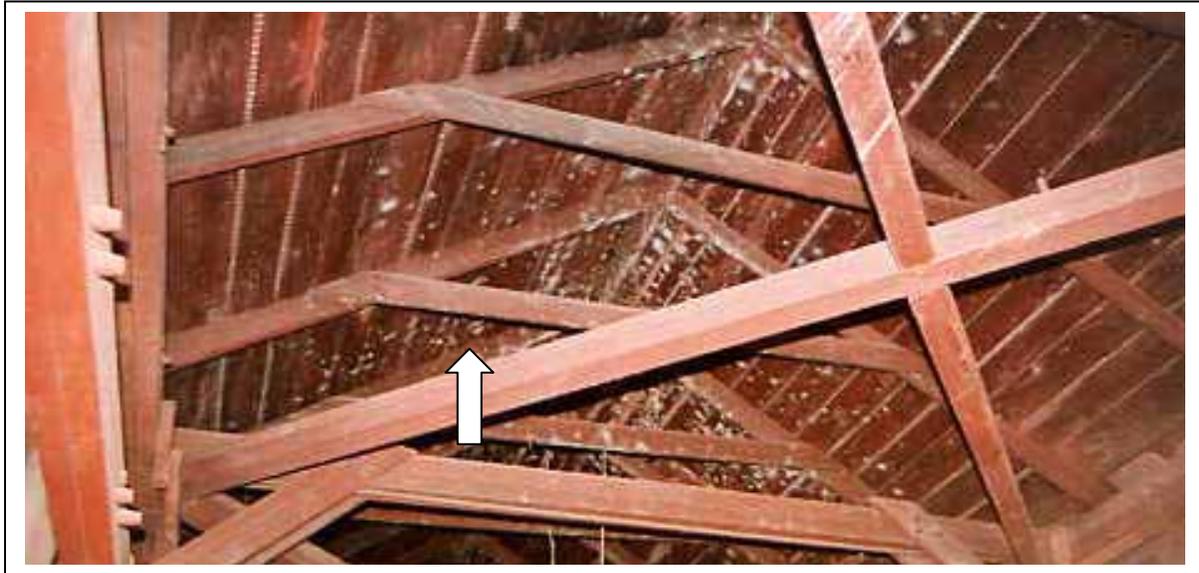
Figure 53. Example of rafter ties—Northfield Falls Bridge, VT.

Rafter ties certainly are not mandatory, and many roofs do not have them. It seems to be more a matter of individual preference on the part of the engineer or builder, yet the advantages of rafter ties outweigh their cost, and they are recommended. Figure 53 presents an example of rafter ties at midheight of the rafters. These are the horizontal members above the X upper laterals in the foreground.

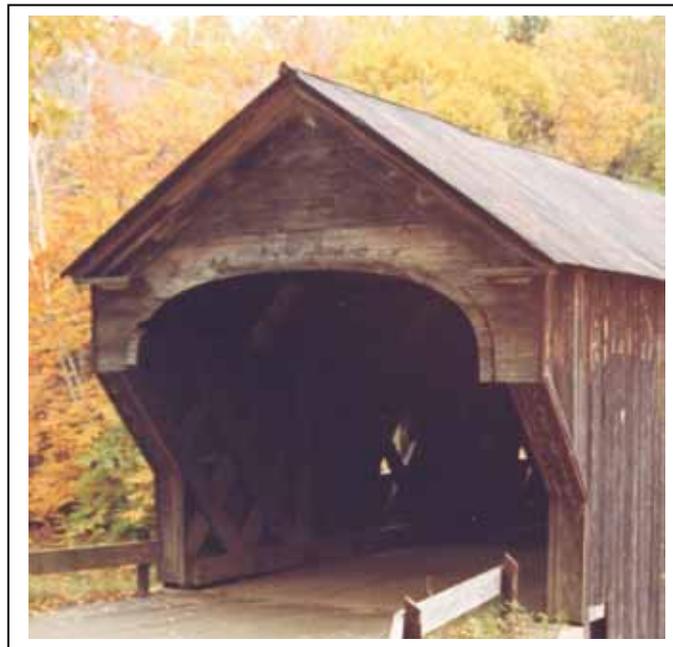
Figure 54. Unusual detailing of a portal—Upper Falls Bridge, Weathersfield, VT.

In large part, the portal represents a nonstructural detail; the designer or builder may simply provide what the owner desires. Very few covered bridges have included especially stiff and strong lateral load bearing elements in the portal detailing. This is not a conservative method—how is the entire lateral load carried in the top chord lateral bracing finally transferred down to the abutments, if not through some particular portal bracing? The knee braces can transfer the loads down to the floor level bracing along the span. The flow of the lateral forces, applied to the upper half of the central zone of the span, usually is resisted by a complex combination of knee bracing and transverse bending in the truss elements down to the deck, and top chord bracing longitudinally to the ends.

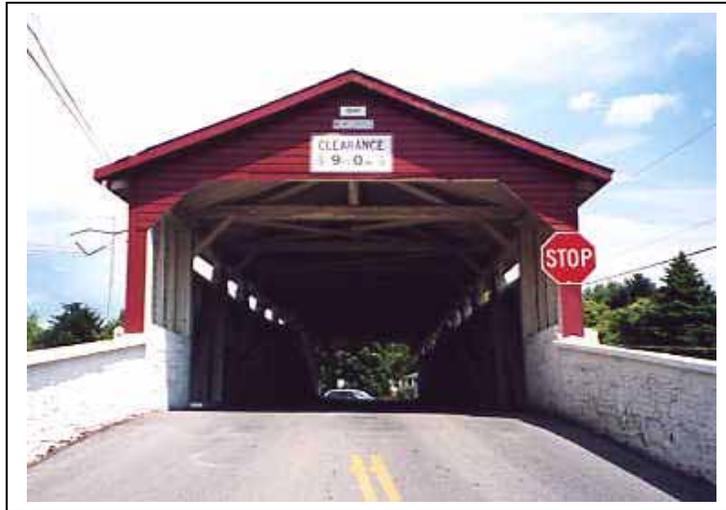
Figure 55. Example of portal extension–Wehr Bridge, Lehigh County, PA.

Some bridges contain a separate panel of structure before the beginning of the actual trusses. This feature is often termed a portal extension, or shelter panel. It helps protect the ends of the trusses from wind-blown rain. An example of a portal extension that protects the ends of the trusses from weather damage is shown in figure 55 (see also figures 14, 15, and 16).

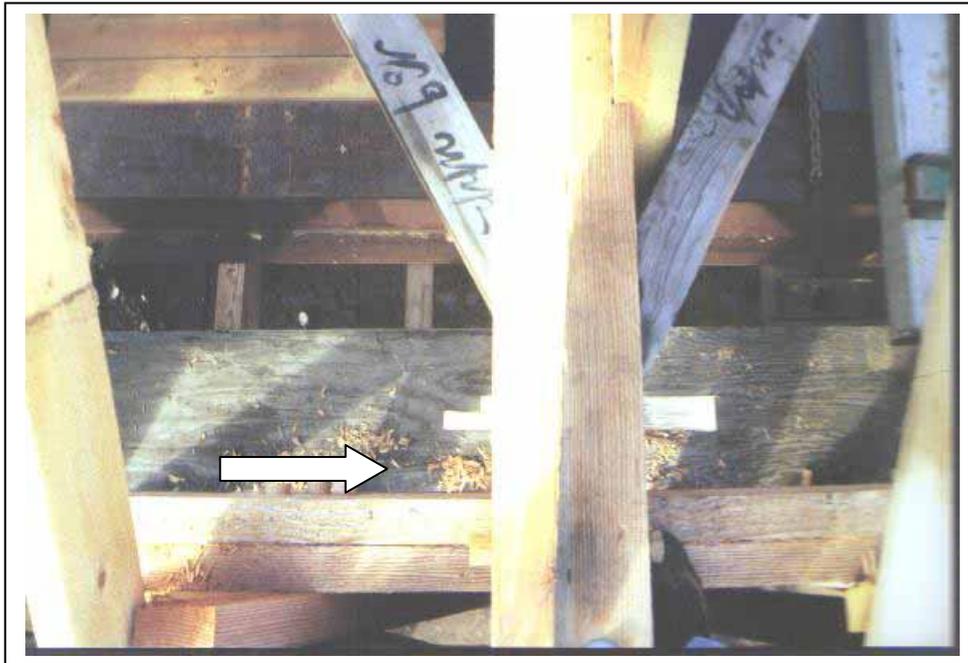
Figure 56. Lateral brace connection at tie beam—Fitch's Bridge, Delaware County, NY.

The lateral braces at the top chord level are usually at least 100- x 150-mm (4- x 6-inch) members and are usually joined to the transverse tie beams with mortise-and-tenon connections. Instead of being pegged, these connections are usually tightened with matched wedges to keep the system tight. This means that only those braces that are oriented to be loaded in compression will be working. The wedges cannot transfer any tension forces from the braces to the tie beams. Figure 56 depicts a typical connection of lateral braces (complete with painted markings from 1885 when this bridge was relocated to its current location) with the light-colored tie beam replacement. The light-colored matched wedges (shown transversely in this view) can be driven against each other to keep the system tight. At the intersection of the lateral X-braces, there may be a vertical bolt, and there might be a matching dado notch cut into both members, to ensure that they are flush and in plane. A common feature of lateral X-braces is that the end mortise-and-tenon connections are cut so that the lateral X-braces must be slightly bowed around one another, to fit into the connections. This bowing adds resistance to potential loosening of the laterals, by inducing some friction forces along the top and bottom surfaces of the joinery. The pretensioning also helps to prevent rattling overhead.

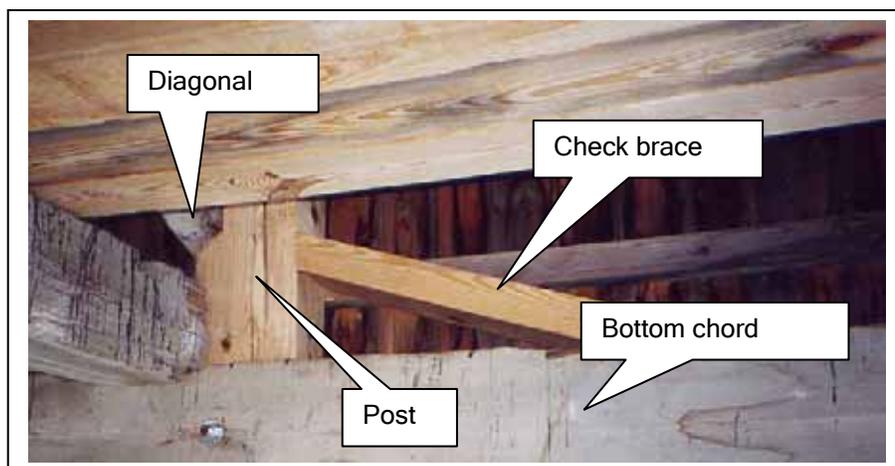
Figure 60. Check brace at bottom chord—Brown's River Bridge, Westford , VT.

Unfortunately, check braces commonly were removed during subsequent rehabilitation of bridges and not reinstalled. These elements are important and must always be reinstalled if removed. Further, in those bridges that do not have them and may not have had them initially, rather than simply strengthening the posts or replacing them with larger elements, this form of bracing element is a good retrofit option to strengthen posts that are overloaded.

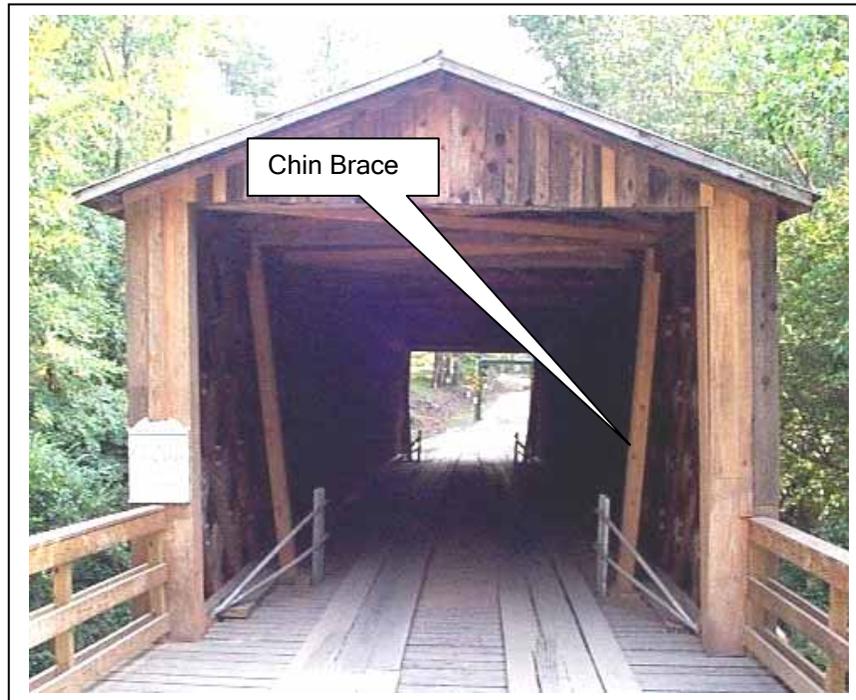
Figure 62. Chin brace—Elder’s Mill Bridge, Watkinsville, GA.

An example of bracing common to a geographic area is a chin brace. Many of Georgia's Town lattice trusses are fitted with a timber brace at each inside corner that projects from the top of the foundation, past the inside of the lower chords, to the inside of the top chord. Its angle is steep, limiting its strength as a bracing element and making its connections vital to its function. Refer to figure 62 for a typical example. Due to their immediate proximity to vehicular traffic, these elements are susceptible to impact damage. These elements are sometimes used in lieu of knee braces.

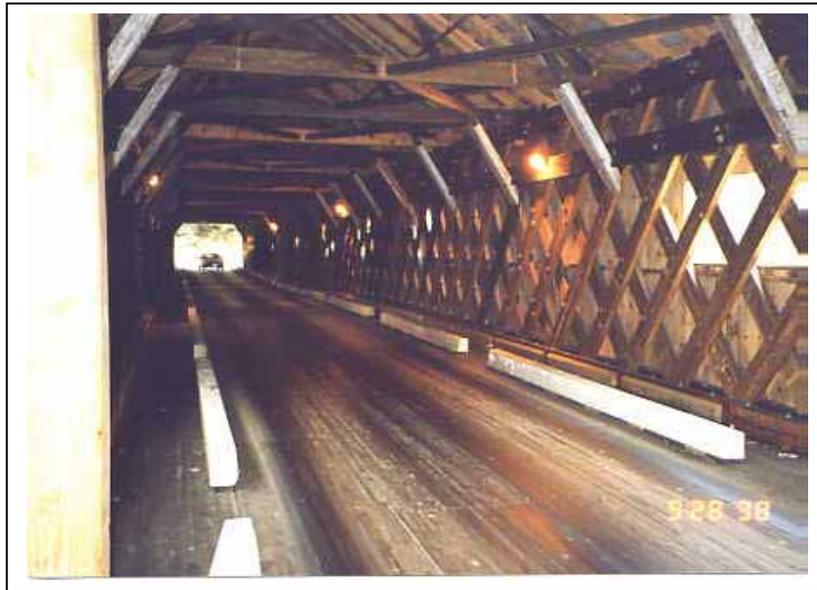
Figure 63. Interior curbing—West Dummerston Bridge, VT.

Figure 63 shows an example of inside curb traffic protection. While not meeting the provisions for railing protection of more modern bridges, this type of application may be prudent and practical for rehabilitation of historic covered bridges.

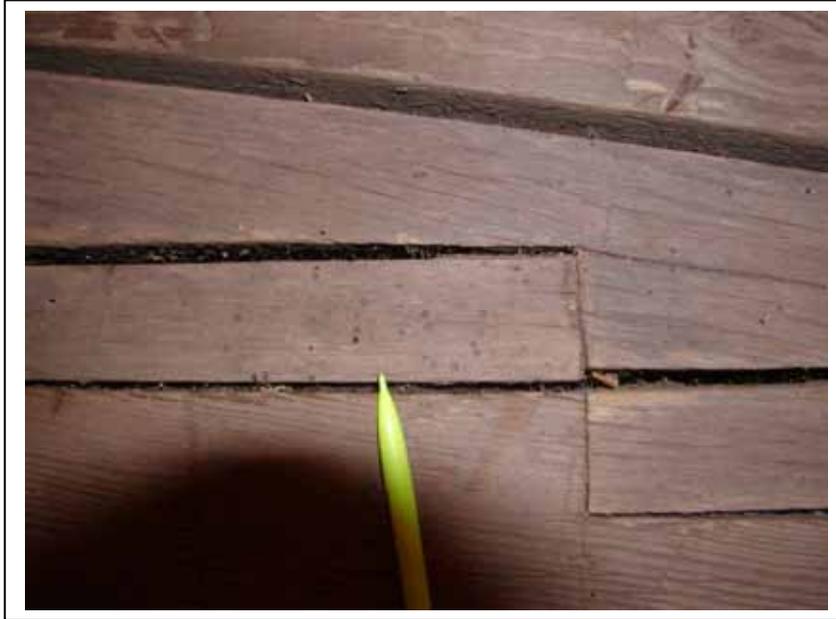
Figure 79. Surface evidence of powder post beetles.

Closely related to preservative treatments in wood (discussed in the previous subsection), some bridges are treated in place to deal with specific infestations of wood-destroying insects. Bridges in southern regions are prone to attack by termites or carpenter ants, and routine treatment against this assault is appropriate. Many bridges are subject to attack by powder post beetles, especially the hardwood peg or trunnel components (see figure 79), in which the surface holes are about 1.5 mm (0.06 inches) in diameter. Just as other preservative treatments against fungi (or rot) are being developed at an accelerating rate, chemical treatments for these infestations are evolving rapidly. These in-place treatments are usually applied with spray applicators.

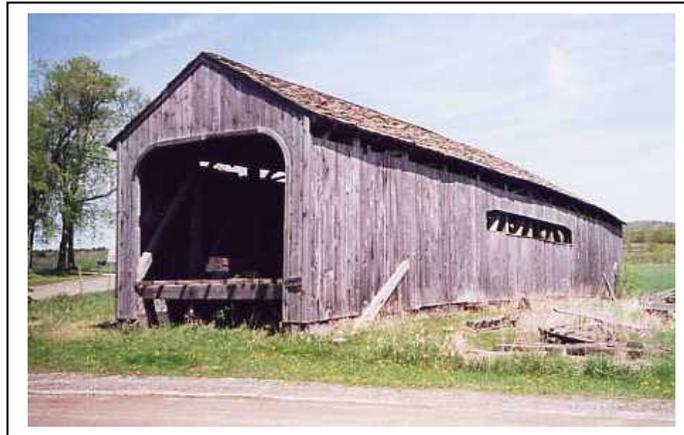
Figure 81. Example of bridge without protective treatment (the Westford Bridge in Vermont before its recent rehabilitation).

However, many bridges do not have such finish treatments. Figure 81 shows a covered bridge with aged, untreated siding. The bridge was built in 1838 (making it one of the oldest in the United States) and has had untreated siding since its original construction.

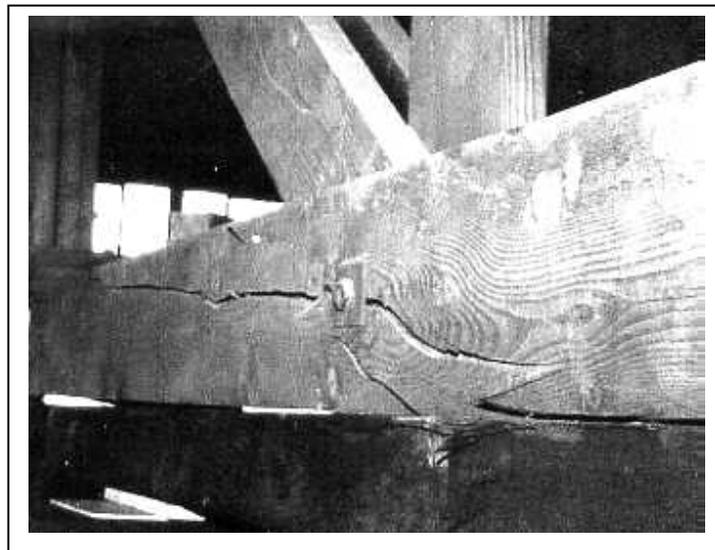
Figure 100. Example of tensile failure of a bottom chord element in a World War II timber building.

Many buildings offer practical examples that illustrate the rationale behind this change in the specifications. Many World War II vintage timber warehouses were built with heavy timber trusses and have demonstrated significant and frequent tensile fractures in the bottom (tension) chords. Figure 100 depicts one such example, albeit in a timber that had substandard slope of grain and a knot defect at a critical joint area. Figure 101 shows a classic example of a tensile failure in the bottom chord of a covered bridge.

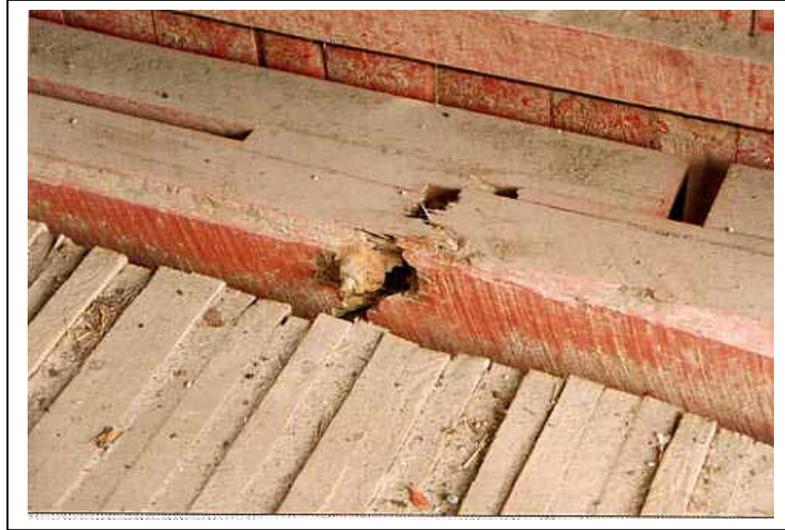
Figure 101. Example of a tensile failure of a bottom chord in a covered bridge.

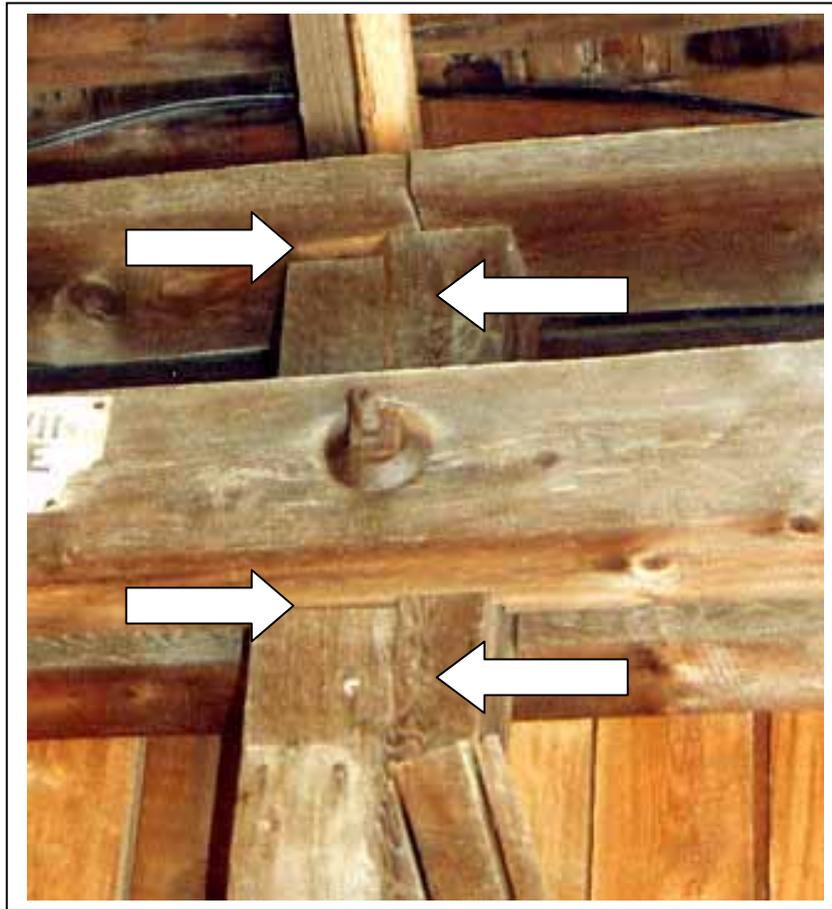
Figure 102. A horizontal shear failure—Mill Bridge, Tunbridge, VT, before its recent collapse due to ice floe impact.

An example of horizontal shear failure (albeit in a vertical plane in this post) is shown in figure 102, above the diagonal notched into the post. Note that the right side is offset upward (with respect to the left side) above the diagonal.

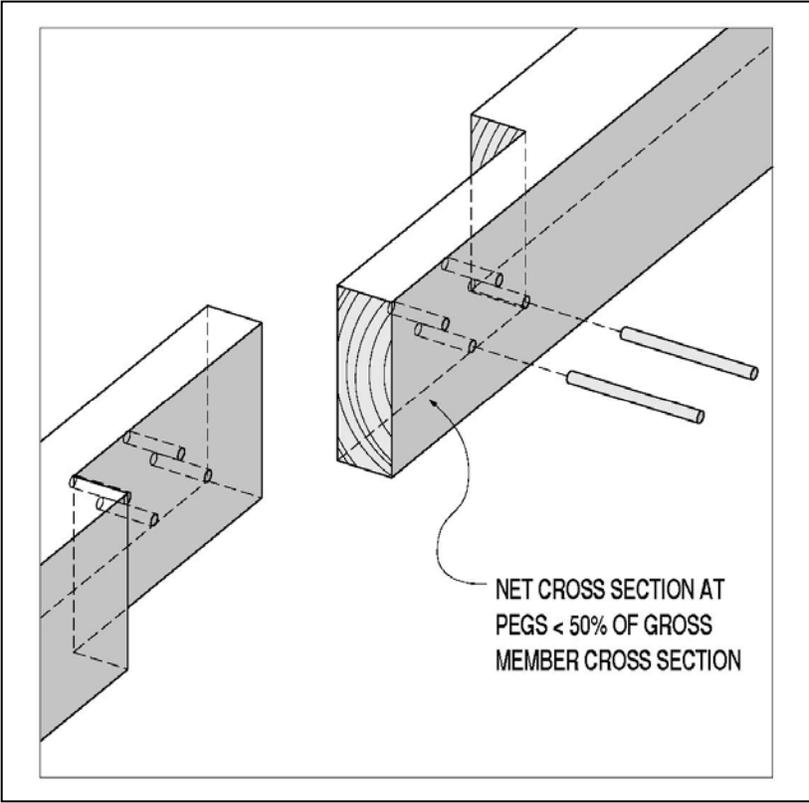
Figure 103. Simple lap joint, with through-plane connectors

double shear. This means the spliced section of the tension member will not attract or resist the same tension forces that it would if it were an uninterrupted timber.

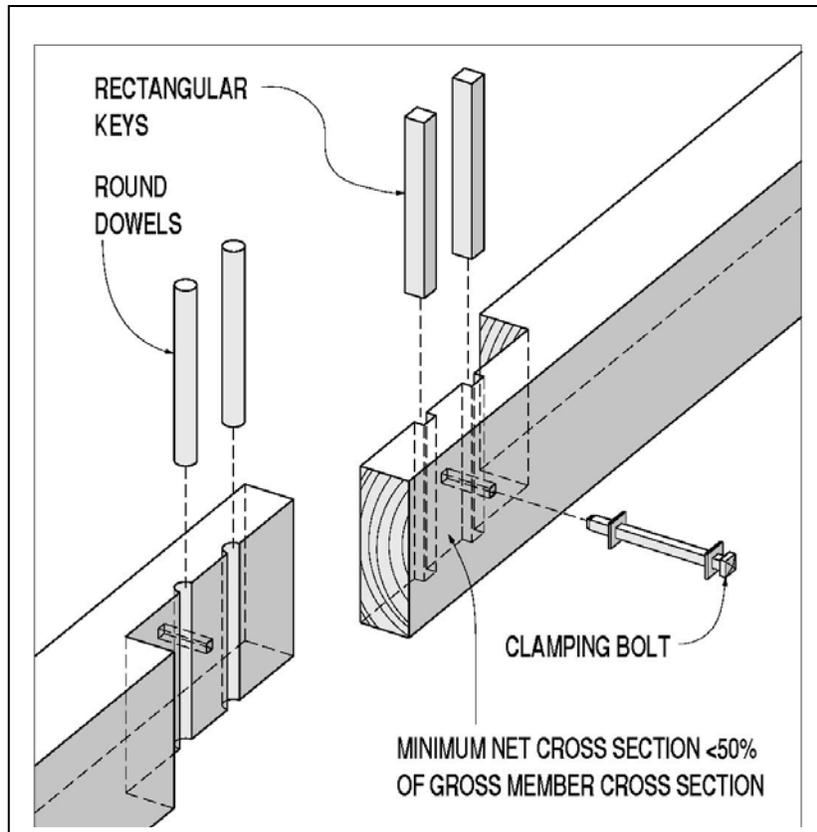
Figure 104. Simple lap joint, with in-plane connectors.

In other lap joints, connectors are lying in the shear plane; in these joints, wooden keys or dowels are the most common in-plane connector form (see figure 104). Again, the net cross section is further reduced from the half that is the lapped timber. The dowels and most shear keys are oriented with their grain lying in the same shear plane, but perpendicular to the longitudinal axes of the spliced members. This grain orientation is a compromise made for the convenience of the builders in the face of available wood component sizes. The dowels or keys are oriented so they are being crushed in side grain, as opposed to end grain, bearing. This is a weaker loading direction, by a factor of about double. Furthermore, the dowels or keys are being sheared in a way that results in their fibers or cells being rolled by one another instead of along each other. This rolling shear stress capacity is about half of that found in along-the-grain shear stress. Figure 105 shows side grain bearing and rolling shear stresses.

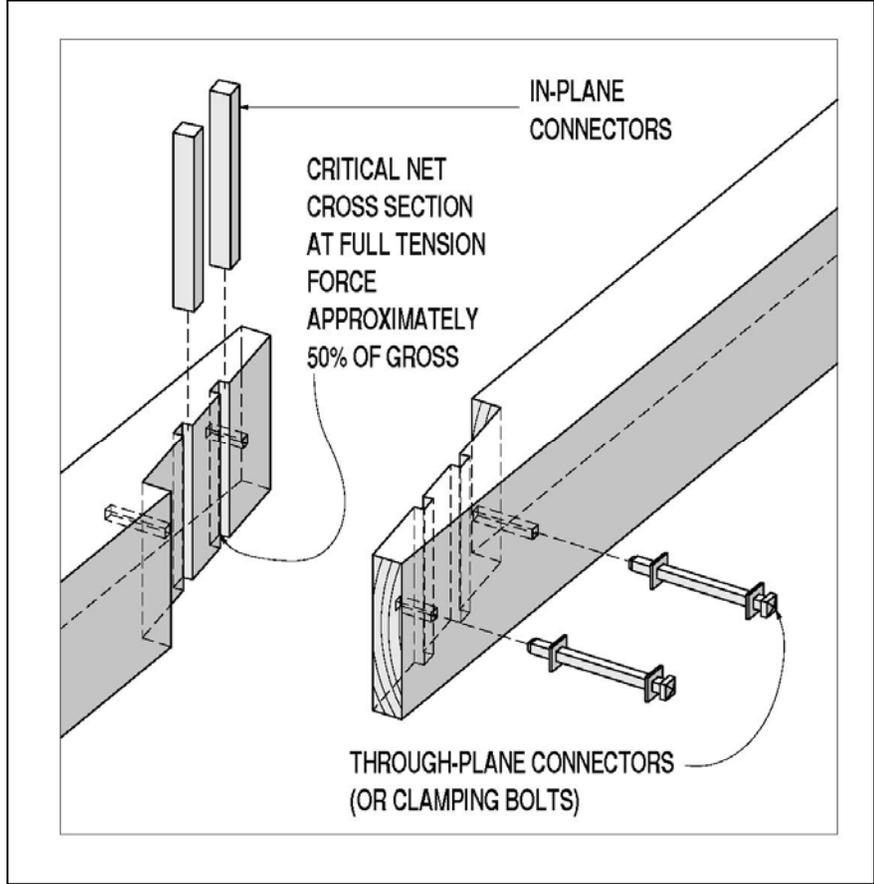
Figure 107. Lap joint with tapered halves and connectors.

One relatively simple but effective way to increase the available tension capacity in a lap joint is to taper the breadth of the halves as the load is transferred from member to member. If the members taper from two-thirds of their gross section at the beginning of the splice to one-third at the end of the splice, the through connectors might weaken the splice to only one-half of each member's gross tensile capacity. Again, both through-plane and in-plane shear connectors can be used to transfer the axial tension from one member to the other. Figure 107 shows a lap joint with tapered halves and connectors.

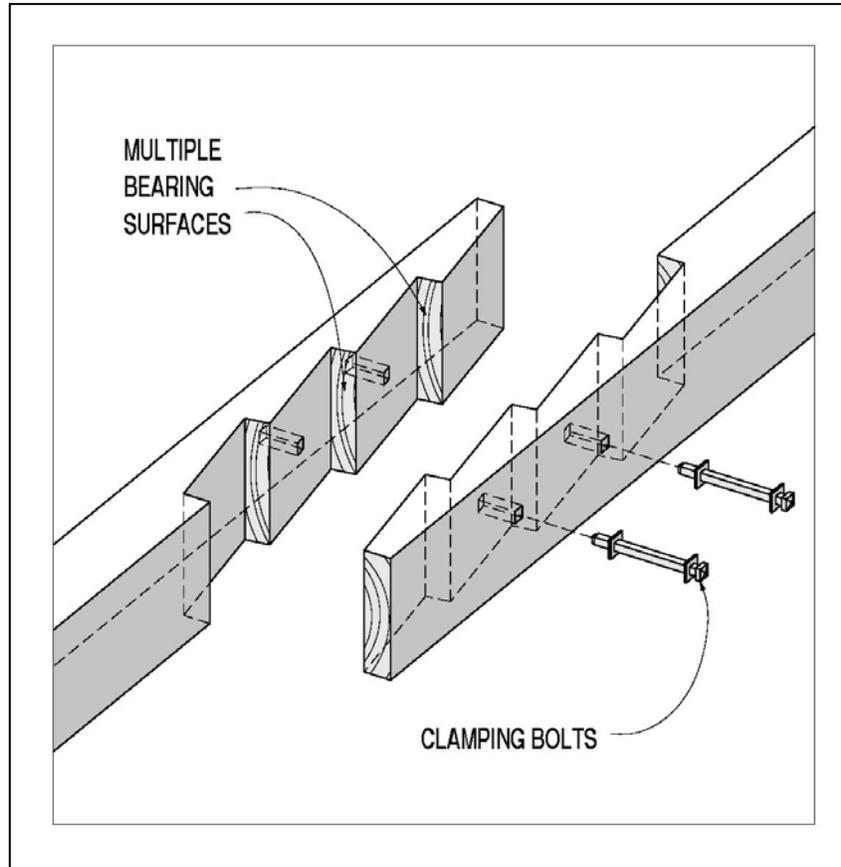
Figure 108. Bolt-of-lightning joint.

Within the family of tension lap splices, perhaps the highest form in efficiency, required craftsmanship, and artistry is the bolt-of-lightning splice (see figure 108). This joint is a tapered, end grain bearing splice with multiple bearing faces. The bearing faces are not cushioned with side grain bearing wedges or keys, and each of the mating faces must be scribe-cut to fit. Furthermore, if only one of the faces is overcut, one of the members would have to be replaced.

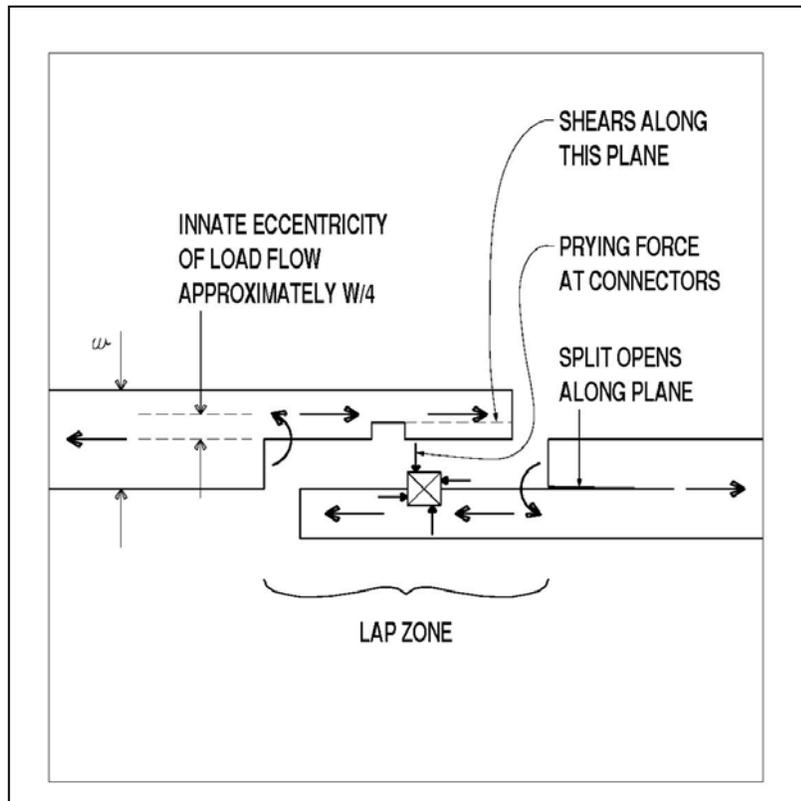
Figure 109. Eccentricity in member layout and prying at connectors.

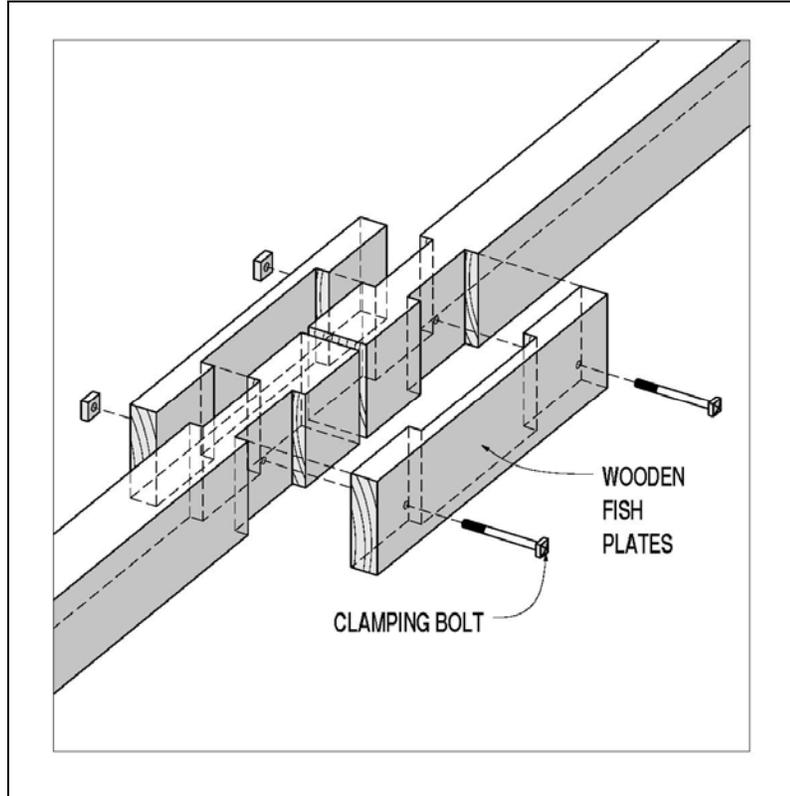
Figure 113. Butt joint with fish plates–wooden plates.

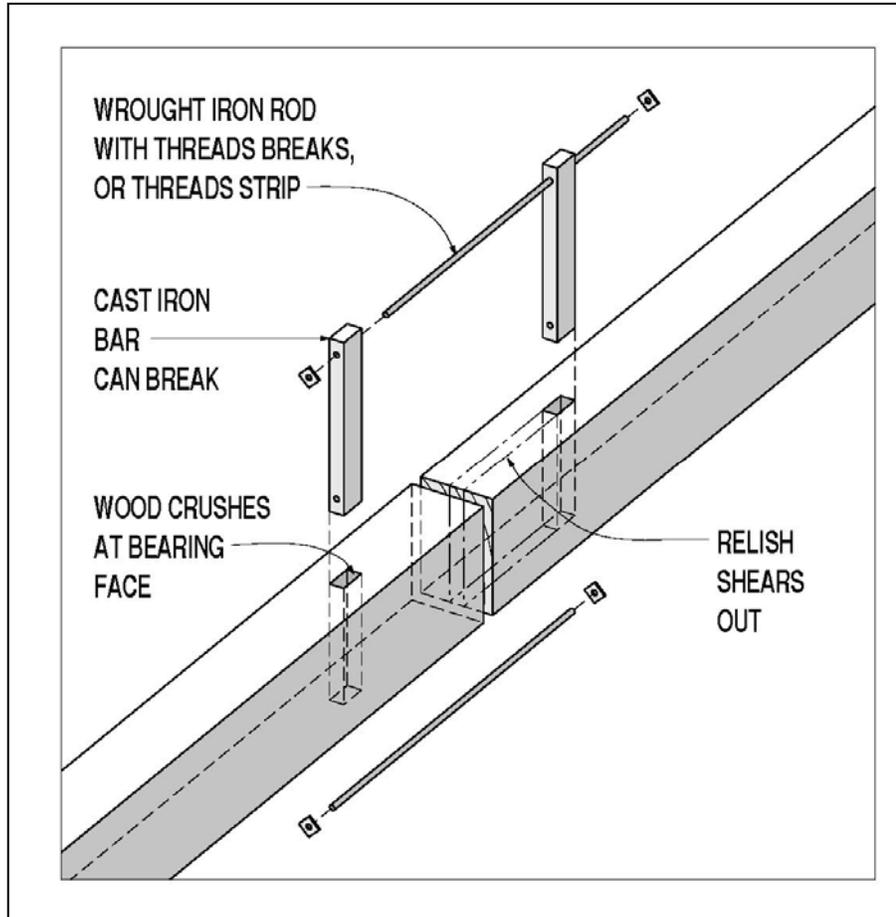
Figure 114. Butt joint with bars and rods splice.

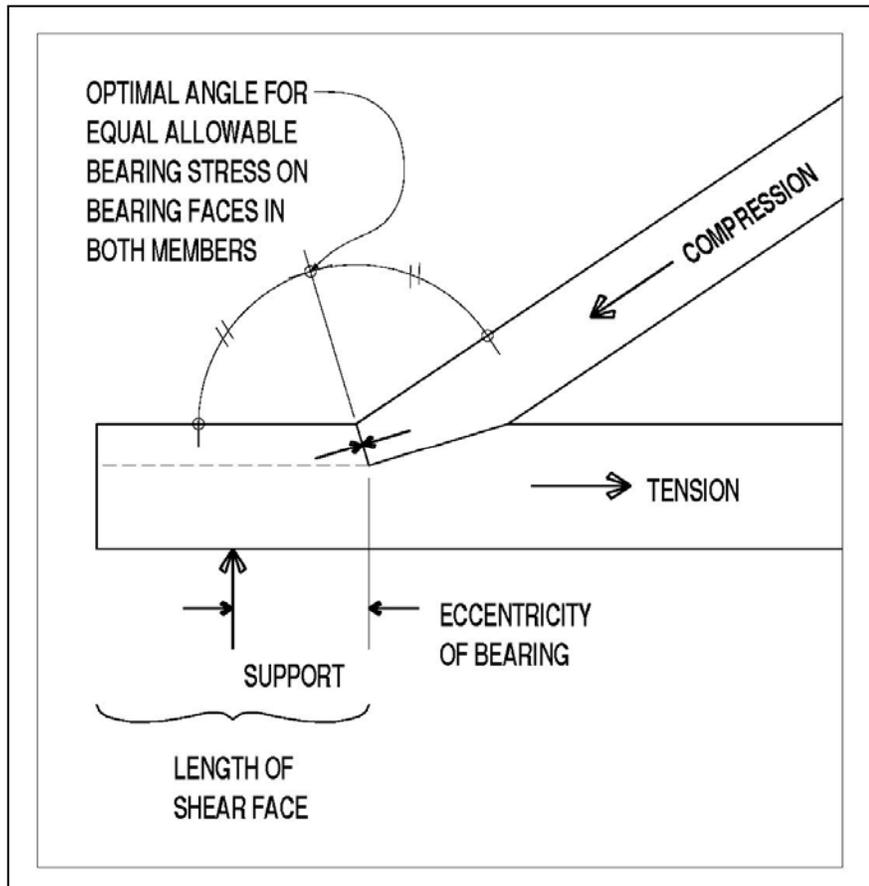
Figure 116. Simple bearing joint at angled notch.

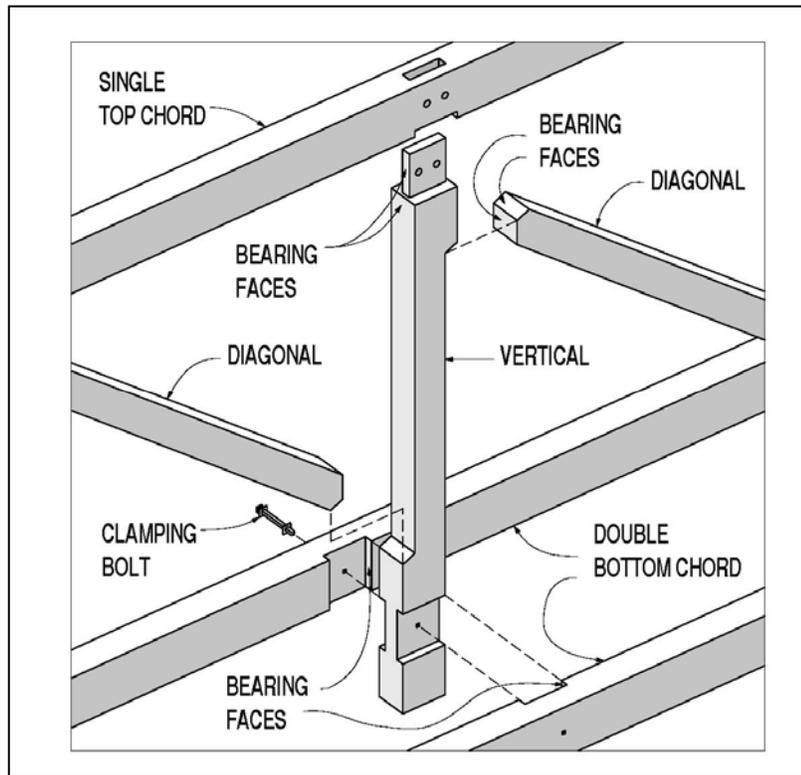
Figure 117. Top and bottom chord connections to vertical.

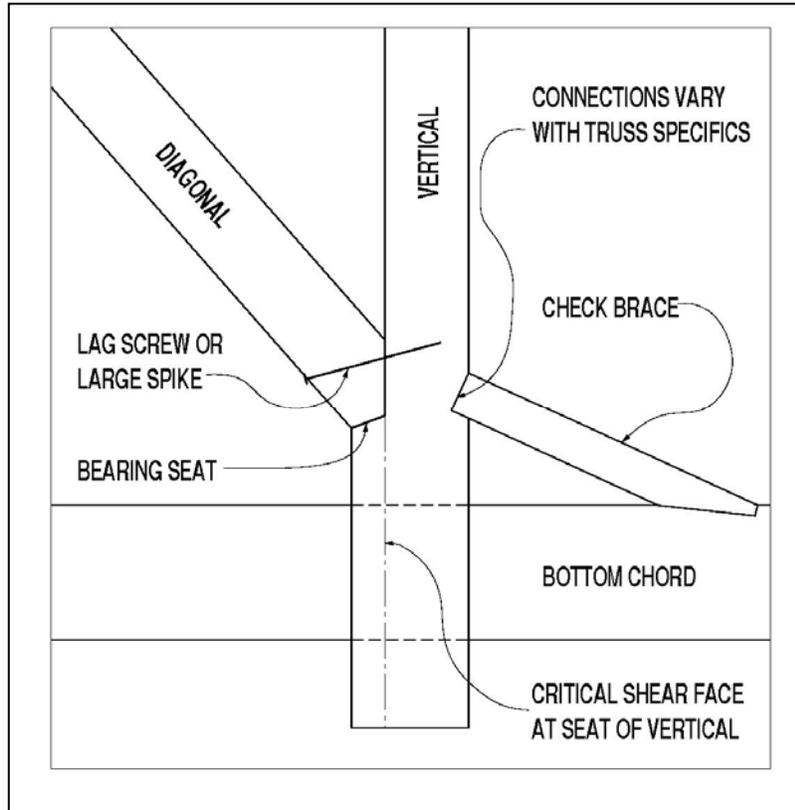
Figure 118. Truss vertical at bearing seat with critical shear face.
