Covered Bridge Manual

PUBLICATION NO. FHWA-HRT-04-098

APRIL 2005

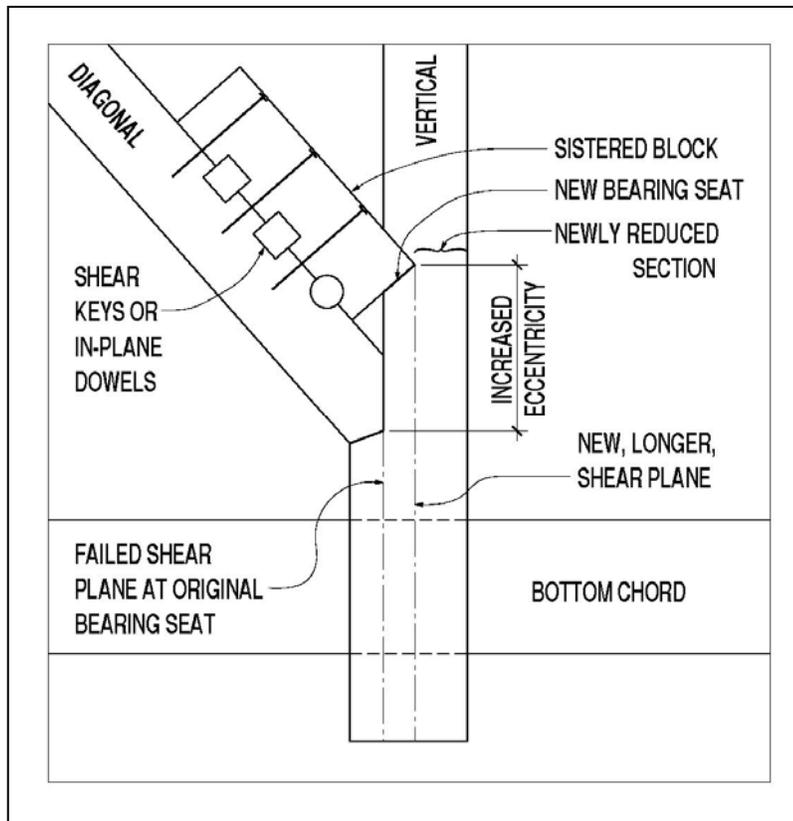
Figure 119. A sistered diagonal.

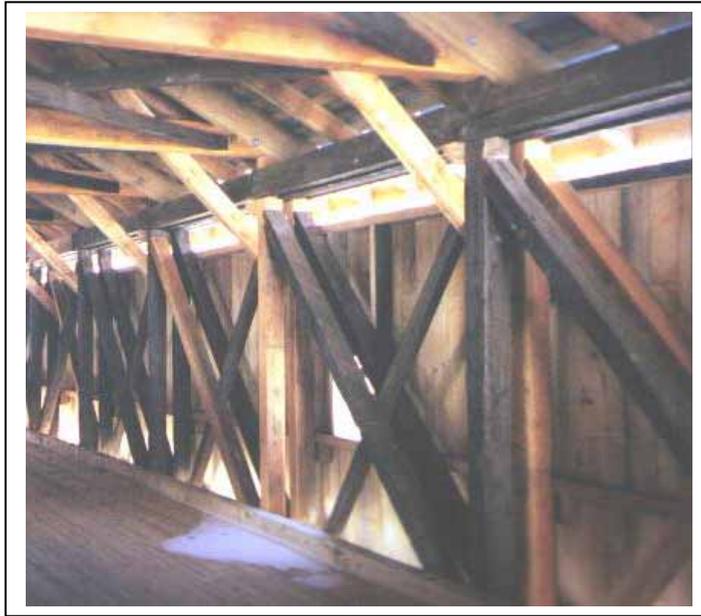
Figure 121. Long truss with counter timbers.

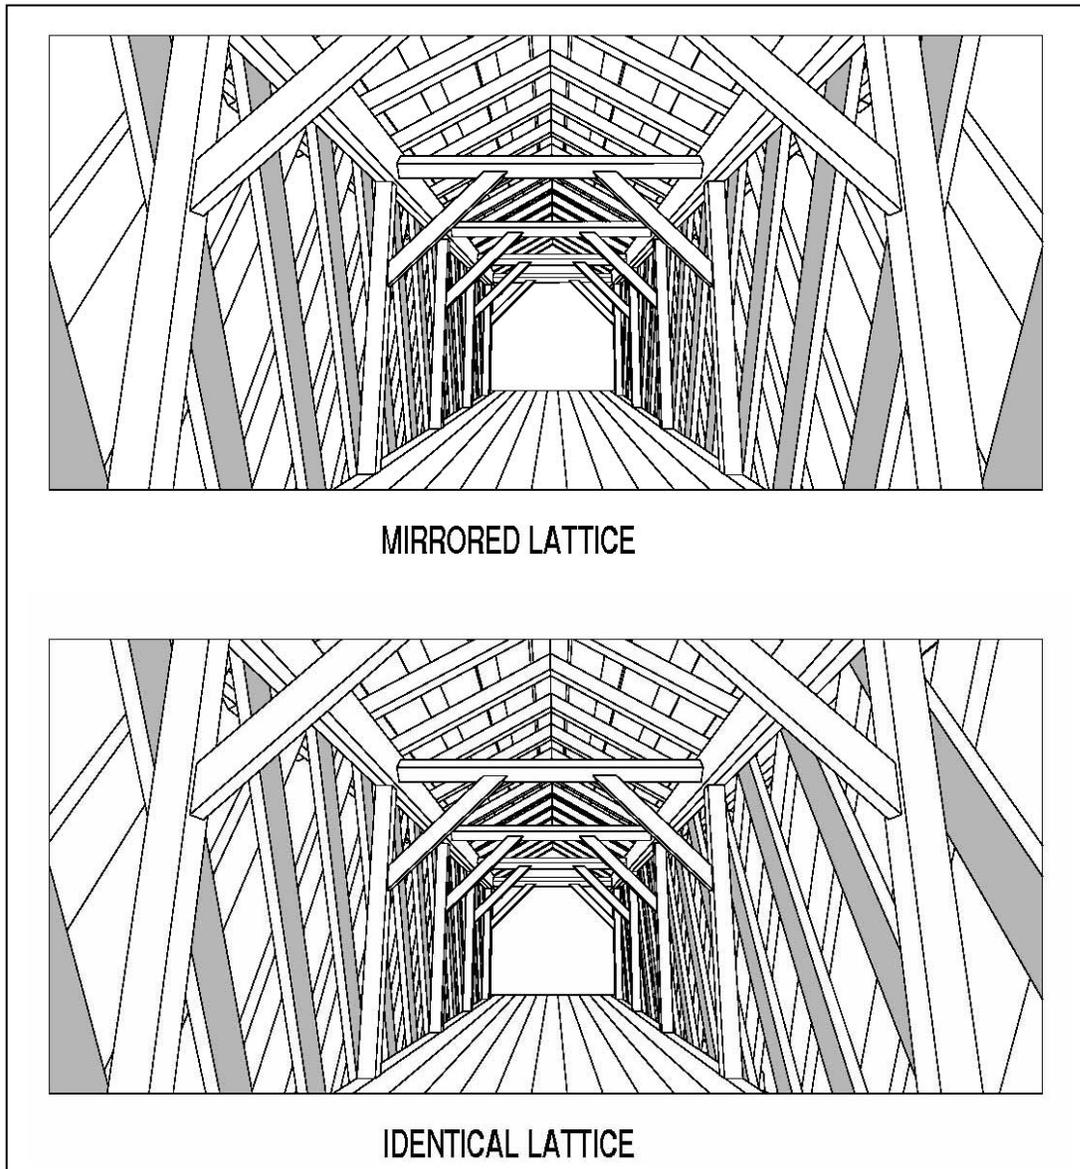
Figure 122. Town lattice trusses with identical versus mirrored web members.

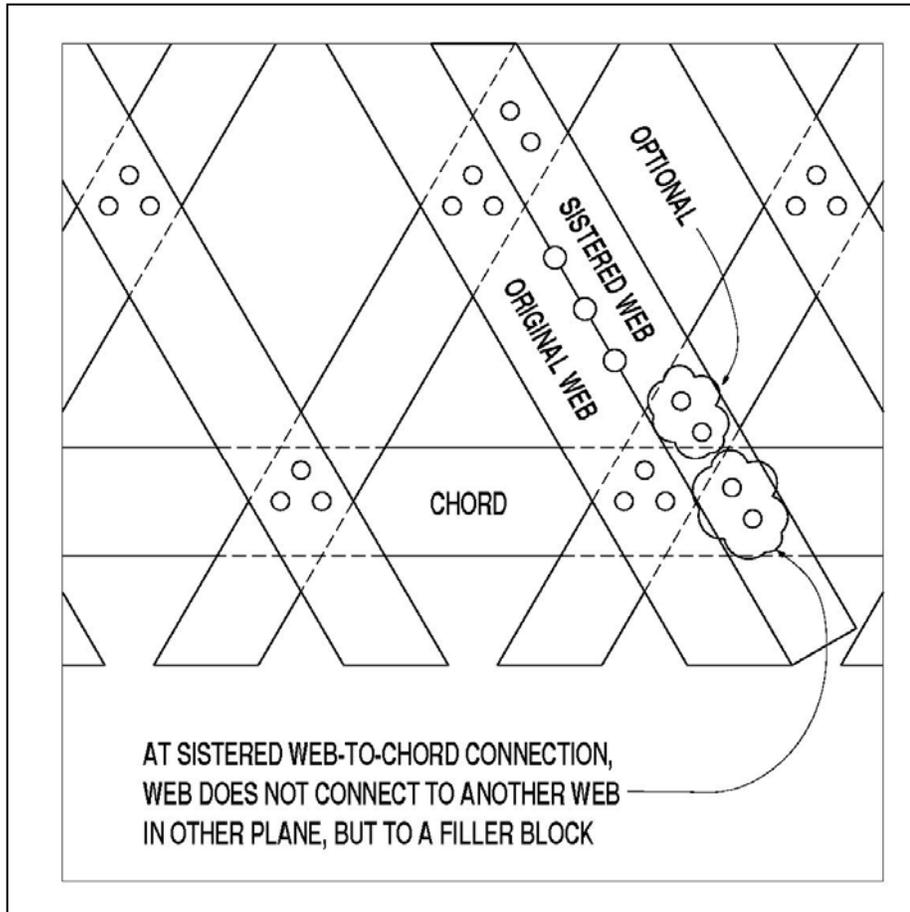
Figure 124. Sistered lattice web at chord connection.

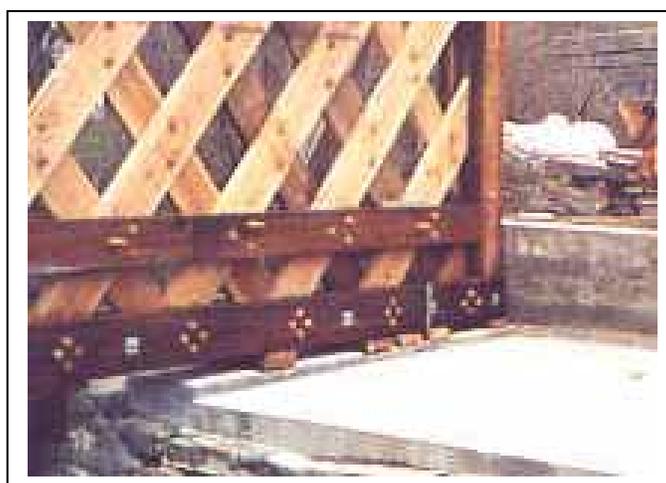
Figure 130. Bearing blocks beneath the bottom chord where tails have been removed—Paper Mill Bridge, Bennington, VT.

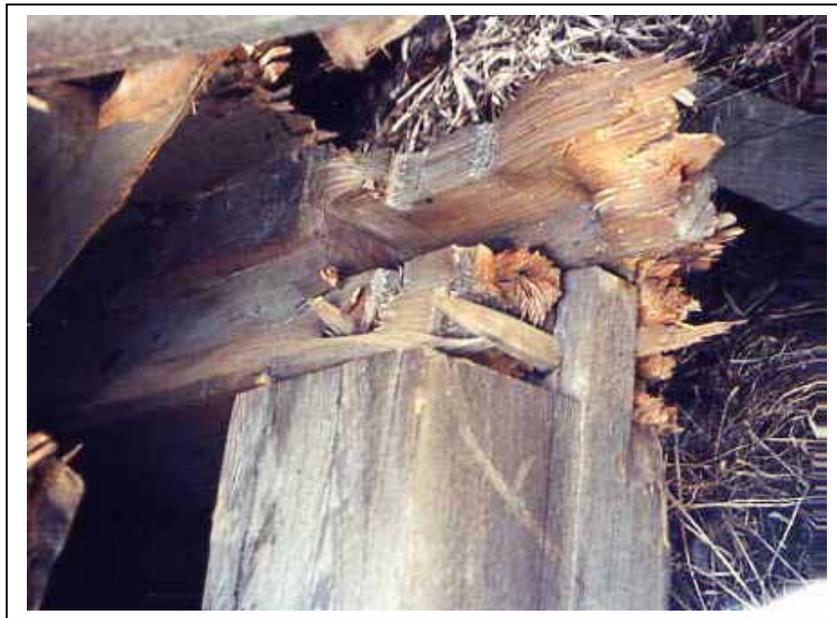
Figure 137. Tie beam to top chord connection details of failed joint.

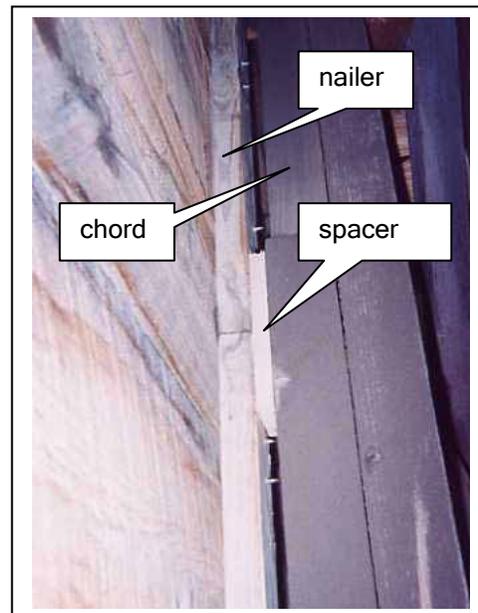
Figure 138. Siding nailers spaced away from truss elements.

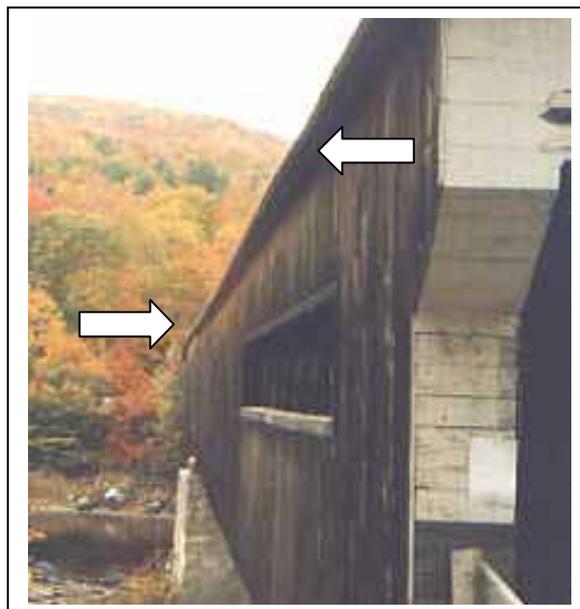
Figure 141. Racked two-span continuous bridge—West Dummerston, VT, before its recent rehabilitation.

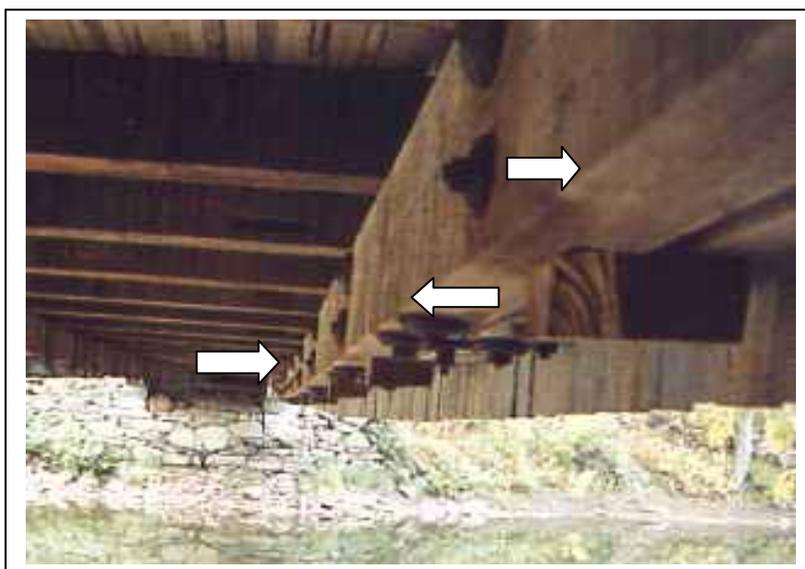
Figure 142. Example of sag—Station Bridge, Cambridge, VT, before rehabilitation.

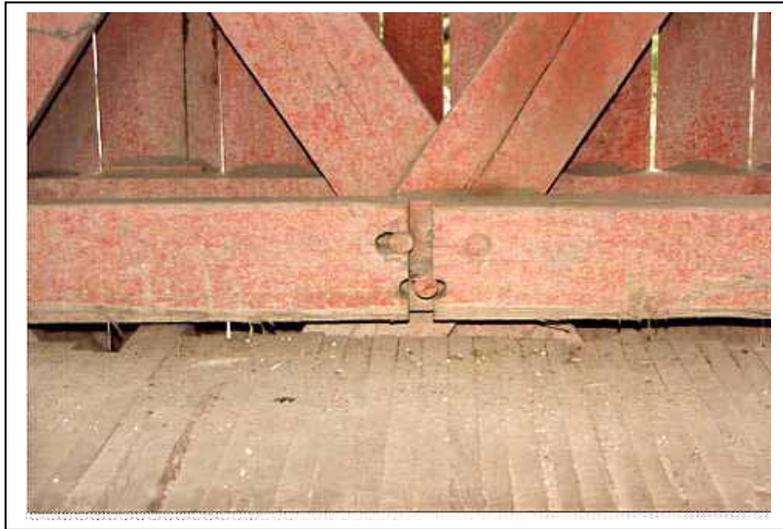
Figure 143. A chord butt joint in trouble—Station Bridge in Northfield, VT.

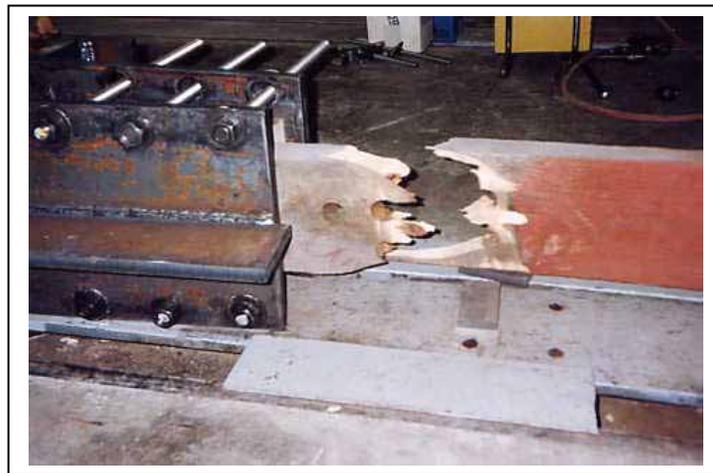
Figure 147. Tensile tests on lattice elements.

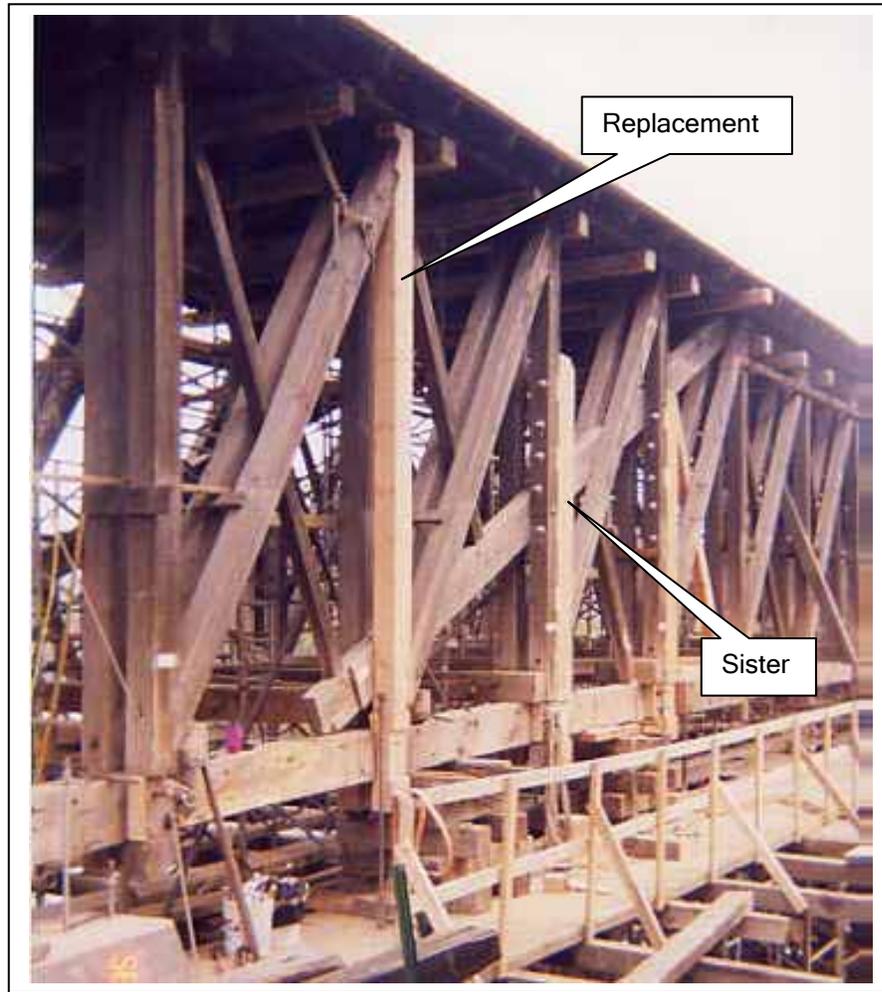
Figure 148. Replacement versus sister elements in Long truss–Downsville Bridge, Delaware County, NY, during its major rehabilitation in 1999.

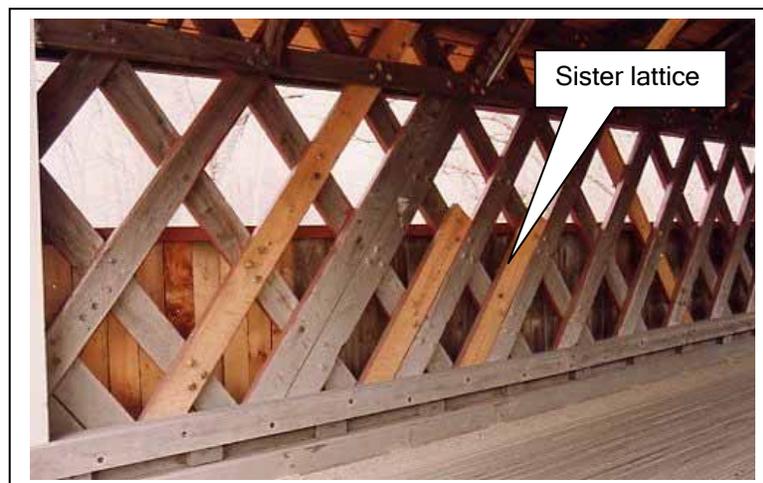
Figure 149. Sister elements in Town lattice—Silk Road Bridge, Bennington, VT.

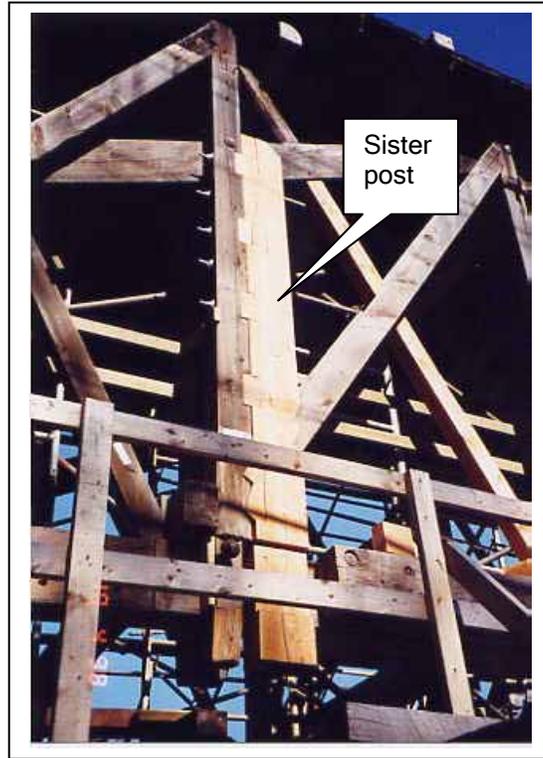
Figure 150. Sistered post repair in Long truss–Downsville Bridge, Delaware County, NY, during its major rehabilitation in 1999.

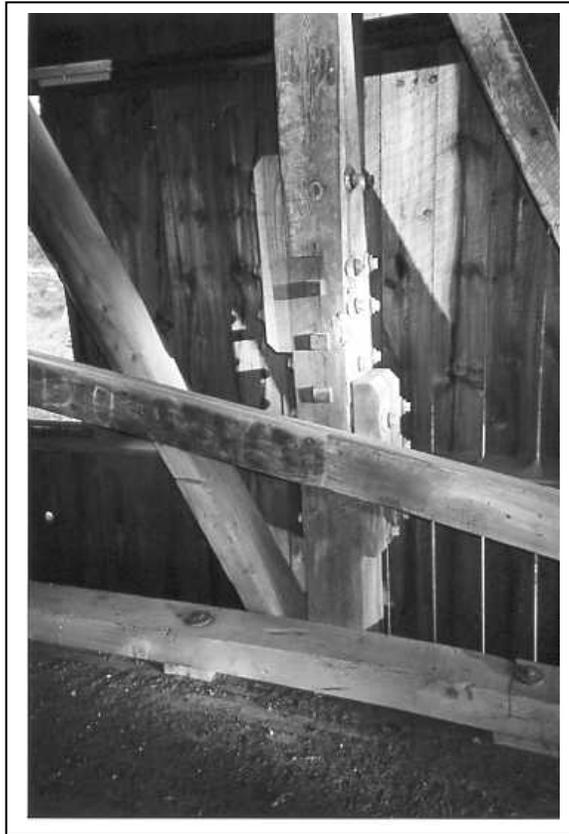
Figure 151. Partial post replacement in multiple kingpost truss—Union Village Bridge, VT.

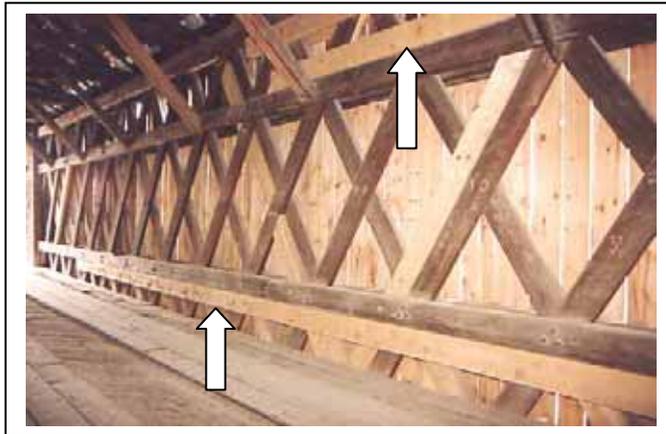
Figure 152. Extra chord elements added to an existing Town lattice truss—Cedar Swamp Bridge, between Salisbury and Cornwall, VT.

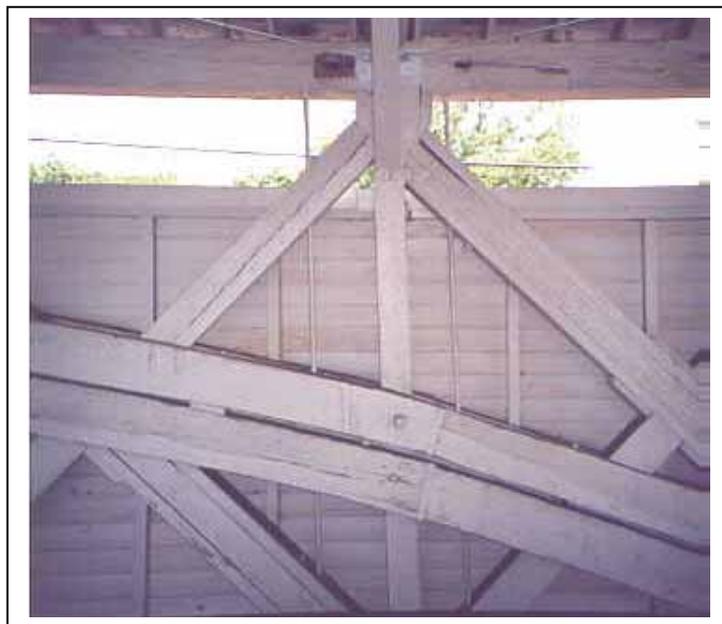
Figure 155. A single bolt connects these single-piece arch segments to the truss post—Wehr Bridge, Lehigh County, PA.

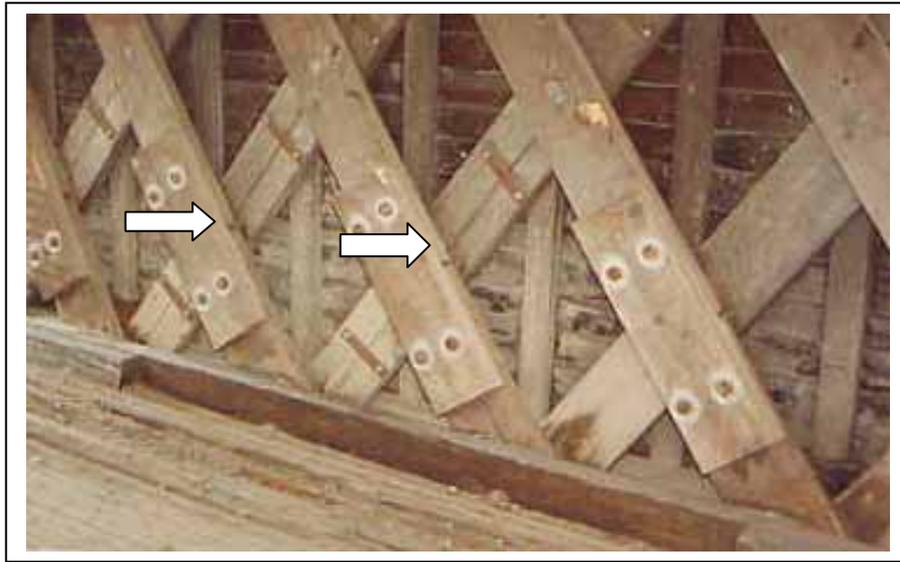
Figure 157. Spliced lattice tail replacements—River Road Bridge, Troy, VT.

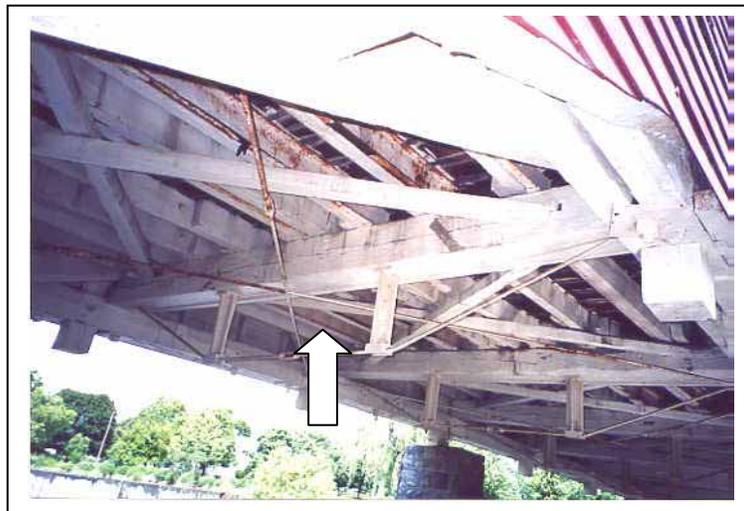
Figure 159. Installation of metalwork beneath a timber floor beam—Wehr Bridge, Lehigh County, PA.

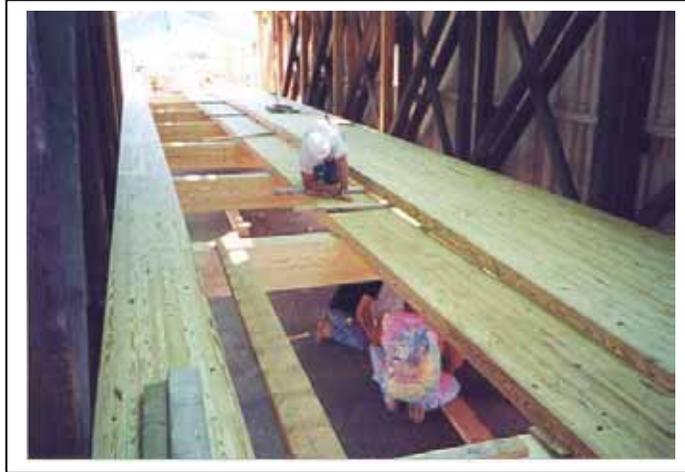
Figure 160. Strengthening by using glue-laminated deck panels and floor beams—Hamden Bridge, Delaware County, NY.

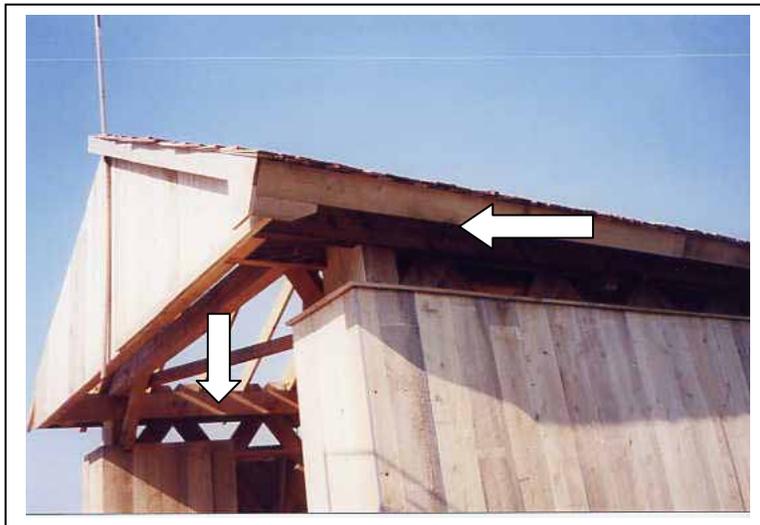
Figure 161. Good siding details—Fitch's Bridge, Delaware County, NY.

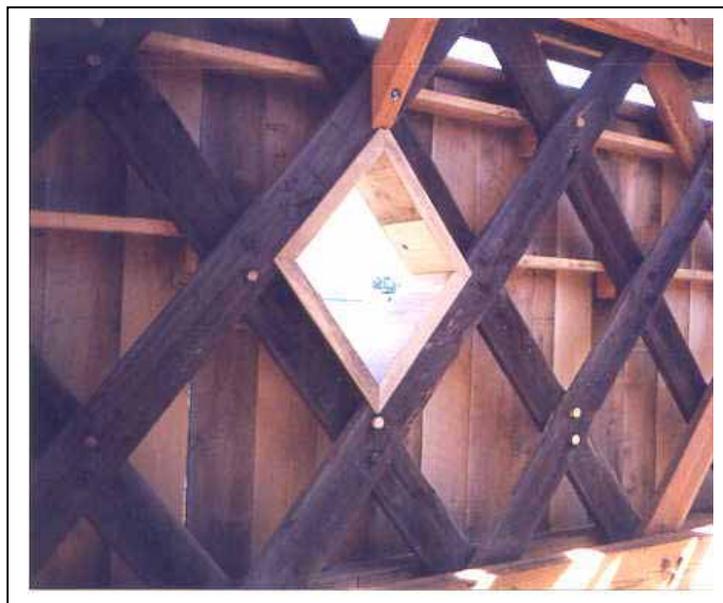
Figure 162. Good siding details around a window—Fitch's Bridge.

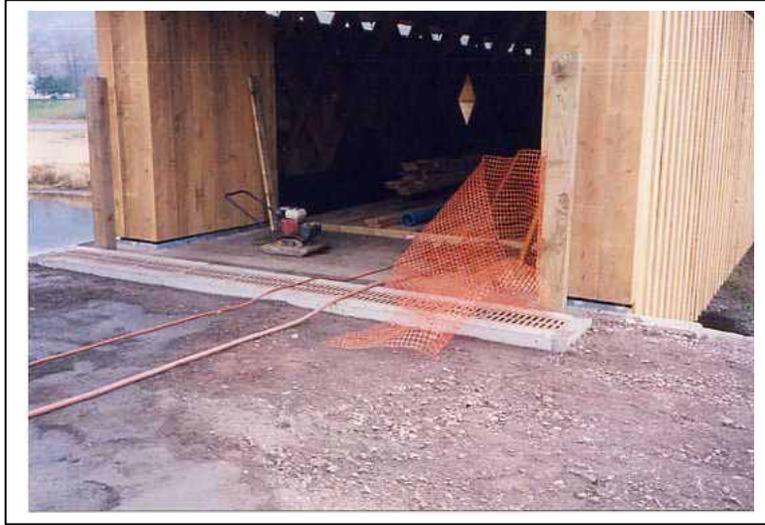
Figure 165. A trench drain at a bridge entrance—Fitch’s Bridge, Delaware County, NY.

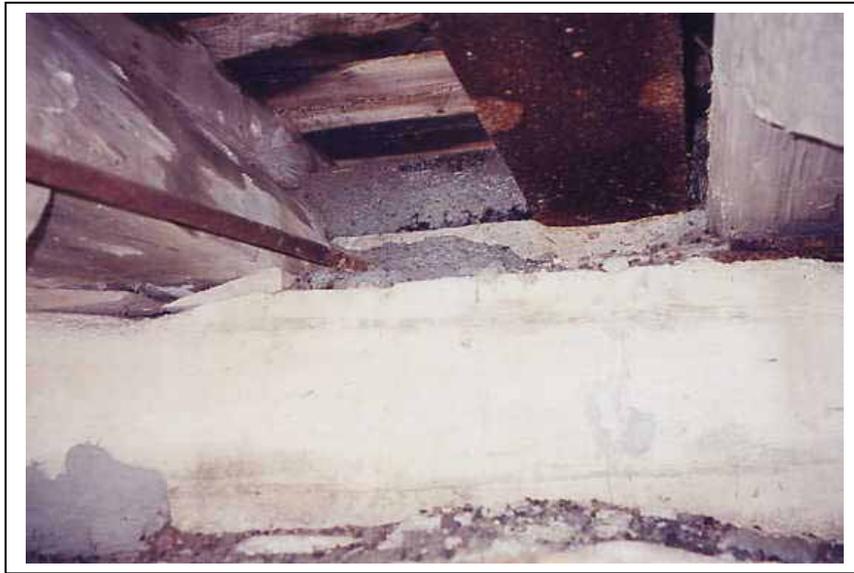
Figure 167. Accumulation of debris and asphalt encasing timber elements.

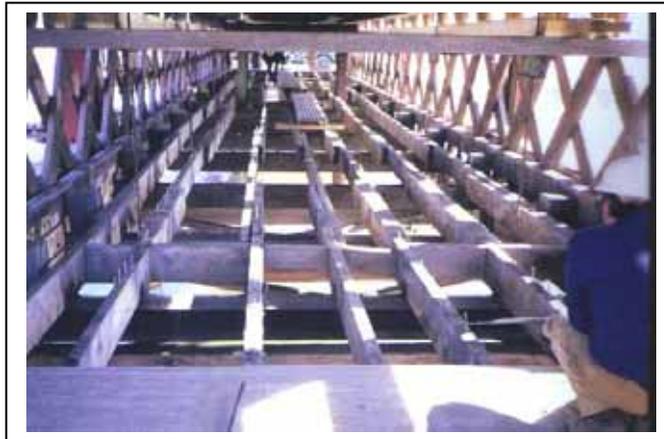
Figure 191. Partially removed 1976 floor.

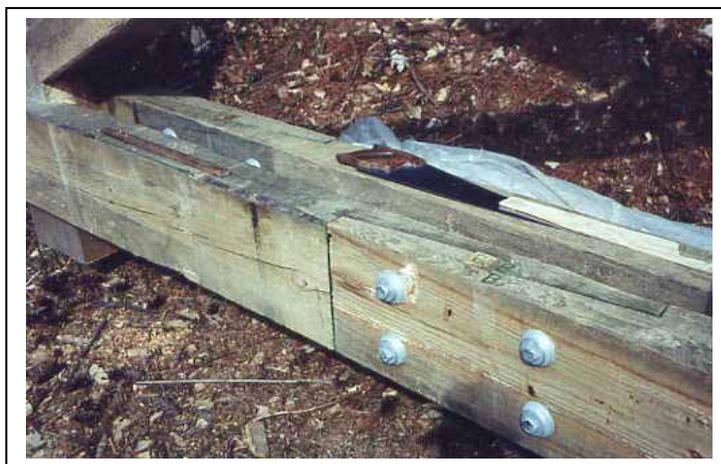
Figure 255. Double bottom chord arrangement with scarf joint.
