# FHWA LTBP Summary—Findings from the New Jersey Bridge Deck

FHWA Publication No.: FHWA-HRT-16-070

This summary report focuses on some of the key findings that resulted from the investigation of the deck of the bridge selected for participation in the LTBP Program pilot study located in New Jersey ("New Jersey pilot bridge"). Findings related to the superstructure and substructure of the bridge will be the subject of a future LTBP Program report. Summarized findings from the testing of the other six pilot bridges will be presented in future publications.

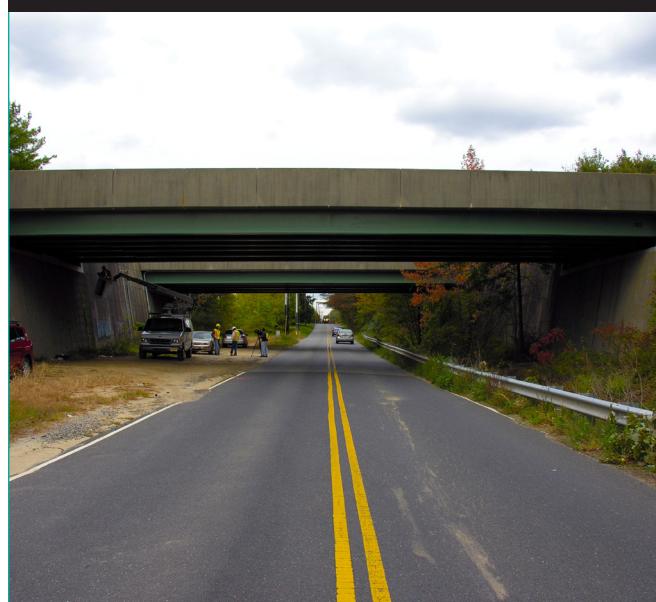
The New Jersey pilot bridge (see figure 1) carries two lanes of eastbound traffic on Interstate 195 over Sharon Station Road in Upper Freehold, NJ. A parallel twin bridge carries westbound traffic. Average daily traffic volume is approximately 23,000 vehicles, 14 percent of which are trucks. It was constructed and opened to traffic in 1969. The bridge has a multigirder steel superstructure consisting of one span supported on two reinforced concrete abutments and has a cast-in-place reinforced concrete deck with stay-in-place forms. A 6.75-inch-thick reinforced concrete deck with a latex modified concrete

Figure 1. New Jersey pilot bridge.

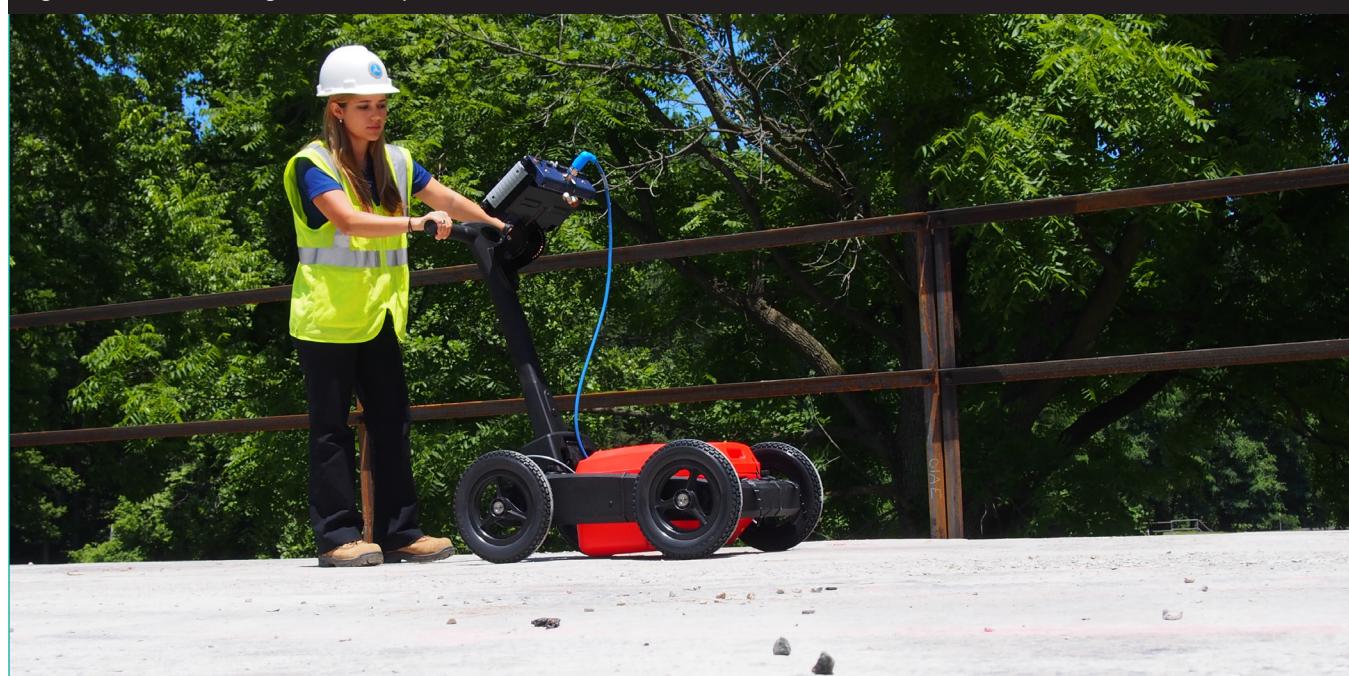
During each round of testing, in 2009 and 2011, the deck was tested using GPR (see figure 2).

Figure 2. GPR with a ground-coupled antenna.

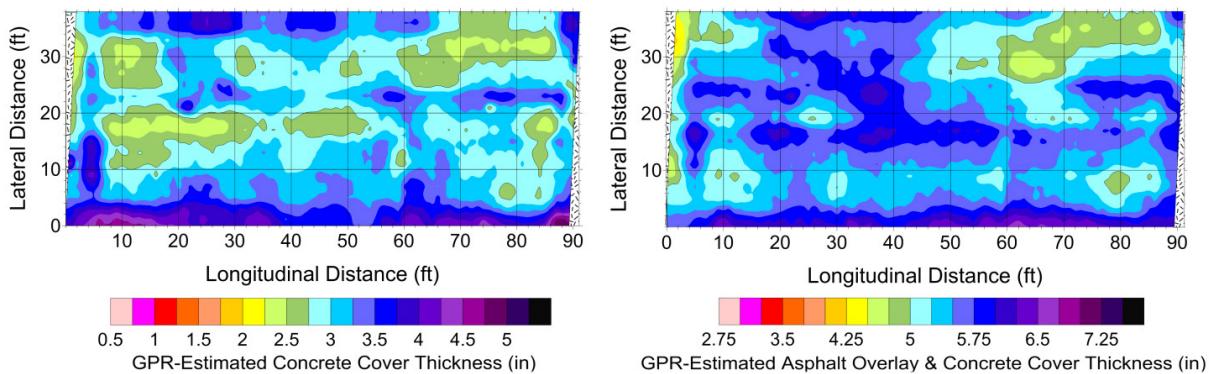
After each round of testing, concrete cover depth maps (depth to the top layer of reinforcement) (see figure 3) and depth-corrected maps of the deck condition (see figure 4) were produced from the GPR testing.

Figure 3. Rebar depth estimated using GPR from the 2009 (left) and 2011 (right) surveys.

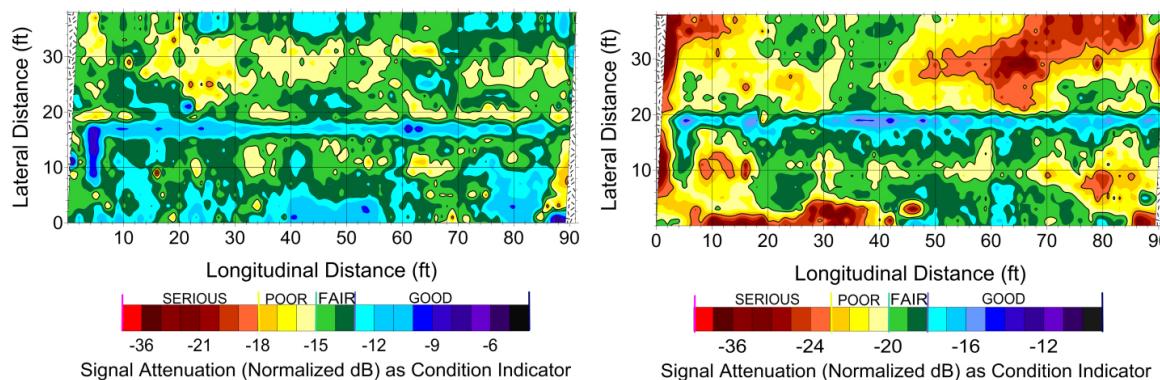
There are significant differences between the depth-corrected GPR condition maps generated in 2009 and 2011. These differences are likely the result of some combination of deterioration of the concrete and the effect of the asphalt overlay on the GPR signals. The amount of attenuation attributable to the overlay depends on the overlay's thickness and homogeneity. Even though asphalt is not a medium that can significantly scatter or attenuate a GPR signal (especially when it is new, thin, and of uniform thickness), the differences attributable

to concrete degradation between 2009 and 2011 cannot be determined with confidence.

Figure 4. Depth-corrected GPR attenuation-based grading from the 2009 (left) and 2011 (right) surveys.

The 2011 condition map of the overlaid deck will serve as the baseline for future comparisons. Additional research would be necessary to attempt to quantify the attenuation loss through the existing overlay more precisely and shed some light on the potential sources of attenuation.

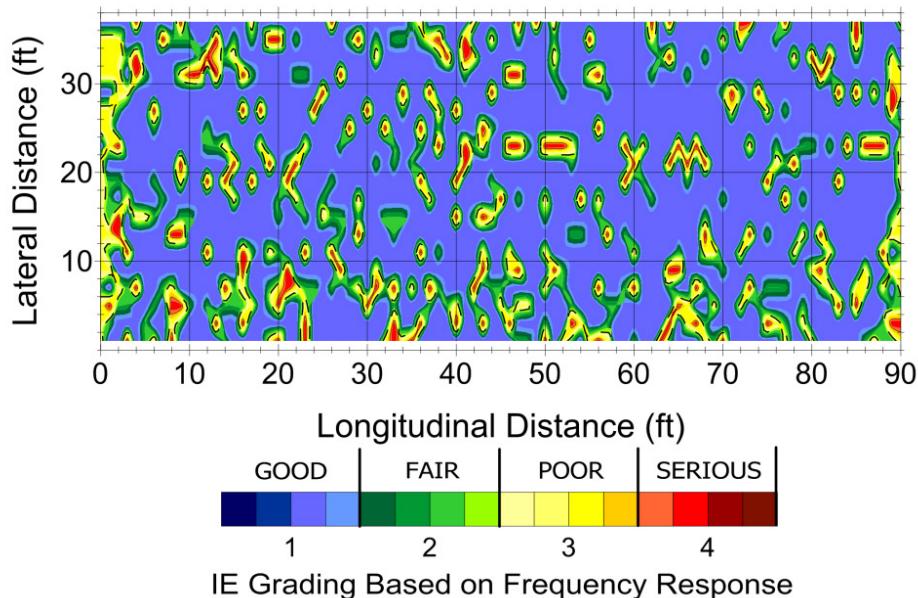
The condition map from the 2009 IE assessment (see figure 5) indicates there is some significant delamination, with roughly 10 percent of the deck in serious condition and an additional 33 percent in fair to poor stages of delamination. Depths to the delaminated surfaces were not estimated.

More than half the deck area displays no evidence of delamination. No significantly large delaminated areas were detected, and delaminations were distributed randomly throughout the deck surface. As noted during the 2009 investigation, only scattered delaminations were detected during the sounding using a chain drag. IE testing was not repeated in 2011 because of the presence of the asphalt overlay, which precludes any possibility of comparing IE results over multiple testing cycles.

Figure 5. IE condition map from the 2009 survey.

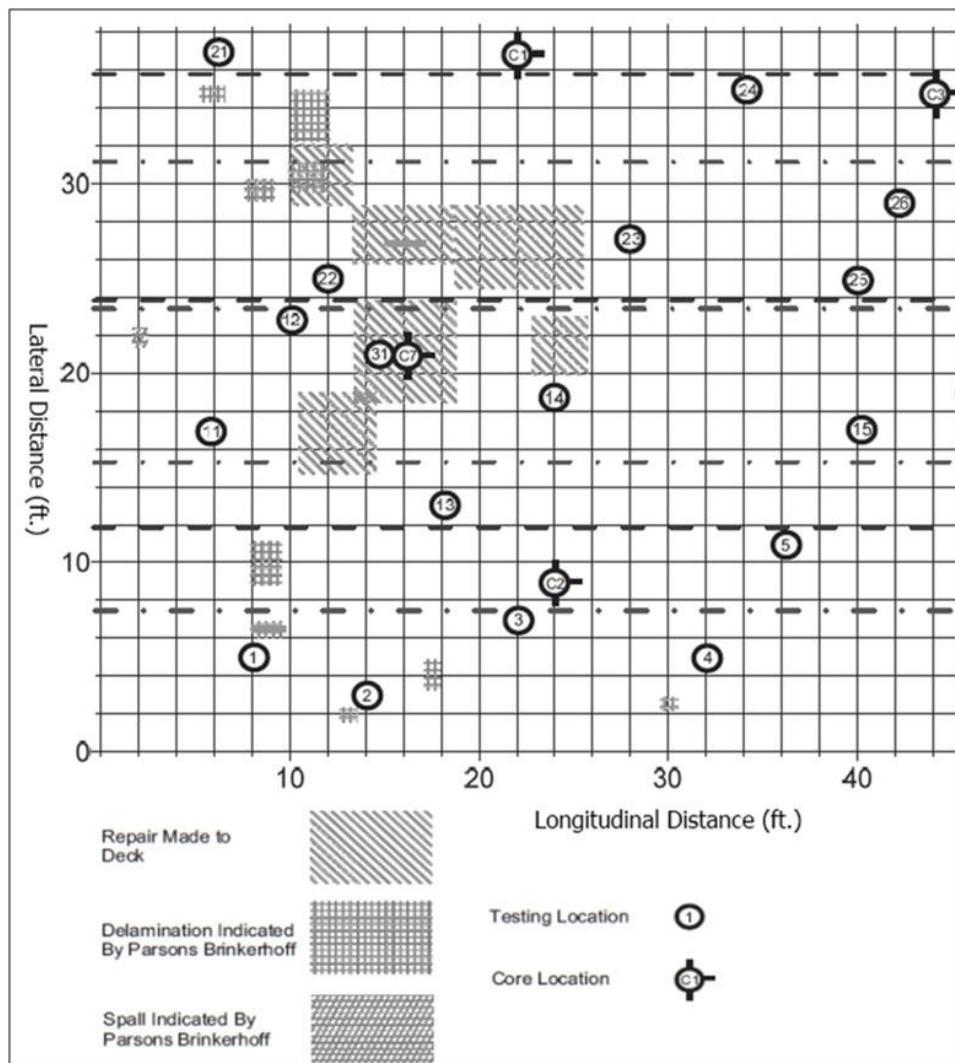
One goal of the pilot phase was to analyze the collected data and experiment with comparing and correlating findings from different data sources to enhance the understanding of the bridge condition and the underlying factors that contribute to that condition. However, in some cases, these comparisons may result in noticeable lack of correlation and ultimately raise additional questions. An example is comparing the findings generated by sounding the concrete deck with chain drag and hammer with the data from IE. The IE results in figure 5 show randomly scattered areas where delamination is likely, but the results of the soundings (see figure 6) show rather concentrated

areas of suspected delaminations that do not correlate well with the IE indications.

Figure 6. Testing locations of first half of deck.

The differences in the indications of delamination provided by these two methods would need to be examined by coring. Alternatively, if the asphalt overlay were not present, a comparison of data from future cycles of testing might show better correlation.

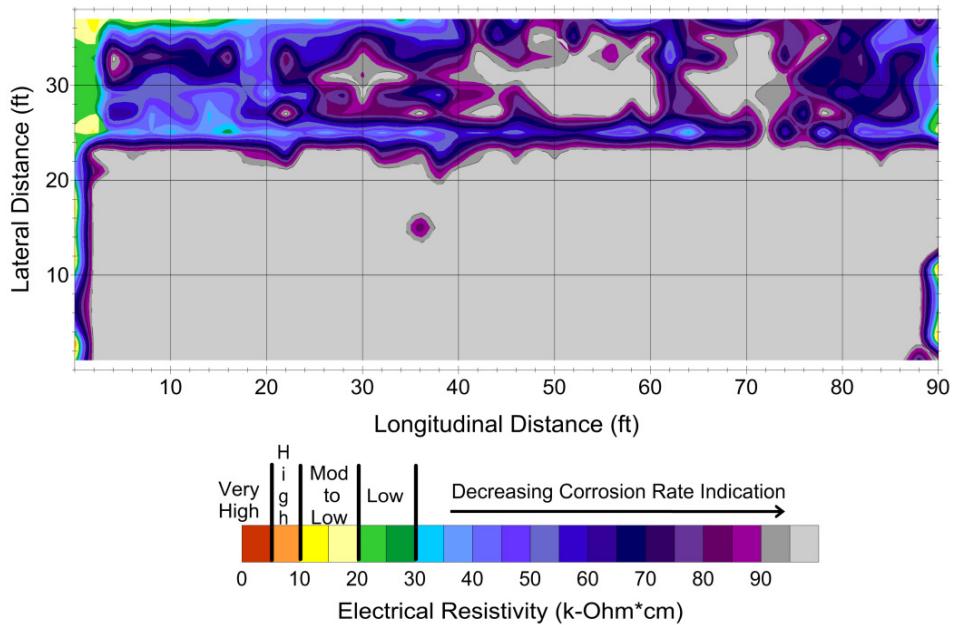
Based on ER (see figure 7) and HCP (see figure 8) condition maps, less than 5 percent of the deck area falls within the range where there is a strong likelihood that active corrosion is occurring in the deck steel. HCP measurements showed that these areas were mainly along one of the bridge joints. ER testing also showed corrosion activity along the bridge joints and along one gutter, with less than 5 percent of the deck area falling within a range of 0 to 35 k $\Omega$ -cm. Over 75 percent of the deck yielded ER measurements exceeding 90 k $\Omega$ -cm, indicating that the electrical conductivity of the concrete environment would likely not support corrosion at the time of testing. This indicates that at the time of

testing, corrosion activity was low. However, a few notable corrosion hot spots were evident, mainly near the abutment joint lines.

In figure 7, there is a distinct border between areas where ER results indicate conditions that support corrosion, and in figure 8, there is a similarly located border where HCP results indicate the likelihood of corrosion. The reason for this

demarcation was uncertain. However, one possible cause might be related to the placement of the LMC overlay. When the overlay was placed circa 1997, the dividing line between the two stages of placement (see figure 9) was at the same location where the border appears on the plots in figure 7 and figure 8. Differences in the LMC mix and/or placement practices may be the cause of the differences in corrosion activity.

Figure 7. ER condition map from the 2009 survey.

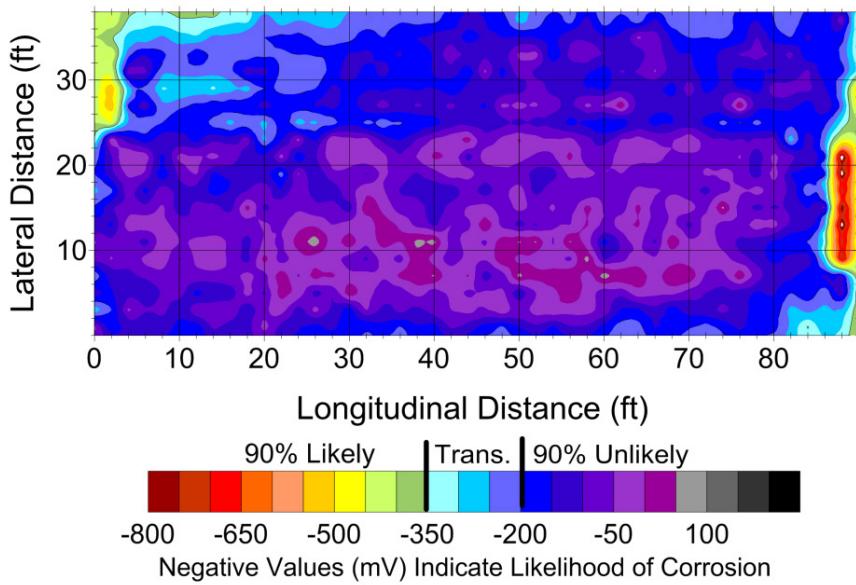
Figure 8. HCP condition map from the 2009 survey.

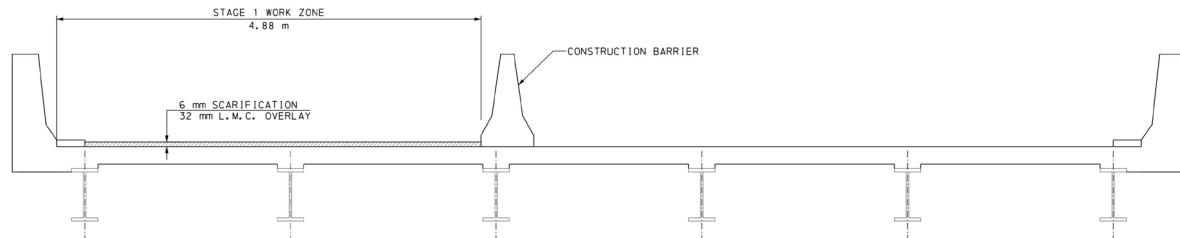
Figure 9. Cross-section of the deck showing the location of the LMC overlay circa 1997.
