5.3. IN-DEPTH INSPECTION RESULTS

5.3.2. Task F

Task F is the In-Depth Inspection of approximately one-fifth of the below-deck superstructure of Bridge B544, a decommissioned bridge at the STAR facility. The bridge and Task F are fully described in Chapter 4.

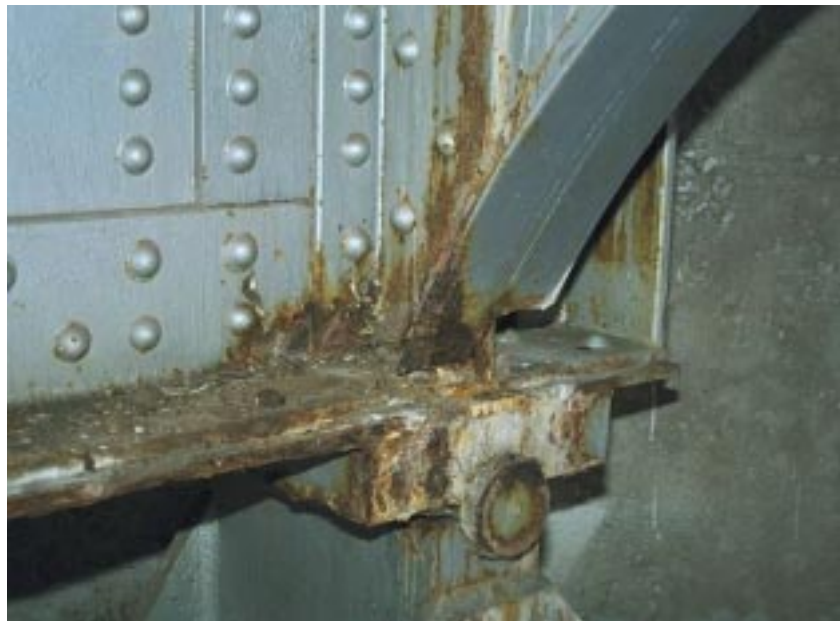
The paint system failure is prevalent throughout the test specimen. This type of defect includes locations where the paint has failed, probably due to poor bonding between the paint and the steel surface at locations of severe corrosion. Figure 127 is indicative of the extent of this deficiency. All 42 inspectors who performed this task indicated that there was some level of paint system failure.

Figure 127. Paint system failure and moderate to severe corrosion.

The moderate to severe corrosion of girders and secondary members also occurs at numerous locations throughout the test specimen. This deficiency includes corrosion ranging from minor corrosion over a large area to severe corrosion that has caused measurable section loss. Figure 127 also illustrates a portion of this global defect. Ninety-eight percent of the inspectors who performed this task noted corrosion problems.

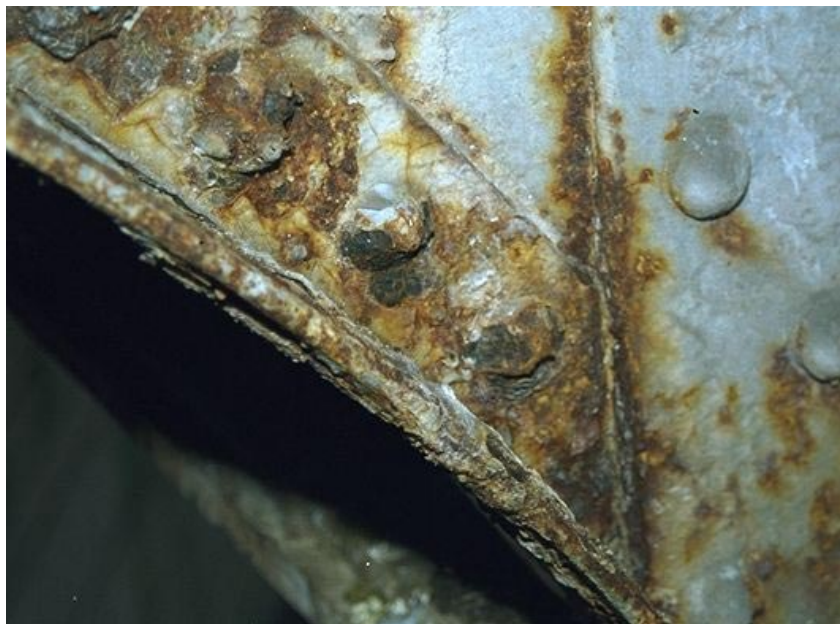
Extensive corrosion of rivets and rivet heads can lead to fastener section loss and eventually a decrease in member capacity. This deficiency is present at various locations throughout the bridge. Figure 128 illustrates an example of this deficiency. Forty-five percent of the inspectors who performed this task noted the severe rivet head corrosion.

Figure 128. Severe corrosion of rivet heads.

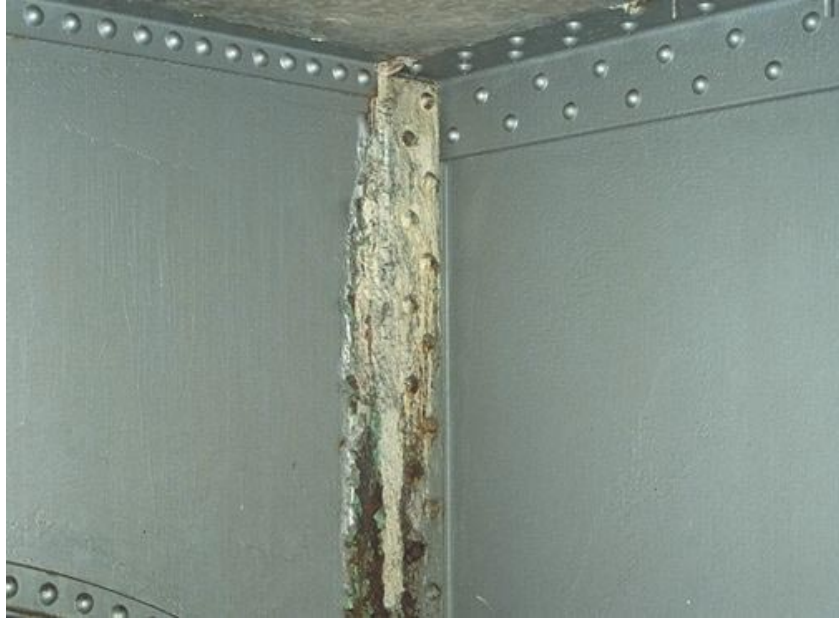
Finally, efflorescence, due primarily to deck-related deterioration, has crystallized on the superstructure in many locations. Sixty-nine percent of the inspectors noted this efflorescence, represented in figure 129.

Figure 129. Typical efflorescence.

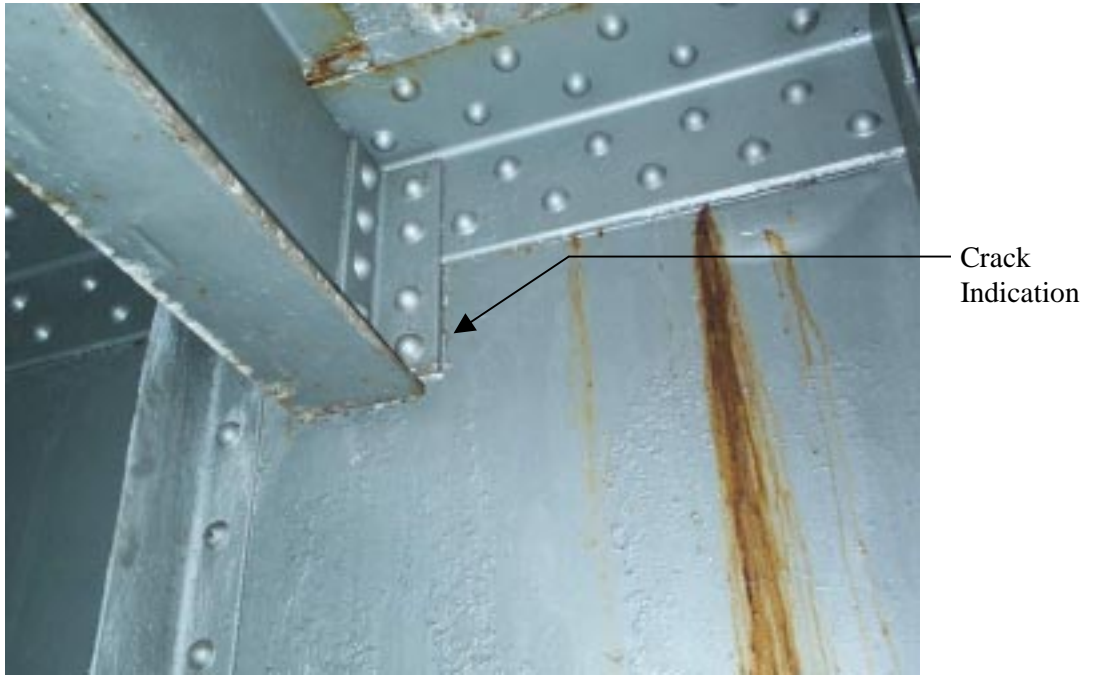
Tack welds exist at a number of locations in this bridge. This type of weld results in a fatigue-sensitive detail. A crack indication was implanted at the root of one of these welds. The schematic drawing shown in figure 130 indicates the location of this defect, while figure 131 shows this defect. The crack indication was identified by 3 of the 42 inspectors (7 percent) who performed this task.

a. General location of implanted defect.

b. Close-up of defect.

Figure 131. Crack indication at the root of a tack weld.

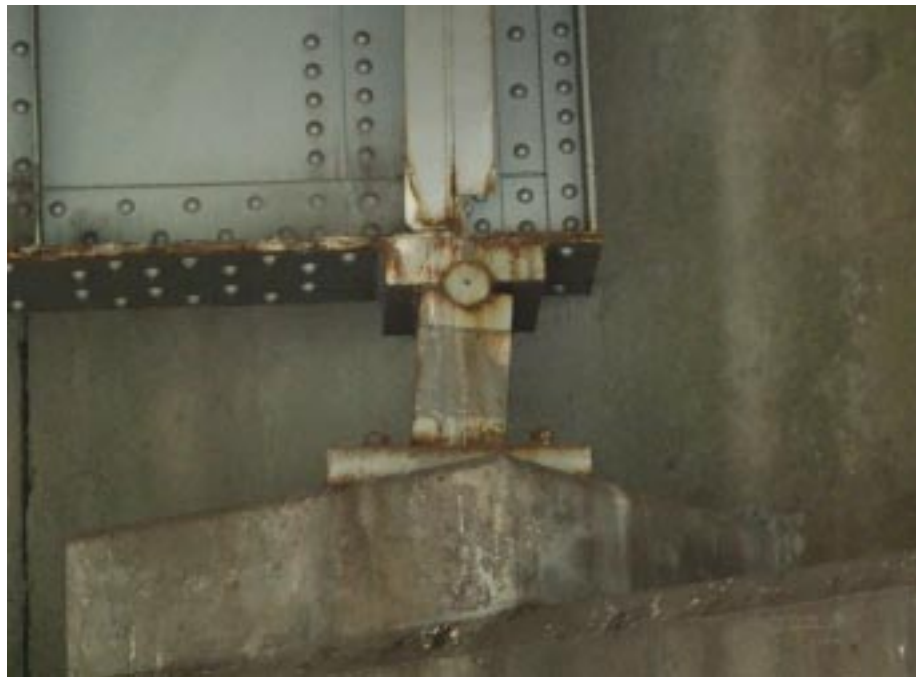
The rocker bearings on the eastern abutment of the southern half of this bridge display an abnormal setting given the thermal conditions surrounding the bridge. First, the three bearings exhibit overly expanded positions. Also, the southern bearing has rotated more than the other two, indicating a possible planar rotation of the bridge. Figure 133 shows one of the rocker bearings when the air temperature is approximately 24 °C. Twenty-one of the inspectors (50 percent) noted this bearing abnormality.

Figure 133. Rocker bearing rotation.

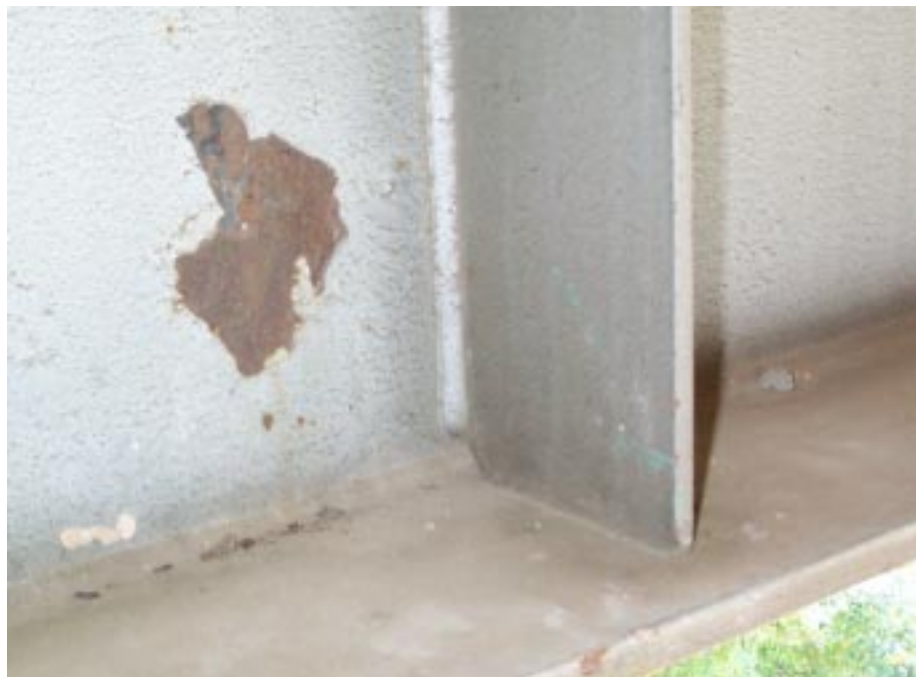
Paint system failure and corrosion are present in various locations throughout the test specimen. Figures 136 and 137 show typical examples of this deficiency. Of the inspectors who completed this task, 66 percent specifically indicated some sort of paint system failure. Corrosion is a bridge defect that is generally directly linked to the paint system failure. Minor localized corrosion, also known as speckled rust, has occurred in various locations throughout the specimen. Fifty-five percent of the inspectors noted that corrosion was present in the test specimen. Hereafter, paint system failure and corrosion will be combined into a general coating deficiency. Sixty-six percent of the inspectors noted the coating deficiency.

Figure 136. Paint failure on girder web.

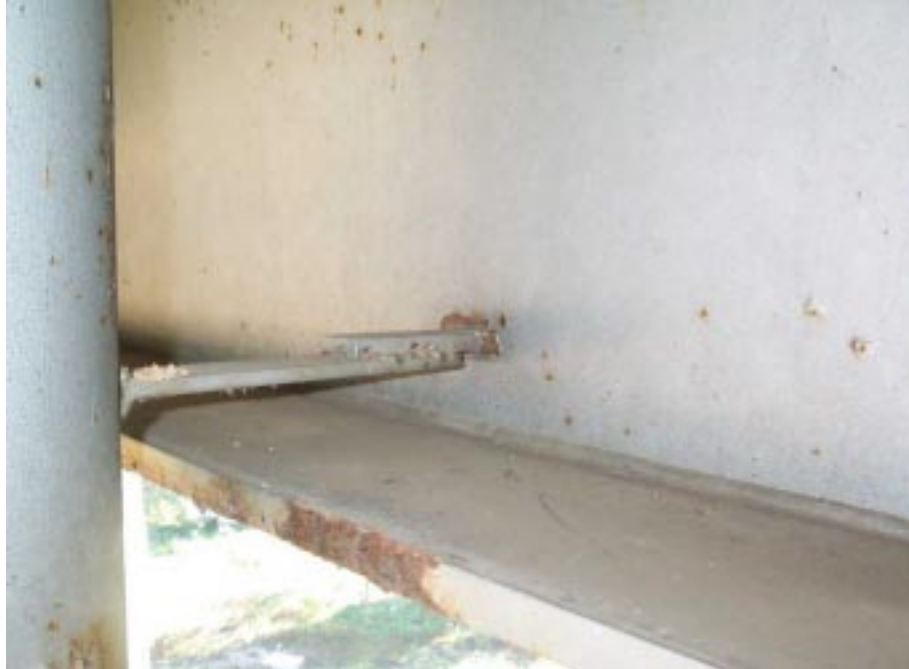
Figure 137. Localized corrosion on flange and web near the drain-to-girder web connection.

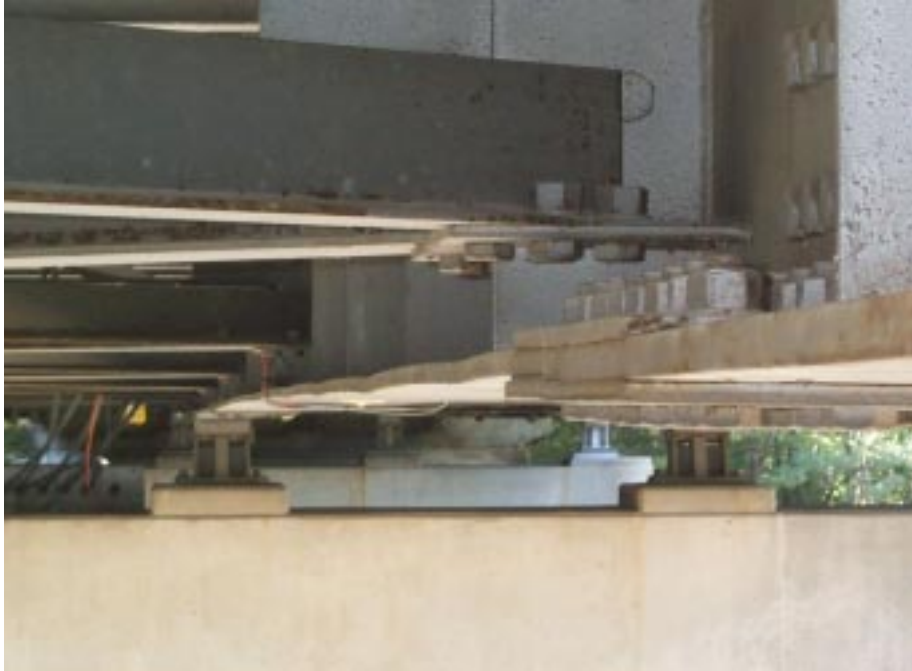
Member distortions can be indicative of, or may lead to, overall problems with the structure. As shown in figure 138, the bottom flange of the interior girder in the test specimen is not entirely straight, having a “wavy” nature between midspan and pier 5. Eleven percent of the inspectors noted this defect.

Figure 138. Flange distortion.

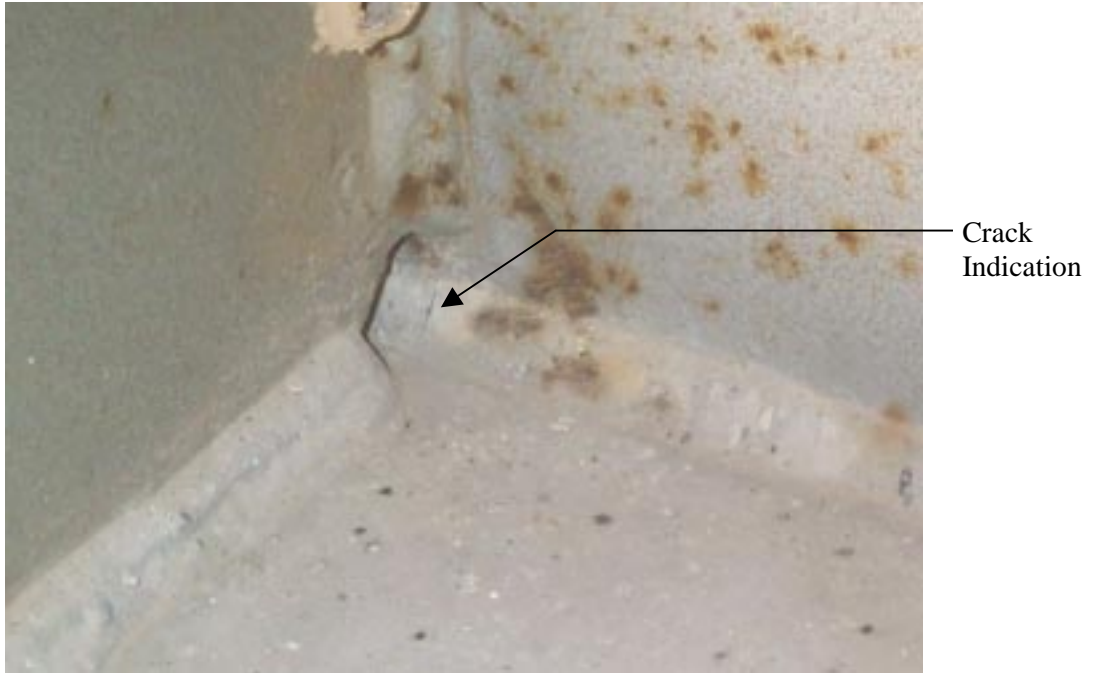
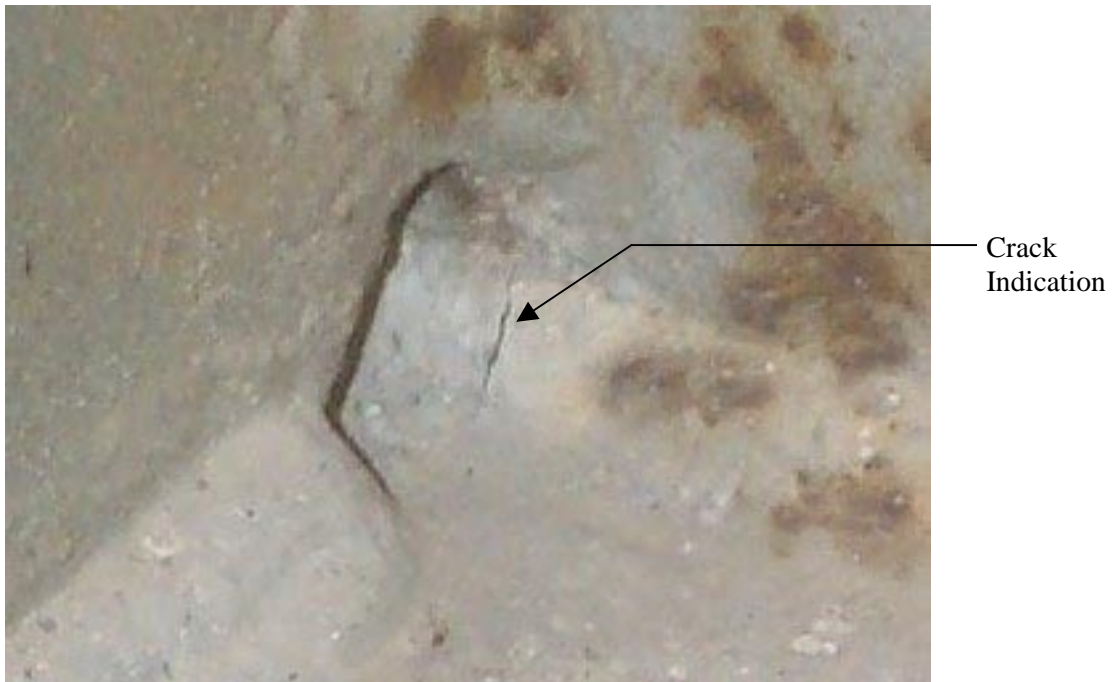
a. Web-to-flange connection.

b. Crack indication enlarged for clarity.

Figure 142. Weld crack indication W2 near the base of a vertical stiffener.

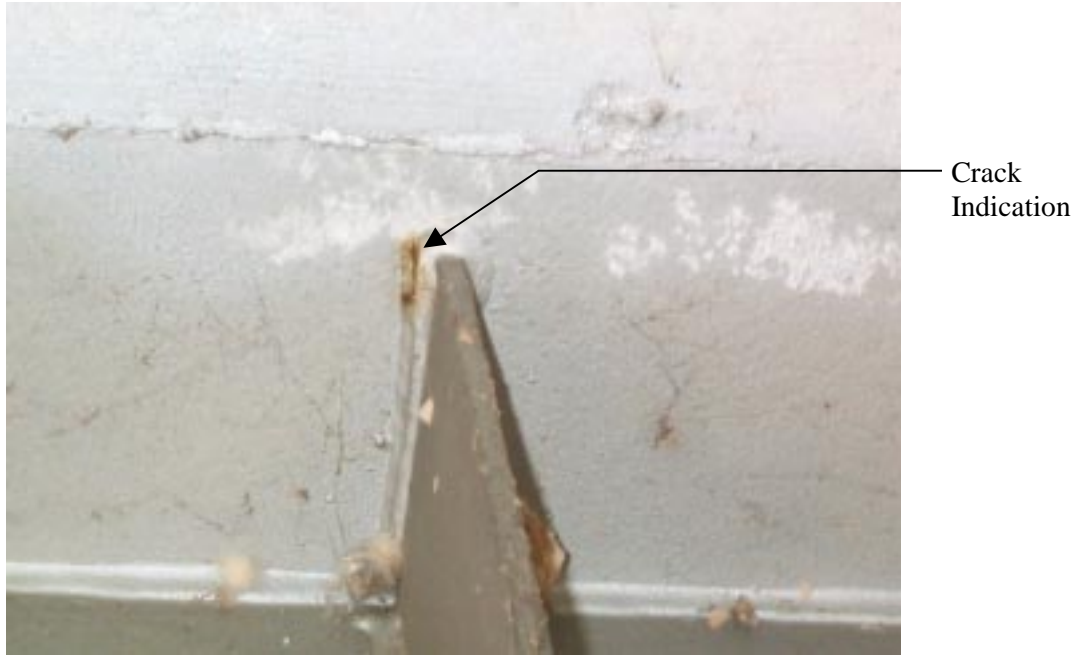
Figure 143. Weld crack indication W3 at vertical stiffener-to-top flange connection.

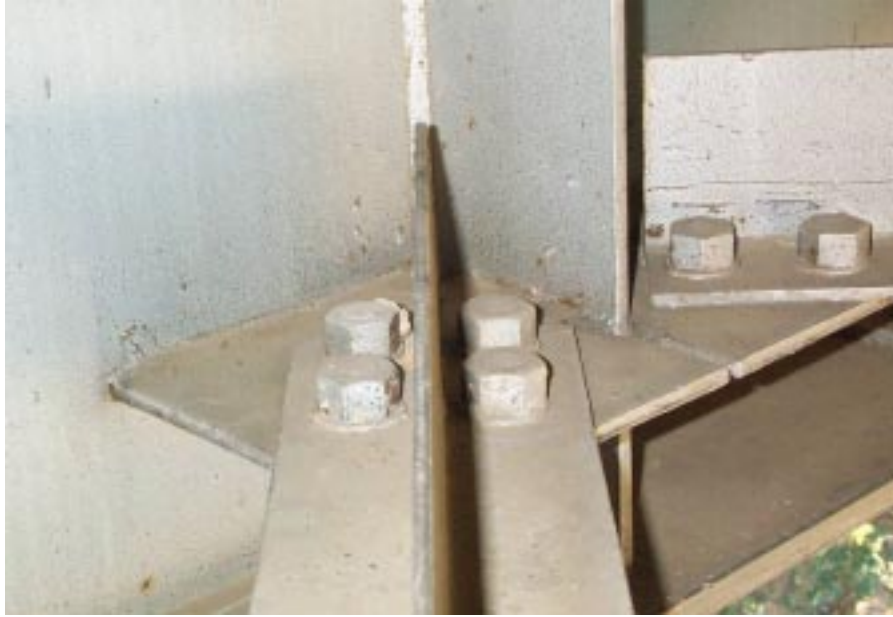
The welds connecting the lateral bracing gusset plate to the girder web and vertical stiffeners are also likely locations for cracks to occur. Thirteen inspection areas of this type exist within the test bed for Task H. Each inspection area contained two gusset plates, one welded to each side of a vertical stiffener. Figure 145 shows half of one inspection area for this type of connection. Crack indications were contained in 3 of the 13 inspection areas.

Figure 145. One-half of the lateral gusset plate-to-girder web and vertical stiffener inspection area.

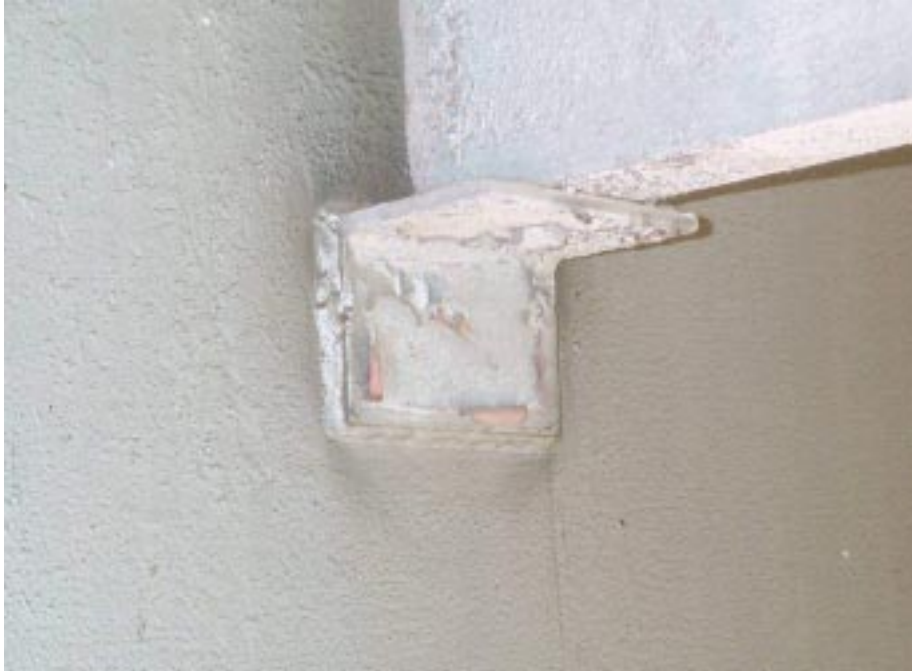
The final suspect welded connection pertains to the utilities that run the length of the bridge. After installation of the main girders of the bridge, brackets were field-welded to the girder web to create a support system for the utilities. This type of connection occurs 54 times within the test specimen; thus, there are 54 inspection areas. Figure 149 shows a photograph of this type of detail. Although the welds are generally of poor quality, no defects were present within these connections. Five inspectors made a total of seven false calls.

Figure 149. Typical utility bracket-to-web welded connection.
