Human Factors Assessment of Pedestrian Roadway Crossing Behavior

PUBLICATION NO. FHWA-HRT-13-098

JANUARY 2014

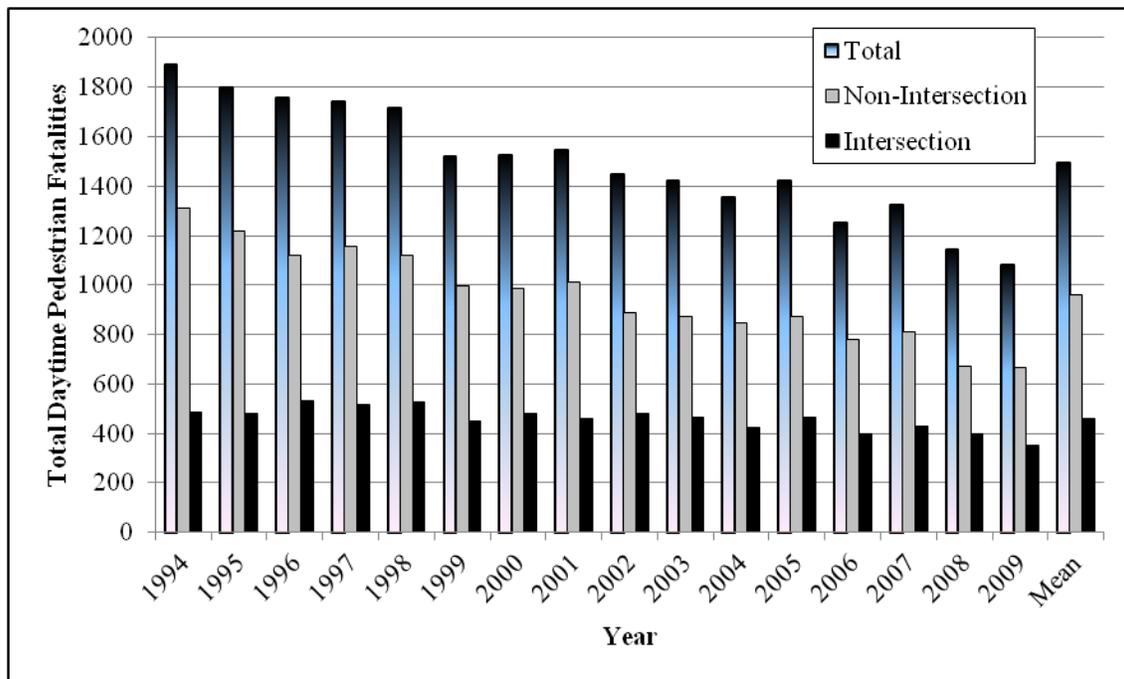
Figure 1. Graph. Total number of pedestrian fatalities, number of urban intersection/ intersection-related fatalities, and number of urban non-intersection fatalities in daytime environments by year.

Figure 1 illustrates this relationship. It should be noted that the number of non-intersection and intersection/intersection-related fatalities do not equate to the total number of daytime fatalities. This is because areas such as driveways, exit ramps, and rail grade crossings were excluded from both the intersection/intersection-related and non-intersection categories. (These areas were excluded from analyses because they result in special circumstances that are distinctly different from traditional non-intersection crossing.) In addition, rural environments, interstates, expressways, and unknown roadway types were excluded from the non-intersection and intersection/intersection-related categories. These areas were excluded from analyses because of the focus of the current study. This study focuses on urban areas where pedestrian populations are the densest. Furthermore, these urban areas have the greatest likelihood of crossing treatment safety enhancements (e.g., pedestrian hybrid beacon). In addition, as a result of the perceptual complexities involved with nighttime pedestrian collisions, the present study focuses only on those occurring during daylight hours.

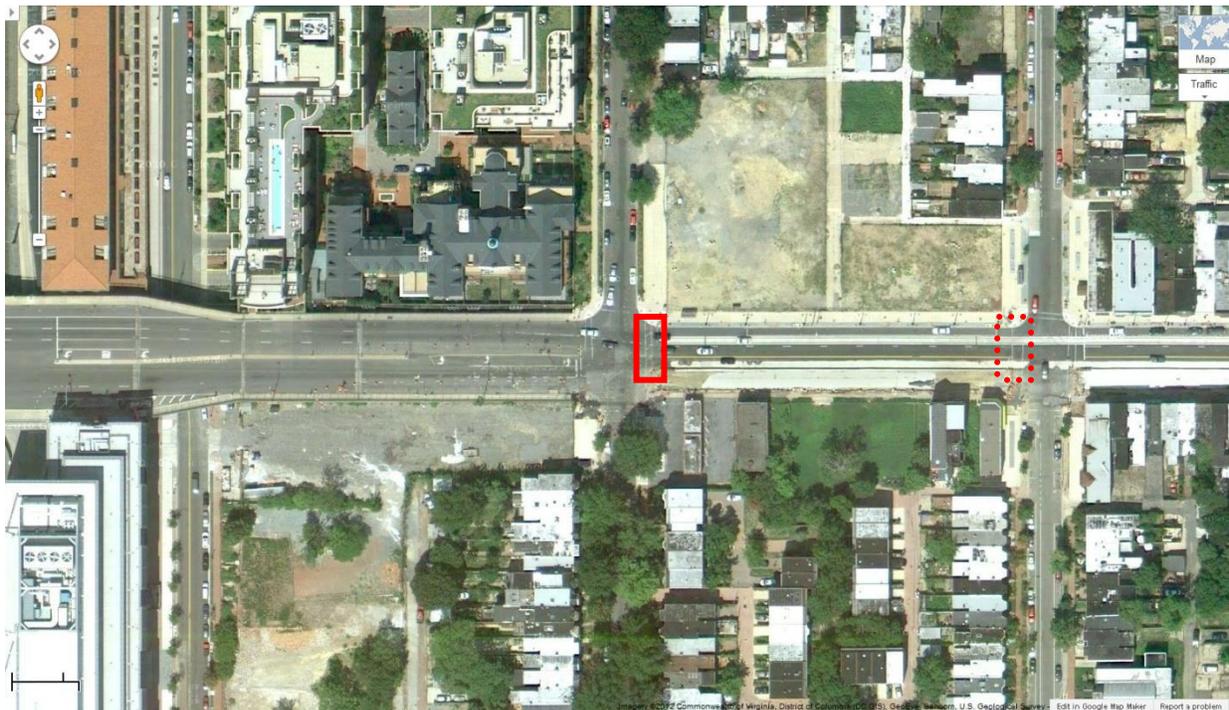
Figure 2. Photo. Aerial view of Location 1.⁽¹⁹⁾

The first data collection area is located at the intersection of 3rd Street Northeast and H Street Northeast in Washington, DC. Figure 2 is an aerial view of this data collection area. Third Street Northeast runs north/south and is located in the center of the image. H Street Northeast runs east/west and is also located in the center of the image. The solid red rectangle highlights the intersection of 3rd Street Northeast and H Street Northeast. The dotted red rectangle highlights

the intersection of 4th Street Northeast and H Street. The DDOT camera was positioned on the southwest corner of the 3rd and H intersection facing east (see figure 3). As a result, pedestrians making north/south crossings on H Street between 3rd Street and 4th Street were captured. The distance from 3rd Street and 4th Street is approximately 352 ft. Figure 3 shows marked crossings are present at both 3rd Street Northeast (solid red line) and 4th Street Northeast (dotted red line). The AADT in this area is 15.8 (expressed in thousands and rounded to the nearest 100).⁽¹⁸⁾

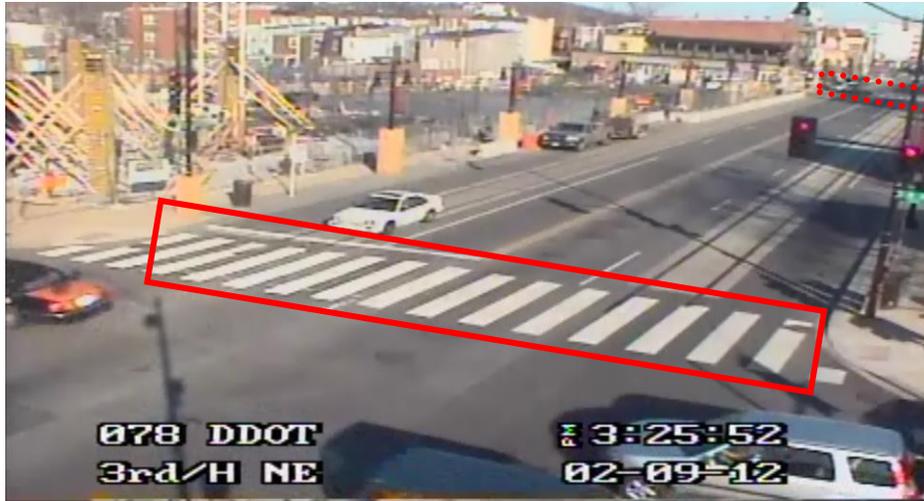
Figure 3. Photo. Still image captured from the Location 1 camera.

The marked intersection of interest at 3rd and H Streets (as highlighted by the solid rectangular box in figure 3) is 61 ft long (curb to curb). The walk phase is illuminated for 20 s, and the don't walk phase is illuminated for 69 s. Figure 4 illustrates what a pedestrian might see as he or she attempts to cross from the north side of H Street Northeast to the south side of the street along 3rd Street Northeast. The image shows a pedestrian waiting to cross to the north side of the street and looking for oncoming traffic.

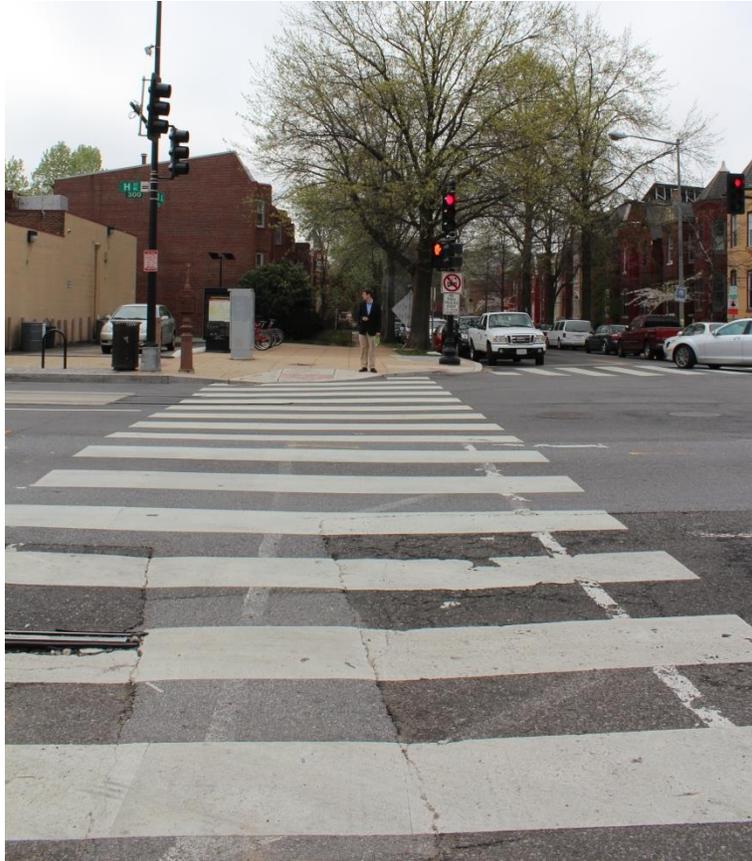
Figure 4. Photo. Illustration of what a pedestrian might see as he or she attempts to cross from the north side of H Street Northeast to the south side of the street along 3rd Street Northeast.

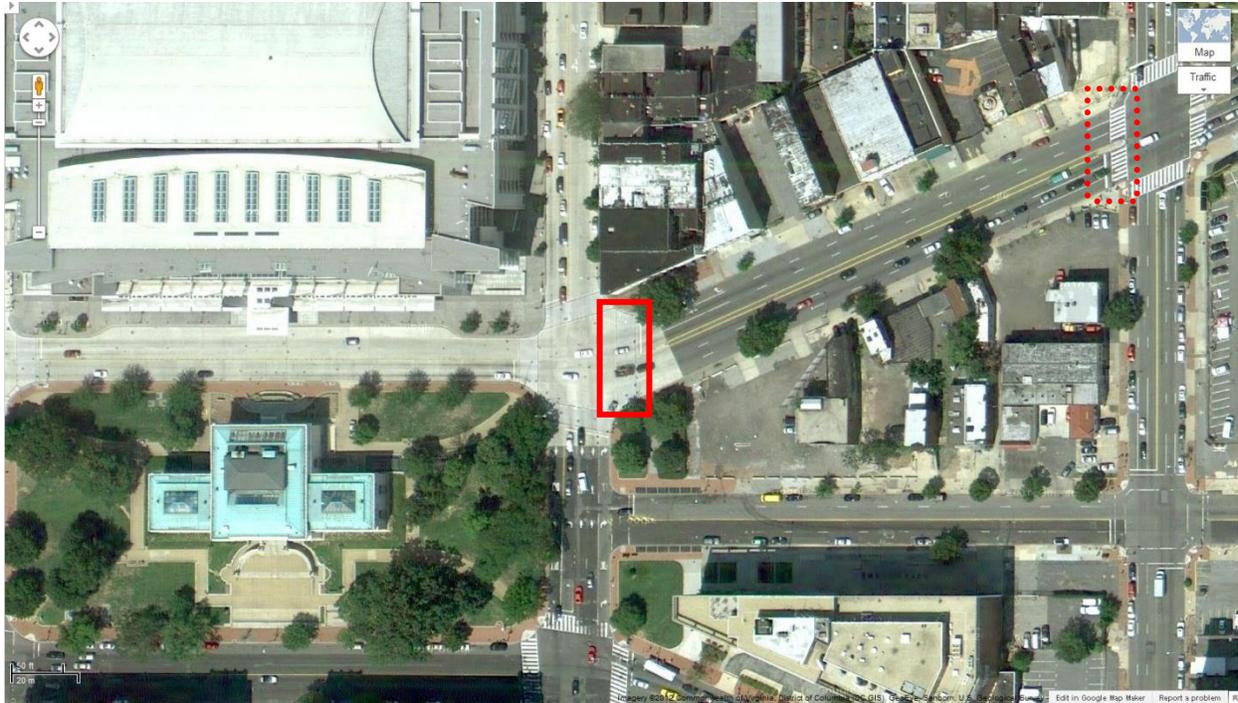
Figure 5. Photo. Aerial view of Location 2.⁽²⁰⁾

The second data collection area is located at the intersection of 7th Street Northwest and New York Avenue Northwest in Washington, DC. Figure 5 is an aerial view of this data collection area. Seventh Street Northwest runs north/south and is located in the center of the image. New York Avenue runs northeast/southwest and is also located near the center of the image. The solid red rectangle highlights the intersection of 7th Street Northwest and New York Avenue Northwest. The dotted red rectangle highlights the intersection of 6th Street Northwest and New York Avenue Northwest. The DDOT camera was positioned on the southwest corner of the 7th and Mt. Vernon Place intersection facing east (see figure 6). (Note that because New York Avenue is a “diagonal” street, it meets Mt. Vernon Place at Mount Vernon Square as can be seen in figure 5.) As a result, pedestrians making north/south crossings on New York Avenue between 7th Street and 6th Street were captured. The distance between 7th Street and 6th Street is approximately 530 ft. Figure 6 shows marked crossings are present at both 7th Street Northwest (solid red rectangle) and 6th Street Northwest (dotted red rectangle). The AADT in this area is 24.2 (expressed in thousands and rounded to the nearest 100).⁽¹⁸⁾

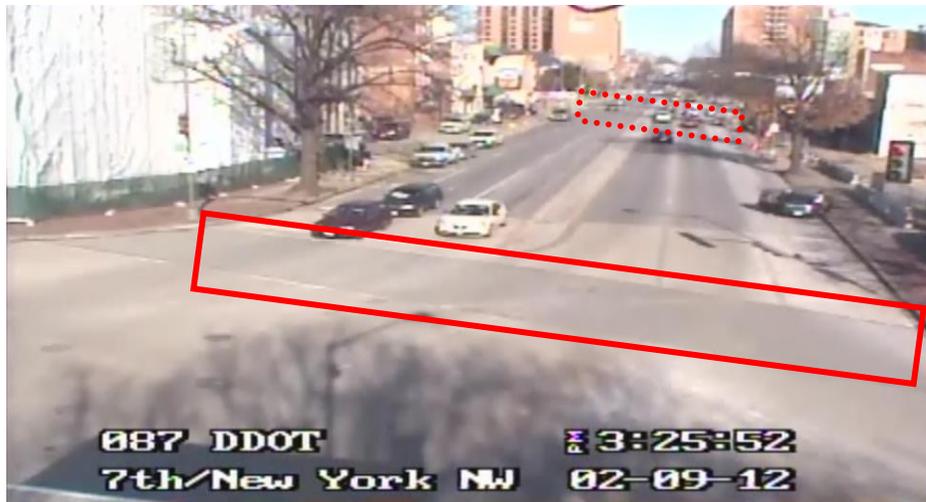
Figure 6. Photo. Still image captured from the Location 2 camera.

The marked intersection of 7th Street and New York Avenue of interest (as highlighted by the solid rectangular box in figure 6) is 81 ft 3 inches long (curb to curb). The walk phase is illuminated for 46 s, and the don’t walk phase is illuminated for 55 s. Figure 7 illustrates what a pedestrian might see as he or she attempts to cross from the north side of New York Avenue Northwest to the south side of the street along 7th Street Northwest. The traffic traveling northbound (closest to the crosswalk) is waiting for the pedestrians to clear before completing a right turn.

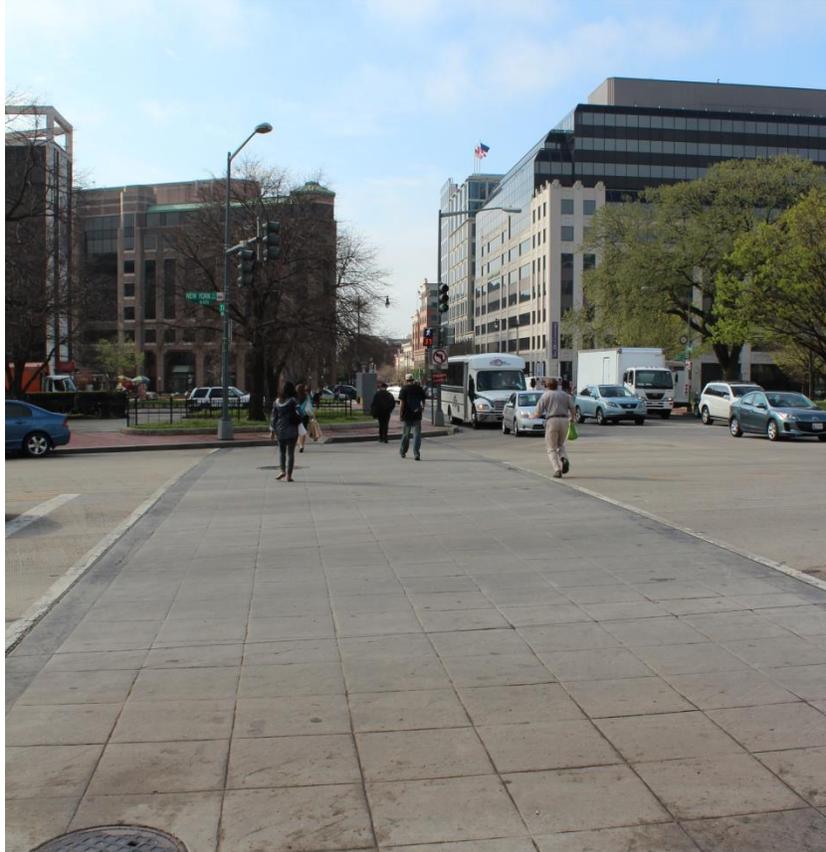
Figure 7. Photo. Illustration of what a pedestrian might see as he or she attempts to cross from the north side of New York Avenue Northwest to the south side of the street along 7th Street Northwest.

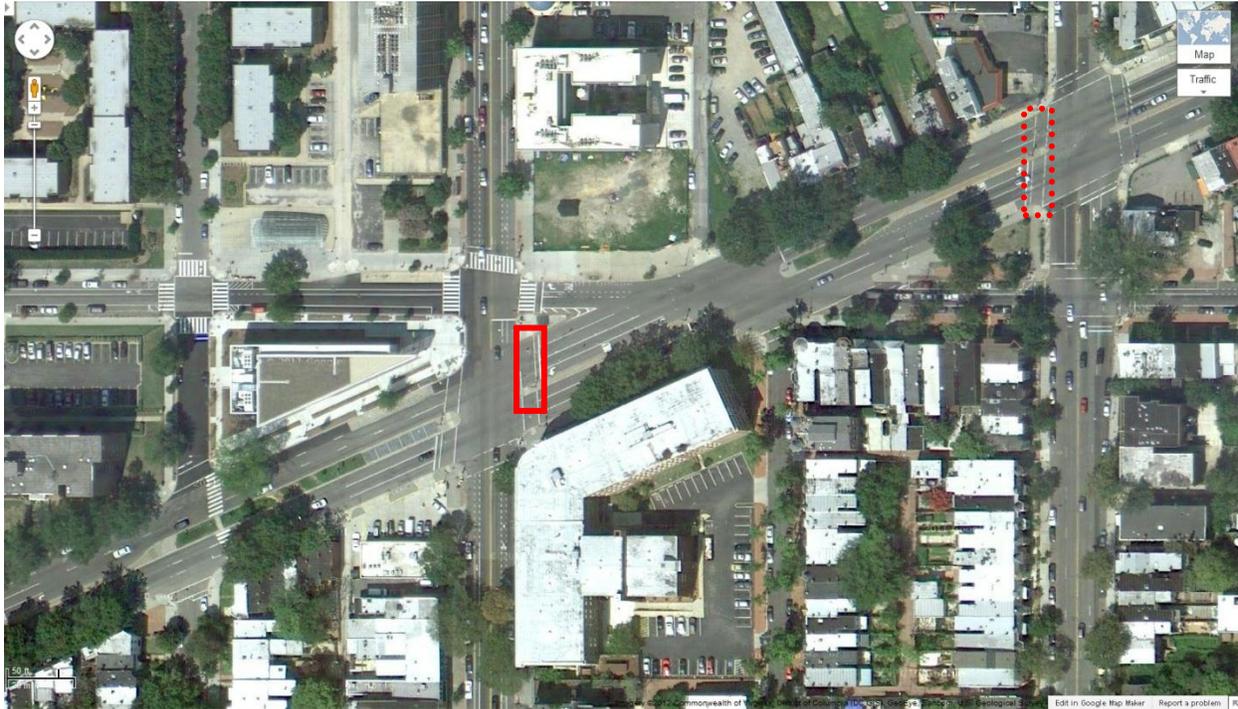
Figure 8. Photo. Aerial view of Location 3. Northwest between 7th and 6th Streets Northwest.⁽²¹⁾

The third data collection area is located at the intersection of 7th Street Northwest and Rhode Island Avenue Northwest in Washington, DC. An aerial view of this data collection area can be seen in figure 8. Seventh Street Northwest runs north/south and is located in the center of the image. New York Avenue runs northeast/southwest and is also located near the center of the image. The solid red rectangle highlights the intersection of 7th Street Northwest and Rhode Island Avenue Northwest. The dotted red rectangle highlights the intersection of 6th Street Northwest and Rhode Island Avenue Northwest. The DDOT camera was positioned on the northwest corner of the 7th and Rhode Island intersection facing east (see figure 9). As a result, pedestrians making north/south crossings on Rhode Island Avenue between 7th and 6th Streets were captured. The distance between 7th Street and 6th Street is approximately 550 ft. Figure 9 shows marked crossings are present at both 7th Street Northwest (solid red rectangle) and 6th Street Northwest (dotted red rectangle). The AADT in this area is 26.3 (expressed in thousands and rounded to the nearest 100).⁽¹⁸⁾

In addition, Marion Street Northwest runs north/south between 6th and 7th Streets. Marion Street is located to the south of Rhode Island Avenue. Northbound Marion Street traffic must turn

(either right or left) when it meets Rhode Island. This intersection does not contain a marked pedestrian crossing. The distance between 7th Street and Marion Street is approximately 277 ft.

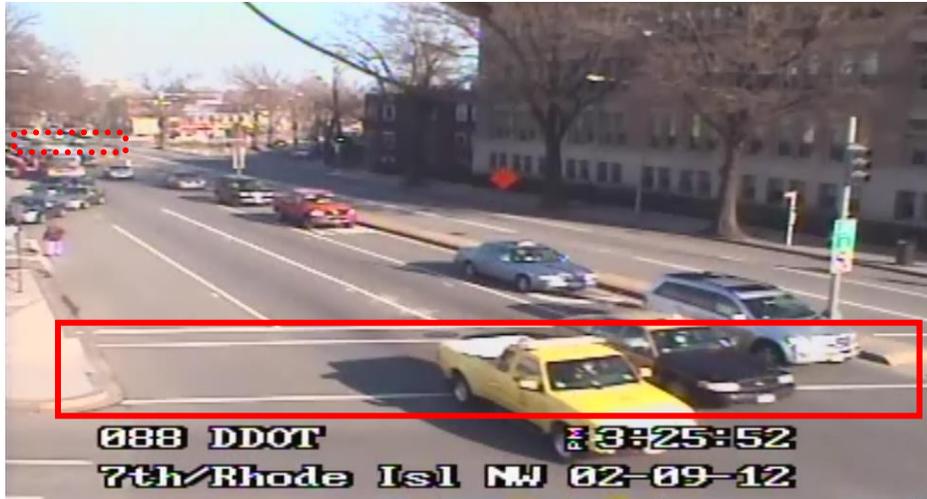
Figure 9. Photo. Still image captured from the Location 3 camera.

The marked intersection of 7th Street and Rhode Island Avenue of interest (as highlighted by the solid rectangular box in figure 9) is 48 ft 3 inches long (median refuge to curb). The walk phase is illuminated for 46 s, and the don't walk phase is illuminated for 71 s. The median between the eastbound and westbound traffic is 7 ft wide. Figure 10 illustrates what a pedestrian might see as he or she attempts to cross from the north side of Rhode Island Avenue Northwest to the south side of the street along 7th Street Northwest.

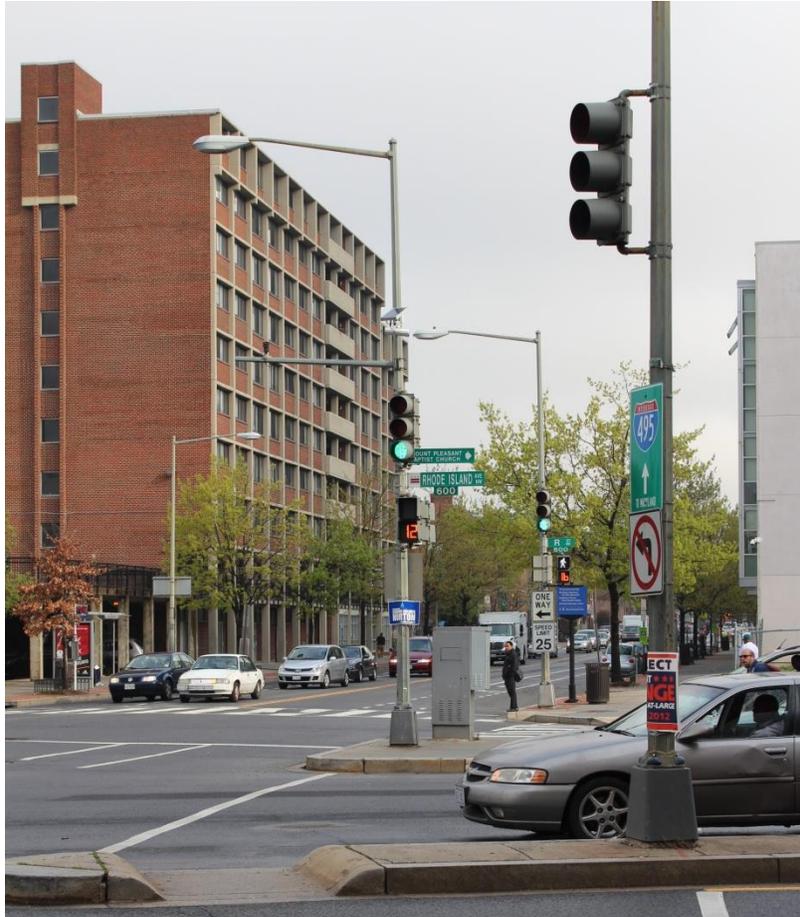
Figure 10. Photo. Illustration of what a pedestrian might see as he or she attempts to cross from the north side of Rhode Island Avenue Northwest to the south side of the street along 7th Street Northwest.

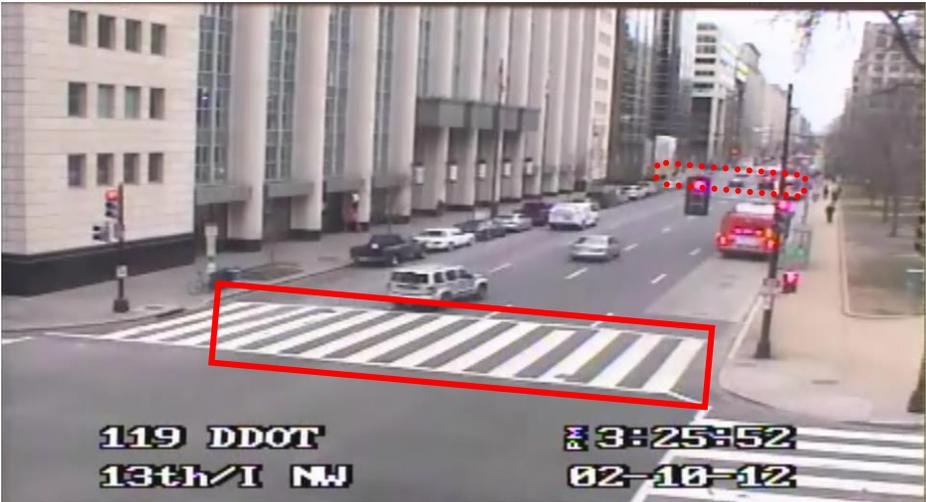
Figure 12. Photo. Still image captured from the Location 4 camera.

The marked intersection of 13th Street and I Street of interest (as highlighted by the solid rectangular box in figure 12 is 54 ft 5 inches long (curb to curb). The walk phase is illuminated for 32 s, and the don't walk phase is illuminated for 45 s. Figure 13 shows the view of the crossing of I Street Northwest at 13th Street Northwest from the southeast corner of the intersection.

I Street Northwest is a one-way street with traffic flowing from east to west. To the east of the relevant 13th Street intersection, vehicles travel in two through lanes along I Street. Parking is available on both the north and south sides of the roadway. As traffic moves west to the data

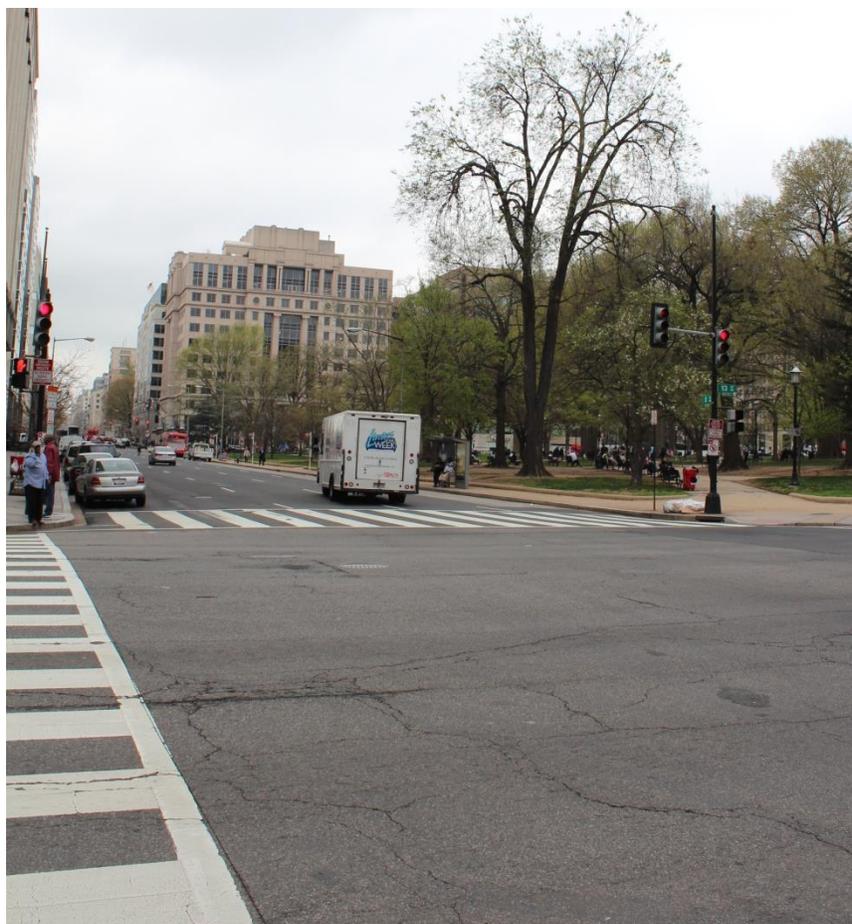
Figure 13. Photo. Image of the westernmost crossing of I Street Northwest at 13th Street Northwest. The photo is taken from the southwestern corner of the intersection.

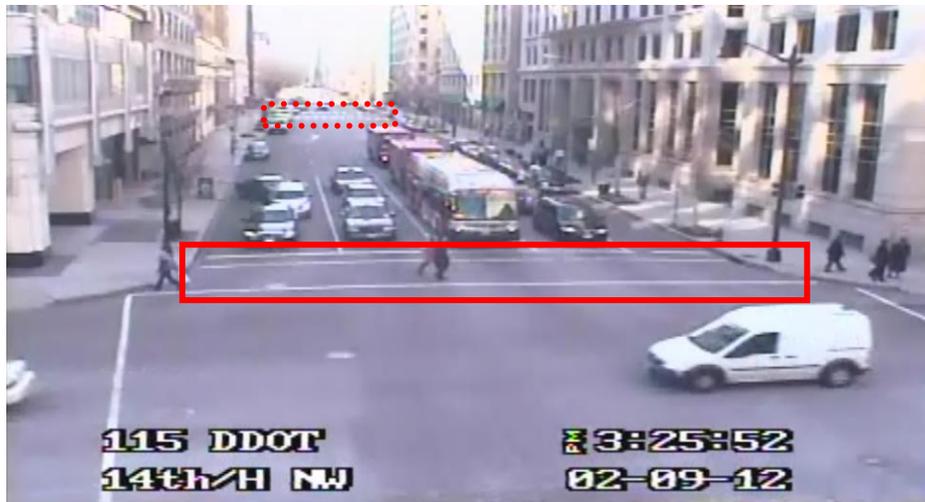
Figure 15. Photo. Still image captured from the Location 5 camera.

was positioned on the southeast corner of the 14th and H intersection facing west (see figure 15). As a result, pedestrians making north/south crossings on H Street between 14th and 15th Streets were captured. The distance between 14th Street and 15th Street is approximately 391 ft. Figure 15 shows marked crossings are present at both 14th Street Northwest (solid red line) and 15th Street Northwest (dotted red line). The AADT in this area is 15.1 (expressed in thousands and rounded to the nearest 100).⁽¹⁸⁾

The marked intersection of 14th Street and H Street of interest (as highlighted by the solid rectangular box in figure 15) is 61 ft long (curb to curb). The walk phase is illuminated for 53 s, and the don't walk phase is illuminated for 50 s.

H Street Northwest is a one-way street with traffic flowing from west to east. H Street between 15th and 14th Streets contains three travel lanes and parking both to the north and south. As vehicles approach the 14th Street intersection, the parking along the north side of H Street becomes a left turn only lane, and the parking along the south side of H Street becomes a right turn only lane. As traffic continues past this intersection traveling east, there are three travel lanes and a parking lane on the north side of H Street.

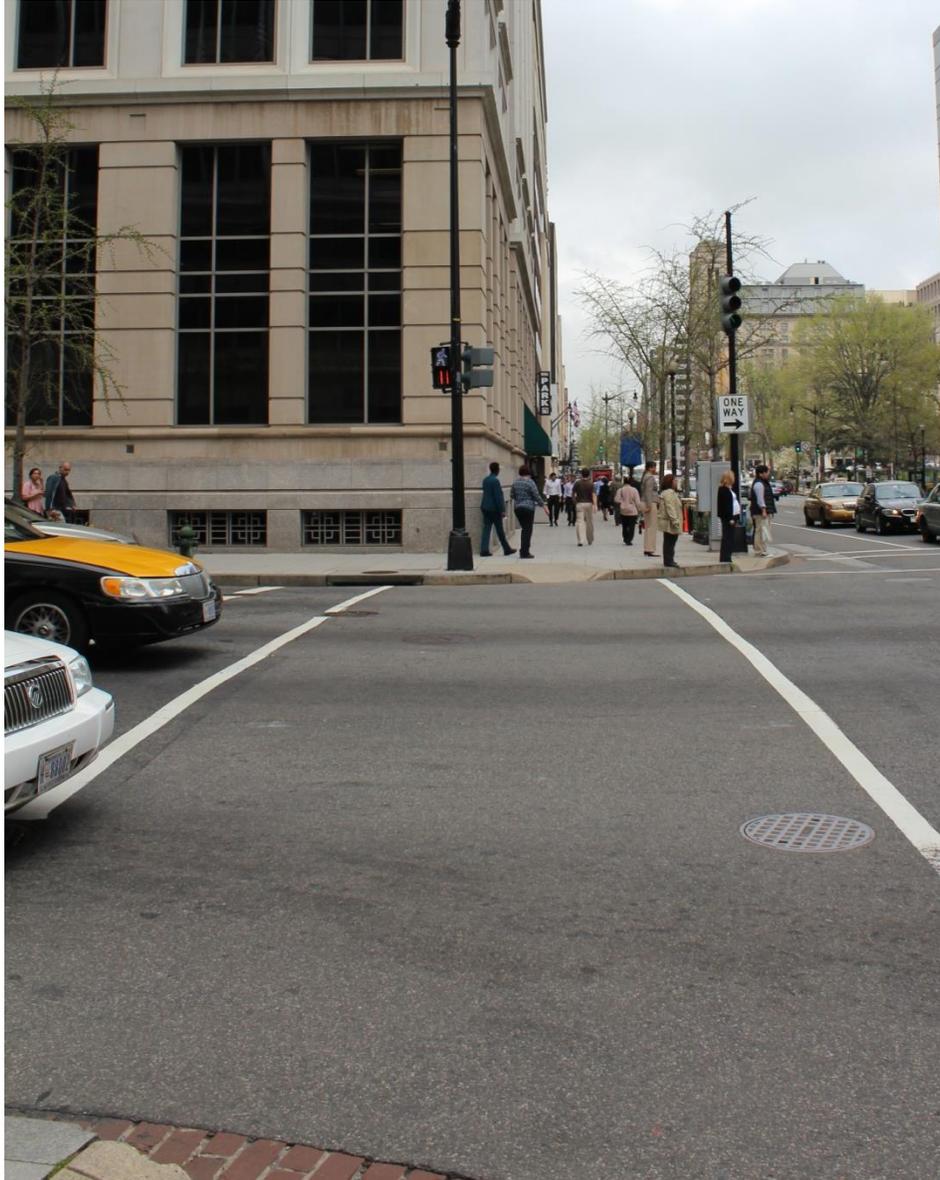
Figure 16. Photo. Illustration of what a pedestrian might see as he or she attempts to cross from the south side of H Street Northwest to the north side of the street along 14th Street Northwest.

Figure 16 illustrates what a pedestrian might see as he or she attempts to cross from the south side of H Street Northwest to the north side of the street along 14th Street Northwest.

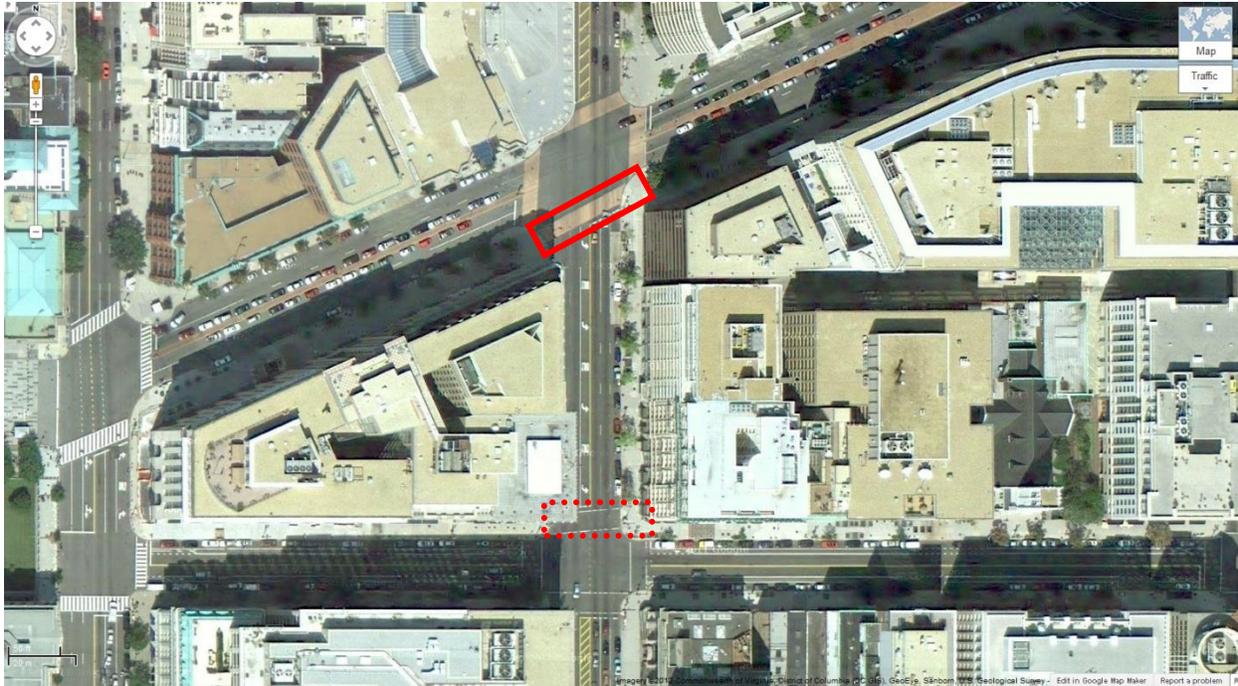
Figure 17. Photo. Aerial view of Location 6.⁽²⁴⁾

The sixth data collection area is located at 14th Street Northwest and New York Avenue Northwest in Washington, DC. An aerial view of this data collection area can be seen in figure 17. Fourteenth Street Northwest runs north/south and is located toward the center of the image. New York Avenue Northwest travels northeast/southwest and is located near the center/top of the image. The solid red rectangle highlights the intersection of 14th Street Northwest and New York Avenue Northwest. The dotted red rectangle highlights the intersection of 14th Street Northwest and G Street Northwest. The DDOT camera was positioned on the northeast corner of the 14th and New York intersection facing south (see figure 18). As a result, pedestrians making

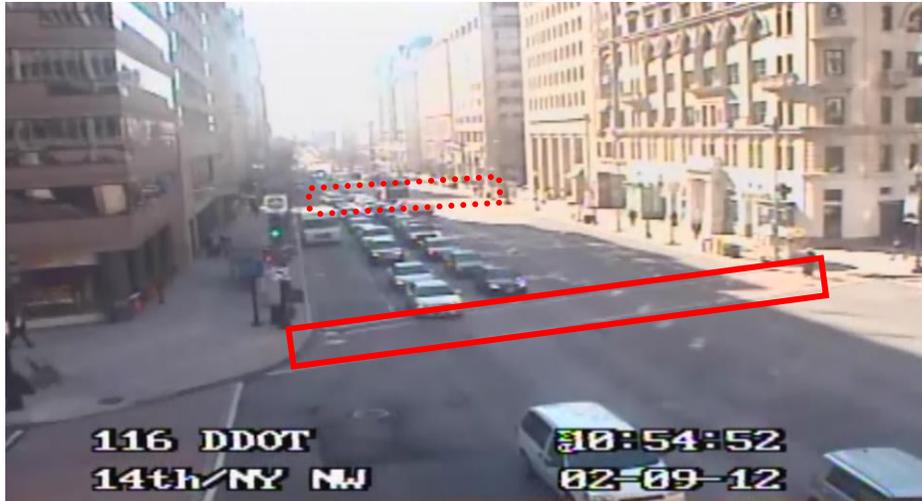
Figure 18. Photo. Still image captured from the Location 6 camera.

east/west crossings on 14th Street between New York Avenue and G Street were captured. The distance between New York Avenue and G Street is approximately 294 ft. Figure 18 shows marked crossings are present at both New York Avenue Northwest (solid red line) and G Street Northwest (dotted red line) along 14th Street Northwest. The AADT was not available for this specific block. However, the AADT for 14th Street Northwest on the block north of New York Avenue is 27.2 (expressed in thousands and rounded to the nearest 100).⁽¹⁸⁾ In addition, the AADT for 14th Street Northwest two blocks south of New York Avenue is 35.7 (expressed in thousands and rounded to the nearest 100).⁽¹⁸⁾ This suggests that the AADT for this block is in the middle 30s range. (An AADT of 31.5 was used for analysis purposes.)

The marked intersection of 14th Street and New York Avenue of interest (as highlighted by the solid rectangular box in figure 18) is 83 ft long (curb to curb). The walk phase is illuminated for 31 s, and the don't walk phase is illuminated for 56 s. Figure 19 shows the southernmost crossing of 14th Street Northwest at New York Avenue Northwest.

Fourteenth Street Northwest is a two-way street with traffic flowing north/south. There are three northbound travel lanes. A bus stop is located in the far right northbound lane near the intersection of 14th and New York. There are three southbound travel lanes, and an additional left turn lane that spans the entire block. A bus stop is located in the far right southbound lane near the intersection of 14th and G Streets.

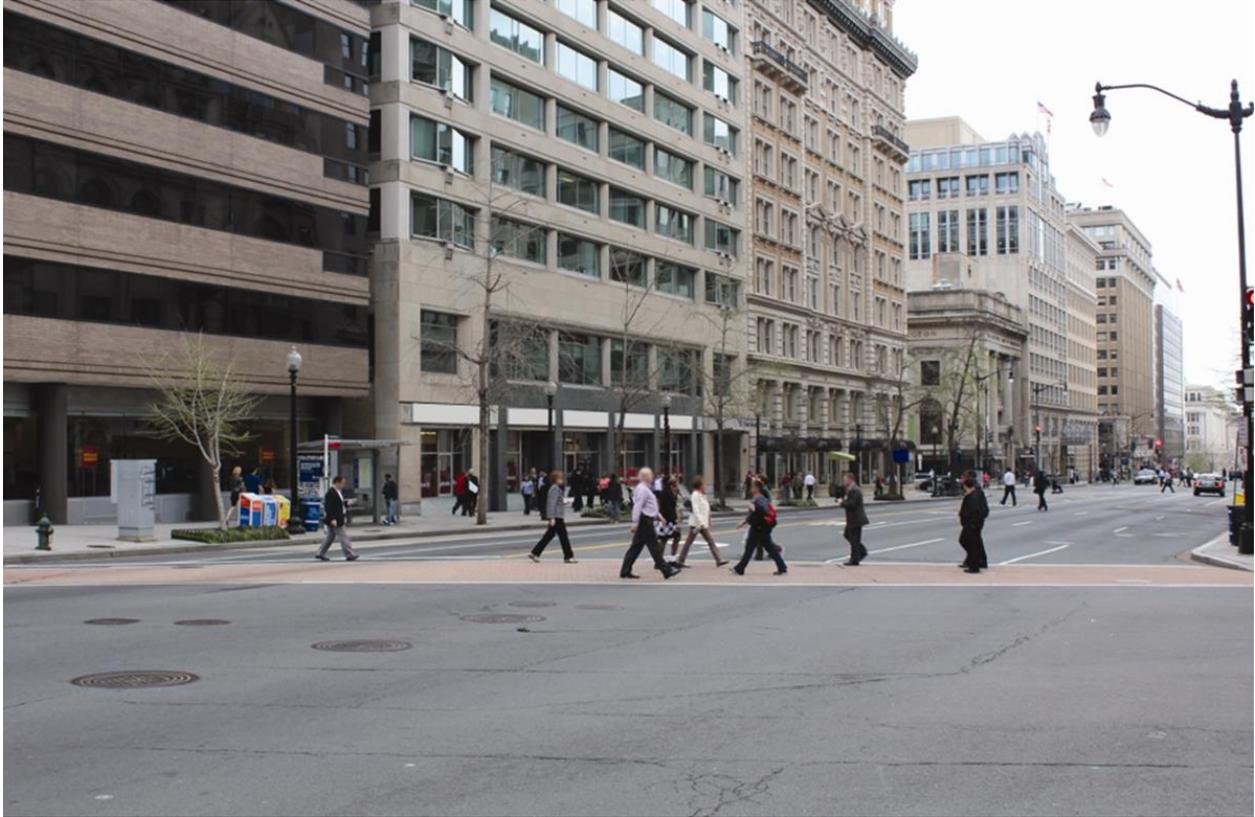
Figure 19. Photo. An image of the southernmost crossing of 14th Street Northwest at New York Avenue Northwest. The photo is taken from the northwestern corner of the intersection.

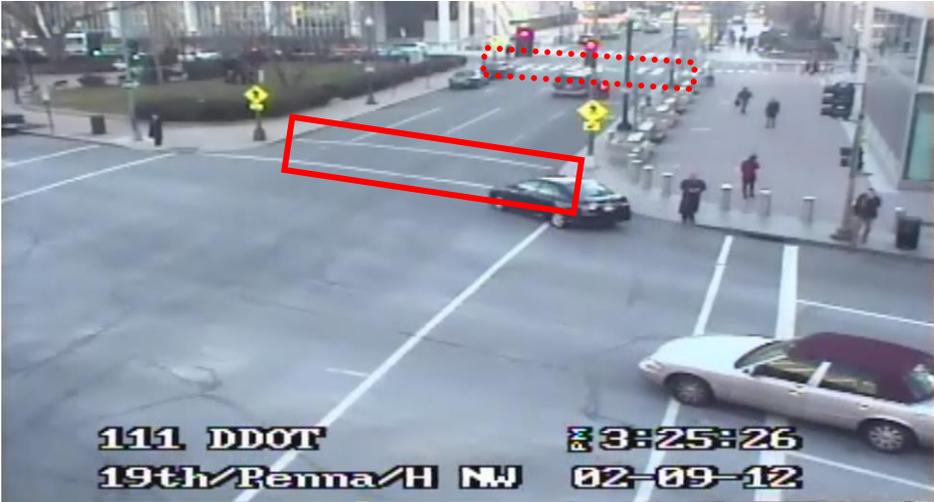
Figure 21. Photo. Still image captured from the Location 7 camera.

The marked intersection of 19th Street and Pennsylvania Avenue of interest (as highlighted by the solid rectangular box in figure 21) is 43 ft long (curb to curb). The walk phase is illuminated for 44 s, and the don't walk phase is illuminated for 52 s. Figure 22 illustrates what a pedestrian might see as he or she attempts to cross from the west side of 19th Street Northwest to the east side of the street along Pennsylvania Avenue Northwest.

Nineteenth Street Northwest is a one-way street with traffic flowing south. There are three travel lanes and a single parking lane on the east side of the roadway. A bus stop is present on the

western portion of the roadway. The roadway north of Pennsylvania (behind the camera view) contains two travel lanes and parking on both sides of the roadway.

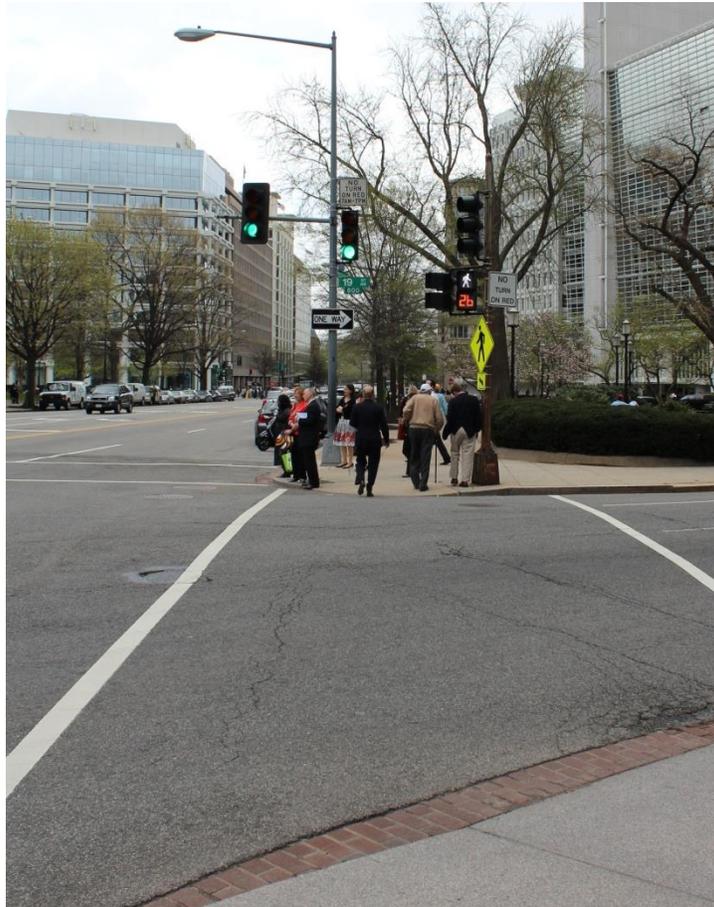
Figure 22. Photo. Illustration of what a pedestrian might see as he or she attempts to crossing from the west side of 19th Street Northwest to the east side of the street along Pennsylvania Avenue Northwest.

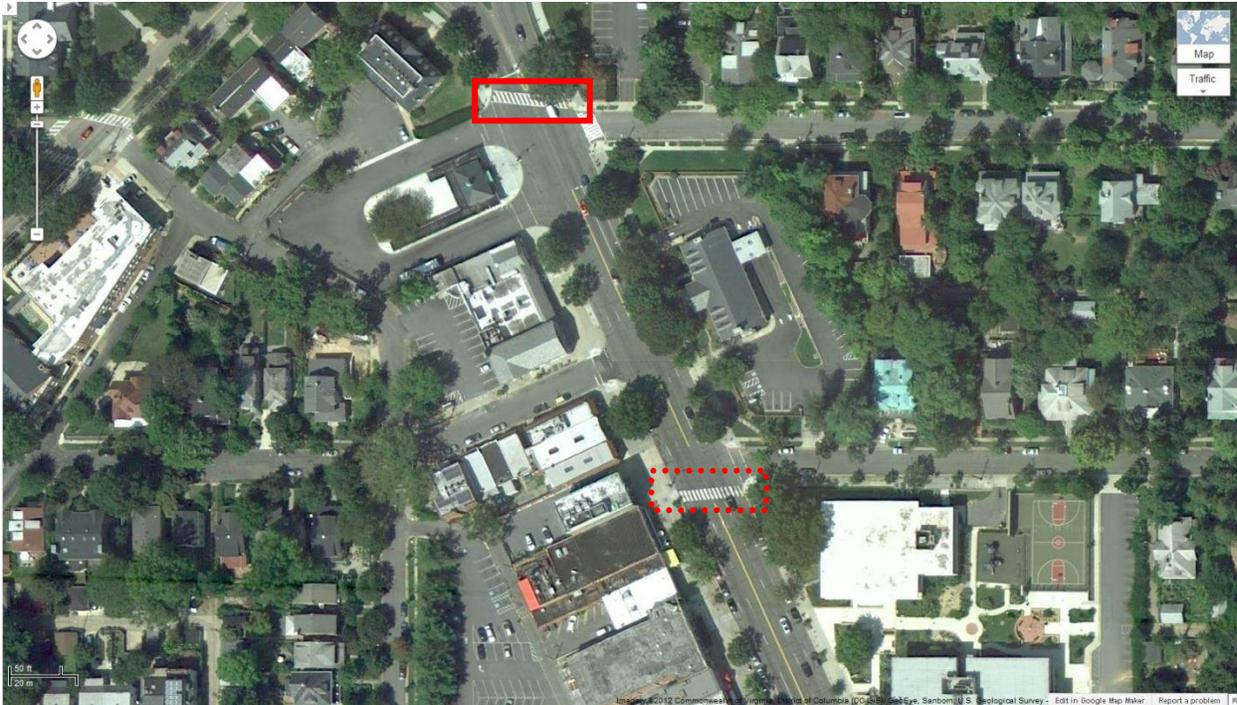
Figure 23. Photo. Aerial view of Location 8.⁽²⁵⁾

The eighth data collection area is located at Connecticut Avenue Northwest and Oliver Street Northwest in Washington, DC. An aerial view of this data collection area can be seen in figure 23. Connecticut Avenue Northwest runs north/south and is located toward the center of the image. Oliver Street Northwest travels east/west and is located toward the top of the image. The solid red rectangle highlights the intersection of Oliver Street Northwest and Connecticut Avenue Northwest. The dotted red rectangle highlights the intersection of Northampton Street Northwest and Connecticut Northwest. The DDOT camera was positioned north of the

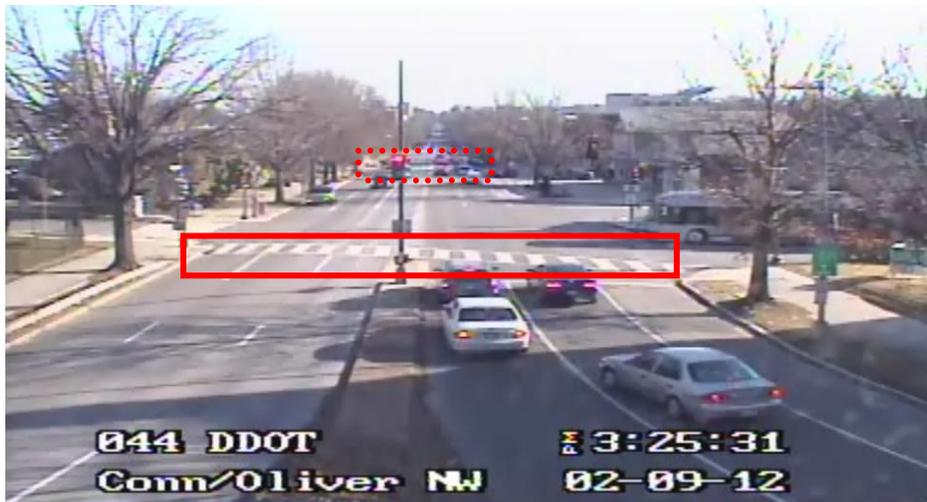
Figure 24. Photo. Still image captured from the Location 8 camera.

Connecticut and Oliver intersection facing south (see figure 24). As a result, pedestrians making east/west crossings on Connecticut Avenue between Oliver Street and Northampton Street Northwest were captured. The distance between Oliver Street and Northampton Street is approximately 433 ft. Figure 24 shows marked crossings are present at both Oliver Street Northwest (solid red line) and Northampton Street Northwest (dotted red line) along Connecticut Avenue Northwest. Unlike the first six data collection sites, the far marked crosswalk is not controlled by a signal (nor is it controlled by a stop sign). The far marked crossing uses a flag crossing system (see figure 25). The AADT in this area is 24.2 (expressed in thousands and rounded to the nearest 100).⁽¹⁸⁾

Connecticut Avenue Northwest is a two-way street flowing north/south. There are three northbound travel lanes and three southbound travel lanes. The marked intersection of Oliver Street and Connecticut Avenue of interest (as highlighted by the solid rectangular box in figure 24) is 70 ft long (curb to curb). The walk phase is illuminated for 19 s, and the don't walk phase is illuminated for 79 s. Figure 26 illustrates what a pedestrian might see as he or she attempts to cross from the west side of Connecticut Avenue Northwest to the east side of the street along Oliver Street Northwest.

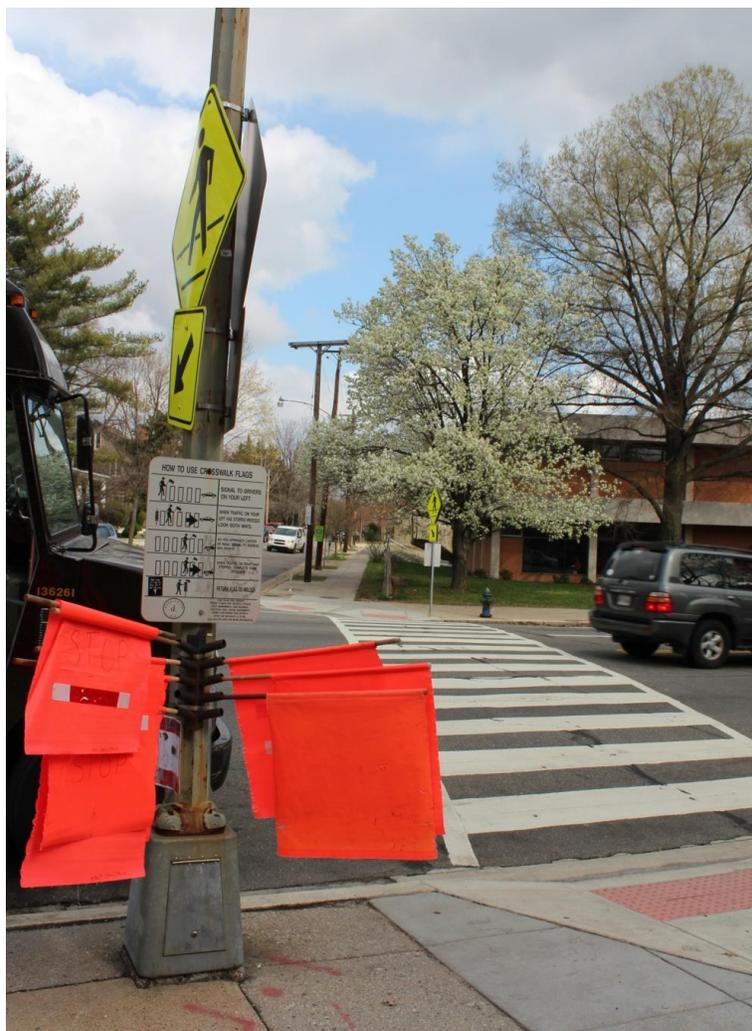
Figure 25. Photo. An image of the (far) flag crossing at Connecticut Avenue Northwest and Northampton Street Northwest.

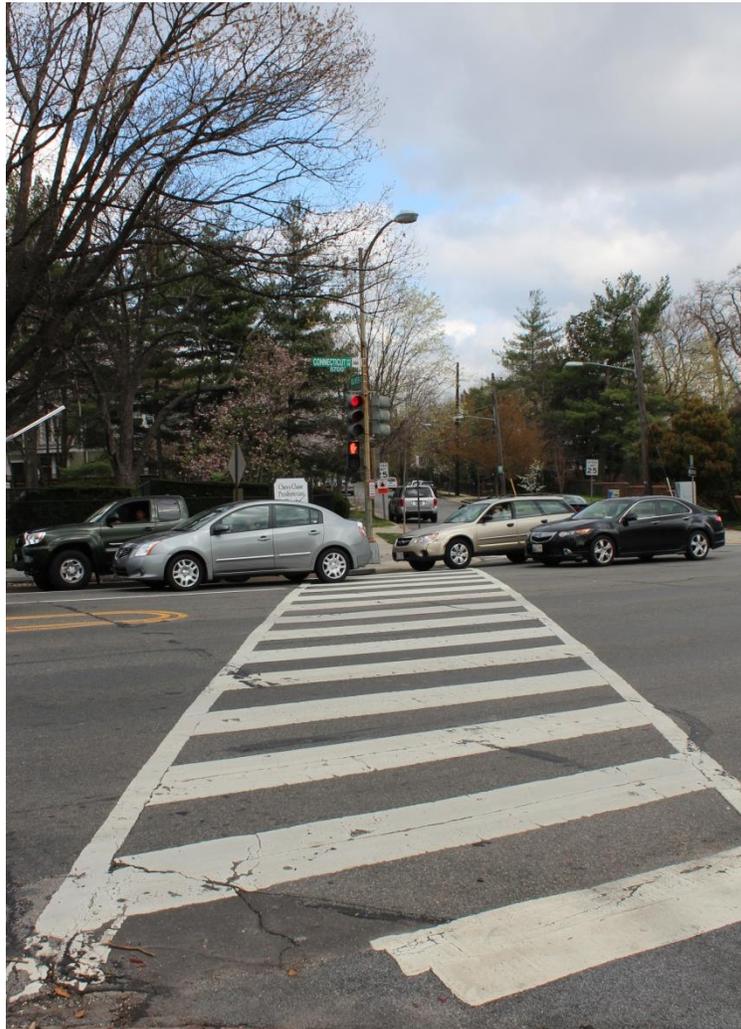
Figure 26. Photo. Illustration of what a pedestrian might see as he or she attempts to cross from the west side of Connecticut Avenue Northwest to the east side of the street along Oliver Street Northwest.

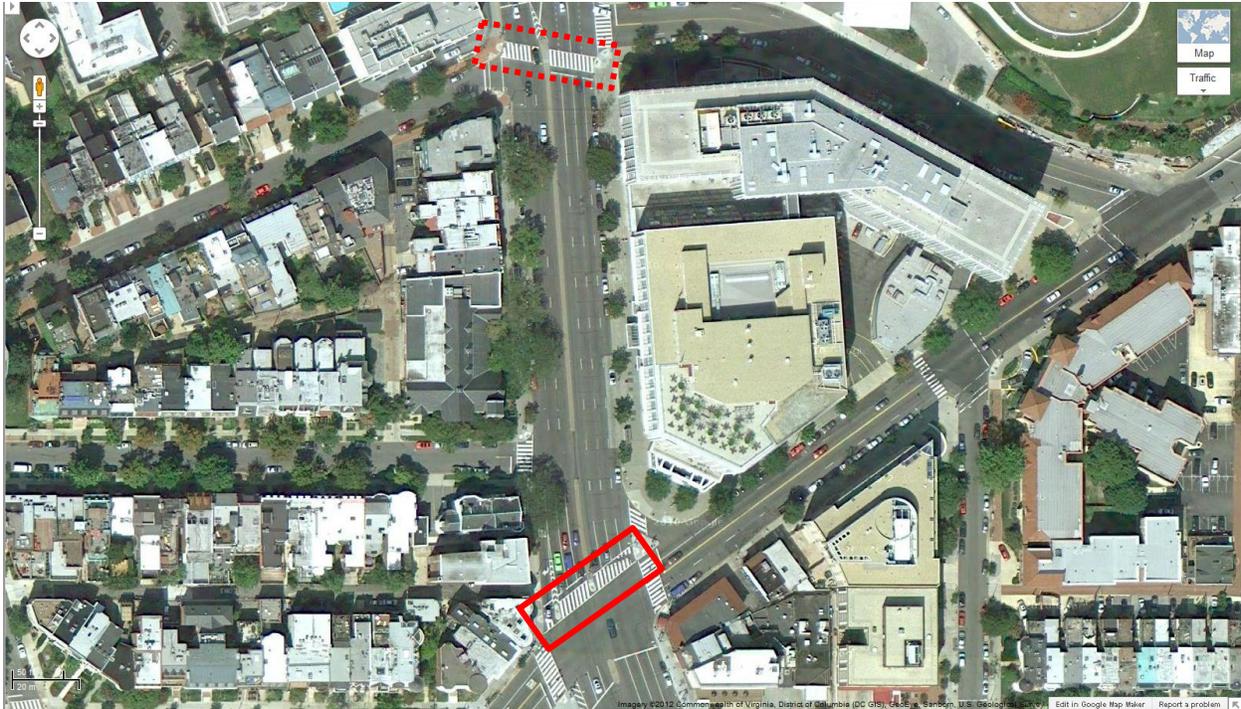
Figure 27. Photo. Aerial view of Location 9.⁽²⁹⁾

The ninth data collection area is located at the intersection of Connecticut Avenue Northwest and Florida Avenue Northwest in Washington, DC. Figure 27 is an aerial view of this data collection area. Connecticut Avenue runs northwest/southeast and is located near the center of the image. Florida Avenue runs northeast/southwest and is located on the right side of the image. The solid red rectangle highlights the intersection of Connecticut Avenue Northwest and Florida Avenue Northwest. The dotted red rectangle highlights the intersection of Connecticut Avenue Northwest and Leroy Place (west of Connecticut)/T Street (east of Connecticut) Northwest. The DDOT camera was positioned on the southwest corner of the Connecticut and Florida facing north (see figure 28). As a result, pedestrians making east/west crossings on Connecticut Avenue between Florida and Leroy Place/T Street were captured. (Leroy Place meets Connecticut on the west and T Street meets Connecticut on the east.) The distance from Florida Avenue to Leroy Place is roughly 551 ft. Approximately 135 ft north of the intersection of Connecticut and Florida, Bancroft Street meets with the west side of Connecticut. Both right and left turns can be made from Bancroft onto Connecticut. Figure 28 shows marked crossings are present at both Florida Avenue Northwest (solid red line) and Leroy Place Northwest (dotted red line). The AADT in this area is 34 (expressed in thousands and rounded to the nearest 100).⁽¹⁸⁾

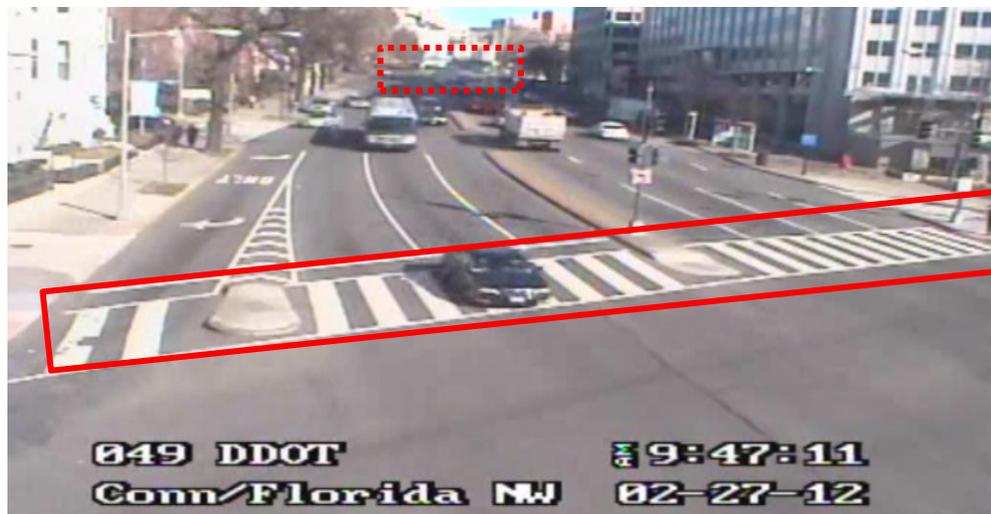
Figure 28. Photo. Still image captured from the Location 9 camera.

The marked intersection of Connecticut and Florida Avenues of interest (as highlighted by the solid rectangular box in figure 28) is 109 ft long (curb to curb). Each of the raised concrete medians is 5 ft in width. The walk phase is illuminated for 30 s, and the don't walk phase is illuminated for 68 s. Figure 29 illustrates what a pedestrian might see as he or she attempts to cross from the west side of Connecticut Avenue to the east side along Florida Avenue Northwest.

There are three northbound and three southbound lanes. (These lanes continue both north and south of the relevant data collection block.) In addition, on the northbound side, an additional

lane serves as a bus lane near the southern portion. Further north, this lane is available for metered parking outside rush hours. On the southbound side, an additional lane serves as a right turn only lane near the intersection with Florida Avenue. Further north, this lane is available for metered parking outside rush hours.
