Human Factors Assessment of Pedestrian Roadway Crossing Behavior

PUBLICATION NO. FHWA-HRT-13-098

JANUARY 2014

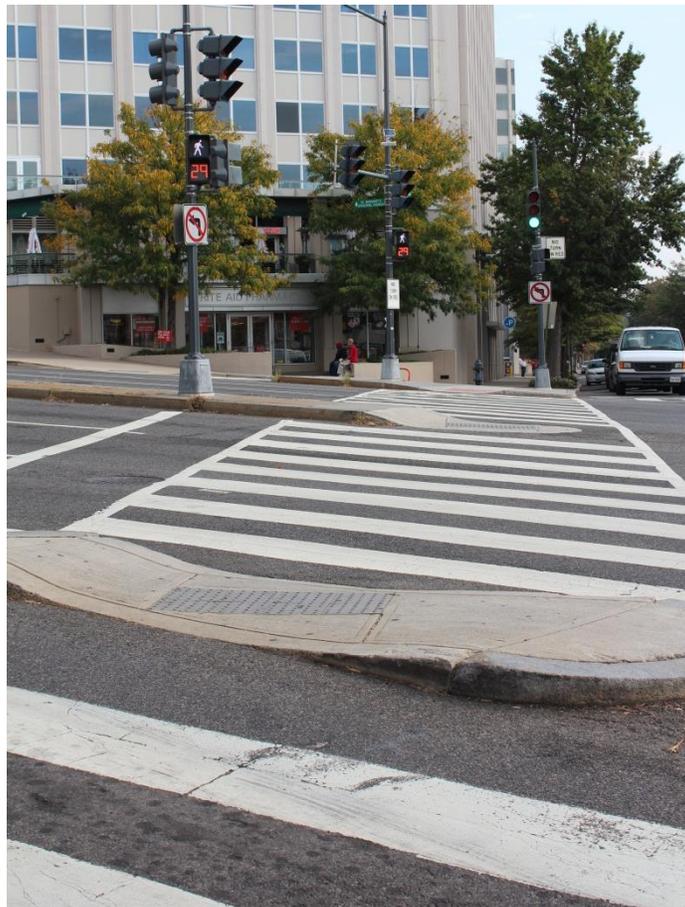
Figure 29. Photo. Illustration of what a pedestrian might see as he or she attempts to cross from the west side of Connecticut Avenue Northwest to the east side of the street along Florida Avenue Northwest.

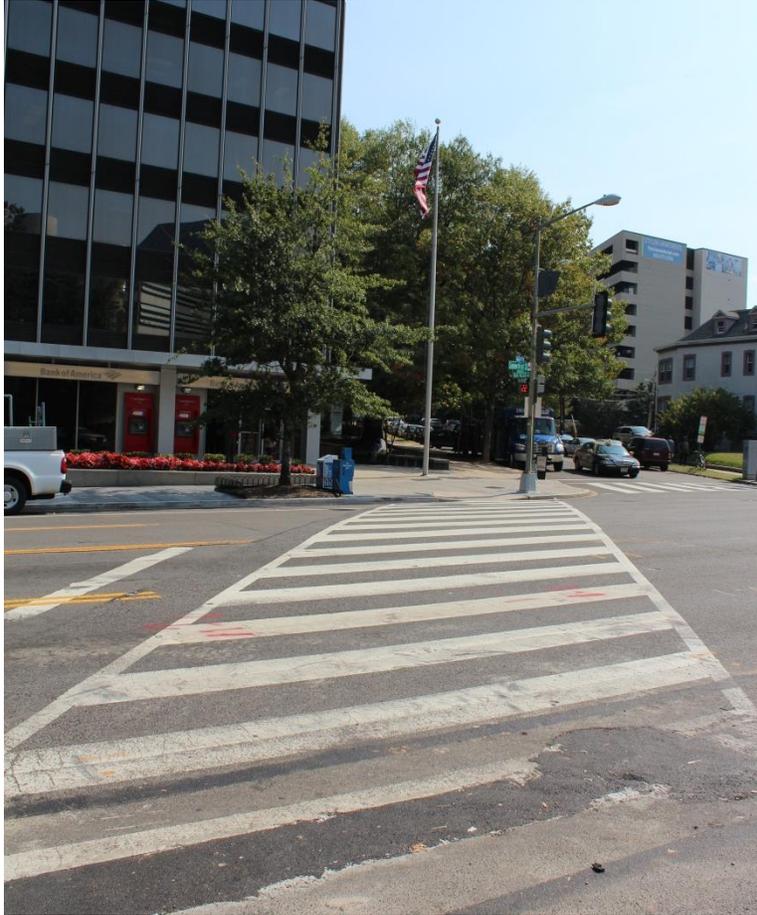
Figure 32. Photo. Illustration of what a pedestrian might see as he or she attempts to cross from the west side of Connecticut Avenue Northwest to the east side of the street along Van Ness Street Northwest.

The marked intersection of Connecticut Avenue and Van Ness Street of interest (as highlighted by the solid rectangular box in figure 31) is 72.5 ft long (curb to curb). The walk phase is illuminated for 24 s, and the don't walk phase is illuminated for 75 s. Figure 32 illustrates what a pedestrian might see as he or she attempts to cross from the west side of Connecticut Avenue to the east side along Van Ness Street Northwest.

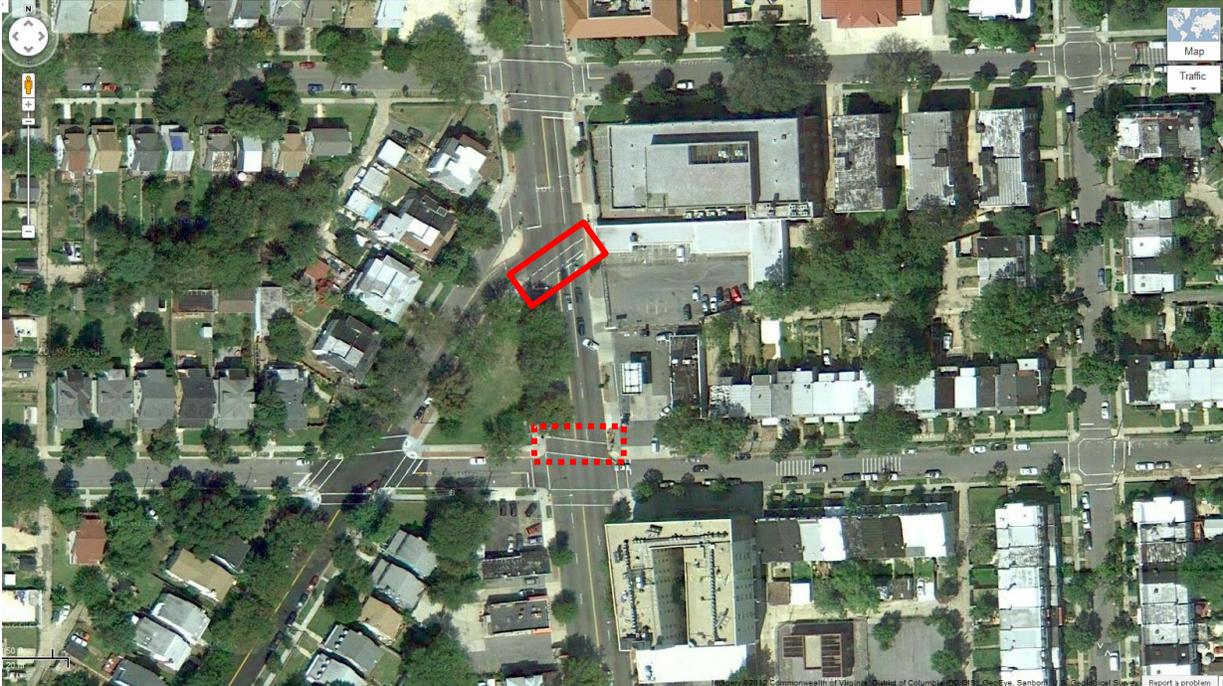
Figure 33. Photo. Aerial view of Location 11.⁽³¹⁾

The 11th data collection area is located at the intersection of Georgia Avenue Northwest and Arkansas Avenue Northwest in Washington, DC. Figure 33 is an aerial view of this data collection area. Georgia Avenue runs north/south and is located in the center area of the image. Arkansas Avenue runs northeast/southwest and is located toward the left in the image. The solid red rectangle highlights the intersection of Georgia Avenue Northwest and Arkansas Avenue Northwest. The dotted red rectangle highlights the intersection of Georgia Avenue and Farragut Street. The DDOT camera was positioned on the northeast corner of the Georgia and Arkansas intersection facing south (see figure 34). As a result, pedestrians making east/west crossings on Georgia Avenue between Arkansas Avenue and Farragut Street were captured. The distance from Arkansas Avenue and Farragut Street is approximately 193 ft. Figure 33 shows marked crossings are present at both Arkansas Avenue Northwest (solid red line) and Farragut Street Northwest (dotted red line). The intersection of Farragut Street and Georgia Avenue is not light controlled. The AADT in this area is 22.9 (expressed in thousands and rounded to the nearest 100).⁽¹⁸⁾

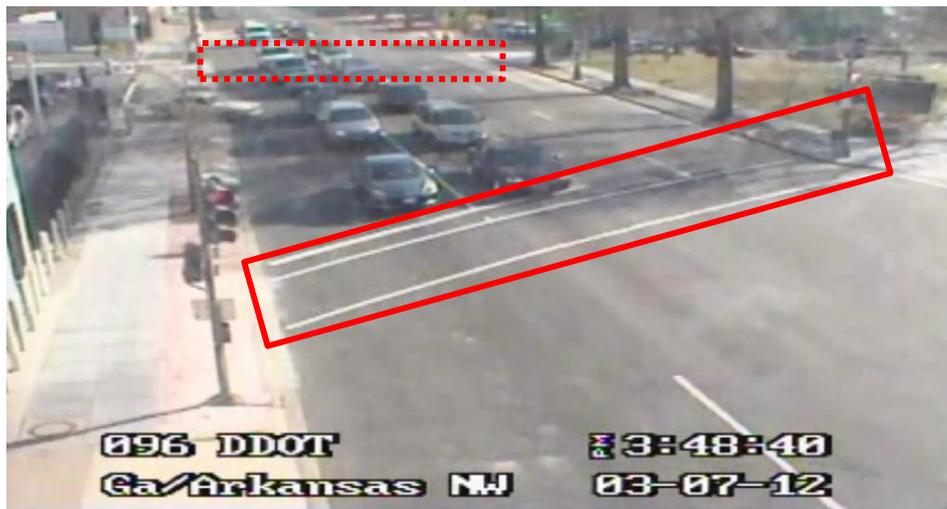
Figure 34. Photo. Still image captured from the Location 11 camera.

There are two northbound and two southbound lanes of traffic. (These lanes continue both north and south of the relevant data collection block.) There is a driveway entrance to Georgia Avenue on the northbound lane. In addition, there is a southbound bus stop near the intersection of Georgia Avenue and Farragut Street.

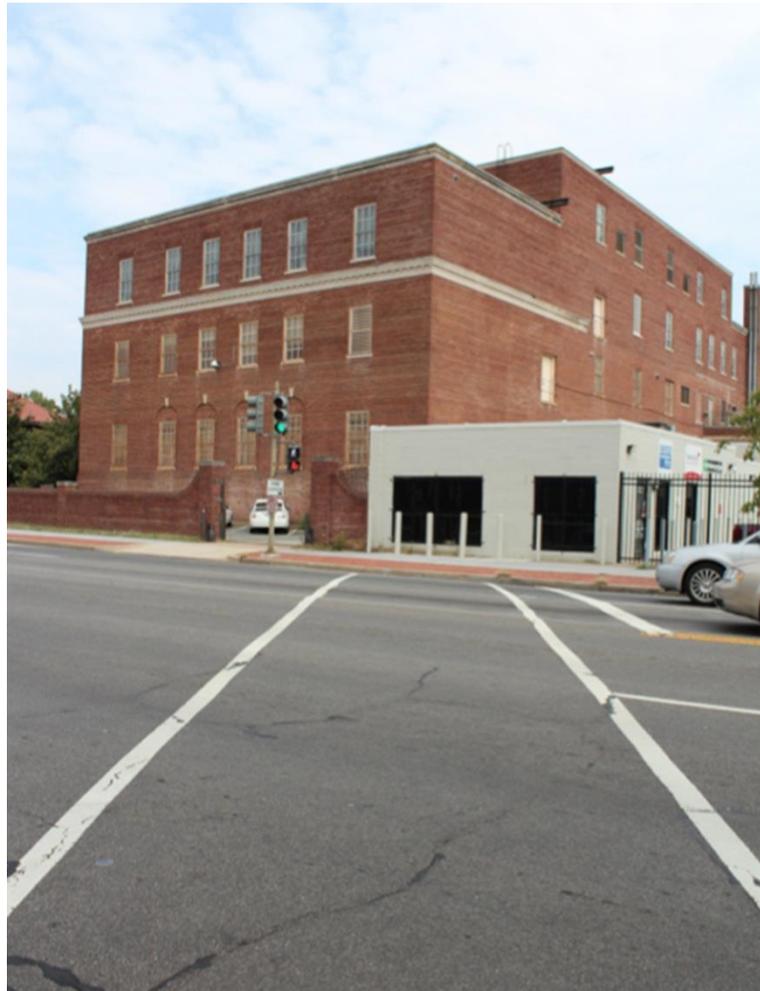
Figure 35. Photo. Illustration of what a pedestrian might see as he or she attempts to cross from the west side of Georgia Avenue Northwest to the east side of the street along Arkansas Avenue Northwest.

The marked intersection of Georgia Avenue and Arkansas Avenue of interest (as highlighted by the solid rectangular box in figure 34) is 68.3 ft long (curb to curb). The walk phase is illuminated for 19 s, and the don't walk phase is illuminated for 80 s. Figure 35 illustrates what a pedestrian might see as he or she attempts to cross from the west side of Georgia Avenue to the east side along Arkansas Avenue Northwest.

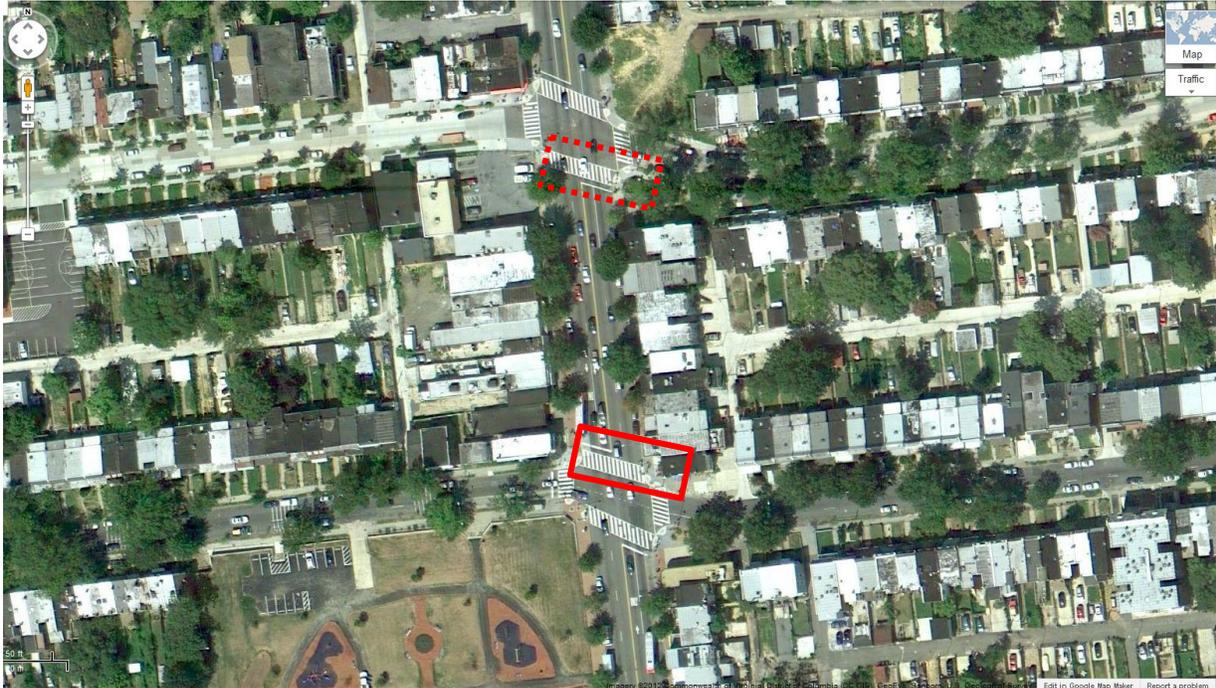
Original image: ©2012 Google®; map annotations provided by SAIC.

Figure 36. Photo. Aerial view of Location 12.⁽³²⁾

The 12th data collection area is located at the intersection of Georgia Avenue Northwest and Irving Street Northwest in Washington, DC. Figure 36 is an aerial view of this data collection area. Georgia Avenue runs north/south and is located in the center of the image. Irving Street runs east/west and is located in the lower portion of the image. The solid red rectangle highlights the intersection of Georgia Avenue Northwest and Irving Street Northwest. The dotted red rectangle highlights the intersection of Georgia Avenue and Kenyon Street. The DDOT camera was positioned on the southwest corner of the Georgia and Irving facing north (see figure 37). As a result, pedestrians making east/west crossings on Georgia Avenue between Irving Street and

Kenyon Street were captured. The distance from Irving Street and Kenyon Street is approximately 277 ft. Figure 36 shows marked crossings are present at both Irving Street Northwest (solid red line) and Kenyon Street Northwest (dotted red line). The AADT of this specific block on Georgia Avenue was not known. As a result, an average value based on the blocks north and south of the relevant block was computed for an estimated AADT of 19.75 (expressed in thousands and rounded to the nearest 100).⁽¹⁸⁾

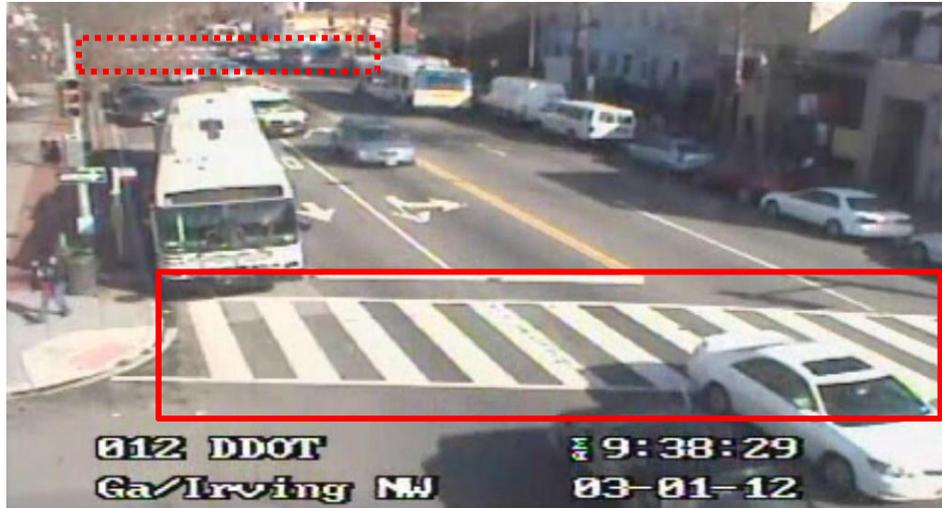
Figure 37. Photo. Still image captured from the Location 12 camera.

There are two northbound and two southbound lanes of traffic, flanked by metered parking on both sides of the roadway. (These lanes continue both north and south of the relevant data collection block.)

The marked intersection of Georgia Avenue and Irving Street of interest (as highlighted by the solid rectangular box in figure 37) is 64.5 ft long (curb to curb). The walk phase is illuminated for 20 s, and the don't walk phase is illuminated for 78 s. Figure 38 illustrates what a pedestrian might see as he or she attempts to cross from the east side of Georgia Avenue to the west side along Irving Street Northwest.

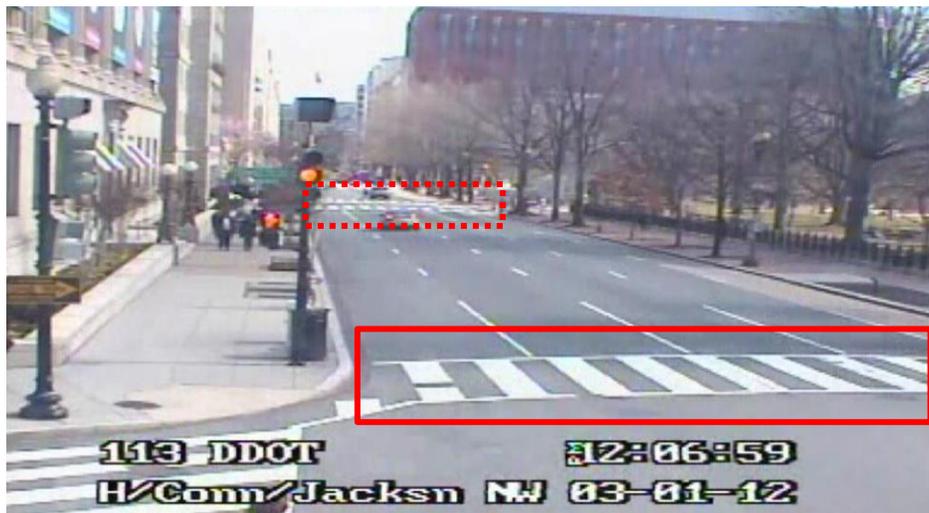
Figure 40. Photo. Still image captured from the Location 13 camera.

There are four eastbound lanes of traffic (H Street is a one-way street) and a bus lane on the southern portion of the street during rush hour. During the remaining hours of the day, the

The marked intersection of H Street and Connecticut Avenue of interest (as highlighted by the solid rectangular box in figure 40) is 50 ft long (curb to curb). The walk phase is illuminated for 10 s, and the don't walk phase is illuminated for 89 s. Figure 41 illustrates what a pedestrian might see as he or she attempts to cross from the north side of H Street to the south side along Connecticut Avenue Northwest.

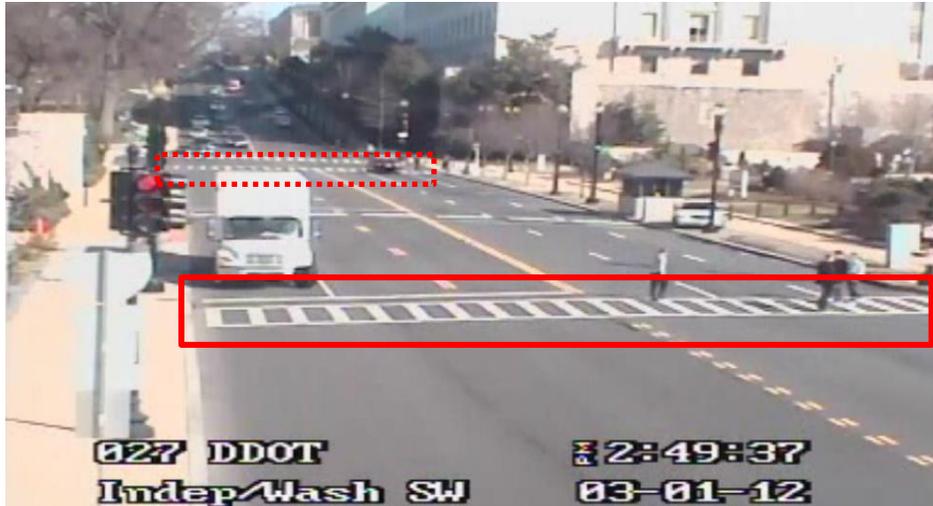
Figure 43. Photo. Still image captured from the Location 14 camera.

There are three eastbound and three westbound lanes of traffic. (These lanes continue east of the relevant data collection block.)

The marked intersection of Independence Avenue and Washington Avenue of interest (as highlighted by the solid rectangular box in figure 43) is 68.25 ft long (curb to curb). The walk phase is illuminated for 30 s, and the don't walk phase is illuminated for 67 s. Figure 44 illustrates what a pedestrian might see as he or she attempts to cross from the north side of Independence Avenue to the south side along Washington Avenue Southwest.

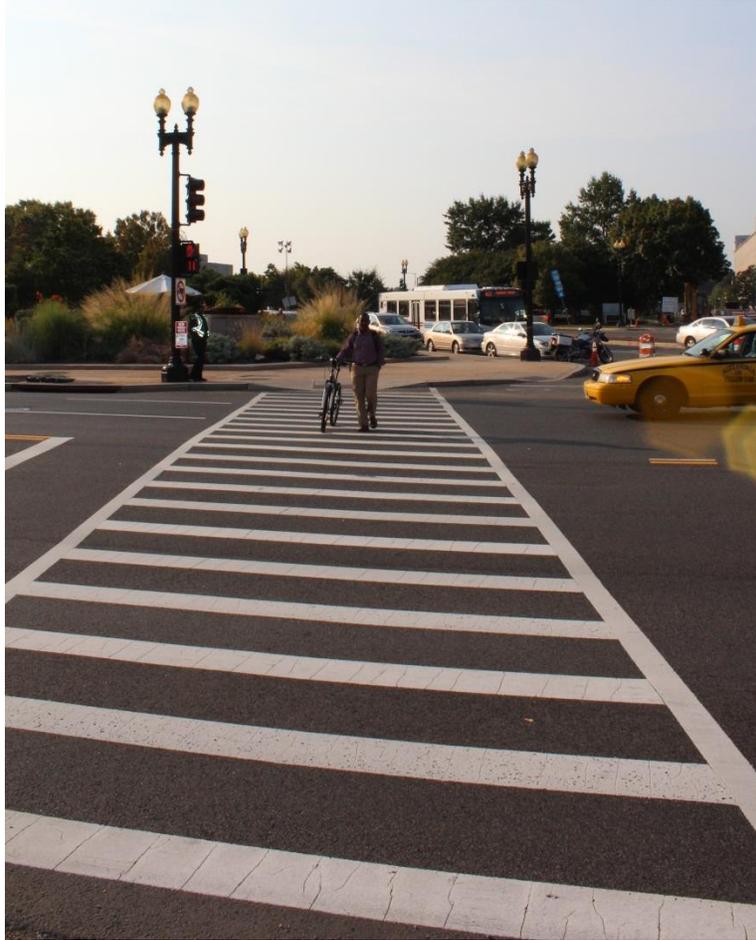
Figure 44. Photo. Illustration of what a pedestrian might see as he or she attempts to cross from the north side of Independence Avenue Southwest to the south side of the street along Washington Avenue Southwest.

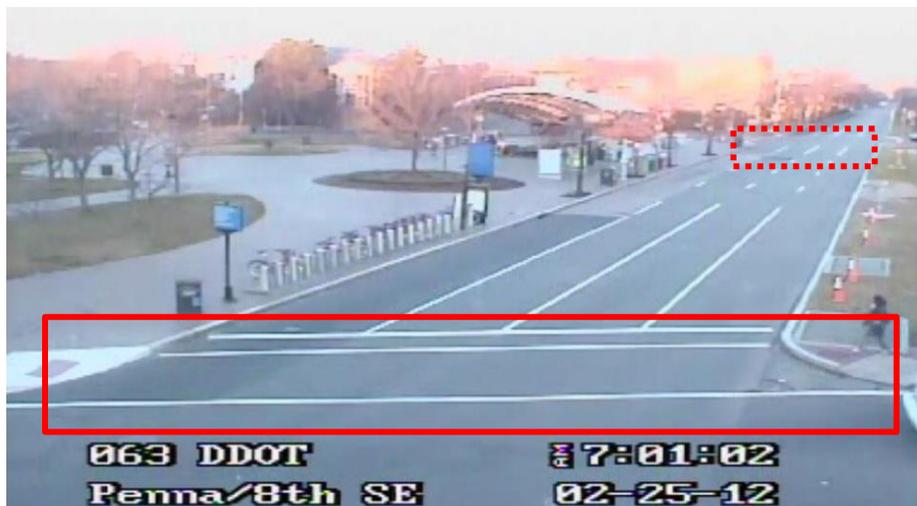
Figure 46. Photo. Still image captured from the Location 15 camera.

There are three southeast bound lanes of traffic on Pennsylvania Avenue. (These lanes continue east of the relevant data collection block.) In addition, there is a fourth bus lane for stops outside the Metro station. Crossings on the north side of the grass median were not assessed.

The marked intersection of Pennsylvania Avenue and 8th Street of interest (as highlighted by the solid rectangular box in figure 46) is 45.5 ft long (curb to curb). The walk phase is illuminated for 39 s, and the don't walk phase is illuminated for 60 s. Figure 47 illustrates what a pedestrian might see as he or she attempts to cross from the south side of Pennsylvania Avenue to the north side along 8th Street Southeast.

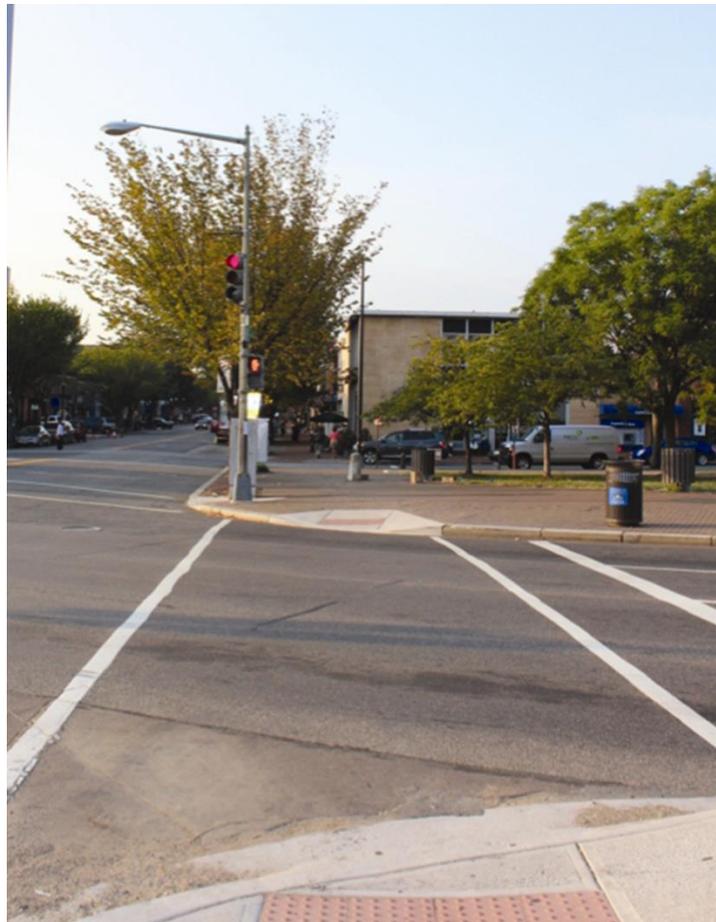
Figure 47. Photo. Illustration of what a pedestrian might see as he or she attempts to make a crossing from the south side of Pennsylvania Avenue Southeast to the north side of the street along 8th Street Southeast.

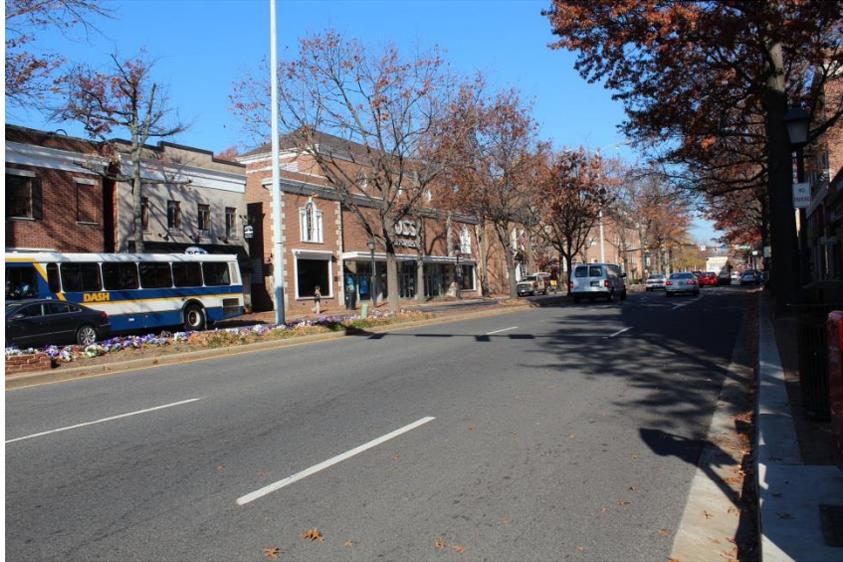
Figure 49. Photo. Illustration of some of the foliage present in the median of North Washington Street.

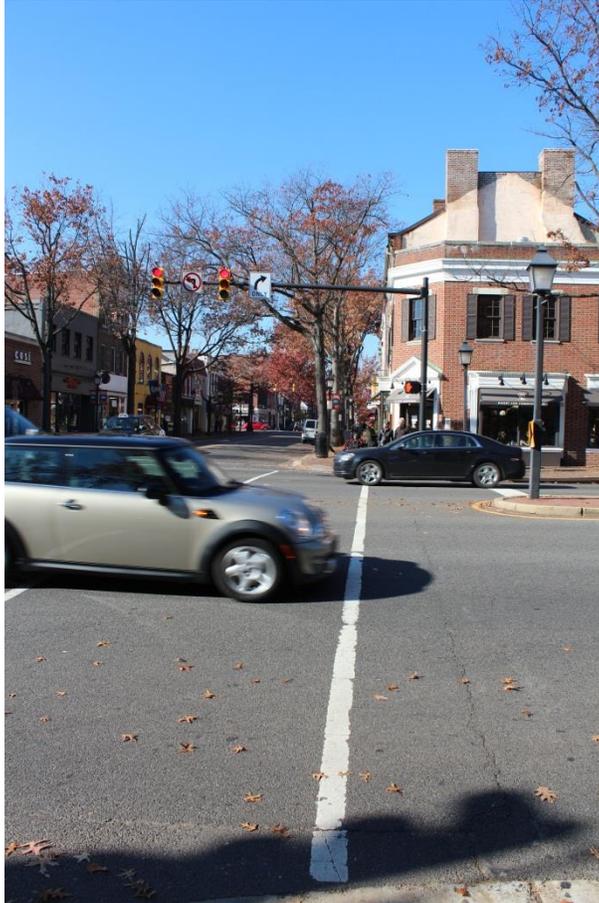
Figure 50. Photo. Illustration of what a pedestrian might see as he or she attempts to cross from the east side to the west side of North Washington Street along King Street.

Figure 50 illustrates what a pedestrian might see as he or she attempts to cross from the east side of North Washington Street to the west side along King Street.

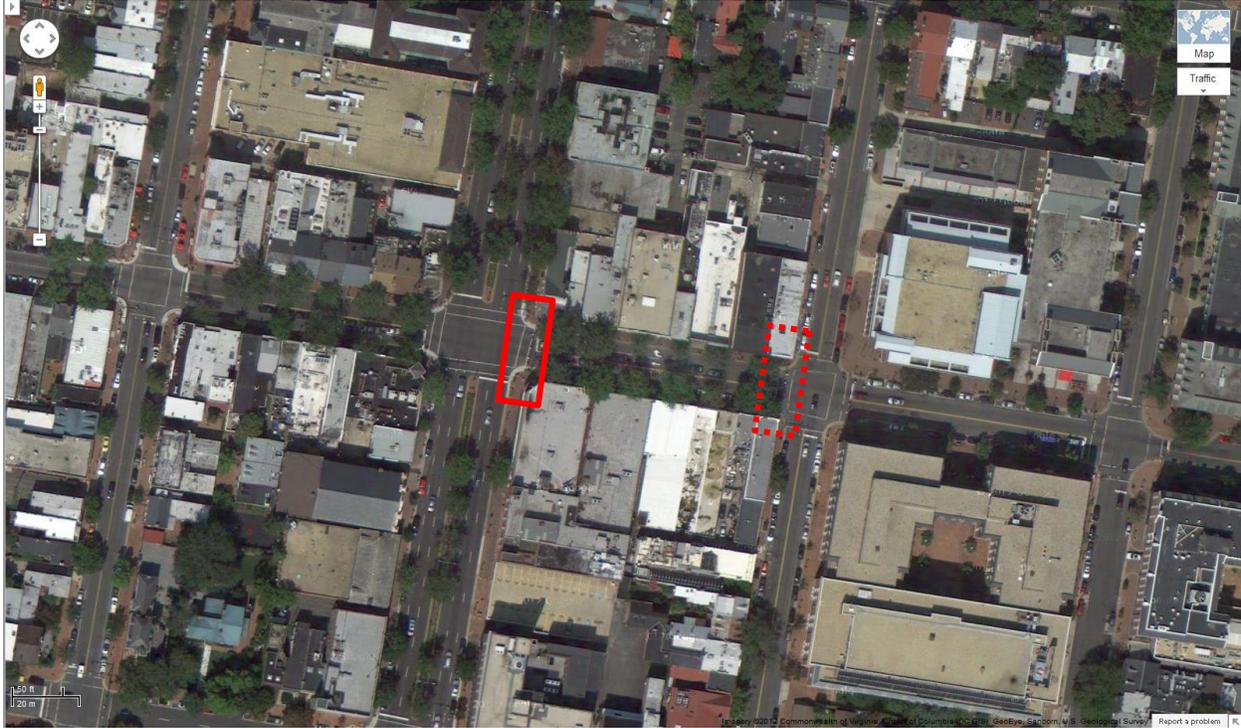
Original image: ©2012 Google®; map annotations provided by SAIC.

Figure 51. Photo. Aerial view of Location 17.⁽³⁷⁾

The 17th data collection area is located at the intersection of King and Washington Streets in Alexandria, VA. Figure 51 is an aerial view of this data collection area. North Washington Street runs north/south and is located just to the left of the center of the image. King Street runs east/west and is located toward the center of the image. The solid red rectangle highlights the intersection of King Street and North Washington Street. The dotted red rectangle highlights the intersection of King Street and North Saint Asaph Street. Researchers recorded pedestrians crossing north/south on King Street between North Washington Street and North Saint Asaph Street. Researchers were positioned on the southeast corner of King and North Washington Streets. One researcher faced north and recorded pedestrians making north/south crossings in the easternmost marked intersection of North Washington and King Streets. Another researcher faced east and recorded north/south crossings on King Street between North Washington Street and North Saint Asaph Street. The distance from North Washington Street to North Saint Asaph Street is approximately 266.5 ft. Figure 51 shows marked crossings are present at both North Washington Street (solid red line) and North Saint Asaph Street (dotted red line) along King Street. The AADT in this area is 8.1 (expressed in thousands and rounded to the nearest 100).⁽³⁶⁾

The marked intersection of King and North Washington Streets of interest (as highlighted by the solid rectangular box in figure 51) is 43.25 ft long (curb to curb). The walk phase is illuminated for 64 s, and the don't walk phase is illuminated for 63 s.

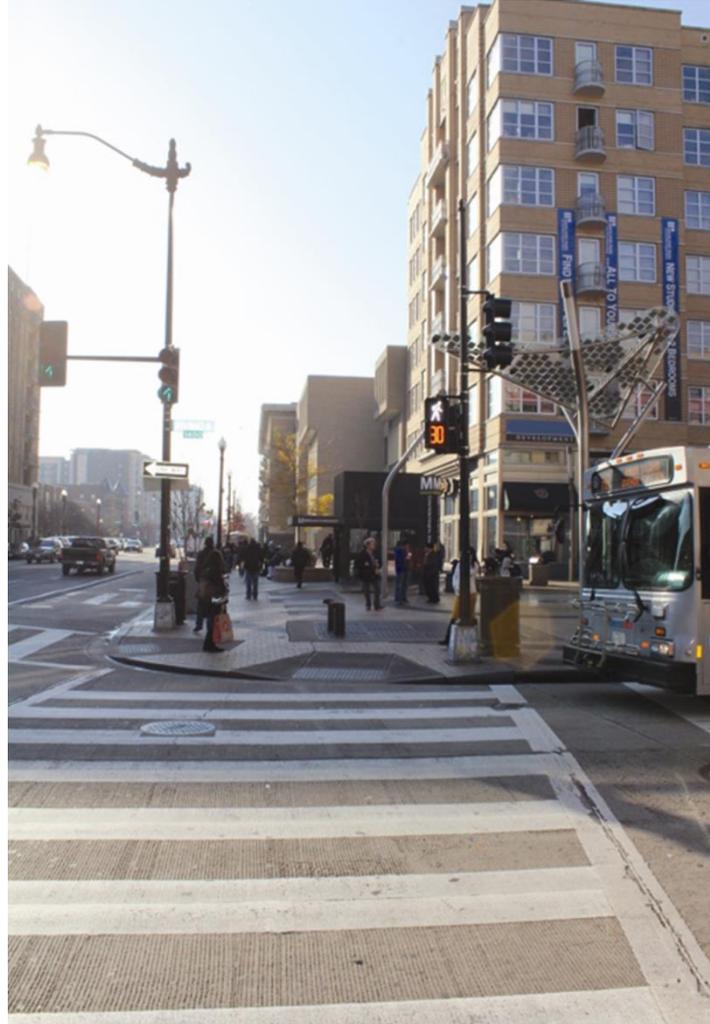
Figure 54. Photo. Illustration of what a pedestrian might see as he or she attempts to cross from the north side to the south side of Irving Street Northwest along 14th Street Northwest in Washington DC.

Figure 54 illustrates what a pedestrian might see as he or she attempts to cross from the north side of Irving Street Northwest to the south side along 14th Street Northwest.

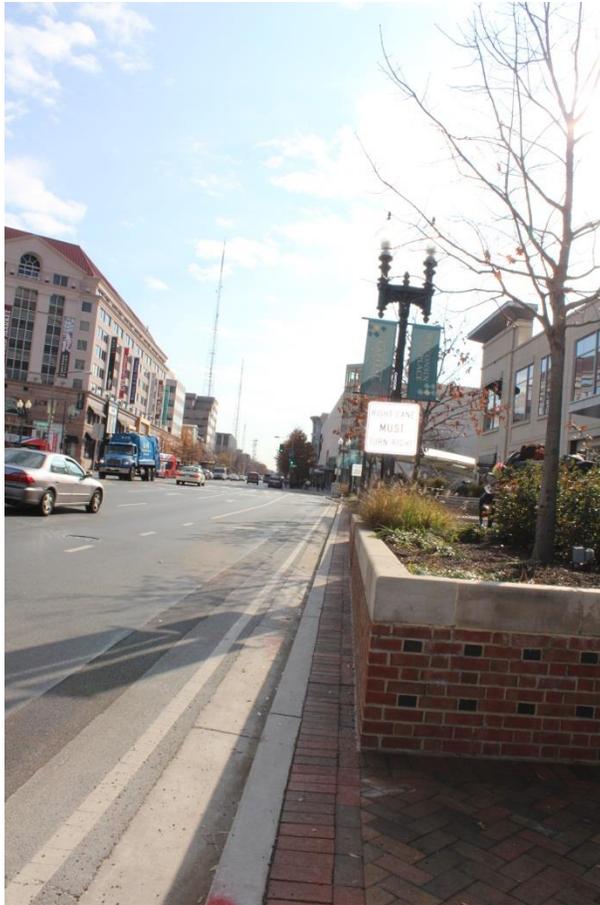
Figure 56. Photo. View of the planters located between the southbound lanes of traffic and the adjacent sidewalk along Wisconsin Avenue.

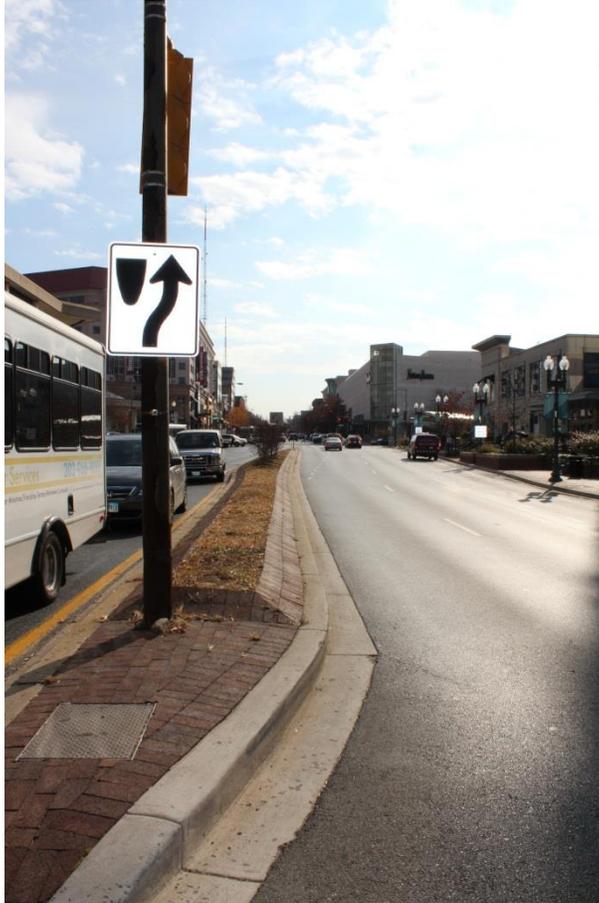
Figure 57. Photo. Illustration of some of the foliage and elevation present in the median of Wisconsin Avenue.

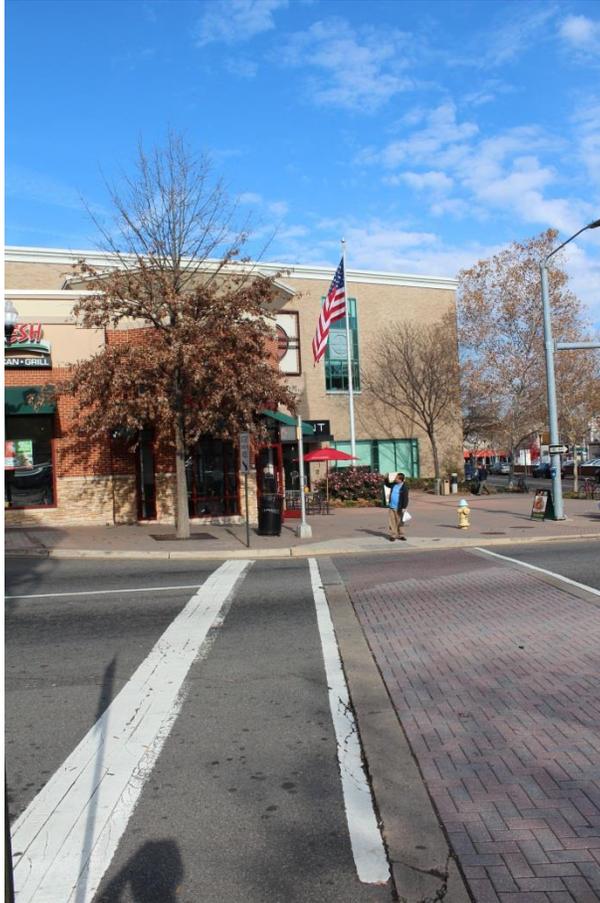
Figure 60. Photo. Illustration of what a pedestrian might see as he or she attempts to cross from the south side to the north side of Clarendon Boulevard along North Edgewood Street.

The marked crosswalk at the relevant intersection of Clarendon Boulevard and North Edgewood Street (as highlighted by the solid rectangular box in figure 59) is 44.5 ft (curb to curb). The walk phase is illuminated for 20 s, and the don't walk phase is illuminated for 63 s. Figure 60 illustrates what a pedestrian might see as he or she attempts to cross from the south side of Clarendon Boulevard to the north side along North Edgewood Street.

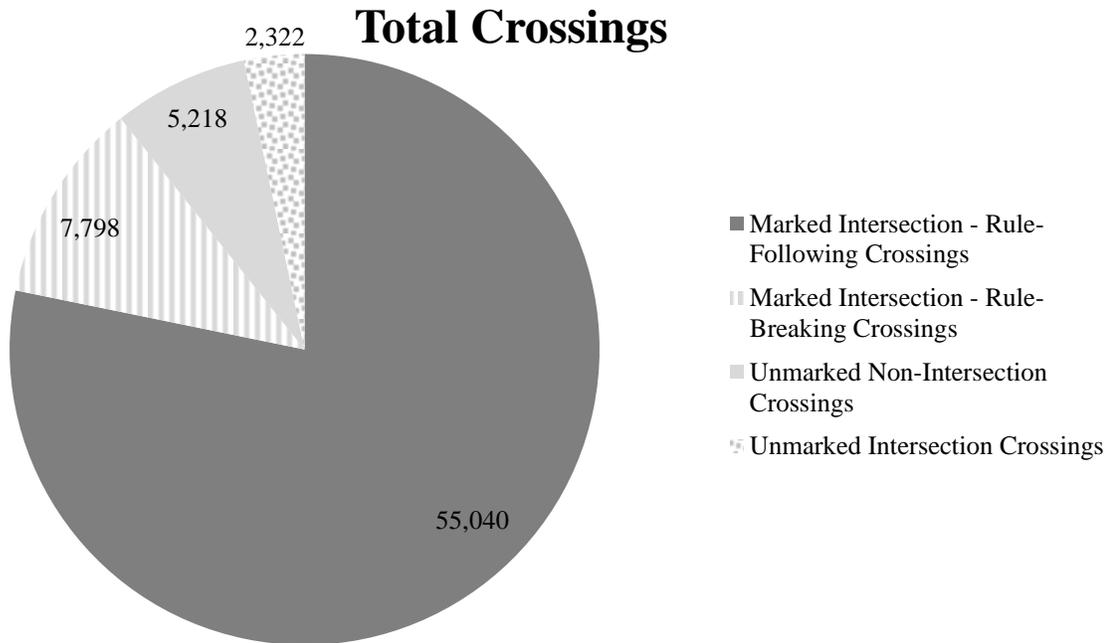
Figure 61. Chart. Distribution of all crossings observed across the 20 different locations by the area in which they took place.

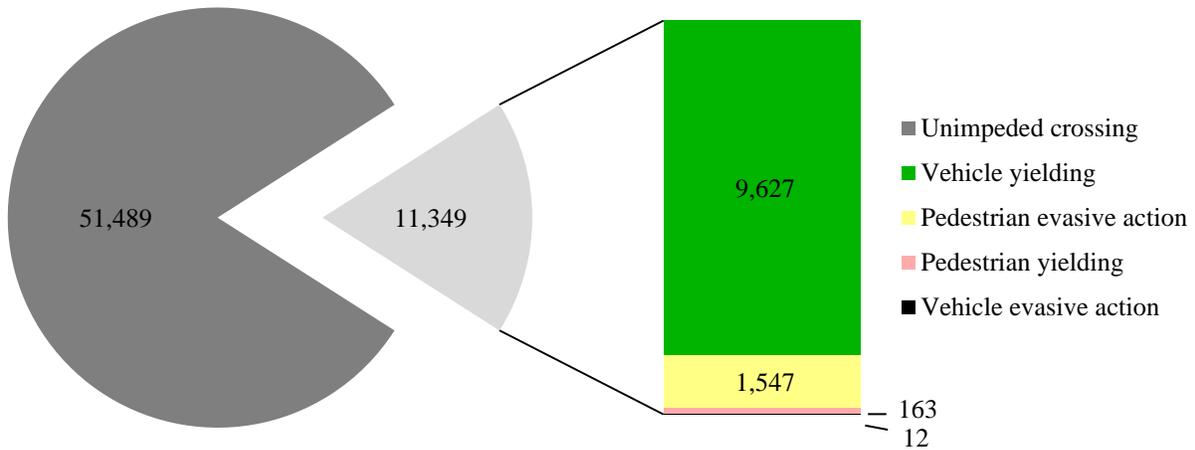
Figure 62. Chart. Distribution of crossings observed across all 20 locations in the marked intersections by circumstances of the crossing.

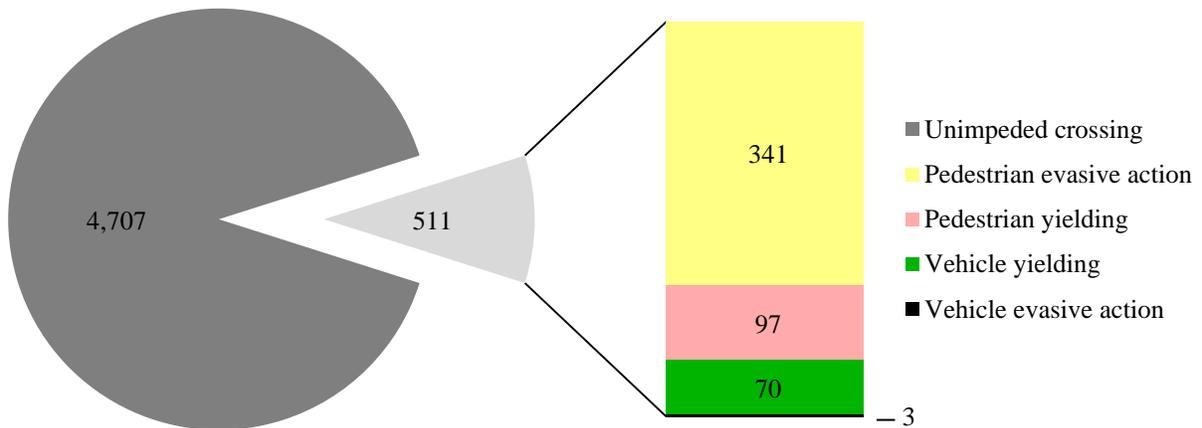
Figure 63. Chart. Distribution of crossings observed across all 20 locations in the unmarked non-intersections by the circumstances of the crossing.

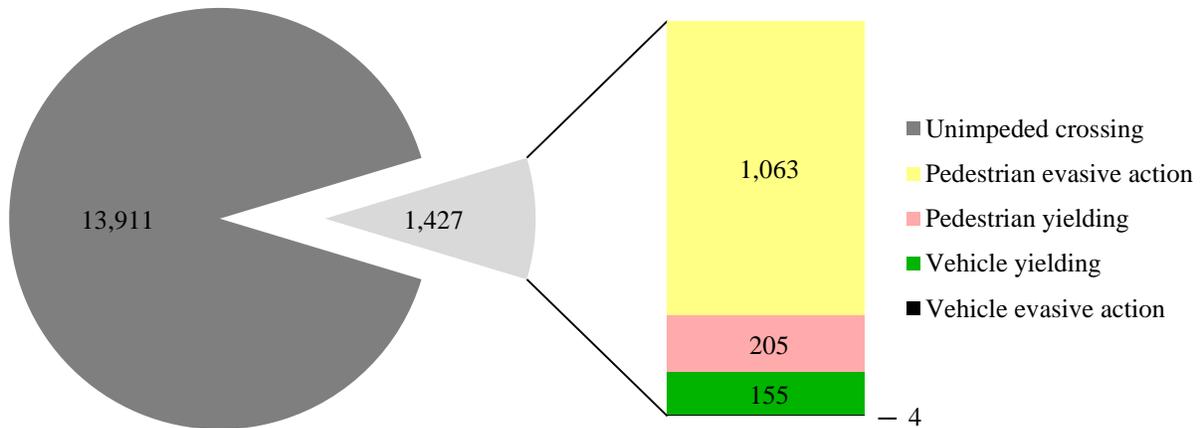
Figure 64. Chart. Distribution of crossings observed across all 20 locations for all rule-breaking crossings by the circumstances of the crossing (including those in the unmarked non-intersections).

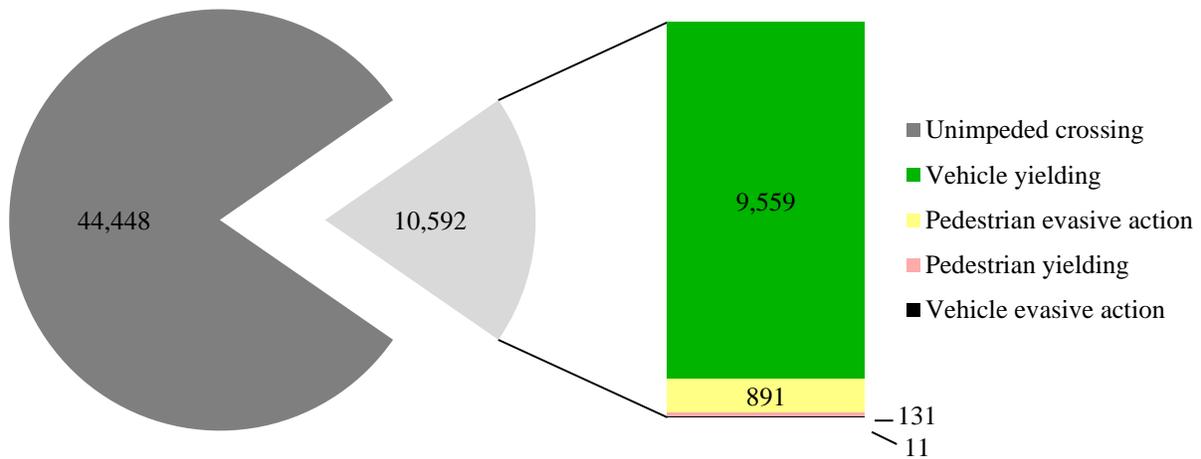
Figure 65. Chart. Distribution of crossings observed across all 20 locations for crossings made entirely during the walk light phase in the marked intersections, by the circumstances of the crossing.

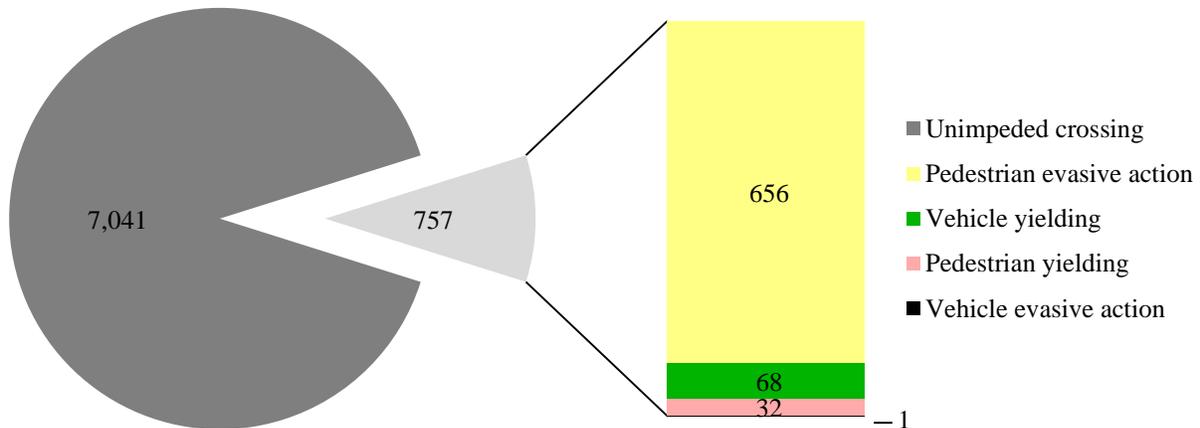
Figure 66. Chart. Distribution of crossings observed across all 20 locations for rule-breaking crossings in marked intersections (i.e., crossings that took place at least partially during the don't walk light phase) by the circumstances of the crossing.

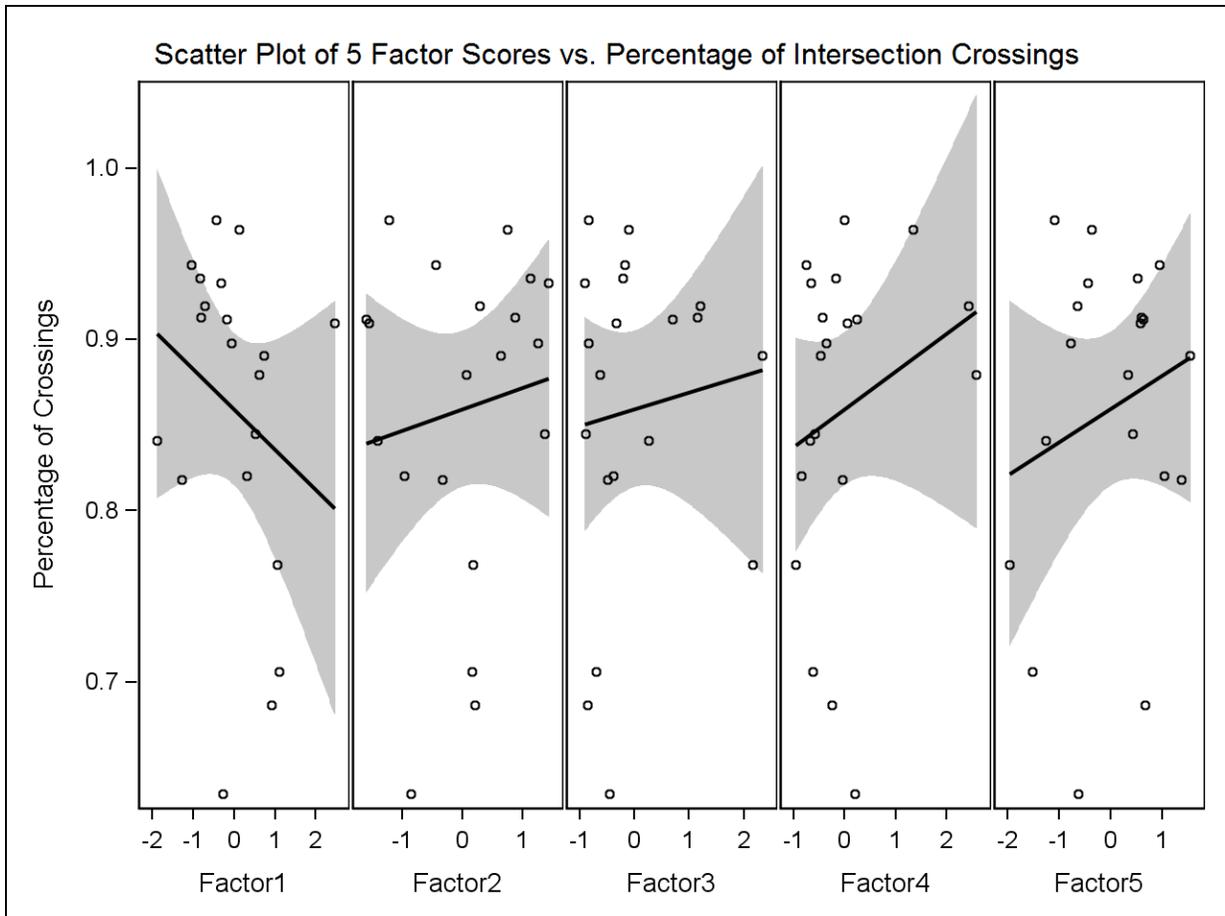
Notes: The dots remain in consistent locations from box to box.
 solid line = regression line, shaded area = 95-percent confidence limits of the regression line).

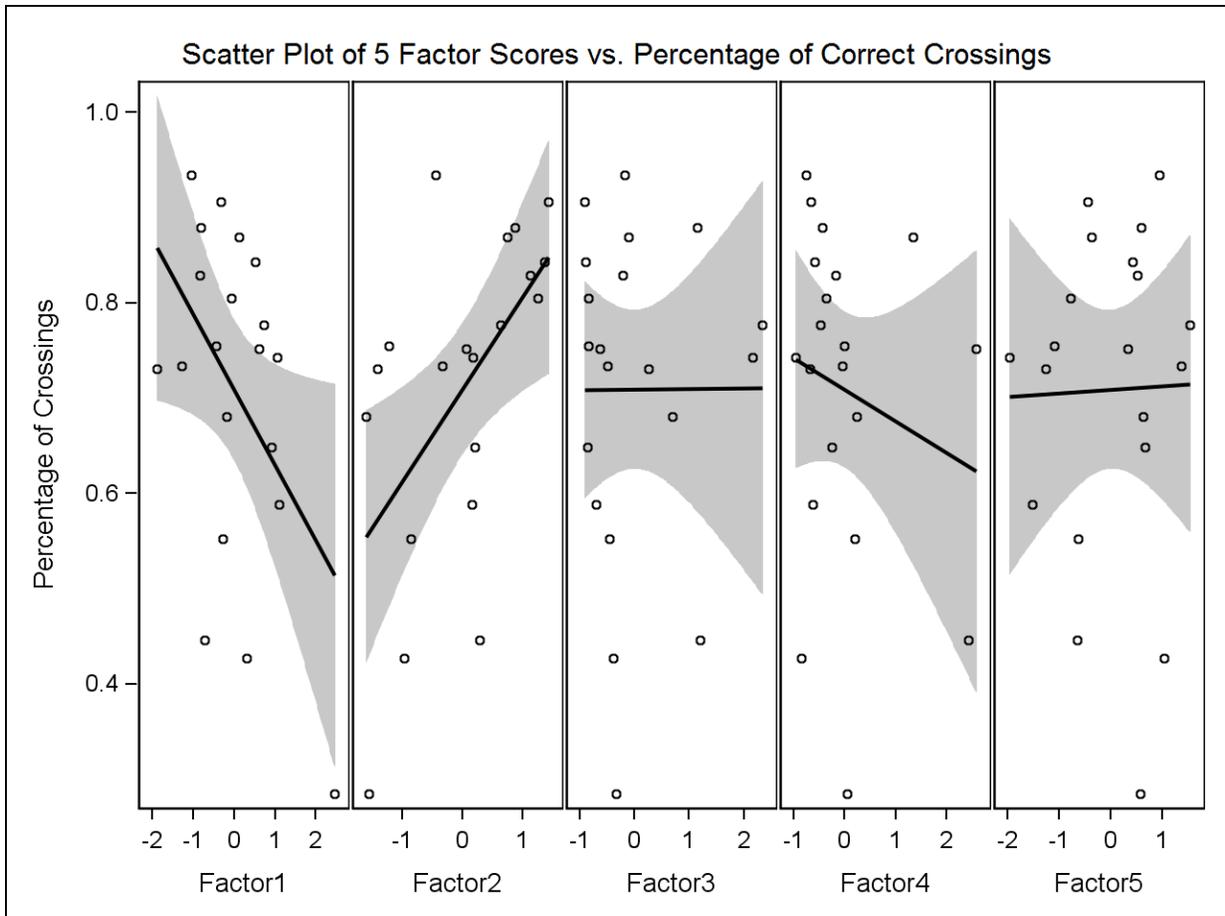
Notes: The dots remain in consistent locations from box to box.
solid line = regression line, shaded area = 95-percent confidence limits of the regression line).
