**Oakland Bay Bridge  
Pile Connection Plate  
Welding Investigation Report**

**Federal Aid Project ACIM-080-1 (085) 8N  
MTE File No. S5021**

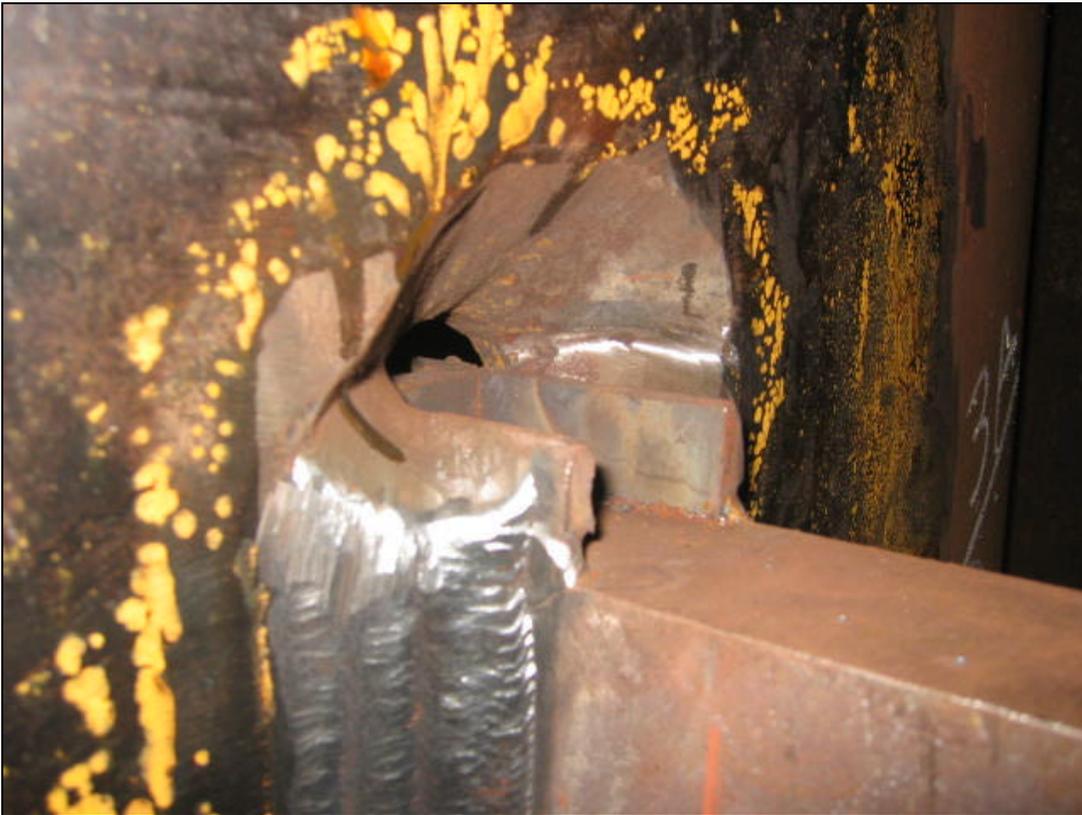
**Figure 8:** Weld tabs in place at top of pile connection plate weld.

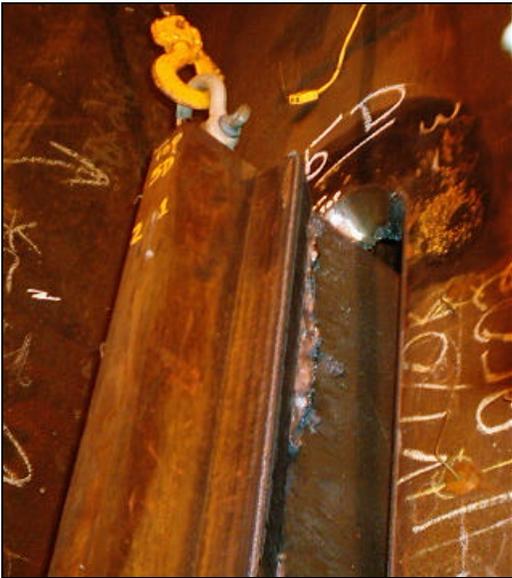
Figure 17: Removal of weld sample 5D.

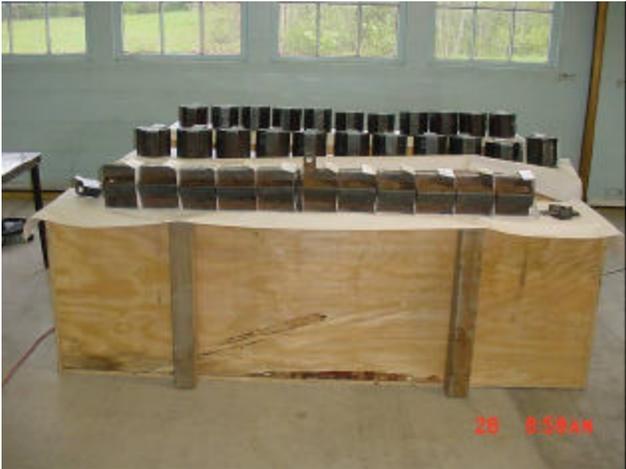
<p>IMPOUND THE SPECIMENS FOR DISPOSITION BY FHWA.</p> <p>PACKAGE THE FINISH MACRO COUPONS IN 3 STORAGE BOXES.</p> <p>PROTECT THE MACRO SURFACES FROM SHIPPING DAMAGE USING 3 SEALED SHIPPING CONTAINERS.</p> <p>STORE THE SEALED CONTAINERS IN A SECURE, DRY ENVIRONMENT.</p> <p>THE 3 SEALED CONTAINERS SHALL BE SHIPPED TO:</p> <p>Federal Highway Administration Turner – Fairbanks Highway Research Center 6300 Goergetown Pike McLean, VA 22101 Attention:</p>

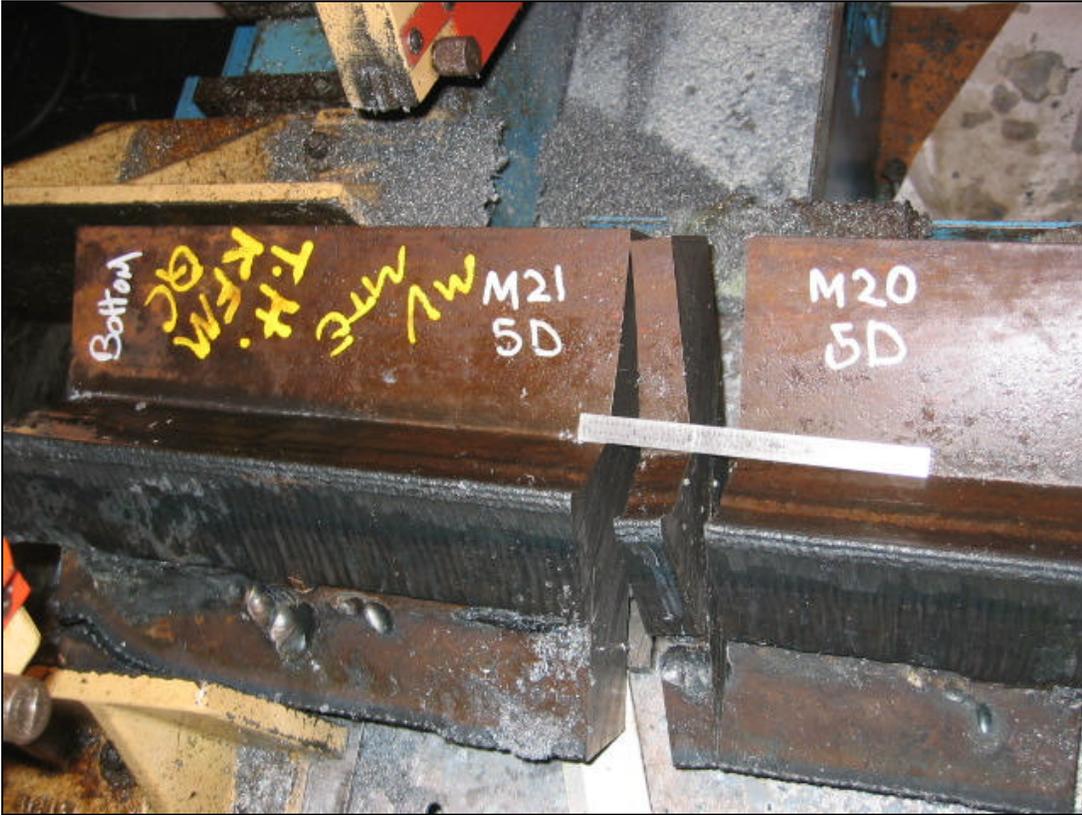
**Figure 20:** Short slice taken from Weld Sample 5D to correct uneven saw cut.

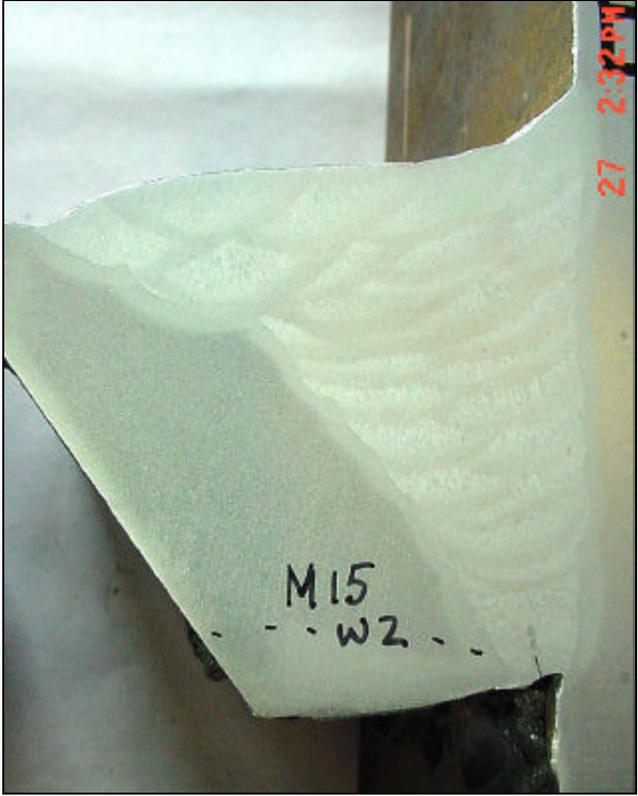
**Figure 25:** Sample M15 from Weld 2 in sample 5D. Note crack in root pass extending from bottom of root to middle of root. Dashed line shows boundary of heat affected zone from gas cutting during sample removal.

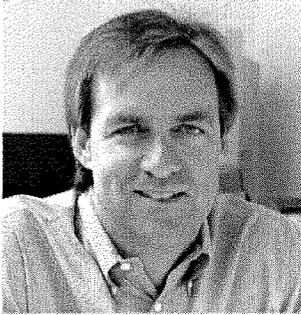
## **Welding Consultant**
