## Hydrologic & Hydraulic News

April 2014  
Vol. 2, Issue 1

### *Scour and the Test of Time: Herbert C. Bonner Bridge Crossing Oregon Inlet, North Carolina*

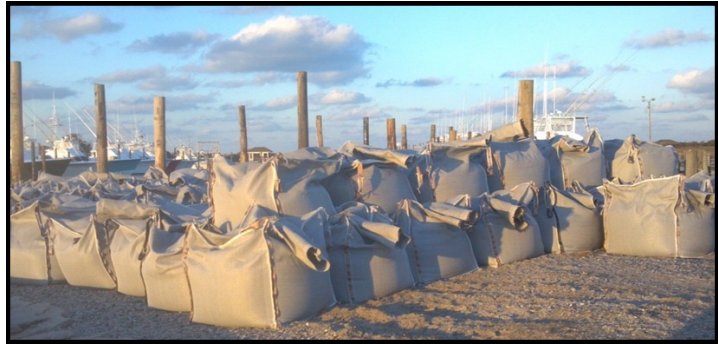
Figure 11—Geotextile Sand Bag Stockpile (4'x4'x4' cubes)

Geotextile bags (Figure 11) begin arriving and filled. Contractor's crane and pile hammer are moved to work off the bridge deck at Bent 164.

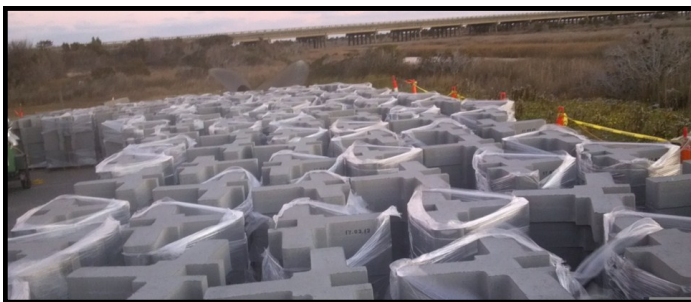
Figure 12—Pallets of 4' A-jacks® (3 jacks per pallet)

Divers confirm consolidation of dredge placed sand at Bent 166. First shipment of A-jack® elements (Figure 12) arrive at staging area.

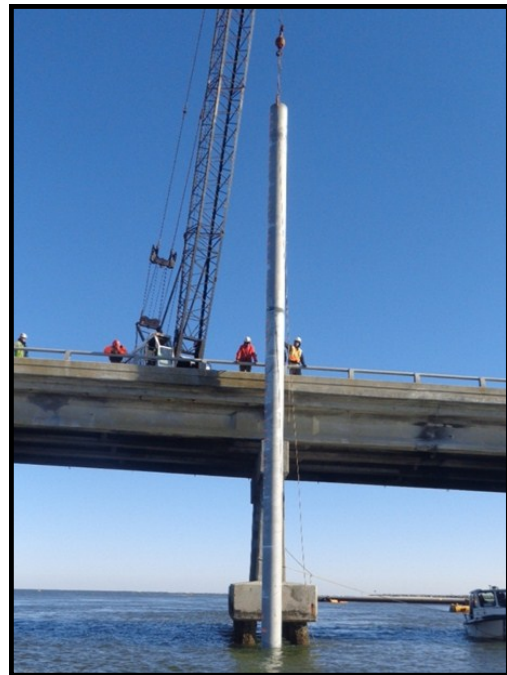
Figure 13—Bonner Bridge Test Pile #2

Carolina Bridge performed restrike hammer test (Figure 13). Strain gage and pile driver analyzer results confirmed pile capacity. Crane, hammer, wooden mattresses, and support equipment are removed from the bridge deck. Underwater inspection confirms sand consolidation at a minimum of 13' embedment above scour critical elevation.
