Non-Destructive Evaluation of Fracture Critical Members Fabricated from AASHTO M244 Grade 100 (ASTM A514/A517) Steel

FHWA Office of Bridges and Structures

January 2022

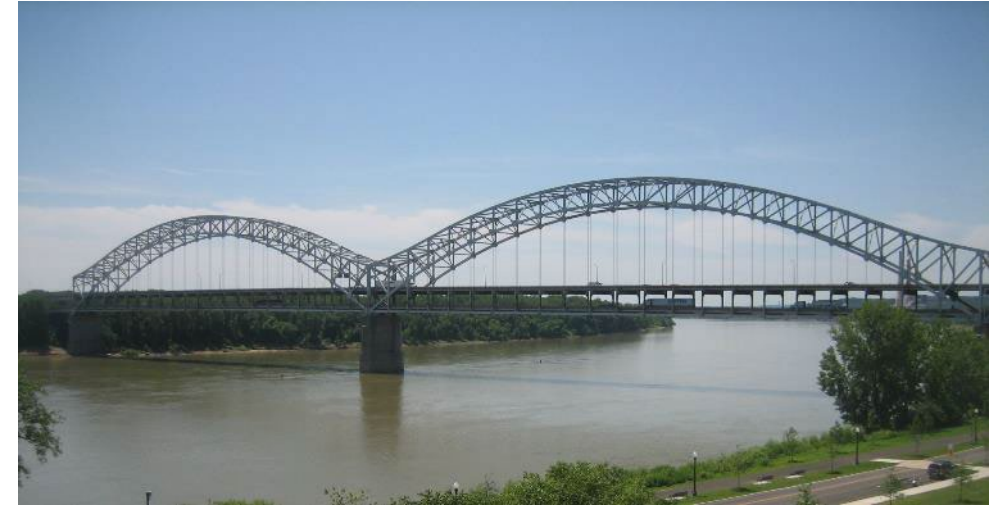
- Double-decked steel tied arch built in 1961.
- Carries Interstate 64 over the Ohio River
- Dual 800 ft. spans.
- Tie fabricated from “T-1” steel.

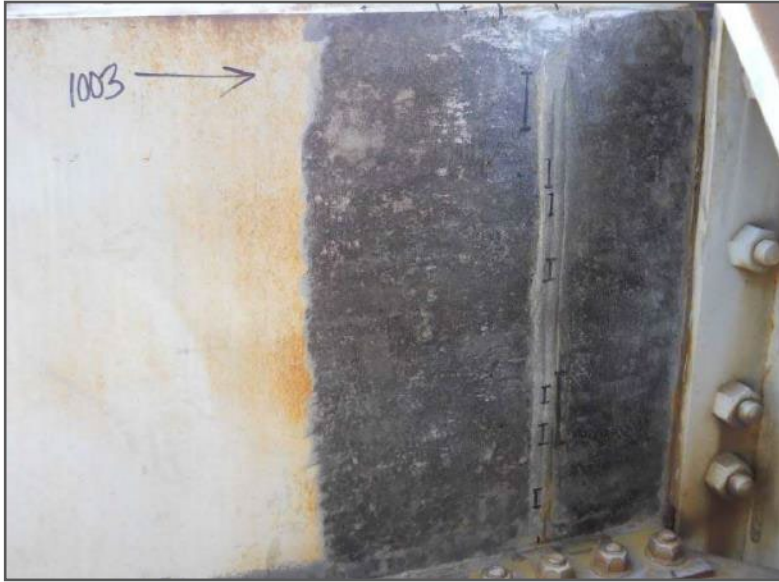
- 704 tie girder CJP butt welds.
- NDT identified discontinuities in over 80% of the web plate butt welds

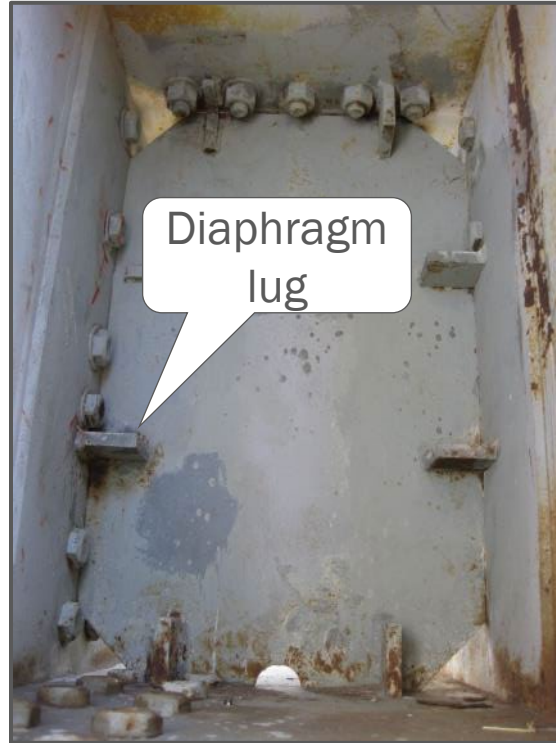
- Diaphragm lugs fillet welded to tie girder.
- 2,112 weld legs.

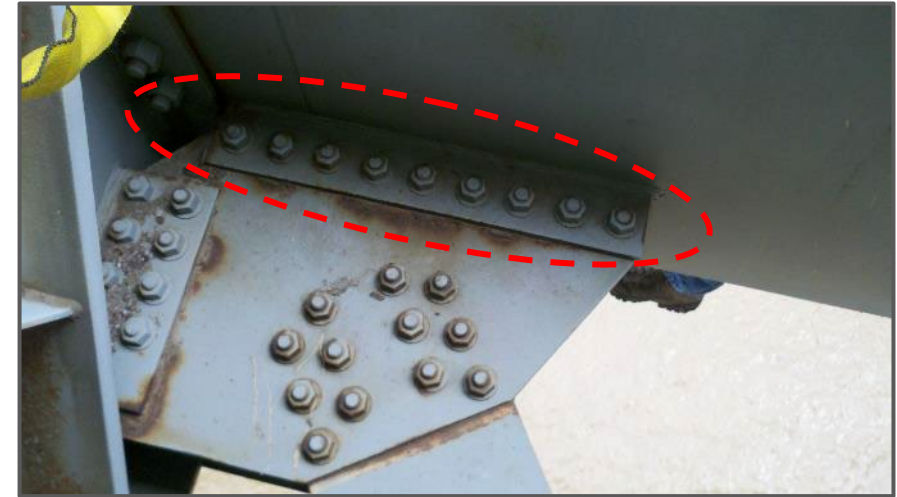
- Lateral bracing gussets CJP tee welds to tie girder.
- 88 welds.

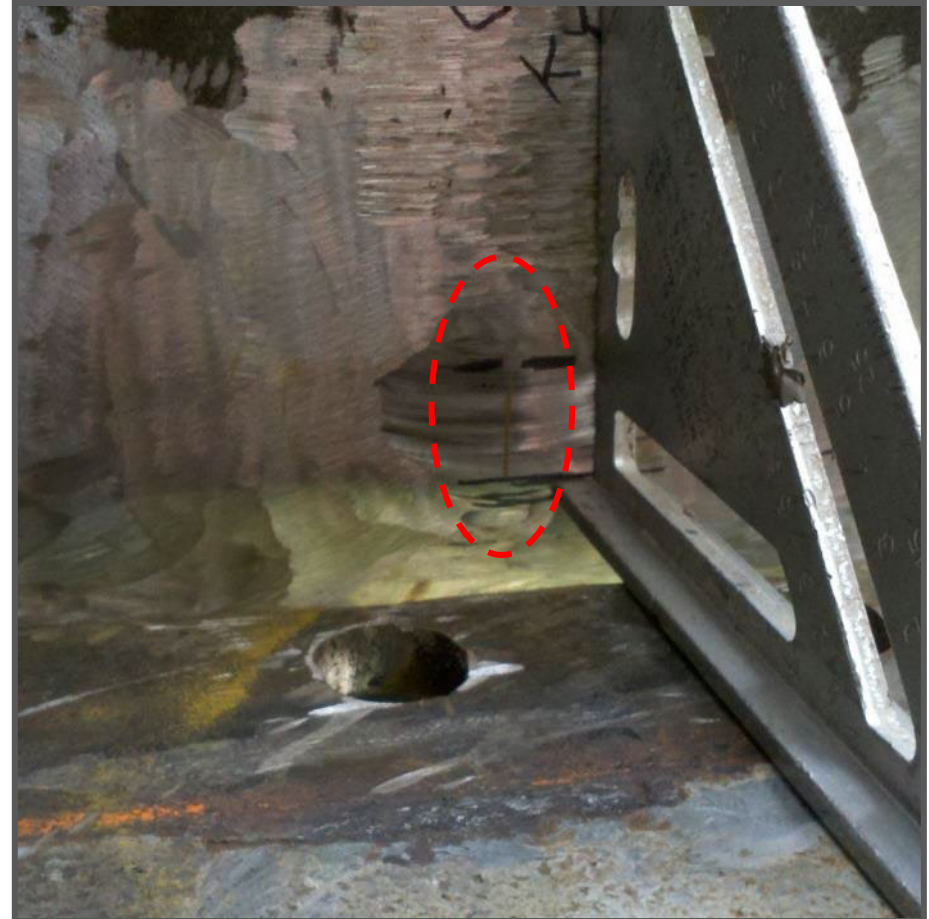
Fracture mechanics predicted crack was a critical size for brittle fracture if ambient temperature dipped below 30 °F.

- Removal of 3rd lateral gusset plate found a discontinuity of concern. Bridge closed Friday, Sept. 9, 2011.
- Bridge remained closed for 5 months to complete repairs

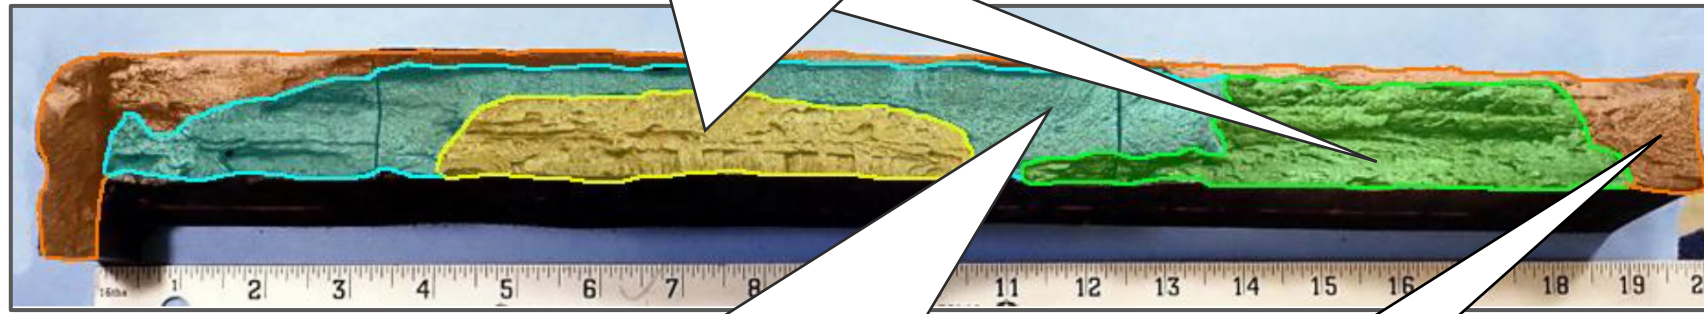
Hernando de Soto Bridge – Fracture Surface

Yellow and green regions were surface breaking hydrogen cracks from fabrication. About 6.5" x 1" and 5" x 1.2".

Pink region was 3rd brittle extension. Happened after 2019.

Blue region was 1st brittle extension sometime after fabrication. Broke surface on inside of box, not outside.

Orange region (both images) was 2nd brittle extension. Broke through outer box surface sometime before 2016.

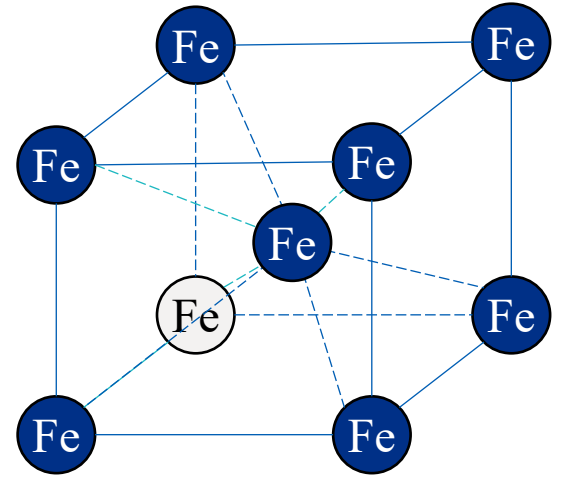
- Hydrogen likes to be a molecule (H_2).
- Energy from welding dissociates H_2 into two atomic H's.
- Atom hydrogen (H) can easily move through a metallic crystal.
- Reconstituting H_2 in the crystal causes internal stress and cracking.

Migrates toward tensile stress....

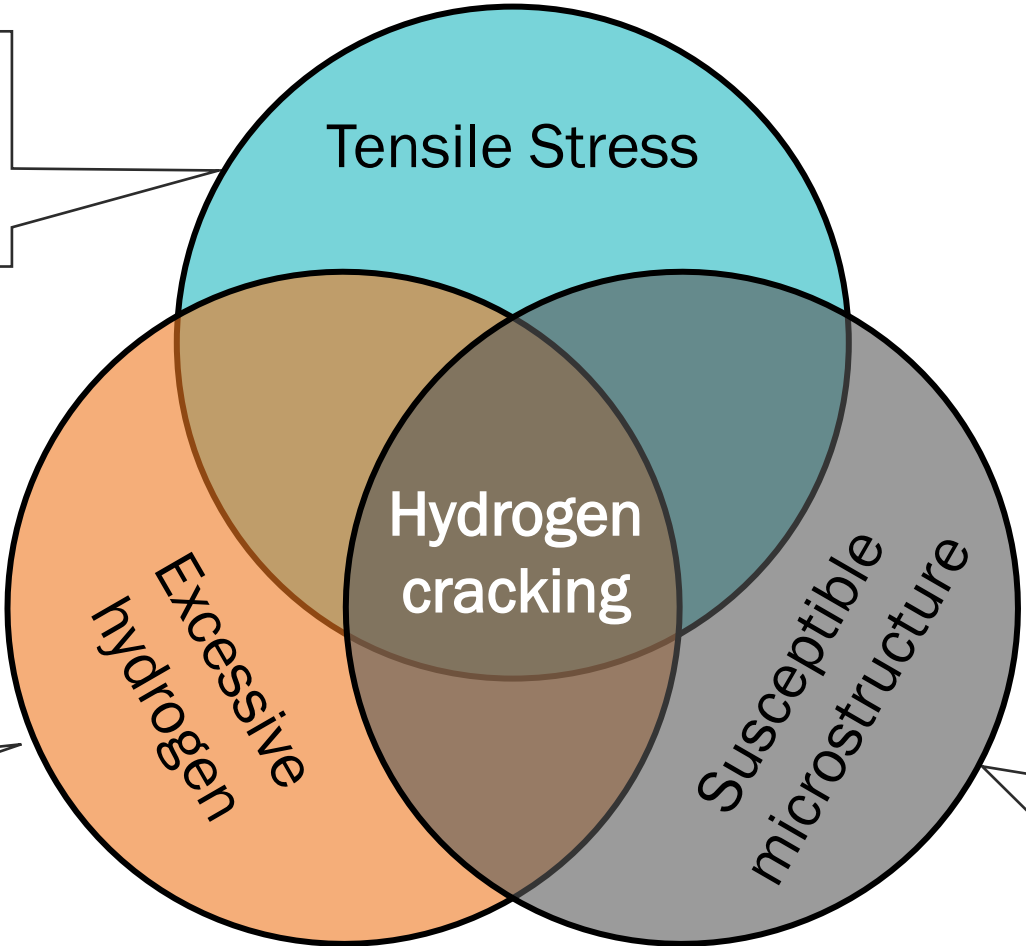
It's a weld, there will always be tensile residual stress. Restraint also influential.

This can be controlled in fabrication.

Q&T steels are tempered martensite, martensite is susceptible. Weld procedure also influential.
