Tech Brief:

# **Insulated Pavements for Low-Volume Roads**

1. Report No. FHWA-HIN-21-013	2. Government Accession No.	3. Recipient's Catalog No.	
4. Title and Subtitle Insulated Pavements for Low-Volume Roads		5. Report Date March 18, 2021

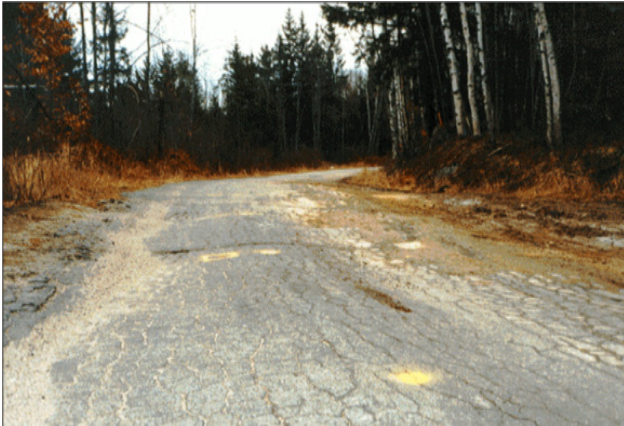
*a. York Pond Road, White Mountain National Forest, New Hampshire.*

*Figure 1. Low-volume road damage due to springtime trafficking, and company whose livelihood depends on transport of goods on these roads.*

Incorporating a layer of extruded polystyrene between the subgrade and base course can provide a cost-effective alternative for preventing damage from frost action in situations where utilizing non-frost-susceptible materials for road construction requires long-distance hauling or where constructing a drainage system is impractical. This layer prevents freezing temperatures from penetrating into the subgrade. As a result, the pavement structure will never undergo frost heaving or thaw weakening—with thaw weakening being a major cause of road damage from springtime trafficking, as shown in Figure 1a.

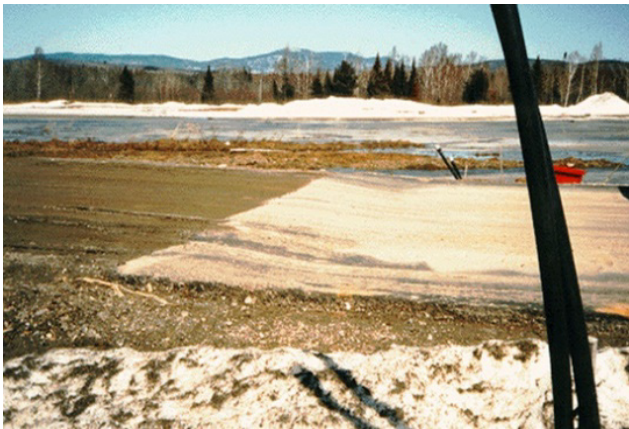
*a. Example of heave as a result of no insulation.*

*Figure 2. Transition from non-insulated to insulated road.*

For both sites, contractors placed a 16-foot-long section of 1-inch-thick extruded polystyrene panels to transition between insulated pavement and adjacent conventional, non-insulated pavement. This transition section prevents abrupt discontinuities in surface elevation during the winter when non-insulated pavement heaves from frost action.

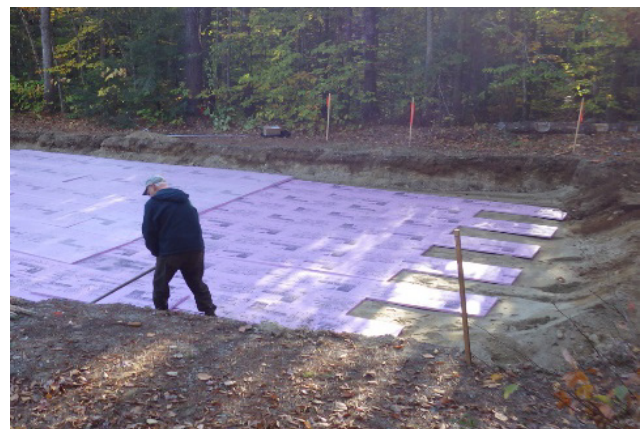
*b. Panel insulation at site.*

A crew of Forest Service and NPS representatives placed the panels by hand, in a staggered configuration as shown in Figures 2b and 3b.

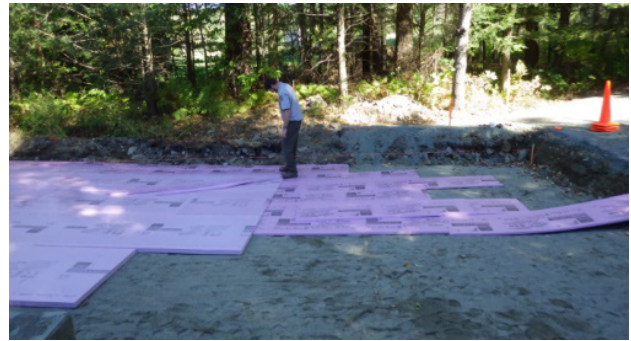
*b. Panel placement.*

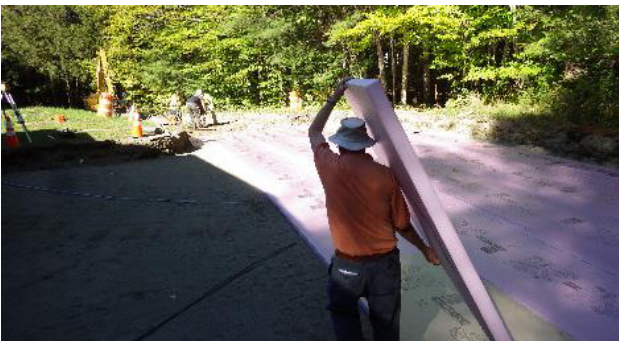
*c. Placing insulation panels.*

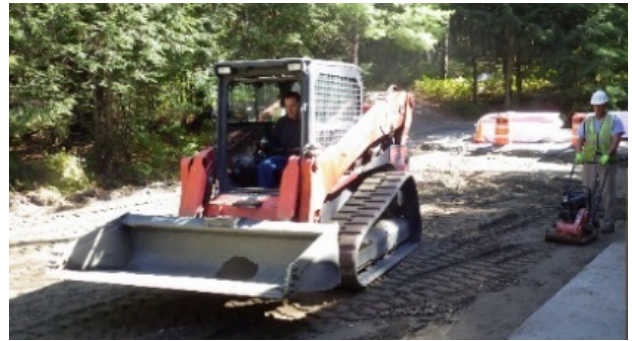
*d. Compacting base course atop insulation panels.*

In addition to working particularly carefully to prevent panel displacement, the contractors used added care in placing and spreading the aggregate base course atop the panels to prevent crushing of the panels, as that would compromise insulating ability. Lifts were placed in the same manner as for standard road construction, except the first lift was slightly thicker to ensure no risk of panel integrity.

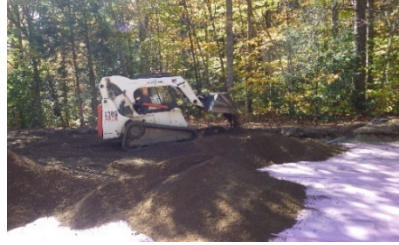
*b. Spreading gravel base course.*

The construction contractor used care in placing and spreading the aggregate base course atop the panels to prevent crushing and ensure insulation capacity was uncompromised. Lifts were placed in the same manner as for standard road construction, except the first lift was again a little thicker than is typical to ensure no risk to panel integrity.

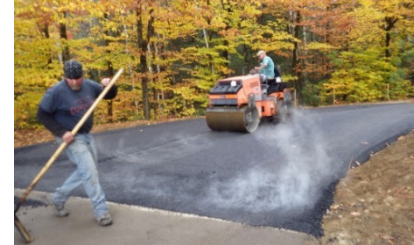
*c. Rolling asphalt surface during construction.*

Once the contractors placed and compacted the gravel base course, they used hot mix asphalt to pave the sections of roadway.

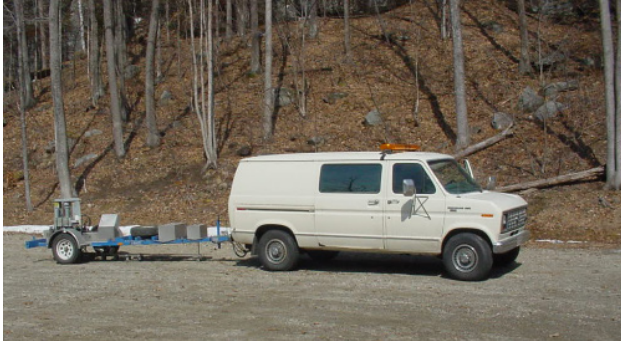
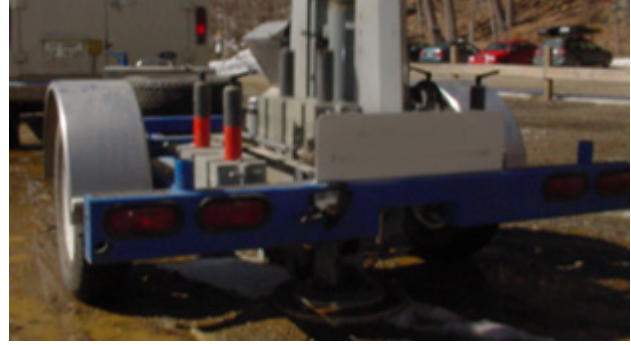
Figure 6. Falling weight deflectometer (FWD) (at a non-CTIP site in New Hampshire).

a. Van pulling a trailer that contains the falling weight deflectometer on a gravel lot.

b. Close up of the back of the trailer holding the falling weight deflectometer.

The FWD, a sophisticated but commonly used pavement testing device, simulates a moving wheel load and can be used to determine a variety of indices that directly or indirectly quantify pavement modulus or stiffness (Figure 6). For this study, we used an FWD to monitor seasonal variations of pavement stiffness for all test sections and chose to use impulse stiffness modulus (ISM), which is simply the ratio of applied load to maximum deflection under the load place, to measure stiffness in each section over time.

- Approximately three seating drops
- Four drops each from four heights, for a total of 16 drops
- 9,000+/- pound load to be within the approximate center of the load range
- 12-inch load plate
- 1-foot spacing between sensors

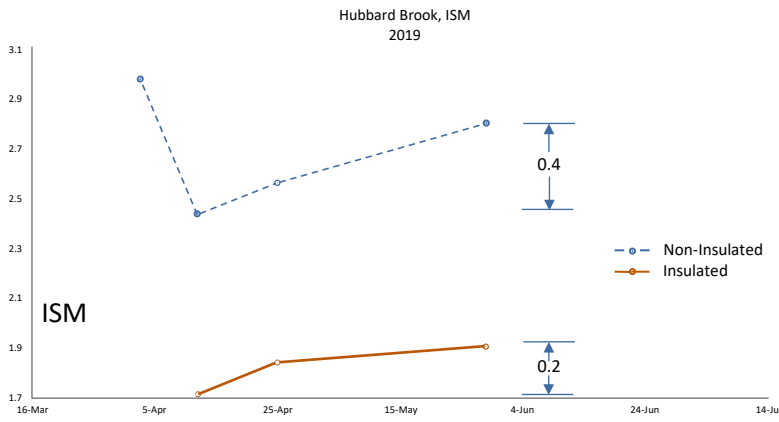
b. ISM for insulated and non-insulated pavements at Hubbard Brook.

Although the difference shown at Hubbard Brook was not as significant, insulated pavement still showed twice as much range, i.e., 0.4 for non-insulated pavement and 0.2 for insulated pavement. It is also clear that the difference will continue to grow as recovery continues (non-insulated pavement had not approached leveling out, as shown in Figure 7), and added FWD tests would need to be conducted into the summer, when full recovery occurs.

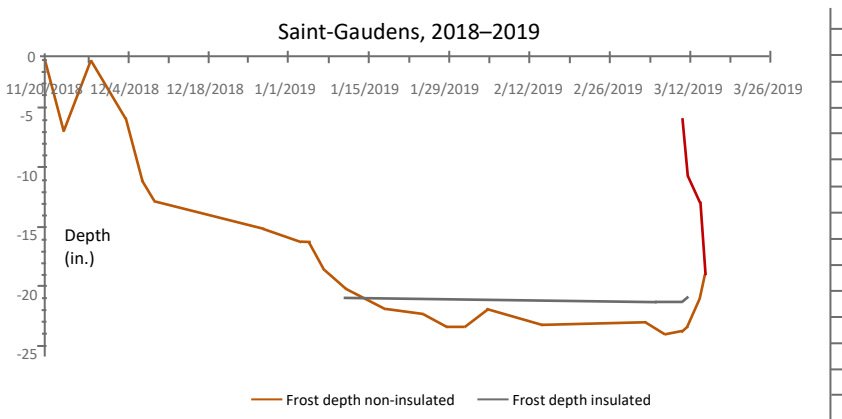
a. Frost penetration/frozen layer through time at Saint-Gaudens.

While frost penetration may not necessarily be considered a performance measure, it is still a feature that does help demonstrate the benefits of incorporating insulation in a pavement, as reflected by other performance measures (heave and stiffness). Figure 8 shows the effect of a layer of extruded polystyrene on the thermal regime of the pavement structure for the two sites for the 2018–2019 winter. Note the 32-degree isotherm is essentially held back within the insulating layer for the insulated sections whereas frost penetrated to greater depths in the conventional, non-insulated pavement. It just so happens that frost depth was not deep enough at Saint-Gaudens for insulation to have made much of a difference during the winter monitored. However, the effect is more pronounced at Hubbard Brook, a little further north, where the frost depth was somewhat deeper. Nevertheless, in both instances, the insulation prevented the frost from penetrating into the subgrade, which is of course critical because frost in the subgrade is generally the source of freeze-thaw problems.

This is most likely attributed to the unfortunate fact that the winter during which frost heave was monitored just happened to be a warmer than a normal winter. We have already seen that at Saint-Gaudens, the frost penetration for the conventional pavement was only slightly deeper than the frost penetration for the insulated pavement during the preceding winter, 2018–2019, which was close to a normal winter. During a warmer than normal winter in this area, freeze-thaw was probably cyclical, and the frost was not deep enough or present long enough to be able to show any reduction in frost heave values for the insulated pavement. Although we believe that this is the most likely cause of the minor overall heave, and non-expected greater heave in the insulated section at Saint-Gaudens, other factors could also have contributed to these results. However, frost heave was so minimal overall, it is likely that all measurements were within a statistically insignificant range already.

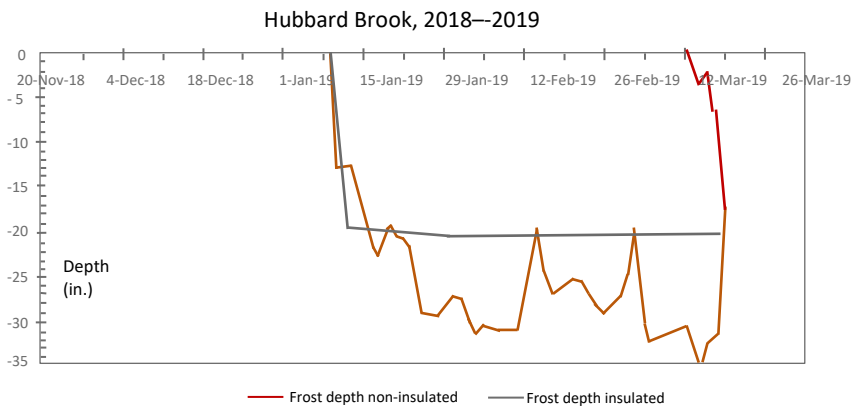
b. Frost penetration/frozen layer through time at Hubbard Brook.
