Hydrologic & Hydraulic News

June 2013
Vol. 1, Issue 1

Spring Rains Bring Torrential Flooding and Damage to the Midwest

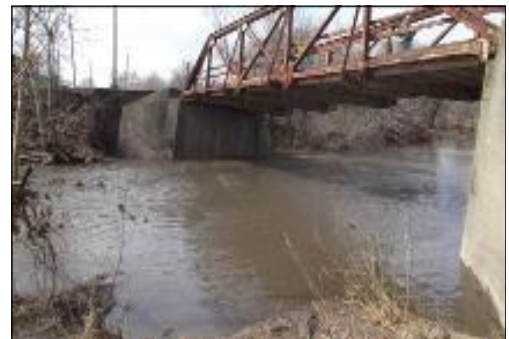
The Township Road 82 (Wilbern Road) bridge is an 80-foot long single span pony truss on closed abutments with spread footings set approximately 6 feet below the sandy streambed of Crow Creek. This bridge, built in 1932, has withstood numerous floods without damage. Longtime local residents reported that this flood, though, encroached on the truss to an elevation higher than ever seen during the life of the bridge. Such flood elevations likely produced pressure flow conditions that resulted in additional scour at the bridge causing both lateral and vertical movement of the south abutment and erosion of the approaches. The township dumped riprap at the north abutment during the flood and reduced damage to the north abutment and approach. After the flood, some of the riprap was observed downstream of the bridge on a sandbar.

View of Township Road 82 Bridge looking at South

The National Bridge Inspection Standards (NBIS) Item 113 code for this bridge was "8", presumably because of its long history of stability, so no defined Plan of Action (POA) existed. However, because of the severity of the storm the county actively monitored all bridges on Crow Creek. Due to the extent of damage, a total replacement of this bridge will be required.

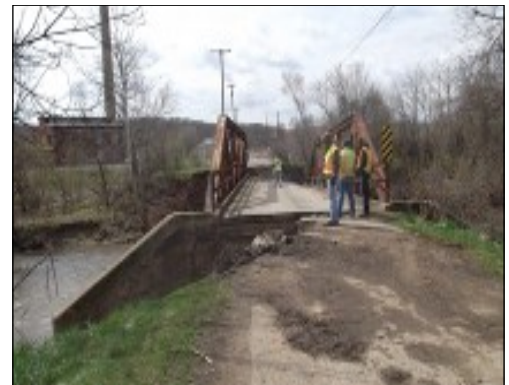
View of Township Road 82 Bridge looking at the South Abutment from on top of the road.

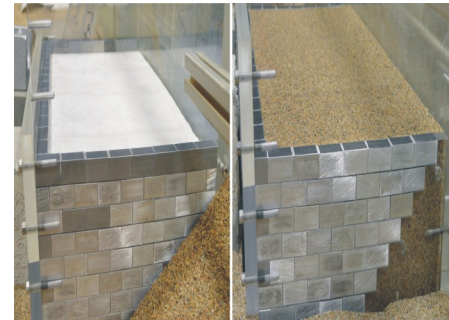
Researchers at the J. Sterling Jones Hydraulics Research Laboratory (HRL) currently are testing the performance of shallow foundations using a scaled model of a Geosynthetic Reinforced Soil (GRS) vertical-wall bridge abutment. The GRS-abutment is seated on a

shallow reinforced soil foundation (RSF) composed of granular fill material compacted and encapsulated in a geotextile. The settlement and external stability (deformation) of the GRS-abutment is monitored with a laser distance sensor.

GRS-Abutment Model

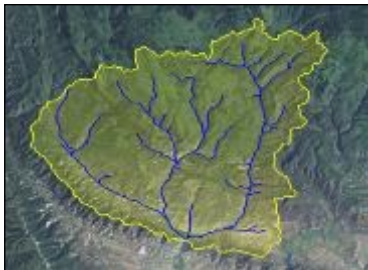
New release of WMS (Watershed Modeling System)

WMS version 9.1 has many new feature upgrades and bug fixes. Some new features include:

- Improved Online Data Tools – links to new sources of online images, maps, and data
- Coordinate Projection on the Fly – all data imported to WMS is automatically converted to the specific project projection
- DGN, DWG, and other

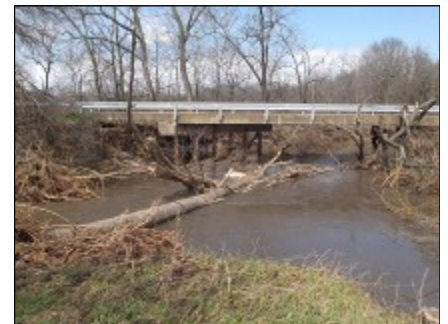
Township Road 68 bridge, downstream of the Township Road 82 bridge on Crow Creek, was also inundated during the flood. The bridge is a 162 foot long, three span deck beam bridge on stub abutments in sand and was built in 1983.

During the flood, water flowed against the deck beams and large debris partially choked the opening. The bridge experienced little apparent scour or damage, in part due to the low lying approaches that provided relief

to flood flows. The abutments did not have riprap countermeasures but were not significantly damaged since they were somewhat protected by the old abutments that were left in place 30 feet upstream.

Both approaches were extensively damaged by overtopping flow.

Upstream View of Bridge

watched closely during the flood. Further post flood and debris removal inspections will determine the extent of scour and if repairs or countermeasures are needed at the piers or abutments.

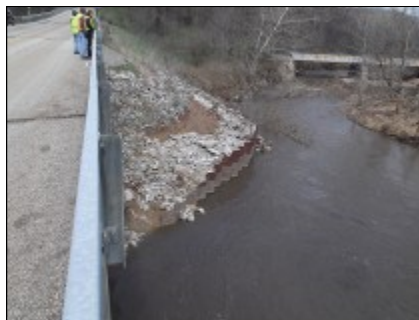
The FAS Route 371/County Highway 12 bridge is a 3-span open abutment structure located on a sharp right angle bend of Crow Creek located one mile upstream of the Township Road 82 bridge. Riprap armoring on the embankment slope above the sheet pile toe on the inside of the bend was lost during the flood. Riprap was also lost at the abutment on the opposite stream bank. No sign of a filter was seen under the riprap at either location. Some bank erosion was

observed on the downstream side of bridge but no apparent scour or other damage was observed.

View of Upstream Abutment Cone

The railroad shown in the background suffered an embankment slide failure and

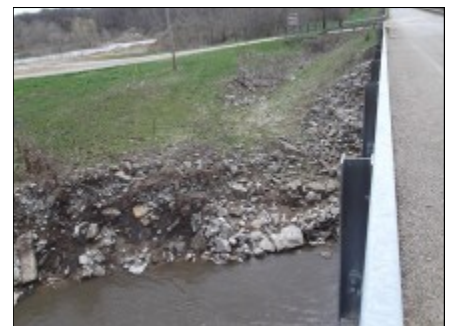
View of Upstream Face Outside Bend

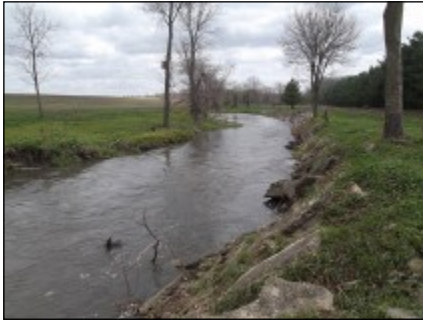
bridge, approximately 3 miles further upstream on Crow Creek, consists of a 131-foot long, 3-span slab bridge on spill through abutments.

View of Straight Alignment Upstream

During the flood, one abutment scoured and the concrete pile foundation was exposed. The soil at this site was a silty sand and the

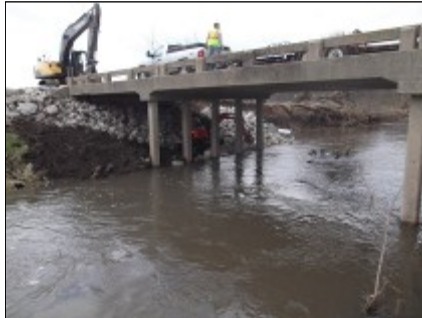
View of Riprap Placement on Abutment

There were signs that broken concrete had been placed along the south upstream bank because of prior bank erosion.

Riprap was being placed to fully armor the abutment cone during our site inspection. The stone was being

dumped off the corner of the abutment and then positioned with a bobcat underneath. A granular bedding was used under the riprap instead of a geotextile filter.

This structure had an NBI coding of “8” for Item 113. It will be reevaluated based on this recent flood event.

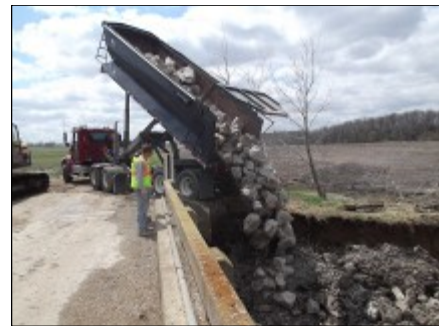
View of Riprap Being Dumped

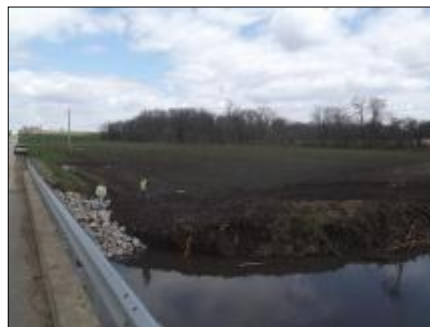
FAS Route 2368/County Highway 19 bridge over Big Sandy Creek is a 119-foot long 3-span deck beam bridge on spill through abutments with concrete piles. During the flood, scour exposed the piling at the north abutment.

The stream bed soil at this site is a silty sand. The stream alignment immediately upstream of the bridge was straight but then turned 90 degrees to the north for several hundred yards resulting in the stream and floodplain

flowing parallel with the roadway embankment. This over-bank flow paralleling the embankment at a high velocity and requiring a sharp turn at the abutment is the probable cause of the abutment scour.

View of Upstream Channel and Floodplain

Riprap was placed at the abutment to repair the scour. Installation of a guide bank could further protect the abutment from future scour.

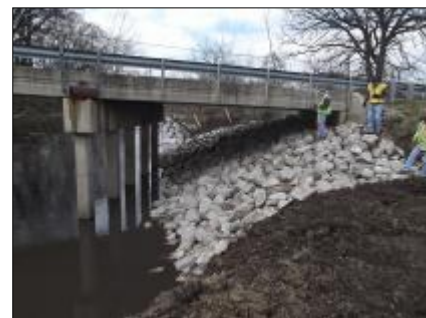
View of Riprap Armor at Abutment
