**Michigan Department of Transportation  
Accelerated Innovation Deployment (AID) Grant  
Final Report – May 22, 2015**

Grand Region Bridge Slides  
Lessons Learned

## 2 US - 131 over 3 Mile Road

### 3 M-50 over I-96, Lowell Township, MI

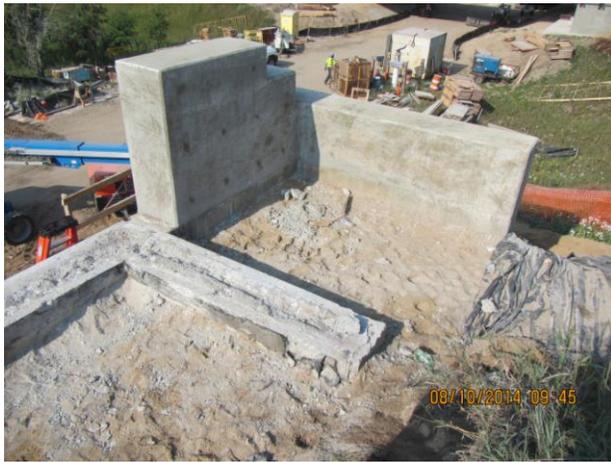
Figure 2 - Extension of abutment with new wing wall

spread box beams with a dependent backwall. The existing abutment top surface was not modified but the abutments were widened to provide a wider shoulder on the structures.

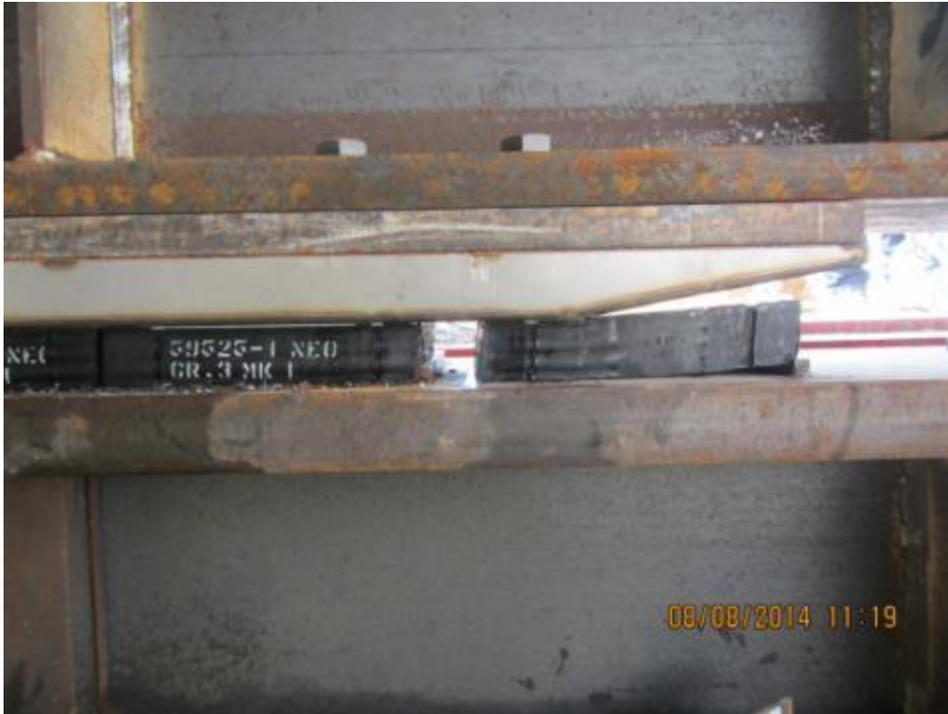
- Shoving – this was where the slide shoe would push the elastomeric bearing along the railing girder. This was due in part to lubricant getting between the bearing and beam. In addition, the PTFE surface was not dimpled; so much of the lubricant was squeezed off the surface. This allowed the bearings to be shoved along the beam as shown in the photo below.

**Lessons:** The issues experienced by the bearings are difficult to quantify empirically from a stress and force perspective. However, it is apparent that the bearings are resisting substantial shear forces. In addition elastomeric bearings are not traditionally designed or expected to function in this manner so the design and detailing must take into account the effects of the shear forces as well as the variances in structural steel fabrication tolerances. From our field observations, several modifications should improve the bearing performance:

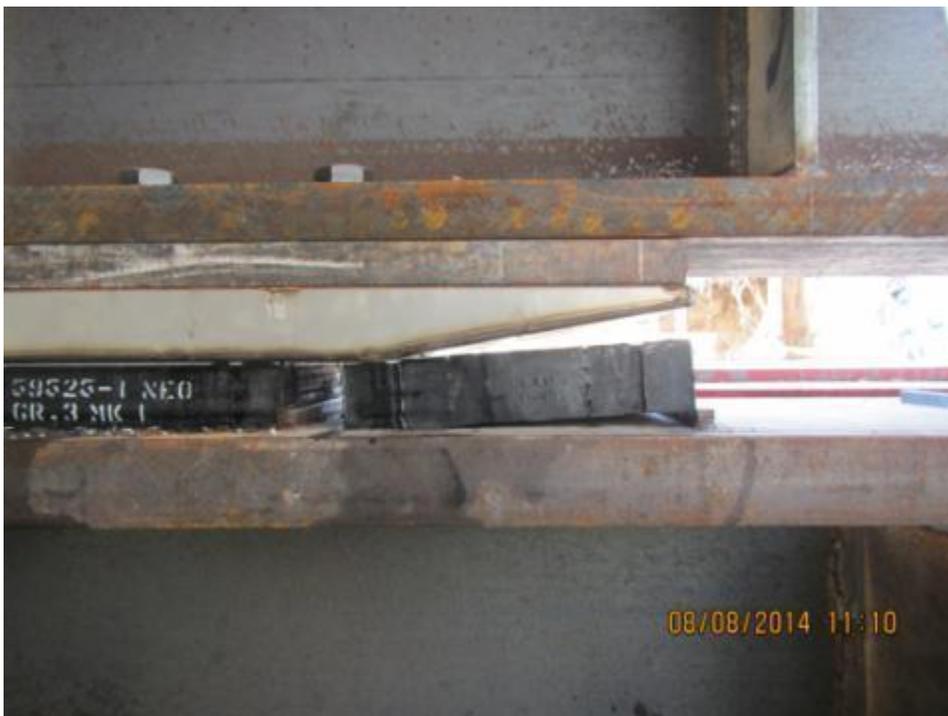
- Tipping – when the slide shoe began to load the temporary bearing the leading edge would tip up as shown in the photo below. This was caused by the bearing being compressed up to 1/8” under load, so as the tapered end of the shoe came in contact with the next bearing that was not compressed it tipped and pushed the bearing. The combined tipping and shoving action caused the bearing to ride up onto the 3/8” keeper bar.

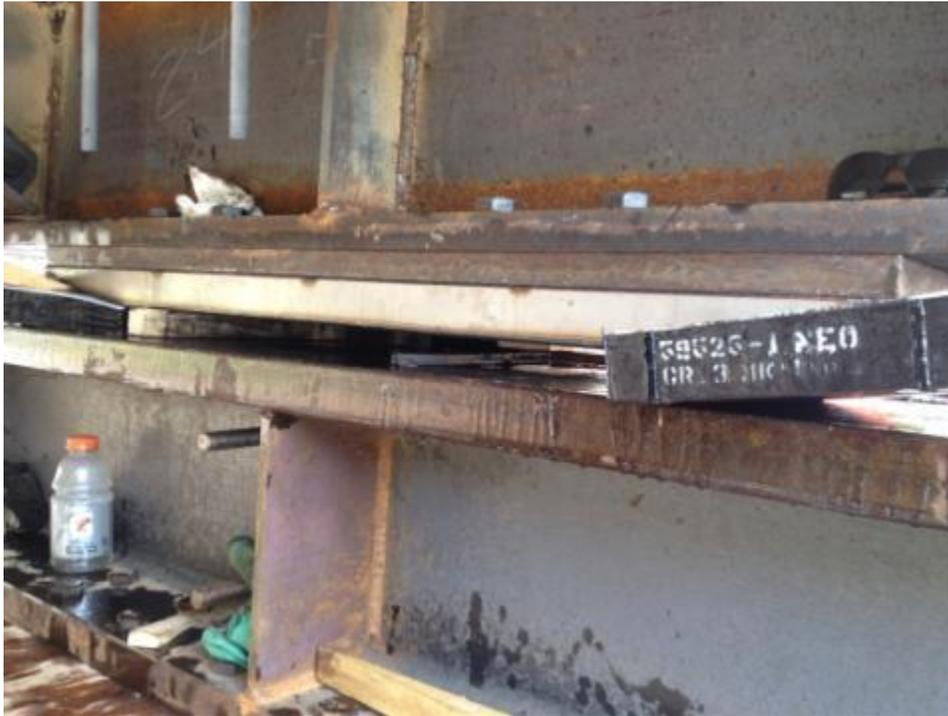
- Expulsion – in one extreme instance the shoving and tipping combined to expel three temporary bearings out of the side of the slide shoe.

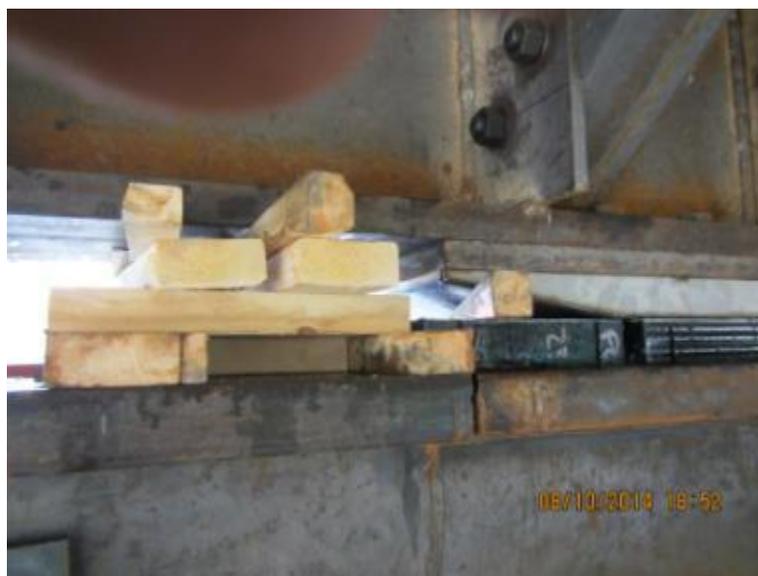
Retaining the bearings due to the shoving and tipping action took a substantial amount of manpower and effort including blocking and wedging as shown in the photo below. In addition the 10" dimension required that the contractor "leap frog" the temporary bearings, which also took a lot of manpower.

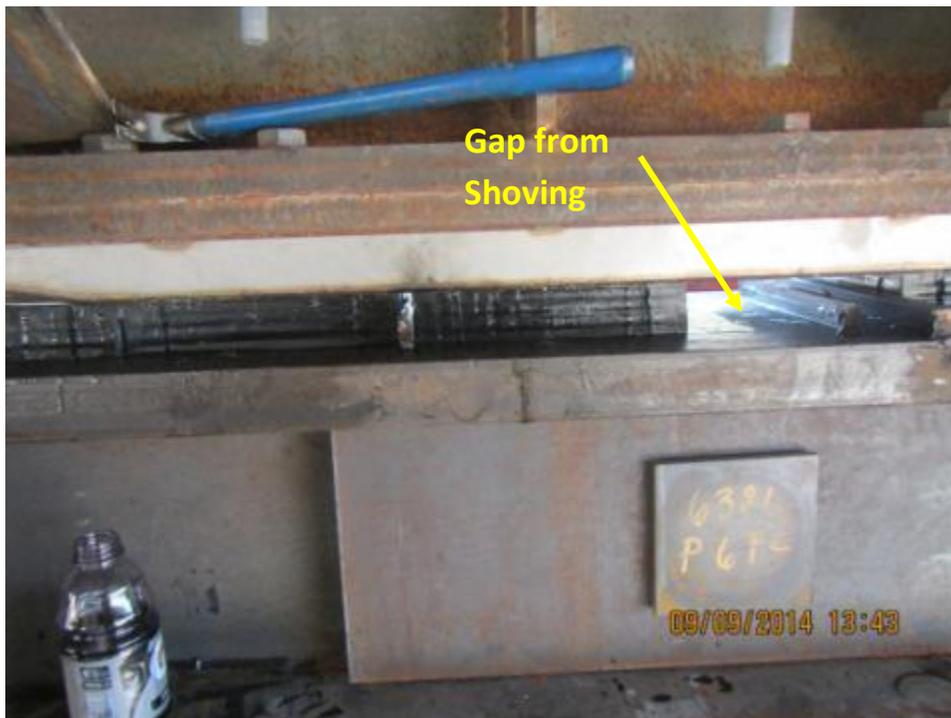
After the experience on the northbound structure the contractor increased the keeper bar size to 1" and bearing length to 20", but did not use a dimpled PTFE surface.

These modifications improved the bearing performance but some shoving and breaking of the welds still occurred.

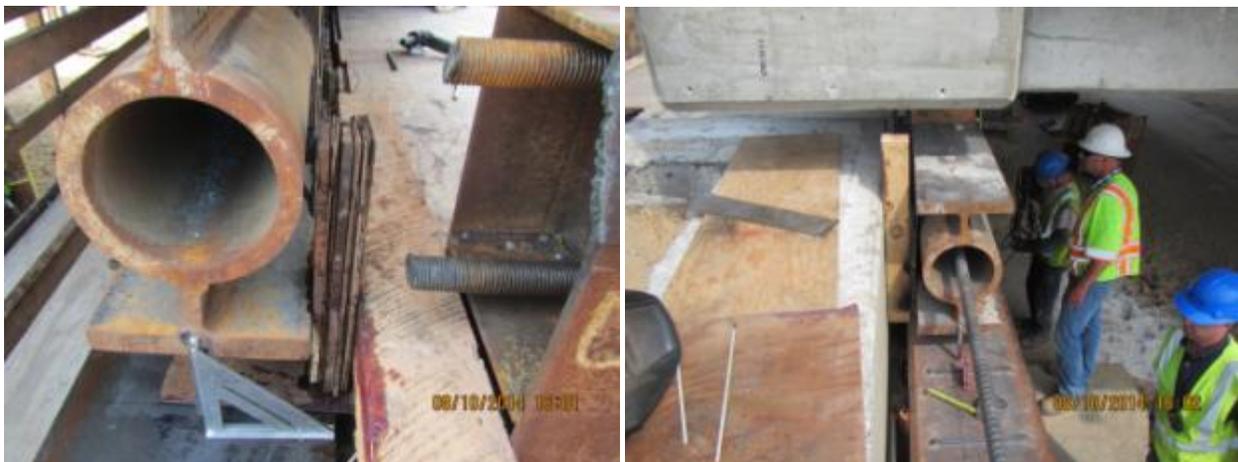
The roadway profile for the bridge was less than one percent grade from north to south, however, the northbound bridge began to drift north during the slide (against the slope). The drifting is likely due to slight imperfections in the flatness and/or straightness of the temporary works. There were no deviations out of specified construction tolerances in the slide specification (cross reference to the 2012 Standard Specifications for Construction section 706.03.M.4). For the northbound slide the contractor used pancake hand jacks to reposition the structure longitudinally, then steel and wood shims to keep the structure traveling within tolerances.

**Lesson:** Provide a lateral drift restraint system. Note that it is critical that the lateral drift system be constructed such that there is a sufficient gap such that racking and binding of the structure cannot occur.

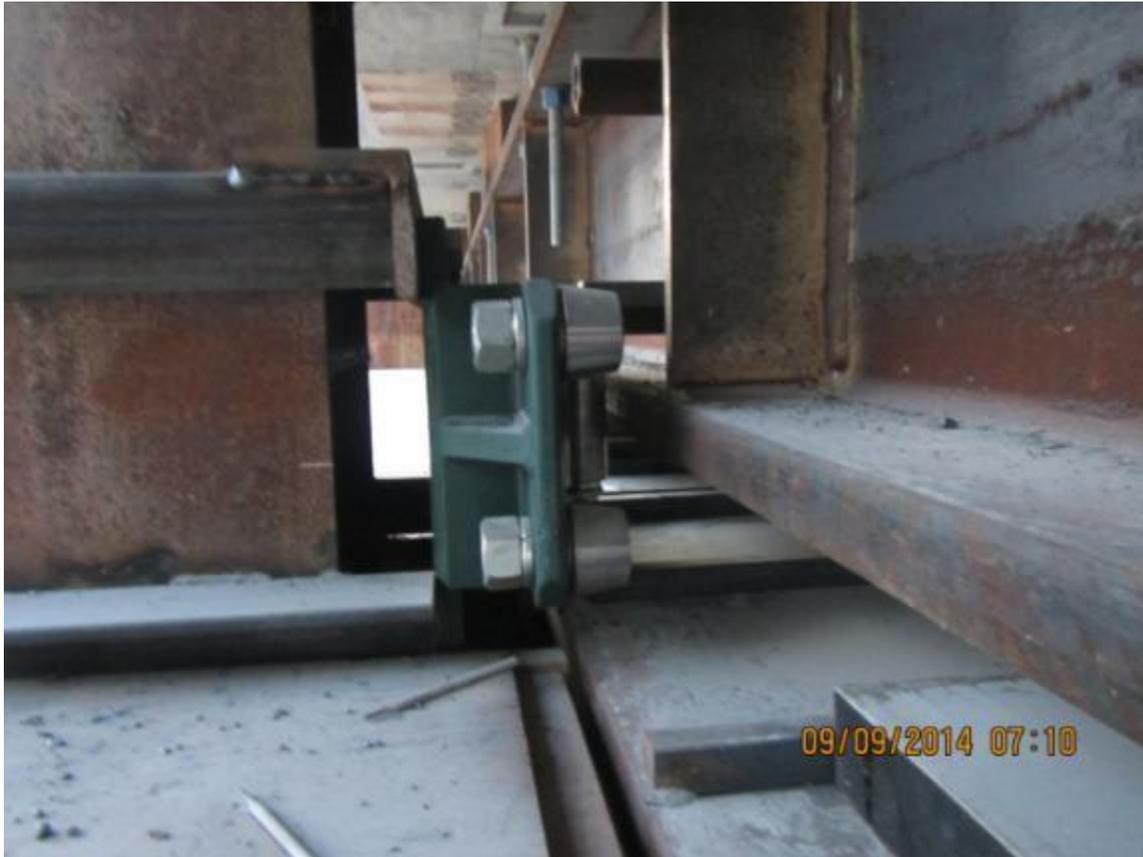
For the southbound structure the superstructure drifted down grade slightly. However, the contractor had developed a Hillman roller assembly on the temporary piles and a Teflon slide bar on the abutment to keep the superstructure in line. The system was constructed such that there was a 2" gap between the restraint and the slide system at each end of the bridge to prevent racking and binding. This system functioned very well.

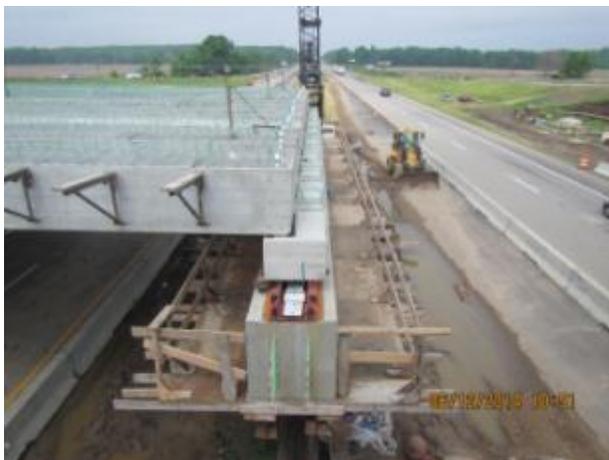
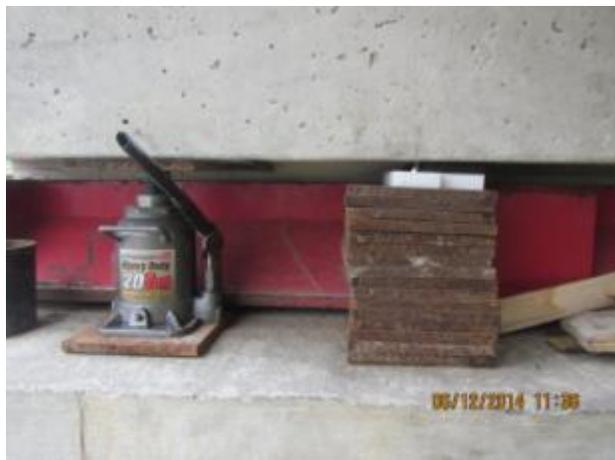
The Span 1 concrete box beams were erected on a precast transverse beam, which were later cast into the diaphragm with the deck pour. At the abutment the beams were set on the centerline of bearing, however, at the pier the beams create an eccentric load until the concrete box beams for span 2 are erected. The piers were checked for the eccentric load, but the method of temporary support was not specified, since it was within the contractor's means and methods. The contractor attempted to counteract this eccentric load using plywood blocking, which was insufficient. The contractor then had to use bottle jacks to right the beam, and steel/plastic shims.

**Lesson:** Ensure that contractor provides detailed erection plan, review full erection plan, and provide oversight of contractors operations.

Another option to this issue would have been to provide vertical tie downs between the transverse beam and temporary pile cap. This would have restricted any movement or rotation of the transverse beam around the temporary bearings. These temporary tie downs could be left in place until the both beam spans are in place and the Contractor was ready to place the pier diaphragm tying everything together.

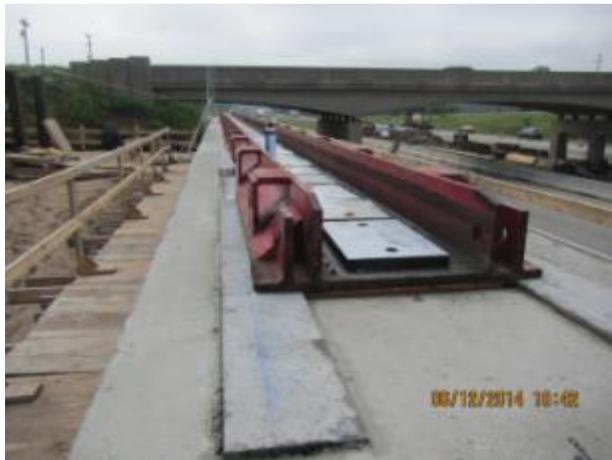
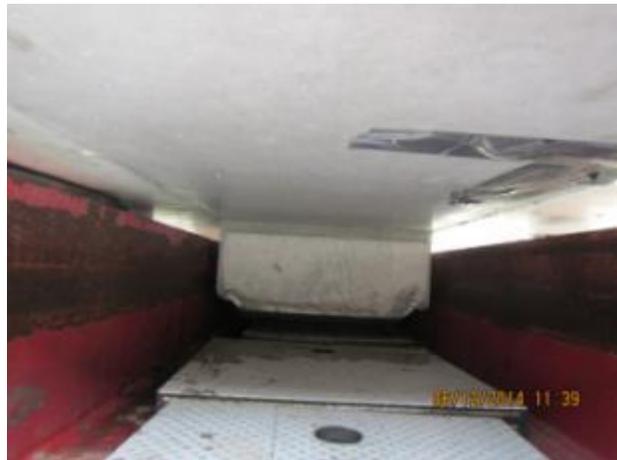
Temporary bearings consisted of a 10x12x1  $\frac{3}{4}$ " elastomeric bearing with dimpled PTFE surface. Permanent bearings consisted of 11"x4'-9"x1  $\frac{3}{4}$ " elastomeric bearing with PTFE surface. The bearings were designed for a 50 durometer hardness with internal steel plates. Permanent bearings were designed similarly. The Mammoet bearings sat inside the Mammoet sliding track and were restrained by a pintle. In order to eliminate vertical jacking, the bridge was constructed on top of the temporary bearings inside the Mammoet track.

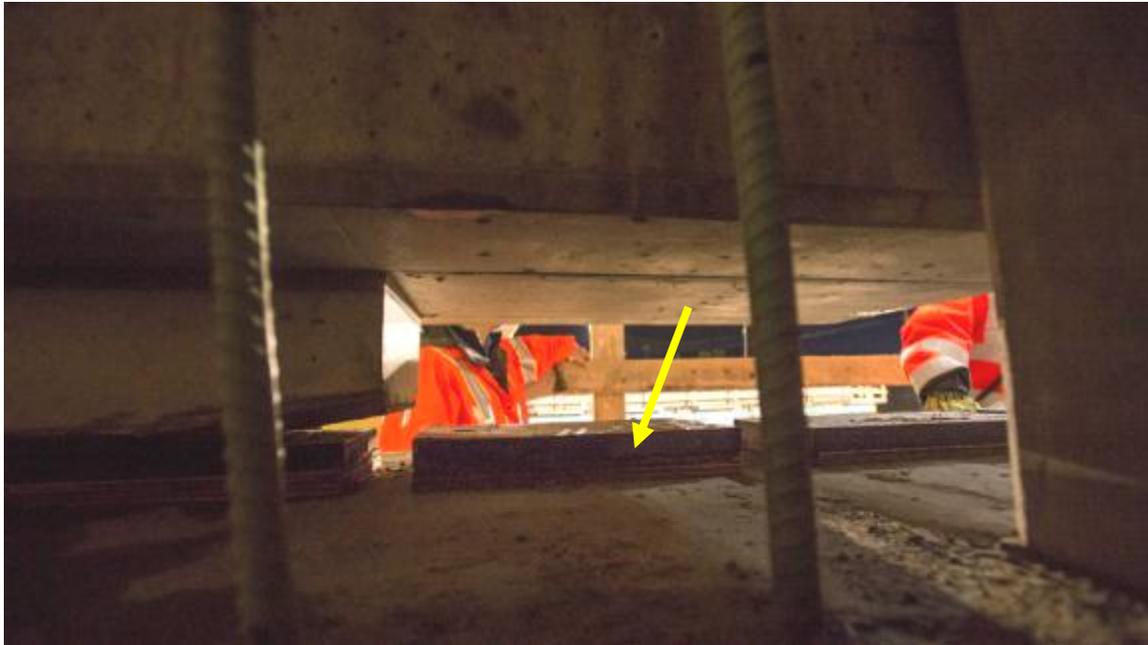
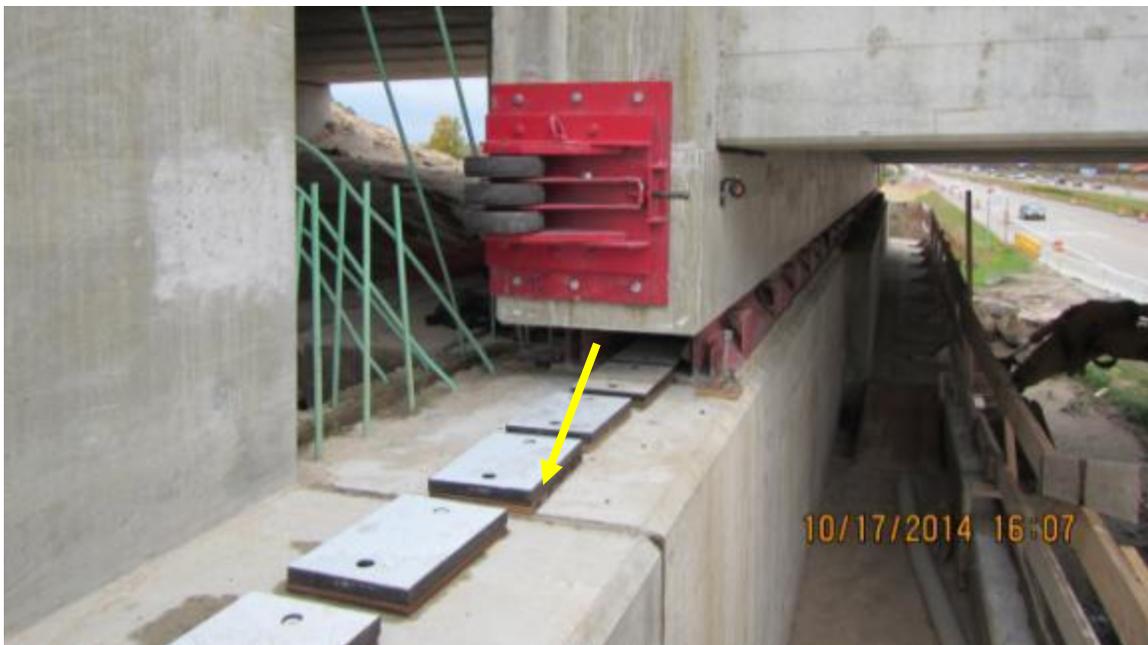
Mammoet requested to use their standard depth 1  $\frac{1}{2}$ " temporary bearing, which was approved. Since this bearing was  $\frac{1}{4}$ " thinner than the permanent bearings wood and steel shims were used. However, the plywood shims used swelled in the wet weather prior to the move, increasing their depth, and the steel plate shims placed on top of the plywood provided a secondary slide plane. Finally, the addition of the secondary slide plane combined with the lateral forces increased the moment force on the temporary bearing restraints. The temporary bearing restraints used a  $\frac{3}{4}$ " diameter mild steel threaded rod screwed into an anchor. Some of these rods bent and broke.

**Lesson Learned:** Coordinate with contractor to ensure consistent temporary bearing thickness.

As noted previously the bridge was constructed on the temporary bearings. In addition, as can be seen in the photo above, the Mammoet track left very little room between the top of the track and the bottom of the transverse beam. Therefore, all of the temporary bearings were placed in the track. This combination prevented the temporary bearings from being adequately cleaned prior to the slide. As the bridge was slid you could hear the grinding of dirt on the PTFE surfaces. Many of the PTFE sheets separated from the elastomeric, or were otherwise damaged, and the additional friction forces may have contributed to pintle damage (see discussion later). Apparently the dirt became embedded in the

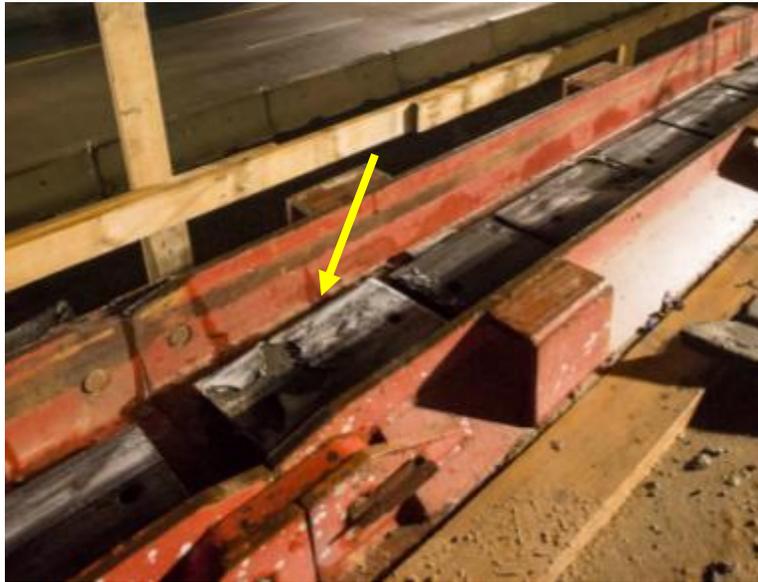
stainless steel surface as the grinding continued through the whole slide. In addition, the selected lubricant (Royal Purple) began to congeal in the low temperatures and rainy conditions so the contractor switched to common dish soap.

**Lesson Learned:** If bridge is constructed on temporary bearings provide adequate space to place and clean the bearings. Alternately, do not construct the bridge on temporary bearings. Use dish soap for lubrication.

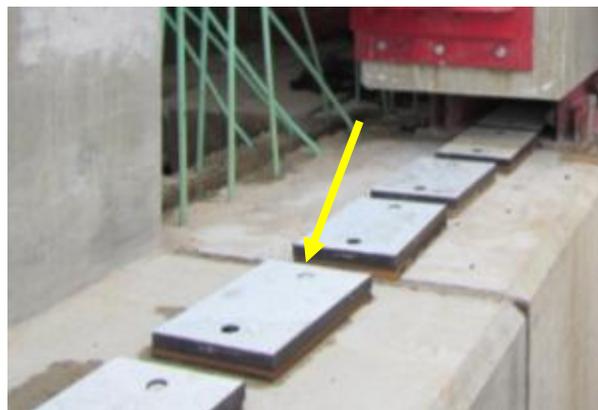
As noted previously, the temporary bearings were restrained using a pintle in the Mammoet track. The pintle was placed on the leading end of the bearing. This configuration eliminated the shoving experienced on the US-131 slide, as the bearing trailing edge would lift up but was restrained by the pintle as the slide shoe transitioned onto the bearing. The Mammoet track was not extended onto the permanent abutment/pier in order to eliminate the need to vertically jack the structure. The contractor elected to use a redhead insert with a  $\frac{3}{4}$ " diameter mild steel rod to restrain the temporary bearings. The permanent bearings were restrained by 1" diameter position dowel.

Several of the rods on the abutment were snapped off during the slide allowing the temporary bearings to shove. This likely occurred due to a combination of factors; the temporary bearing shims noted earlier; the dirt on the bearings; and, the weather conditions diluting the lubrication. All of these factors likely increased the coefficient of friction between the bearing and slide shoe creating a combination of shear and bending moment that broke the mild steel rods.

**Lesson Learned:** Temporary pintles diameter and material should match the permanent pintles. Keeping the sliding surface clean needs to be a priority to reduce friction during the slide.

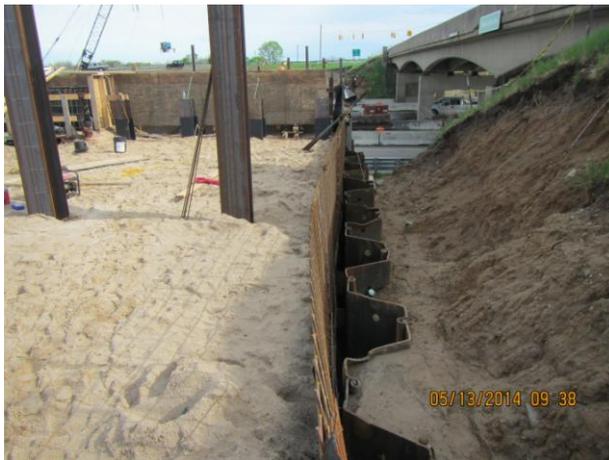
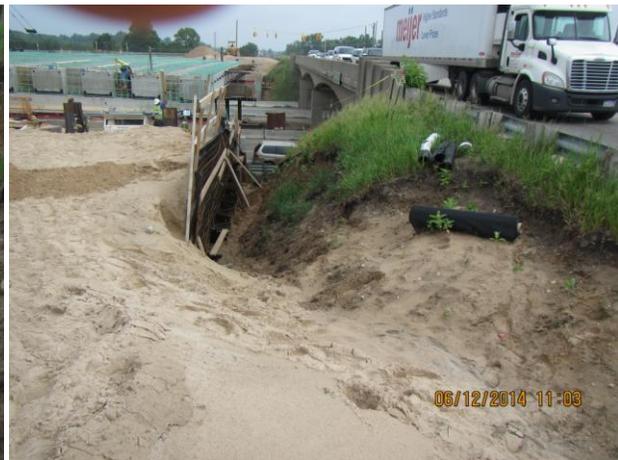
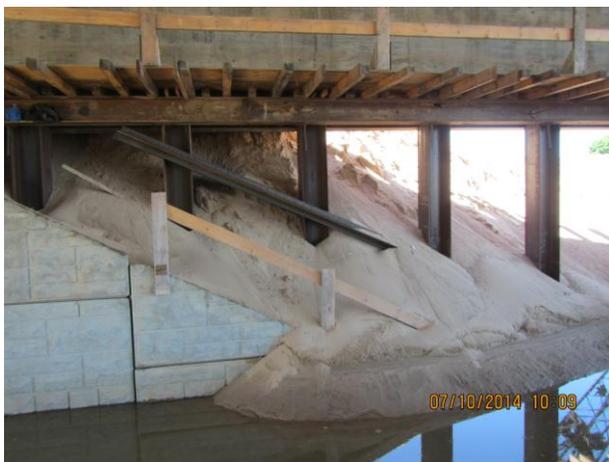
No drainage was specified between the construction of the temporary MSE wall and the existing structure. In addition, no temporary erosion control measures were specified.

**Lesson Learned:** Particular care must be given to the drainage of the roadway and erosion control measures during the temporary conditions.
