**Federal Highway
Administration**

Publication No. FHWA-HIF-22-043

Infrastructure Resilience to Extreme Events & Climate Change Federal Lands Sensitivity Case Studies

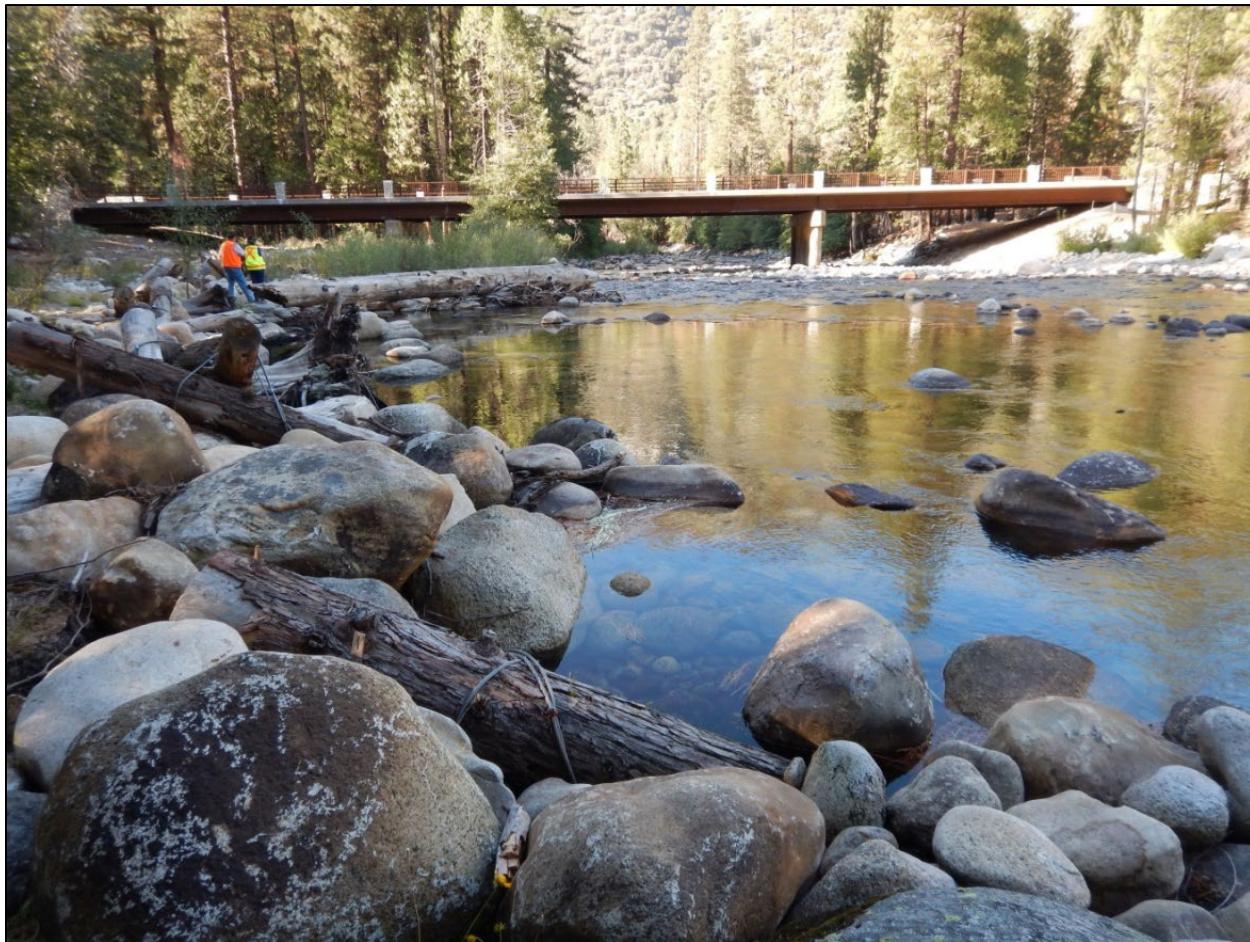
Figure 12. South Fork Kings River, Cedar Grove Bridge, view upstream of bridge.

Replaced in 2012, the Cedar Grove Bridge (Figure 12) is 280-feet wide and consists of three spans with two 3-foot wide piers; each consisting of three 3-foot diameter columns connected with a debris wall and 2H:1V riprap spill through abutments. The 6-foot thick bridge superstructure slopes at 0.5% downward to the west. Low chord elevations at the left and right abutments are 4,618.4 feet and 4,617.1 feet, respectively.

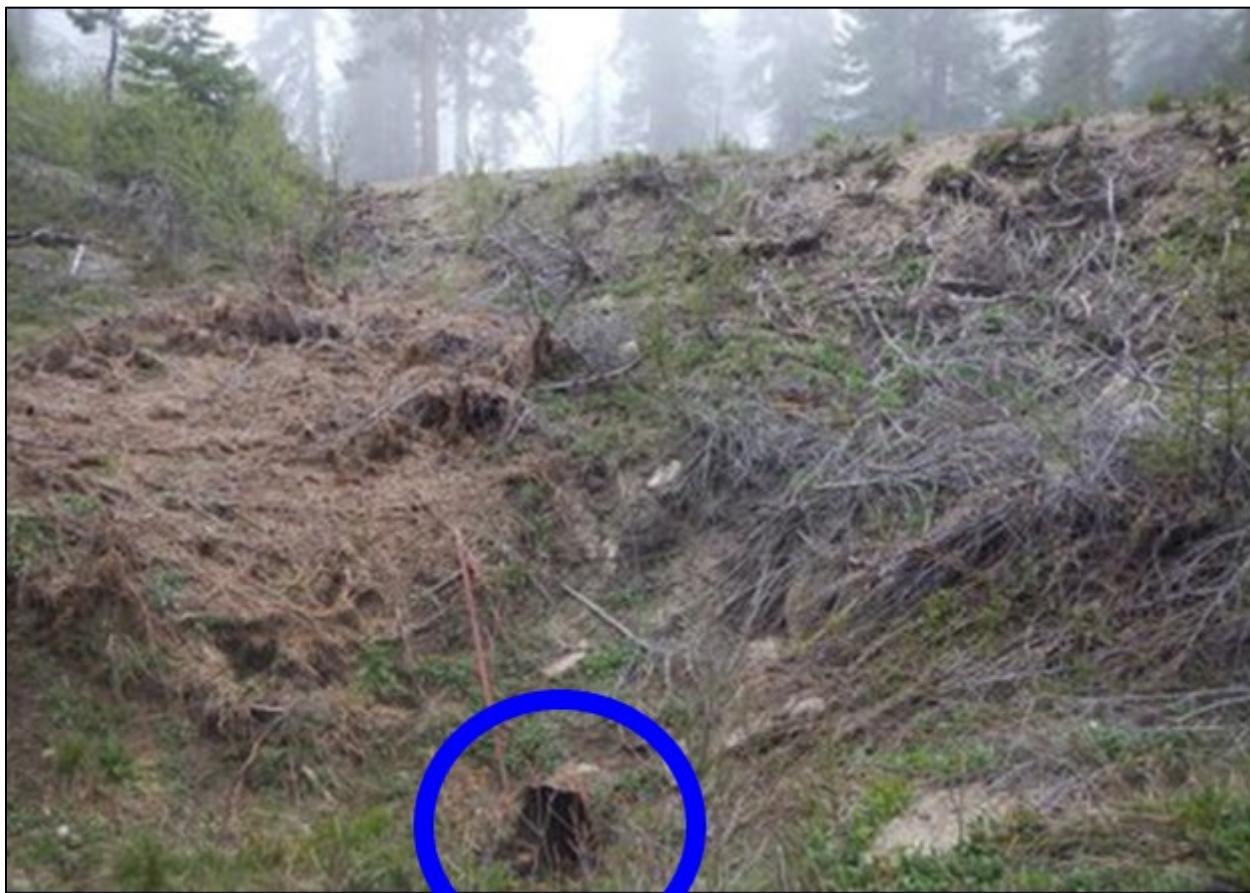
Figure 24. Outlet of Existing Culvert at the Wye.

As depicted by Figure 24, the culvert outlet is at the bottom of a steep roadway embankment. The site conditions would preclude use of traditional cut and cover approaches to culvert repair or replacement. However, the culvert may be a candidate for slip lining approaches.

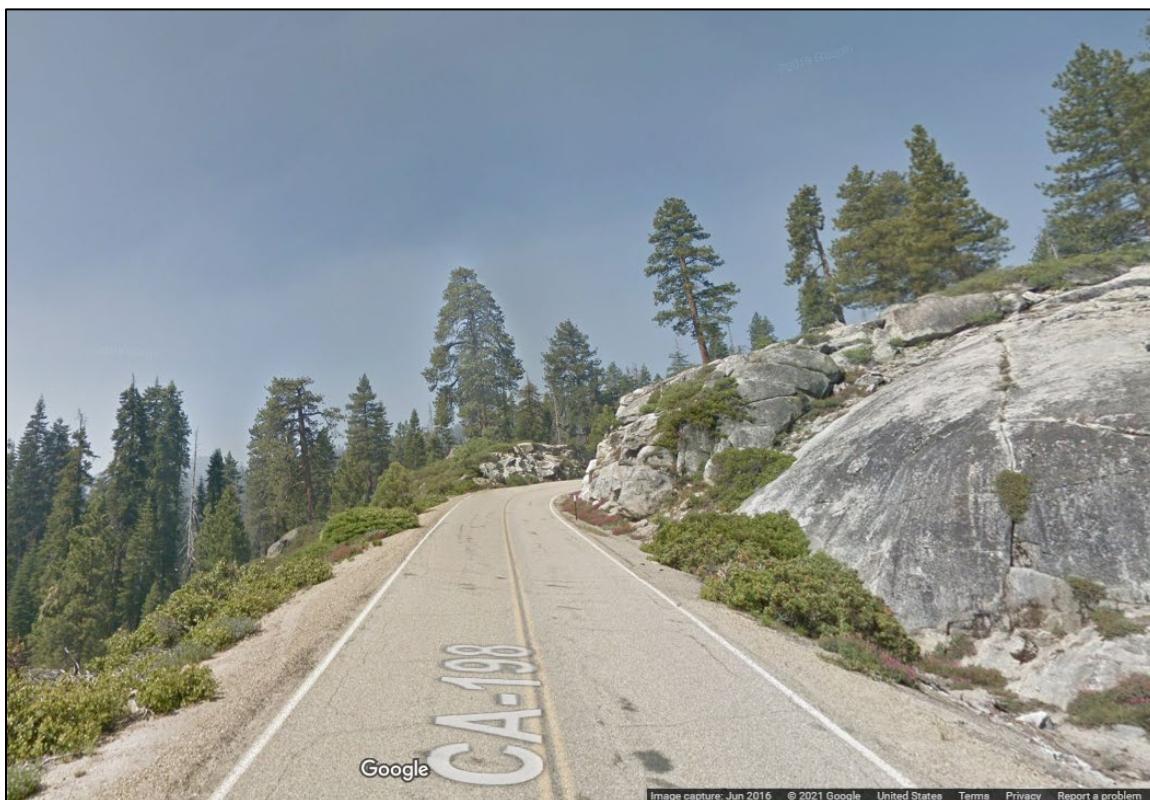
Figure 30. Looking southwest to depict slopes and terrain (Google 2021).

As depicted in Figure 29 and Figure 30, the project area in a mountainous region with land cover in the watershed is entirely forested with slopes over 10% and with rock outcrops that total less than 5% of the watershed area (Figure 30). The predominant soil type in the area is sandy loam (Hydrologic Soil Group B). The contributing watershed is approximately 5.7 acres.

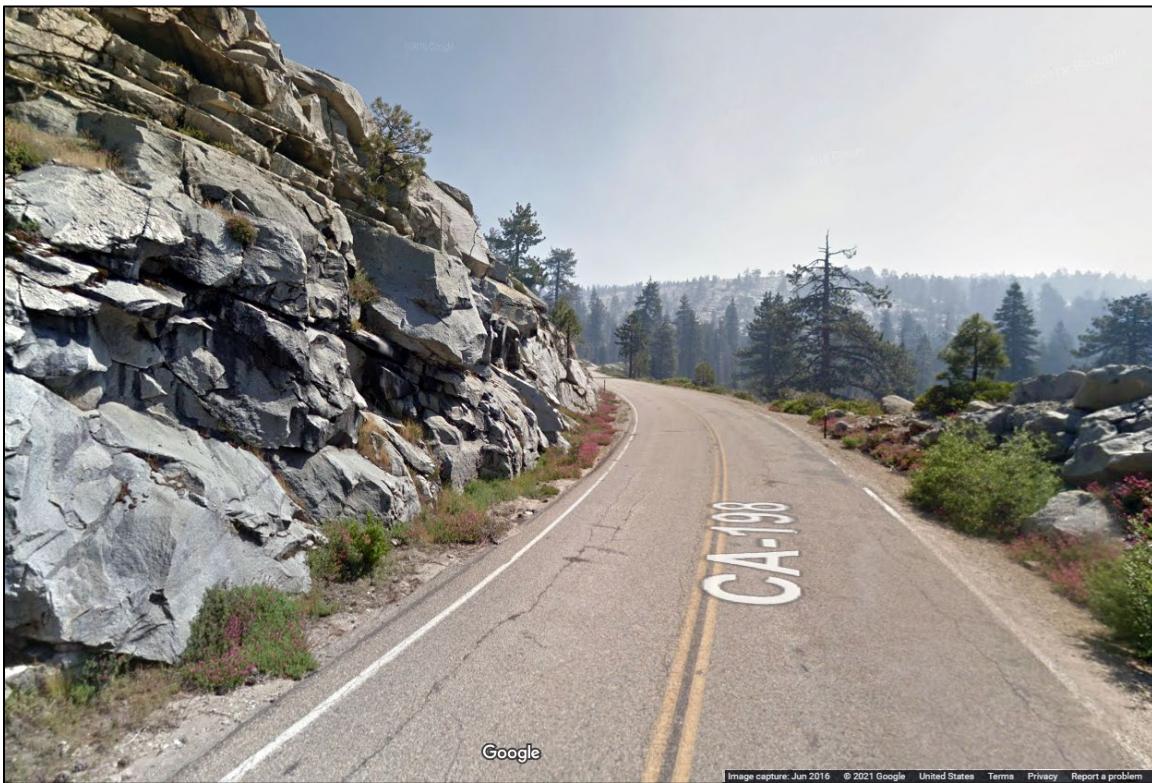
Figure 31. Looking northeast along north side curb and gutter (Google 2021).

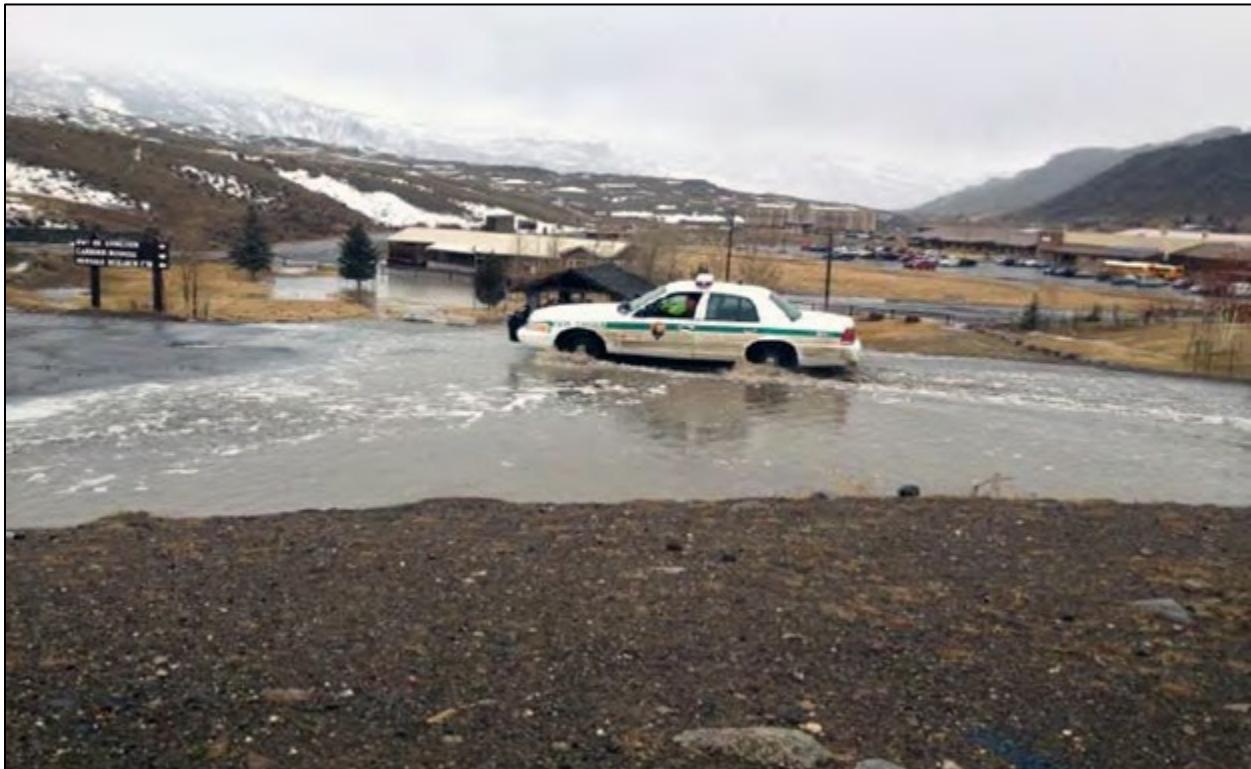
Figure 39. Runoff ponding at road profile sag west of the Arch.

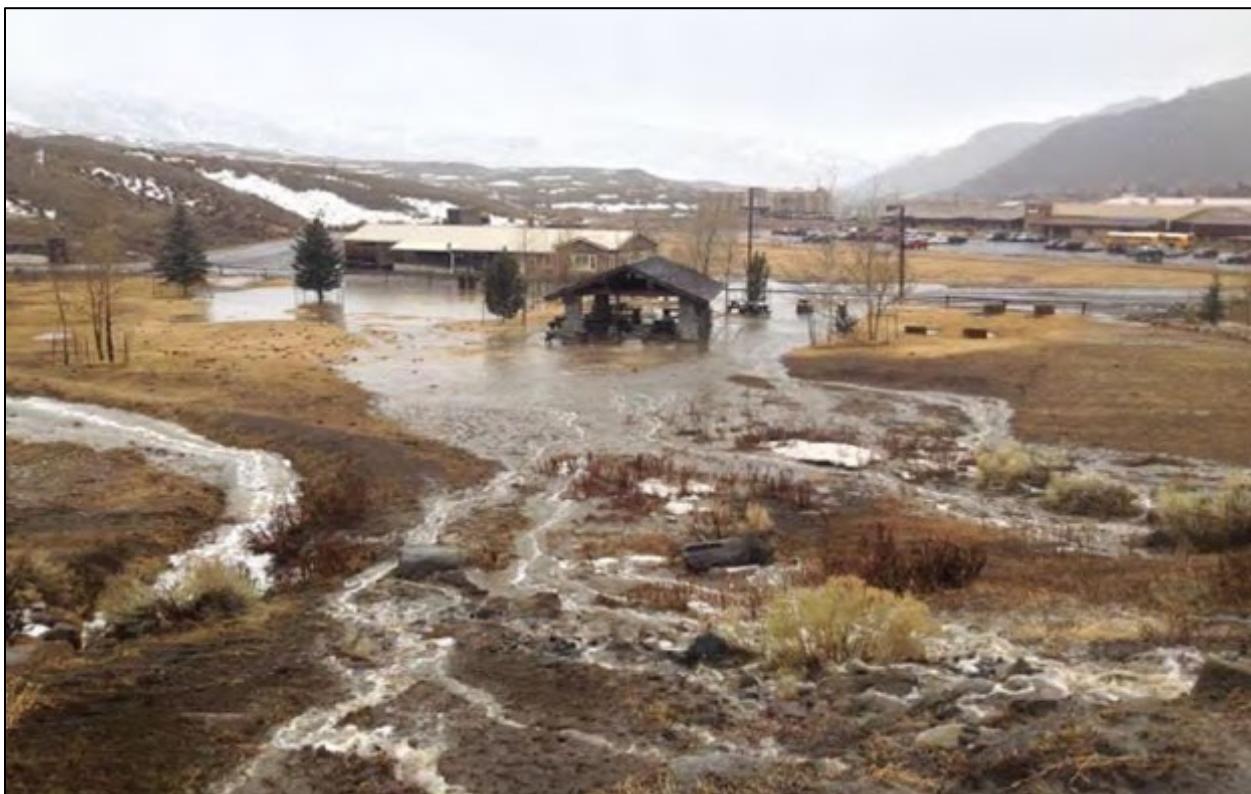
Figure 40. Runoff overtopping existing system and impacting Arch Park.

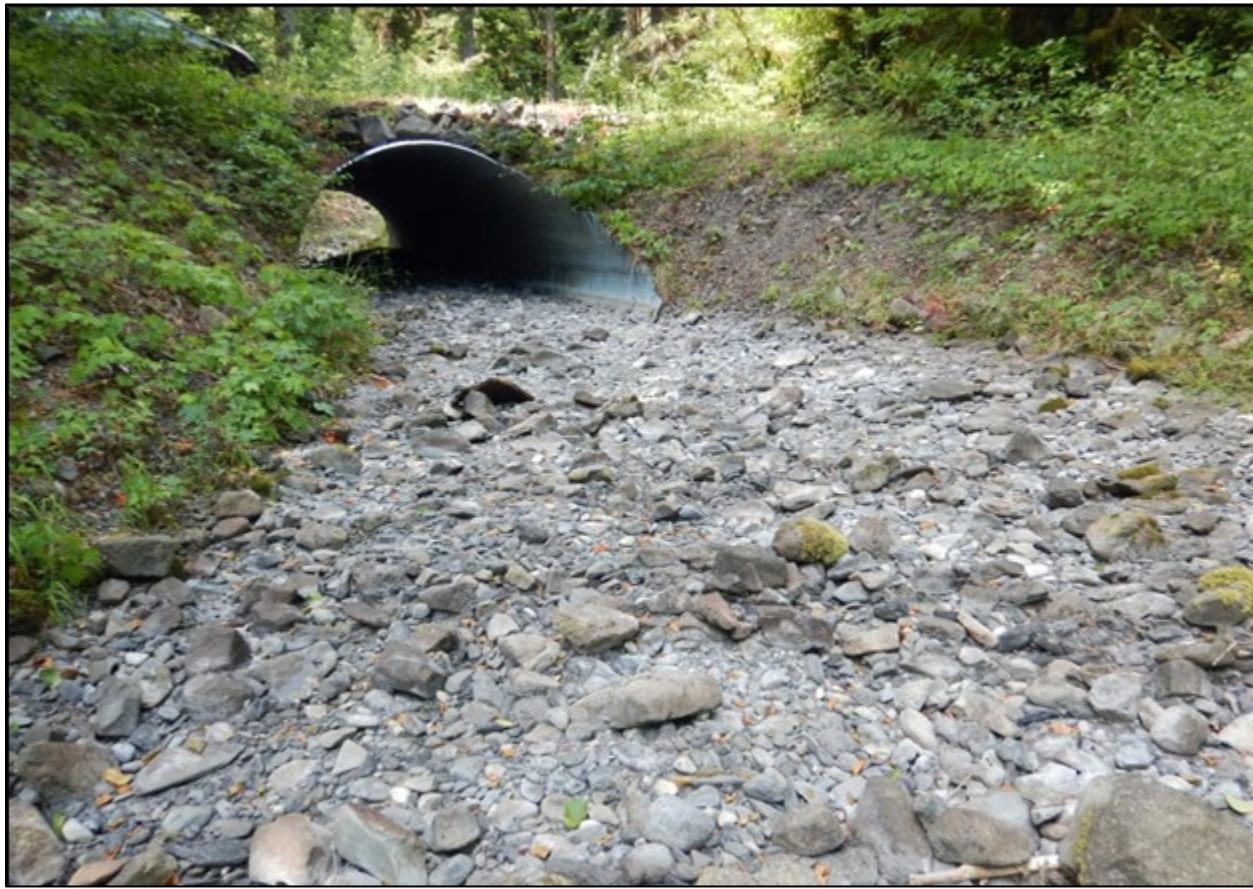
Figure 56. Looking upstream towards the Snider Creek Culvert.

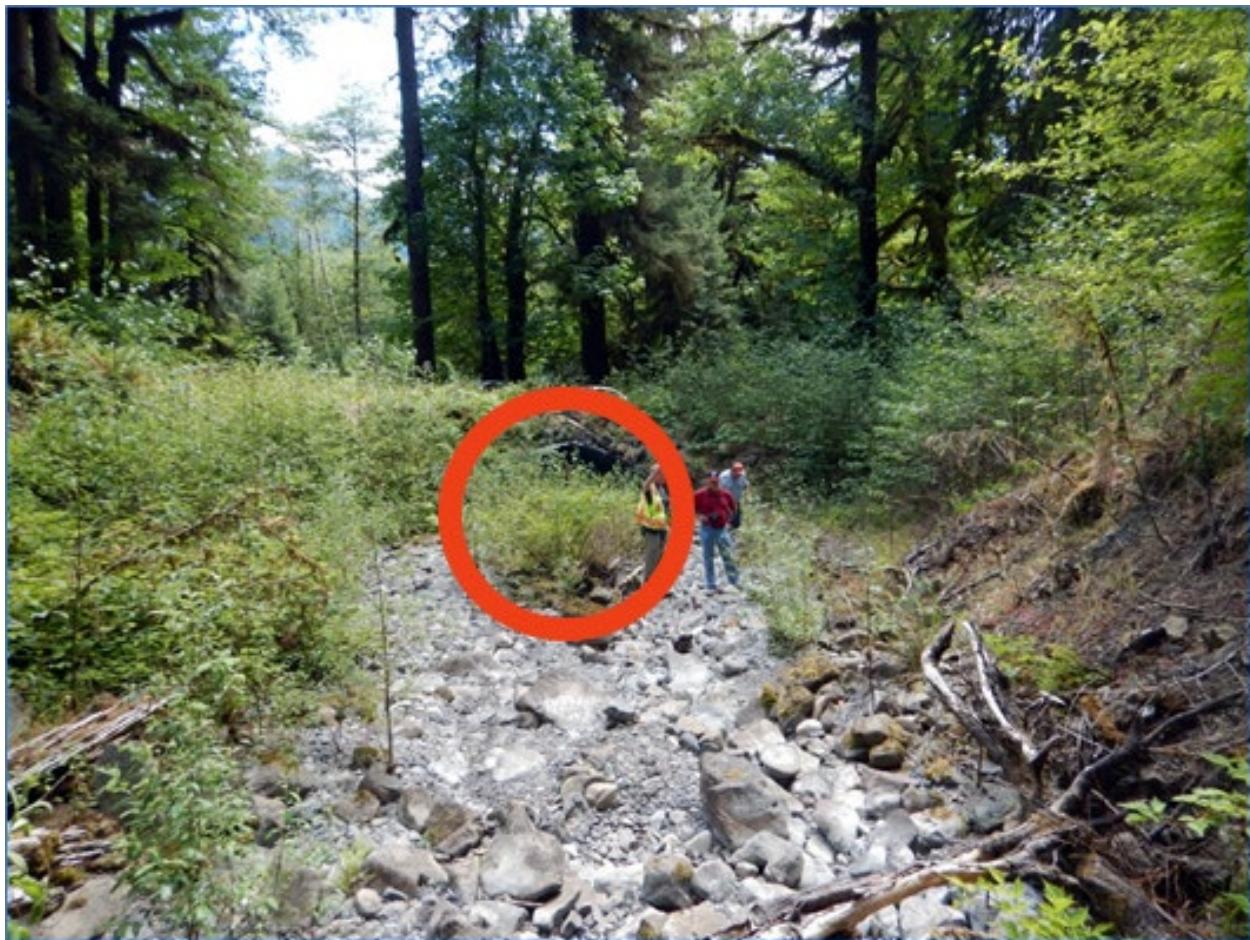
Figure 61. Point bar upstream of Snider Creek culvert crossing.

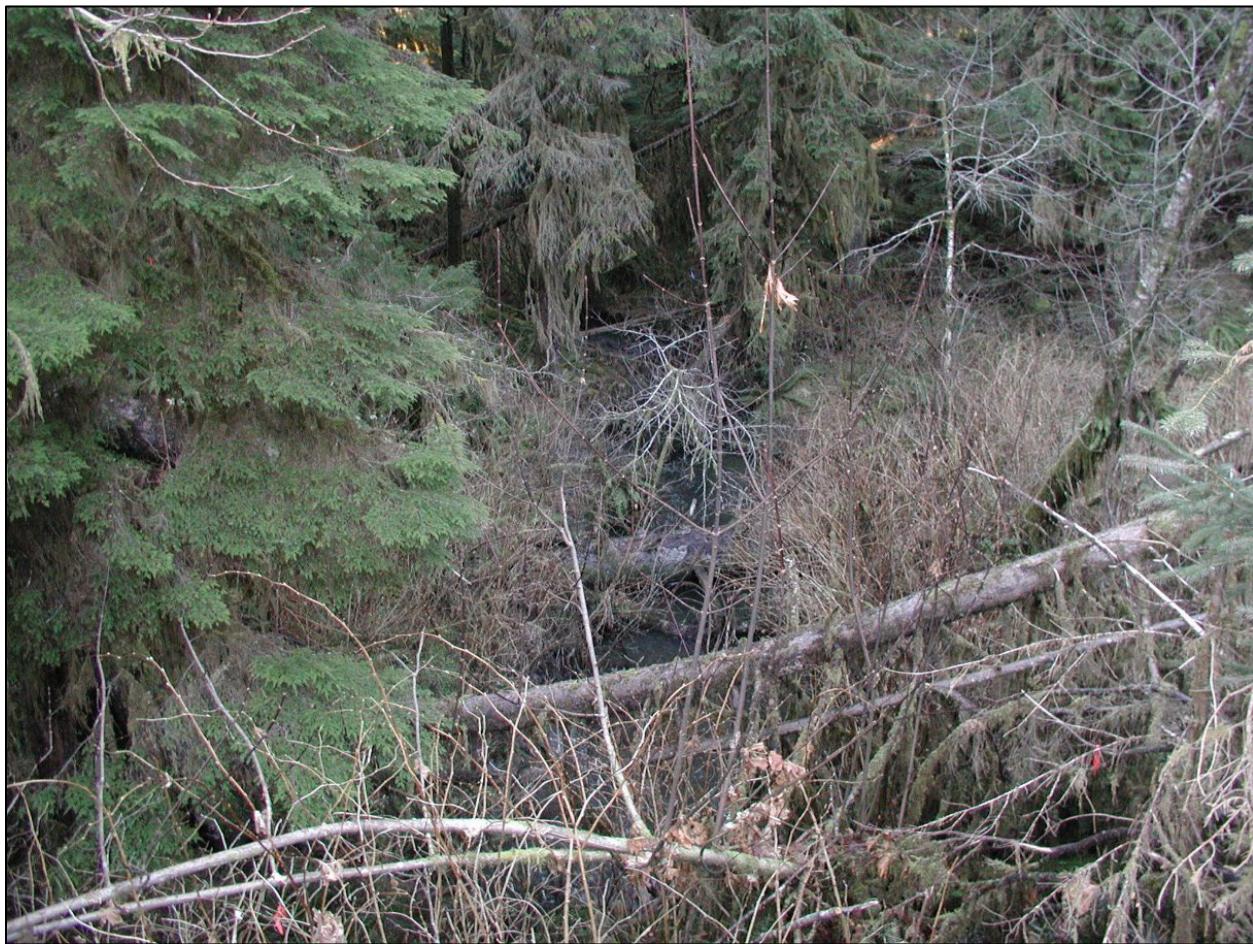
Figure 65. East Twin Creek AOP Culvert – Looking downstream.

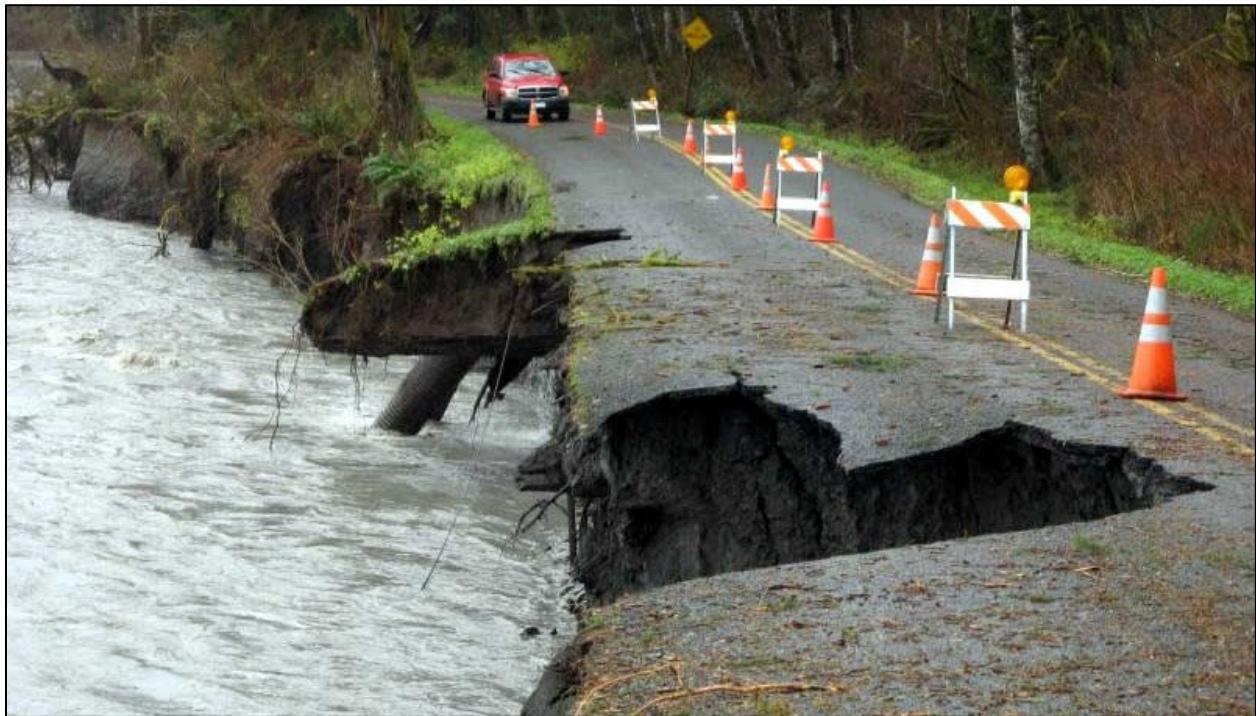
Figure 73. Embankment and roadway erosion along banks of Hoh River (NPS 2021).
