Massachusetts State Police

Collision Reconstruction Report

Commonwealth of Massachusetts
Collision Analysis and Reconstruction Section **2011-CAR-000303**
Collision Reconstruction Report

1. On Thursday 8/4/2011 at approx. 1744 hours, a single vehicle collision occurred on Rt. 395 North, just north of the Cudworth Rd overpass, in the town of Oxford. On 8/4/2011 at 1800 hours, I was contacted by Lt. Robert Boutillete, CHQ Duty Office, and assigned to reconstruct this collision. I arrived on scene at approx. 1820 hours and was assisted by Tpr. Colleen Tanguay, MSP Crime Scene Services Section and Troopers from the Sturbridge Barracks. Trooper Brian Pearl was the investigating officer for SP Sturbridge.
2. The roadway remained open during the on-scene investigation. The following reconstruction report summarizes an investigation conducted at the request of and in conjunction with the State Police CSSS and the Sturbridge Barracks. The scope of this Trooper's investigation was limited to the reconstruction of the collision.

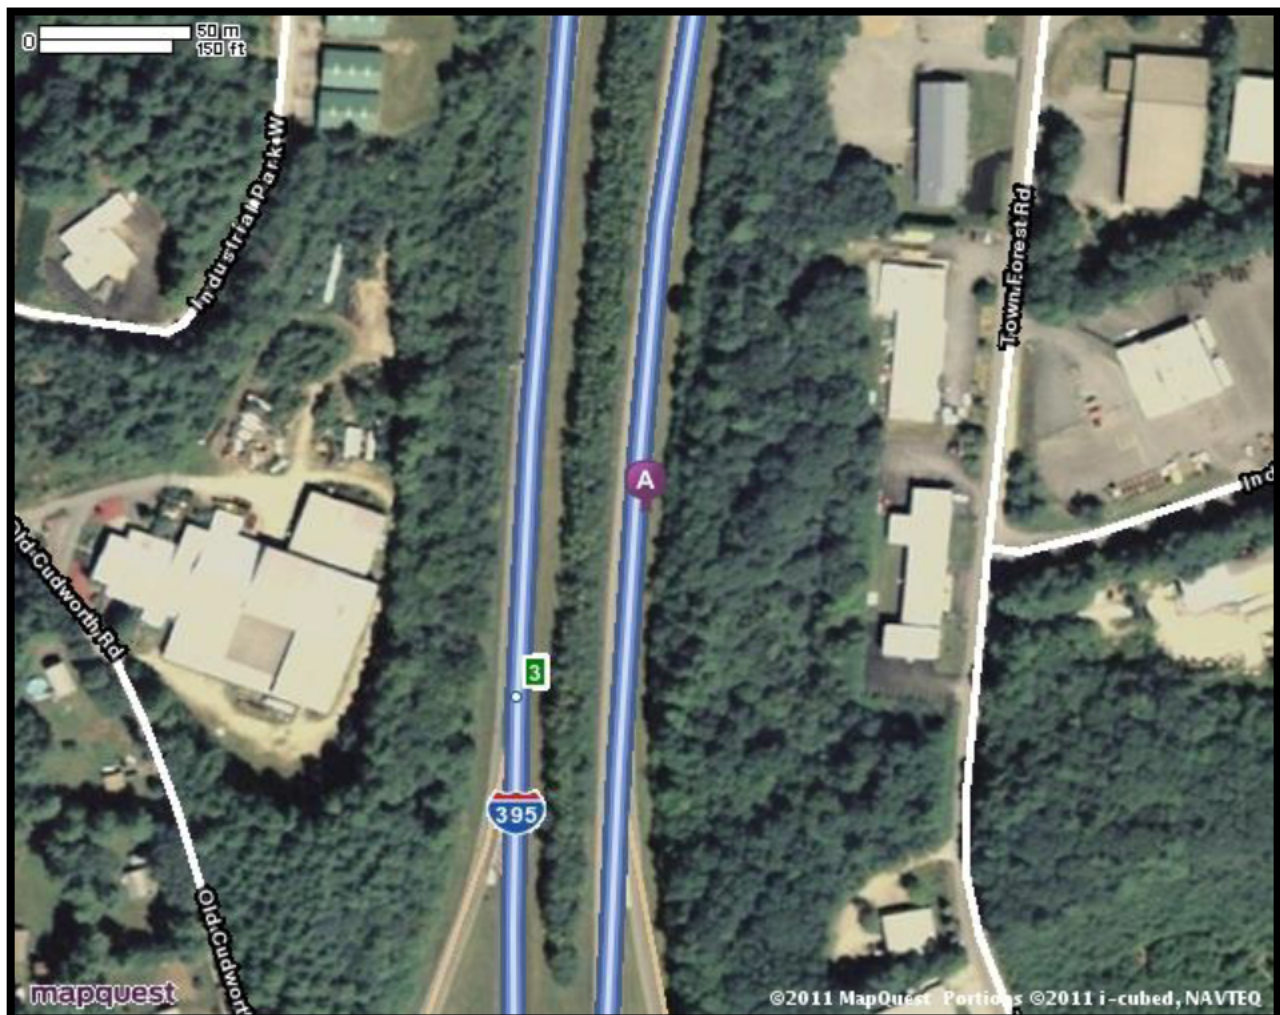
3. This officer observed Rt. 395 north near the collision to be a three lane interstate highway. The far right lane is an acceleration lane that stretches from the onramp at Cudworth Rd. and gradually merges into the second lane prior to mile marker 4.4. Rt. 395 runs in a north / south direction and is maintained by the Commonwealth. The roadway is comprised of an asphalt surface. There are white skip lines that separate the travel lanes. There is a solid yellow line that separates the left travel lane from the paved shoulder. The shoulder was measured to be approx. 3.33 feet wide with an accompanying rumble strip. There is approx. 2 feet of asphalt curbing to the left of the median shoulder. A guardrail is present approx. 1 foot west of the asphalt curbing. The left travel lane was measured to be approx. 12.16 feet wide. The center travel lane was measured to be approx. 11.33 feet wide and the right travel lane was measured to be approx. 11.91 feet wide. There is a solid white line that separates the right travel lane and the paved shoulder. There is approx. 2.5 feet of paved shoulder and granite curbing that defines the edge of the roadway. A guardrail begins on the right side of the roadway approx. 528 feet south of the 4.4 mile marker. There is a slight incline in the roadway of 1.2 % as you travel north through the collision location. The roadway is generally straight as you travel north through the collision location. The speed limit for Rt. 395 north in the area of the collision is regulated under Mass General Law Chapter 90 Section 17-18 and posted at 65 Mph.

4. The weather was clear at the time of the collision. The road surface was dry when the collision occurred. At the time of the collision, the roadway was clear and free of any debris or defects. The crash occurred during the daylight hours. This area of Rt.395 is a

rural area with trees lining either side of the roadway. The collision locus is measured to be at Latitude 42.0849 and Longitude -71.86604.

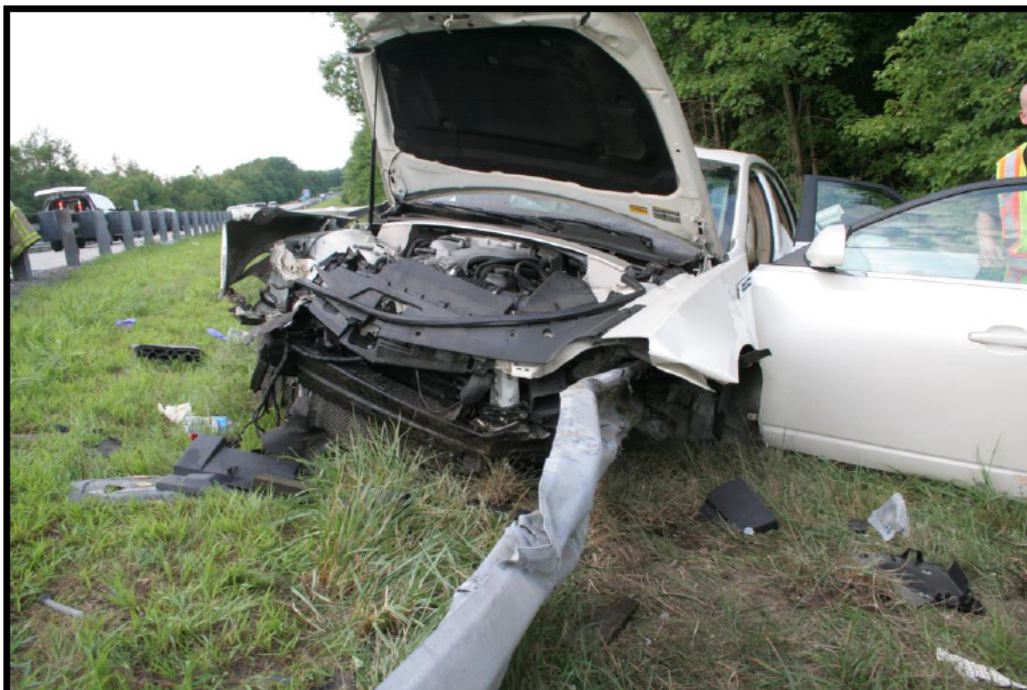
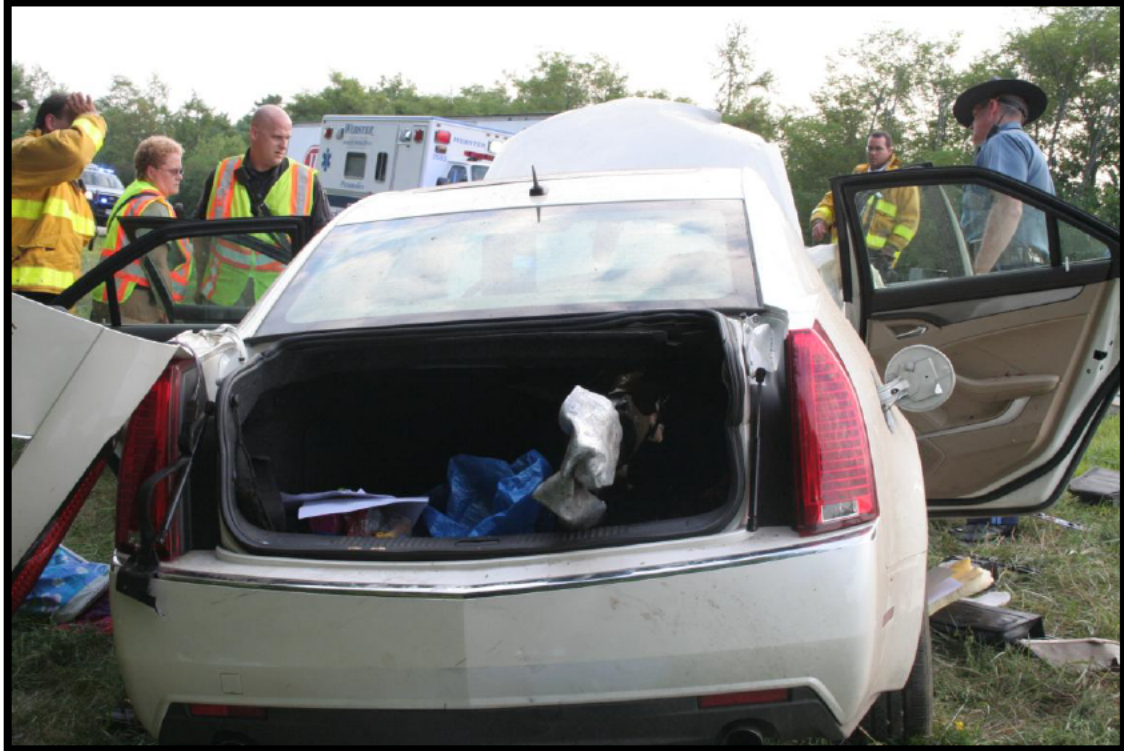
5. This officer observed a tire mark along the granite curbing that borders the right side/eastern edge of the roadway. The tire mark was located approx. 16.25 feet south of

the start of the guardrail. A tire print was also visible along the grassy surface just east of the curbing where the tire mark was present. The tire print traveled in a north, northeasterly direction towards the start of the guardrail. The tire mark and print were made by the right front tire of the Cadillac as it departed the roadway. There was no tire mark evidence located on any portion of the asphalt travel lanes.

6. The guardrail design was comprised of an inverted rectangular shaped end cap at the start, with panels and support posts thereafter. This officer observed 8 damaged guardrail posts. The end cap and approx. 2.5 feet of guardrail paneling had been sheared off and displaced approx. 153 feet north of its original location. The end cap and paneling were located along the wood line approx. 34 feet east of the edge of road. There was an additional +/- 63 feet of connected guardrail paneling that was damaged or displaced due to impact with the Cadillac. Approx. 15 feet of the damaged guardrail had pierced the left front end of the Cadillac. The guardrail had severed the linkage components that attach the tire and rim to the axle. The guardrail continued, piercing the firewall and floorboards in the area of the brake and accelerator pedals. The guardrail continued up and along the center console before striking both inner sides of the front occupant seats. The guardrail then proceeded into the rear passenger compartment where it continued through the right rear passenger seat and into the trunk area. The guardrail struck the interior of the trunk, dislodging the trunk after the right rear hinge broke loose.

7. The left front wheel assembly was separated from the Cadillac and found approx. 52 feet from the CTS's first point of departure from the roadway. The wheel assembly was in the wooded area approx. 46 feet adjacent to the roadway.

8. The center mass of the Cadillac traveled approx. 89 feet from its first point of roadway departure to its final rest. The Cadillac rotated counterclockwise approx. 135 degrees before coming to final rest facing a southwesterly direction approx. 15.5 feet from the edge of the roadway.
