Section I - Synopsis

On Wednesday, [REDACTED] the Major Crash Investigation Unit, Team #1, was notified of a fatality motor vehicle accident involving felony charges that had occurred on [REDACTED], in Clay County, Missouri. Sergeant H. A. Sears was assigned to the case that had been initiated by Corporal C. O. Tubbs who also submitted the original report of the collision, indicating that it occurred on Missouri 92 (MO 92), 0.5 mile west of US 169. The accident involved two vehicles with one fatality.

The collision occurred as Vehicle #1 was [REDACTED] when it struck the front driver's side of Vehicle #2, which was [REDACTED] a private drive located north of the highway. After impact, Vehicle #1 crossed the centerline, hit a bridge wall, and came to rest in the [REDACTED] lane on First [REDACTED]. Vehicle #2 rotated clockwise, struck two bridge marker signs, and slid up the bridge guardrail coming to rest partially on the guardrail and in the westbound lane of MO 92.

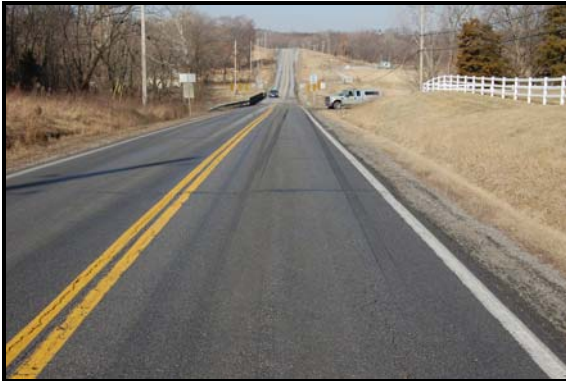
DSC6.JPG - View of crash scene, looking west

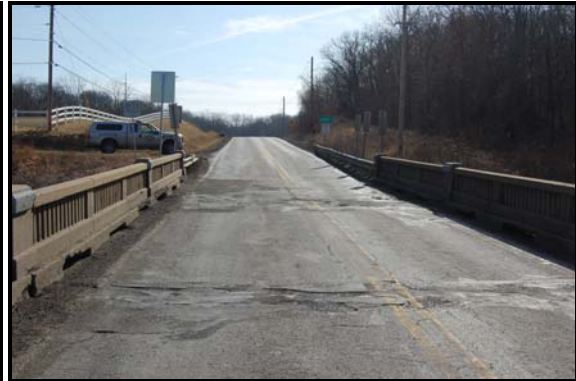
DSC14.JPG - View of crash scene, looking east

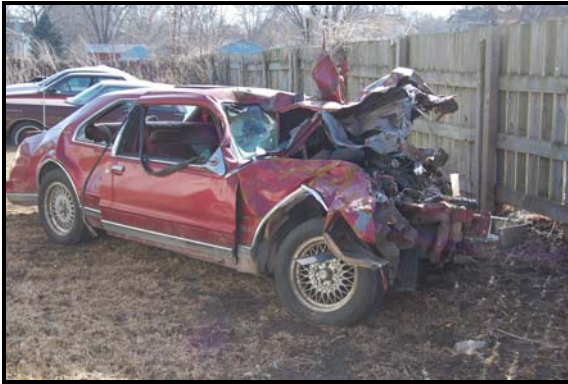
Vehicle #1, identified in Section I, was a red 1990 Lincoln Mark VII LSC two-door coupe with 19,182 miles registered on its odometer at the time of examination. It was equipped with a driver's side air bag that had deployed¹ and integrated lap and shoulder seat belt restraints for the driver's position that extended and latched when checked for operability. Vehicle #1 exhibited massive front-end damage.

The Vehicle #1 front bumper was forced rearward and folded just over two feet to the right of the left front corner. Front-end and engine components were forced rearward over two feet on the passenger side and over three feet on the driver's side. The Vehicle #1 hood was crumpled and forced upward and rearward, and its roof was crumpled in two places along its front edge. The left front quarter panel was completely detached, while the right front remained, but was crumpled along its entire length. Both headlight assemblies were completely detached. The Vehicle #1 driver's door front and window frame was forced rearward and outward, and the driver's side "A" pillar, that vehicle member at which the door hinges, was forced rearward about 1.5 feet. Interior dash components were forced rearward, as well. The car body behind the rear axle was forced downward and body components on both sides were crumpled to the rear quarter panels.

DSC20.JPG - View of Vehicle #1 from right front

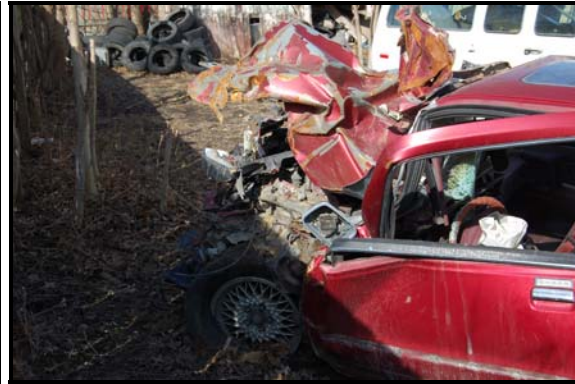
The Vehicle #1 windshield was partially detached and completely cracked. The remaining vehicle glass was completely gone except the rear driver's side window, which

remained intact. The left front tire was deflated while the remaining Vehicle #1 tires remained inflated.

DSC24.JPG - View of Vehicle #1 left front

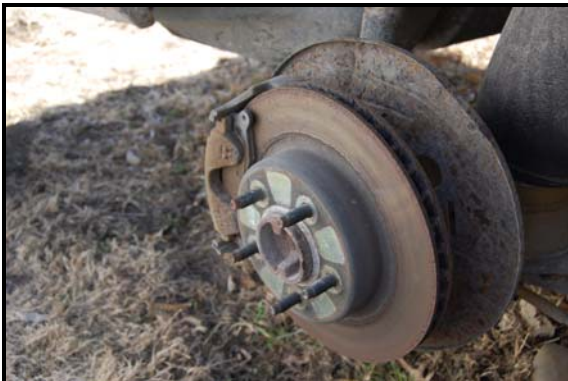
On [REDACTED], the Vehicle #1 right rear wheel was removed by Sgt. Sears in order to examine the right rear disc brake. The brake pad appeared thick and remained in contact with the disc, which also appeared in good condition. No evidence that the Vehicle #1 rear brakes were “anti-lock” equipped was observed.

DSC40.JPG - View of Vehicle #1 right rear disc brake

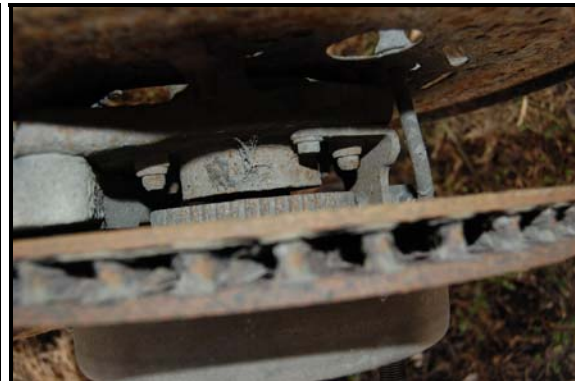
DSC42.JPG - View of Vehicle #1 disc brake

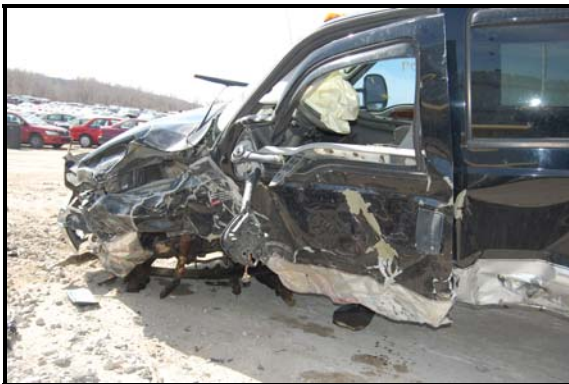
The Vehicle #2 grille was broken and partially detached, and the left side of the front bumper was forced inward and downward. The radiator was forced forward and to the right at its left side, and the left headlight assembly was completely detached. The Vehicle #1 driver's side from the left front quarter panel, including the portion of the hood above it, to the rear driver's side door, was completely crumpled. The left rear corner of the truck bed was scraped and the left brake light cover was broken.

DSC29.JPG - View of Vehicle #2 front left driver's side

All Vehicle #2 glass remained intact except for the driver's door window that was completely gone. The left front wheel was completely detached, and the left rear tire was deflated, but the right side tires remained inflated.

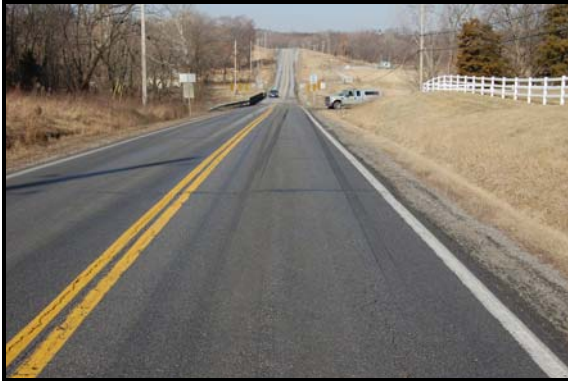
A pair of pre-impact tire marks attributable to the Vehicle #1 front tires was observed in the westbound lane and gave indication of its travel prior to the collision. The right front mark began approximately 294 feet east of the reference line and about 2 feet south of the westbound white line while the left front mark became visible

approximately 279 feet east of the reference line and about 7 feet south of the white line. The marks were fairly straight and led into the area of impact where the right front ended on the white line approximately 73 feet east of the reference line and the left front approximately 76 feet east of the reference line and about 5 feet south of the white line.

DSC6.JPG - View of Vehicle #1 pre-impact tire marks in westbound lane

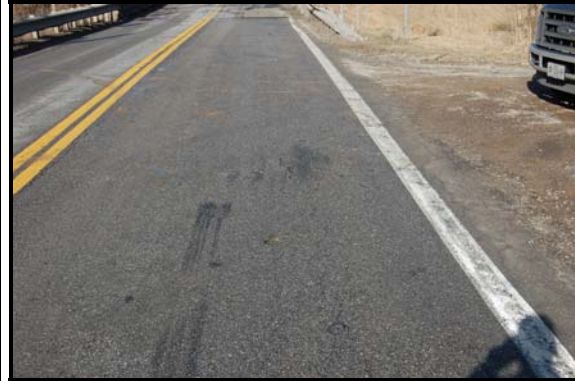
DSC8.JPG - View of Vehicle #1 left front pre-impact tire mark end

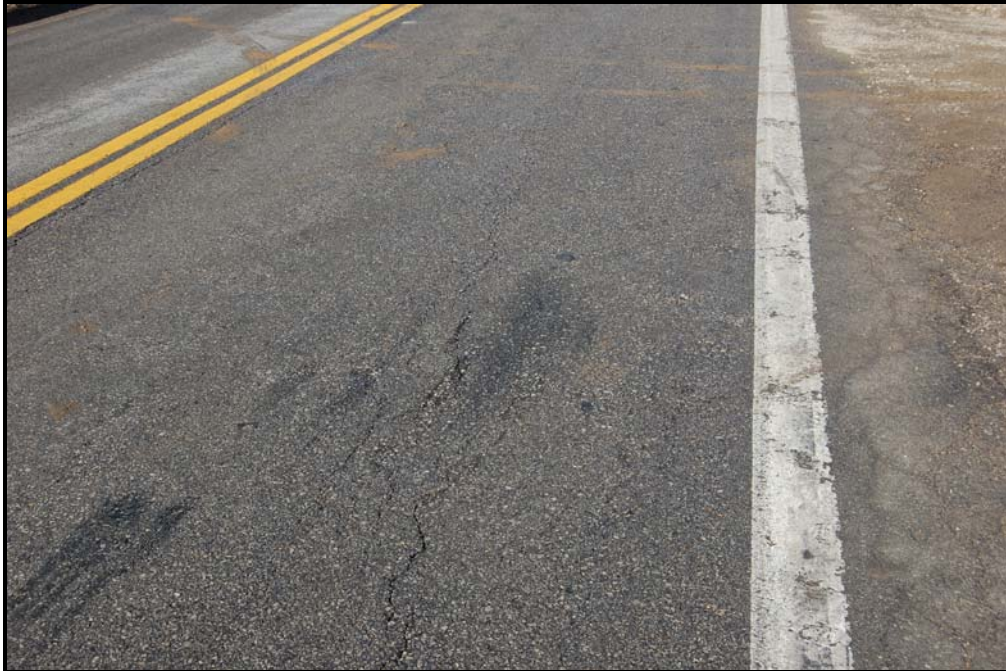
A tire mark, measuring about 3.5 feet in length, attributable to the Vehicle #1 left front tire after impact with Vehicle #2 was observed in the westbound lane. It began approximately 75 feet east of the reference line and about 4.3 feet south of the westbound white line.

A tire scrub mark, measuring about 5 feet in length, attributable to the Vehicle #2 front left tire during impact events, was observed in the westbound lane. It began approximately 75 feet east of the reference line and about 3 feet south of the westbound white line. Two gouges were observed on either side of the scrub mark measuring about 2 feet in length each, and were attributable to the Vehicle #2 left front tire rim.

DSC9.JPG - View of Vehicle #1 front left pre- and post-impact tire marks and Vehicle #2 left front post-impact tire mark and gouges in the westbound lane, looking west

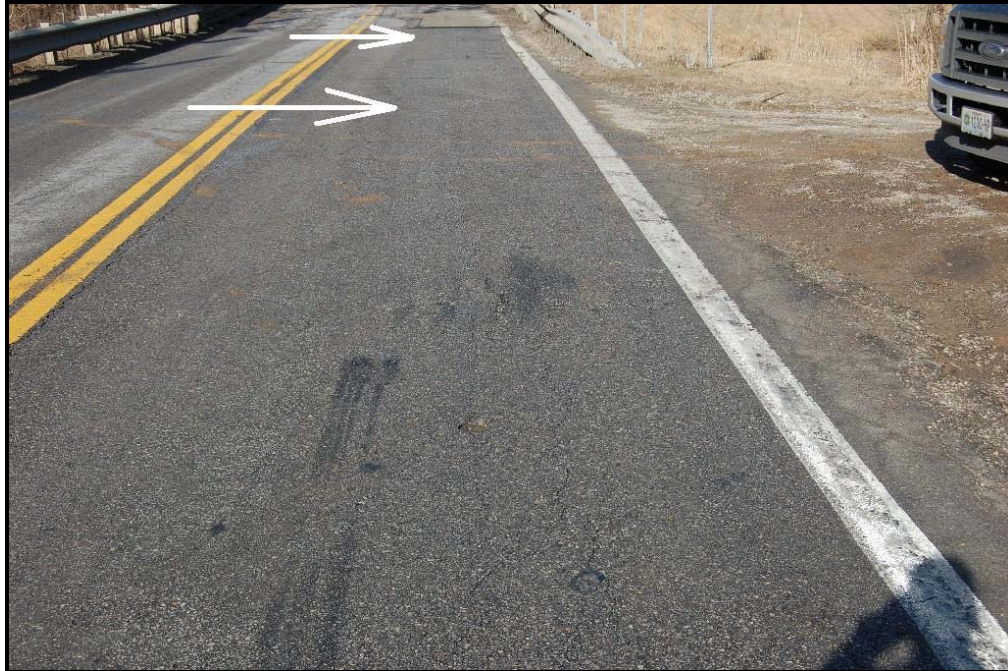
A tire mark, attributable to the Vehicle #2 left rear tire during post-collision travel was observed in the westbound lane. It became visible approximately 52 feet east of the reference line and about 4 feet south of the westbound white line and curved toward the northwest, ending near the position of Vehicle #2 at final rest. (This mark was originally charted as leading toward the position of Vehicle #1 at final rest, was later determined to be the first portion of the Vehicle #2 left rear tire mark evident in the digital image below).

DSC10.JPG - Arrows point to Vehicle #2 left rear post-impact tire mark
