Subject: Post-Test Occupant Compartment Measurement Methodology for ET Plus® Test ET31-30

This letter provides a detailed description of the methodology used to measure post-test deformation of the vehicle used in Test ET31-30 under Southwest Research Institute (SwRI®) Project 18.20887. This letter is supplemental to SwRI Test Report 18.20887.05.100.FR4, Issue 1, “Full-Scale Crash Evaluation of the ET Plus® End Terminal with 4-inch Wide Guide Channel Installed with a Rail Height of 31 Inches,” and is not intended to be a stand-alone description of the test.

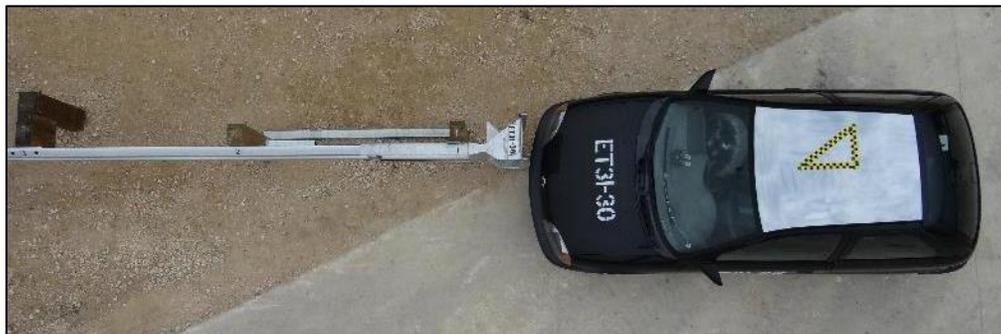
Figure 1: Vehicle Positioned for Test ET31-30, Pre-Test

Test ET31-30 was conducted on January 27, 2015. Testing was conducted in accordance with Test 3-30 of National Cooperative Highway Research Program (NCHRP) Report 350. A summary of the test parameters for Test ET31-30 is provided below, and photographs of the vehicle pre- and post-test are provided in Figure 1 through Figure 3.

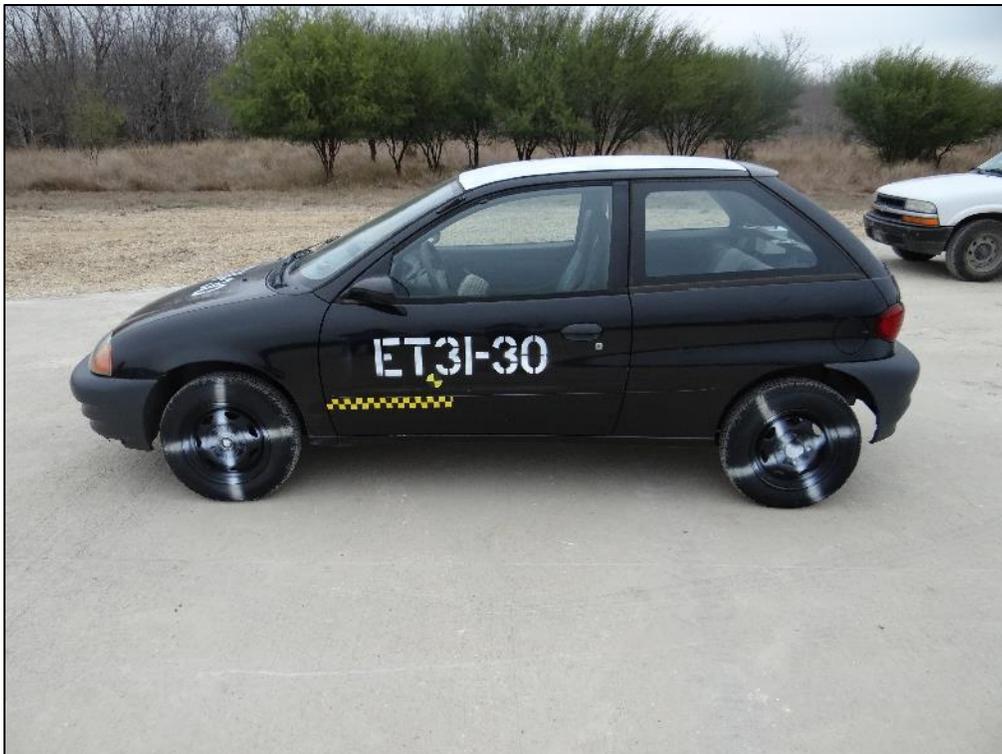
Figure 2: Test ET31-30 Vehicle, Pre-Test

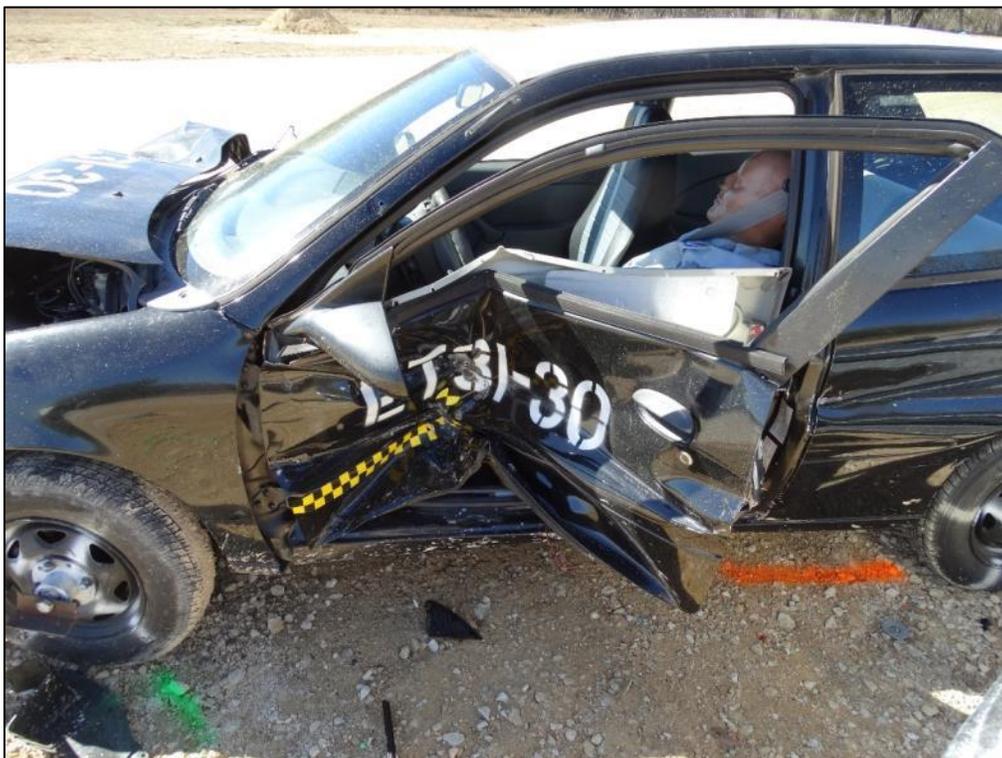
Figure 3: ET31-30 Test Vehicle Post-Test, Driver's Side Exterior

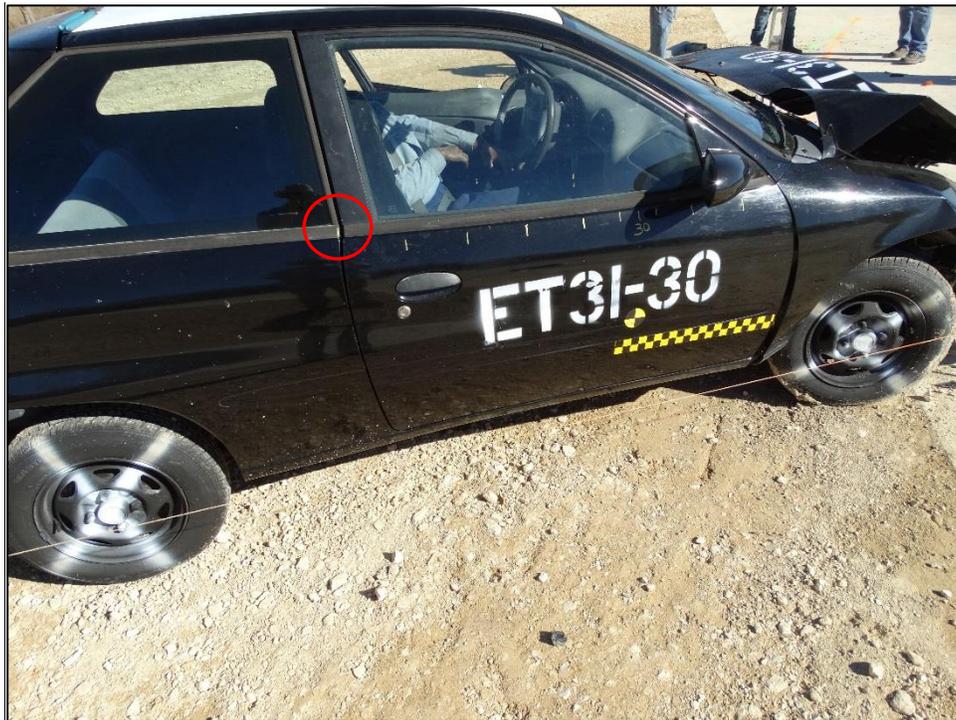
Figure 4: Exterior Reference Marks on Passenger Side Door, B-Pillar Forward

For both internal and external measurements, attention was focused on the front seat area of the vehicle. Reference marks were made on both sides of the vehicle starting at the B-Pillar as shown in Figure 4, and proceeding every 15.2 cm (6 in.) towards the A-Pillar at the front of the vehicle. In the area near the most significant damage, marks were made in 5.1 cm (2 in.) increments.

Prior to taking interior deformation measurements, the anthropomorphic dummy was removed from the driver's seat of the vehicle through the passenger door to ensure minimal disturbance of the driver's side door. The reference marks shown in Figure 4 were transferred to the interior of the vehicle on the passenger side as shown in Figure 9, and then to the associated location on the driver's side door as shown in Figure 10. Measurements for both the driver and passenger side of the vehicle were made at each of these reference marks.

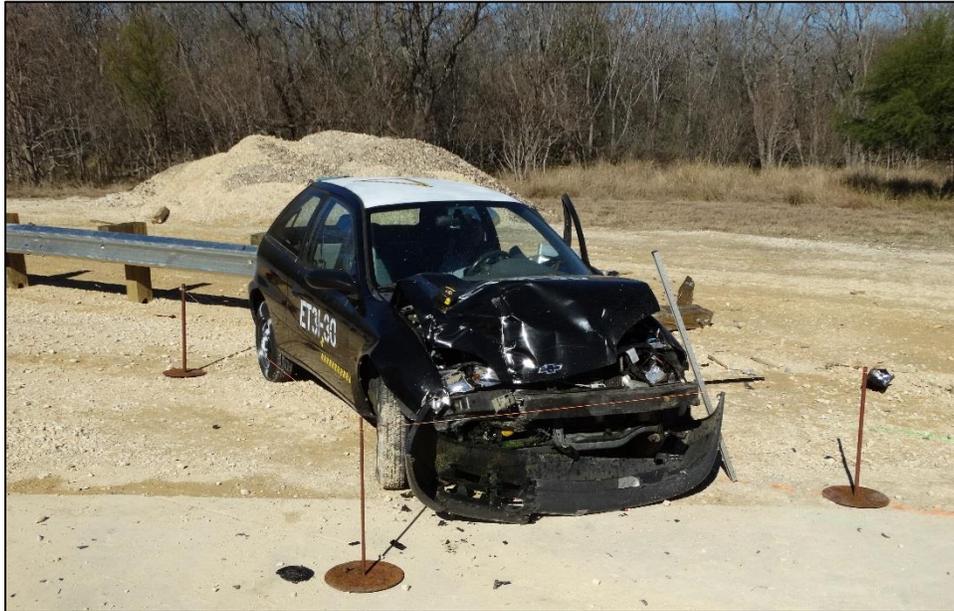
Figure 5: String Line for External Deformation

Before the vehicle was disturbed following the test, external deformation was measured relative to a string line that was positioned parallel to each side of the vehicle. The string was placed 122 cm (48 in.) from the centerline on both sides of the vehicle at a height of 45.7 cm (18 in.), and measurements were recorded from a vertical plane represented by the string line as shown in Figure 7 and Figure 8, and were made at each reference mark between the A-Pillar and B-Pillar. The measurements of external deformation are not used to determine compliance to NCHRP Report 350, and were recorded for reference only.

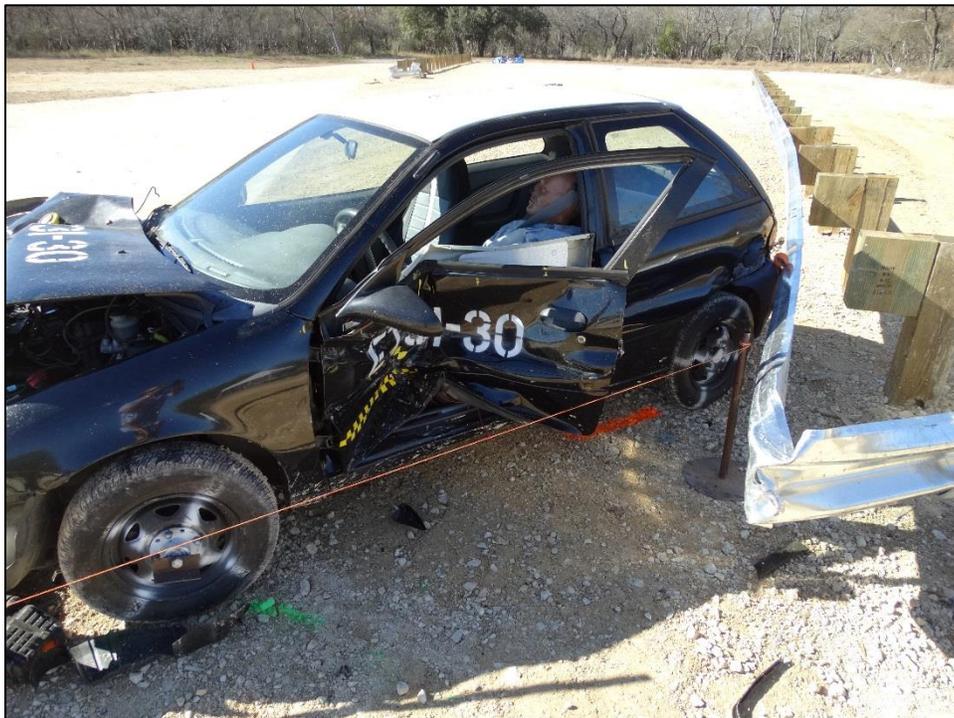
Figure 6: Reference String on Driver's Side

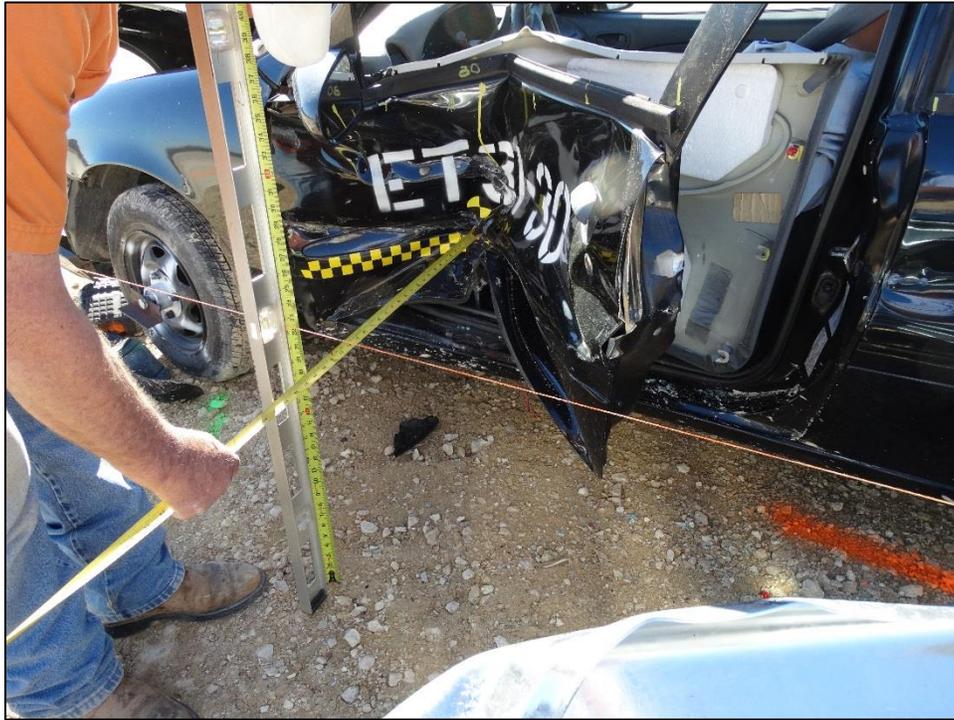
Figure 7: External Measurements - Driver's Side

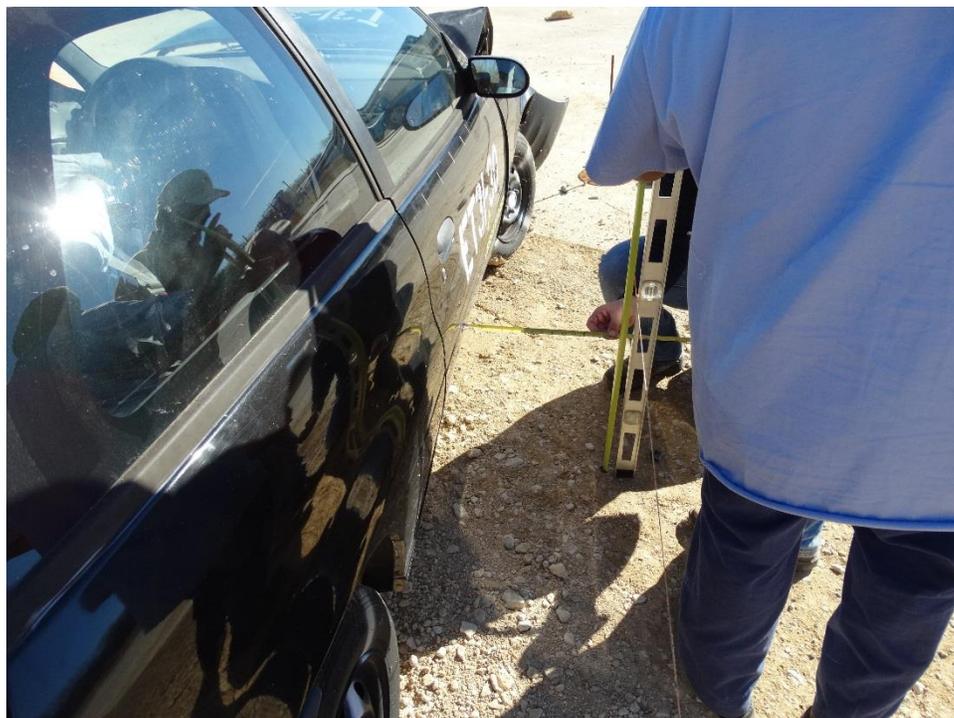
Figure 8: External Measurements - Passenger Side

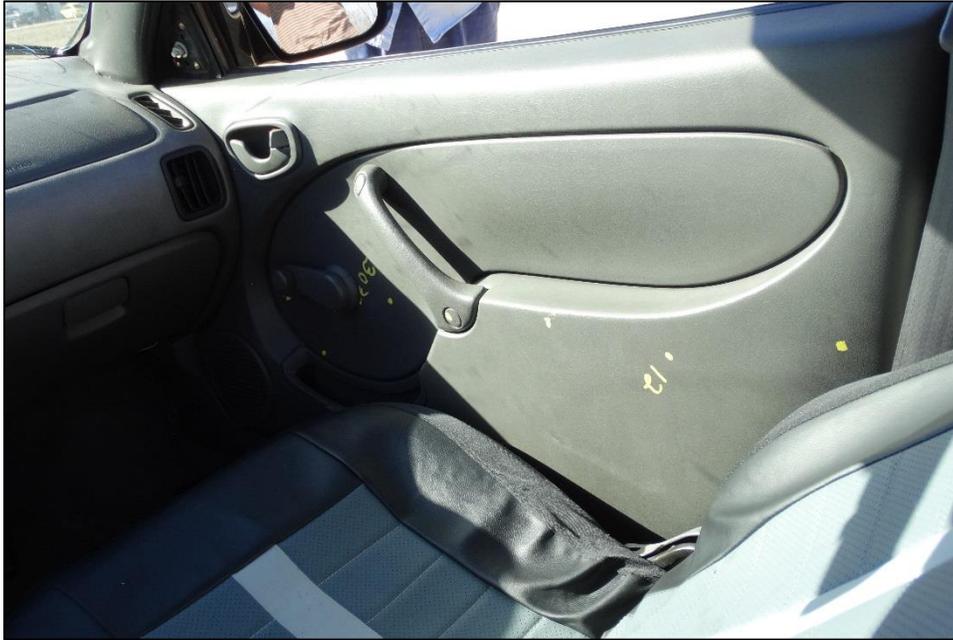
Figure 9: Reference Marks Transferred to Interior Passenger Side Door Panel

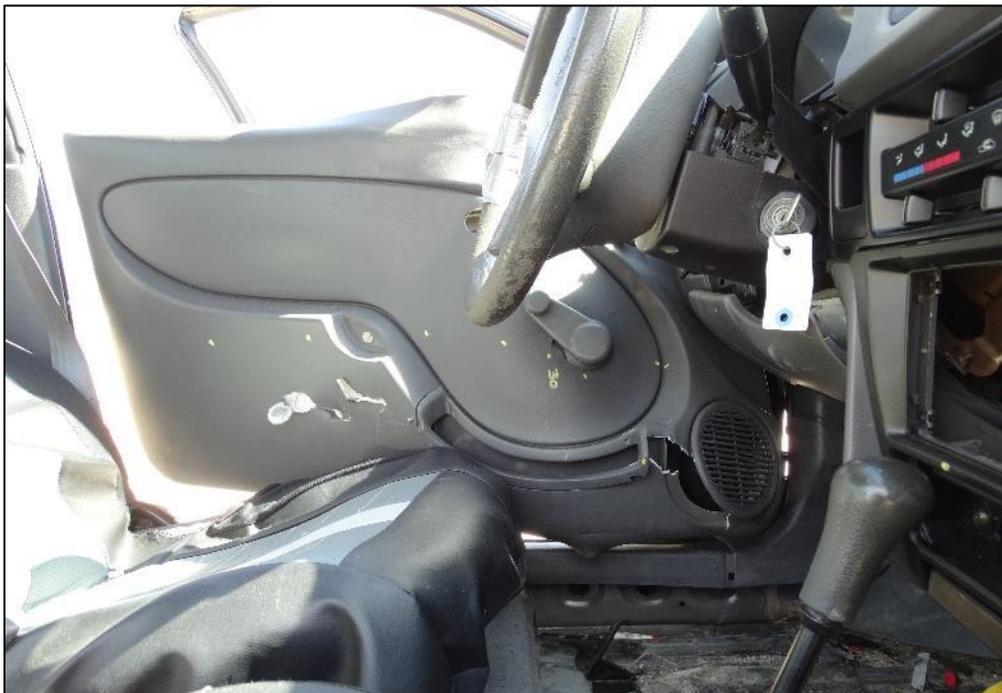
Figure 10: Corresponding Reference Marks on Driver's Side Door Panel

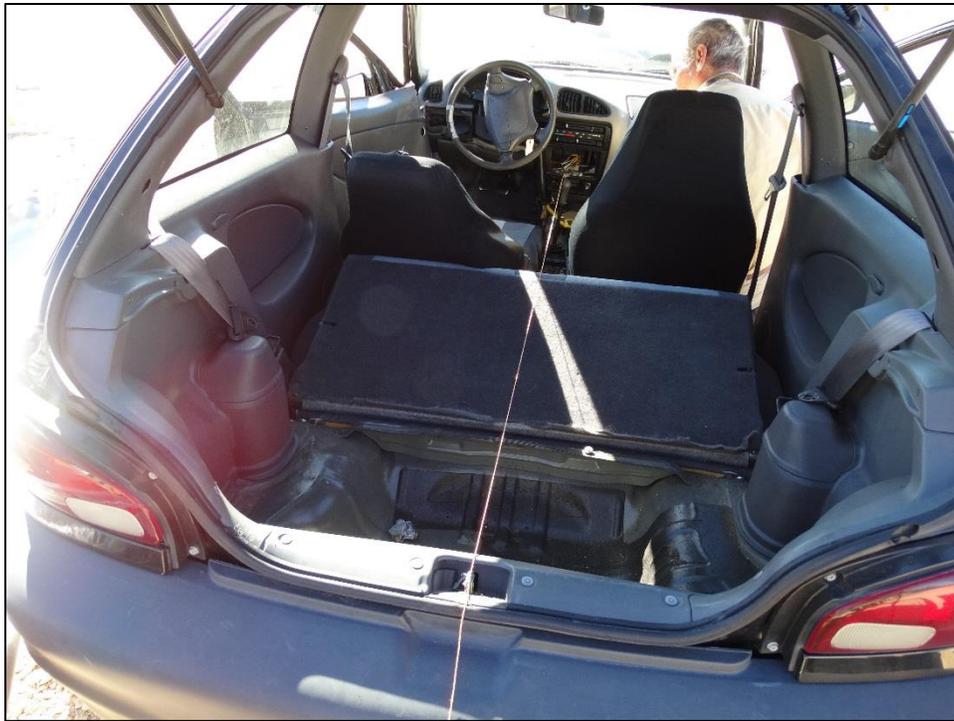
Figure 11: Centerline Strung from Radio Panel to Rear Hatch Latch

To facilitate comparative lateral measurements between the driver's side and passenger side of the vehicle, a string line was stretched between the radio console and the rear hatch latch in the center of the vehicle as shown in Figure 11. The lateral location of the centerline was verified by measuring surrogate vehicles of the same model with no internal damage, and was verified to be consistent within 0.5cm (3/16 in.). The vertical location of the string line was recorded by referencing it to the position of the onboard Electronic Data Recorder (EDR) mounting bracket shown in Figure 12, which could be related to the position of the center of gravity of the vehicle as follows:

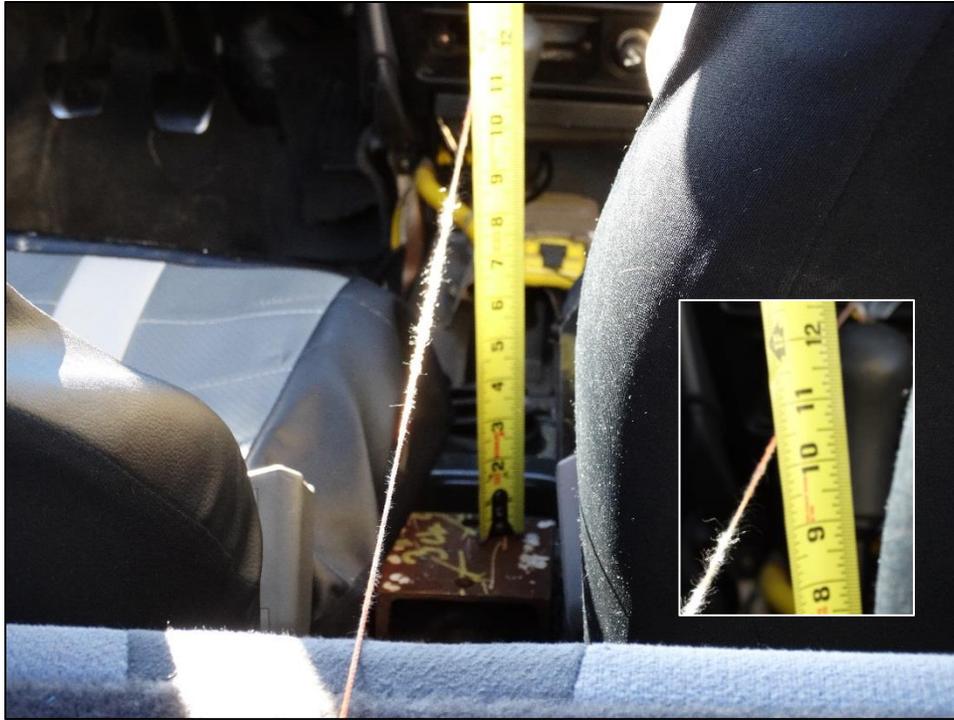
Figure 12: Vertical Location of Centerline Relative to EDR Bracket

- The string was located vertically 26.7 cm (10.5 in.) above the EDR mounting bracket.
- The vehicle's center of gravity was 13.6 cm (5.35 in.) above the center of the EDR unit, which places it 18.7 cm (7.35 in.) above the EDR mounting bracket.
- Subtraction locates the string 8 cm (3.15 in.) above the vehicle's center of gravity.

These dimensions were later used to relate the location of maximum deformation to the vehicle's center of gravity.

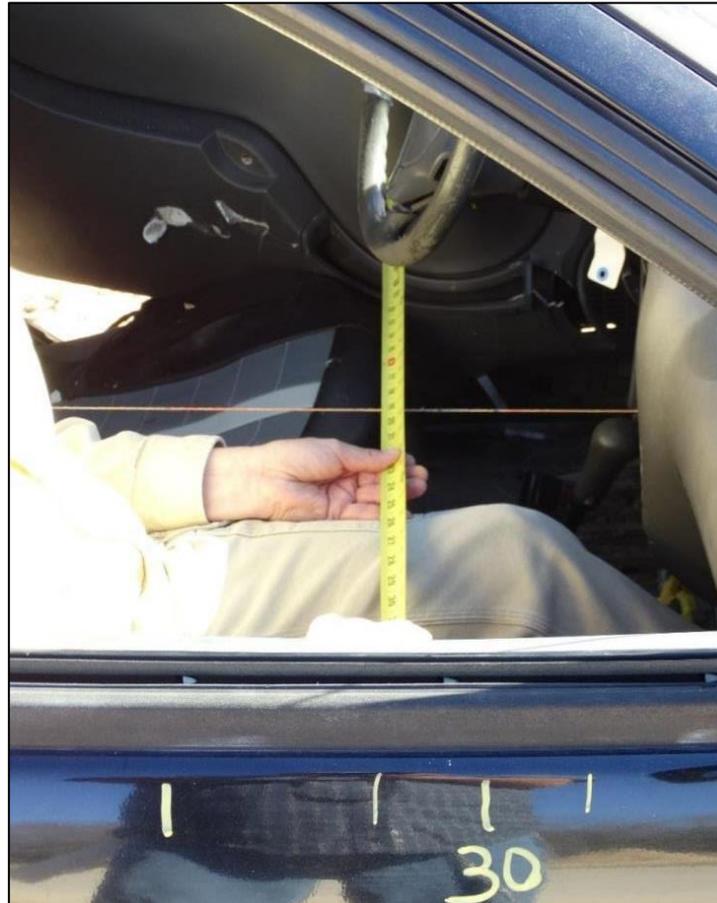
Figure 13: Representative Measurement of Driver's Side Compartment to Centerline

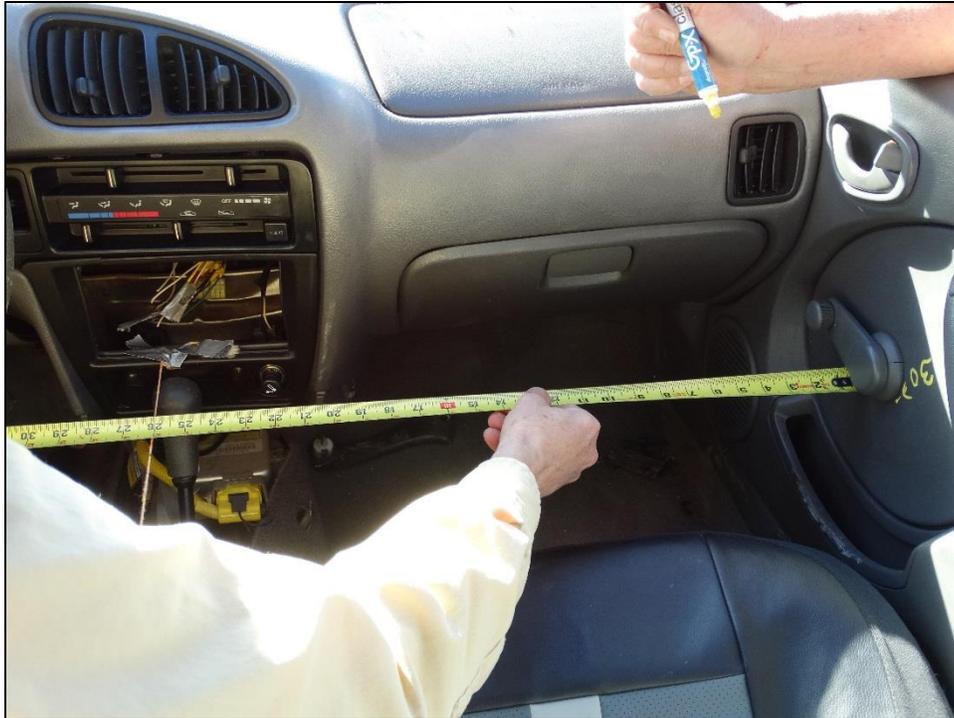
Figure 14: Representative Measurement of Passenger Side Compartment to Centerline

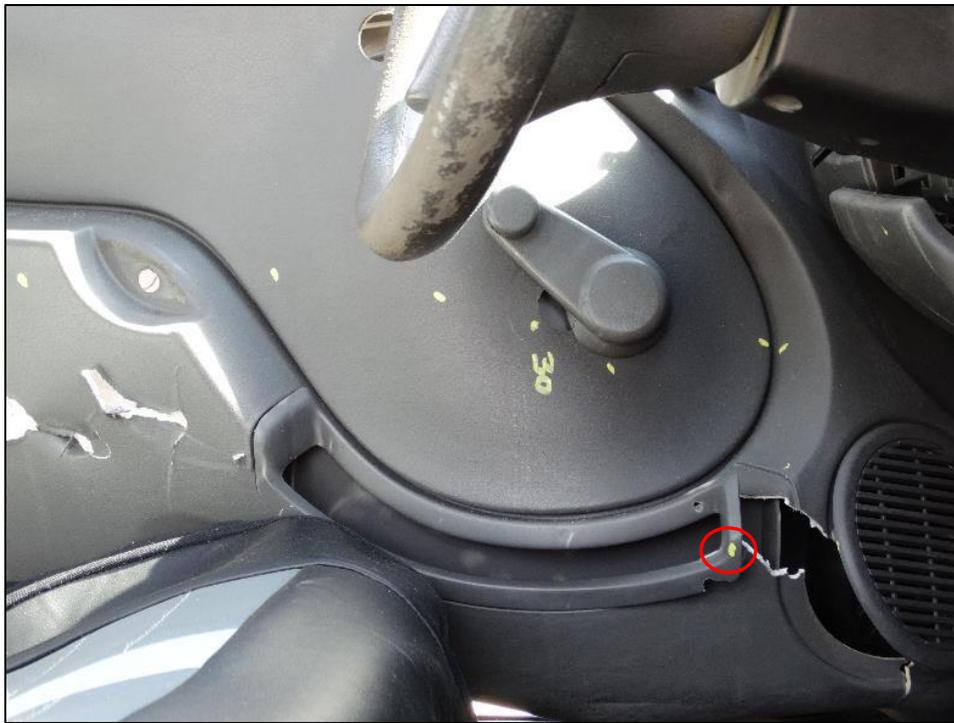
Figure 15: Location of Maximum Occupant Compartment Deformation

Following the test, internal measurements were made at each of the longitudinal reference marks between the A-Pillar and B-Pillar, and the maximum relative reduction was noted at the lower front corner of the map pocket on the driver's side door, shown in Figure 15. To measure the relative deformation at this location, the top edge of the loose trim on the map pocket was pressed against the door panel as shown in Figure 16, and the resulting measurement to the centerline was compared to the measurement for the corresponding corner of the map pocket on the passenger door. The maximum post-test occupant compartment deformation at the point of maximum compartment reduction was measured to be approximately 17.1 cm (6.75 in.) at a point located approximately 2.2 cm (0.85 in.) below the center of gravity and approximately 5.1 cm (2 in.) aft of the radio panel, roughly even with the height of the front edge of the seat. This measurement equated to a reduction in the width of the occupant compartment of 14% and an Occupant Compartment Deformation Index¹ (OCDI) rating of LF0000200. Note that all measurements with the exception of the location of maximum reduction were made at the height of the centerline string.

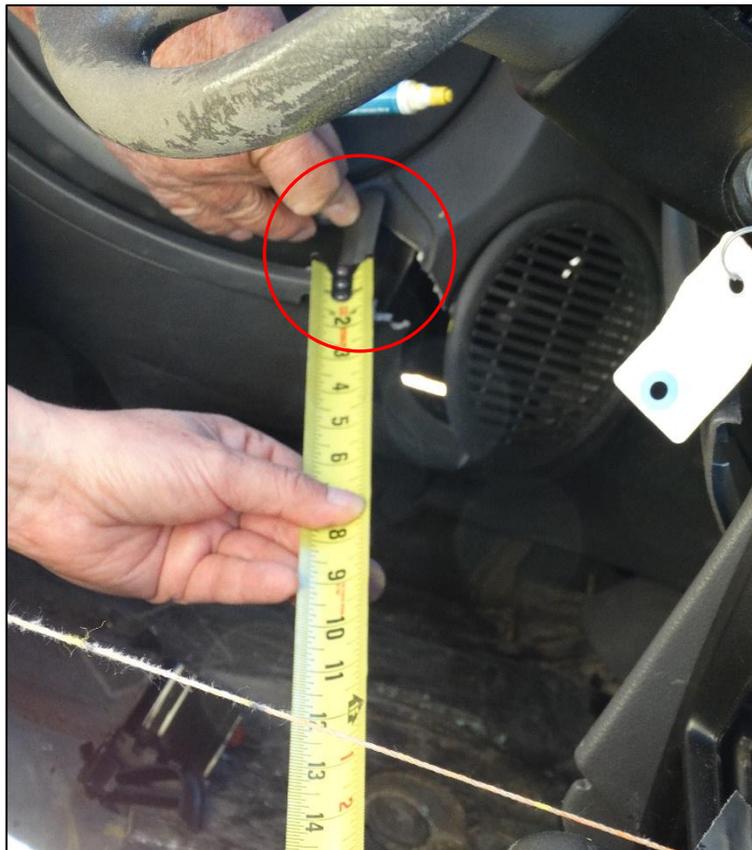
Figure 16: Top Corner of Map Pocket Trim Held against Door Panel for Measurement
