Phase I Design Report

Composite Bridge Decking

Publication No. FHWA-HIF-13-030
January 2013

7. Author(s) J. S. O'Connor		8. Performing Organization Report No.	
9. Performing Organization Name and Address BridgeComposites, LLC 121 Upper Bennett St. Hornell, NY 14843-1451		10. Work Unit No. (TRAIS)	11. Contract or Grant No. DTFH61-09-RA-00006

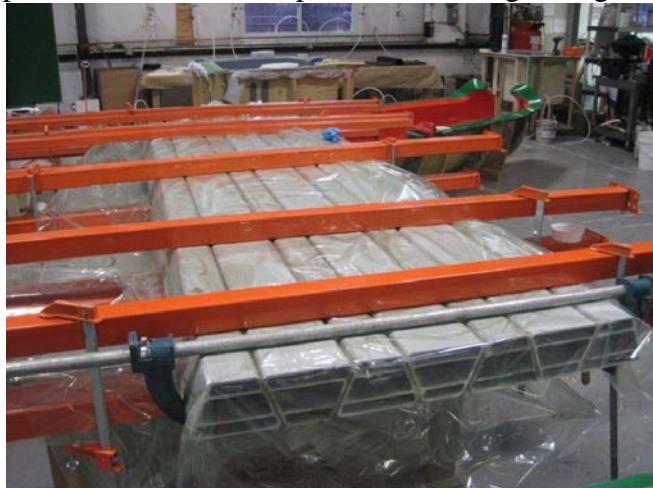
Figure 2. Photo. Tube subcomponents are bonded together with adhesive to form a panel.

Figures 1 through 7 illustrate the assembly of deck panels from tube subcomponents.

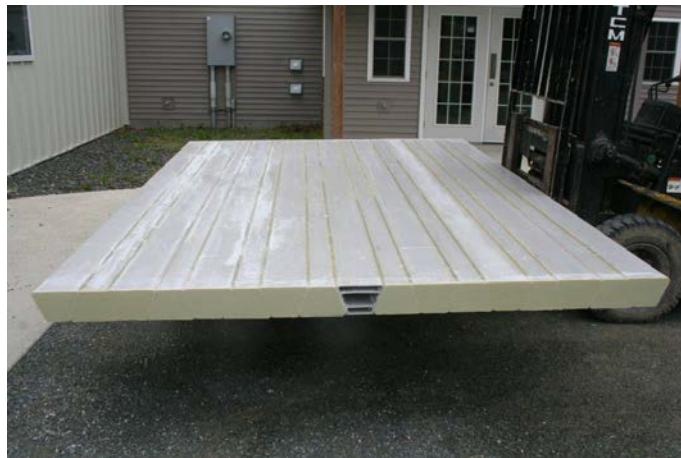
Figure 3. Photo. Panel ends are capped and radii between tubes filled with thixotropic resin.

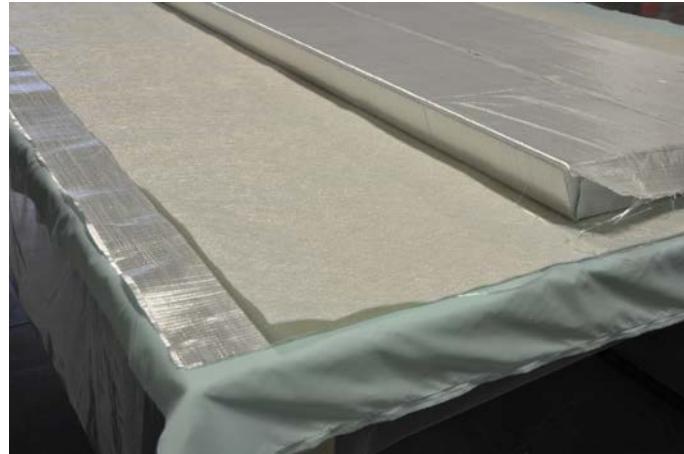
Figure 4. Photo. The panel is wrapped in glass fiber in preparation for infusion with vinyl ester resin.

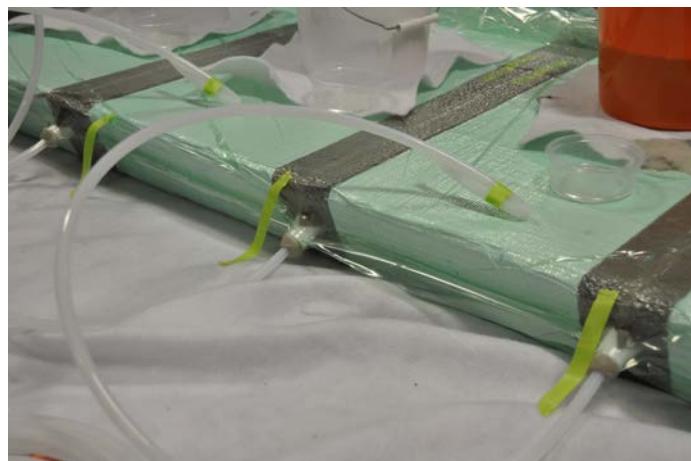
Figure 5. Photo. Resin is infused for the outer wrap using a vacuum-assisted resin transfer molding (VARTM) method.

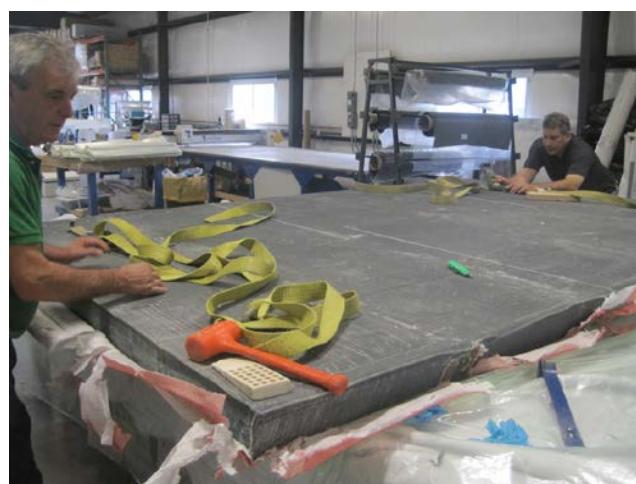
Figure 6. Photo. Each infused deck panel is stripped and inspected to ensure that fibers have been thoroughly wet-out with resin.

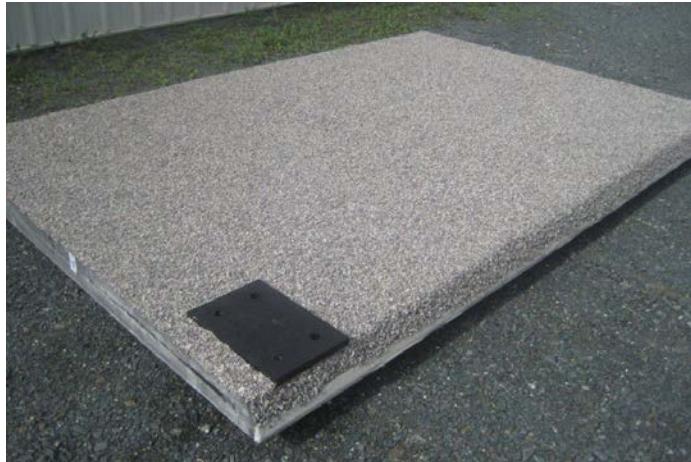
Figure 7. Photo. Adhesive and stone are applied for course 1 of the wearing surface. (The black rectangle is a bearing pad for the bridge railing post.)

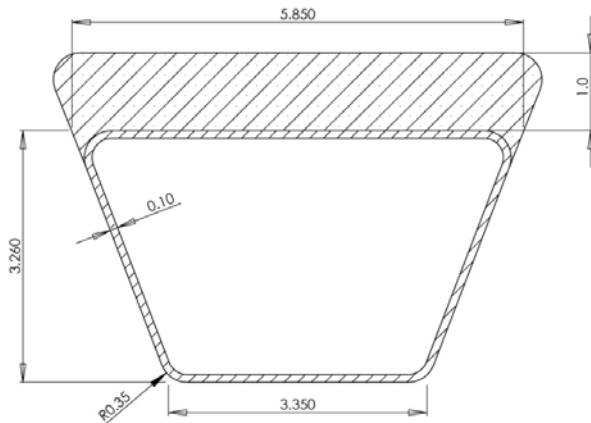
Figure 8. Diagram. Geometry of ice shield profile with single cavity.

The trapezoidal profile used to create the replacement deck slabs in this project was developed from an earlier design developed at the University of Buffalo. In July 2010, XC Associates fabricated a protective ice shield for a bridge in Erie County, NY, using this profile design. The trapezoidal shape was slightly different than that proposed for the current project in that it only used a single grout cavity rather than two (see figure 8). The structure was fabricated from two trapezoids each approximately 0.1 inch thick. The smaller trapezoid was designed to be adhesively bonded inside the larger trapezoid. A series of these tubes were then adhesively bonded together to form a wall unit. To ensure the structural integrity of the wall unit, the assembly was completely wrapped by an outer laminate.

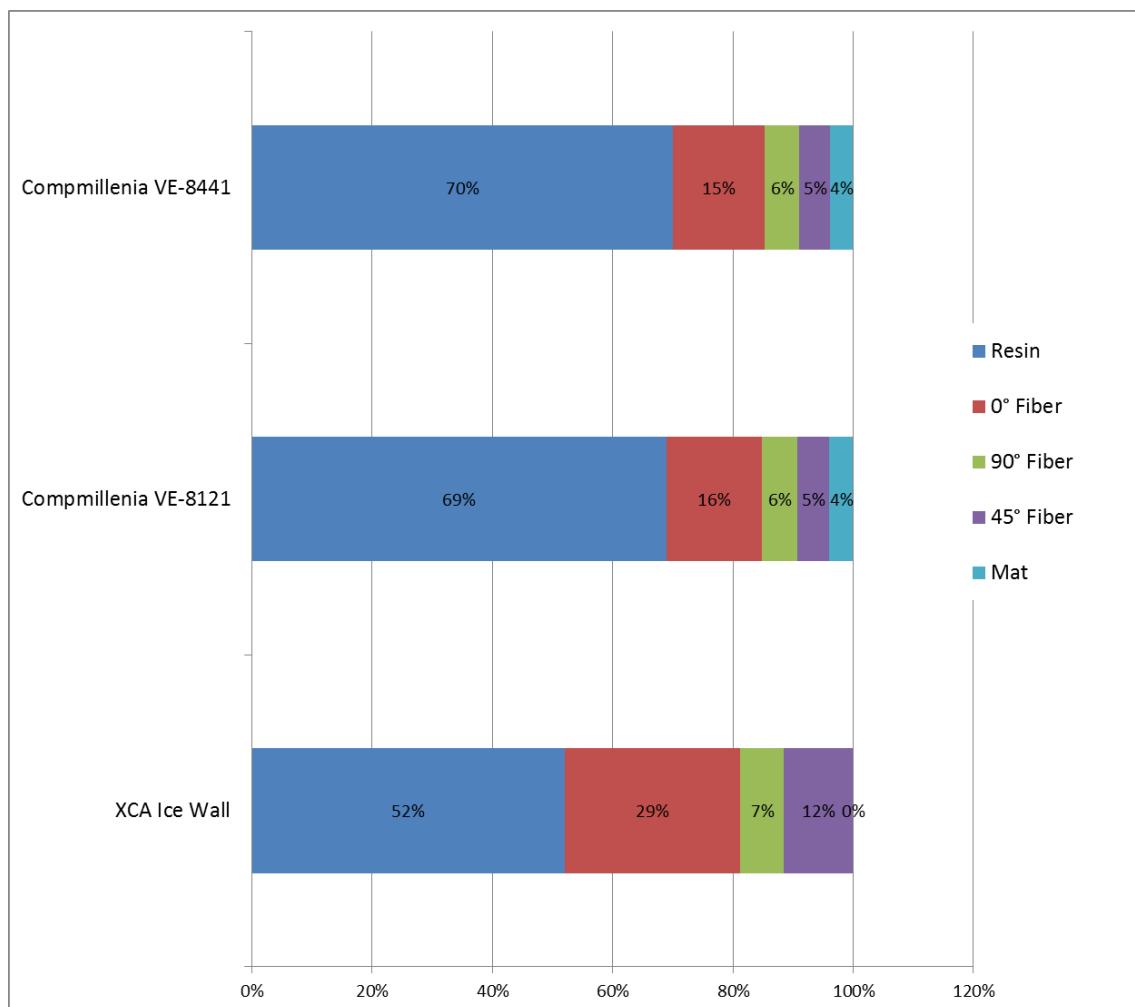
Figure 9. Graph. Constituent content of test laminates as a percentage of total laminate thickness.

In the 90° direction it can be seen that the proportion of the laminate thickness aligned with the load (90° fibers aligned with 90° axial load) is relatively close for all the panels (7.24 percent vs. 5.94 percent and 5.74 percent). It would therefore be anticipated that for fiber dominated properties the observed values in the 90° direction would be relatively close to each other. This is consistent with the observed data.

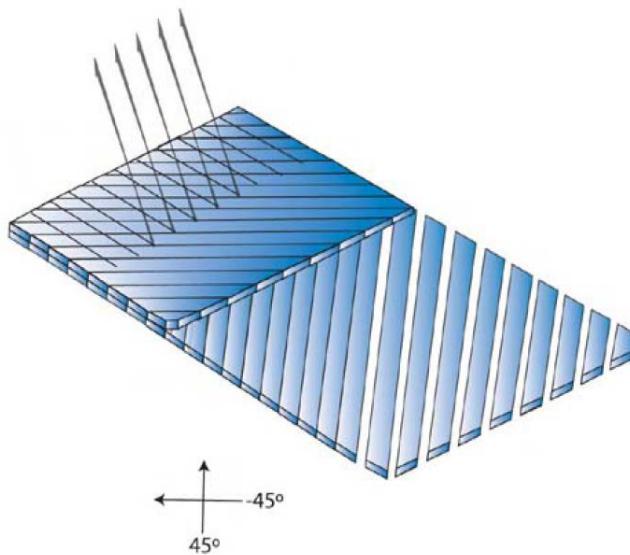
Figure 11. Diagram. Structure of double bias laminate.

The double bias fabric used in this test series consisted of two unidirectional layers of 6.27 oz/yd² each stitched together at $+45^\circ$ and -45° relative to the principle axis (0°), which is defined as the direction off the fabric roll. The layers are stitched together with a cotton thread running in the 0° direction (see figure 11). As there is an equal amount of reinforcement at each bias angle, it would be expected that properties at 0° and 90° would show to be from a common statistical population. This thought is supported by manufacturer data, which shows equal values for modulus of elasticity and strength in both directions. However, this type of behavior is not supported by the test data. Examination of the modulus and strength data shows significant difference at both 0° and 90° for tension and compression loadings.

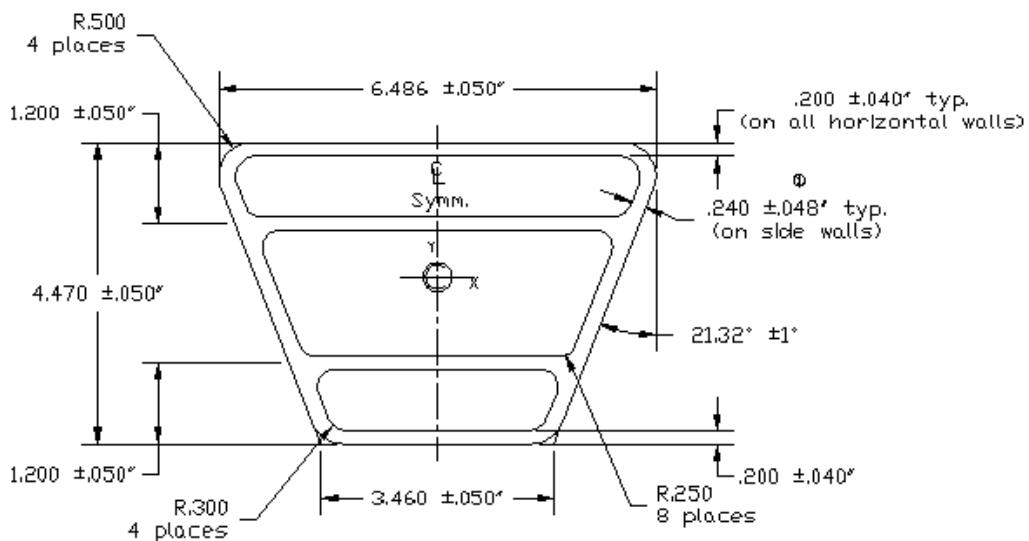
Figure 14. Diagram. Pultruded FRP combination tube

The design solution selected for the replacement deck in this project utilizes an FRP profile with three cavities (see figure 14). These profiles will be bonded together to form a large deck unit. To improve the stiffness of the deck panel and to increase resistance to localized loading, the upper and lower cavities may be filled with an appropriate grout material. This grout may be used in either the upper or lower cavity or both. Development testing on the original design concept showed a significant increase in deck performance could be gained through use of the grout.

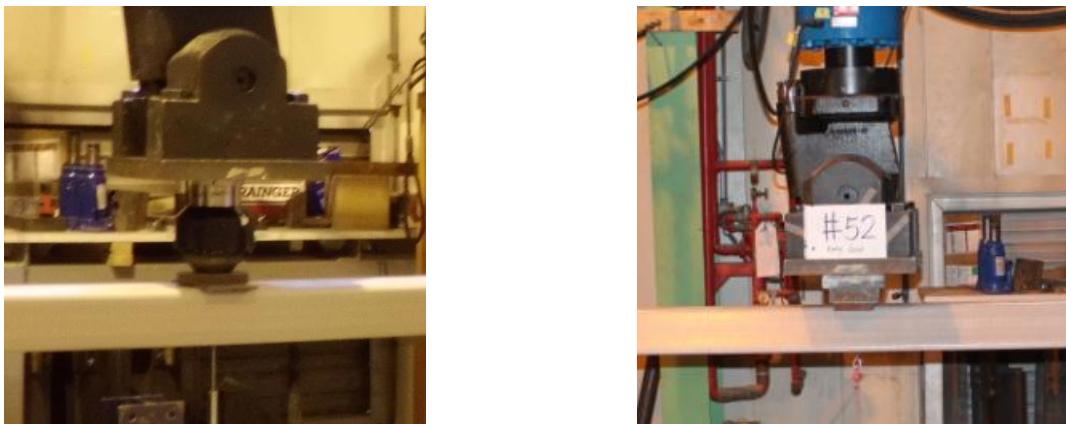
Figure 17. Photo and diagram. Testing setup.

22-kip load cell

110-kip load cell

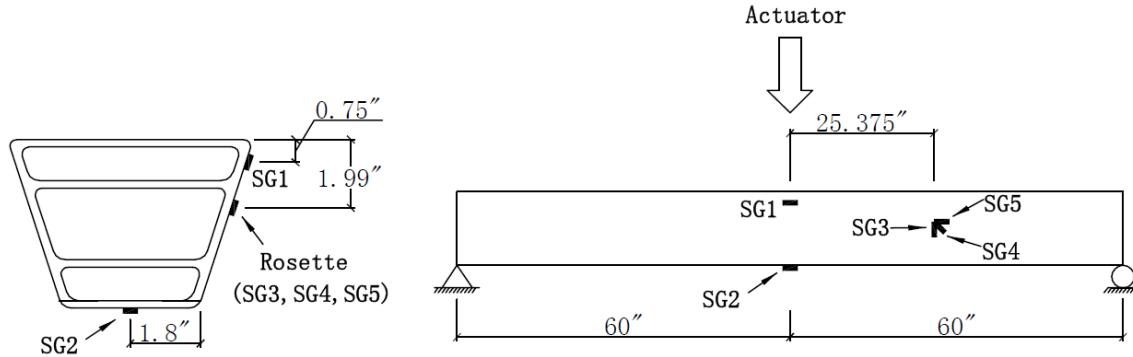
Figure 19. Diagram. Strain gage locations for the FRP tube specimen #30.

failure (WSU). Figure 19 shows the strain gages locations. Table 23 provides additional details on this test program.

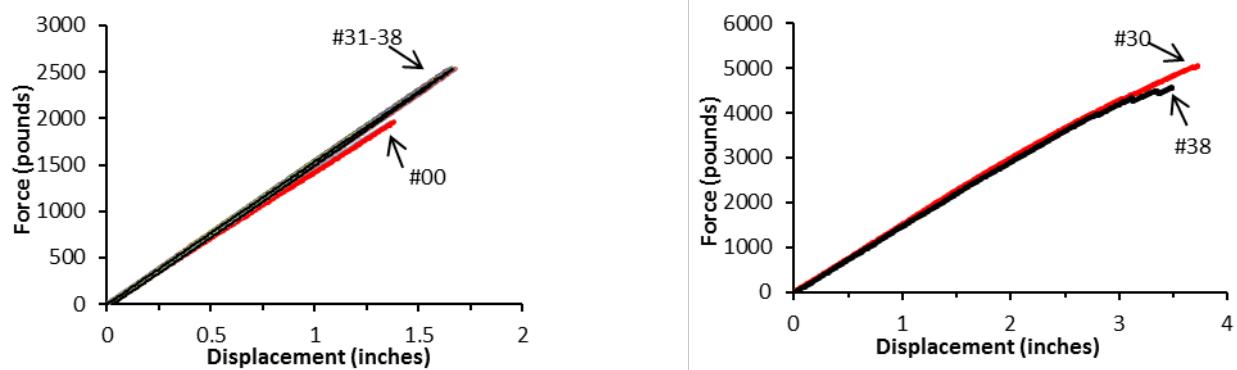
Figure 20. Graphs. Load-deflection elastic response of FRP tubes with no grout (left); Load-deflection response up to failure (tubes #30 and #38) (right).

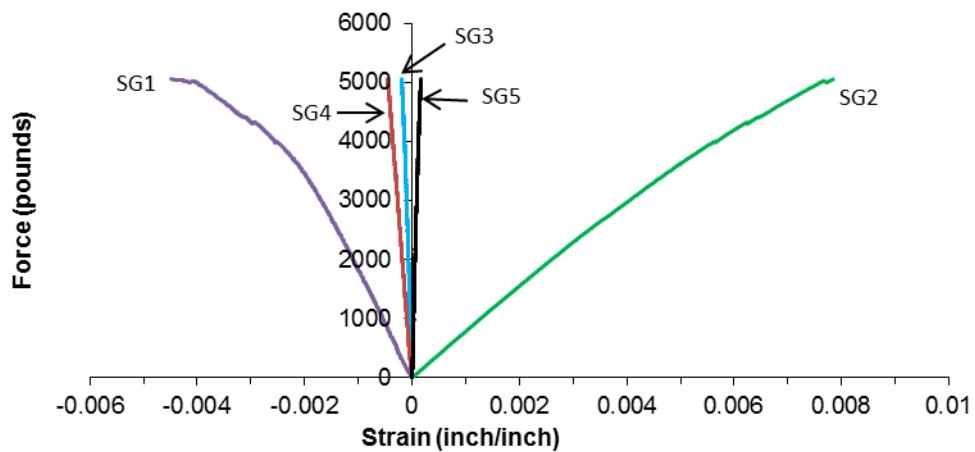
Figure 21. Graph. Load-strain response of FRP tube #30 (no grout, WSU).

Strain data from the test to failure of FRP tube #30 shows that the strain gage on the bottom "flange" (SG2) has a quite linear response up to failure load . By contrast SG1, near the top flange exhibited a nonlinear response beyond 4,000 lb of applied load. The strain gage rosette (SG3-5) displayed a very small magnitude of strain values, as expected.

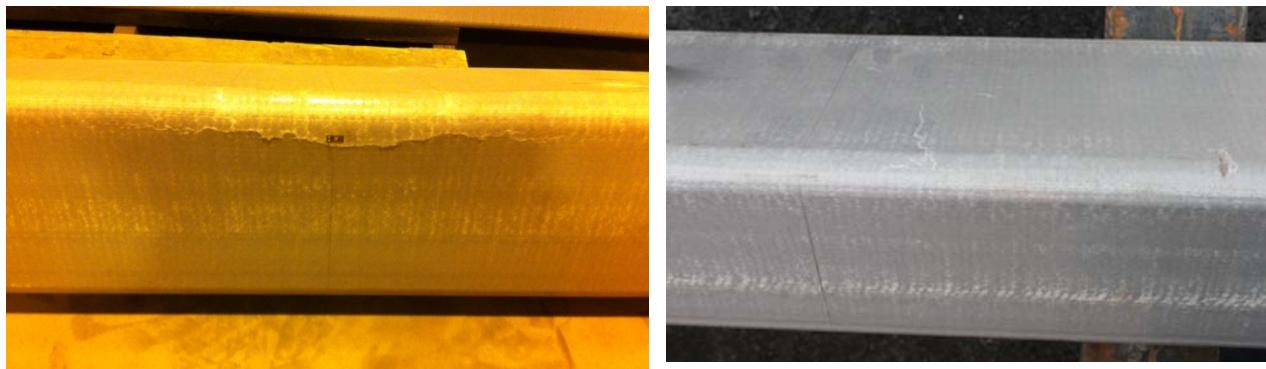
Specimen #30

Specimen #38

Figure 22. Photos. Failure modes of FRP tubes with no grout.

The FRP tubes with no grout (#30 and #38, both WSU) failed by crushing of the top flange under the point load. Figure 22 shows photographs of these specimens after failure.

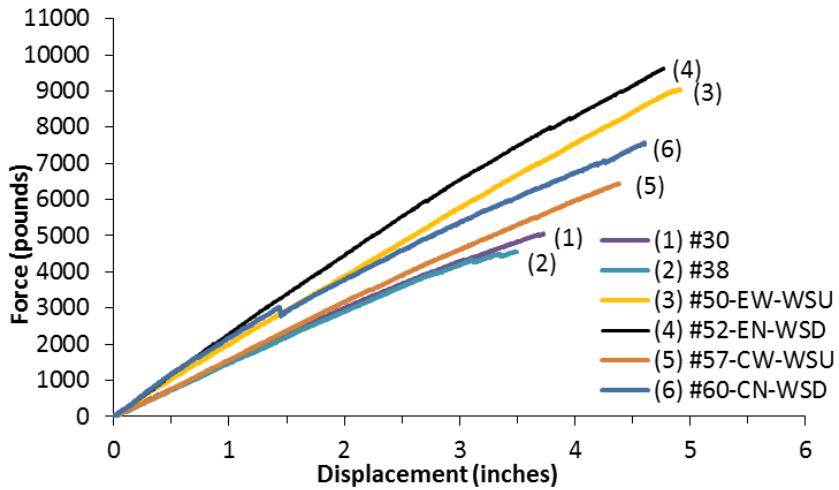
Figure 23. Graph. Load-deflection behavior up to failure for grouted FRP tubes.

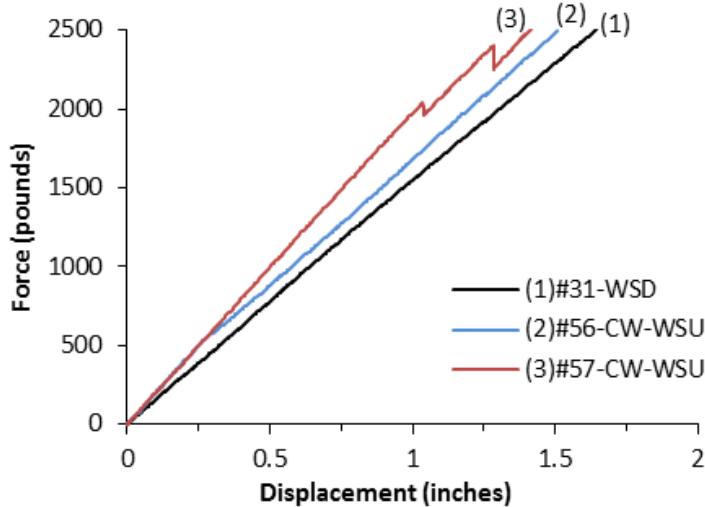
Figure 24. Graph. Load-deflection curve (up to 2,500 lb) of specimens #56, 57, and #31.

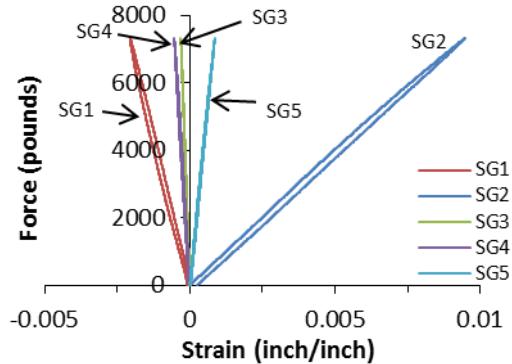
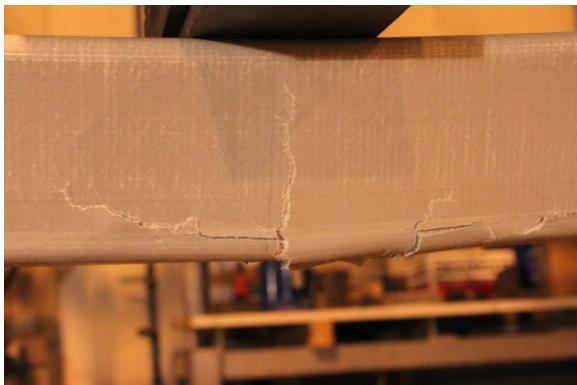
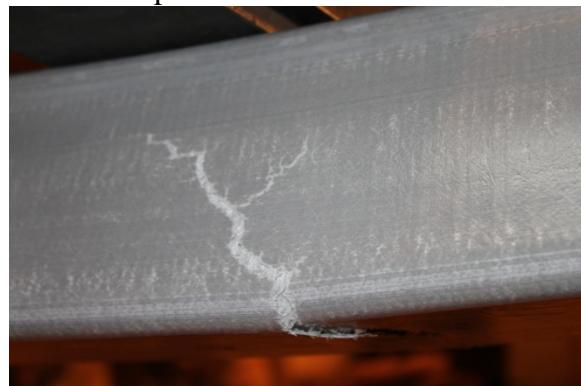
Figure 26. Photos. Photographs of failure modes of grouted FRP tubes.

Failure mode for the grouted tubes originated with a tensile rupture of the bottom flange, regardless of the location of the grout (wide or narrow cell in compression). Cracks propagated vertically for all specimens, and also horizontally in specimen #50 (the location of this horizontal crack is 0.5 inches from the bottom, apparently at the splice between wall tube and the bottom horizontal section of the FRP tube). Figure 26 shows photographs of the damage regions for all four tested specimens.

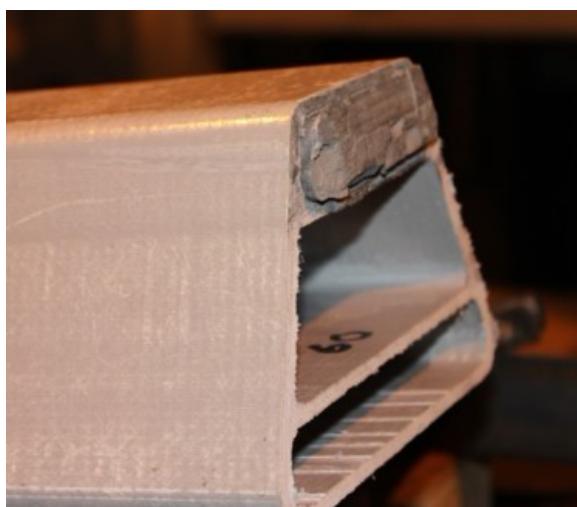
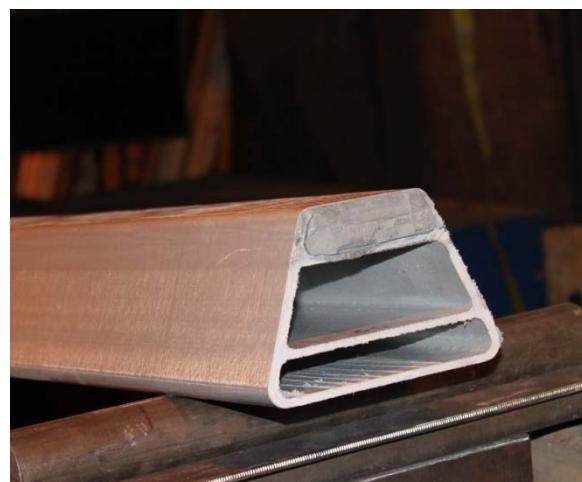
Figure 27. Photos. Cementitious grout slipping at the end of FRP tube #60.

Specimen #60 also showed slip of the cementitious grout (top) during testing at one of the ends of the specimen (the other side was covered by the manufacturer with tape), indicating that the bond between the grout and the FRP tube had failed. The load-deflection curve has a significant load drop around 3,000 lb, probably related to the debonding initiation. Load-strain curves for a cementitious-grouted specimen also registered a significant load drop, in this case around 6,000 lb.

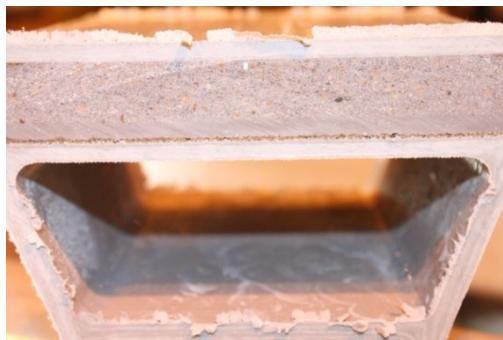
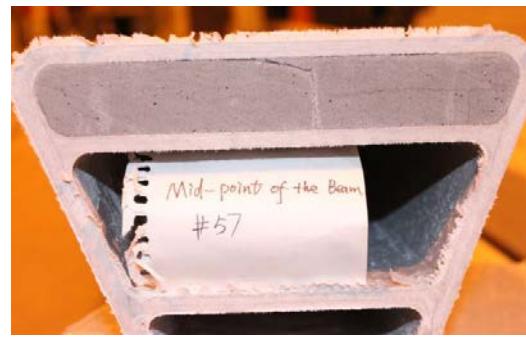
Specimen #50- EW-WSU

Specimen #57-CW-WSU

After testing to failure, specimens #50 and #57 were cut using a wet cutting block saw near the damaged region (around the center span) to look in detail at the debonded region. Inspection of the cut surfaces shows that debonding between the epoxy grout and the FRP tube (specimen #50) occurred along the lower interface, whereas cracks between the cementitious grout and the FRP tube (specimen #57) were present along the top interface, as shown in figure 28. Specimen #37 also had a vertical crack inside the cementitious grout, a possible indication of additional damage on this grouted region.

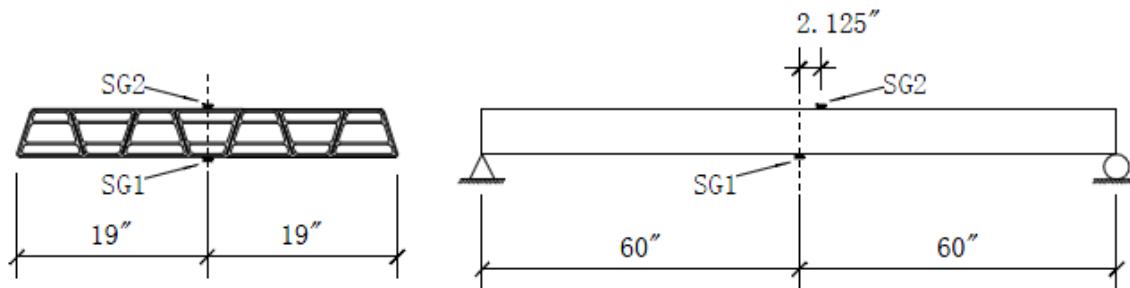
Figure 33. Diagrams. Strain gage location for panel #3 (tested to failure).

The panels with no grout were tested using the test setup described above. They were all loaded and unloaded in an elastic range (up to 20 kips). Panel #1 was tested both WSU and WSD. Panel #2 was tested WSD. Panel #3 was loaded and unloaded (up to 20 kips), then tested to failure. It was instrumented with two strain gages installed at the centerline of the panel width. SG1 was placed at midspan on the bottom surface; SG2 was attached 2.125 inches away from midspan on the top surface; see figure 33. Panel #4 was instrumented with one strain gage at midspan and centerline of the panel width on the bottom surface. Table 26 provides additional details on this test program.

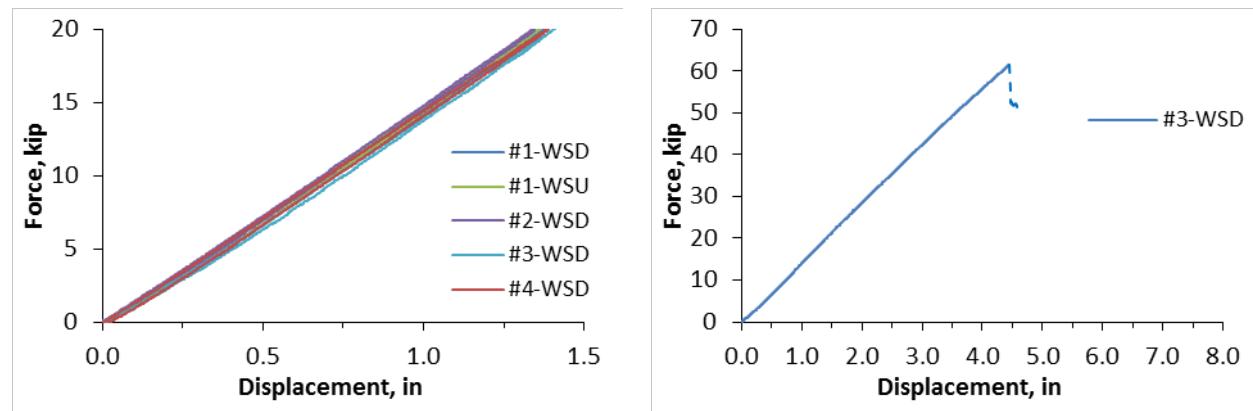
a) elastic response of all FRP panel-no grout

Figure 34. Graphs. Load-deflection response of FRP panels with no grout.

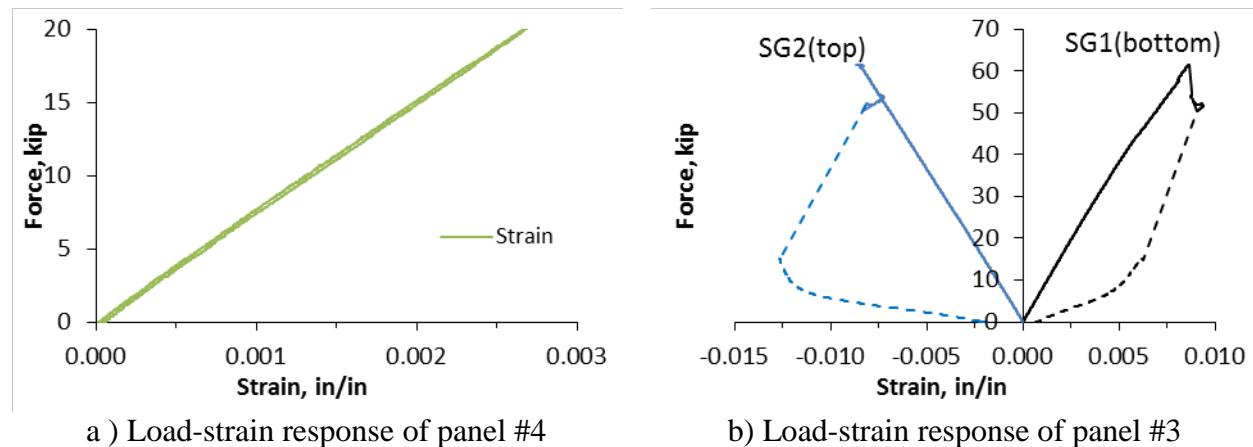
a) Load-strain response of panel #4

Strain data from the test of panel #4 has a linear response up to 20 kips of load; see figure 35 (left). Strain data from panel #3 are illustrated in the graph on the right in figure 35. This shows that the strain gage on the top (SG2) behaves quite linearly, whereas SG1, located at the centerline and mid-width of the panel (bottom), exhibited a nonlinear response beyond 40 kips of applied load. Strain behavior during unloading of the specimen after failure is shown with dotted lines.

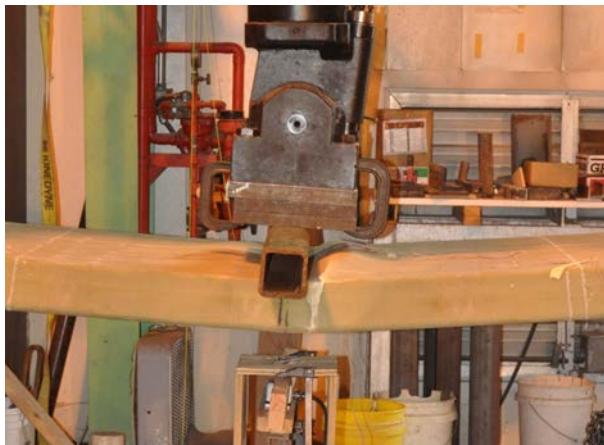
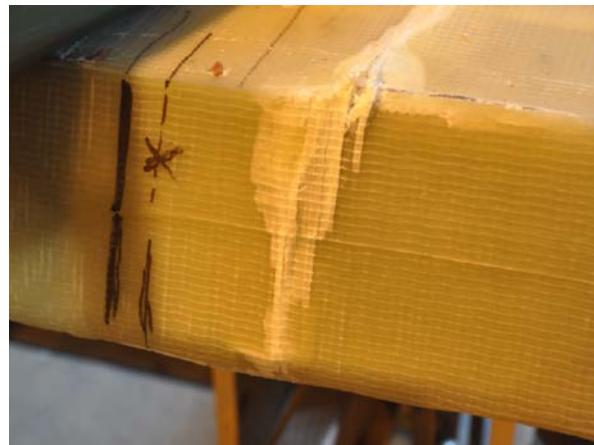
Failure at midspan: buckling of outer wrap

Top surface of the damaged outer wrap

Panel #3 was loaded manually under displacement control. The first crack was heard around 32 kips. Additional cracking noises were heard with incremental loading, and they seemed to come from localized damage regions. At around 62 kips and 4.5 inches of deflection, a significant cracking noise was heard. It appears that one or more of the FRP tubes failed (compression at the top layer), and additional sounds were heard (the load dropped to around 52 kips). At this point, it was observed that the top of the outer wrap buckled in the vicinity of the steel tube. The test continued under increasing displacement, and after just few more major cracking sounds, the load dropped to around 15 kips (perhaps all the FRP tubes had failed at this point). The outer wrap showed a region of damage near the point load. The specimen was unloaded at this point. It was observed that very small permanent deformation (0.5 inches) remained after the specimen was fully unloaded. Residual strain values were also determined: SG1 (bottom) registered 0.07 percent, and SG2 (top) registered 0.18 percent of permanent deformation. Figure 36 shows the sequence of events.

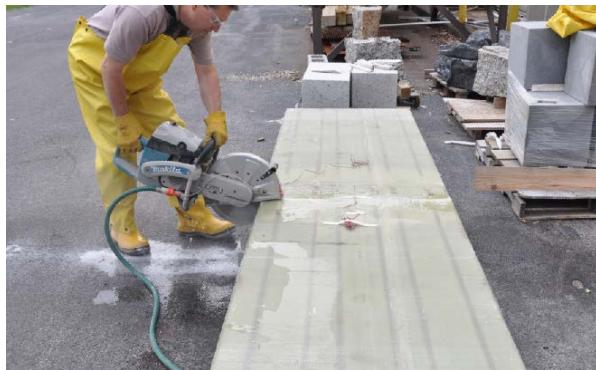
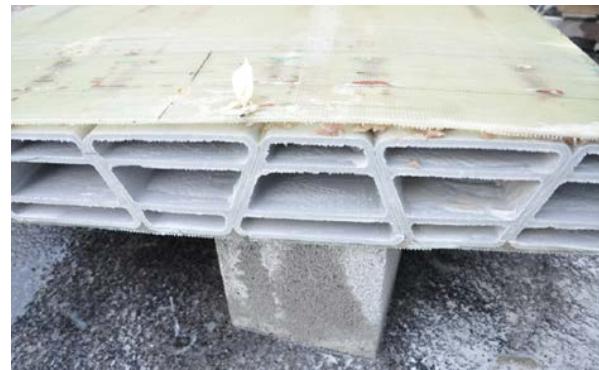
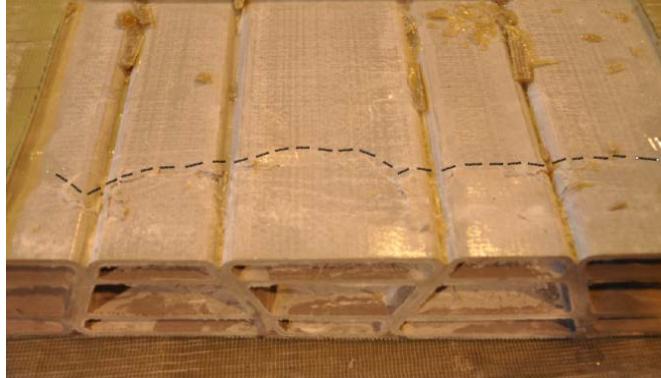
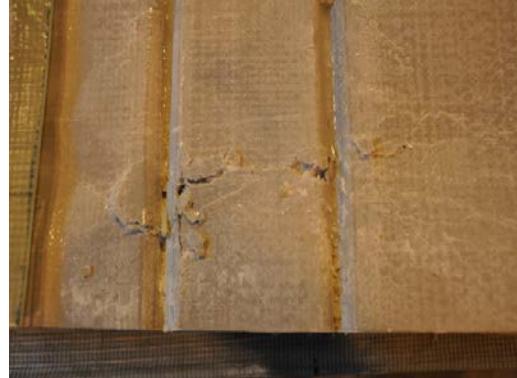
Cutting of the FRP panel #3

Cross section of panel #3 near damage region

Compression cracks on top of FRP tubes

Craking detail-top surface FRP tubes

Four pieces of the outer wrap were obtained by additional cuts along the top surface of the FRP panel and were sent to a laboratory to determine “as-built” properties of the laminate. The laminate was tested in tension, compression, and shear to compare with previous test results. Fiber fraction was also determined.

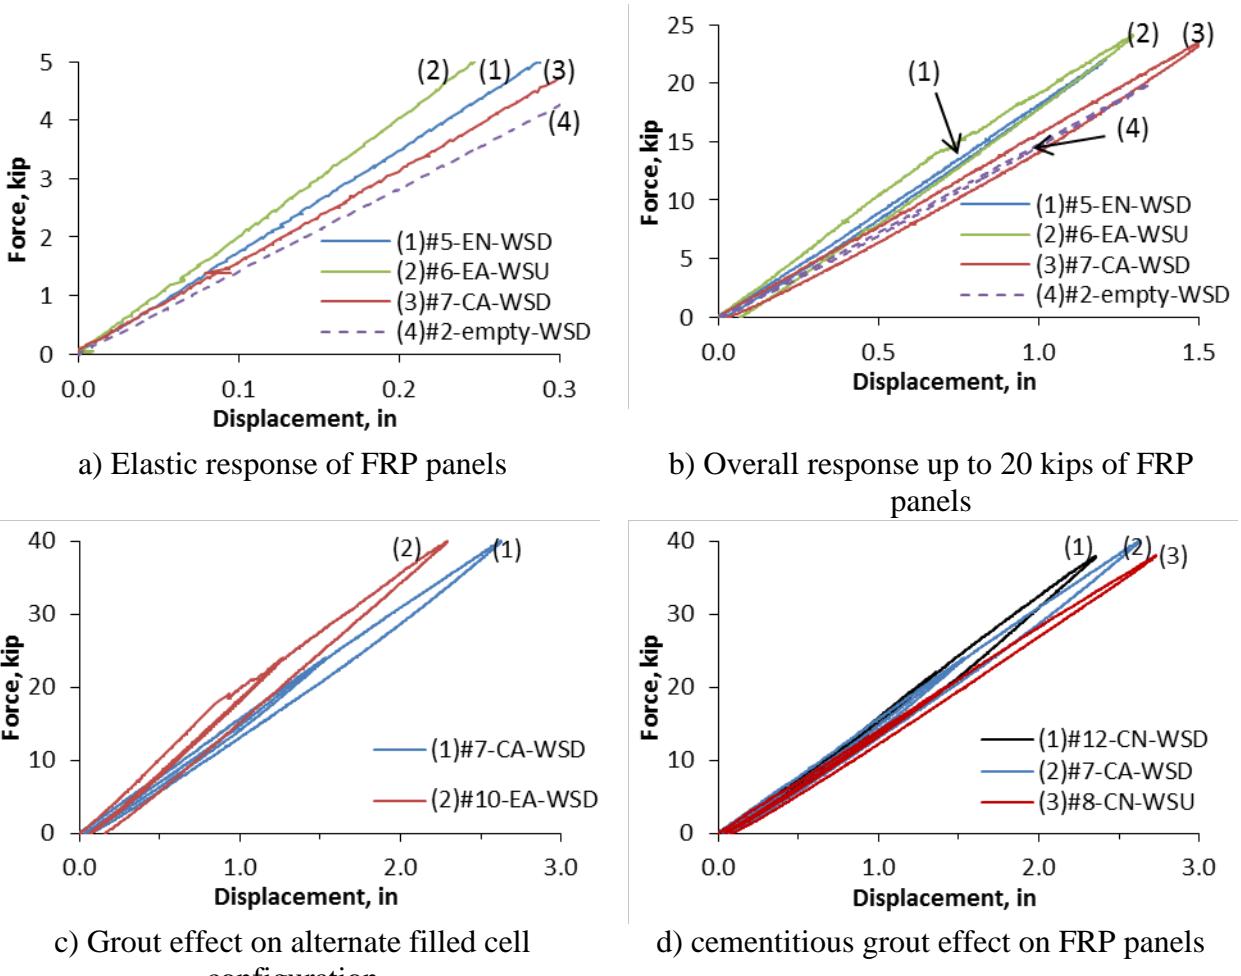
Figure 38. Graphs. Load-deflection response of FRP grouted panels.

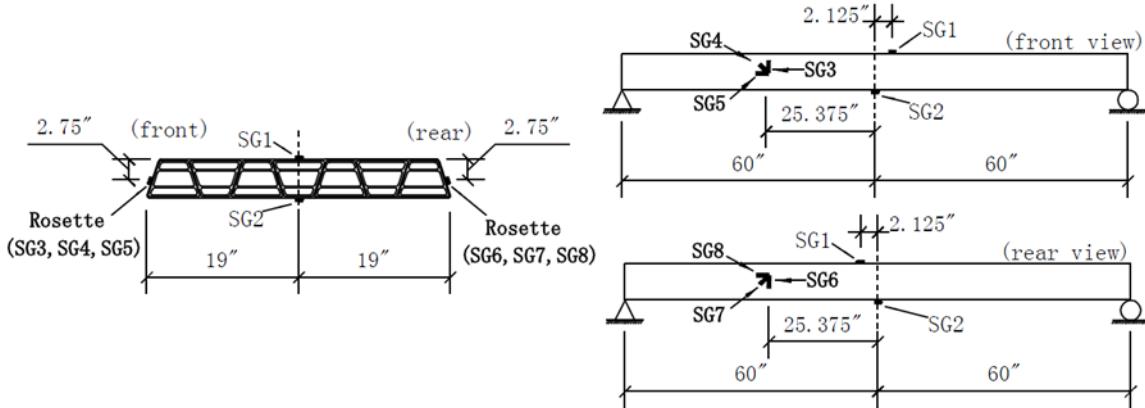
Figure 39. Diagrams. Strain gage location for panel #7.

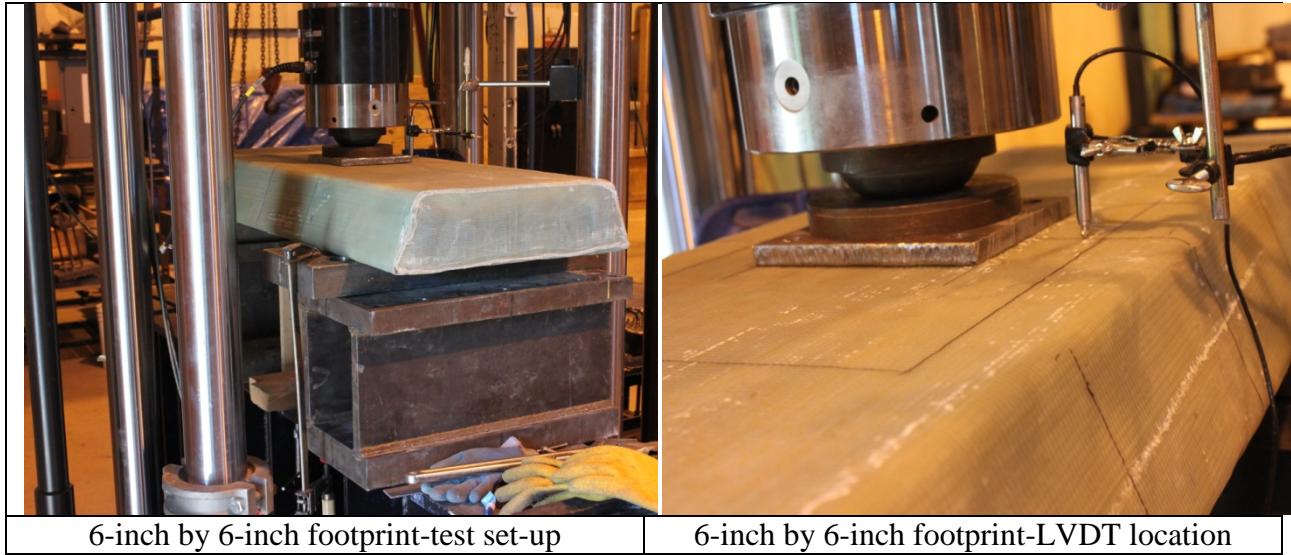
Figure 46. Photos. Test setup details.

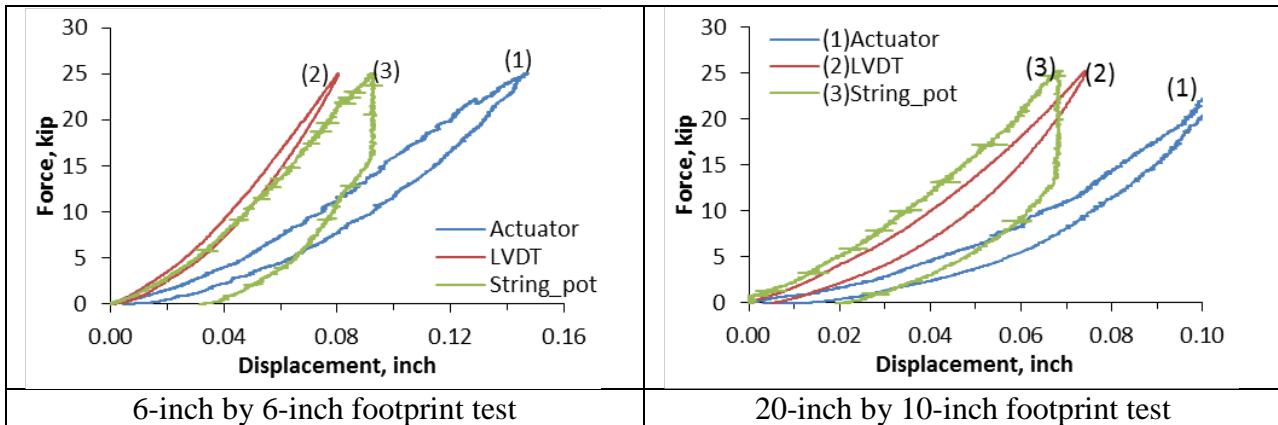
Figure 47. Graphs. Load-deflection responses of the two footprint tests.

- 6-inch by 6-inch footprint test: Max load is 25.1 kips. Max displacement: 0.146 inch registered by actuator; 0.080 inch by LVDT; 0.092 inch by the string pot.
- 20-inch by 10-inch footprint test: Max load is 25.12 kips. Max displacement: 0.109 inch registered by actuator; 0.074 inch by the LVDT; 0.068 inch by the string pot.

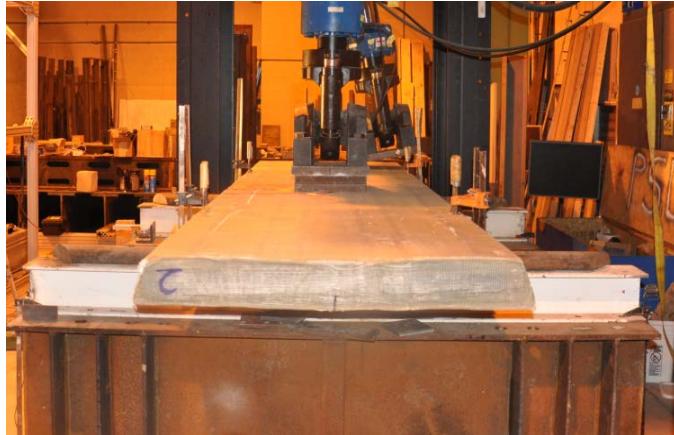
Figure 49. Photo. FRP panel (WSD).

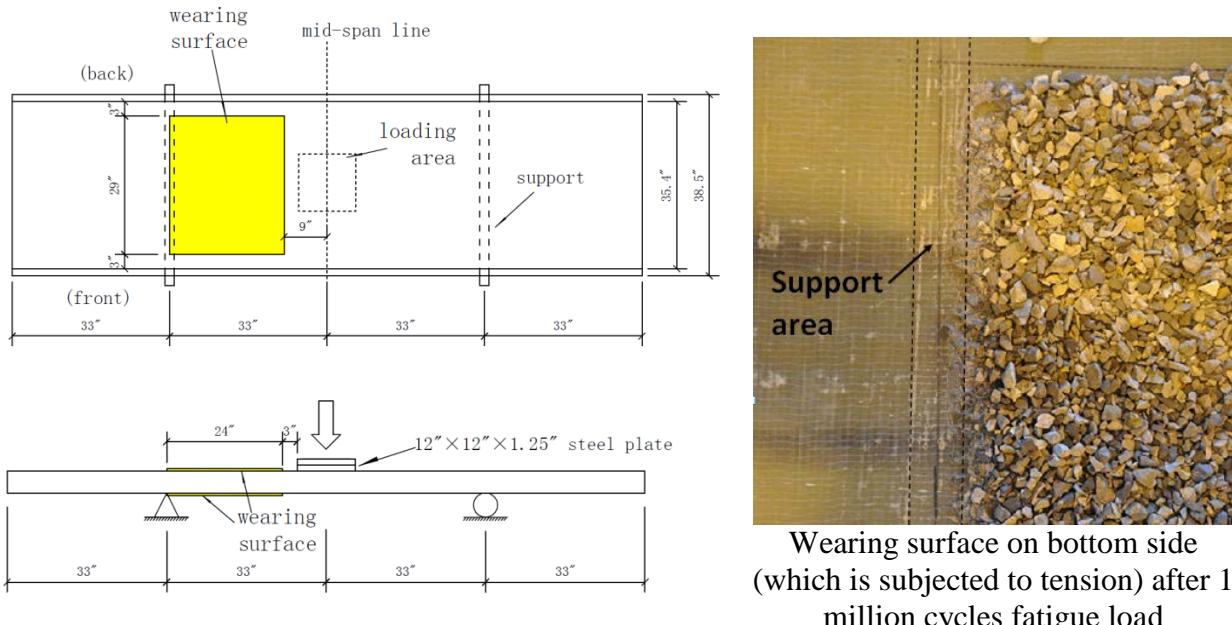
Figure 53. Diagrams and photo. Location of wearing surfaces: applied to top and bottom of deck panel to assess performance in compression and tension.

cycles there is no evidence of stiffness degradation. At 500,000 cycles, the test was temporarily stopped so a wearing surface could be applied to the bottom face of the FRP panel deck; see figure 53. After the cyclic testing resumed, a drop on the stiffness ratio was experienced for about 130,000 cycles, as shown in the graph at the right of figure 52. The maximum value corresponded to a 6 percent drop at 570,000 cycles; however, it vanished after that (650,000 cycles). It is hypothesized that because the wearing surface was applied quite close to the support area (see the photograph in figure 53), it might have produced a gap between the support and the panel, which caused the stiffness to temporarily drop.

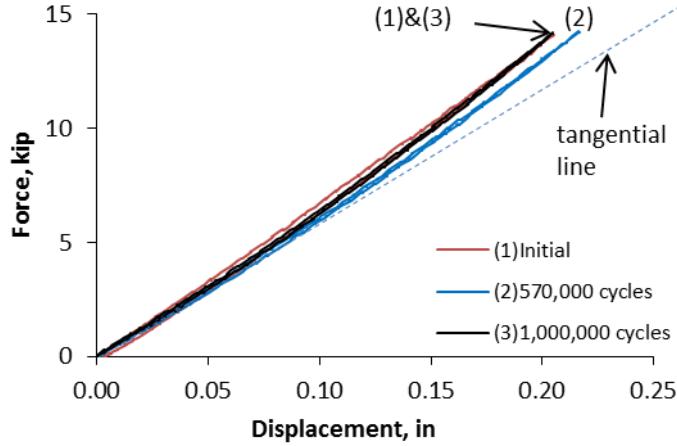
Figure 54. Graph. Load-deflection behavior at different fatigue cycles.

Figure 54 shows the load-deflection behavior at different fatigue cycles. The load-deflection curve is not quite linear; see for comparison the tangential line drawn in figure 54. The panel becomes “stiffer” after the load reaches 6 kips. The initial load-deflection curve matches well with the curve after 1 million cycles of fatigue loading. The slope of the load-deflection curve at 570,000 fatigue cycles is slightly smaller than the slope of the initial curve, which is indicated as a stiffness drop in figure 52.

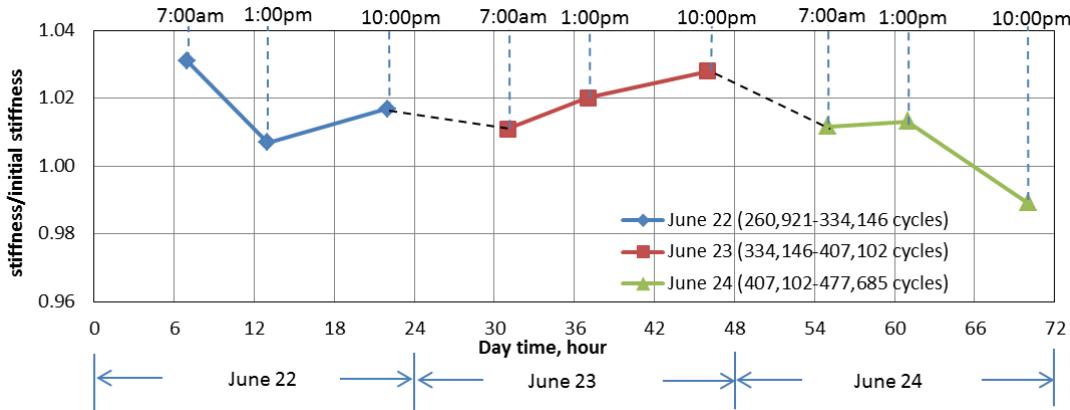
Figure 55. Graph. Stiffness change during daytime.

To evaluate the sensitivity of the stiffness measurements to the time of the day when they are taken, the flexure stiffness was measured three times a day from June 22 to June 24, 2012 (at 7:00 am, 1:00 pm, and 10:00 pm.) Results are shown in figure 55. Although these results show that the stiffness measurements change within the day (changes in the order of 2 percent were found), no clear pattern was determined, although it appears that there is a drop of stiffness overnight.

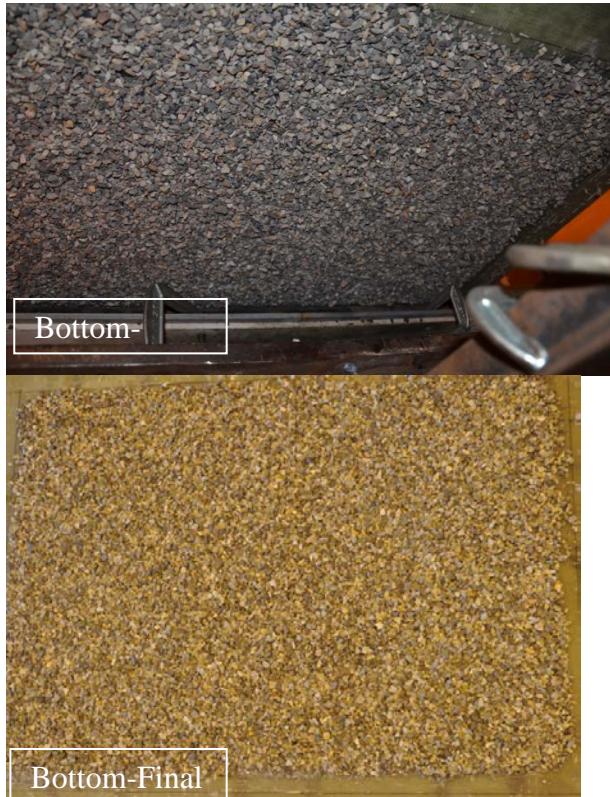
Figure 56. Photos. Bottom wearing surface before and after 500,000 cycles fatigue load.

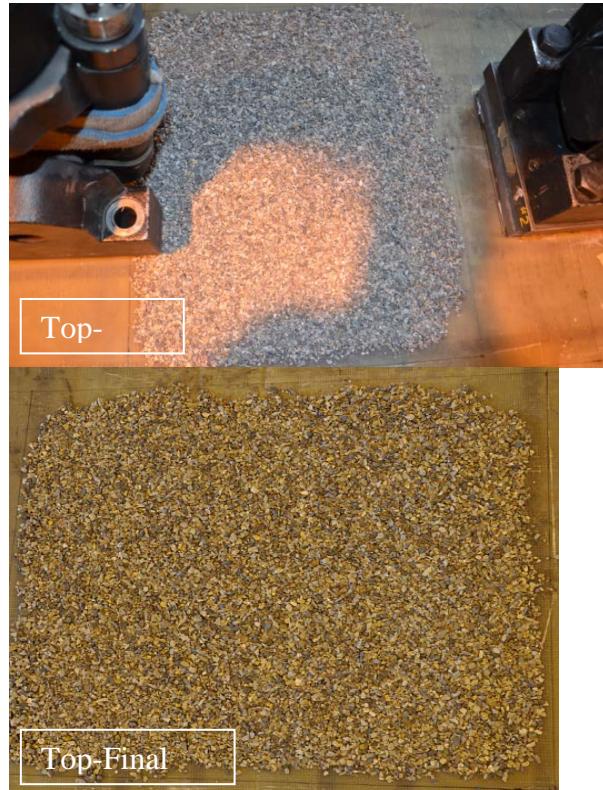
Figure 57. Photos. Top wearing surface before and after 350,000 cycles fatigue load

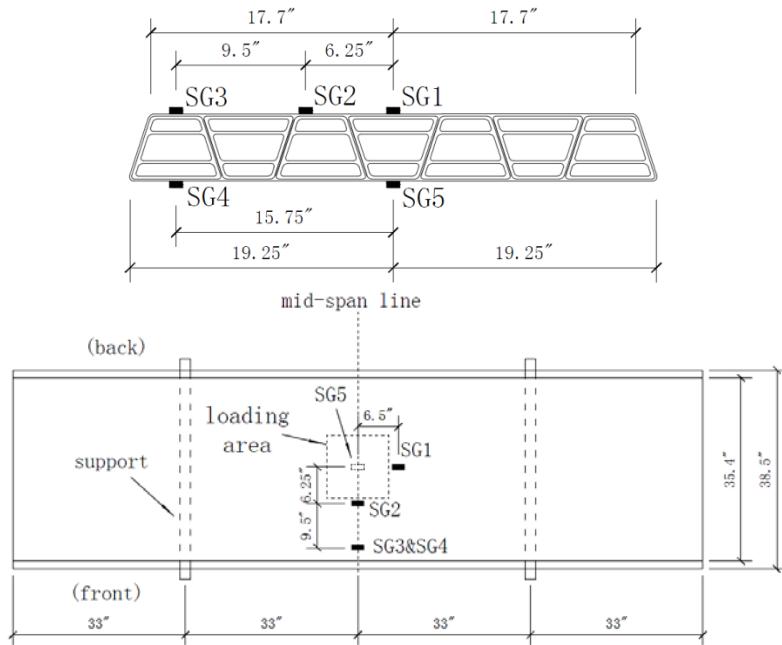
Figure 58. Diagrams. Strain gage position.

(bottom) were placed at midspan toward the edge of the panel. SG5 was installed at the midpoint of the bottom face of the panel.

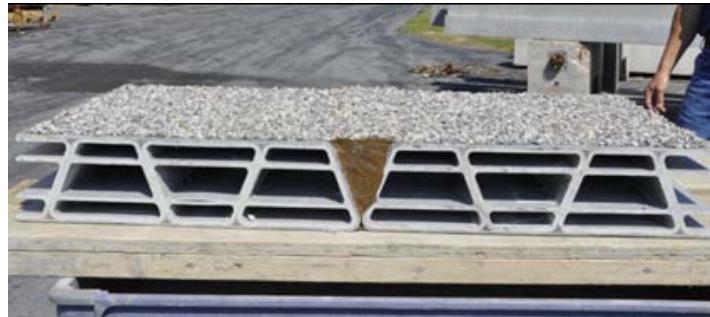
Figure 64. Photo. Panel-to-panel field joint.

The test specimen for a panel-to-panel field connection was made by joining the edges of two small panels together (FRP tubes and outer wrap) and filling the gap between them with an epoxy grout compound and aggregate, as shown in figure 64. The width of the specimen is 18 inches. The cross section dimensions are shown in figure 65.

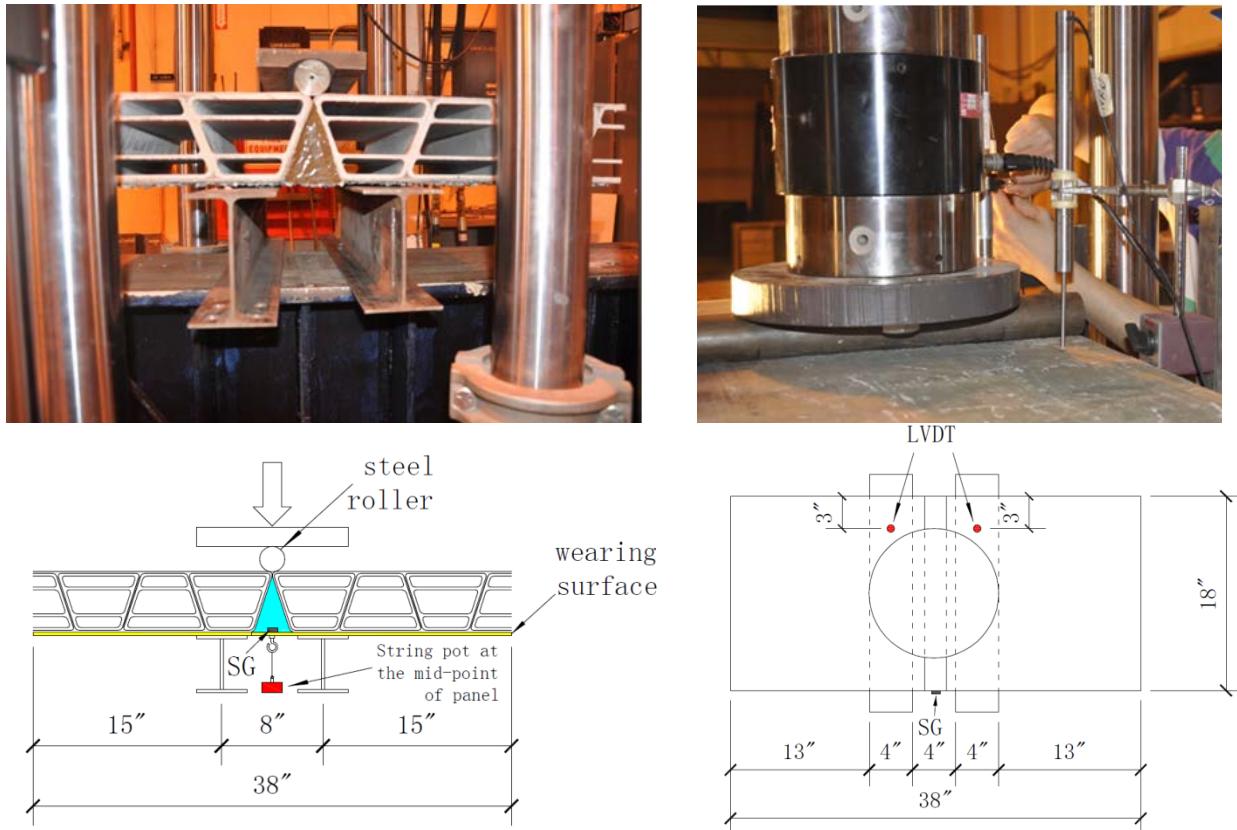
Figure 66. Photos and diagrams. End panel connection test setup.

this location. The specific locations of the string pot, LVDTs, and strain gage are shown in figure 66.
