Phase I Design Report

Composite Bridge Decking

Publication No. FHWA-HIF-13-030
January 2013

7. Author(s) J. S. O'Connor		8. Performing Organization Report No.	
9. Performing Organization Name and Address BridgeComposites, LLC 121 Upper Bennett St. Hornell, NY 14843-1451		10. Work Unit No. (TRAIS)	11. Contract or Grant No. DTFH61-09-RA-00006

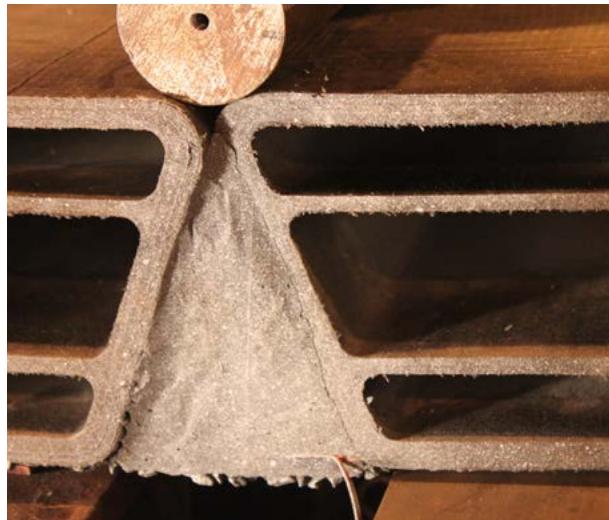
Figure 67. Photo. Crack at load of 7 kips.

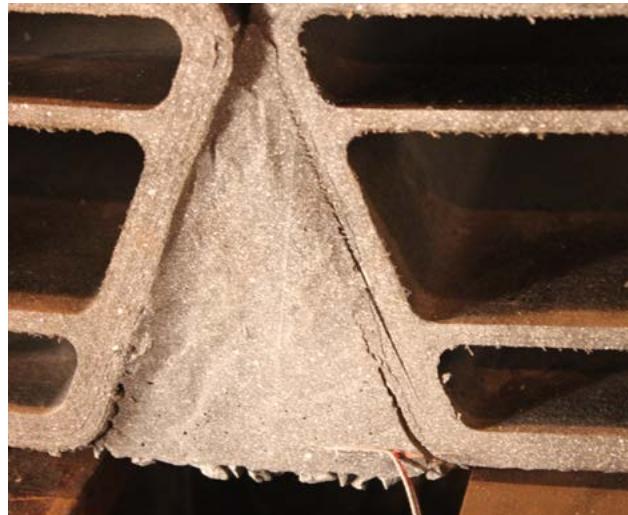
Figure 68. Photo. Crack at maximum load of 14.7 kips.

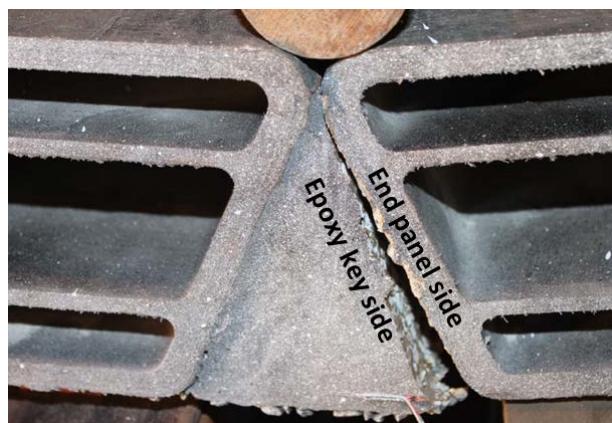
Figure 69. Photo. Failure of the specimen (11.8 kips).

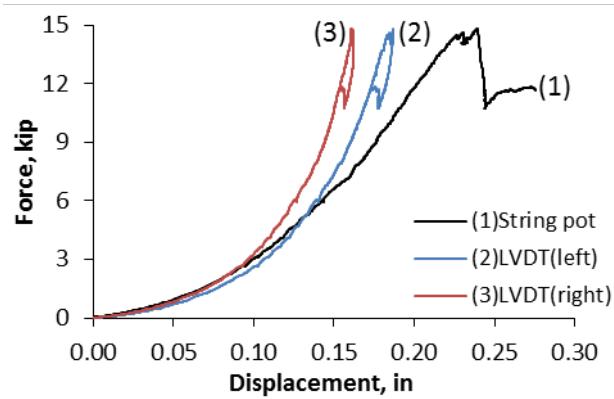
Figure 70. Graph. Load-deflection behavior.

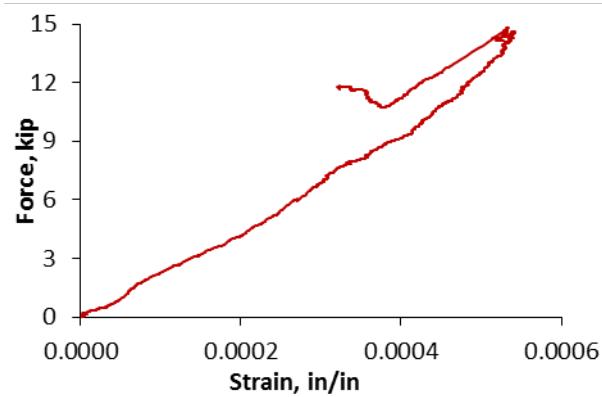
Figure 72. Graph. Load-strain behavior of the epoxy key.

Figure 72 shows the load-strain behavior of the epoxy key. It shows an overall linear behavior. The maximum tensile strain at failure load is $534 \mu\epsilon$.

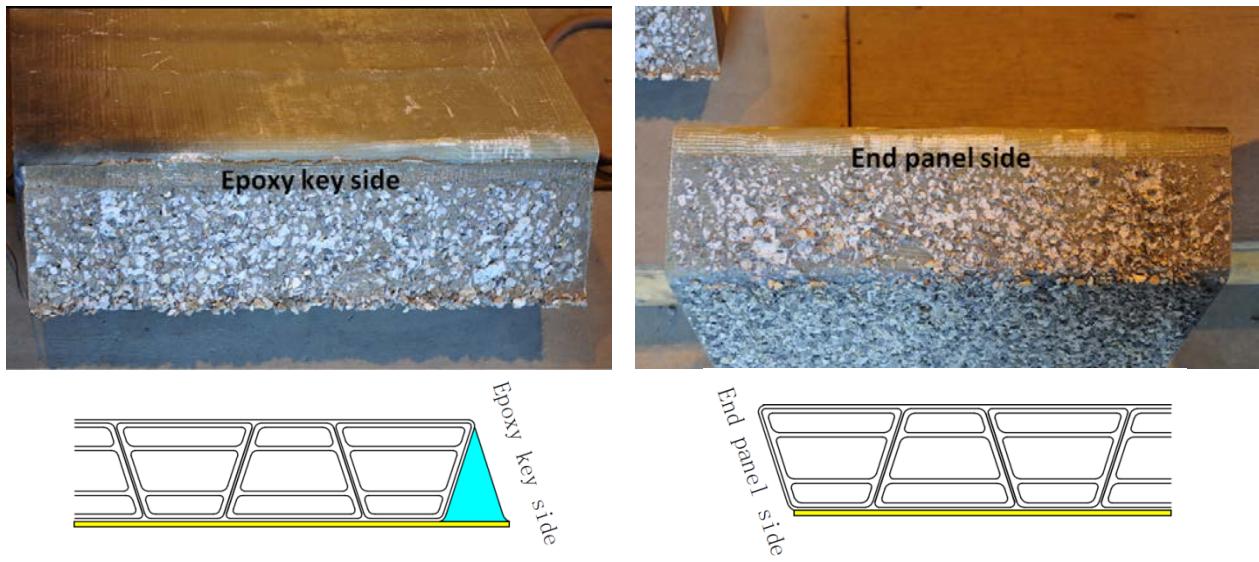
Figure 73.. Photos The two failed surfaces.

Figure 73 shows the two surfaces of the failed specimen. It should be pointed out that a layer of wearing surface was applied on the surface of the end panel prior to filling out the gap with epoxy compound to form the epoxy key. After failure, it was observed that the aggregates of the wearing surface were almost totally detached from the end panel surface and were primarily attached to the epoxy key side. The end panel failed surface shows a layer of the epoxy from the wearing surface and a small remaining portion of the aggregates. The crack line is shown as a dotted line in Figure 11.

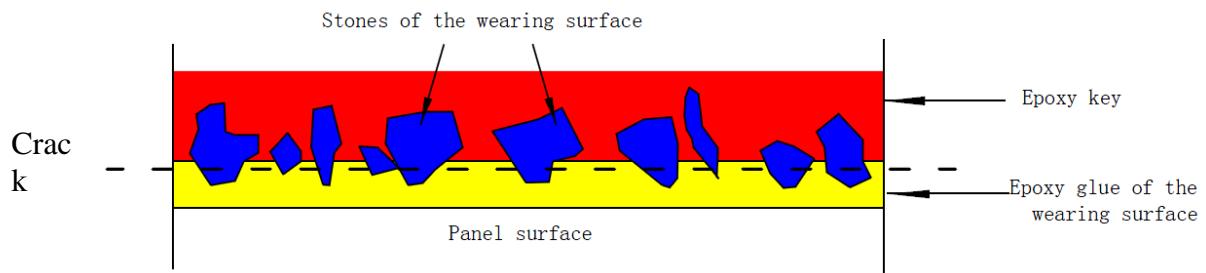
Figure 74. Diagram. Sketch of the crack line.

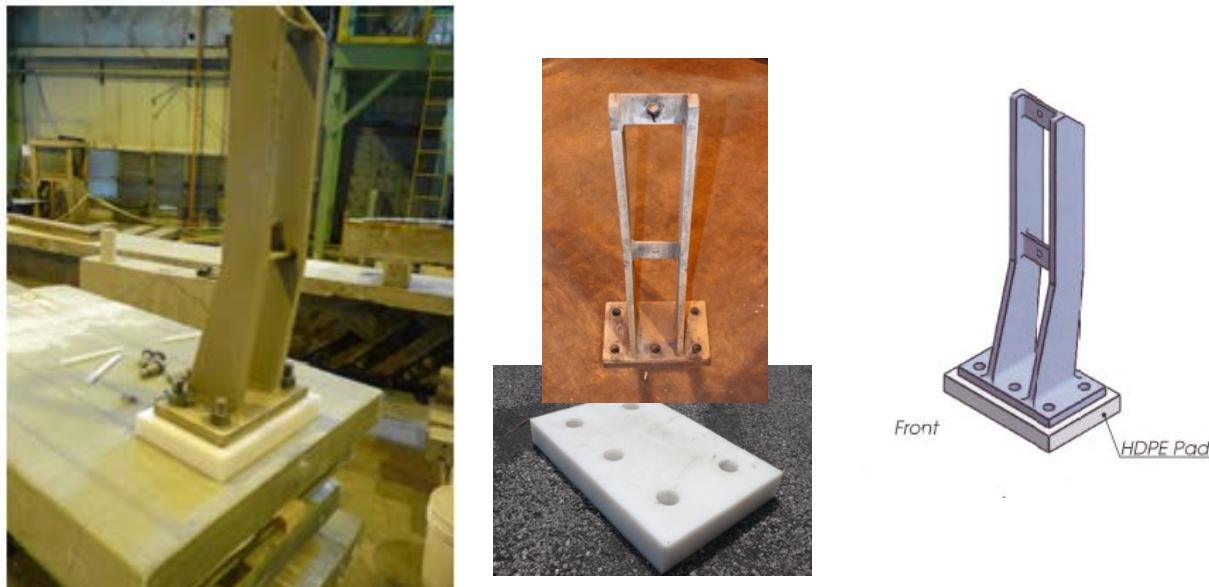
Figure 75. Photos and sketch. Railing post specimen.

An empty FRP panel, used previously to determine flexure stiffness (panel #3), was selected to fabricate the railing post-FRP deck connection. The FRP panel consisted of seven FRP tubes with the narrow side of the panel facing the rail. A steel railing post was mounted over a high-density polyethylene (HDPE) pad and attached to the FRP deck using four 1-inch threaded anchors, connecting the railing post to a steel base plate on the bottom face of the FRP deck. Figure 75 shows details of the different components of the railing post specimen. The steel base plate had four bolts welded onto the plate; the anchor rods were bolted to the rail base until they felt “snug-tight.”

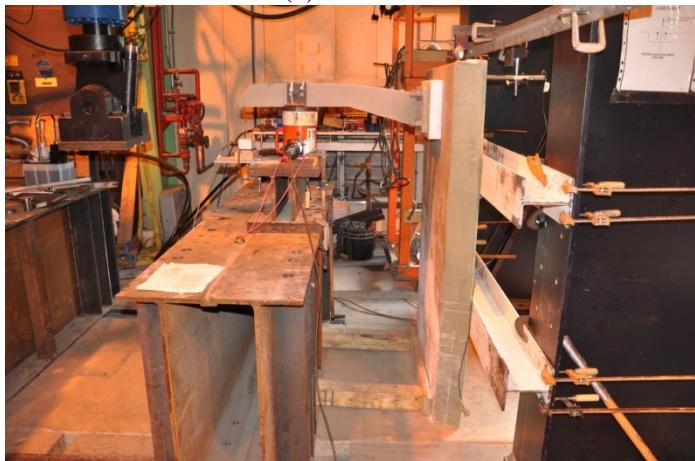
(c) Photograph of Test Set-up

Figure 76. Photo and diagrams. Railing post test setup.

Figure 76 shows details of the specimen test setup. Two steel beams (W6x20) were used to attach the FRP panel to a structural frame; their distance to the railing post base as well as to each other was based on the full-scale prototype. A hydraulic ram (22-ton capacity and 6-inch stroke) was used to apply force on the railing post at 25 inches from the base of the deck panel. The FRP deck was connected to the steel beams using hollo-bolts, flat-clips, and washers (see figure 77) similar to those that will be used in the full-scale prototype. The hollo-bolts were tight using the “turn-of-the-nut” procedure: the nuts were turned 1/3 after snug-tight conditions. After the bolts were tensioned, the torque in each bolt torque was verified using a calibrated torque wrench, and it was found to be in the order of 65 to 75 lb-ft.

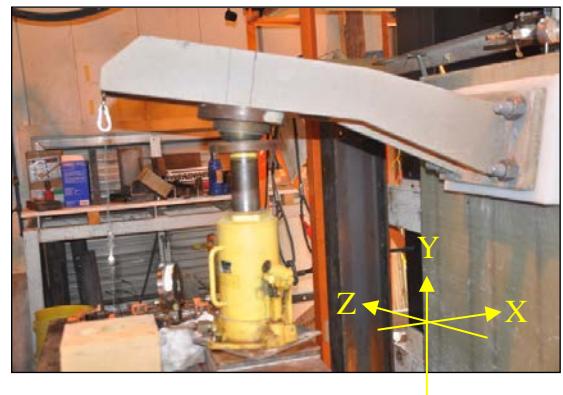
(b) View of hydraulic ram at 32 kip-failure

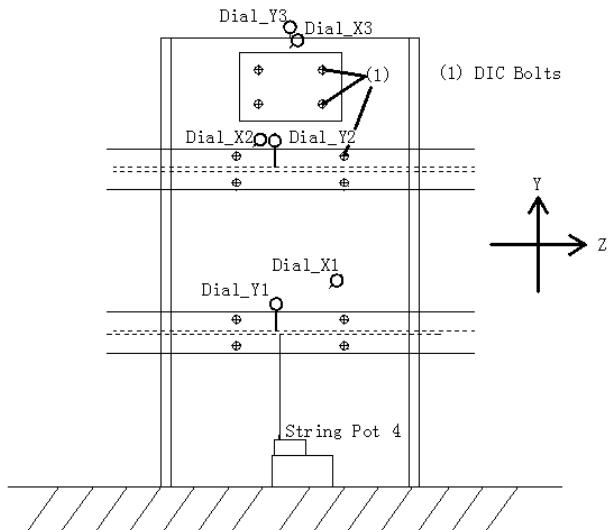
(c) Back view of gage locations

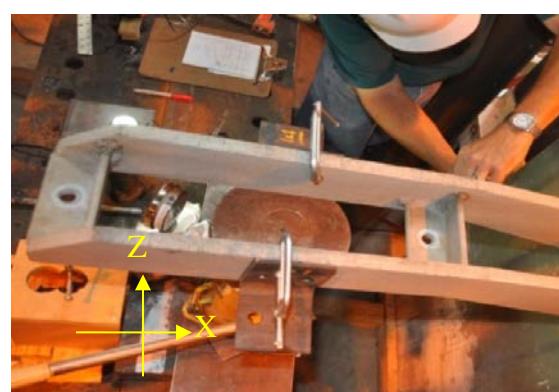
(f) Top view of post & L-brackets - Test 1

Figure 78. Photos and diagrams. Location of transducers used during the test.

To measure deflections, six dial gages and four string pots were attached to the FRP deck, railing post and W6x20 girders. In addition, digital image correlation was used to monitor the movements of few of the bolts on the back side of the panel. Figure 78 shows photographs and location of all these transducers; their orientation with respect to a Cartesian axis of reference is also indicated in these images.

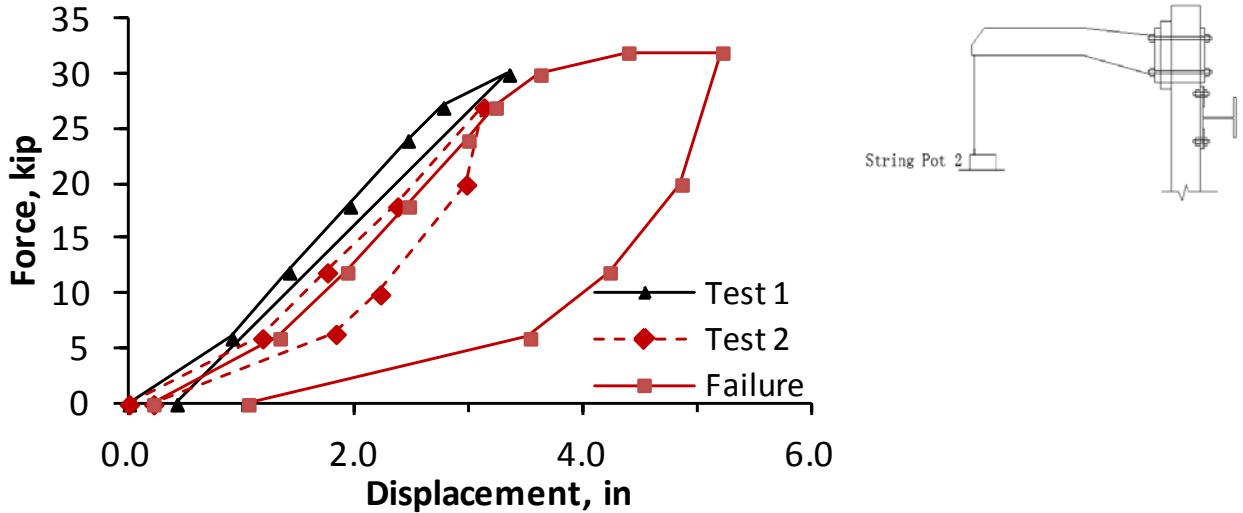
Figure 79. Graph. Load-displacement behavior of railing post end (string pot 2).

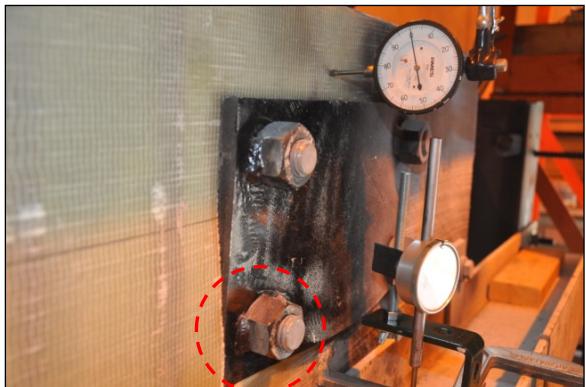
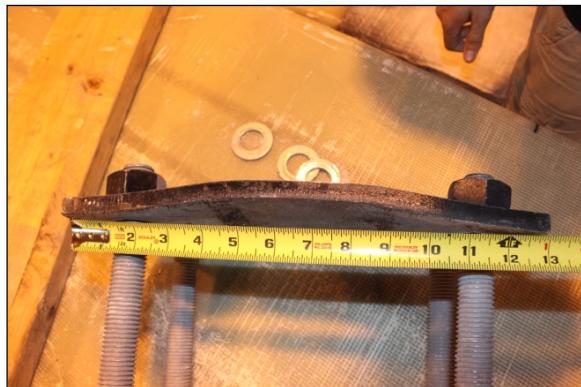
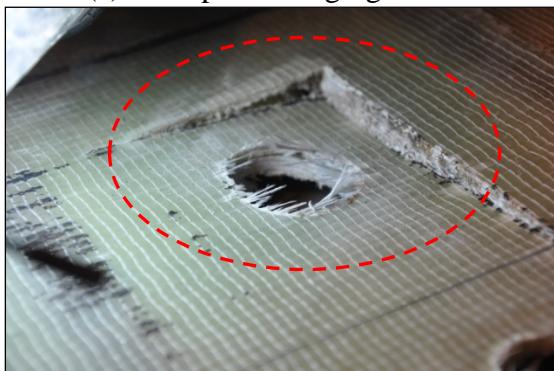
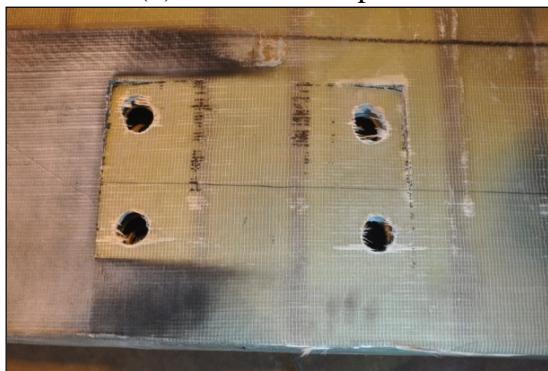
(a) Steel plate wedging failure

(b) Bent on steel plate

(c) FRP deck panel failure-close-up

(d) FRP deck failure-photograph post-test

No cracking sound was heard during Test 1 or Test 2 up to 27 kips. When the specimen was reloaded again (Test 2-Failure), cracking sounds were heard around 32 kips. It was also observed that, under increasing displacement, no further load increase was obtained. At a displacement of 5.2 inches, registered by string pot 2 (see figure 78b), the railing post-FRP deck connection failed when a corner of the back steel plate was pulled (wedged) into the FRP deck, as shown in figure 80a. As noted, the significant deformation of the rail base and HDPE pad is believed to be the reason for the increasing pulling forces on the bolts at the bottom of the steel base plate. The steel plate was bent as a result of this pulling effect; figure 80b shows the extent of the deformation. The wedging effect caused a local shear failure of the deck through the first layer of the tubes (aka punching shear), shown in detail in figures 80c and 80d. Post-test visual observations of all bolt holes in the FRP panel both at the railing post and hollo-bolt connections revealed no signs of bearing failure. Figure 79 shows that non-linear deformation (most likely coming from the failure of the connection) started between 30 and 32 kips. Permanent deformation registered by string pot 2 was in the order of 1 inch.

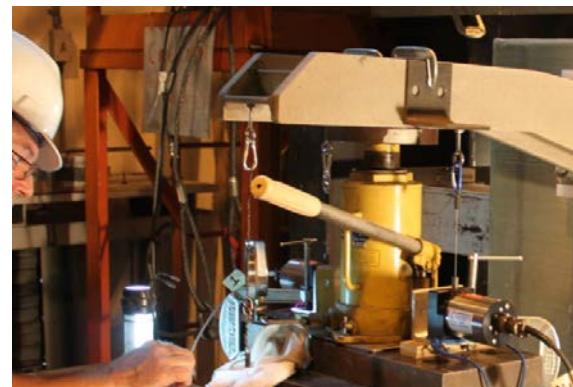
Figure 81. Graph and photo. Vertical displacement of the railing post, Test 1.

(b) Photograph of 3 string pots used

The large amount of vertical displacement registered by the string pots indicates that, in addition to the railing post deformation, other sources of deformation also contributed to this displacement: 1) the rotation and movement of the anchor bolts connecting the post to the FRP deck panel, which in turn allowed for railing post base and HDPE rotation, 2) the HDPE pad deformation, 3) the FRP deck panel deformation, 4) the possible movement of the hollo bolt connections, and 5) movement of the bracing system used to secure the steel beams to the structural frame. Figure 82 shows a sketch illustrating these possible sources of deformation. In the next sections, they will be described in more detail.

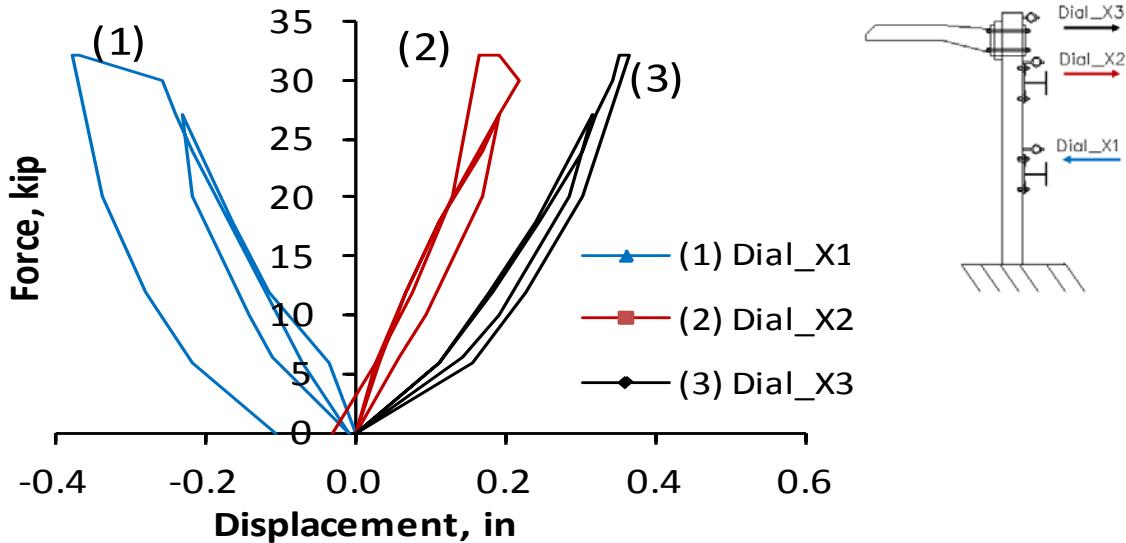
Figure 84. Graph. Horizontal deflection (x-direction), Test 2.

Movement of the FRP deck panel in two directions was recorded using LVDTs and dial gages. Displacement in the direction perpendicular to the applied load (x-direction) was estimated from dial gages Dial_X1, Dial_X2, and Dial_X3. Dial_X2 and Dial_X1 measure the FRP deck movement with respect to the top and bottom steel girder, whereas Dial_X3 measures the total movement of the top of the panel relative to the structural frame (attached to the floor). Figure 84 shows these deformations for Test 2. As expected, the deformation of the FRP deck panel is larger toward the cantilever edge and smaller near the steel girder support. At the location near the second (bottom) steel girder, the FRP panel experiences a reversed curvature, thus deforms in the opposite direction than the cantilever edge. The curves on figure 84 show that the FRP deforms linearly up to 30 kips; beyond that load level, non-linear deformations appear, possibly associated with the damage of the railing post connection. At 27 kips, the displacements registered by Dial_X3, Dial_X2 and Dial_X1 are 0.195, 0.188, and -0.233 inches, respectively.

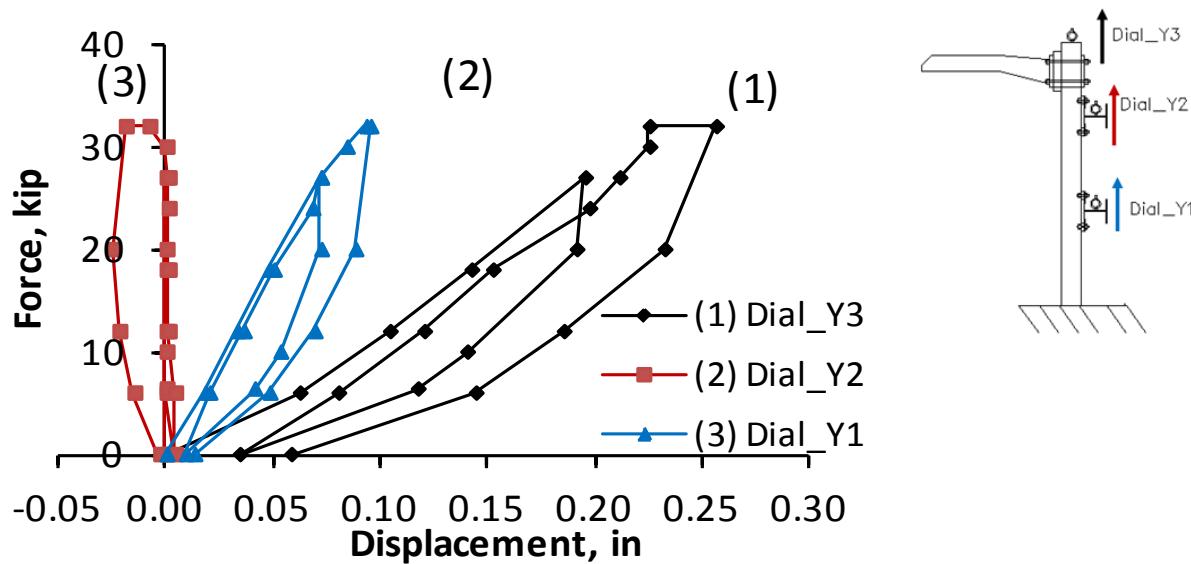
Figure 85. Graph. Vertical displacement (y-direction), Test 2.

Figure 85 shows the vertical displacements (in the y-direction) recorded by the three dial gages during Test 2. Dial_Y1 and Dial_Y2 measure the vertical movement of the FRP panel relative to the adjacent steel girders while Dial_Y3 measures the overall movement of the top of the FRP panel (with respect to the structural frame, attached to the floor). As expected, the displacement of the top of the FRP panel is larger than those near the steel girders. The behavior of Dial_Y3 shows that the panel does not return to its initial position after the first unloading. After failure of the railing post connection, the specimen was unloaded; the permanent displacement of the FRP deck at the top was found to be 0.058 inches.

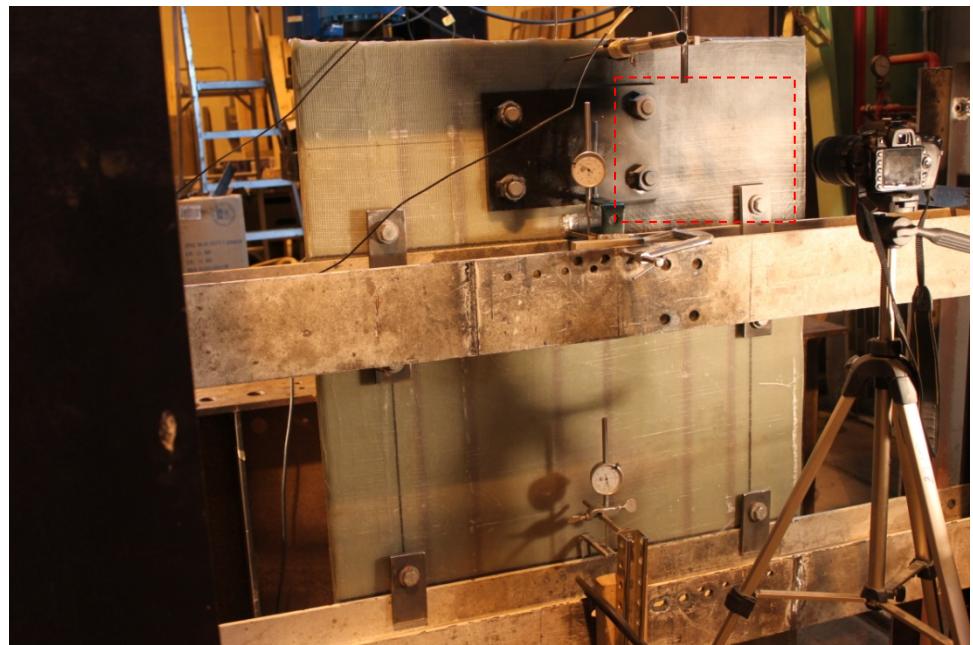
(a) Photograph of the back of the FRP deck; area used for digital image correlation is highlighted

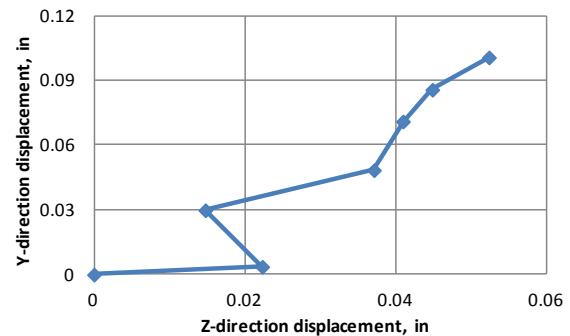
(e) Bolt 3 displacement

Figure 87. Photos and graphs. Movement of three bolts on FRP back panel using digital image correlation, Test 1.

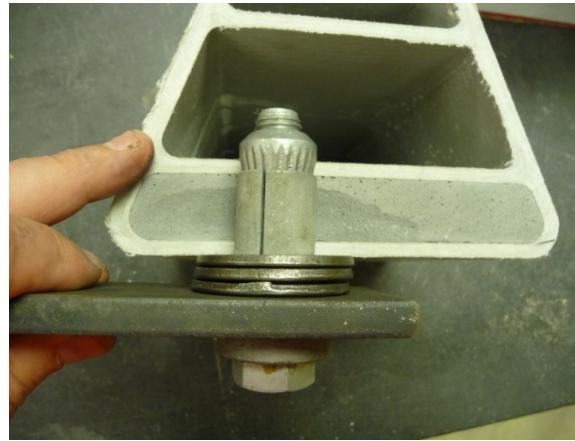
(b) Cross section of FRP tube & connection

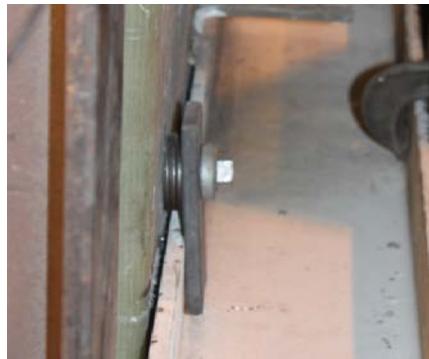
(c) Profile view of bolted connection

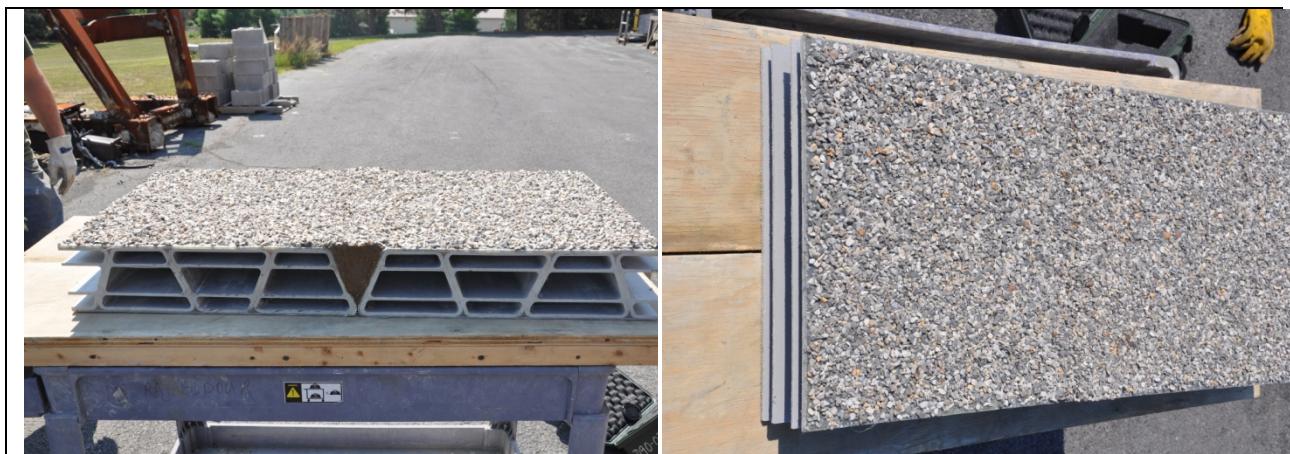
Figure 89. Photos. FRP specimen used for pull-off tests.

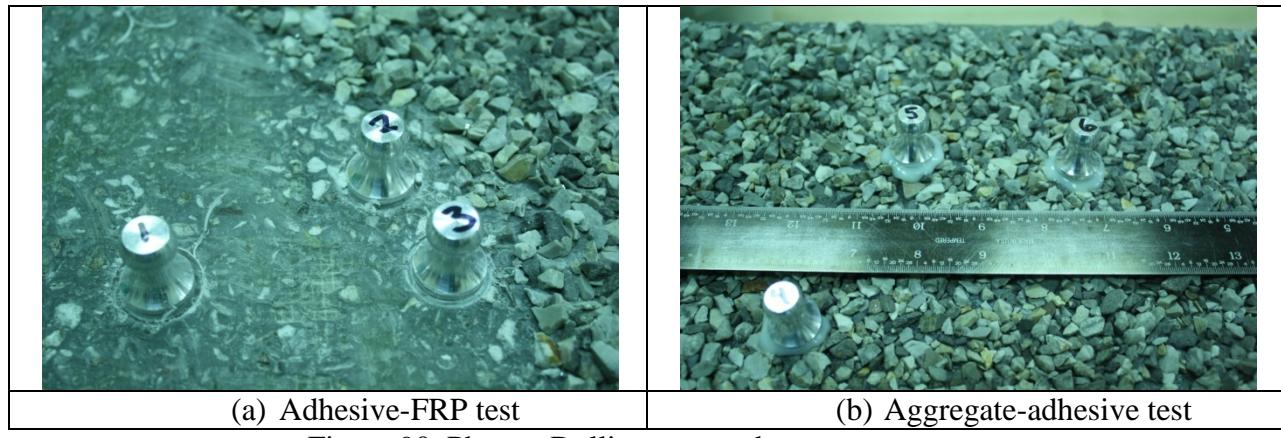
Figure 90. Photos. Dollies mounted to two test areas.

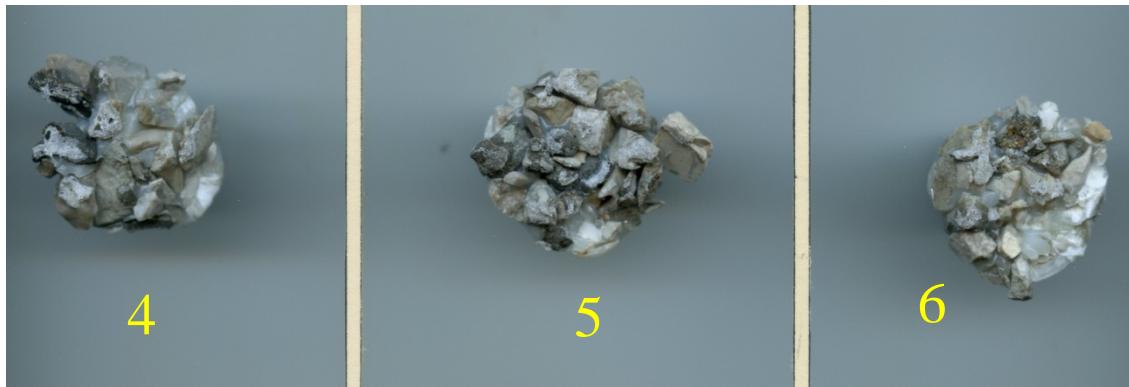
Figure 91. Photos. Failure surfaces of aggregate to adhesive pull-off tests (dollies 4, 5, and 6).

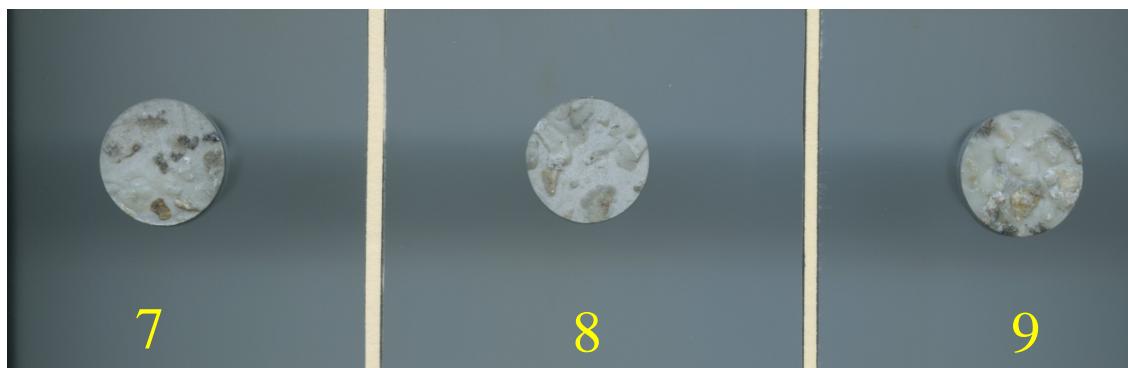
Figure 92. Photos. Failure surfaces of adhesive to FRP pull-off tests (dollies 7, 8, and 9).

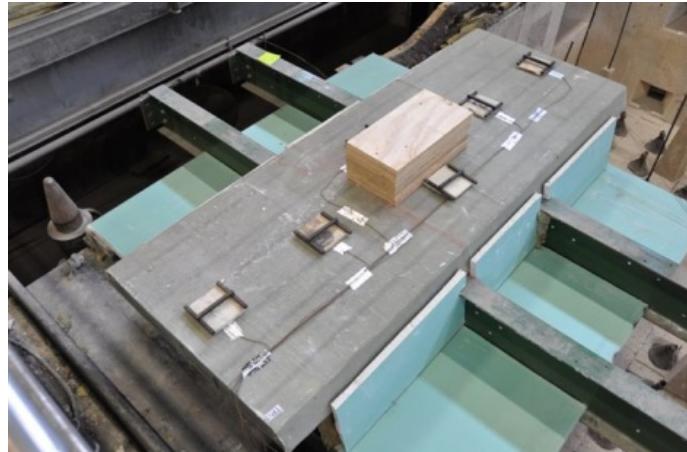
Figure 93. Photo. Test panel mounted on top of fire chamber.

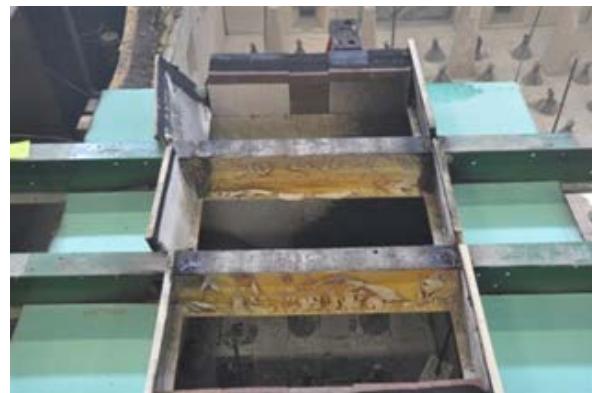
Figure 94 shows the fire test chamber and the steel beams used to support the deck. This picture was taken after the test; note the peeled paint above the fire chamber.

Figure 94. Photo. Support beams spaced at 2 feet.

The test specimen was placed over the pilot scale combustion chamber, resting atop and perpendicular to two structural steel support beams (I-beams) spaced 24 inches on center (to be consistent with the proof-of-concept bridge in Allegany County). The support beams each measured 10.5 inches high with 4-inch-wide flanges and 0.25-inch web thickness. The surrounding exposed areas were enclosed with 1-inch-thick non-combustible gypsum shaft liner panels. Only a portion of the length was exposed to the fire over the combustion chamber.

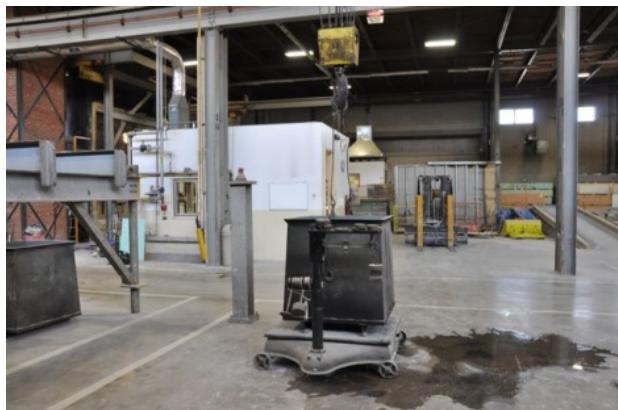
The panel was loaded to a total superimposed load of 1,600 lb, nominally, using a water-filled steel tank, shown in figure 95, and instrumented with numerous thermocouples. Figure 96 and table 32 detail the placement of the thermocouples. The tank rested on the wood shown at the center of figure 93. This wood was dimensioned to reflect the standard AASHTO 10-inch by 20-inch footprint of a design vehicle.

Figure 95. Photo. 1,600-lb water tank used as concentrated load.

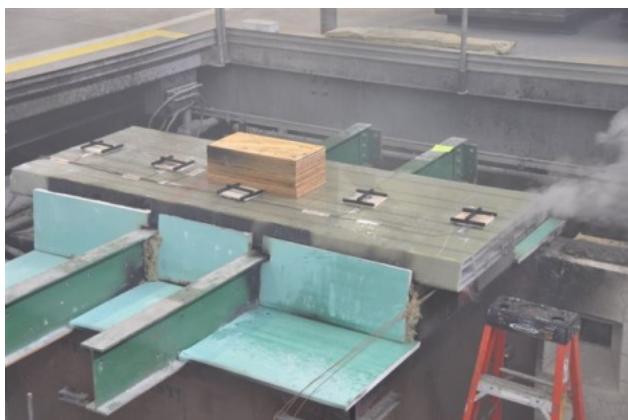
Figure 97. Photo. The test panel just after the test stopped. Note that the top surface kept cooler and ended up with little deterioration.

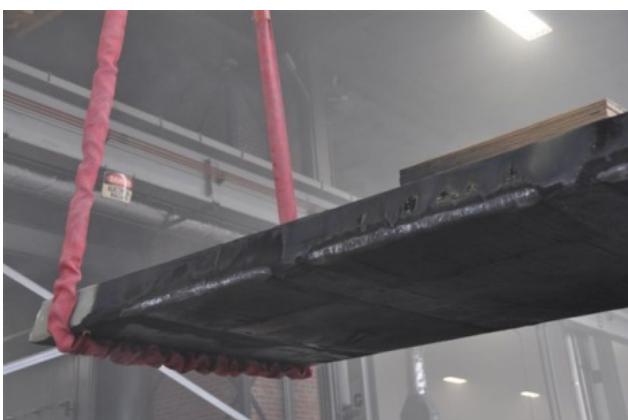
Figure 98. Photo. Specimen immediately after the test. Note the extent of damage on the bottom.

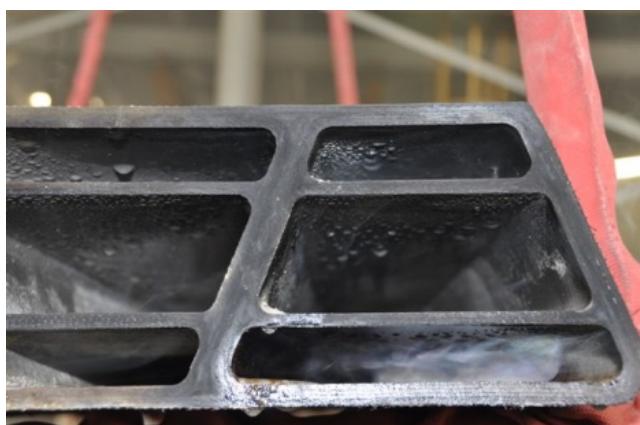
Figure 99. Photo. Close-up of the open end of the panel after the test.

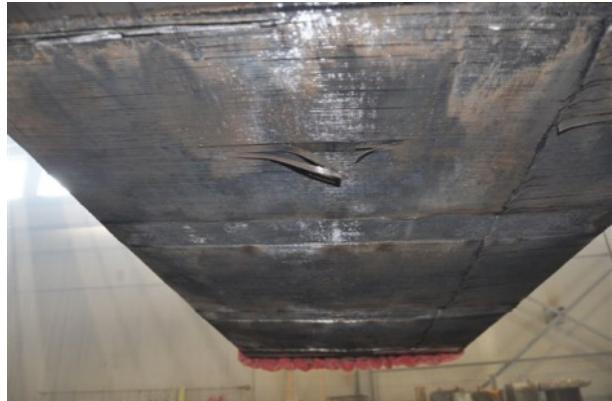
Figure 100. Photo. The glass fiber on the bottom has frayed due to burn-off of the resin matrix.
