Precast Bent System for High Seismic Regions

Laboratory Tests of Column-to-Footing Socket Connections

Publication No. FHWA-HIF-13-039

June 2013

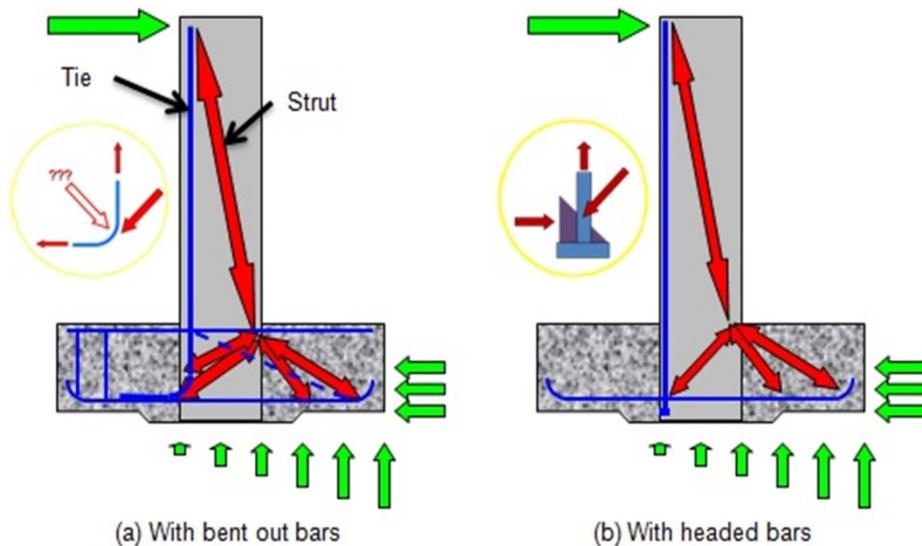
Figure 2. Diagram. Strut-and-tie models for (a) bent out bars and (b) headed bars.

The structural details differ from those of a conventional, cast-in-place system in two ways. First, no bars pass from the footing into the column, so the only resistance to vertical load comes from shear friction across the interface between the precast column and the cast-in-place footing. That interface is intentionally roughened to facilitate this load transfer. Second, the longitudinal column bars are not bent out at the bottom, but instead, they achieve their anchorage by headed anchors. This choice simplifies transportation and handling, and it reduces the hazard posed by protruding bars. The configuration also provides a much simpler and more direct flow of internal forces than is possible with bent-out bars. The transfer of internal forces is illustrated by the strut-and-tie model shown in figure 2. Figure 2a shows that, with conventional bent-out bars, the force in the diagonal strut must be transferred to the vertical bar by bond around the curved region of the bar. That mode of transfer is relatively weak, and a diagonal crack forms in the footing when the bond fails. By contrast, the headed bar shown in figure 2b achieves the load transfer very effectively at a compression-compression-compression (CCC) node.

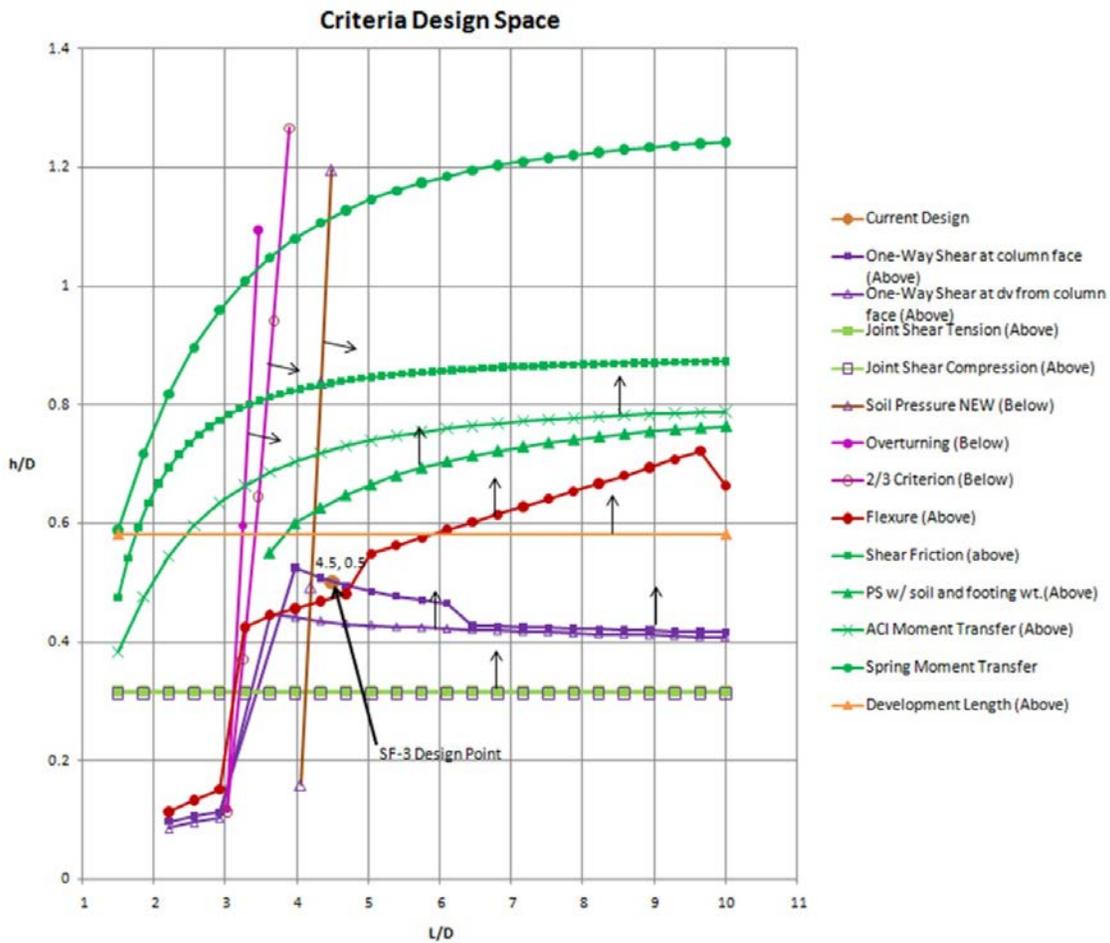
Figure 7. Graph. Final criteria design space for specimen SF-3.

To estimate the failure load and mode of the footing, a design space was created based on AASHTO code criteria. However, the demands were based on the columns strength calculated using expected material properties ($f_y = 68$ ksi and $f'_c = 5.2$ ksi), while the footing and connection capacities were based on nominal strengths, calculated with ϕ factors according to the AASHTO LRFD and AASHTO Seismic Guide Specifications. The design space (displayed in figure 7 for specimen SF-3) shows combinations of the normalized column depth ($h_{footing}/D_{column}$) and normalized footing length ($L_{footing}/D_{column}$) that would lead to failure. Each curve in the figure corresponds to a particular failure mode. Combined shear and moment transfer was also added to the design space, where it is designated “ACI moment transfer.” Each curve is marked “above” or “below,” to indicate whether the design point on the graph should lie above or below the curve.

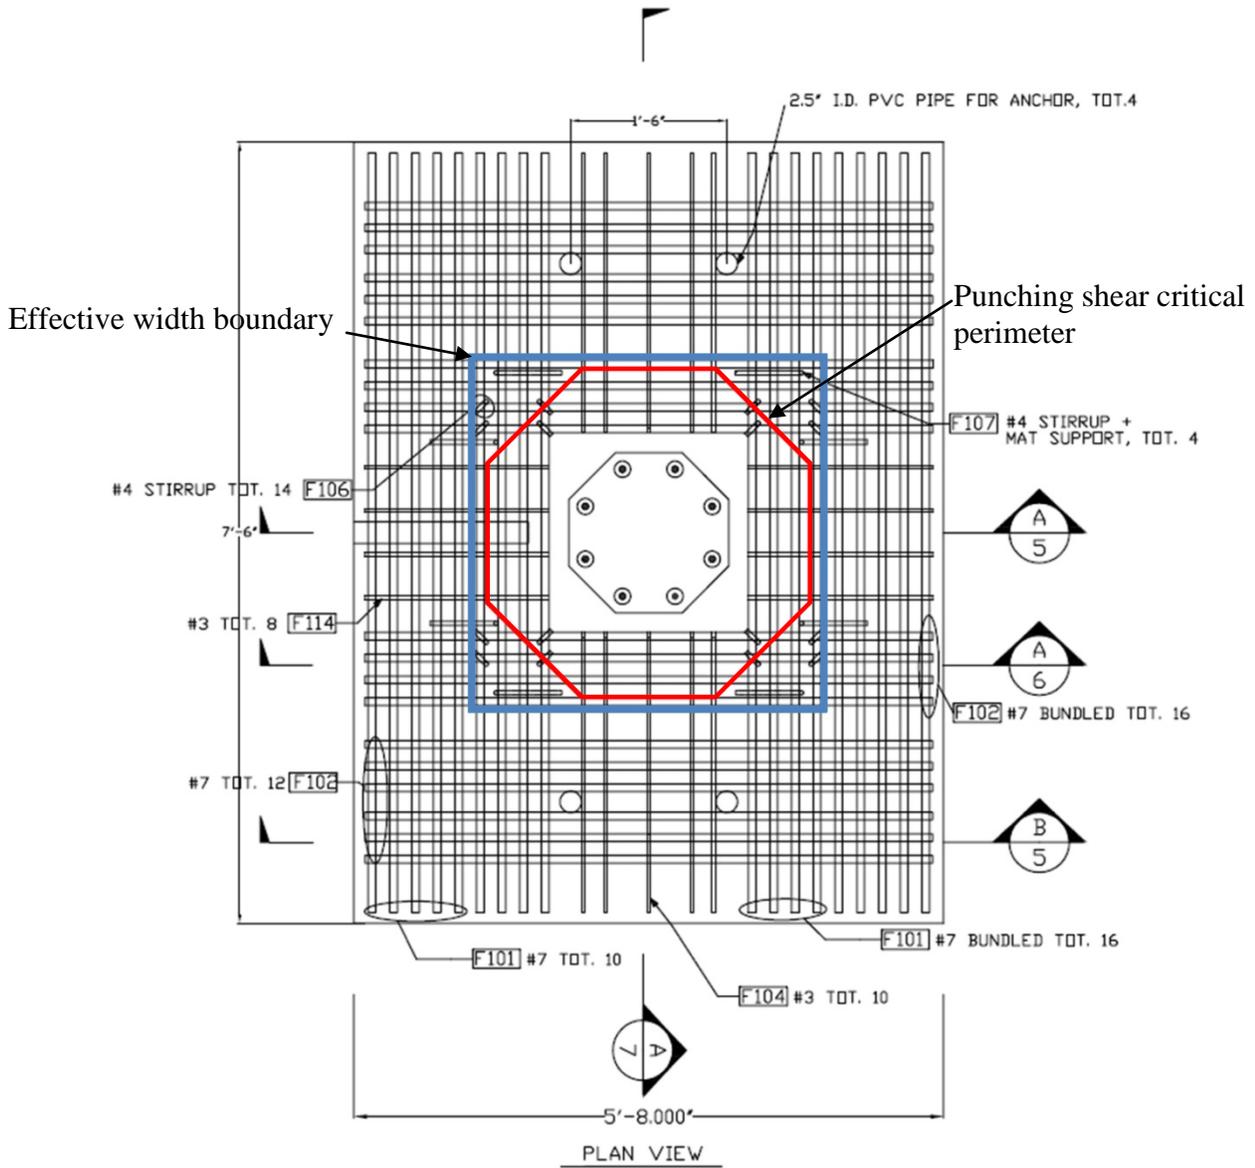
Figure 8. Diagram. Specimen SF-3 footing steel arrangement.

The result of this design procedure was a footing depth that was half the column diameter. Unlike specimens SF-1 and SF-2, the bottom flexural reinforcement of specimen SF-3 was not controlled by minimum requirements. Strength considerations resulted in No. 7 bars at 2.5 inches o.c. in which the first four lines of steel on either side of the column were bundled. Minimum steel was placed in the top mat, and instead of distributing those bars along the specimen’s width, fewer and larger bars were used and were placed near the column to hold up the ties. Since the tie steel was designed to suppress the one-way shear failure mechanism, it exceeded the Caltrans SDC minimum requirement of $2\sqrt{f'_c}$ (psi) stress capacity and resulted in a stress of about $5\sqrt{f'_c}$ (psi) (area of steel within the effective width, b_{eff} , 40 inches). The 2 to 1 ratio of column diameter to footing depth, along with suppression of beam shear, predicted that the footing would fail in combined punching shear and moment transfer. Figures 9 and 10 show sections through the footing.

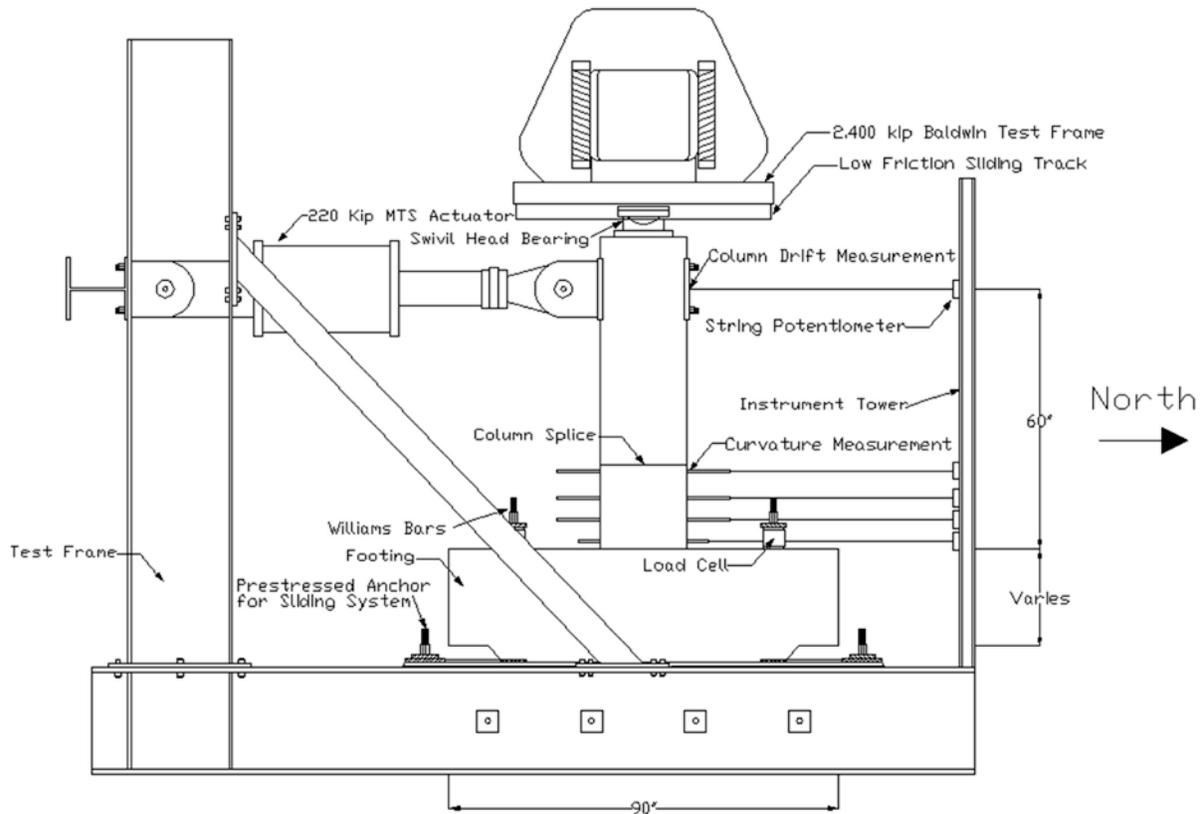
Figure 11. Diagram. Test setup.

The three specimens were tested using the self-reacting loading assembly shown in figure 11. The specimen was placed in the loading assembly, leveled with shims, and attached to the underlying footing with Hydrostone. To prevent possible overturning, four threaded 1.25-inch-diameter Williams bars were placed in plastic tubes through the footing and threaded into nuts cast into the underlying concrete block. The top nuts on these bolts were left with a clearance of 1/16 inches to prevent them from providing resisting forces until the base started to overturn. This gap was introduced because the specimen had been designed to simulate a spread footing in the field, in which no such holding down force could exist. The bolts were used only as a backup system to prevent overturning in the event that the column proved unexpectedly strong, and the lateral strength was controlled by overturning rather than the strength in one of the structural components.

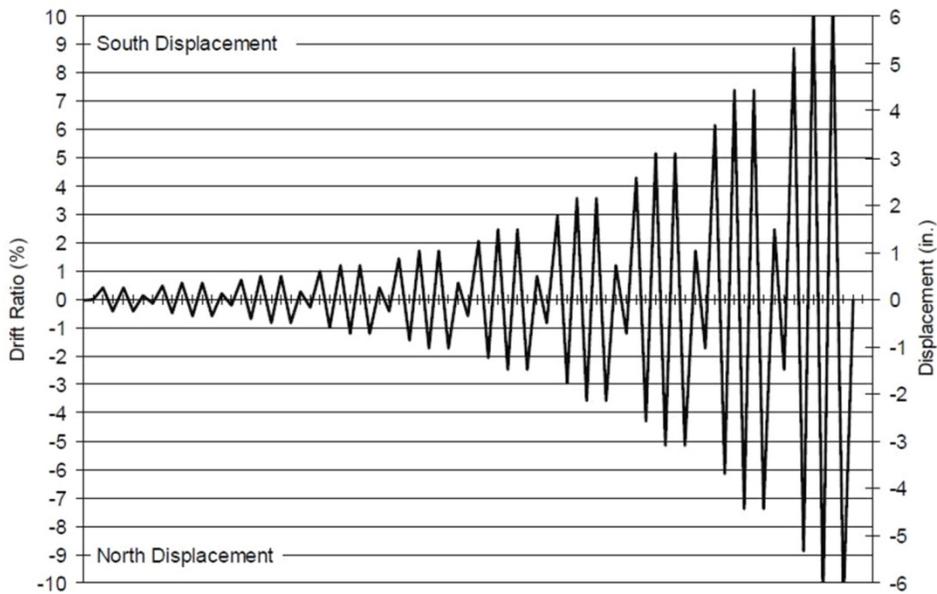
Figure 15. Graph. Lateral loading displacement history.

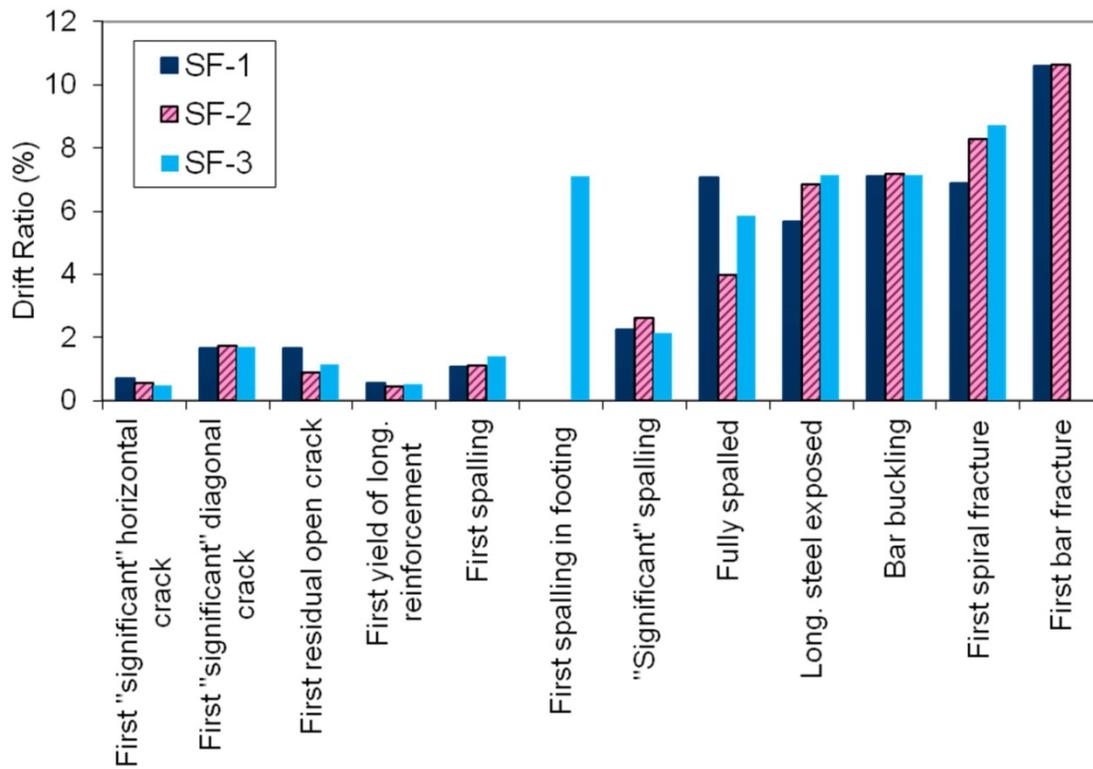
Figure 16. Chart. Comparison of specimens' drift ratios for the major damage states.

ratio of 0.69 percent, which slightly exceeded the drift ratios for this state for SF-2 (0.56 percent) and SF-3 (0.49 percent).

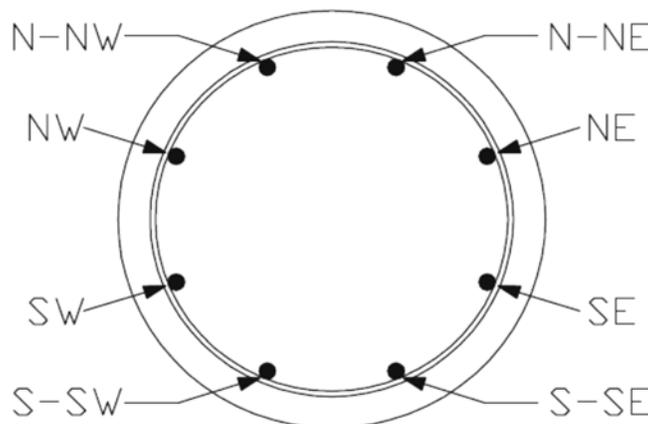
Figure 17. Diagram. Column vertical bar naming convention.

The nomenclature for identifying the longitudinal bars is shown in figure 17. First yield in the column longitudinal bars was detected at the level of the column-to-footing interface. It occurred at nearly the same drift for all three specimens. The S-SW bar in specimen SF-1 yielded at 0.55 percent drift, the N-NE bar in specimen SF-2 yielded at +0.47 percent drift, and the S-SW bar in specimen SF-3 yielded at a drift ratio of -0.51 percent (valley in cycle 3-2).

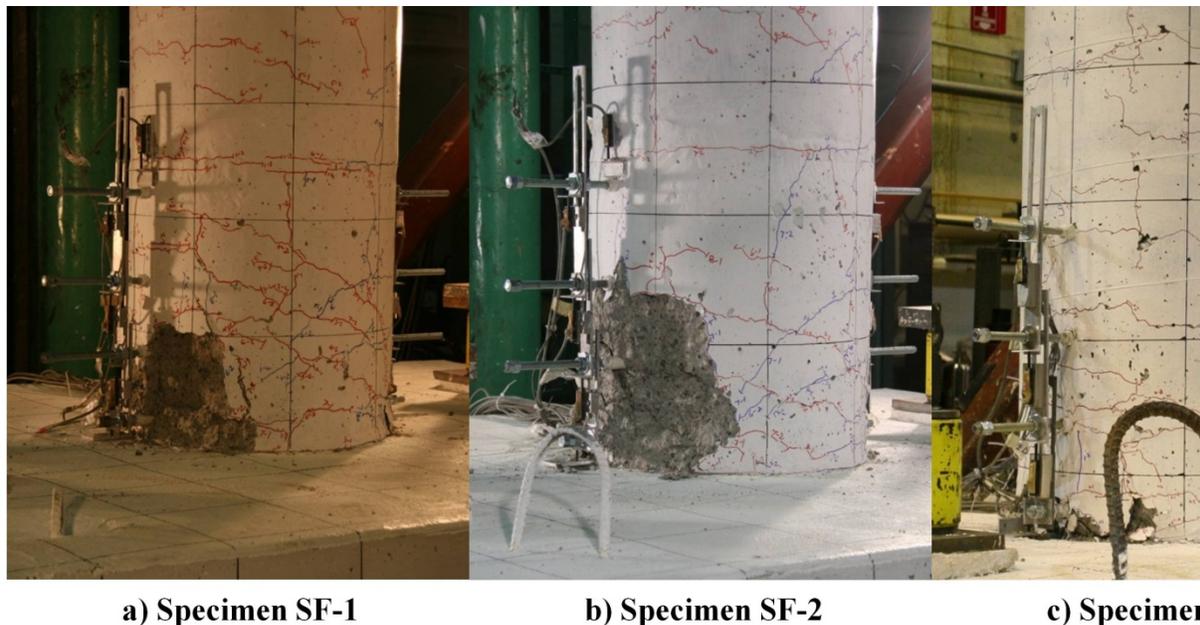
Figure 18. Photos. Test specimens after a cycle of maximum drift ratio of 4.28 percent.

The spalling patterns among the three specimens were similar but not identical. Minor spalling first appeared in specimens SF-1 and SF-2 at drift ratios of approximately 1.1-1.2 percent. Specimen SF-3 reached this level of damage slightly later, at a drift ratio of 1.4 percent. All three specimens reached the level of “significant spalling” (spalled height $\geq 1/4$ of column diameter) at about 2.2 to 2.6 percent drift. The fully spalled state (above which point spalling no longer progressed) varied both in terms of drift ratio and extent of spalling. This state was reached for specimens SF-1, SF-2, and SF-3 at drift ratios of 7 percent, 4 percent, and 6 percent, respectively. The spalling in SF-1 and SF-2 extended over the bottom 10 to 12 inches, whereas in SF-3, the spalling extended up only to a height of 7 inches (to the top of the second curvature rod). Figure 18 compares spalling of the three columns at a drift ratio of 4.28 percent (cycle 8-1).

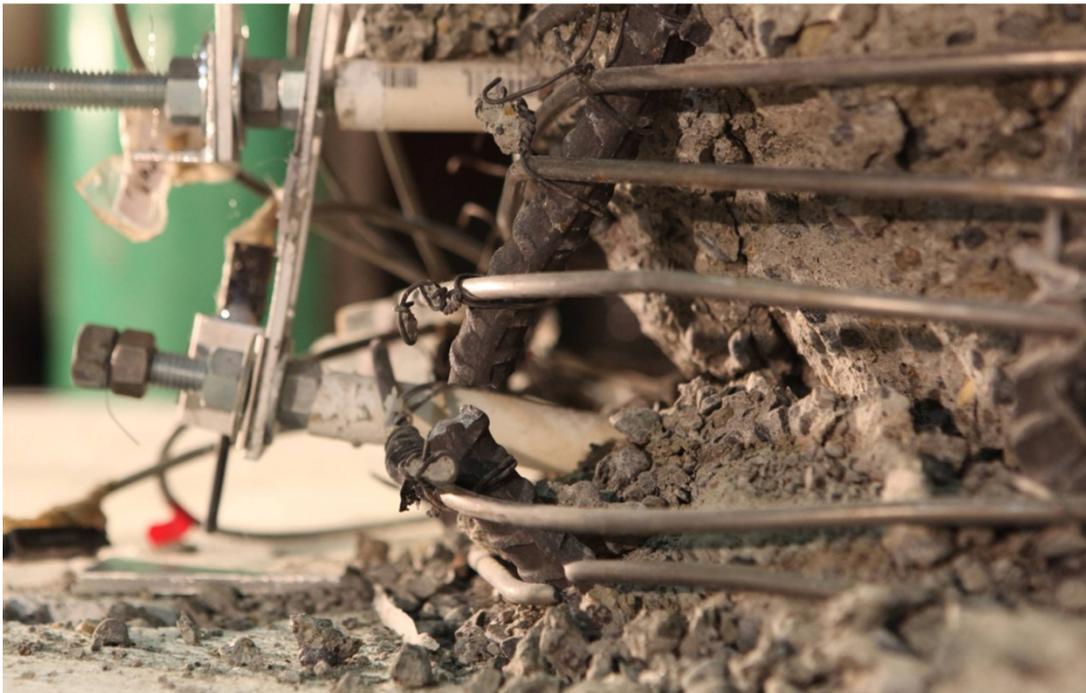
Figure 19. Photo. Specimen SF-1 longitudinal bars fractured after one cycle to 10.65 percent drift ratio.

In subsequent cycles, those bars at extreme tension and compression (N-NE, N-NW, S-SW, and S-SE) underwent alternating axial shortening and elongation, and cyclic bending and straightening. This behavior induced large cyclic strains, which caused them to fracture a few cycles after the spirals failed in both specimens SF-1 and SF-2. In both columns, the first longitudinal bar fractured going south to peak in cycle 10-2 (maximum drift ratio = 10.65 percent). In specimen SF-1, a total of three bars fractured, and in specimen SF-2, four bars fractured. The condition of the bars in specimen SF-1 is shown in figure 19. No bars fractured in specimen SF-3.

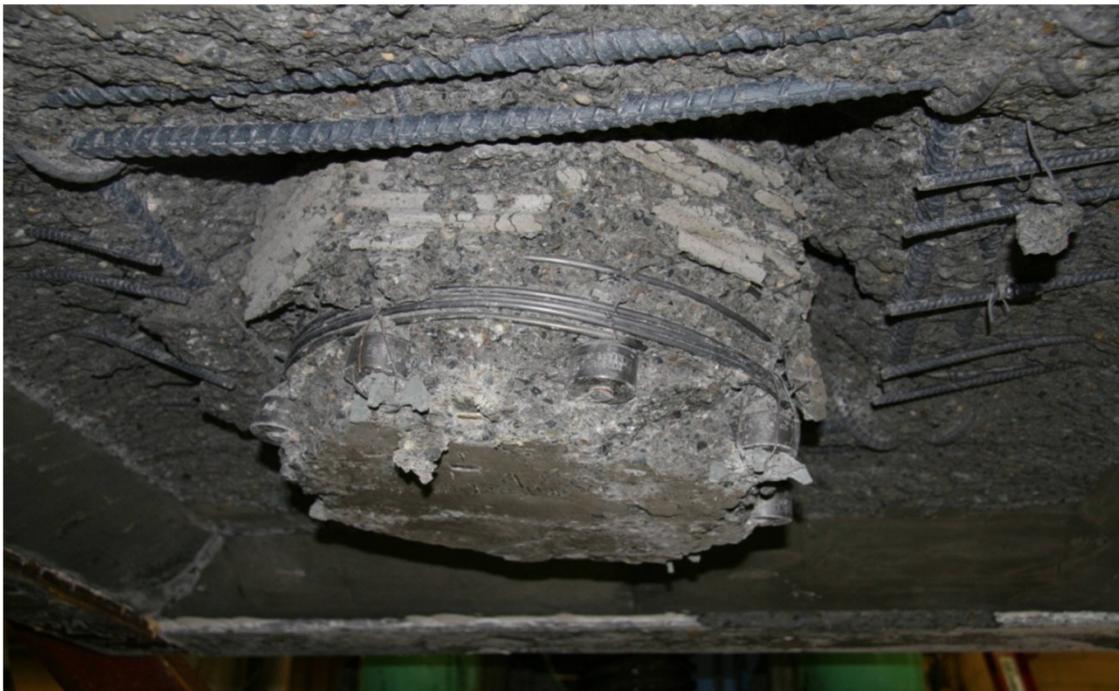
Figure 20. Photo. Specimen SF-3 footing failure.

Since the octagonal section in the connection region was smaller than the column, some of the load was likely taken by this bearing surface. When enough spalling occurred in the column, no resistance could be provided by this bearing surface, and the stress in the connection increased, leading to failure. The last cycle, during which the footing failed, can be seen in figure 20.

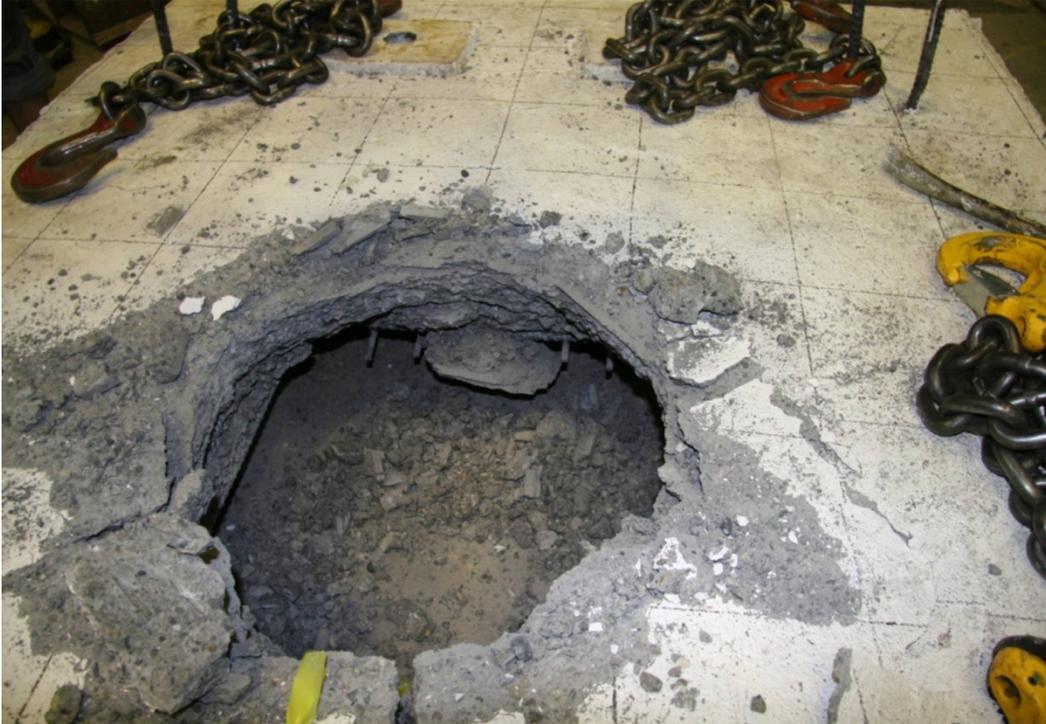
Figure 21. Photo. Damage on top of footing after test.

Based upon inspection of the SF-3 footing after the test, spalling on the bottom of the footing had occurred as well. Measurements were taken after the test to obtain a profile of the failure plane in the footing (figures 21 and 22).

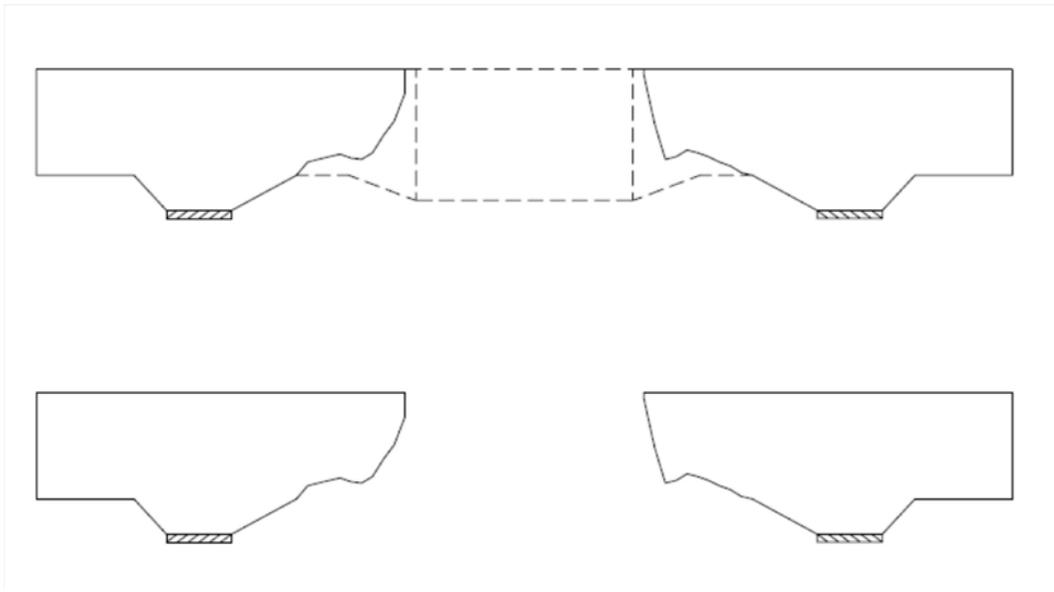
Figure 22. Diagram. Punching shear profile in the north-south direction (loading direction).

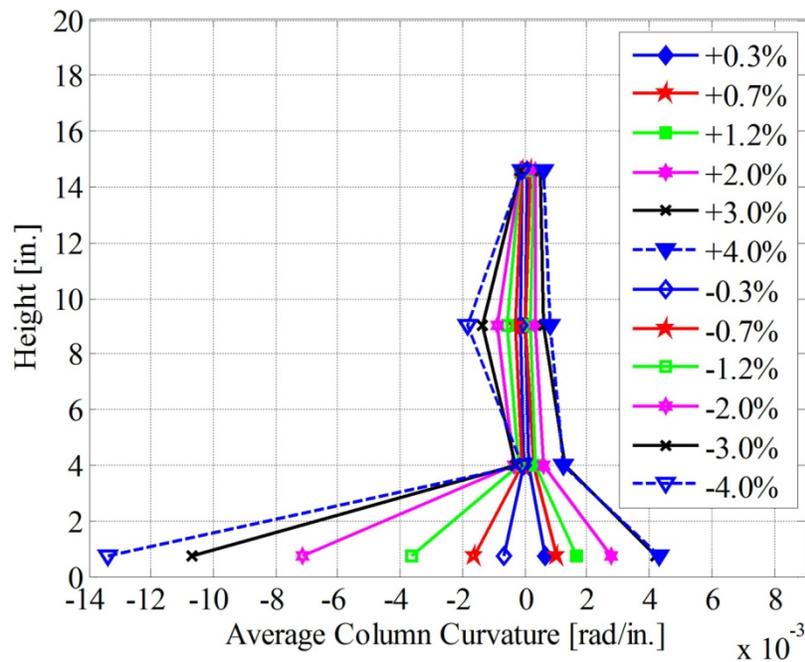
Figure 37. Graph. Specimen SF-3 average column curvature.

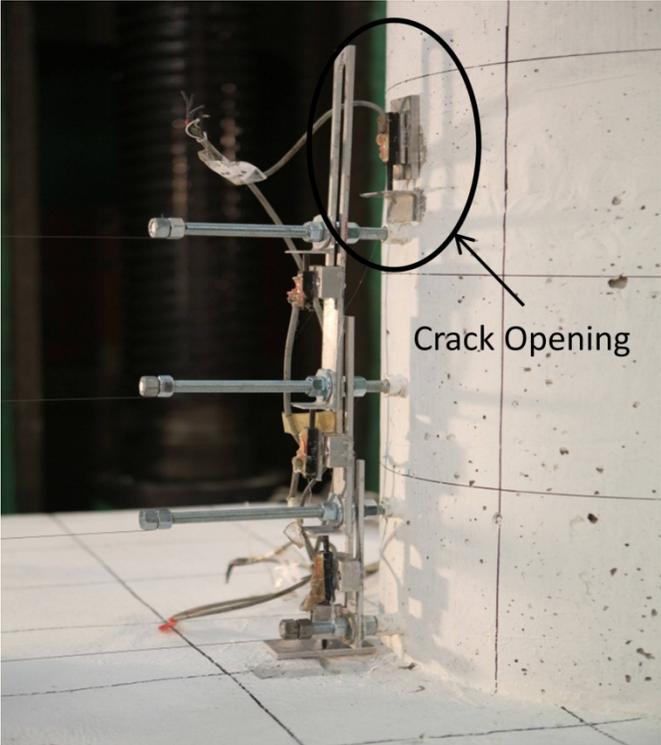
Figure 38. Photo. Crack opening measurement pot.

to monitor potential crack opening, as shown in figure 38. The measured splice interface openings are plotted in figures 39 and 40.

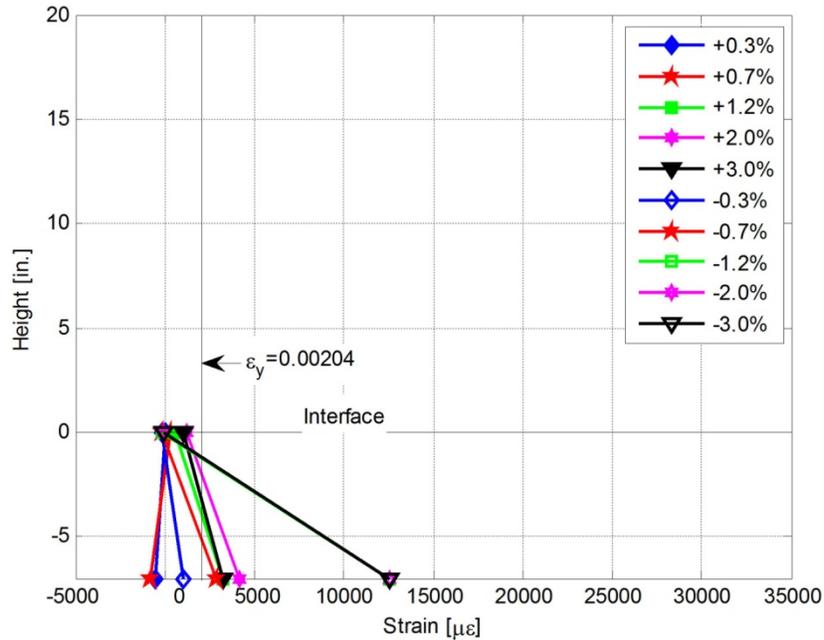
Figure 43. Graph. Strain profiles in S-SW bar in specimen SF-3.

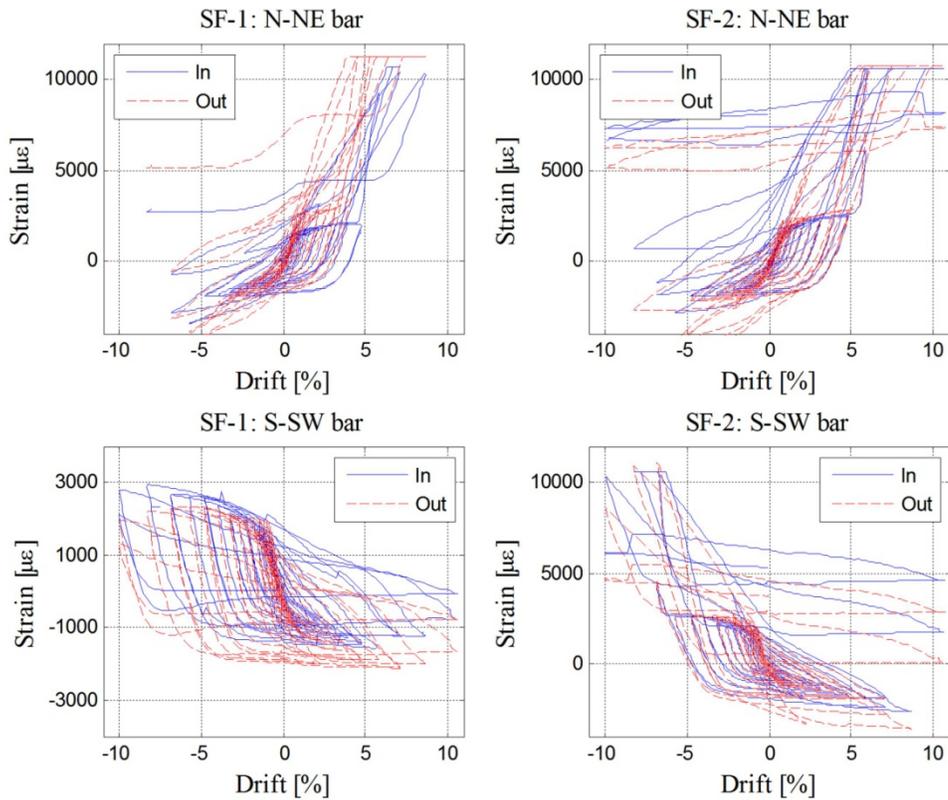
Figure 44. Graphs. Strain-drift relationship 2 inches below the column splice interface.

Figure 44 shows the strain histories for the strain gauges located 2 inches below the segment splice (18 inches above the spread footing). These gauges indicate that the gauged N-NE bars started to yield at 0.8 percent drift for specimen SF-1 and 1 percent drift for specimen SF-2. For the S-SE bars it was about 3.2 percent drift for SF-1 and 1.2 percent drift for SF-2.

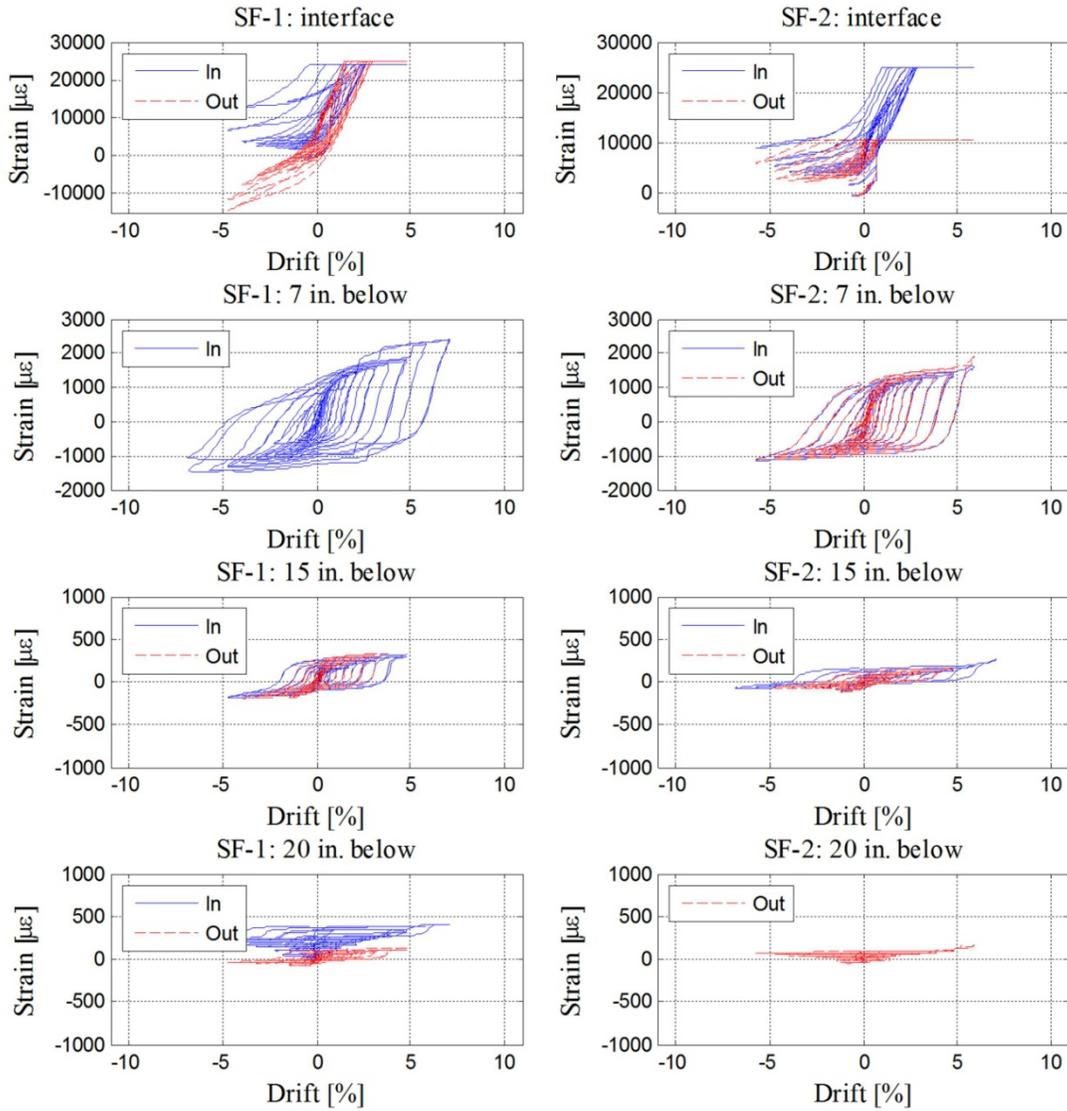
Figure 45. Graphs. Strains in N-NE bars in specimens SF-1 and SF-2 at various heights below the interface.

Figures 45 through 47 show for all three specimens the strain-drift relationship at locations within the footing. In the figures, each strain gauge is plotted individually. The gauge marked “In” refers to the gauged facing towards the column core, and the one marked “Out” faced the column concrete cover. Strains were plotted until voltage spikes were detected frequently, at which point the gauges were deemed unreliable. Two strain gauges were damaged from the very beginning and therefore are not included in the plots.

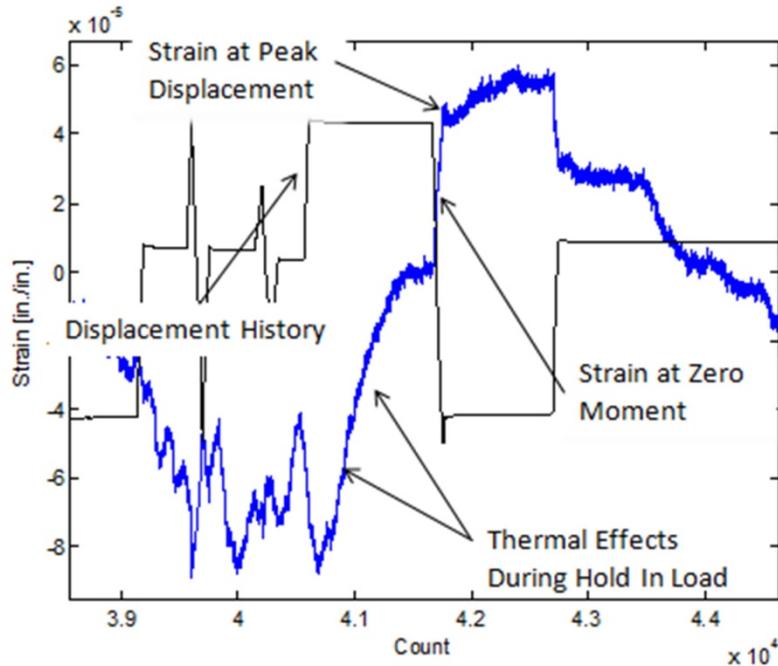
Figure 48. Graph. Thermal effects in strain gauges.

Strains reported in the spread footings for specimens SF-1 and SF-2 are the mechanical strains derived from the measured strain values. The strains in the bottom mat were so small that they were affected strongly by thermal effects (see figure 48). This behaviour was not observed in specimen SF-3. In specimens SF-1 and SF-2 it was believed to have been caused by heat from the lights acting on the strain gauges lead wires. To determine the mechanical strain during cyclic testing, thermal strains needed to be accounted for. The mechanical strains were obtained by calculating the difference between the strain value measured at the peak of the cycle and the strain value when the moment in the column was zero. It was assumed that the change in thermal strain during that time (about 20 seconds) was negligible. The largest rate in thermal strain change occurred in specimen SF-1 between data counts 40681 and 41672 at an average rate of 0.083 microstrain/count. If this rate were applied to the period of loading (94 counts, going from “peak” to “valley”), it would imply a thermal strain change of 7.8 microstrain during that time. The calculated mechanical strain value was then added to the initial strain obtained when the specimen was loaded axially up to 159 kips before starting the cyclic test.

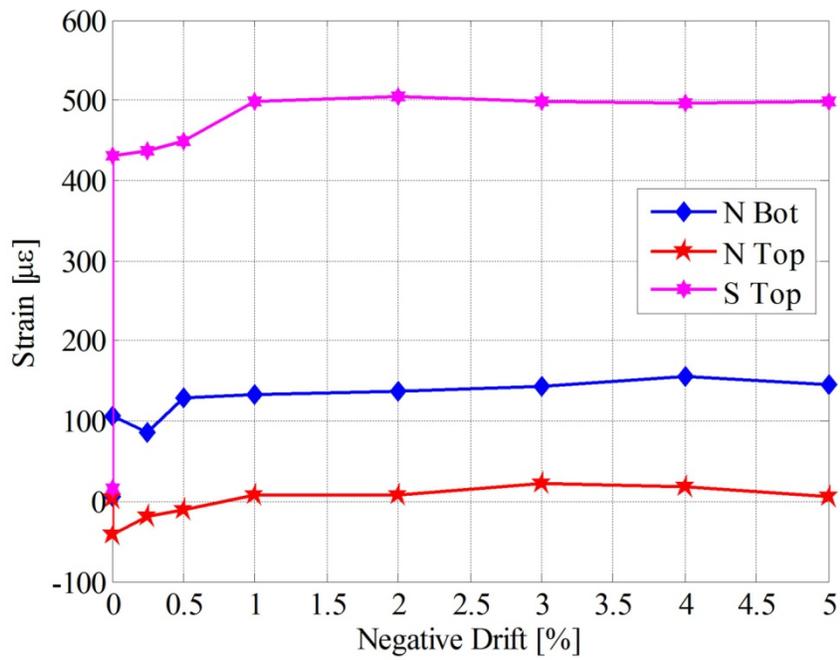
Figure 55. Graph. Specimen SF-1 strains in diagonal steel in footing.

In all specimens, two diagonal bars in the bottom mat and two diagonal trim bars in the top mat were gauged as shown in figure 13. The strains in the south bottom steel in specimens SF-1 and SF-3, and north bottom steel in specimen SF-3 as well are not reported because the gauges were damaged during casting. The strains in the diagonal bars are plotted in figure 55 through 57.

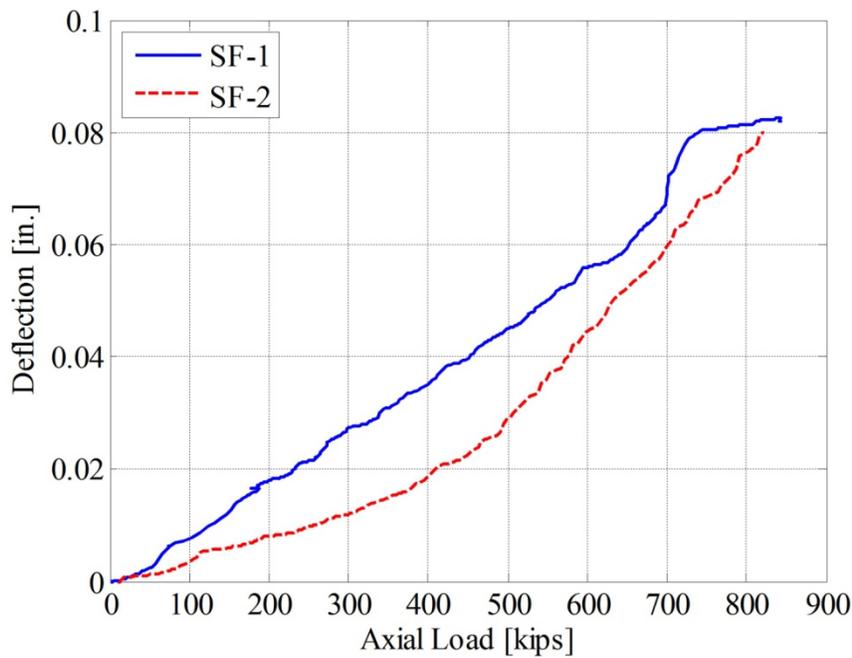
Figure 62. Graph. Axial response of specimens SF-1 and SF-2.

The axial load-deflection response is shown in figure 62. The load reached was about the scaled equivalent of $3.5 P_u$, where P_u is the factored axial load given by $1.25DL+1.75LL$ in the prototype. The load was measured by a load cell in the Baldwin Universal Testing Machine, and the column vertical displacement was measured by the LVDT beneath the column. The potentiometer instrument itself was located just outside the column, and the motion was delivered to it by a lever mechanism that was treated as sacrificial in the event of the column slipping.

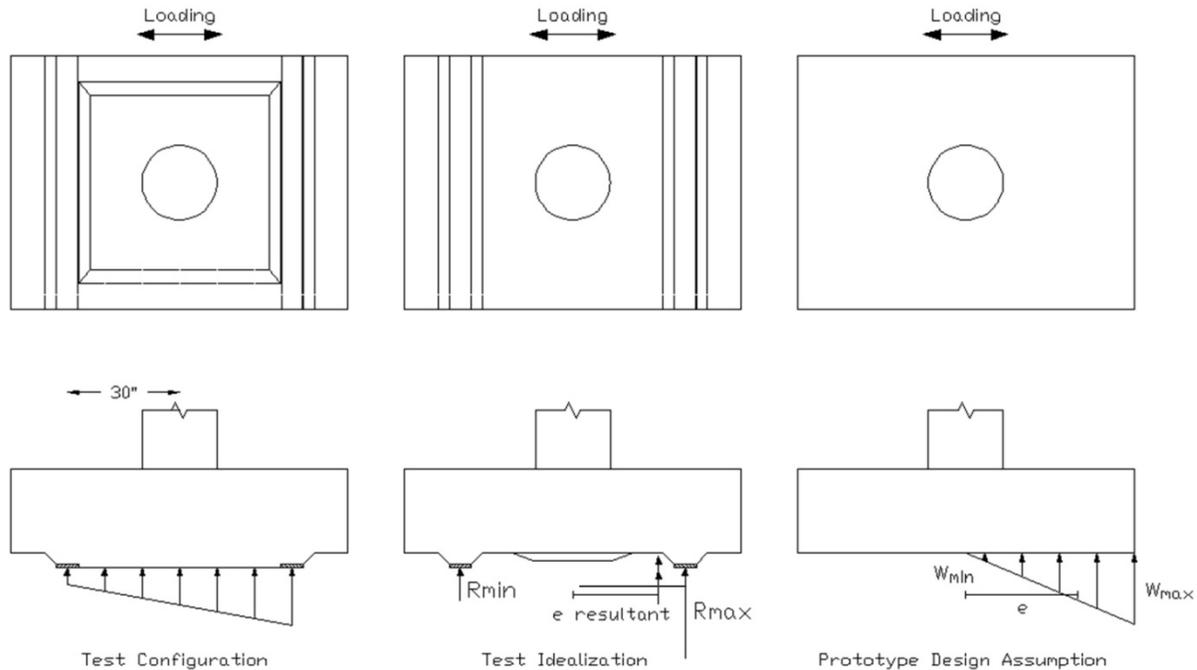
Figure 64. Diagram. Support conditions.

To replicate this situation as closely as possible in the laboratory, the three specimens were supported along two lines, each situated (at lab scale) at the same eccentricity as the centroid of the limiting soil pressure block in the field. That distance was 42 percent of 5.9 feet, or 30 inches. However, to make it possible to conduct axial-load tests with support from all four edges of the footing, support was also provided, in all specimens, along the sides of the footing, as shown in figure 64. Doing so created a pressure distribution that consisted of a distributed load (along the sides) and two line loads (at the ends).

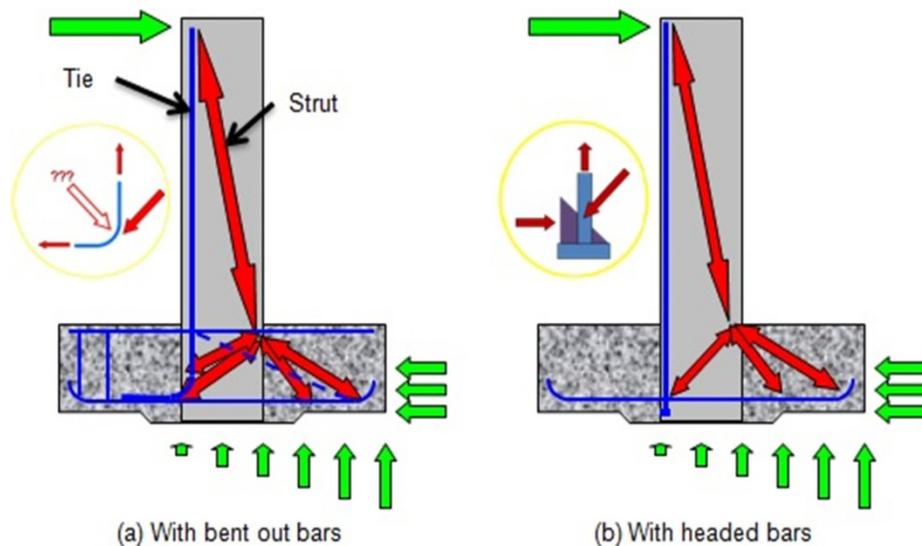
Figure 74. Diagrams. Strut and tie models for bent-out bars (left) and headed bars (right).

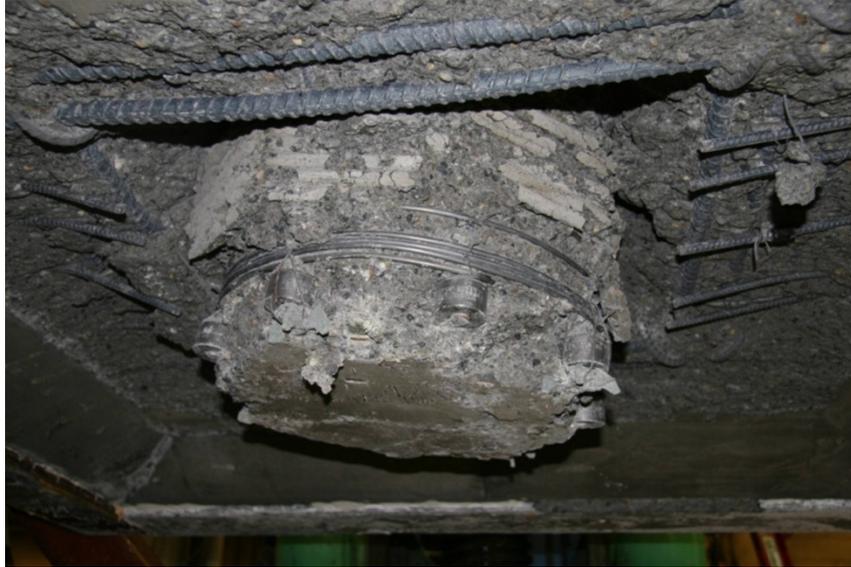
Figure 75. Photo. Joint region of specimen SF-3 after failure.

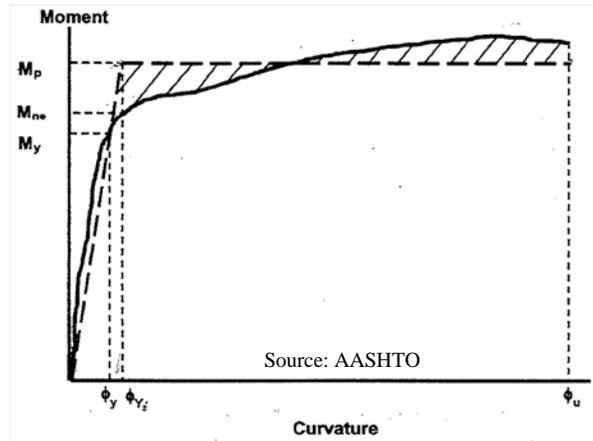
Figure 77. Graph. Moment-curvature model.⁽¹⁵⁾

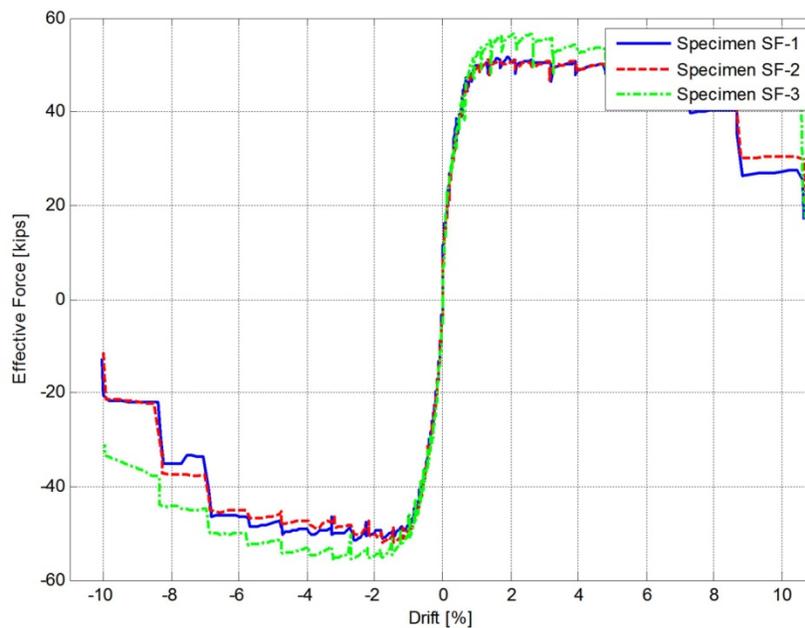
Figure 89. Graph. Comparison of effective force vs. drift.

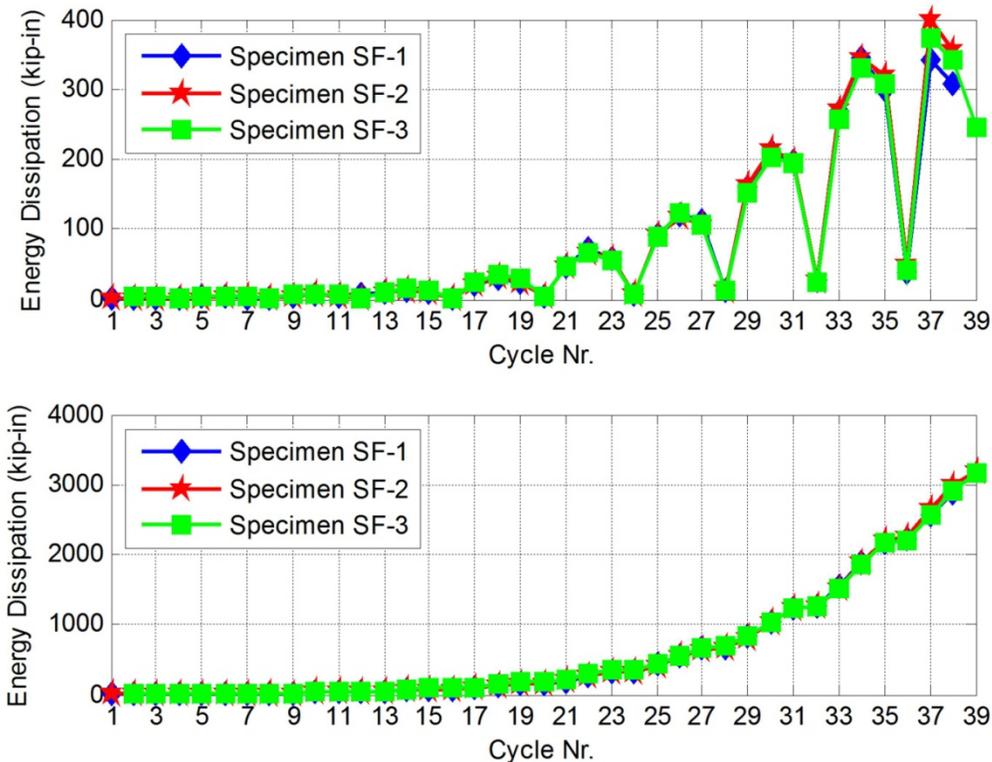
Figure 91. Graphs. Calculated energy dissipation per cycle (top), and calculated cumulative energy dissipation (bottom).

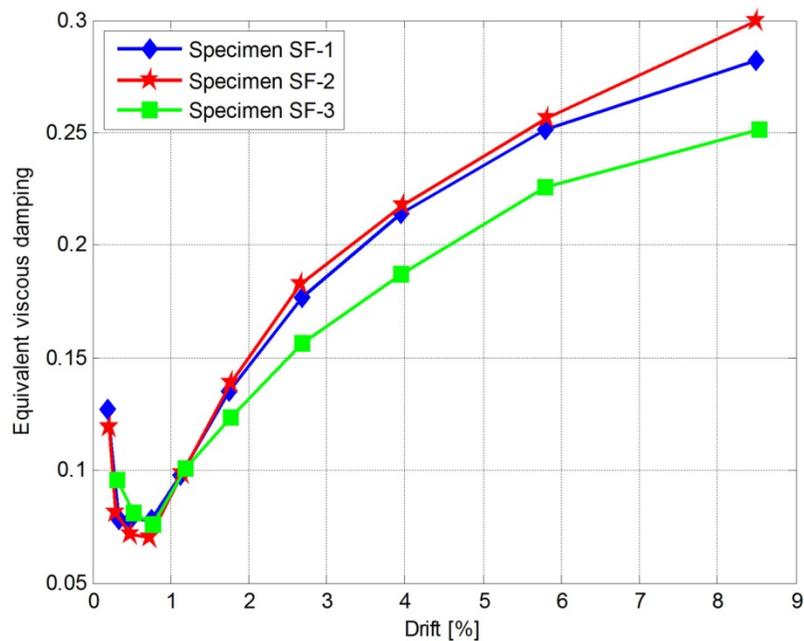
Figure 94. Graph. Equivalent viscous damping vs. drift.
