Precast Bent System for High Seismic Regions

Laboratory Tests of Column-to-Footing Socket Connections

Publication No. FHWA-HIF-13-039

June 2013

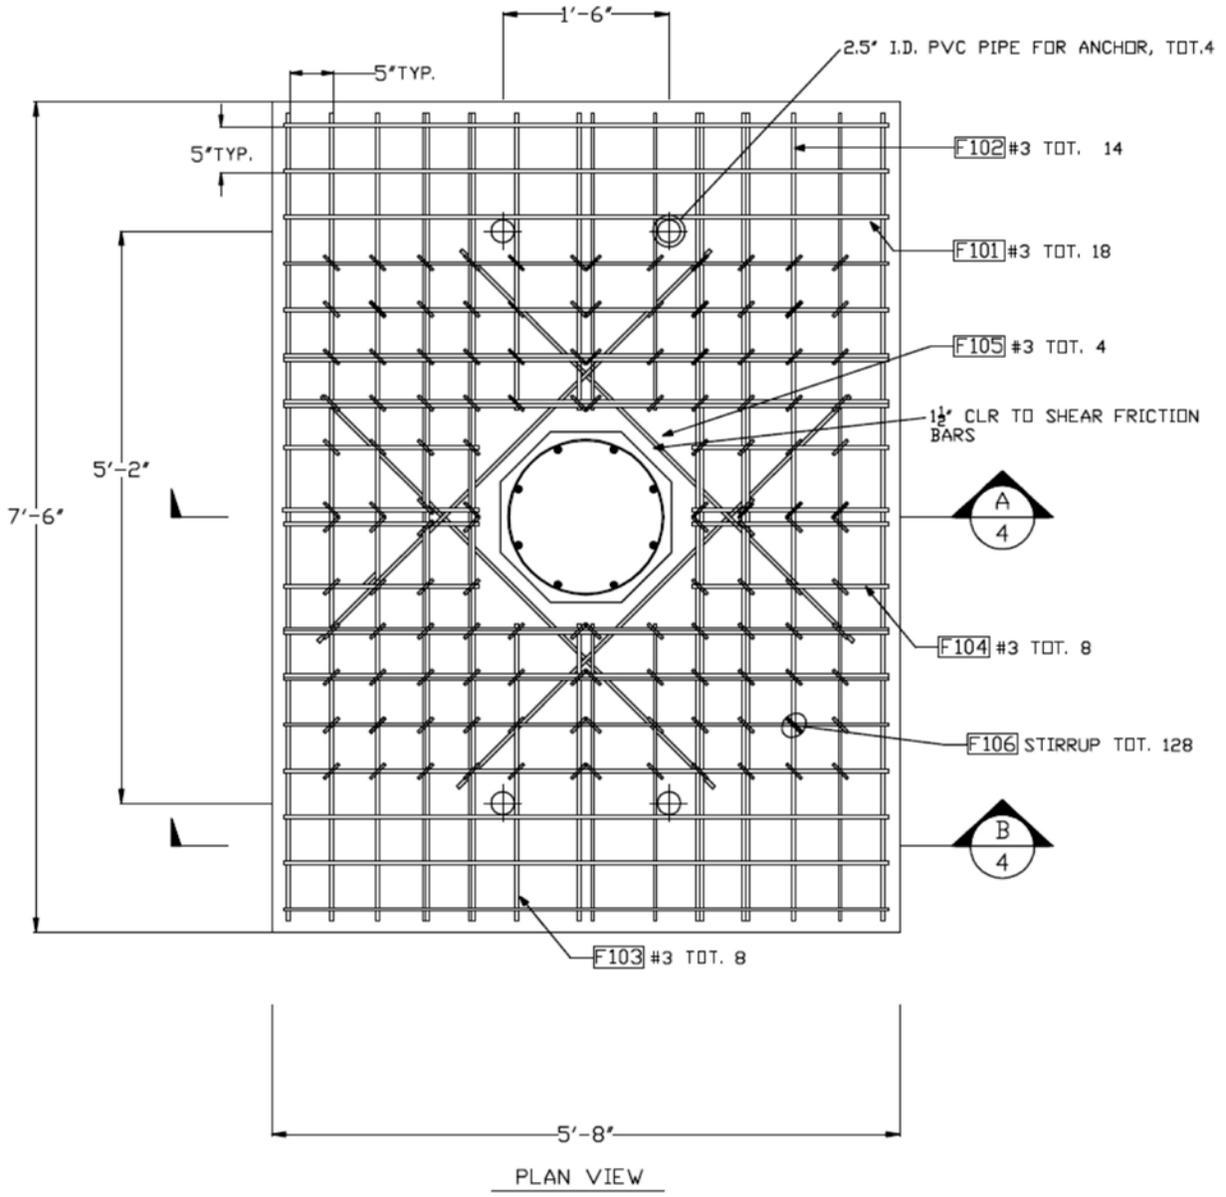
Figure 97. Diagram. Specimen SF-1 top mat plan view.

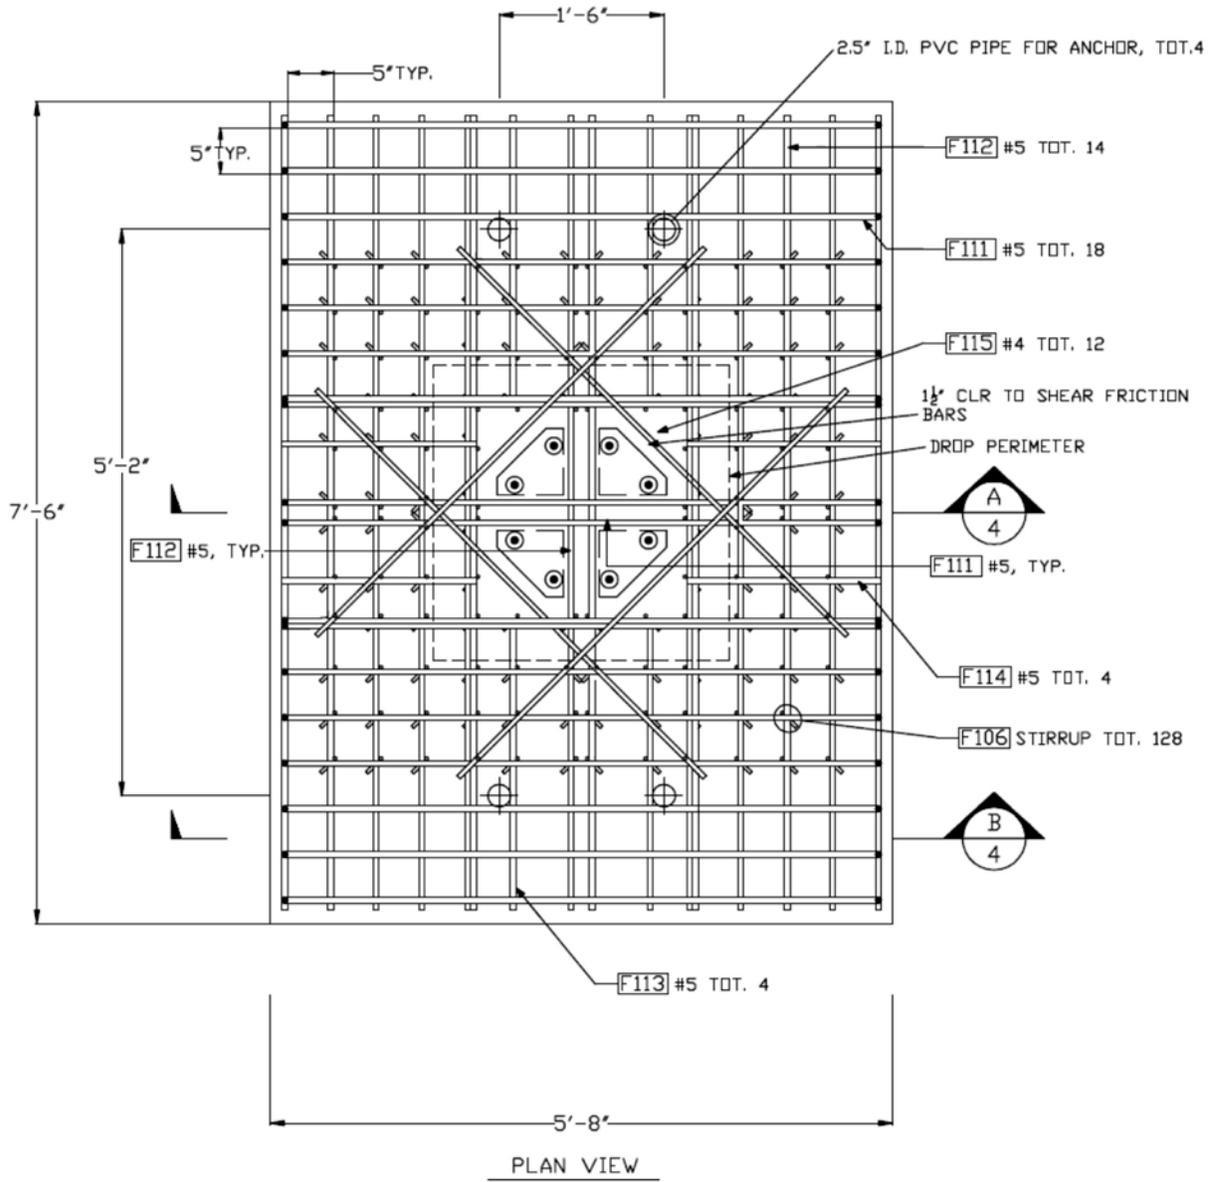
Figure 98. Diagram. Specimen SF-1 bottom mat plan view.

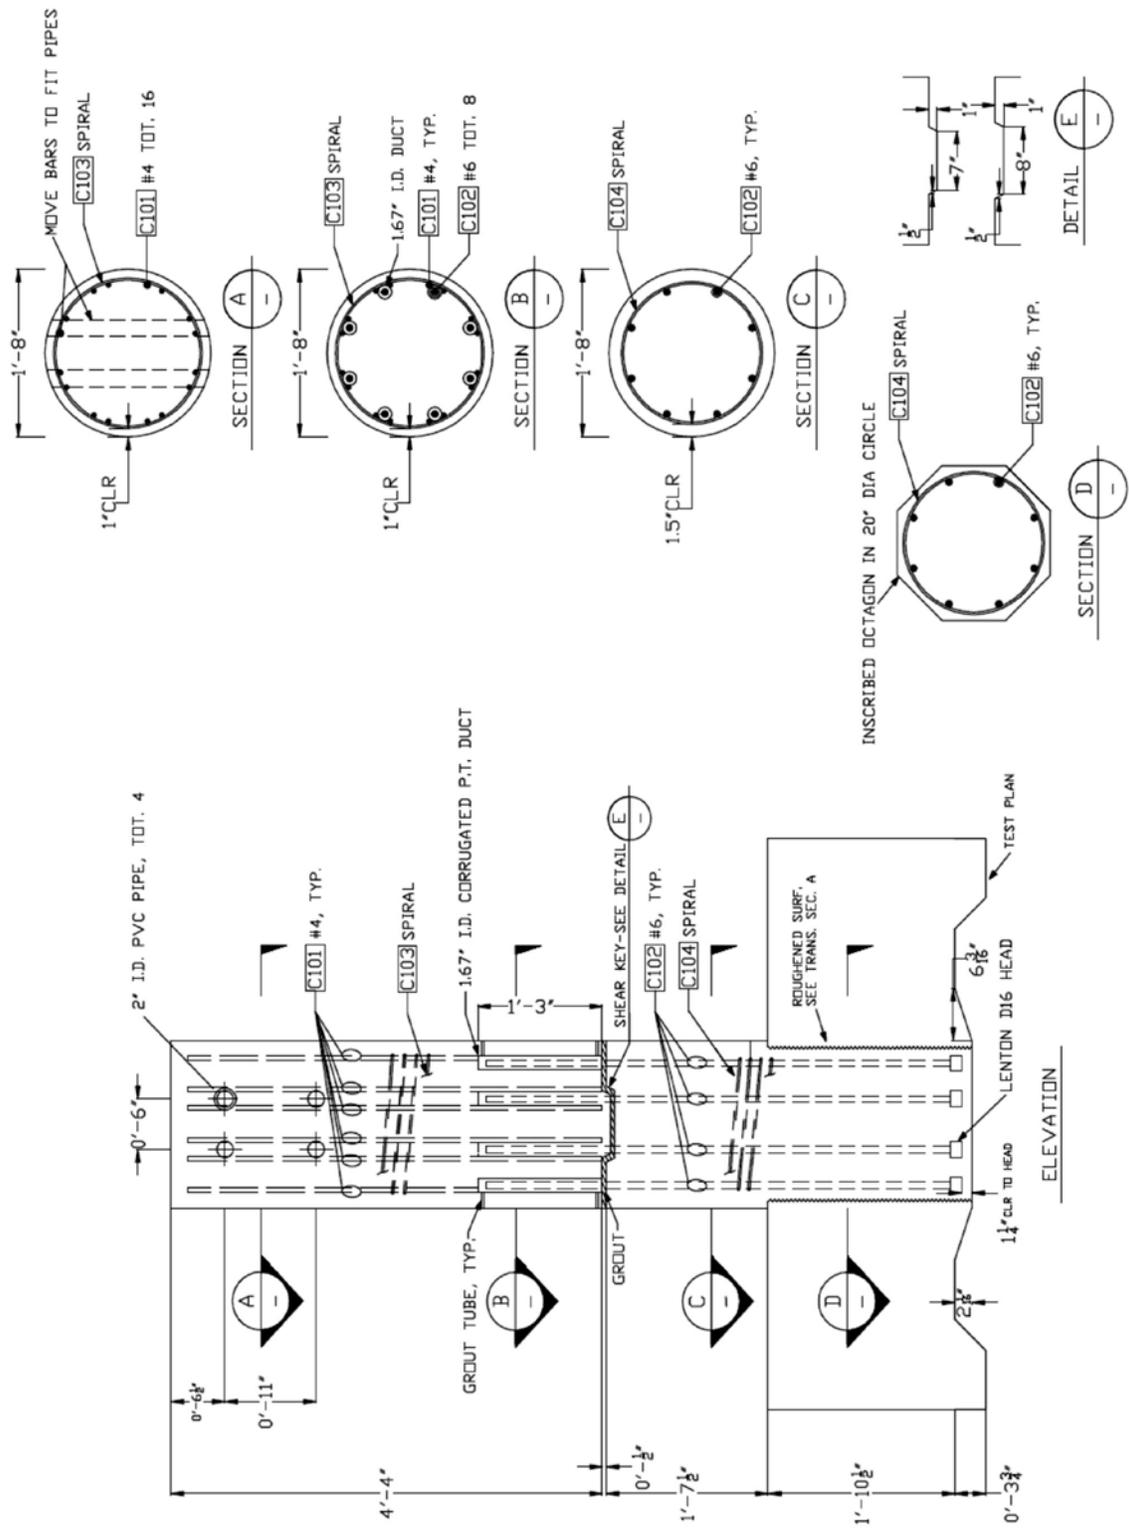
Figure 100. Diagram. Specimen SF-2 column elevation and sections.

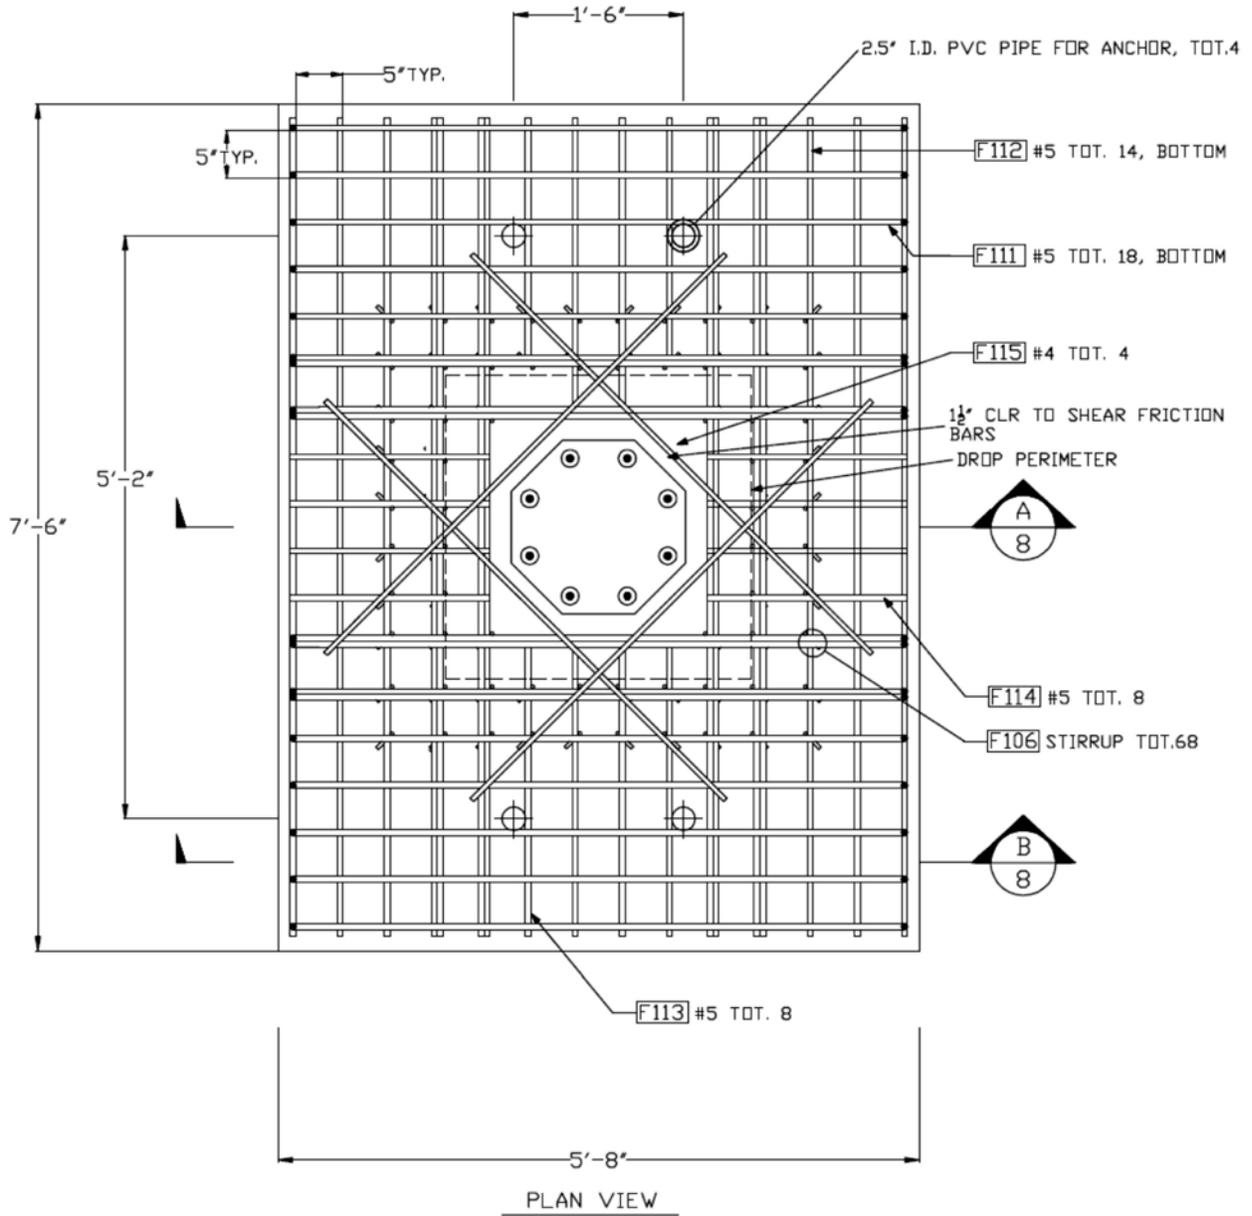
Figure 102. Diagram. Specimen SF-2 bottom mat plan view.

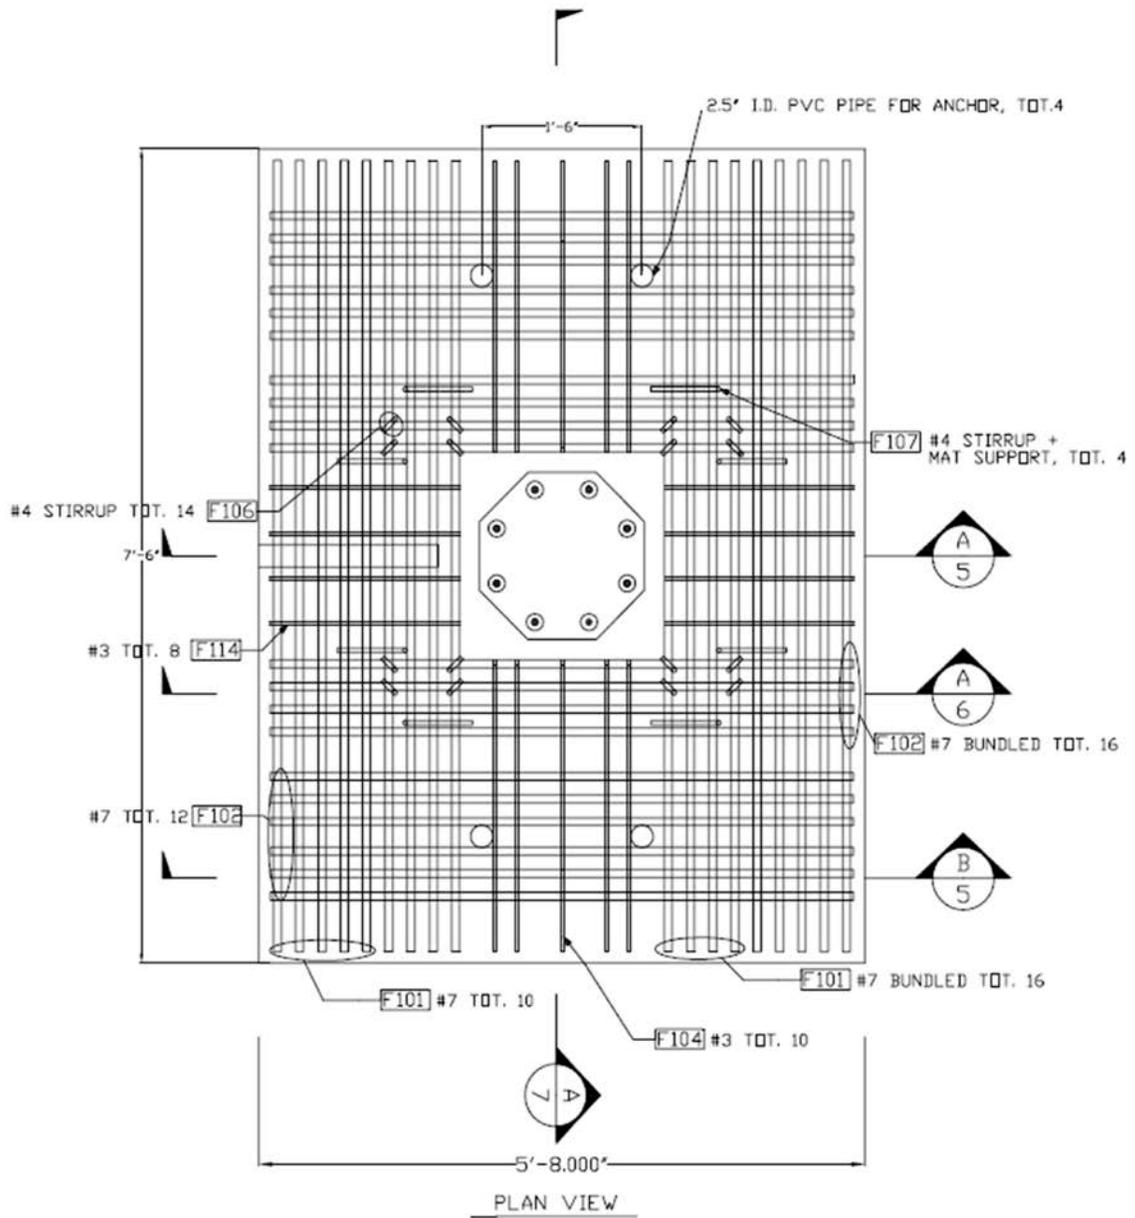
Figure 106. Diagram. Specimen SF-3 bottom mat plan view.

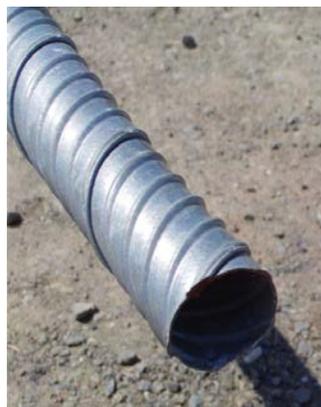
Figure 121. Photo. Corrugated metal duct used in test specimens.

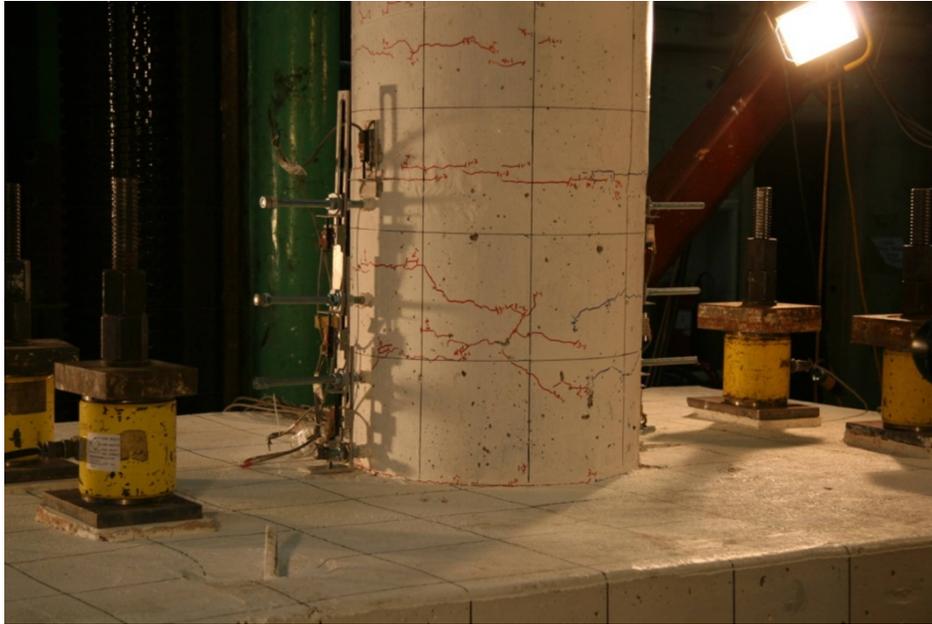
Figure 122. Photo. Specimen SF-1 flexural cracks after cycle 4-1 (+1.00/-1.00 target drift ratio).

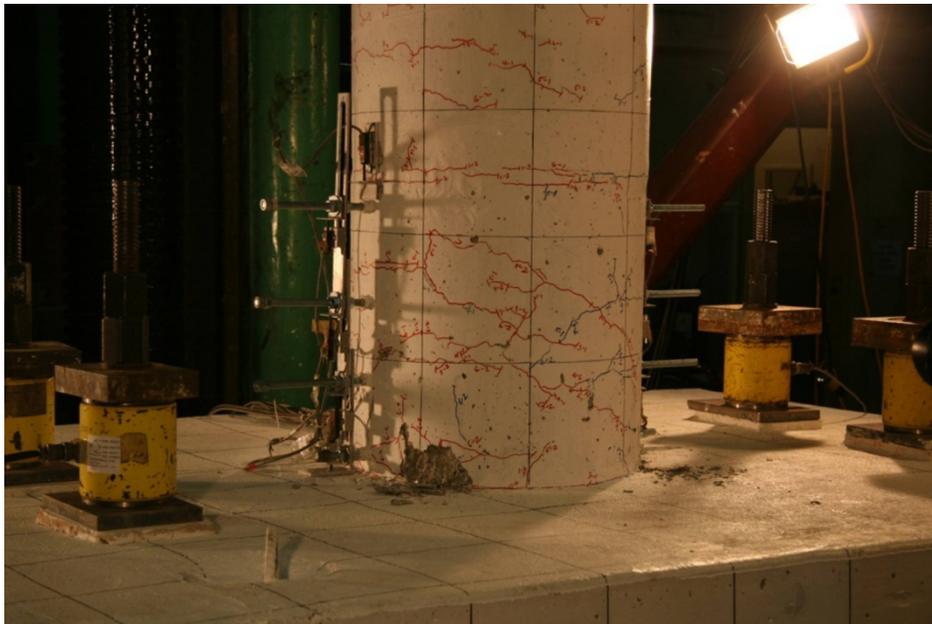
Figure 123. Photo. Specimen SF-1: first significant spalling at cycle 6-2 (+2.48/-2.48 target drift ratio).

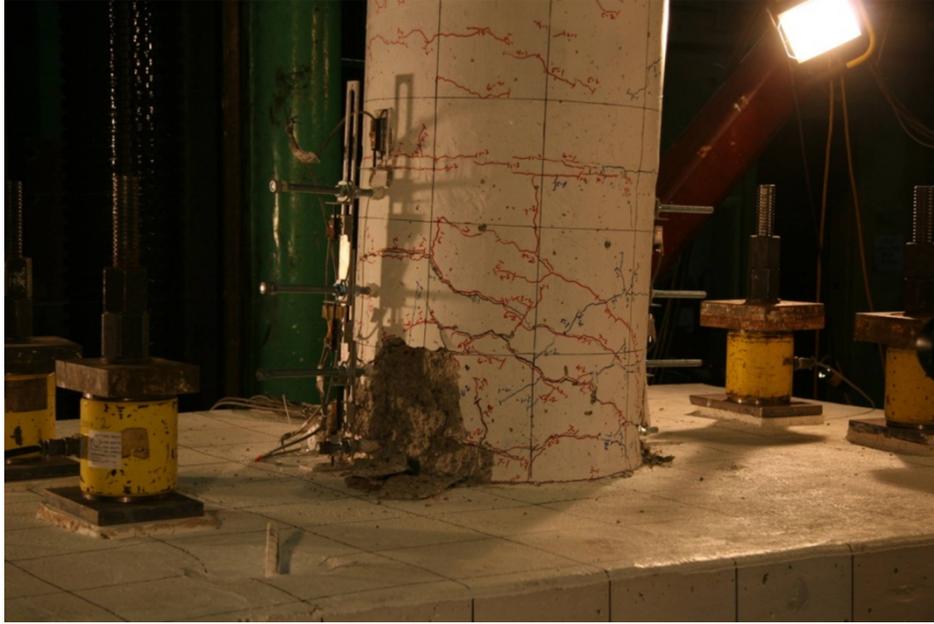
Figure 124. Photo. Specimen SF-1: plastic hinge became more pronounced in subsequent cycles. Photo taken during cycle 8-1 (+4.28/-4.28 target drift ratio).

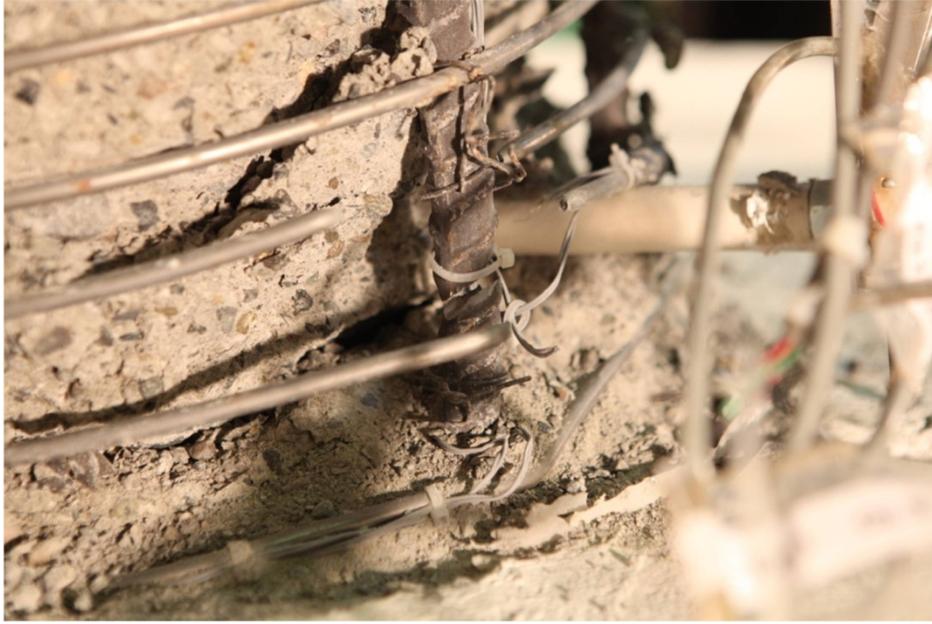
Figure 126. Photo. Specimen SF-1: N-NE bar fractured first when the column was loaded to peak in cycle 10-2 (+10.65/-10.65 target drift ratio).

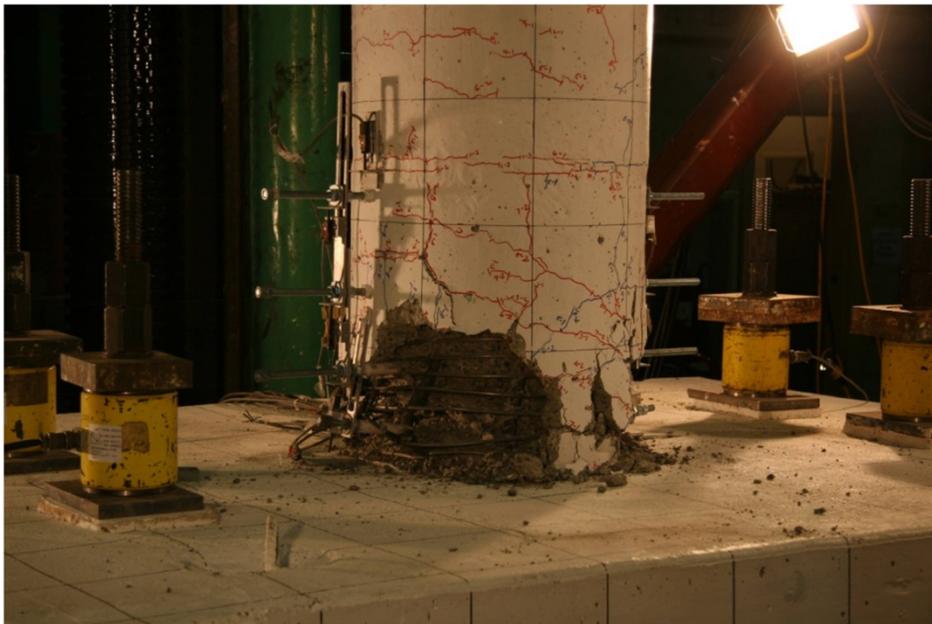
Figure 127. Photo. Specimen SF-1: damage after the cyclic testing.

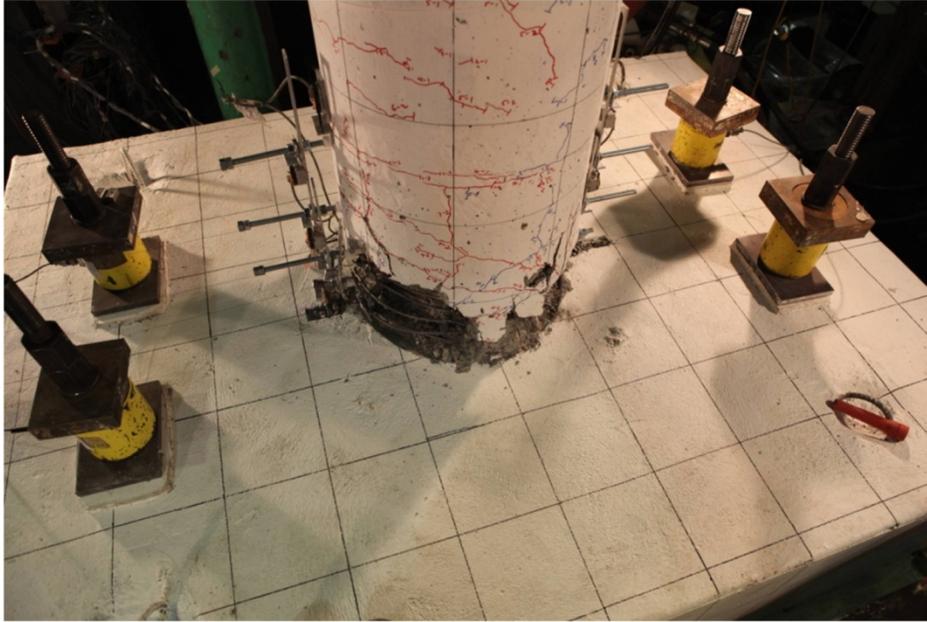
Figure 128. Photo. Specimen SF-1: no damage to the footing was observed after the cyclic testing.

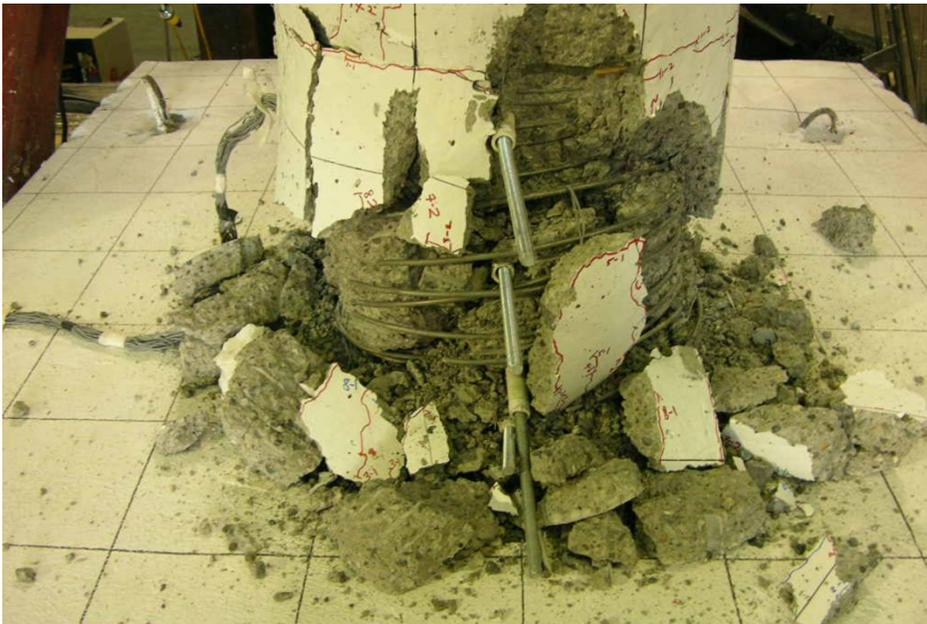
Figure 129. Photo. Specimen SF-1: damage the end of testing. The column crushed after application of vertical load of 842 kips.

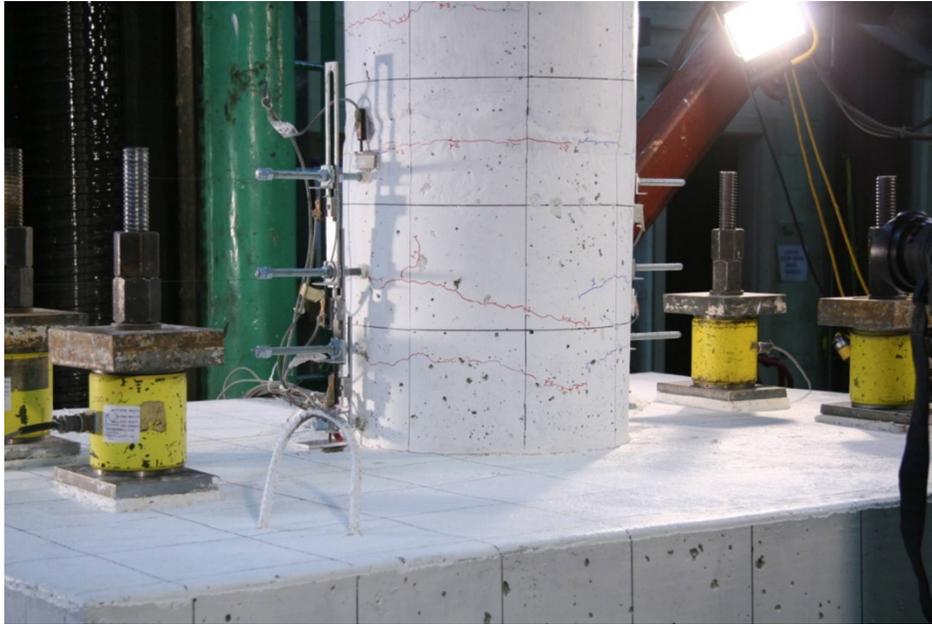
Figure 130. Photo. Specimen SF-2: flexural cracks after cycle 3-2 (+0.83/-0.83 target drift ratio).

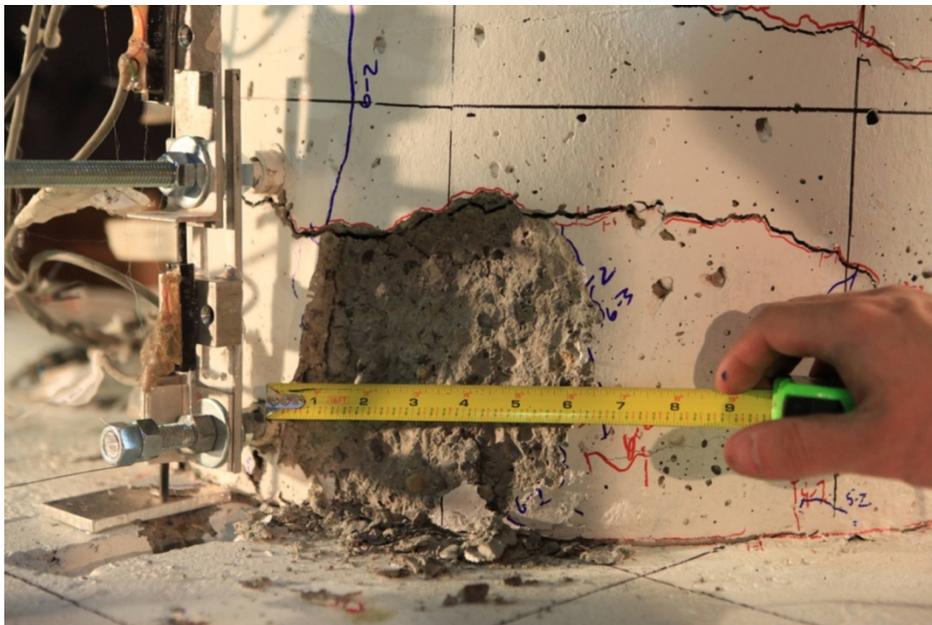
Figure 131. Photo. Specimen SF-2: first significant spalling at cycle 7-1 (+2.97/-2.97 target drift ratio).

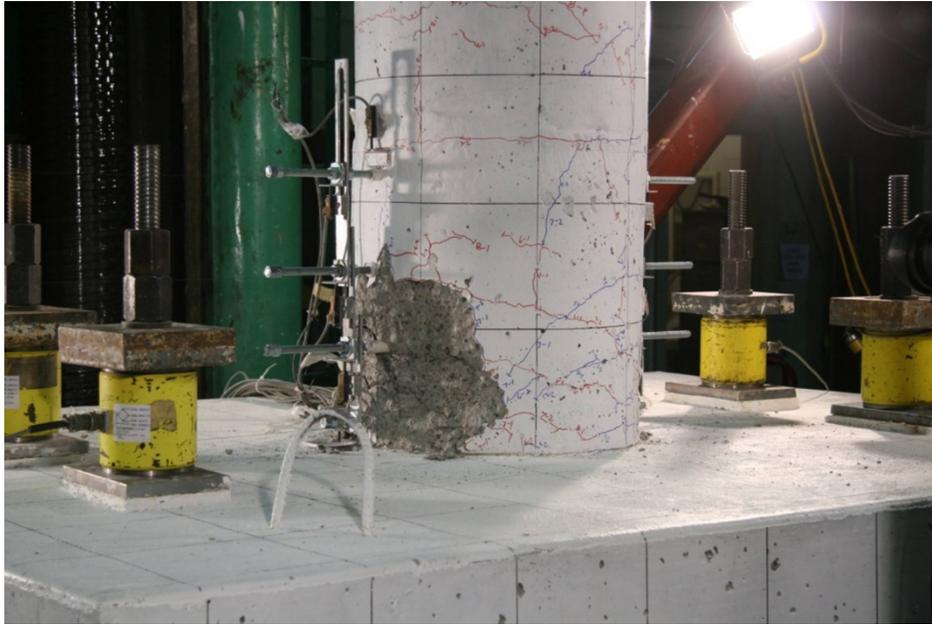
Figure 132. Photo. Specimen SF-2: the column fully spalled after cycle 8-1 (+4.28/-4.28 target drift ratio).

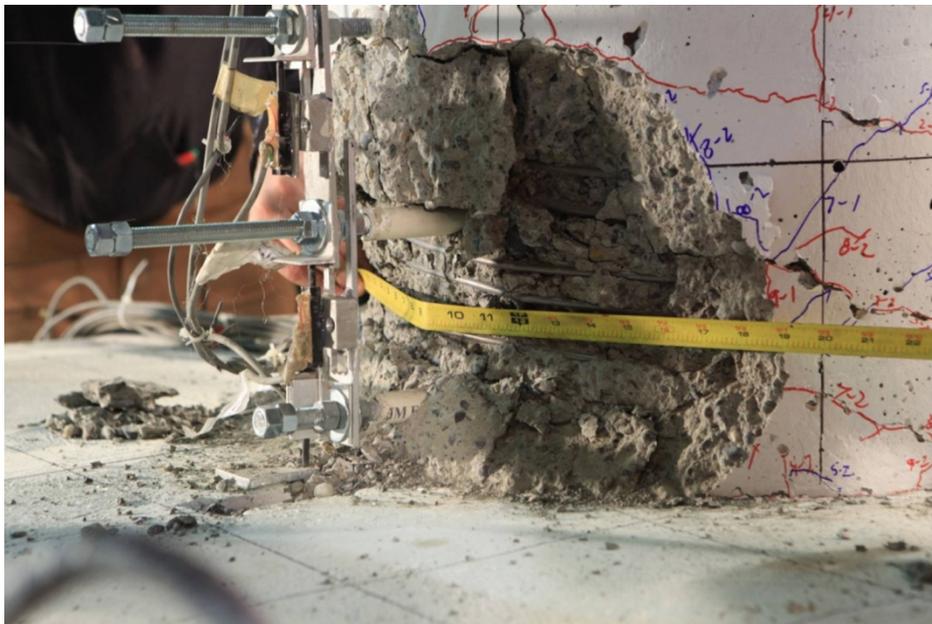
Figure 133. Photo. Specimen SF-2: first noticeable bar buckling was the N-NW bar in cycle 9-3 (+7.40/-7.40 target drift ratio).

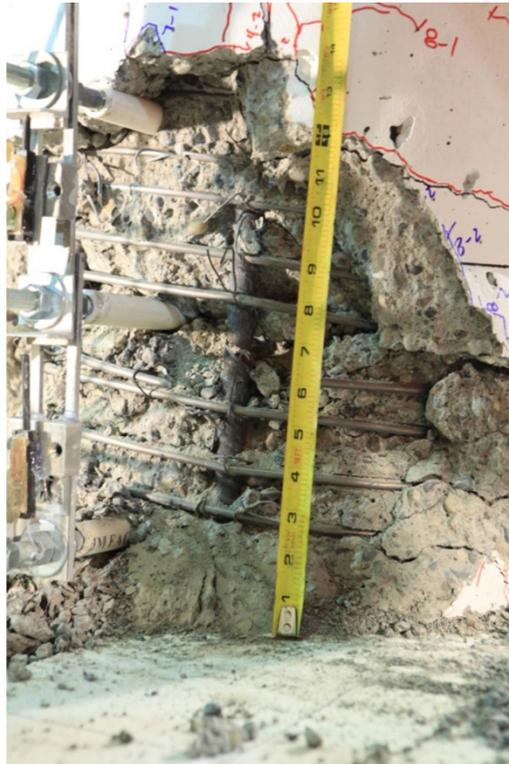
Figure 134. Photo. Specimen SF-2: N-NW bar fractured first when the column was being loaded to peak in cycle 10-2 (+10.65/-10.65 target drift ratio).

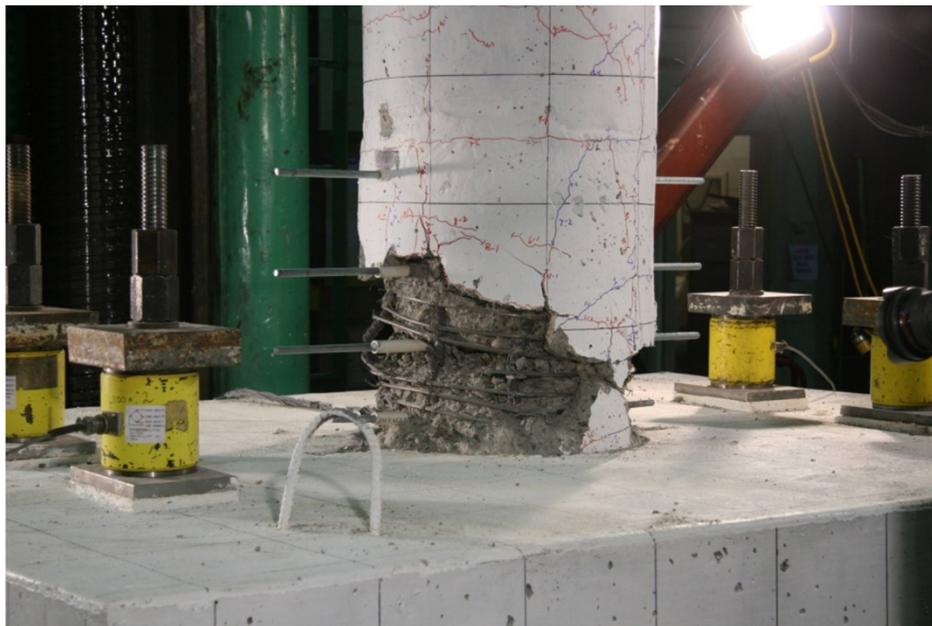
Figure 135. Photo. Specimen SF-2: damage after the cyclic testing.

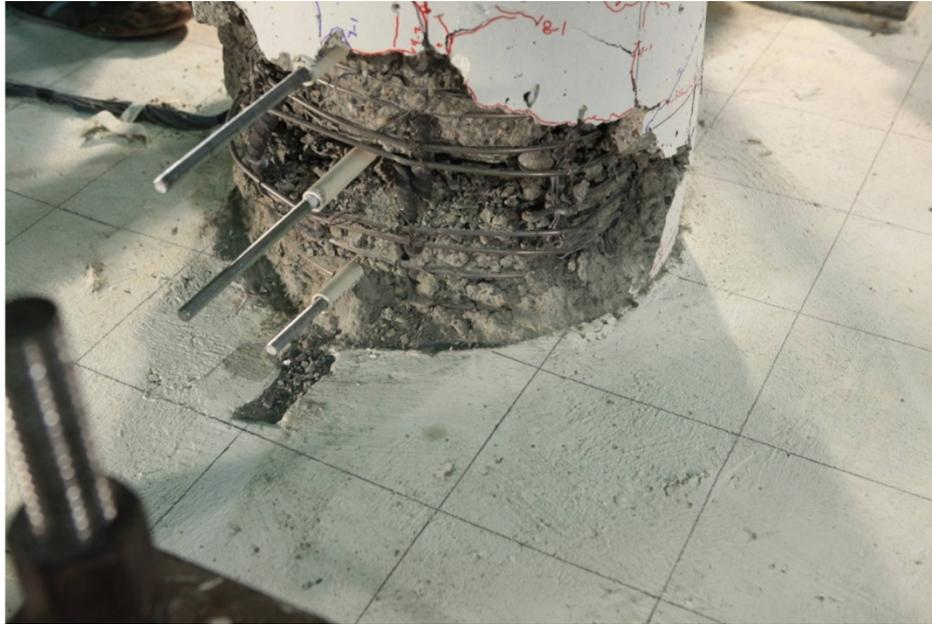
Figure 136. Photo. Specimen SF-2: no damage to the footing was observed after the cyclic testing.

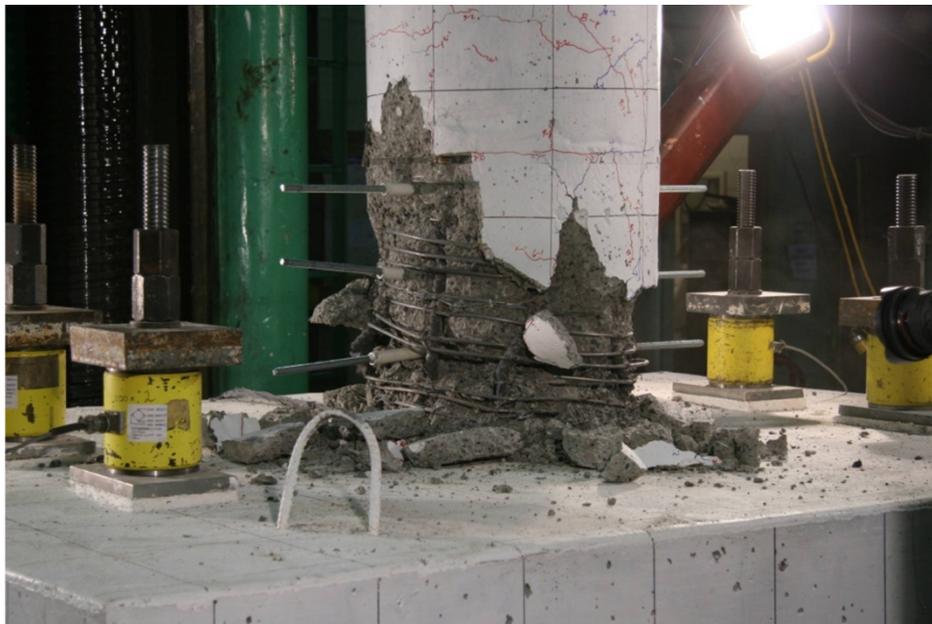
Figure 137. Photo. Specimen SF-2: damage the end of testing. The column crushed after application of vertical load of 819.5 kips.

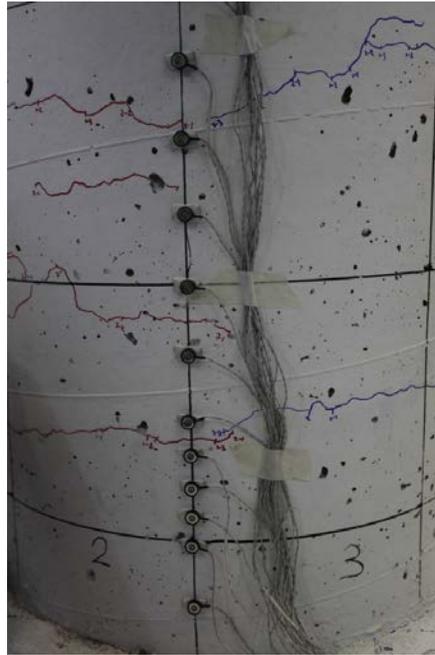
Figure 138. Photo. Specimen SF-3: significant horizontal crack in cycle 3-1 (+0.69/-0.69 target drift ratio).

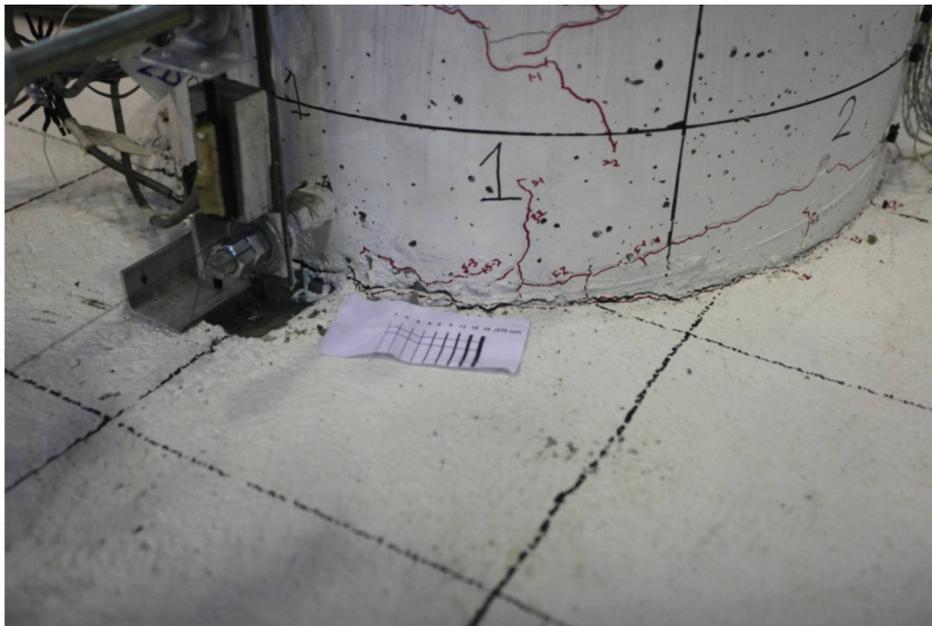
Figure 139. Photo. Specimen SF-3: separation at column-footing interface in cycle 5-3 (+1.72/-1.72 target drift ratio).

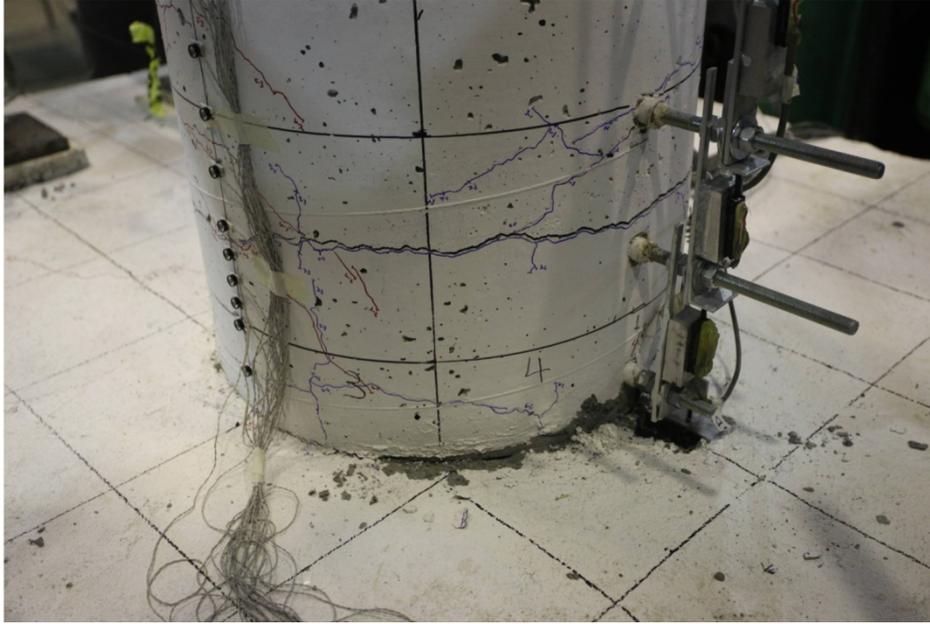
Figure 140. Photo. Specimen SF-3: first diagonal cracking in cycle 6-1 (+2.06/-2.06 target drift ratio).

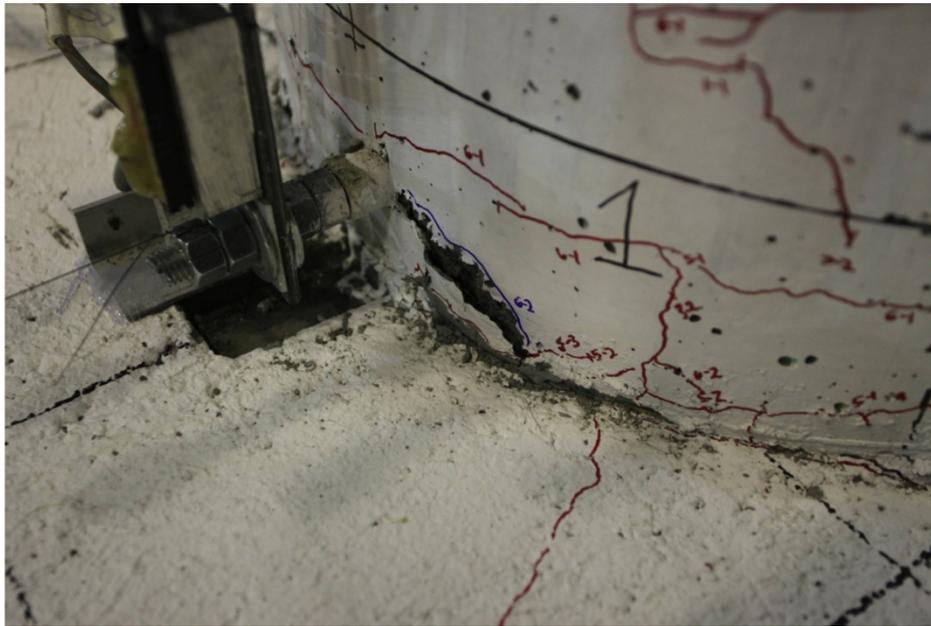
Figure 141. Photo. Specimen SF-3: first column spalling in cycle 6-2 (+2.48/-2.48 target drift ratio).

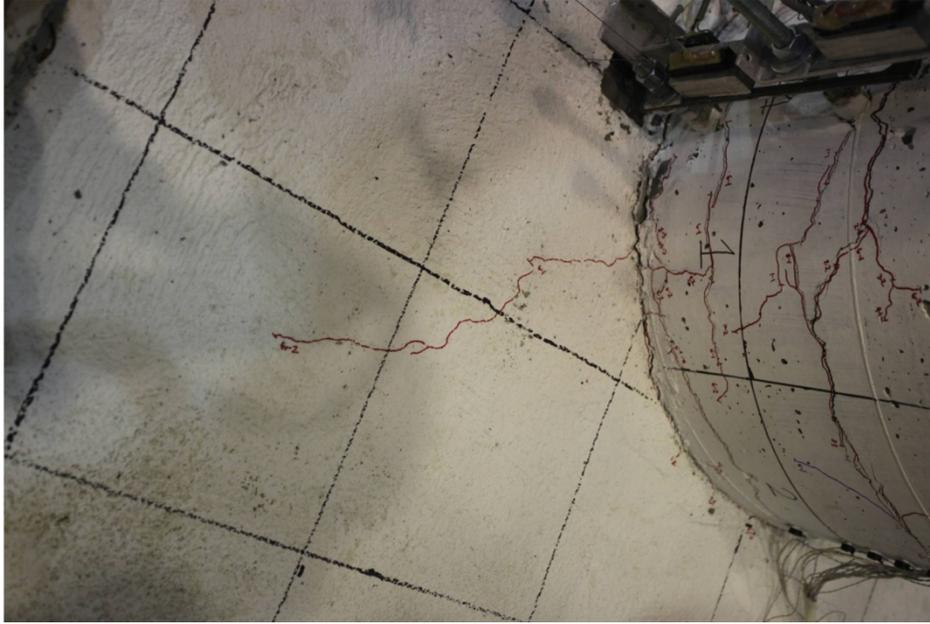
Figure 142. Photo. Specimen SF-3: radial footing crack propagation in cycle 6-2 (+2.48/-2.48 target drift ratio).

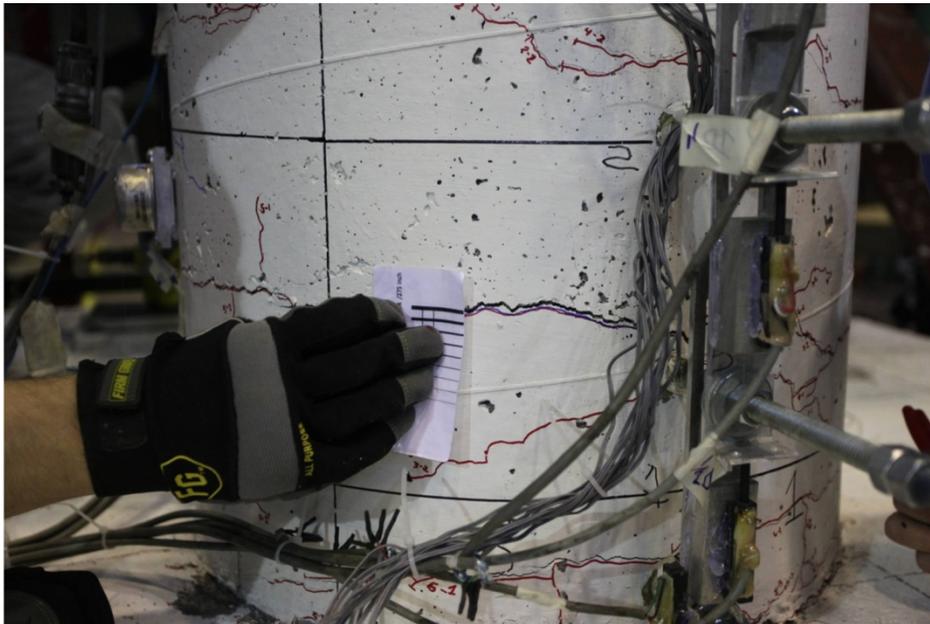
Figure 143. Photo. Specimen SF-3: large horizontal crack in cycle 6-2 (+2.48/-2.48 target drift ratio).

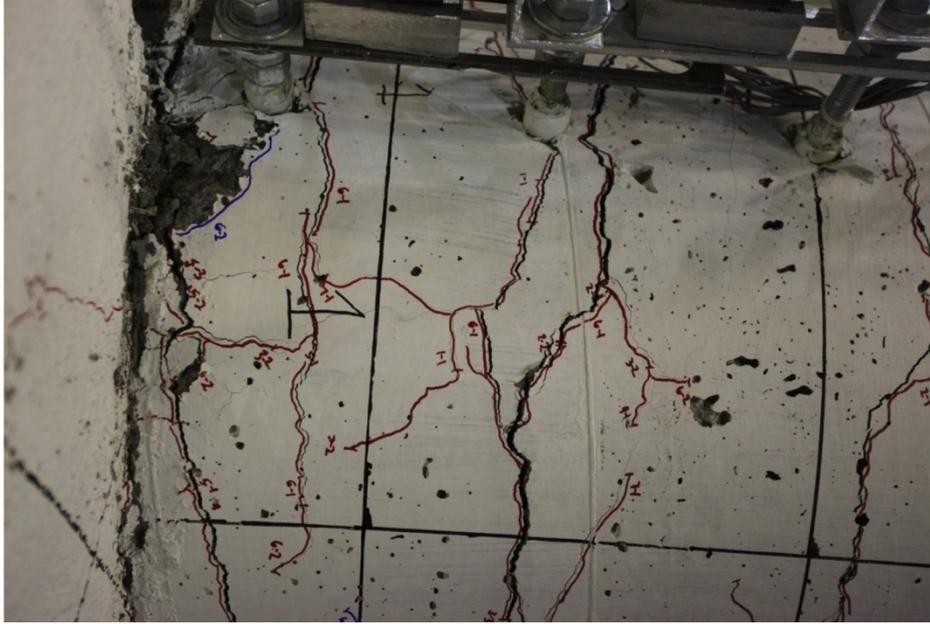
Figure 144. Photo. Specimen SF-3: large column flexural cracks occurring in cycle 7-2 (+3.57/-3.57 target drift ratio).

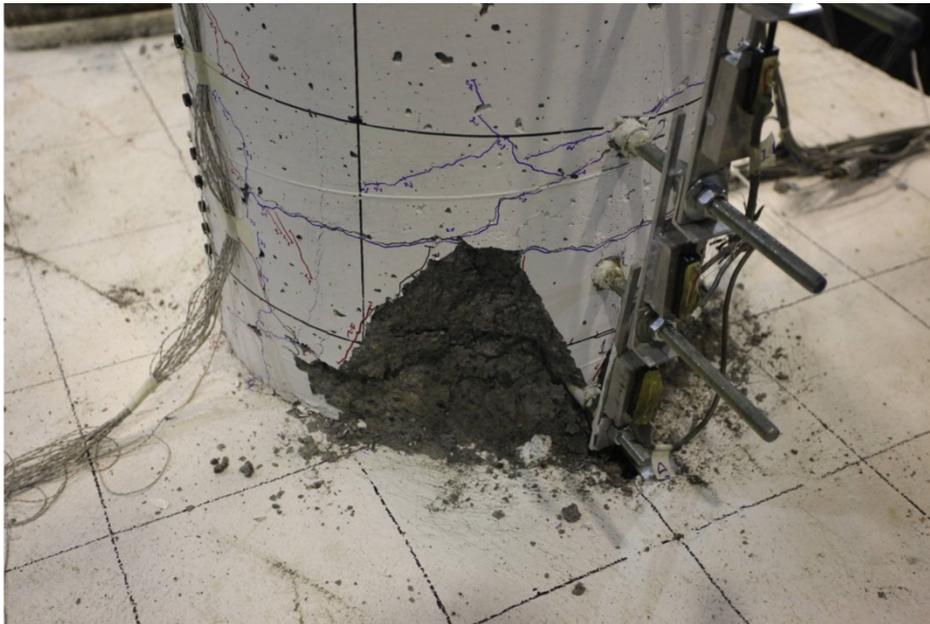
Figure 145. Photo. Specimen SF-3: full column spalling in cycle 9-1 (+6.16/-6.16 target drift ratio).

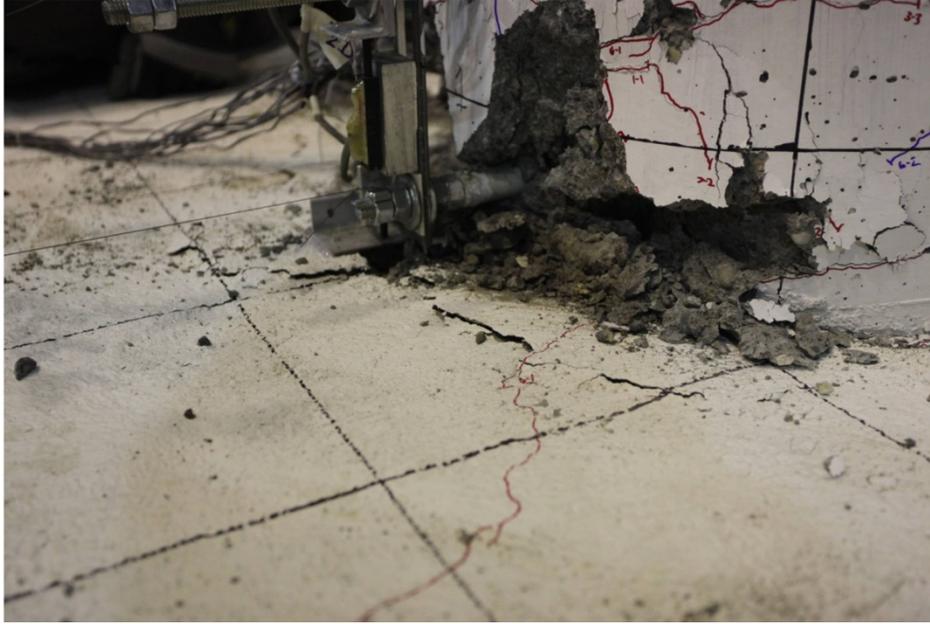
Figure 146. Photo. Specimen SF-3: first footing spalling in cycle 9-2 (+7.40/-7.40 target drift ratio).

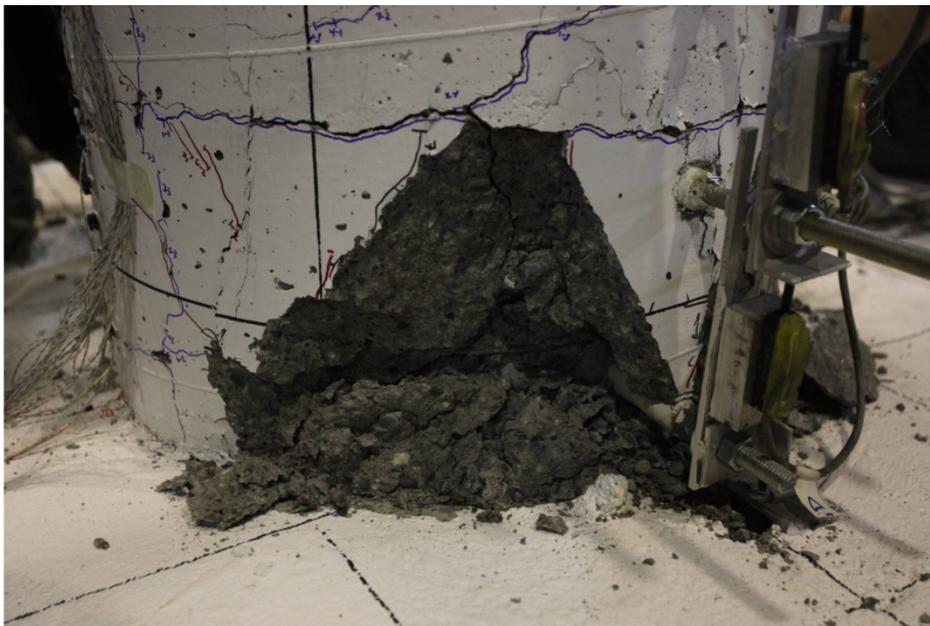
Figure 147. Photo. Specimen SF-3: transverse steel exposed in cycle 9-3 (+7.40/-7.40 target drift ratio).

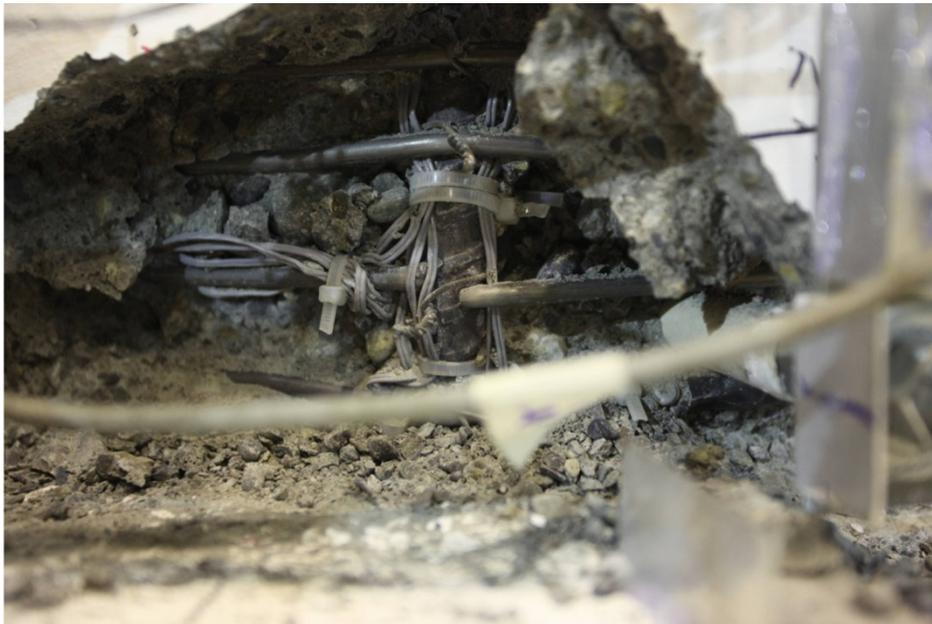
Figure 149. Photo. Specimen SF-3: fracture of transverse reinforcement in cycle 10-1 (+8.87/-8.87 target drift ratio).
