Precast Bent System for High Seismic Regions

Laboratory Tests of Column-to-Footing Socket Connections

Publication No. FHWA-HIF-13-039

June 2013

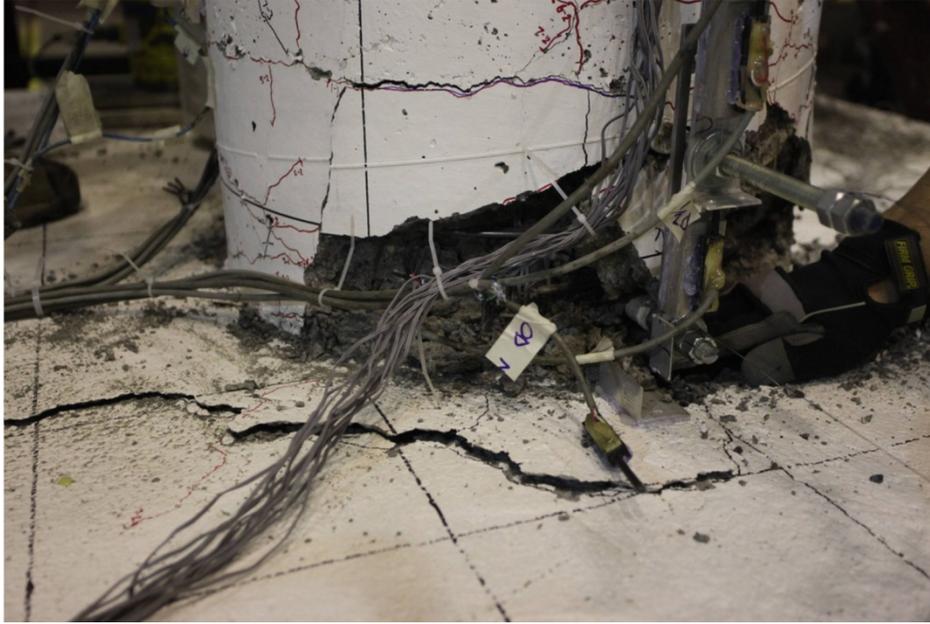
Figure 150. Photo. Specimen SF-3: major footing spalling occurring in cycle 10-1 (+8.87/-8.87 target drift ratio).

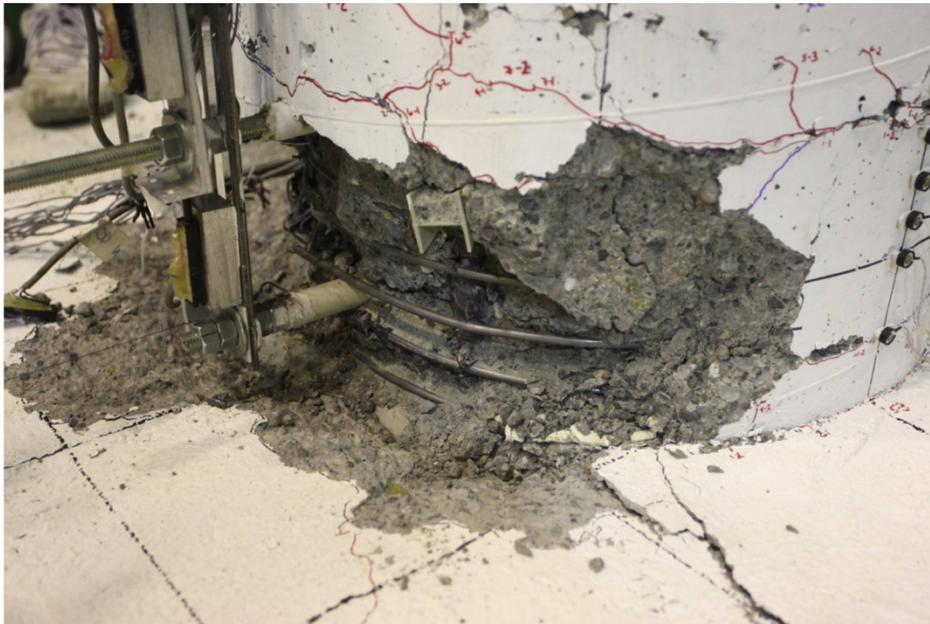
Figure 151. Photo. Specimen SF-3: major cracks in the concrete core in cycle 10-2 (+10.65/-10.65 target drift ratio).

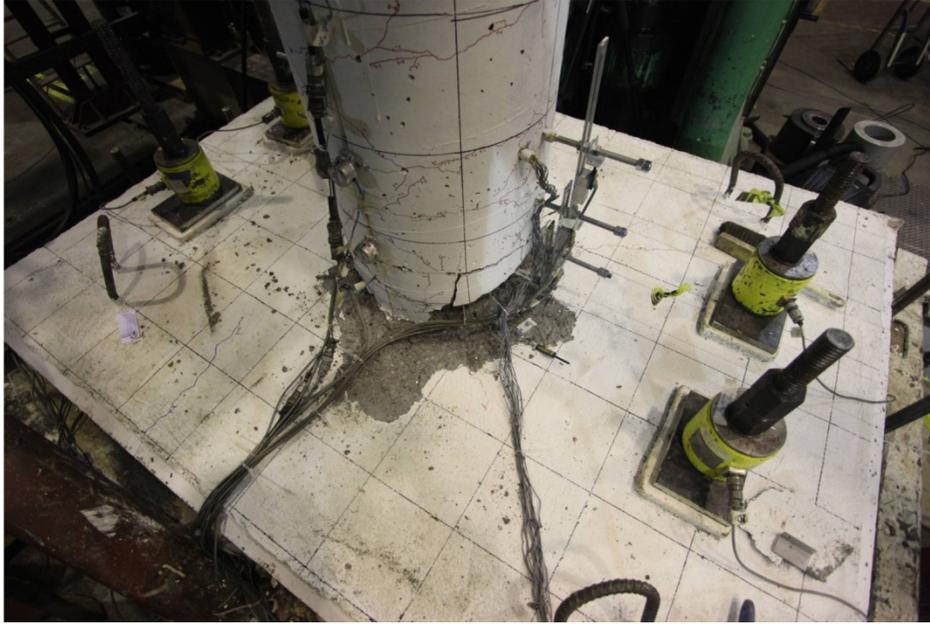
Figure 152. Photo. Specimen SF-3: condition of specimen just before last cycle.

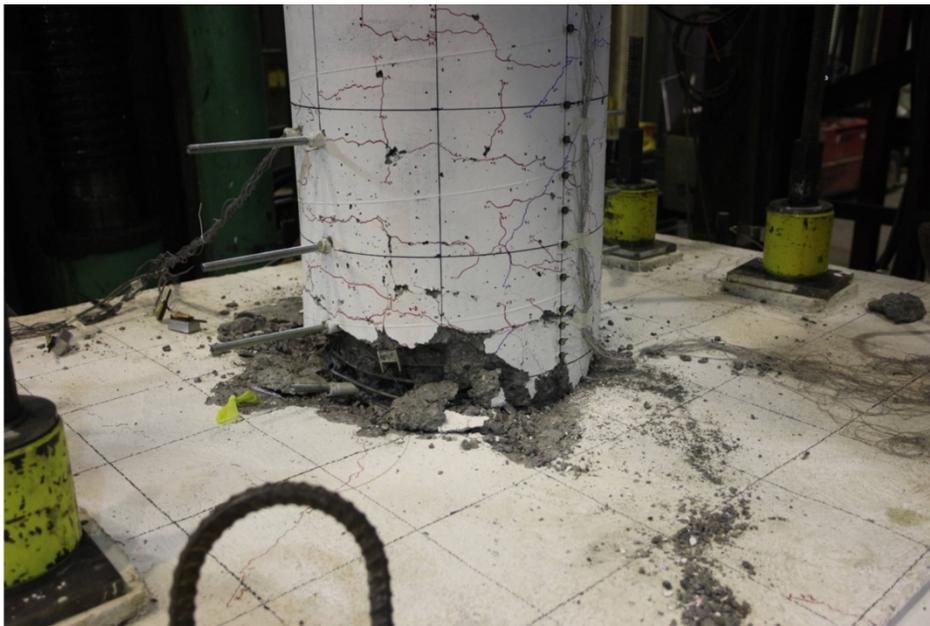
Figure 153. Photo. Specimen SF-3: column after punching through in last cycle (cycle 10-3, +10.65/-10.65 target drift ratio).

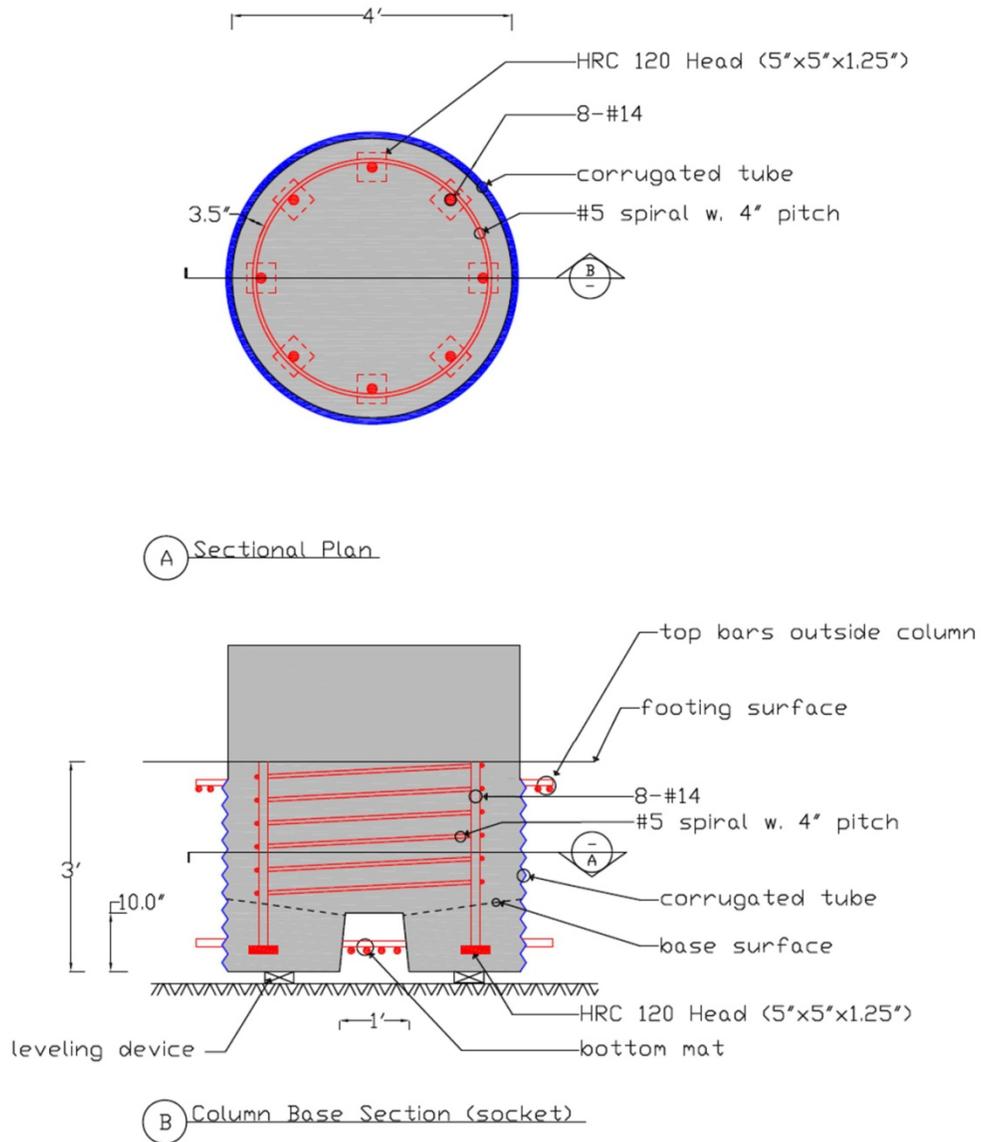
Figure 164. Diagram. Socket column concept.

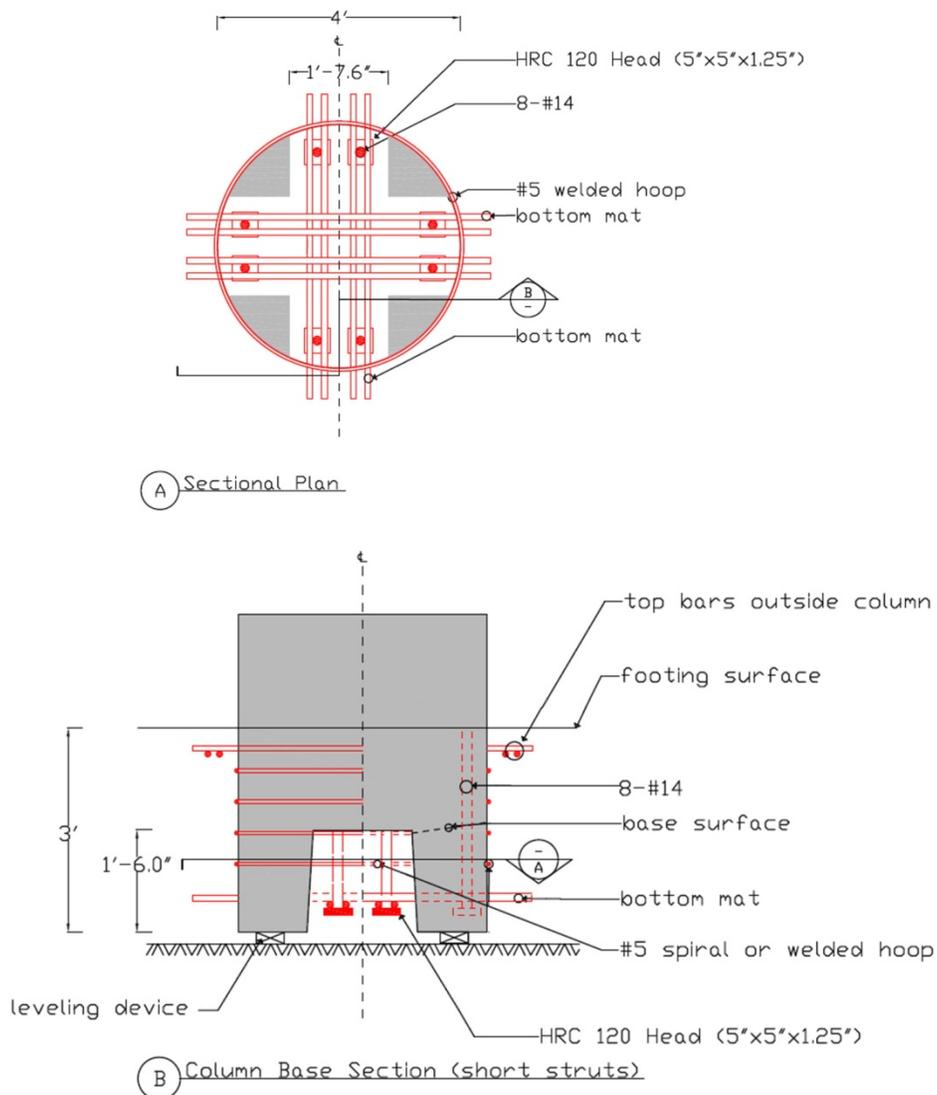
Figure 166. Diagram. Short struts concept.
