# **THE IMPLEMENTATION OF FULL DEPTH UHPC WAFFLE BRIDGE DECK PANELS**

## **PHASE 1 FINAL REPORT**

Sponsored by  
**Highways for LIFE**  
**Technology Partnerships Program**

Prepared by  
**CORESLAB STRUCTURES (OMAHA) INC.**  
802 Allied Rd. Bellevue, Nebraska 68123  
[www.coreslab.com](http://www.coreslab.com)

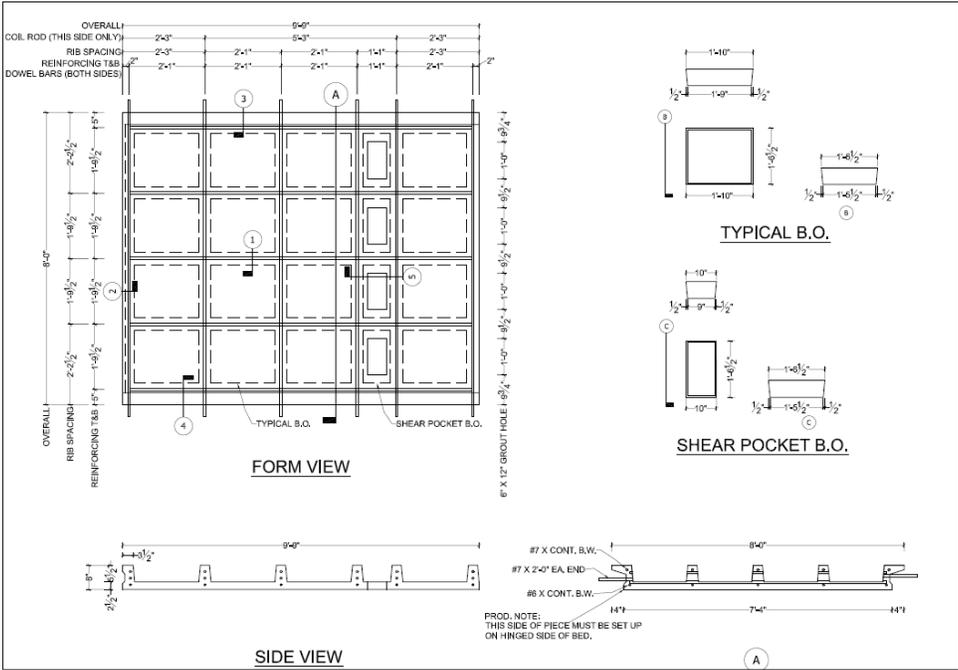
**Figure 1**  
Prototype Panel Shop Drawing

The design of the waffle slab was completed by the IDOT in late August of 2009, and shop drawings for use by Coreslab Structures (Omaha) Inc. production staff were complete by early September. Coreslab Structures and Lafarge North America consulted on the fabrication and aspects of the design relating to ease of production and requirements for UHPC joint fill respectively. The prototype panels were 8'-0" wide by 9'-9" long, with a number six bar in the top and a number 7 bar in the bottom of each rib (See Figure 1 below). One girder to girder span along the length of the bridge was modeled by the prototype panel. It was determined that two slabs would be necessary to test the transverse panel to panel joint.

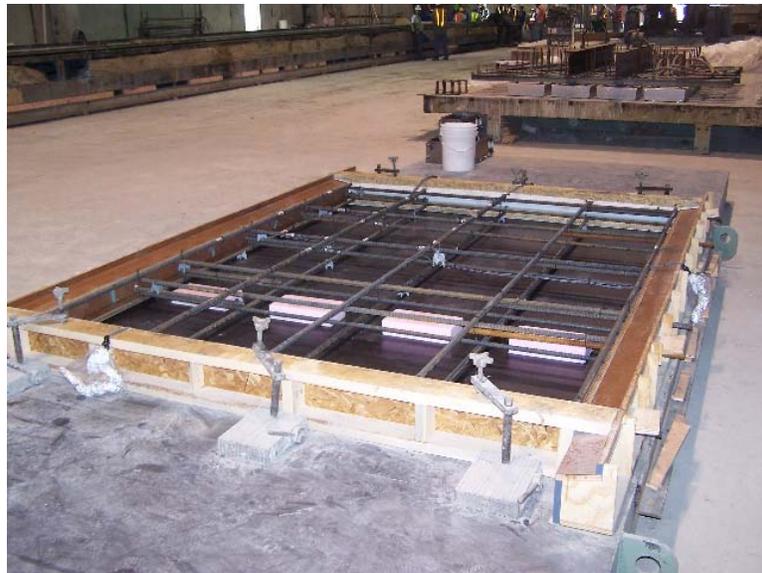
**Figure 2**  
Final Form Setup

Figure 2 shows the reinforcing layout of the first casting. Uncoated reinforcing was used due to the fact the UHPC is effectively impermeable, eliminating the need for epoxy coated, galvanized, or stainless steel reinforcing to resist corrosion. The prototype panel formwork was made of wood in order to provide an inexpensive and temporary form. This strategy was employed due to the fact the design was preliminary and changes to the rib size, spacing, and joint profiles were possible between the prototype and demonstration panels. The final formwork will be made of steel and adjustable to fit different rib spacings for various panel configurations. In addition to the standard reinforcing, several monitoring instruments were also cast into the panels to monitor the internal responses of the UHPC and reinforcing.

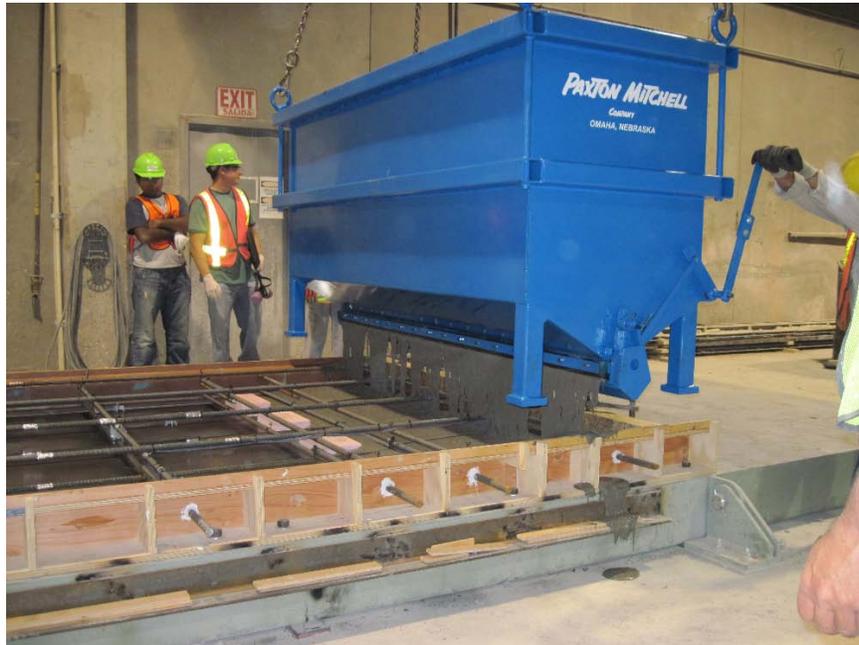
**Figure 3**  
Casting

Figure 3 shows the placing of the UHPC into the form. The UHPC was placed with a specially designed bucket that is as wide as the form, which aligns the steel fibers in the UHPC in the longest direction of the panel. This alignment helps to increase the flexural strength of the panels. The bucket was moved along the length of the form and kept behind the leading edge of the flow to eliminate any discontinuity in the fiber orientation. The form was filled to a predetermined level and then the voids were set as an assembly (See Figure 4 page 3). Each of the prototype panels required approximately one cubic yard of UHPC.

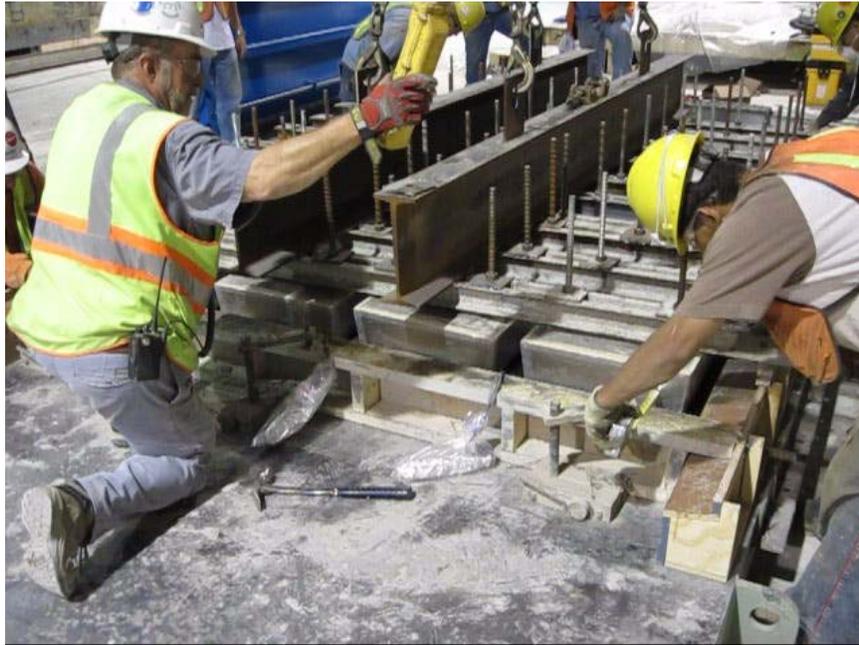
**Figure 4**  
Placing the Voids

As mentioned previously this casting method also allows the voids to be removed after the initial set off the UHPC, which allows the UHPC to shrink without inducing internal stresses. This is very important because the UHPC will reach initial set within 12-14 hours, but will not reach release strength for approximately 40 hours after casting. Damage from shrinkage can occur during this time if the appropriate precautions are not taken.

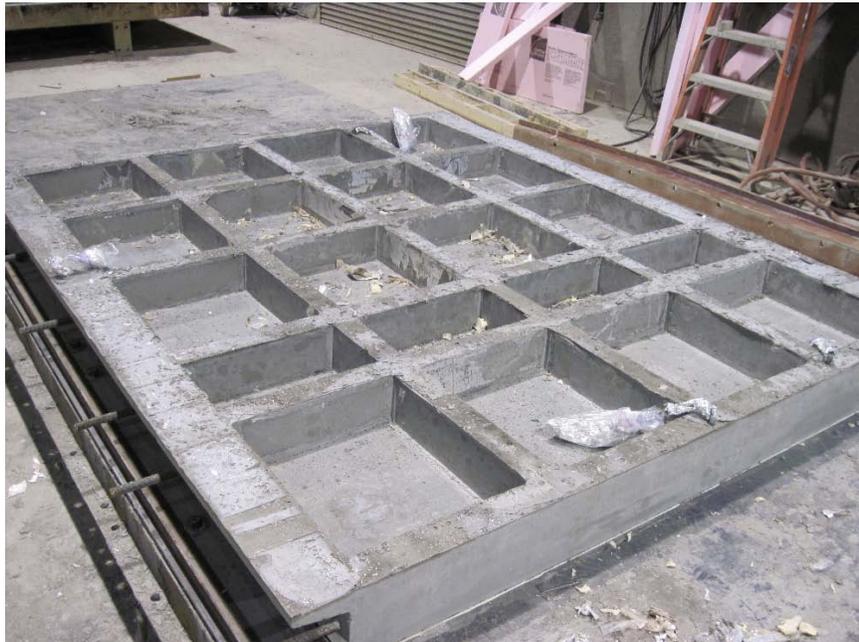
**Figure 5**  
Formwork Removed

Figure 5 on page 5 shows the panel after the side forms and voids were removed. After the panels reached the required 14,000 psi release strength, they were moved from the casting area to the curing area. The panels were lifted into the vertical position, rotated 180 degrees and lowered back to the horizontal position in the proper orientation by the casting bed. This technique was used to reduce the handling stresses on the panels. Even though the concrete strength is very high at release, the sections where the panels are rotated from are very thin, limiting the amount of stress that can be taken without cracking. The critical section is at the very thin area where the toe of the transverse joint edge and the longitudinal rib intersect. By rotating the piece with the casting bed the issue of handling stresses is eliminated.

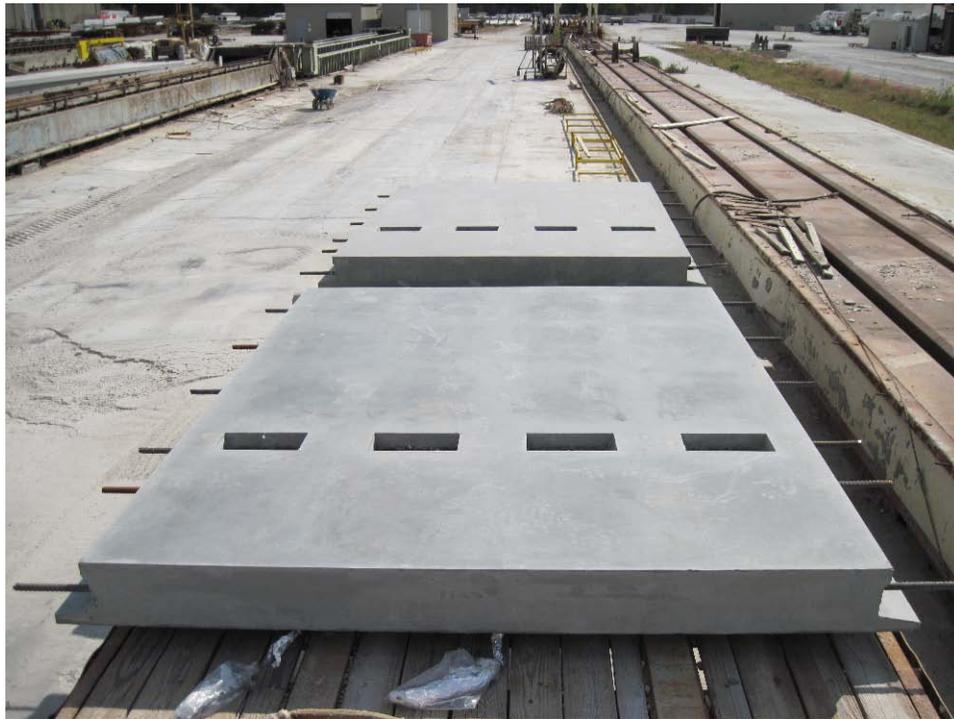
**Figure 6**  
Completed Panels

After the pieces were cast, they were cured for 48 hours at 195 °F as required by Lafarge for maximum strength and durability. Before the pieces were steam cured they measured approximately 15,000 psi compressive strength. A test cylinder was broken before the steam was turned off to verify that the panels had cured correctly, and the compressive strength of the UHPC at that time was 29,800 psi, exceeding the required design strength of 24,000 psi. After curing was complete, the panels were loaded on a truck and transported to ISU to be load tested.

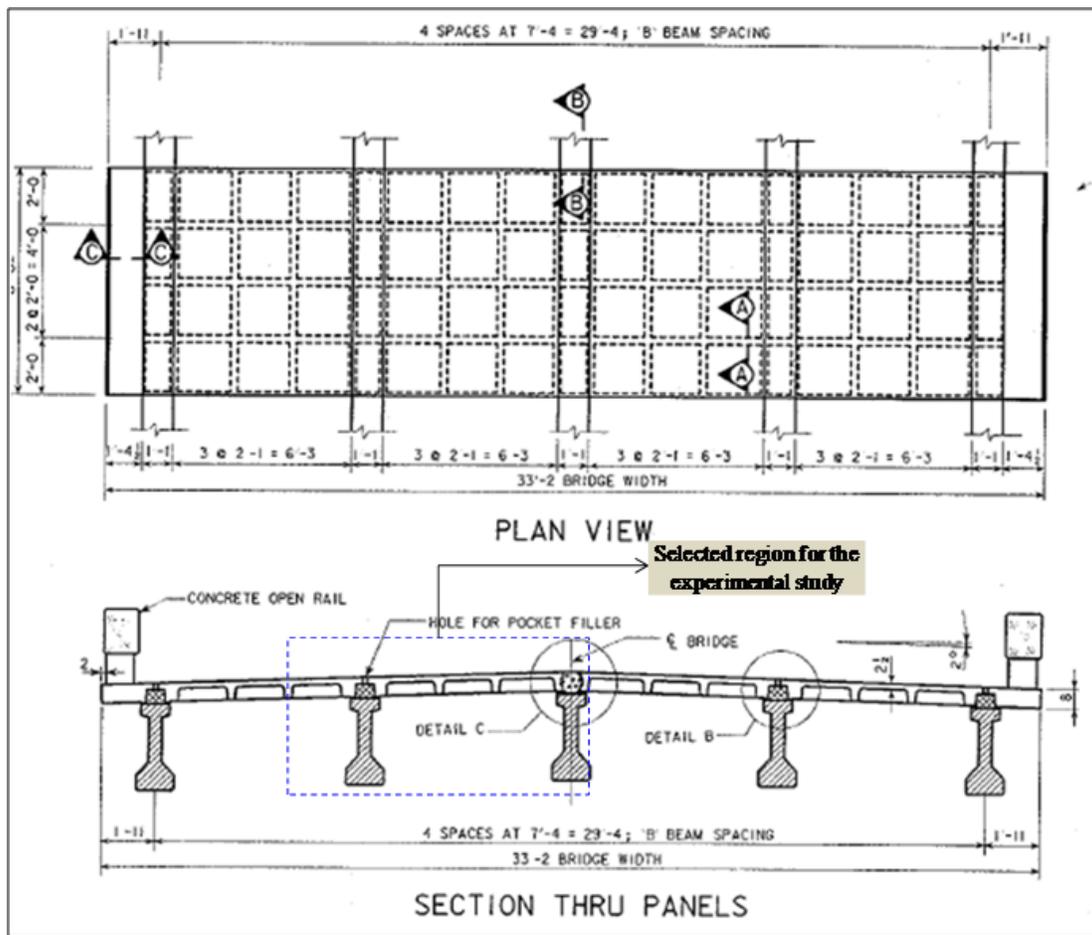
A full-scale single-span, two-lane, prototype, full-depth bridge system was designed as a replacement of an existing bridge in Wapello County, Iowa, and the details of this structure are shown in Figure 1. The prototype bridge is 33 ft wide and 60 ft long and it consisted of prefabricated, full-depth, precast concrete panels installed on five standard Iowa “B” girders placed at a center-to-center distance of 7ft 4 inches.

**Figure 1** Plan and cross section details of the proposed UHPC Waffle Deck Bridge in Wapello County.

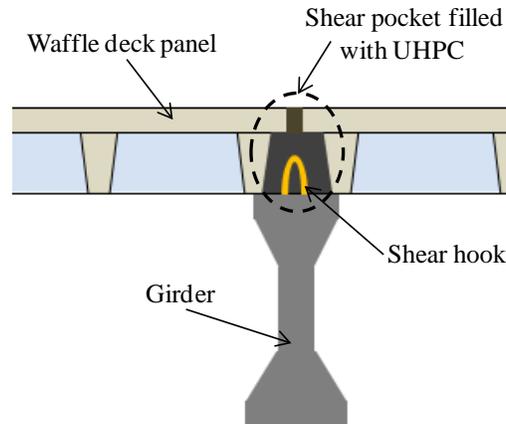
1. Shear pocket connection: This connection is formed between the girder and the waffle deck using shear pockets. In this connection, the shear pockets in the waffle deck are filled with UHPC and a shear hook extended from the girder is embedded into the UHPC fill (see Figure 2). This will cause the girders and the waffle deck to act in a composite manner.

**Figure 2** Shear pocket connection details between girder and the waffle deck

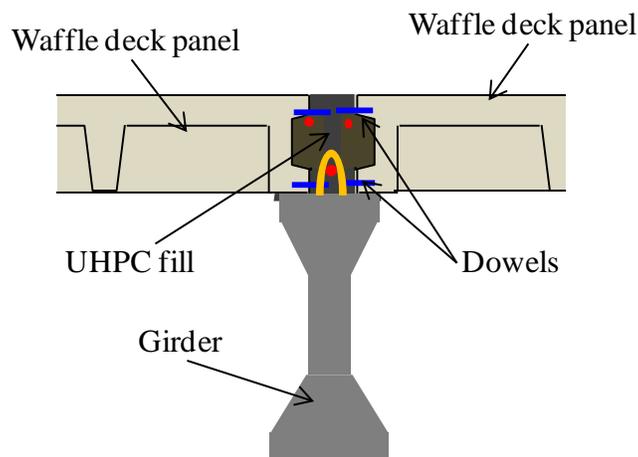
2. Waffle panel to girder longitudinal connection: This connection is formed between the central girder and the waffle deck. In this connection, the dowel bars from the panels and the shear hook from the girder are tied together with additional reinforcement along the girder length and the gap between the panels is filled with UHPC (see Figure 3). This connection will provide a positive moment connection between the girder and the panels.

**Figure 3** Connection details between the central girder and the waffle deck

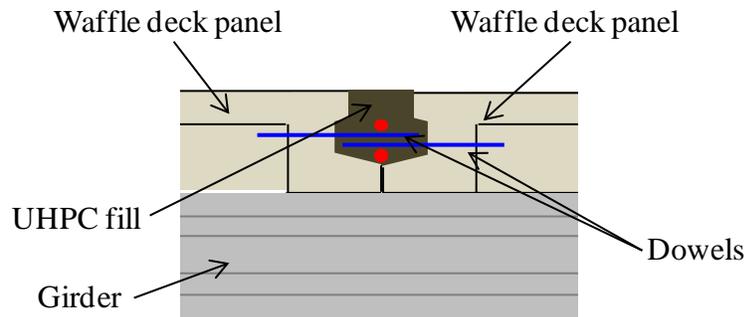
The bridge consisted of waffle deck panels which were 16 ft wide (full width) and 8 in. thick. They are connected across the length of the bridge using a transverse joint connection shown in Figure 4. In this connection, the dowel bars from the panels are tied together with additional transverse reinforcement and the gap between the panels is filled with UHPC (see Figure 4). This connection will provide continuity between the panels and facilitate load transfer between the panels.

**Figure 4** Connection details between the waffle deck panels

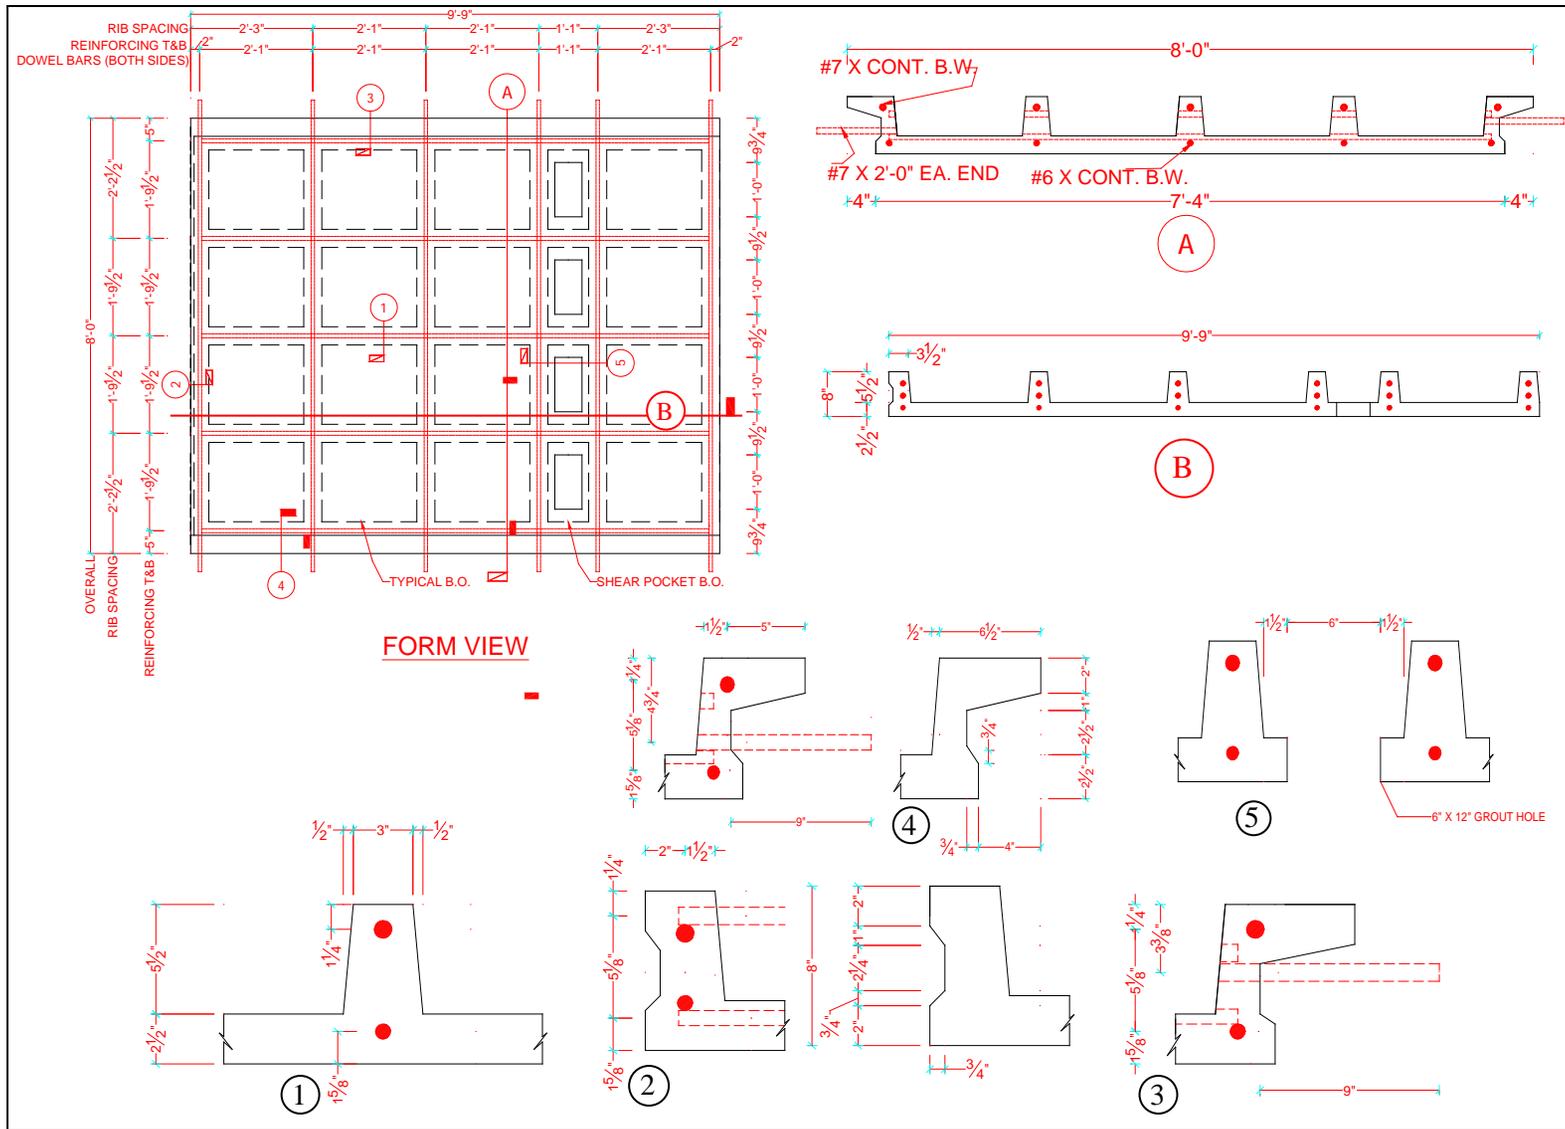
Figure 5 Reinforcement details of the UHPC waffle deck test panels.

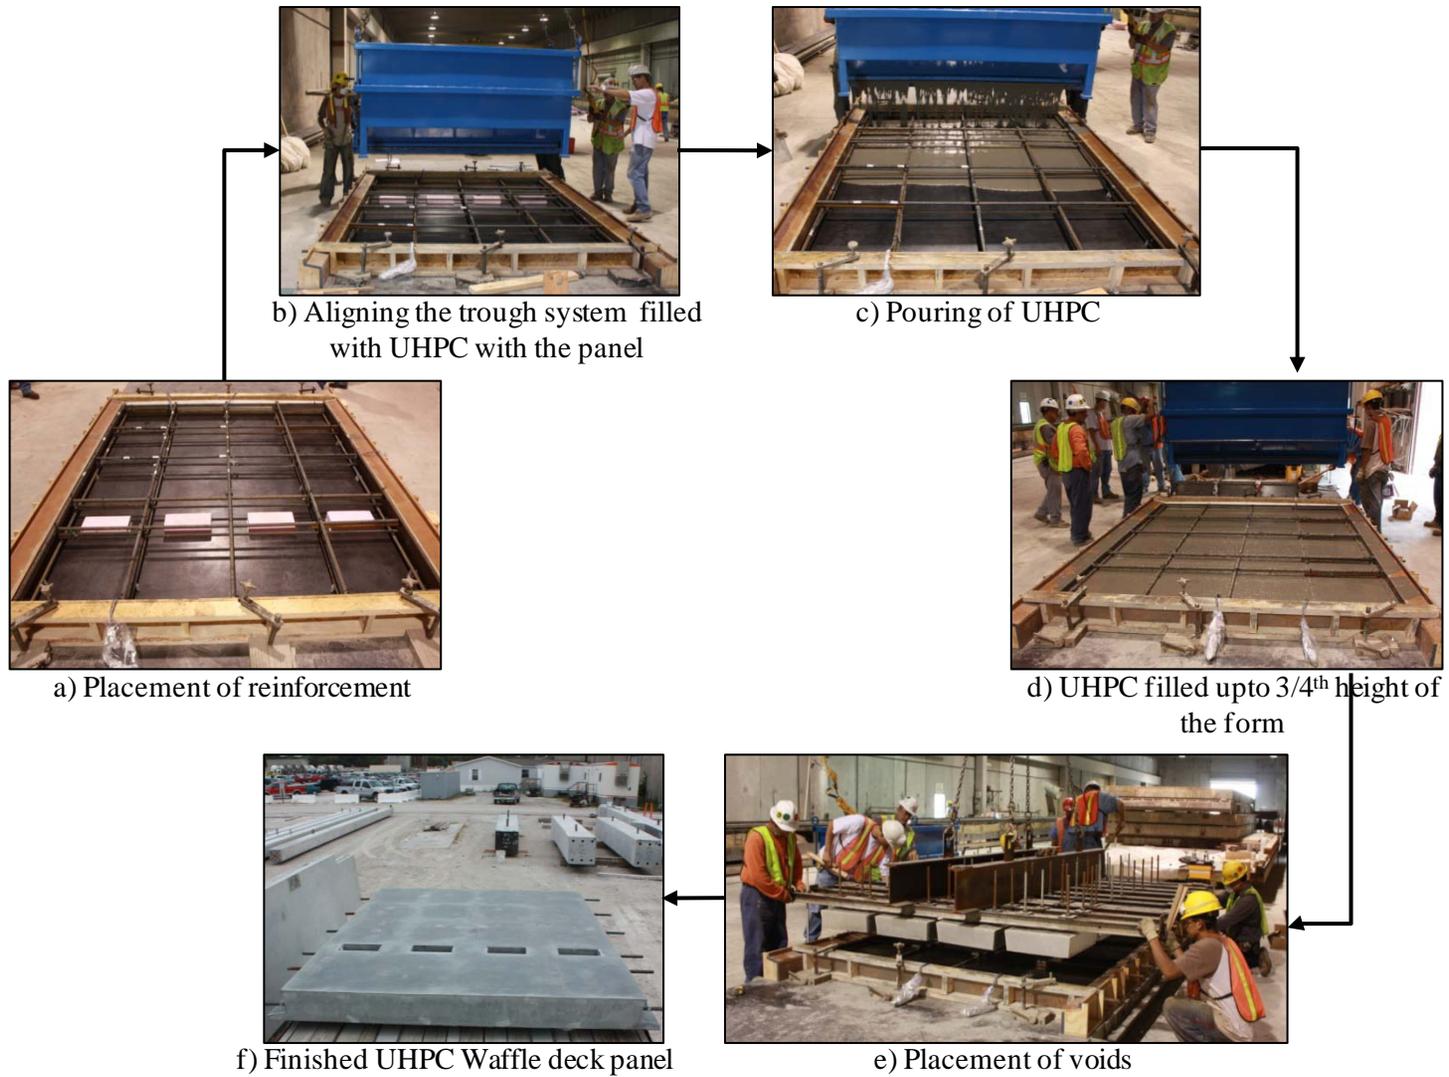
**Figure 6** Construction sequence of the UHPC Waffle deck panel at the precast plant.

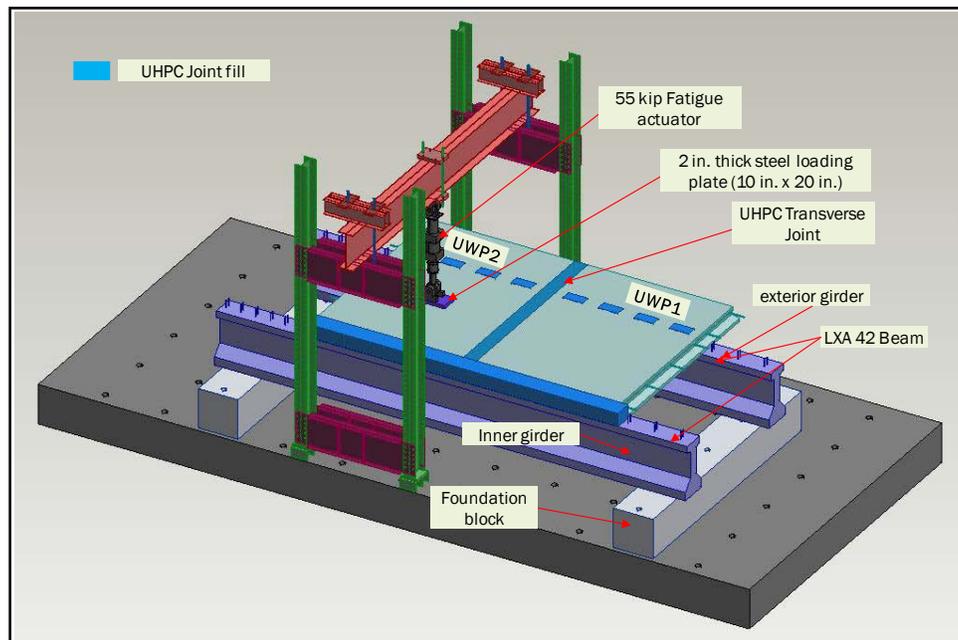
A schematic of the test setup used for the UHPC waffle deck system is shown in Figure 7, which was established to closely replicate the critical regions of the field structure in the laboratory. As noted earlier, the setup represented an end section of the prototype bridge encompassing two adjacent girders including a portion of an exterior girder. The UHPC deck panels were supported on two 24-ft long prestressed concrete girders having cross sections of girder type LXA 42, which were simply supported at the ends on concrete foundation blocks as shown in Figure 7.

**Figure 7** Schematic of the test setup used for testing of the UHPC Waffle deck panel system.

The foundation blocks were post-tensioned to the strong floor of the laboratory using a total of four one-inch diameter high strength threaded rod to prevent them from experiencing any lateral movement during testing. The girders were established by cutting a 48-ft long LXA 42 prestressed concrete girder, which was used by Iowa DOT as a standard girder in the past. The girders were placed on the foundation blocks at a center-to-center distance of 7ft and 4 inches

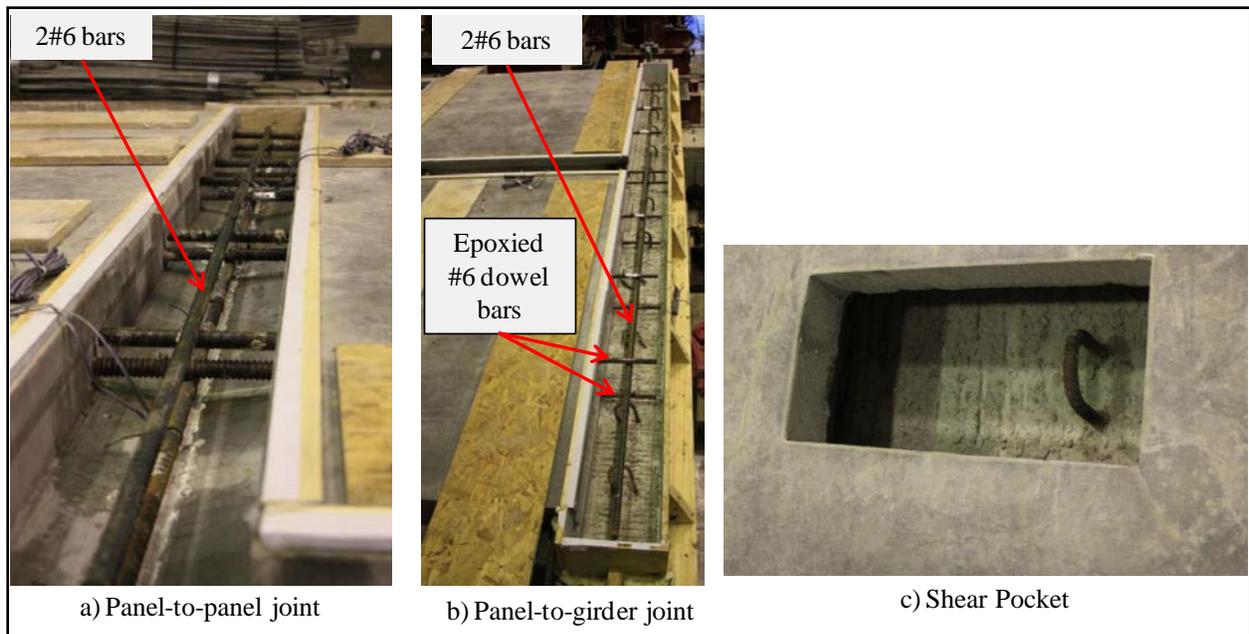
To establish a positive moment connection between the waffle deck and the interior girder, 12 in. long Grade 60, No.6 ( $d_b = 0.75$  in, where  $d_b$  is diameter of the bar) mild steel dowel bars were embedded at the left end face of the panels using high strength epoxy (see Figure 8b). In addition, two No.6 bars were placed and tied to the dowel bars along the girder length to represent the effect of the continuous slab over the inner girder, which is expected in the prototype bridge. Two No.6 bars were provided in the panel-to-panel joint (transverse joint) as the main reinforcement to resist the bending moment about the longitudinal axis (see Figure 8a). The connection between the exterior girder and the waffle deck was established using a shear pocket (see Figure 8c). Every shear pocket contained at least one shear hook extending from the girder.

**Figure 8** Details of the reinforcement provided in various joints.

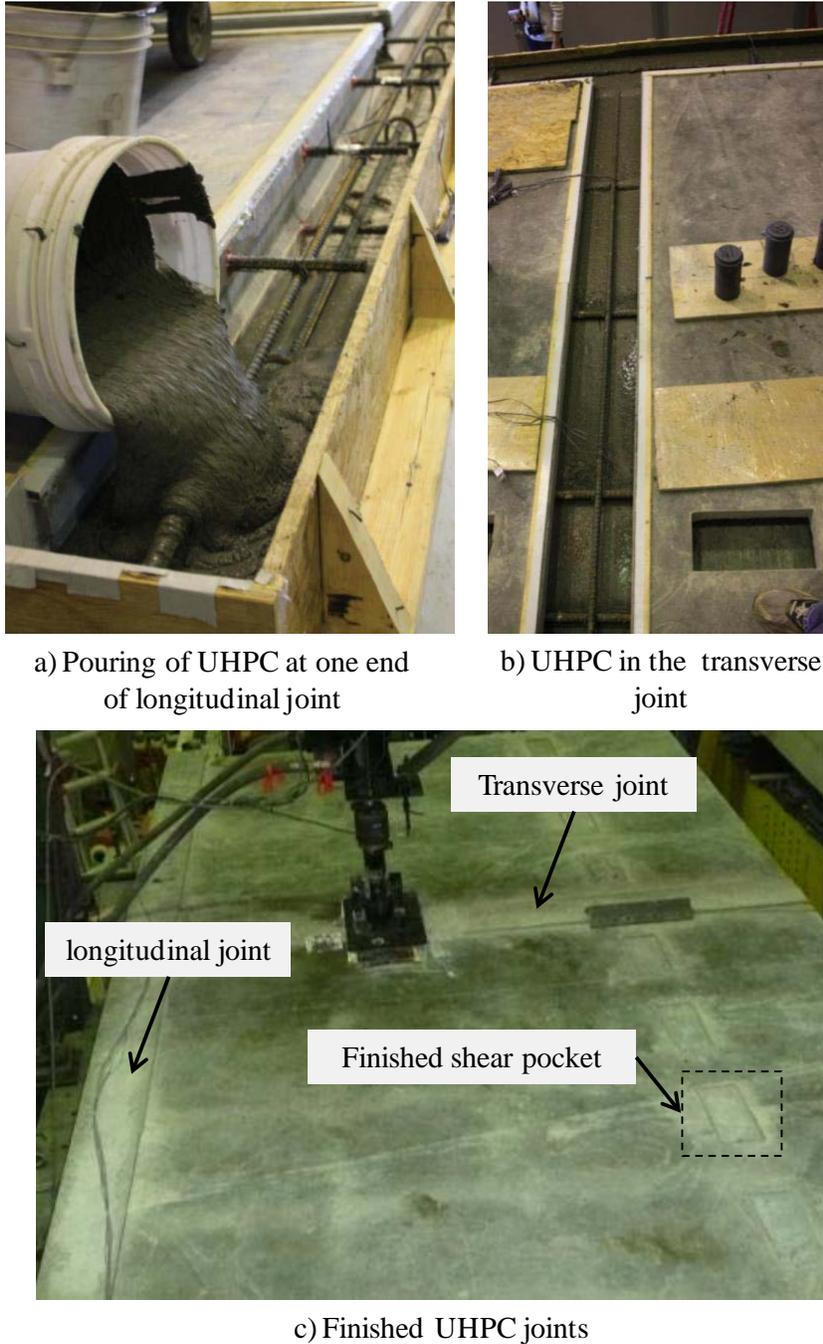
joint) and it travelled along the entire length of the joints (see Figure 9). After casting, all UHPC joints were covered with form plywood to minimize any moisture loss. The test cylinders were also subjected to the same curing conditions as the joints. They were tested at ISU in regular intervals to monitor the strength gain with time. Table 3 shows the details of the UHPC strength gain with time.

**Figure 9** UHPC joint pour

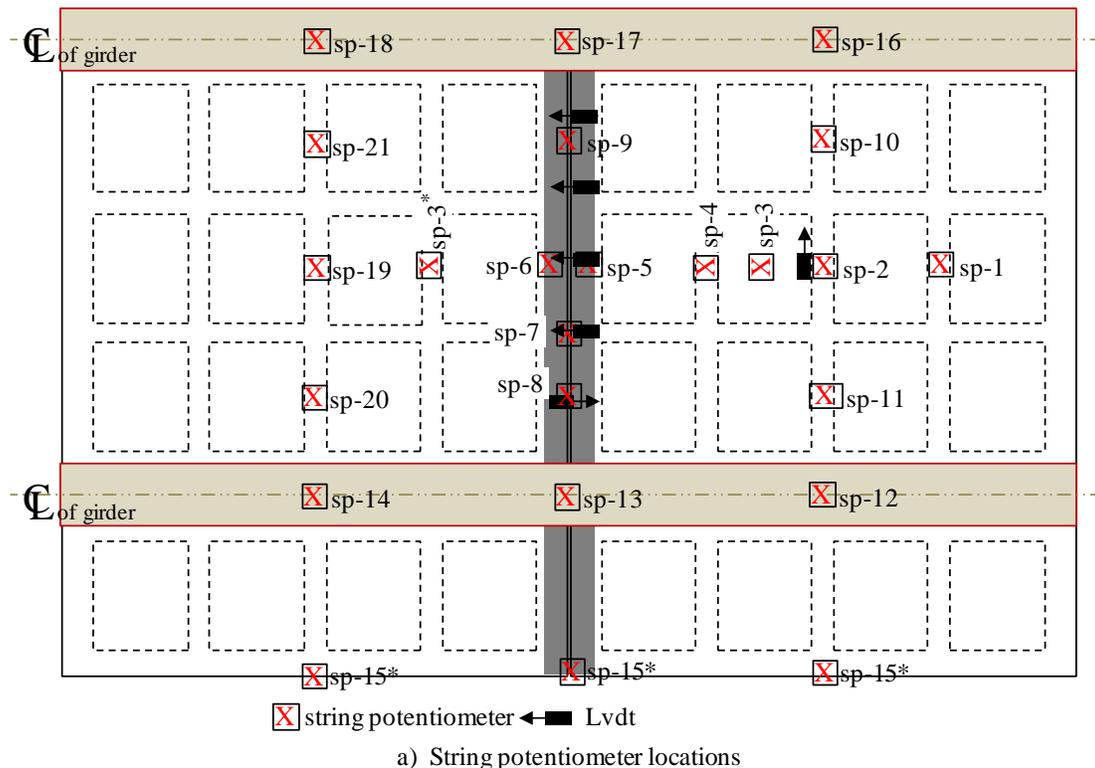
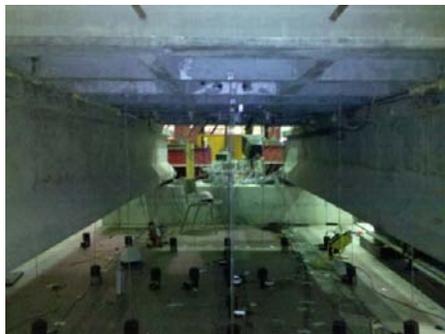
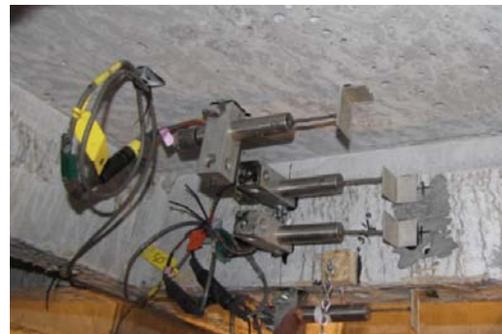
panels to measure average strains and neutral axis depth during loading (see Figure 10c). Also, the width of the flexural cracks along the transverse ribs was monitored during testing using LVDTs. A number of embedded strain gauges were used to measure the strain demands in the reinforcement along the transverse and longitudinal ribs of the panels and in the reinforcement placed within the joints. The No.6 ( $d_b = 0.75$  in., where  $d_b$  is diameter of the bar) dowel bars epoxied into the side face of the deck panels were also gauged to monitor the strain demands in these bars during testing. Figure 11 and Figure 12 show the locations of the strain gauges on the bottom and top deck reinforcement, respectively. During the test, the data from all gauges and displacement devices were recorded using a computer based data acquisition system.

b) String potentiometer configuration

c) LVDT attached to a transverse rib

**Figure 10** Schematic of the displacement transducers mounted to the test unit.

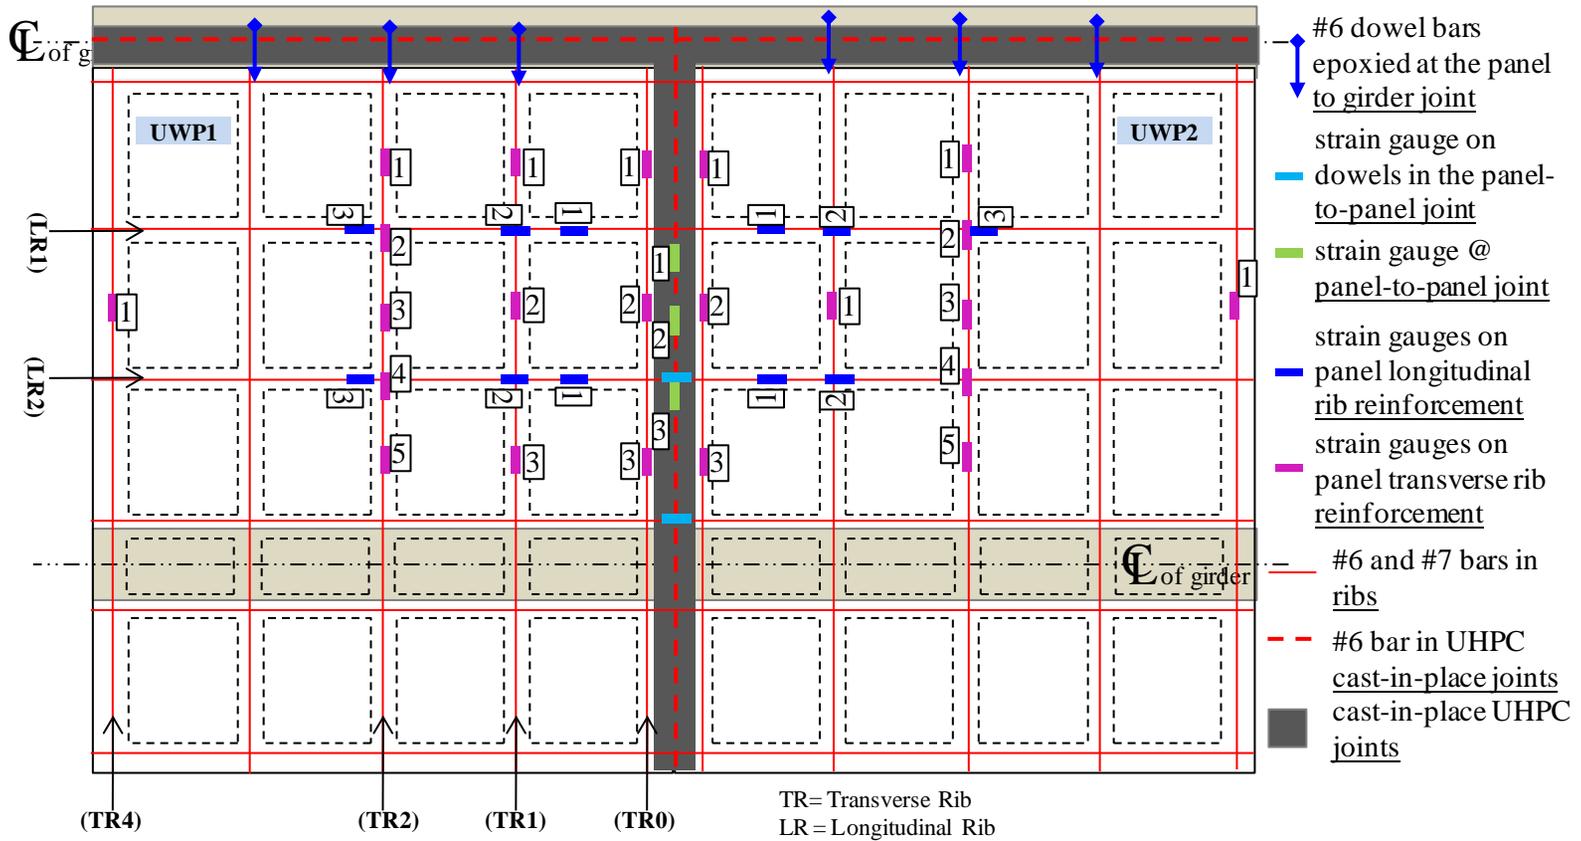
**Figure 11** Location of strain gauges used on the bottom deck reinforcing bars.

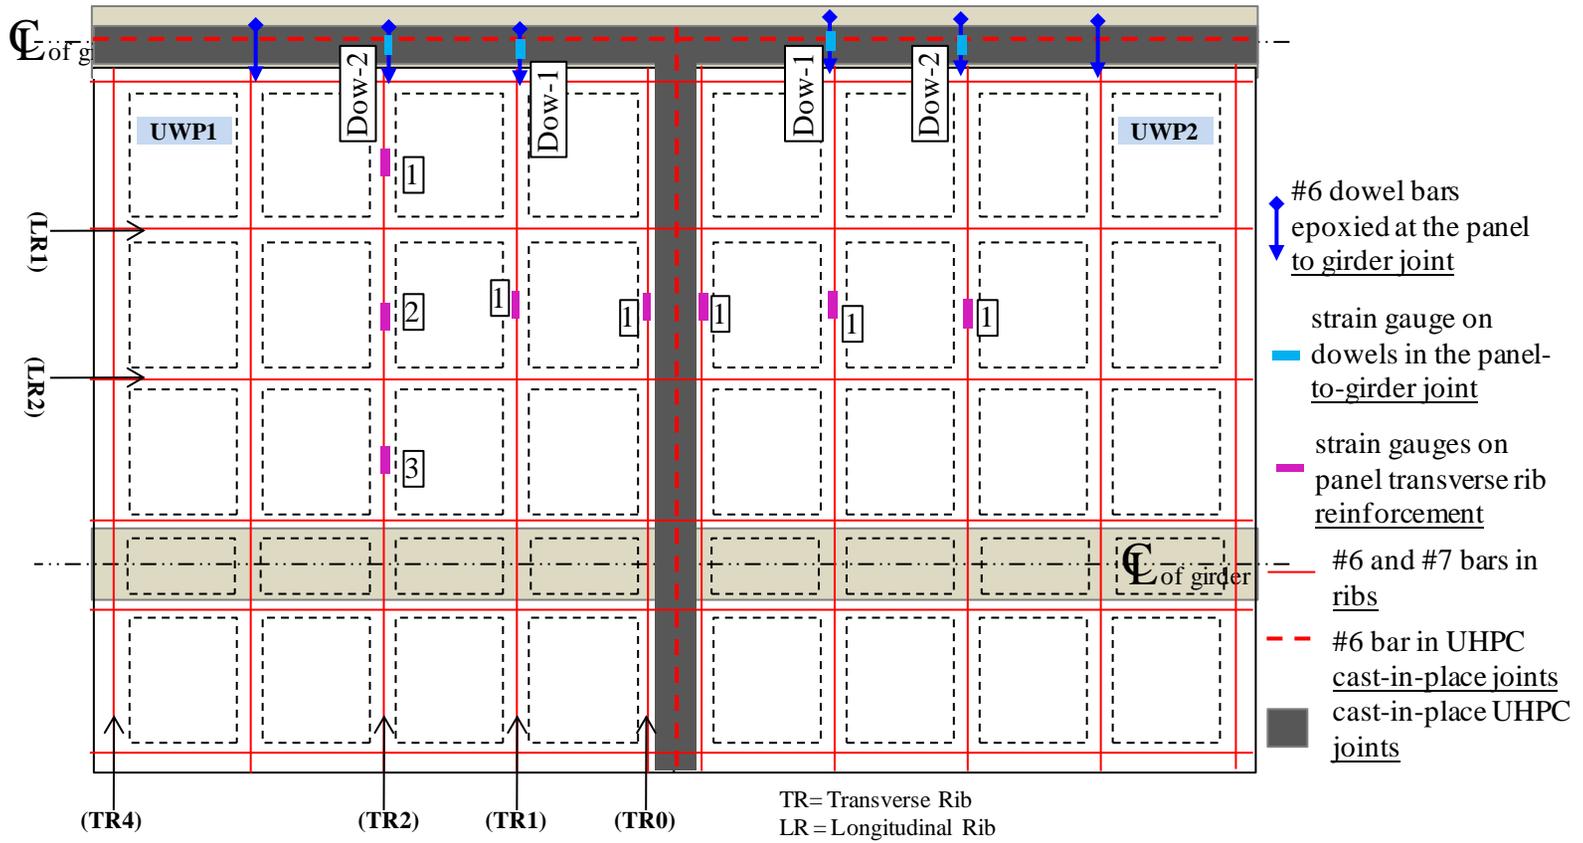
**Figure 12** Location of strain gauges on the top deck reinforcing bars and dowel bars.

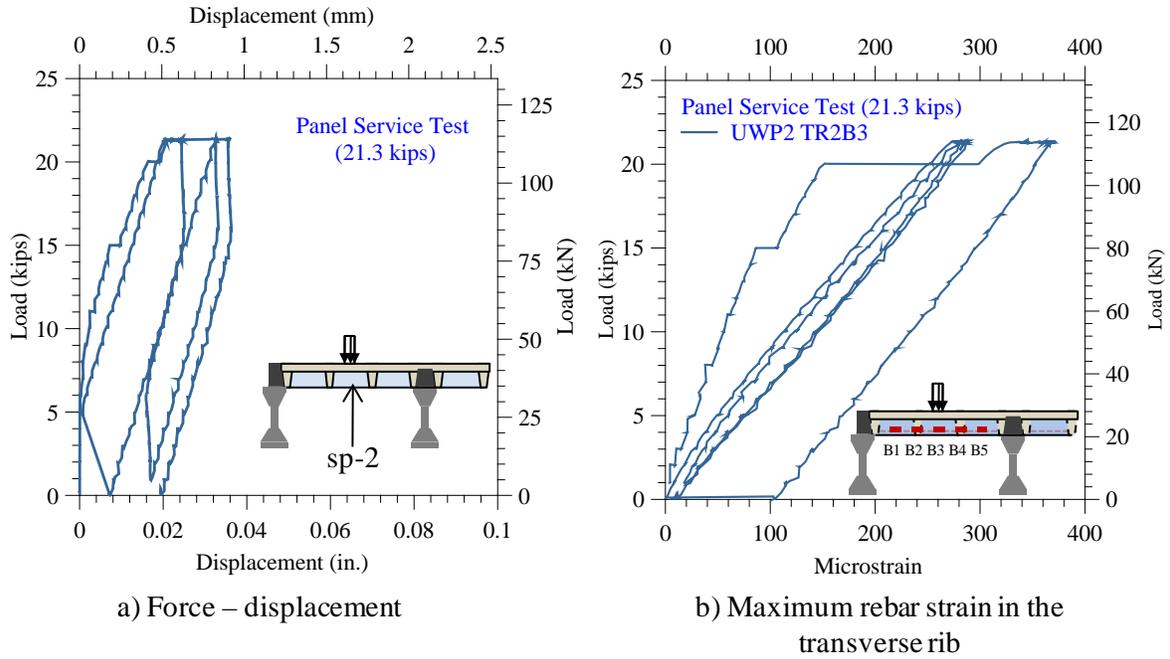
The peak recorded strain in the bottom reinforcement of the center rib running in the transverse direction is shown in Figure 13b, which reached a maximum strain of only  $375\mu\epsilon$  or 18% of the yield strain. The strain variations along the length of the bottom reinforcement in the transverse rib TR2 of panel UWP2 and the panel-to-panel joint are shown in Figure 14 and Figure 15, respectively. Strain in the joint reinforcement was  $40\mu\epsilon$ , indicating no damage to the joint region. A single crack having a width less than 0.002 in. was observed on the transverse rib under the load and is identified in Figure 16. In comparison to traditional normal concrete, it is important to realize that the material behavior of UHPC is quite dependent on the crack width. Hence, it may not be appropriate to use the AASHTO crack width provisions to qualify the serviceability and durability considerations for the behavior of UHPC structural members. Due to the lack of any specific UHPC bridge design serviceability criteria available in the literature, the crack width limits suggested for UHPC to control the fiber pullout criteria are used to comment on the implication of the crack developed in this test. Based on the AFGC 2002 recommendations, the fiber pull out and strength degradation in UHPC initiate when a crack width reaches a width of 0.0118 in. (0.3 mm) (see Figure 17). This limit is nearly more than 10 times the observed crack width during the service test, confirming that the overall behavior of the precast waffle deck system was outstanding. In addition, it is noted that the test results also confirmed that the system performance satisfied the deflection and crack width requirements recommended for the serviceability condition by AASHTO (AASHTO, 2007).

**Figure 13** Measured force-displacement response and peak rebar strain from gauge B3 at the center of the transverse rib TR2 of panel UWP2.

As noted earlier, a 10 in. x 20 in. plate represented the dimensions of a wheel, and a maximum load of 21.3 kips was applied at the center of panel UWP2 to simulate the service load condition. This load was established using the AASHTO service truck wheel load of 16 kips with a 1.33 factor to account for the 33% load increase suggested to account for the wheel load impact from the moving loads. The 3D finite element analysis of the test setup using ABAQUS confirmed the most critical location being one wheel at the center of the panel than placing two wheels at off-centered positions. To ensure no strength or stiffness degradation would take place due to repeated loading, the panel was subjected to three load cycles at this load level. The load-deflection curve established at the center of the panel for this test is shown in Figure 13a. For this test, a nearly linear relationship was observed between the load and deflection, with the maximum recorded deflection during the first cycle being 0.02 inches. This deflection corresponds to  $L/4400$  ( $L$  = the span length between the girder), which is significantly less than the specified AASHTO limit of  $L/800$  recommended for the serviceability condition (Section 9.5.2) of continuous span bridges with pedestrian traffic. The AASHTO allowable serviceability displacement of  $L/800$  would lead to 0.11 inches for the tested system.

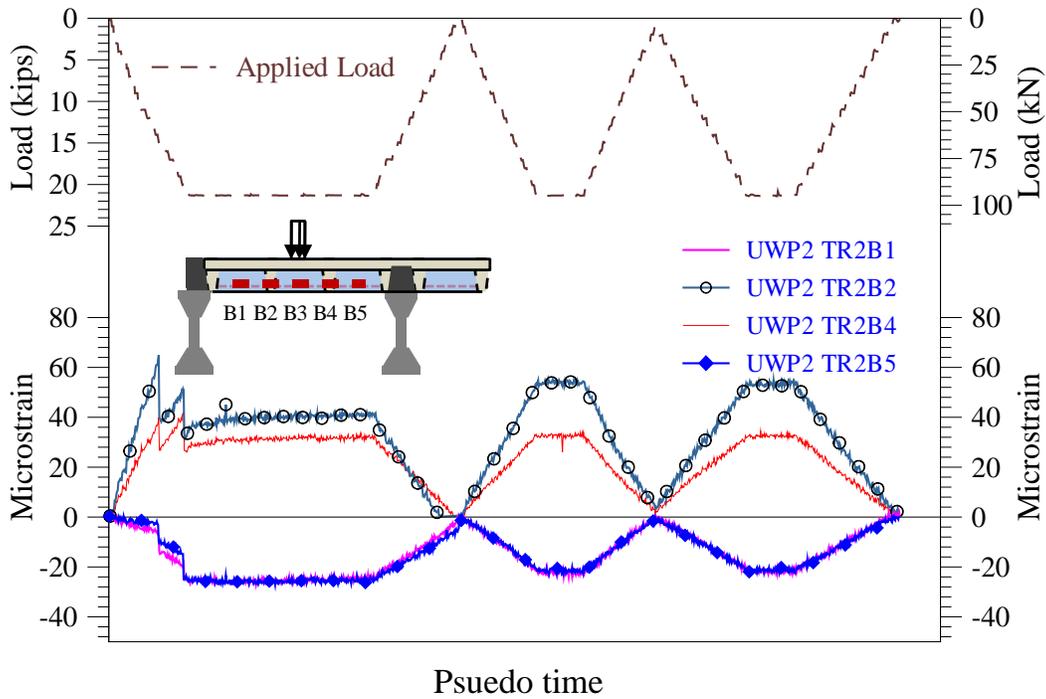
**Figure 14** Measured strains along the bottom reinforcement of the transverse rib TR2 of panel UWP2.

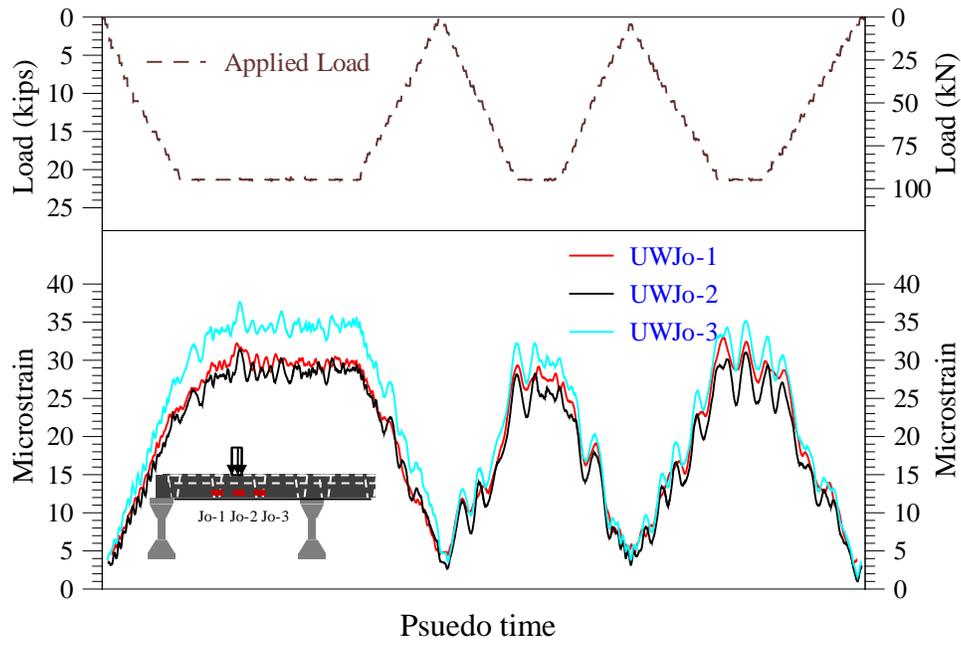
**Figure 15** Measured strains along a bottom reinforcement of the panel-to-panel joint.

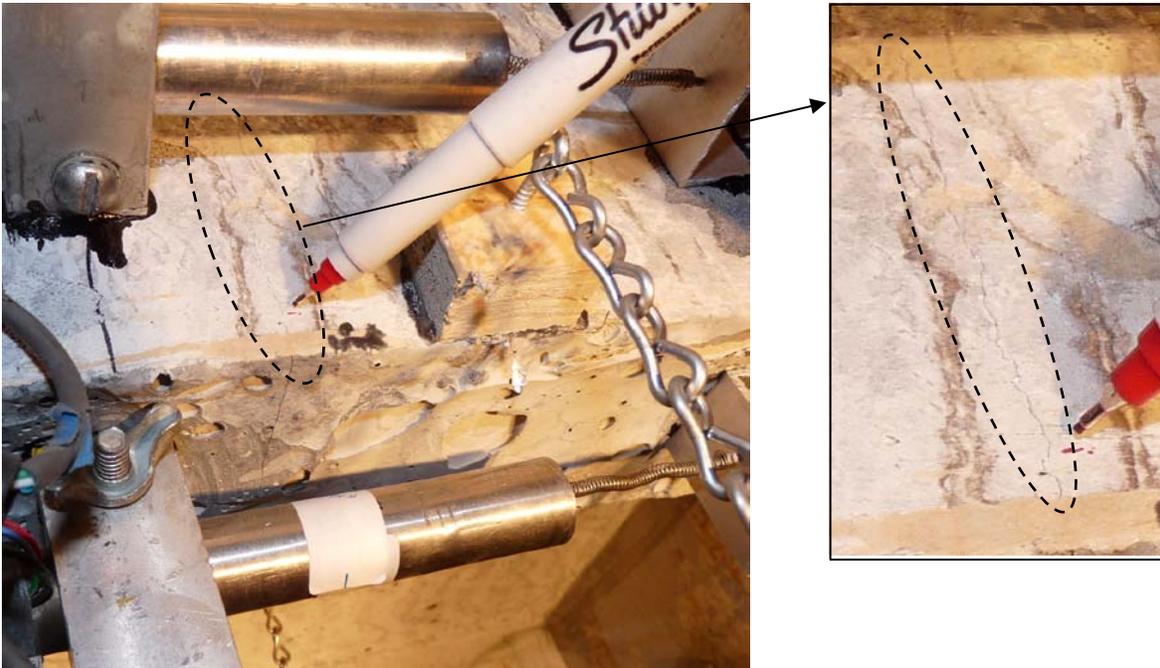
**Figure 16** A hairline crack in the UWP2 panel transverse rib TR2 at 21.3 kips.

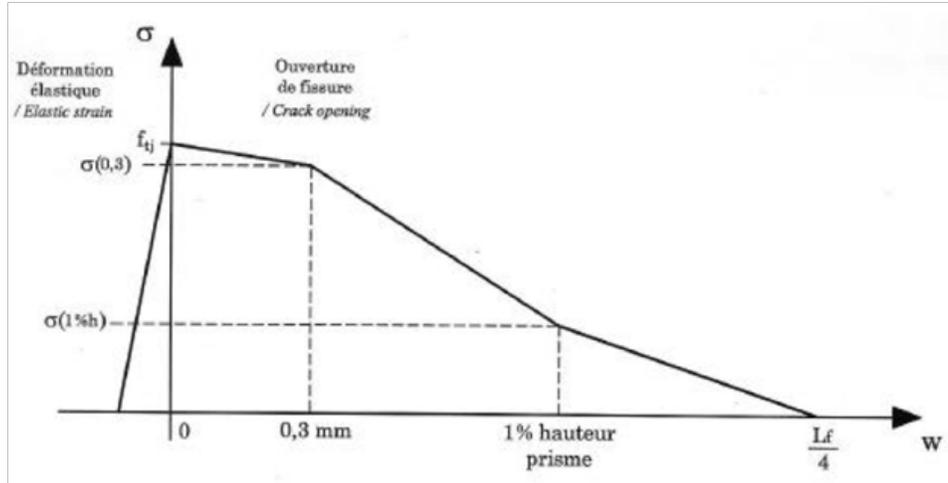
**Figure 17** A relationship proposed for the UHPC tensile strength variation as a function of crack width (AFGC 2002).

joint (see Figure 23). Given that this crack is significantly smaller than 0.0118 in. (0.3 mm) (see Figure 17) corresponding to initiation of fiber pull out and strength degradation of UHPC in tension, it is concluded that the overall behavior of the transverse joint subjected to service load was outstanding. The test results also indicated that the system performance satisfied the deflection and crack width requirements recommended for the serviceability condition by AASHTO (AASHTO, 2007).
