# **THE IMPLEMENTATION OF FULL DEPTH UHPC WAFFLE BRIDGE DECK PANELS**

## **PHASE 1 FINAL REPORT**

Sponsored by  
**Highways for LIFE**  
**Technology Partnerships Program**

Prepared by  
**CORESLAB STRUCTURES (OMAHA) INC.**  
802 Allied Rd. Bellevue, Nebraska 68123  
[www.coreslab.com](http://www.coreslab.com)

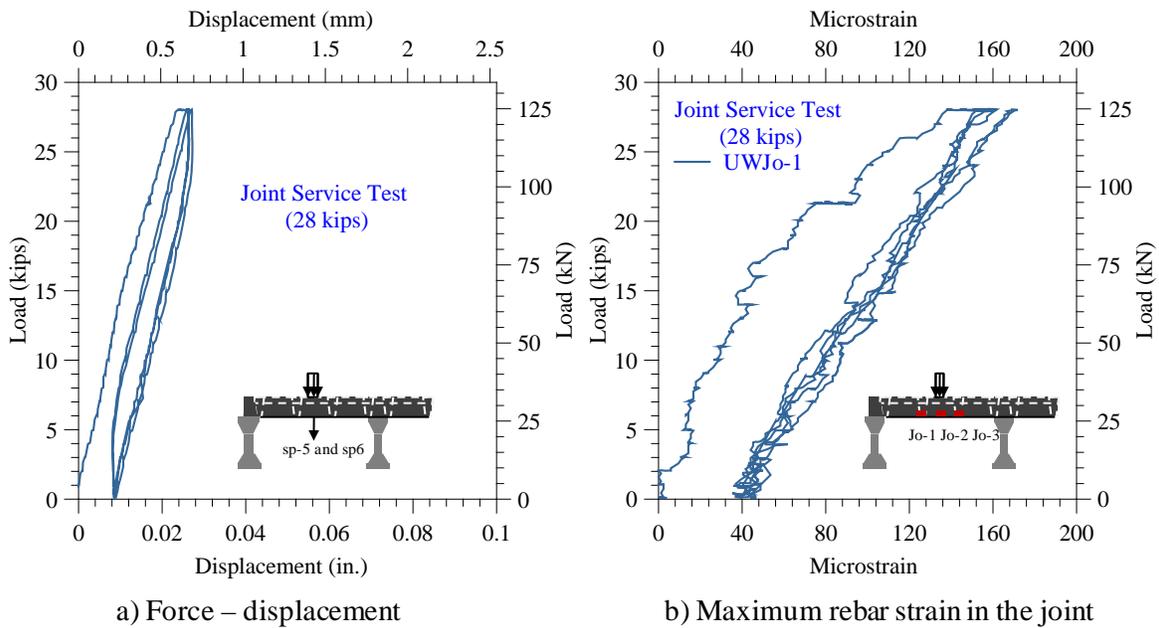
**Figure 18** Measured force-displacement response and peak rebar strain at the center of the joint at the service load.

Similar to the panel service load test, the transverse panel-to-panel joint test was then conducted under the service loading condition. In this case, the maximum load of 28 kips was used, which represented the AASHTO service load of 16 kips for one wheel times 1.75 factor, which accounted for 75% increase in load to account for the wheel load impact on joints due to moving loads. Similar to the previous service load test, the critical location of the load was determined from the finite element analysis and the load was repeated three times to ensure the stability of the force-displacement response of the system. The applied load vs. the measured deflection at the center of the joint is shown in Figure 18a. Again, a linear response was obtained with a maximum deflection reaching only 0.022 in. during the first load cycle. This deflection corresponds to  $L/4000$ , which is 20% of the specified AASHTO limit of  $L/800$  (Section 9.5.2 in AASHTO (2007) for continuous spans with pedestrian traffic under the serviceability condition.

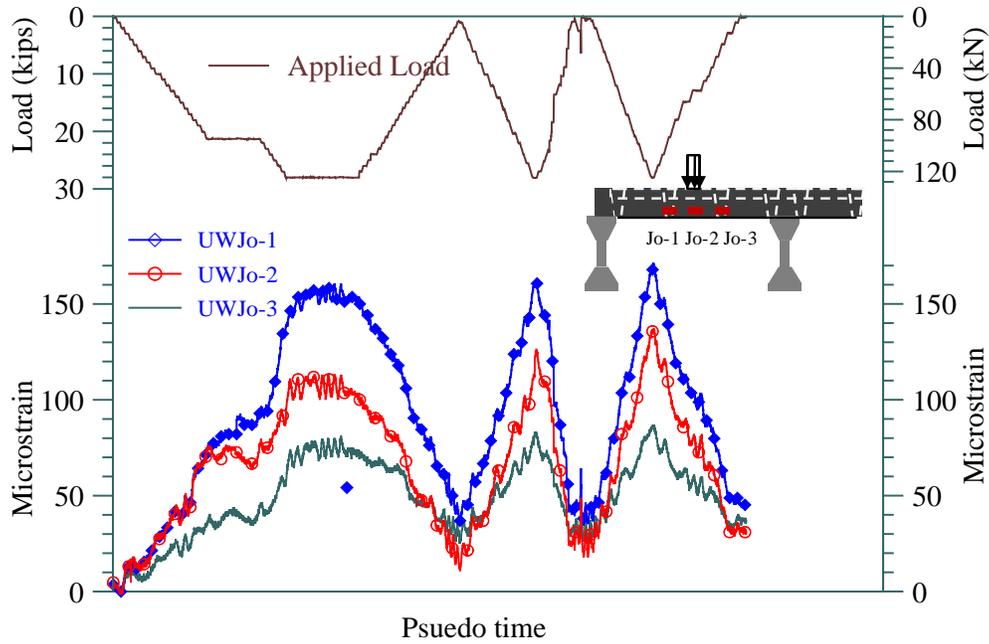
**Figure 19** Measured strains along the bottom reinforcement of the joint during the service load test.

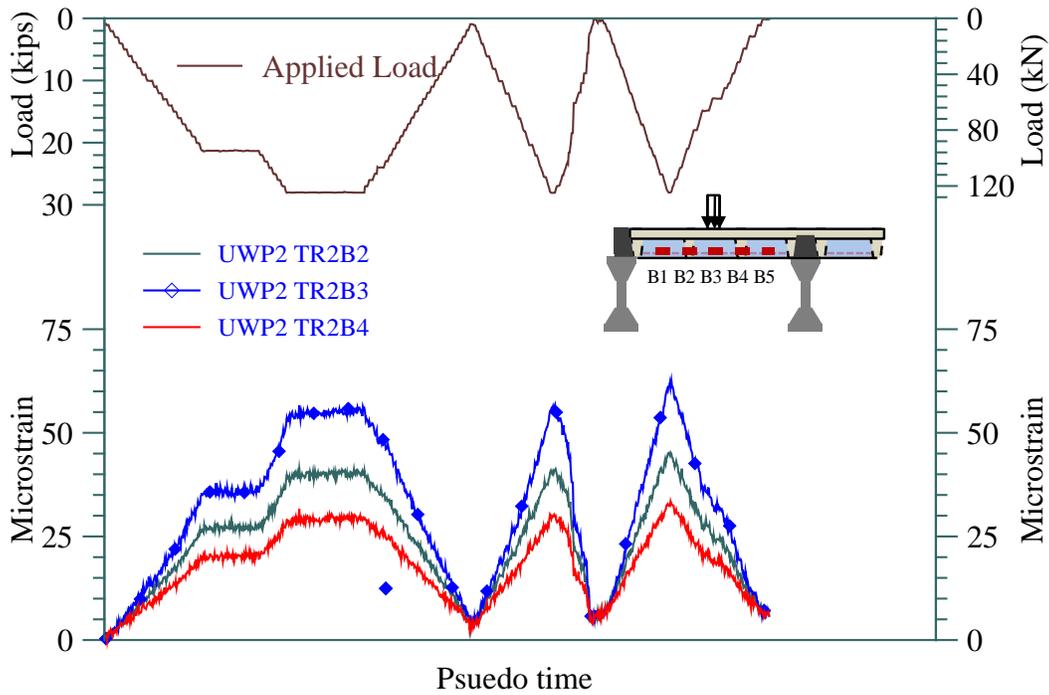
**Figure 20** Measured strains in the bottom reinforcement of the transverse rib (TR2) along the length of panel UWP2 at service load.

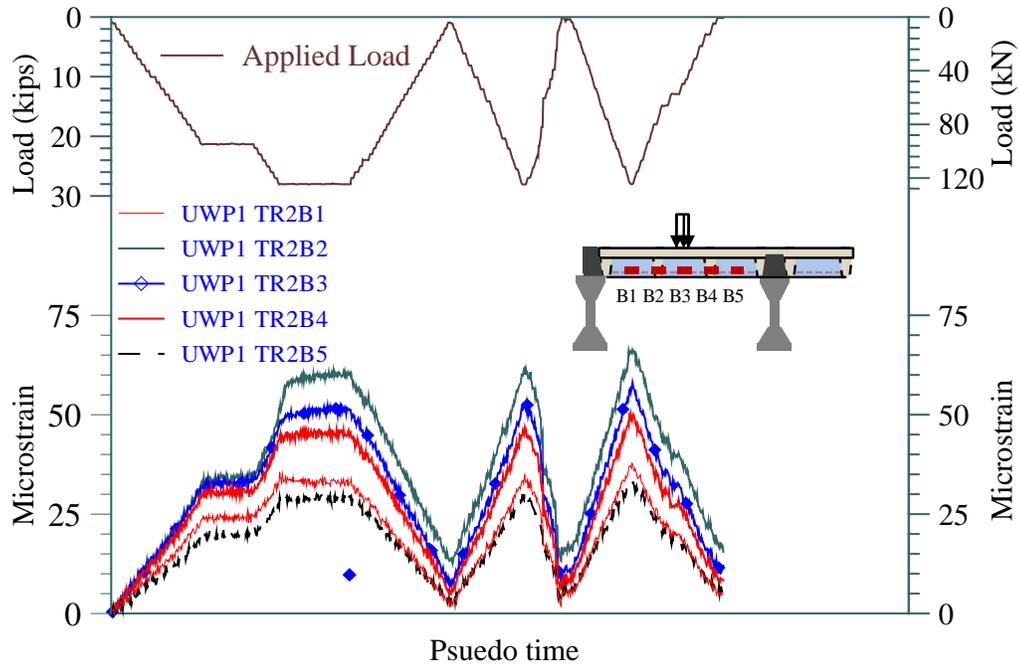
**Figure 21** Measured strains in the bottom reinforcement of the transverse rib (TR2) along the length of panel UWP1 at service load.

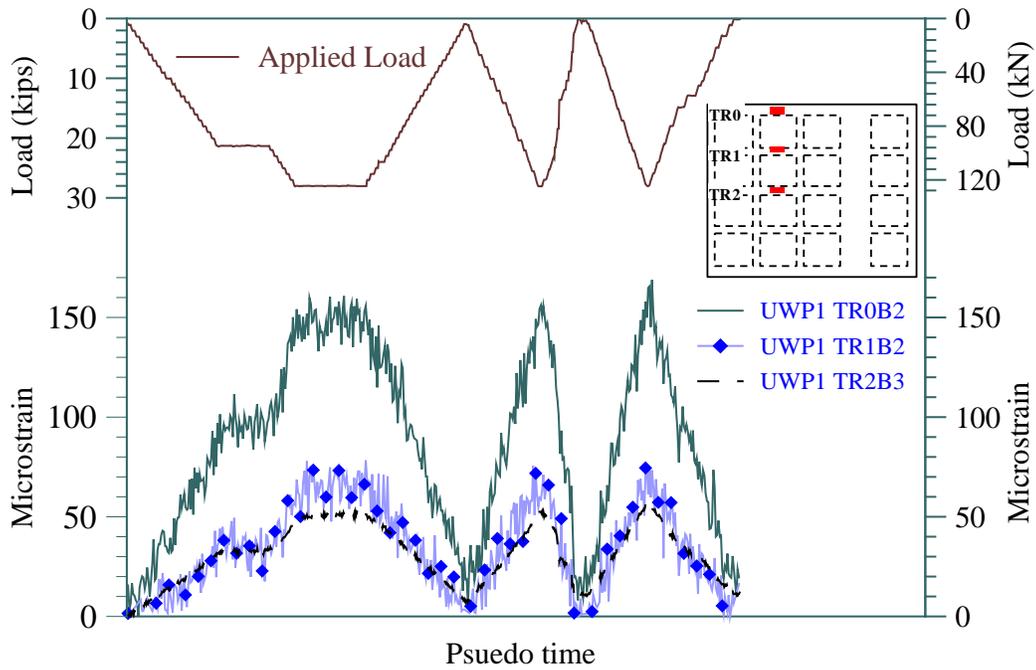
**Figure 22** Measured strains at the center of the panel across the transverse ribs of UWP1 at service load.

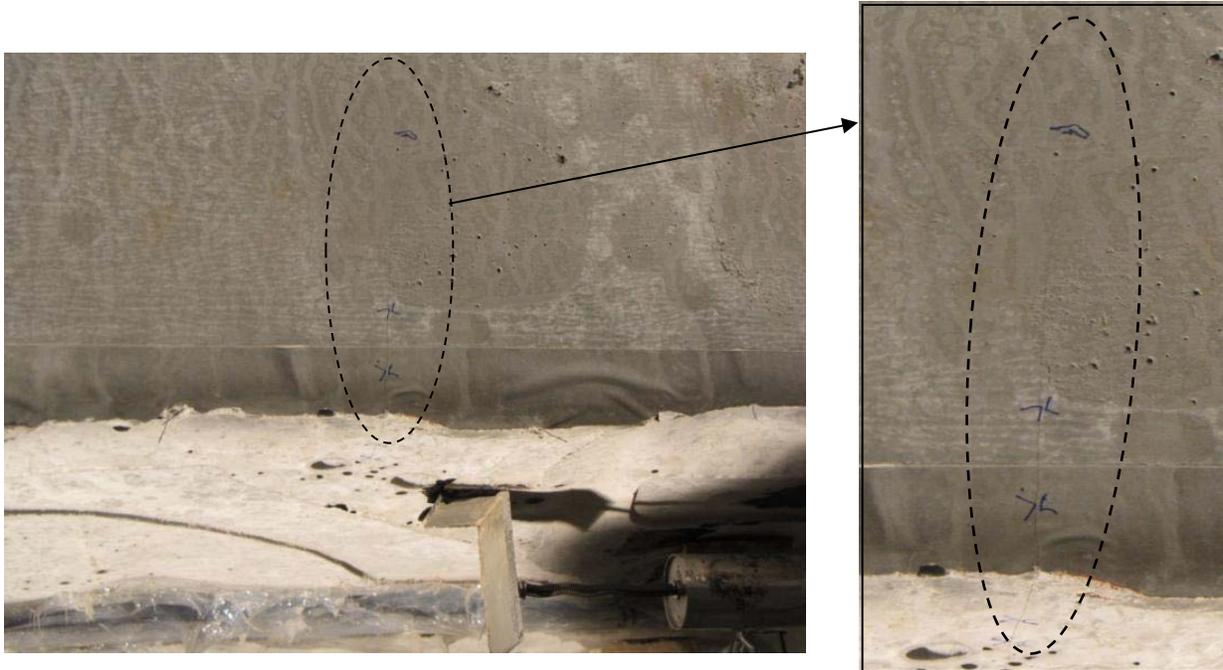
joint (see Figure 23). Given that this crack is significantly smaller than 0.0118 in. (0.3 mm) (see Figure 17) corresponding to initiation of fiber pull out and strength degradation of UHPC in tension, it is concluded that the overall behavior of the transverse joint subjected to service load was outstanding. The test results also indicated that the system performance satisfied the deflection and crack width requirements recommended for the serviceability condition by AASHTO (AASHTO, 2007).

**Figure 23** A hairline crack formed at the center of underside of the transverse joint at 28 kips.

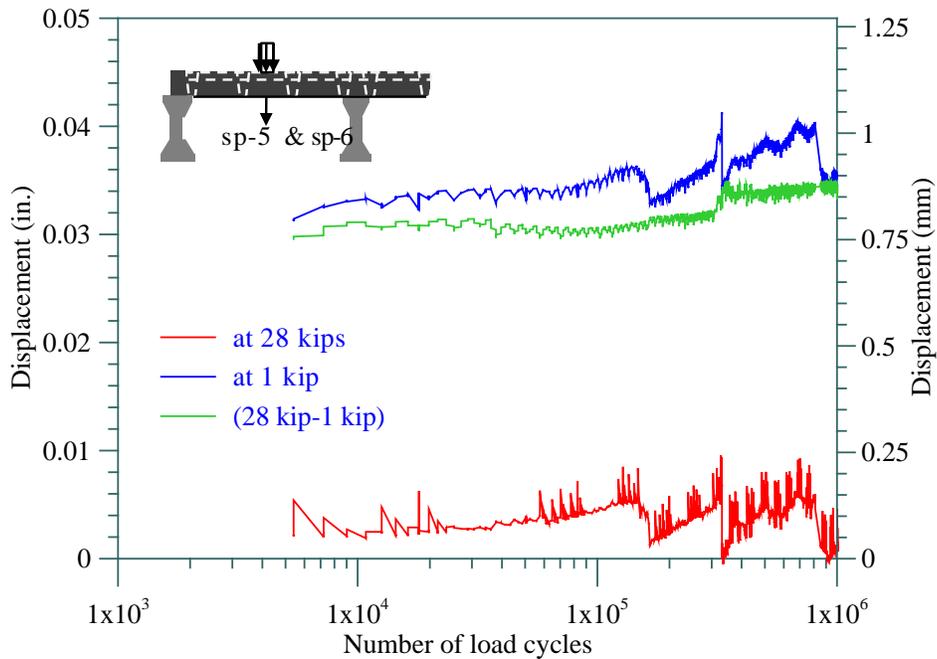
throughout the test and the change in the displacement reading is largely due to noise observed at 1 kip. With the variation of the displacement being very small and limitations with the sensitivity of the string potentiometers, it is concluded that the UHPC did not experience any fatigue damage.

**Figure 24** The variation of the peak displacement at the center of the joint during the joint fatigue test.

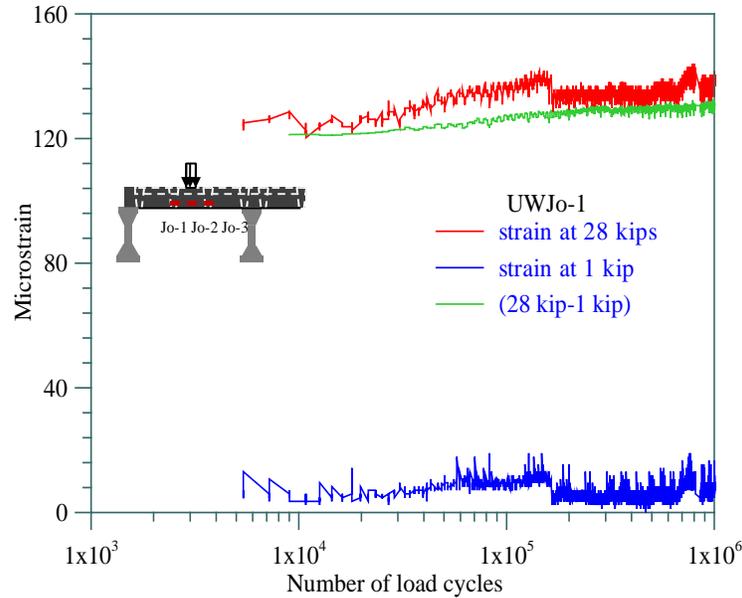
Figure 25 shows the strains recorded by the gauge mounted to the joint transverse reinforcement located at the center of the joint as a function of the load cycle. Although the drifts in measured data are apparent, the change in strain remained almost constant at a value of  $135 \mu\epsilon$  as the load increased from 1 to 28 kips. This variation is comparable to the peak strain of  $170 \mu\epsilon$  recorded during the service load test. Except for the noise in the data, the crack width in the transverse joint was nearly constant over the entire fatigue test and is shown in Figure 26.

**Figure 25** The variation of the peak strain in the bottom joint transverse reinforcement during the joint fatigue test.

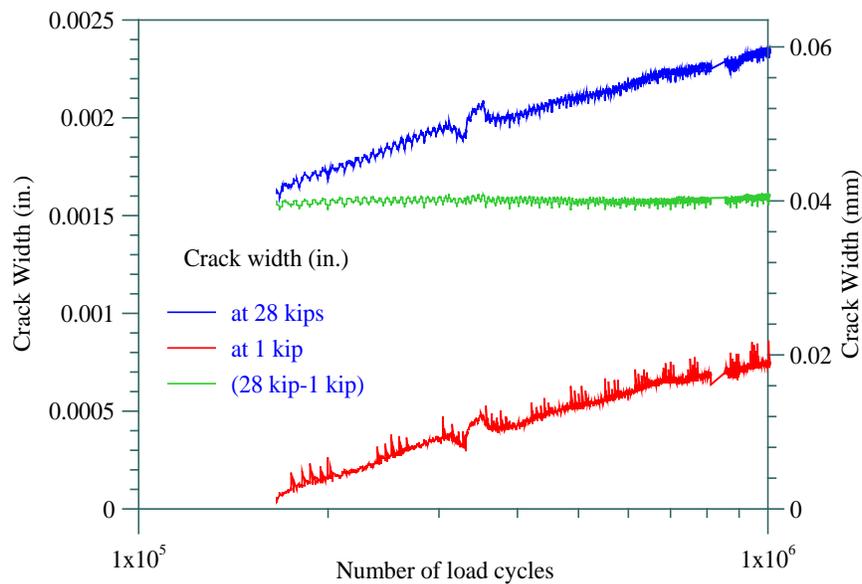
**Figure 26** The variation of the crack width in the transverse joint with number of load cycles.

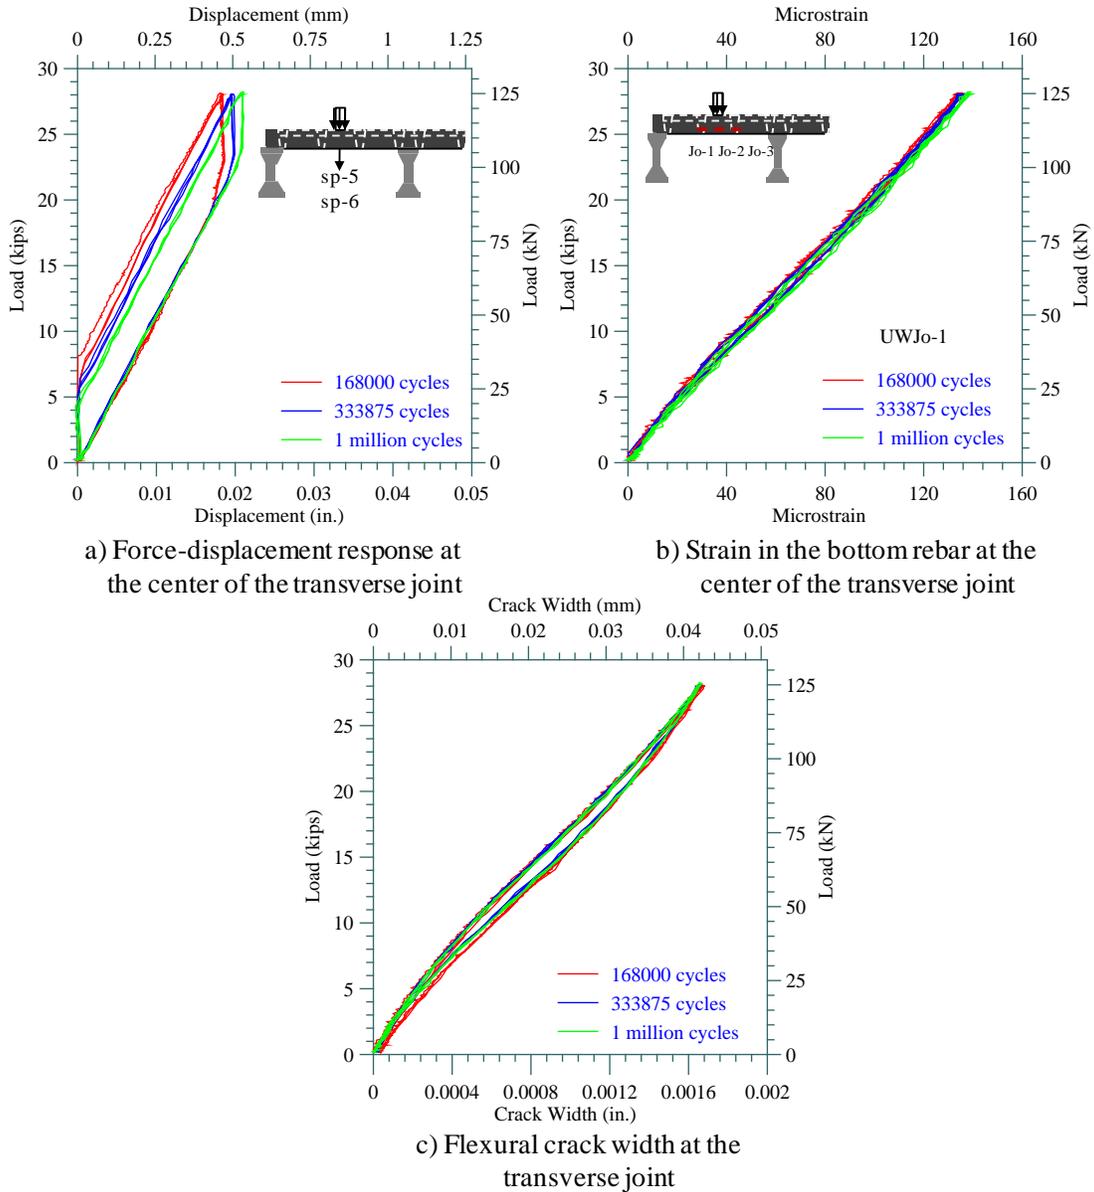
3%. It can be seen from these figures that the joint or the UHPC waffle deck system did not experience any significant fatigue damage after subjected to one million cycles of amplified serviced load.

**Figure 27** Measured responses of the waffle deck system from the static service load tests conducted during the joint fatigue test.

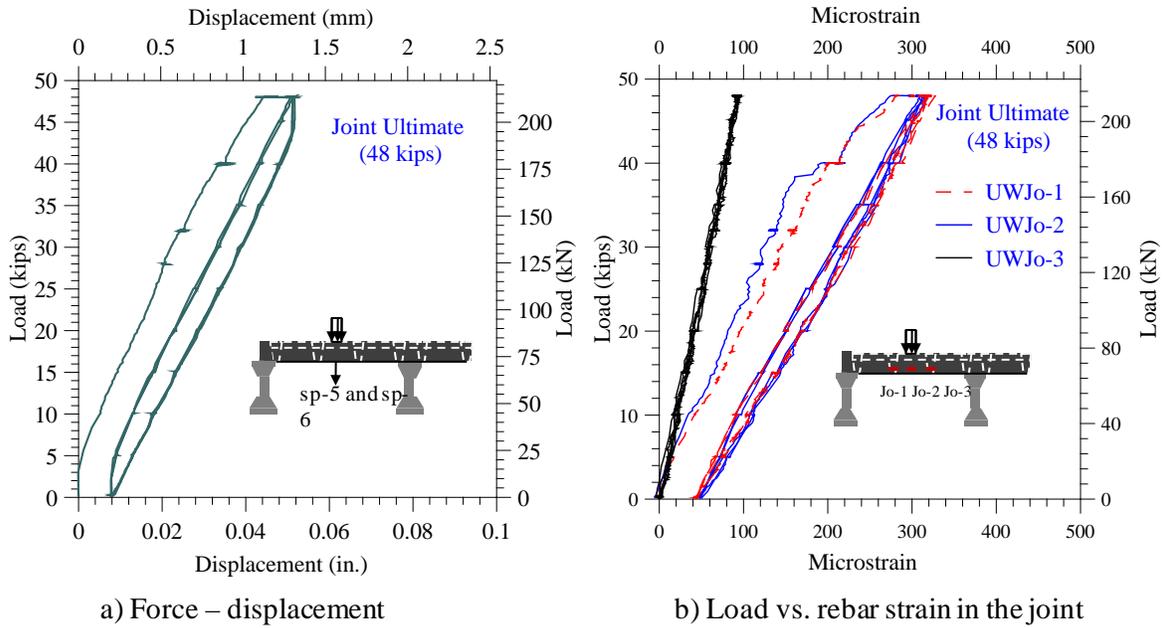
The strain variations along the bottom reinforcement in the joint as a function of the applied load are shown in Figure 28b. The peak strain in the joint region bottom reinforcement was  $330 \mu\epsilon$ , which is only about 15% of the yield strain of the reinforcement. The strain variations in the bottom reinforcement in the transverse rib TR2 of the panels UWP2 and UWP1 are shown in Figure 29 and Figure 30, respectively. Figure 31 shows the variation of the strain at the center of the rib across the transverse ribs of panel UWP1, indicating their relative participation in resisting the load. A series of hairline cracks were observed in the central region of the joint and are shown in Figure 32. The maximum crack width measured along the transverse ribs forming the joint was 0.003 inches, which can be seen in Figure 33.

**Figure 28** Measured force-displacement response and peak rebar strain at the center of the joint at the ultimate load of 48 kips.

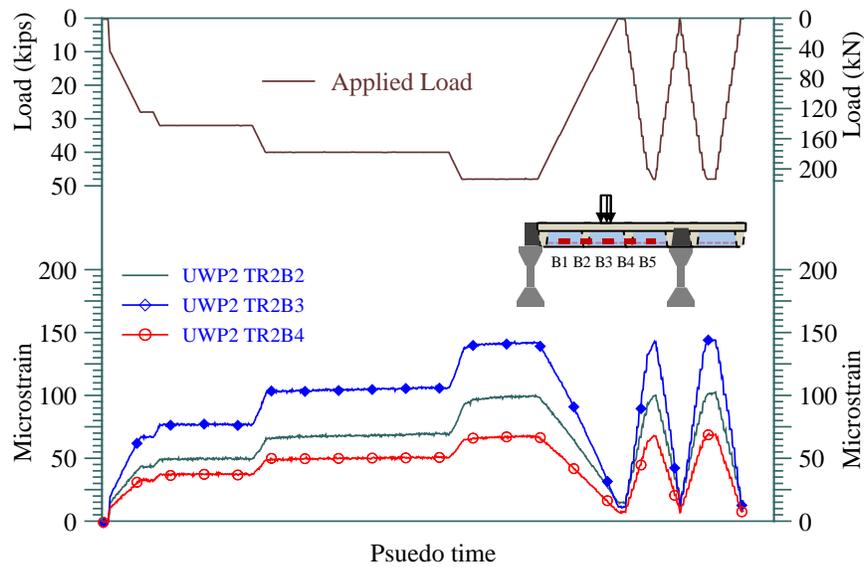
**Figure 29** Measured strains in the bottom reinforcement of transverse rib TR2 along the length of Panel UWP2 at the ultimate load.

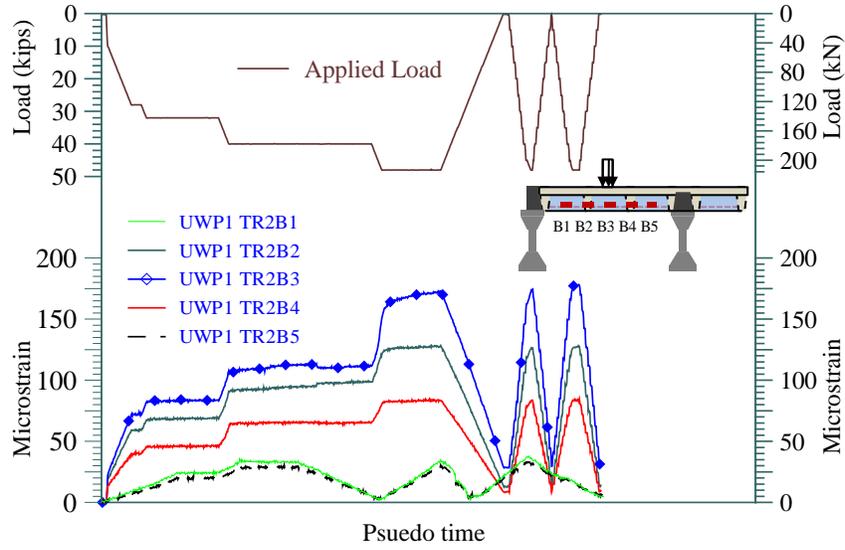
**Figure 30** Measured strains in the bottom reinforcement of transverse rib TR2 along the length of Panel UWP1 at the ultimate load.

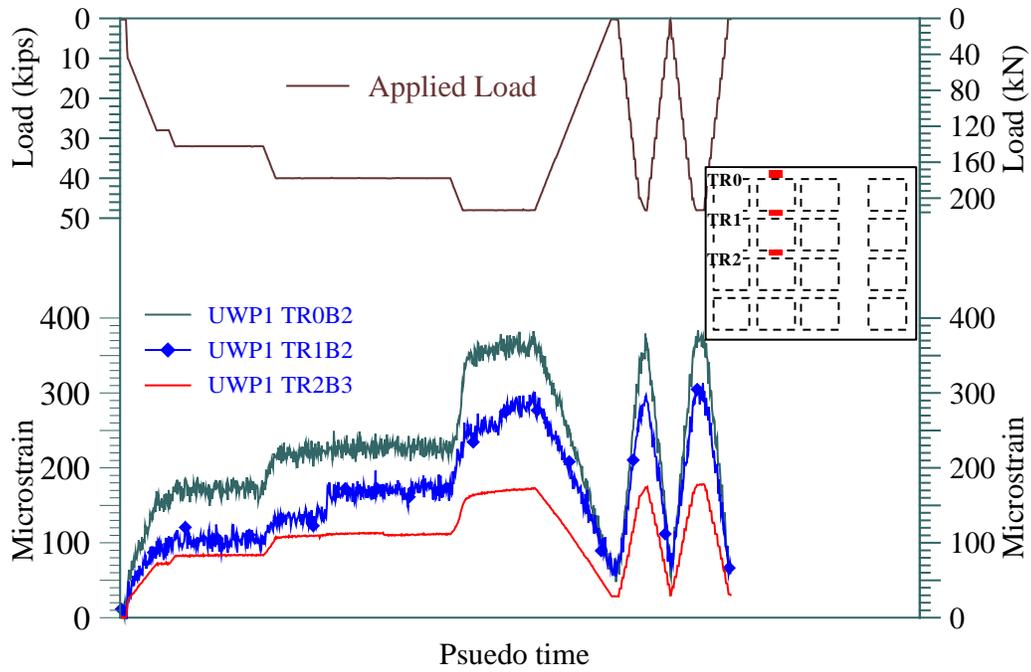
**Figure 31** Measured strains at the center of the panel across the transverse ribs of panel UWP1 at joint ultimate load.

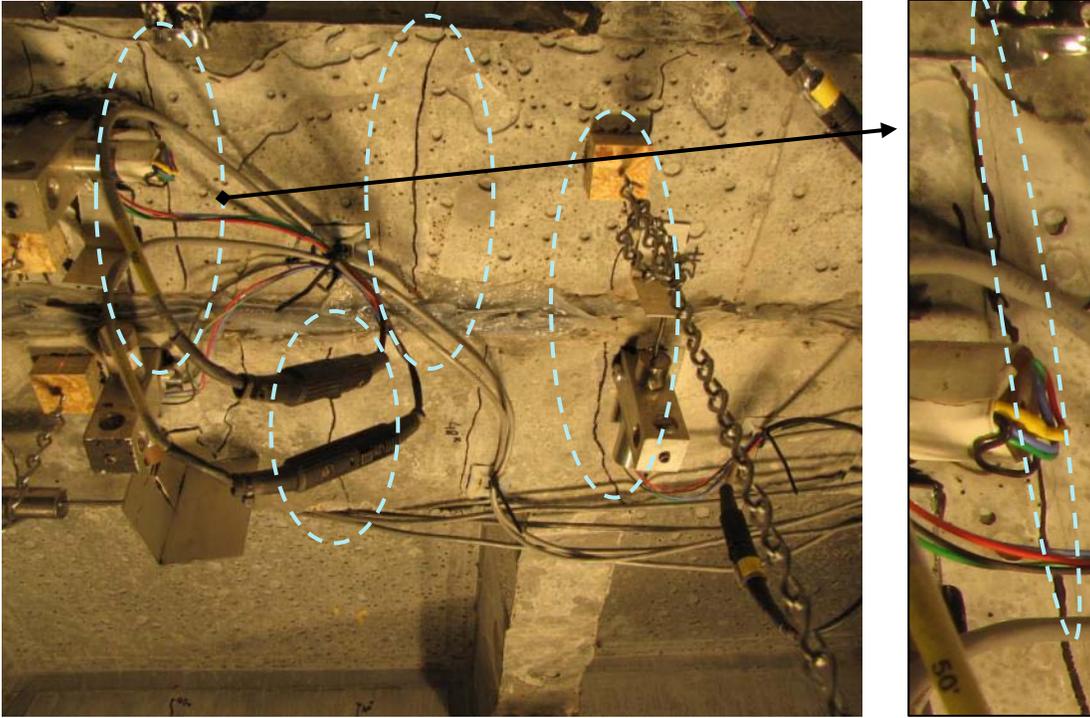
**Figure 32** Hairline cracks formed at the center of underside of the transverse joint at the ultimate load of 48 kips.

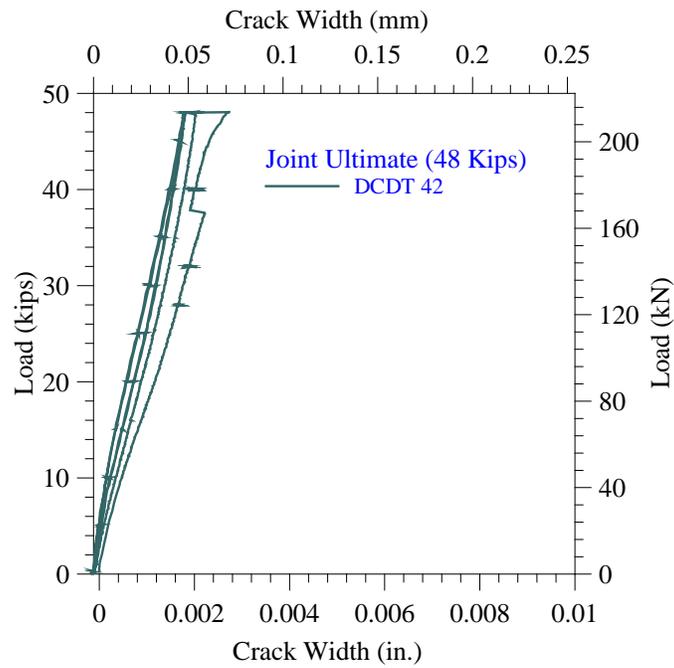
**Figure 33** The variation in the width of the most critical crack in the ribs forming the transverse joint.

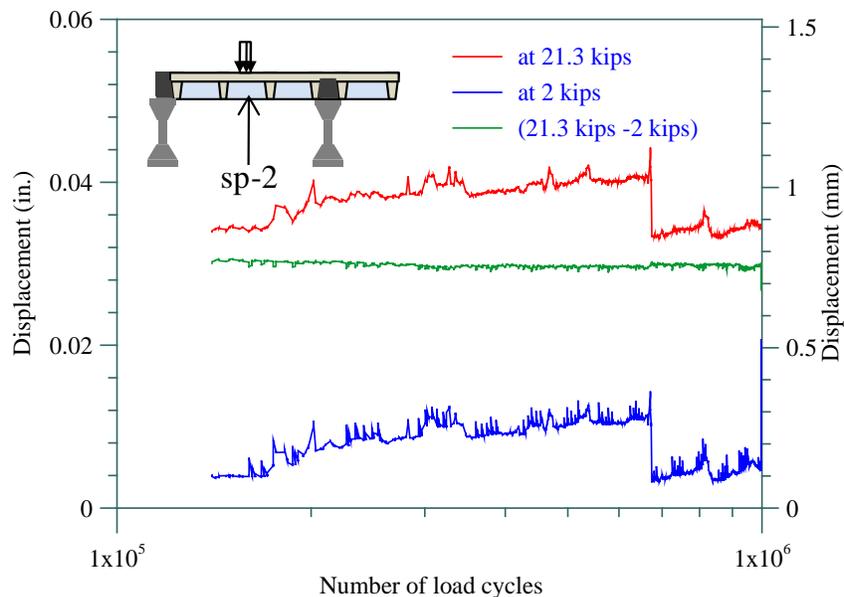
Based on the recorded data, the displacements recorded at the center of the panel UWP1 at 21.3 kips and 2 kips are plotted as a function of the load cycle during in Figure 34. It is apparent that the gauges experienced drifts due to ambient variations and that the data was influenced by high frequency noise. However, when the displacement corresponding to the load increment of 19.3 kips (i.e., 21.3 kips – 2 kips) was examined, it is clear that this displacement remained nearly constant throughout the test. Based on these observations, it is concluded that the UHPC panel did not experience any fatigue damage.

**Figure 34** The peak displacement variation at the center of Panel UWP1 during the joint fatigue test.

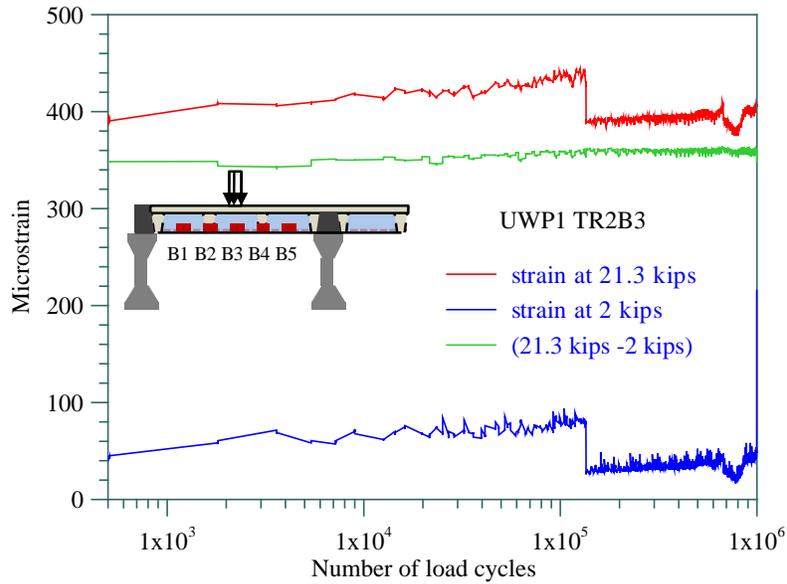
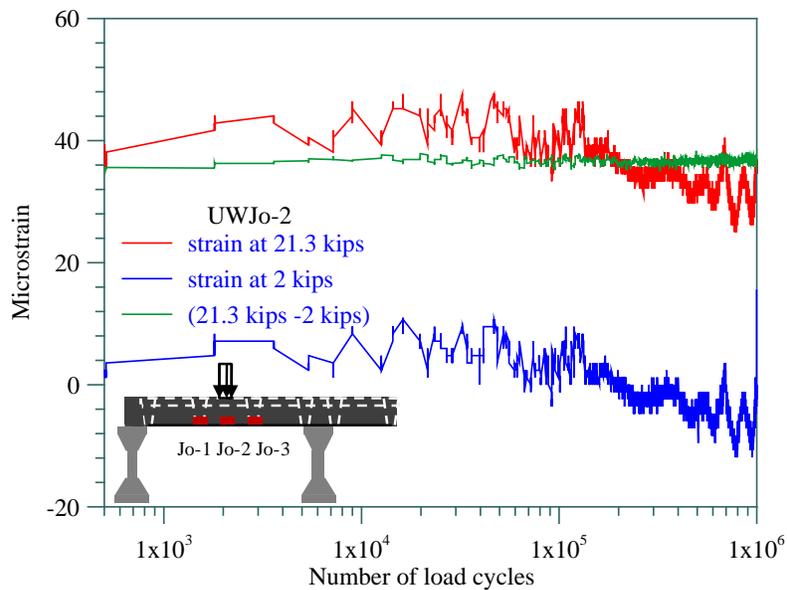
at a value of  $360\mu\epsilon$  as the load increased from 2 to 21.3 kips. This variation is comparable to a strain of  $375\mu\epsilon$  recorded during the service load test of panel UWP2. Figure 35b shows the strains recorded by the gauge mounted to the joint transverse reinforcement located at the center of the joint as a function of the load cycle.

a) Peak rebar strain in the transverse rib

b) Peak rebar strain in the joint

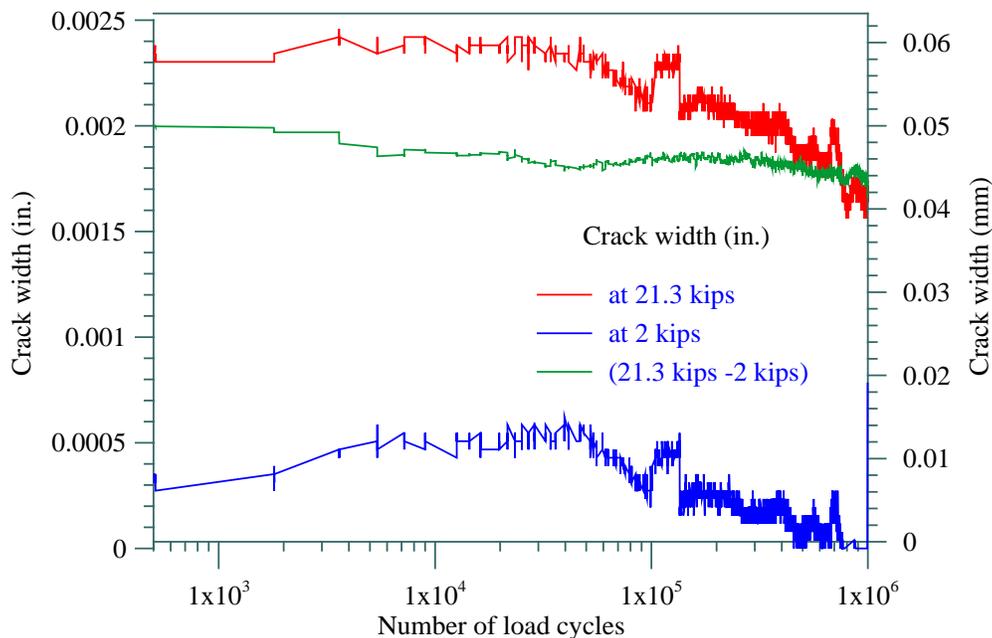
During the fatigue test, no additional cracking in the panel was observed besides those formed during the service load test. The crack width at the bottom of the transverse rib was nearly constant over the entire fatigue test and is shown in Figure 36. This data varied between 0.0018 in. and 0.0023 in. or within a range of 0.0005 inches, which is close to the sensitivity of the LVDTs used to measure the crack width. For the static load tests performed at the end of 135000, 670000 and 1 million cycles, the load-displacement, peak strain in the bottom reinforcement in the transverse joint, and the crack width in transverse rib TR2 of panel UWP1 during the intermediate static load tests are presented in Figure 37. The initial stiffness of the panel at the end of 135000, 670000 and 1 million cycles of loading was 667.71 kip/in., 637.72 kip/in., and 653.34 kip/in., respectively. These values compare closely with each other and show variations within 5%. From these observations and Figure 37, it is clear that the joint or the UHPC waffle deck system did not experience any significant fatigue damage even after subjected to one million cycles at an amplified level of the service load.

**Figure 36** The crack width variation in transverse rib TR2 of panel UWP1 during panel fatigue test

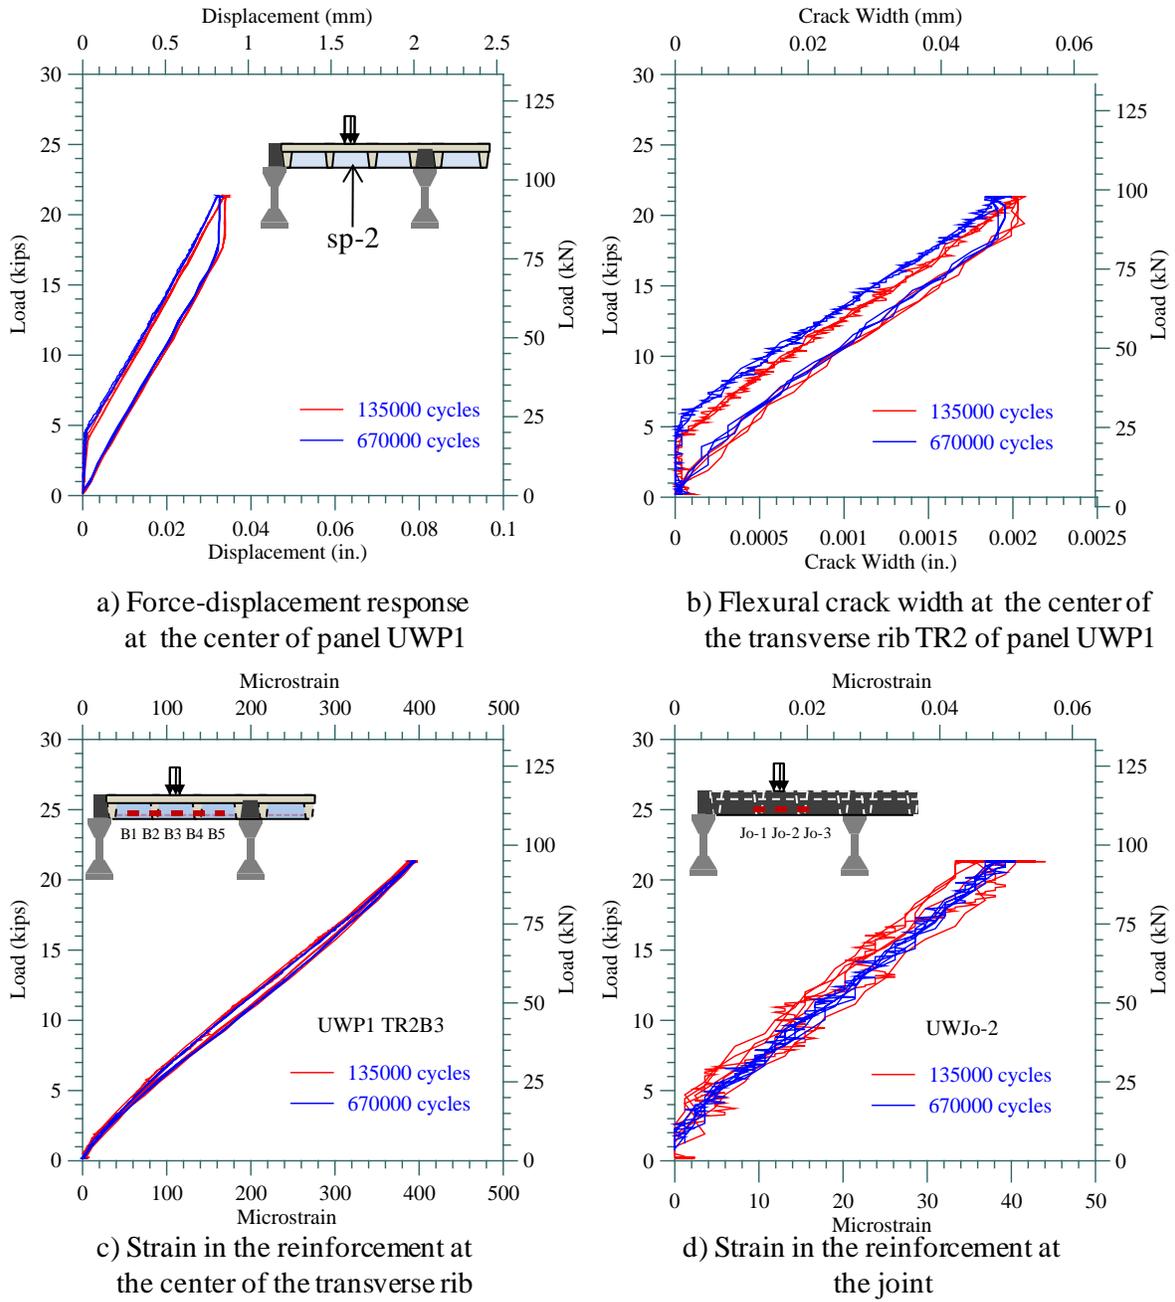
**Figure 37** Measured responses of the waffle deck system for static service load tests conducted during the panel fatigue test.

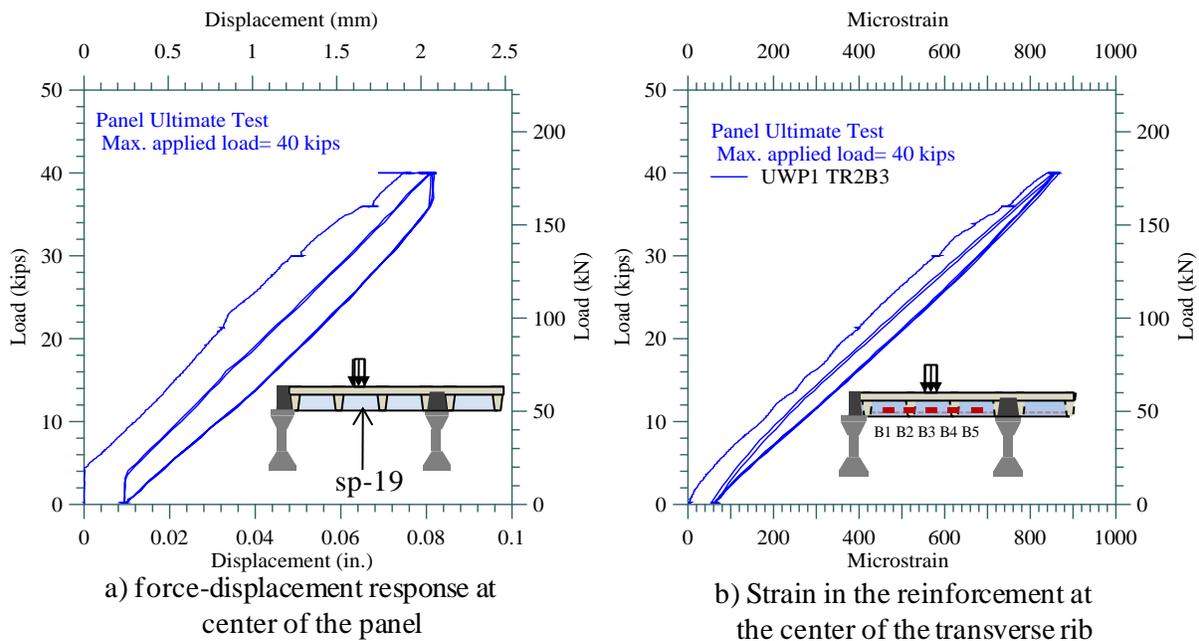
Similar to the previous service load tests, three load cycles at this load level were conducted to ensure the stability of the force-displacement response of the system. The load-deflection curve established at the center of panel UWP1 for this test is shown in Figure 38a. The panel exhibited a linear force-displacement behavior response with insignificant damage. A maximum deflection of 0.08 in. was measured at the center of panel UWP1. This deflection corresponds to  $L/1100$ , which is 73% of the AASHTO specified serviceability limit of  $L/800$  for continuous spans with pedestrian traffic.

**Figure 38** Measured force-displacement response and peak rebar strain at the center of the transverse rib of UWP1 at the ultimate load of 40 kips.

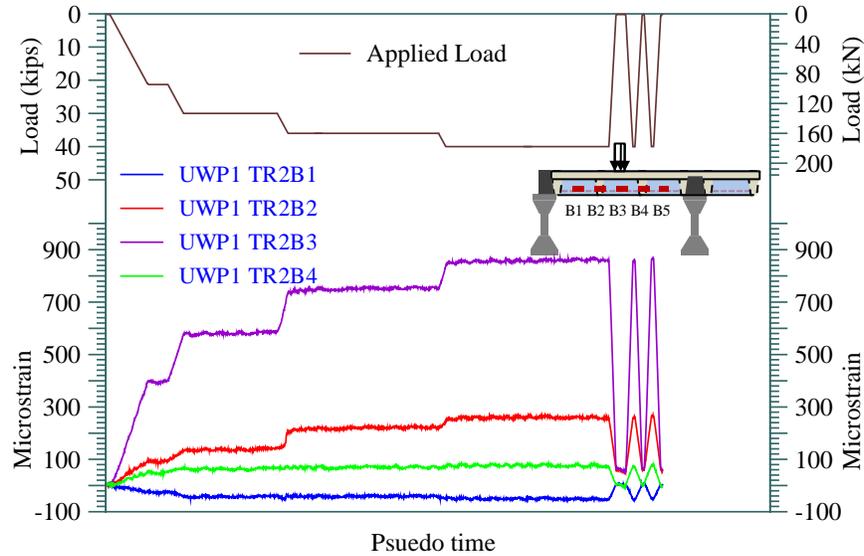
**Figure 39** Measured strains in the bottom reinforcement of the transverse rib along the length of UWP1 at during the ultimate load test.

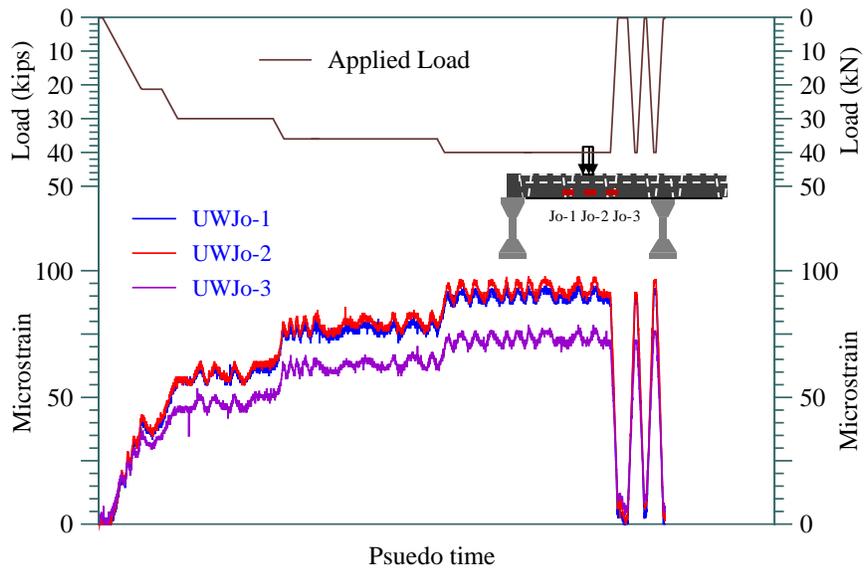
**Figure 40** Measured strains in the bottom reinforcement of the joint along the joint length during the ultimate load test.

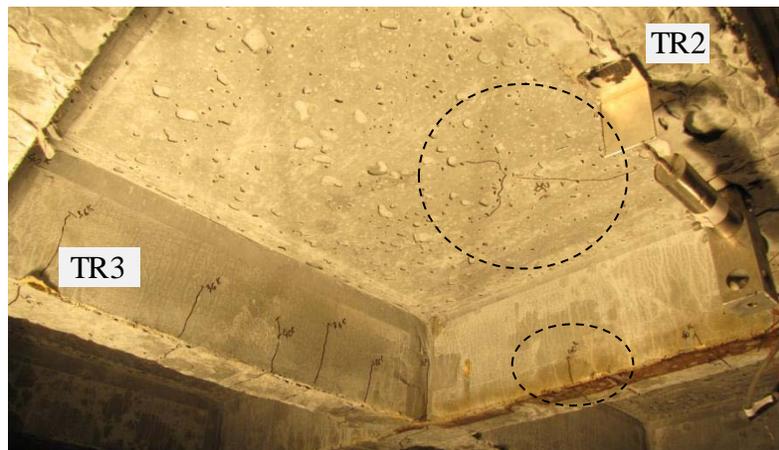
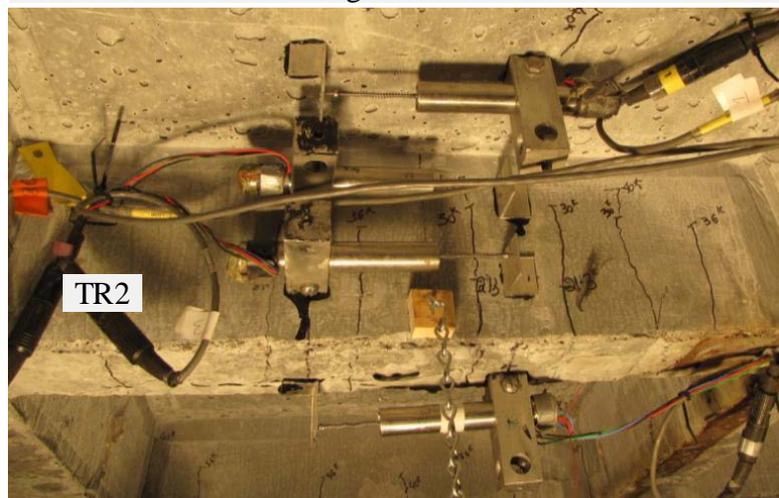
respectively. Three to four hairline cracks were observed on both transverse ribs (TR1, TR2 and TR3) and longitudinal ribs (LR1 and LR2) of panel UWP1 (see Figure 41). A hairline crack was seen on the bottom surface of UWP1 (between ribs TR2 and TR3) at the peak load (see Figure 41a). The maximum crack width measured along the transverse rib TR2 in UWP1 was 0.008 inches and its variation with the applied load is shown in Figure 42. Figure 43 shows the strain demand on the dowel bar in the panel-to-girder joint during the panel ultimate load test. It is clear that the dowel bars were engaged in load transfer when 35 kips load was applied at the center of the panel.

a) Cracking on the bottom surface of the slab and on a longitudinal rib

b) Cracking along transverse rib TR2 of UWP1

**Figure 41** Hairline cracks developed on panel UWP1 at an ultimate load of 40 kips

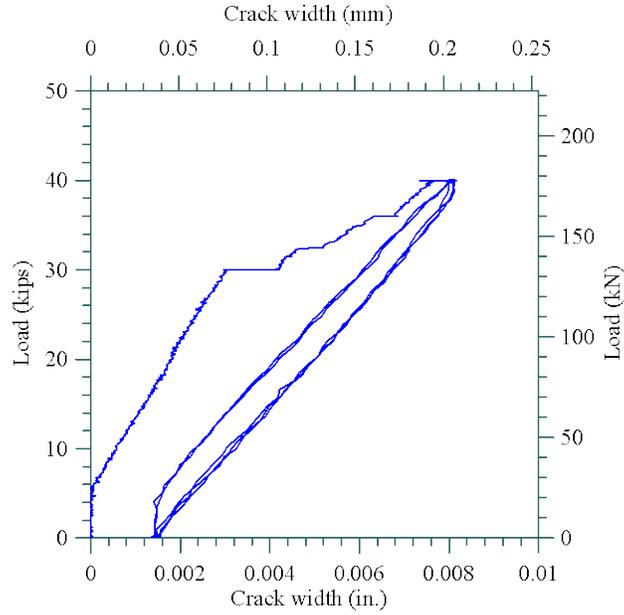
**Figure 42** Measured crack width in transverse rib TR2 of UWP1 at during the ultimate load test.

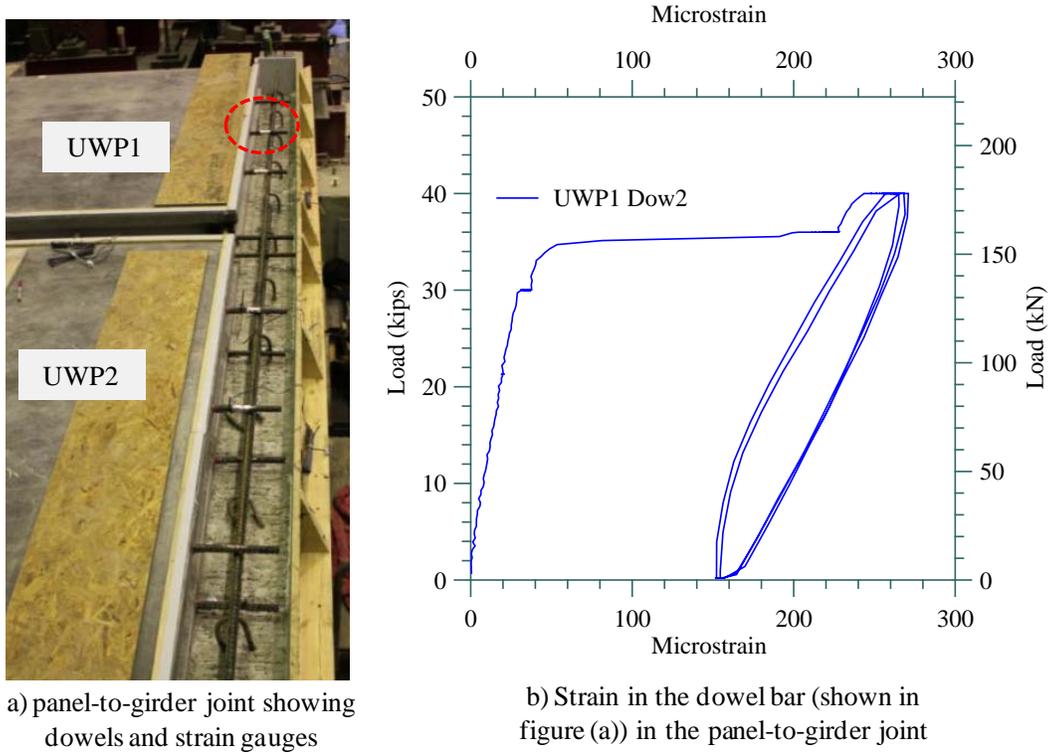
a) panel-to-girder joint showing dowels and strain gauges
