Vermont Demonstration Project:  
Warm-Mix Asphalt  
Overlay and Rehabilitation  
of U.S. 4A and VT 30

Final Report  
June 2013

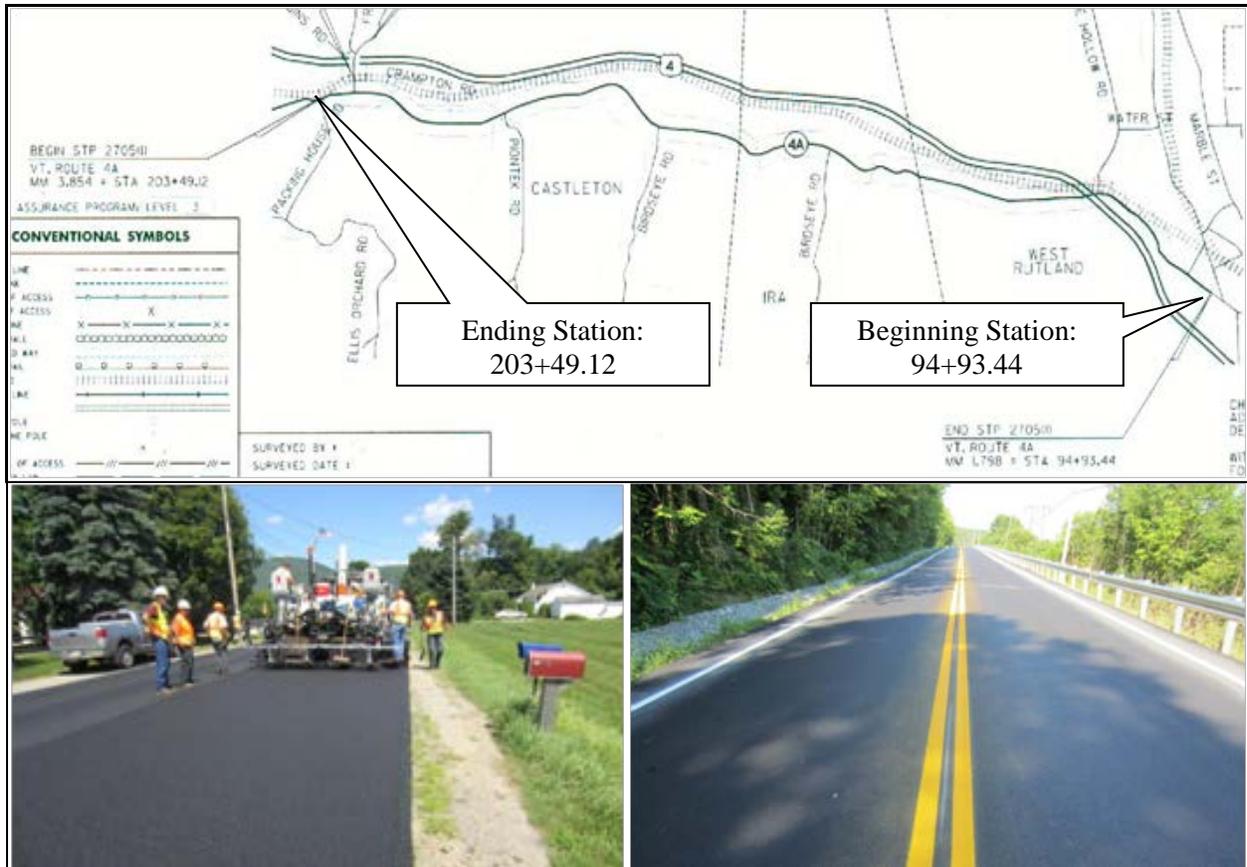
Figure 2. Project #2705—Limits and general view of U.S. 4A segment east of Castleton.

The purpose of this rehabilitation project was to improve ride quality and safety for the more than 10.5 centerline miles of U.S. 4A and VT 30 in and near Castleton (see Figures Figure 1 through Figure 3). As noted previously, the rehabilitation project was a mill and fill or replacement of the existing wearing surface. Construction began in midspring 2012, with cold-planing of the existing wearing surface beginning in May 2012. Paving was completed in September 2012. The bid construction cost was around \$5 million for all three projects or roadway segments. The Highways for LIFE grant was \$1 million, about 20 percent of the project cost. Figures Figure 5 and Figure 6 show the project construction team members. Peckham Construction Corp. of Lake George, NY, was the contractor for the project. Figure 5a shows the agency personnel directly involved in the project. Figures Figure 5b and Figure 5c show the paving crew and compaction team members, and Figure 6 shows the key inspection personnel and the contractor's quality control (QC) team members.

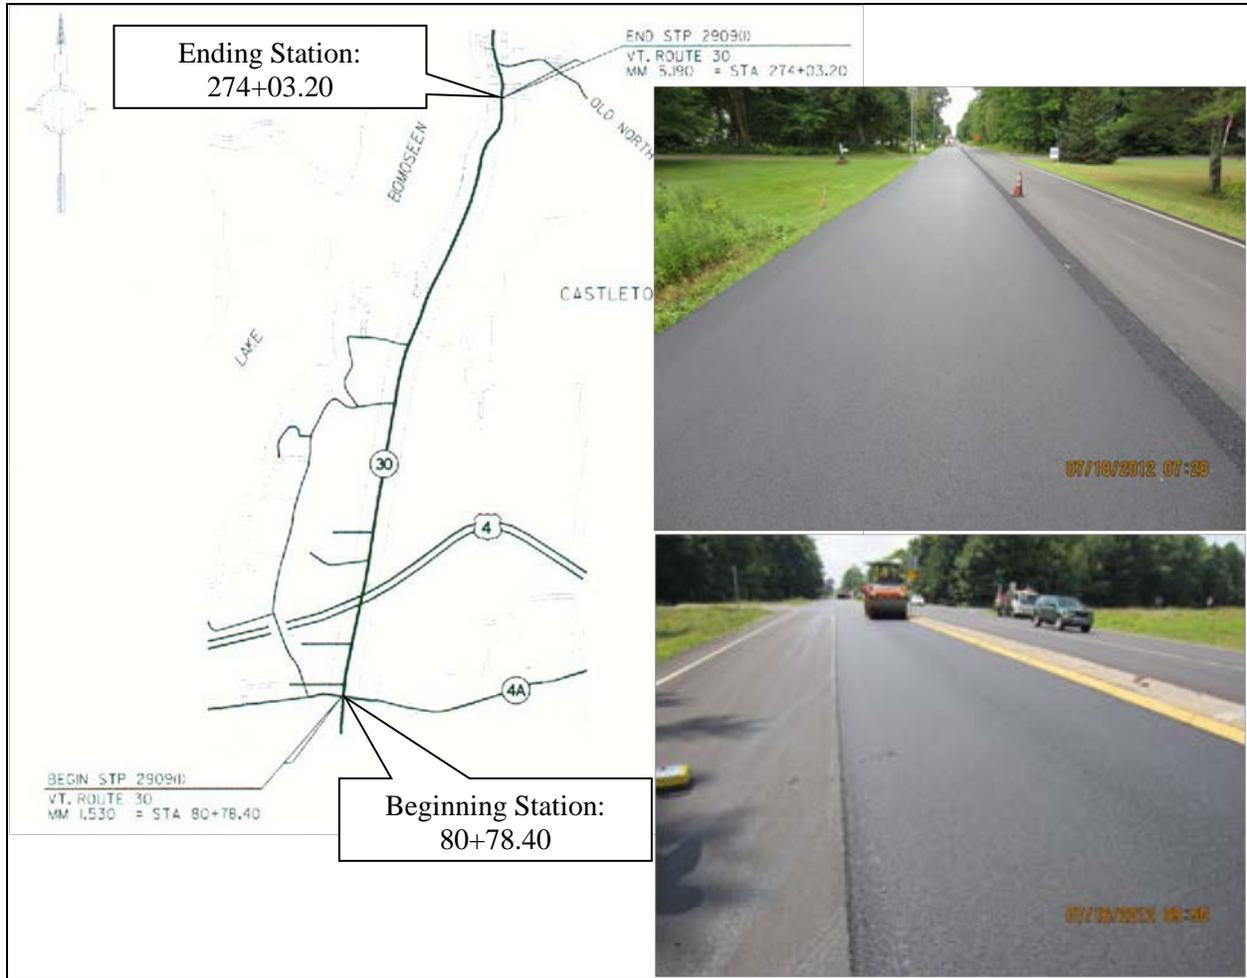
Figure 3. Project #2909—Limits and general view of VT 30 segment north of Castleton.

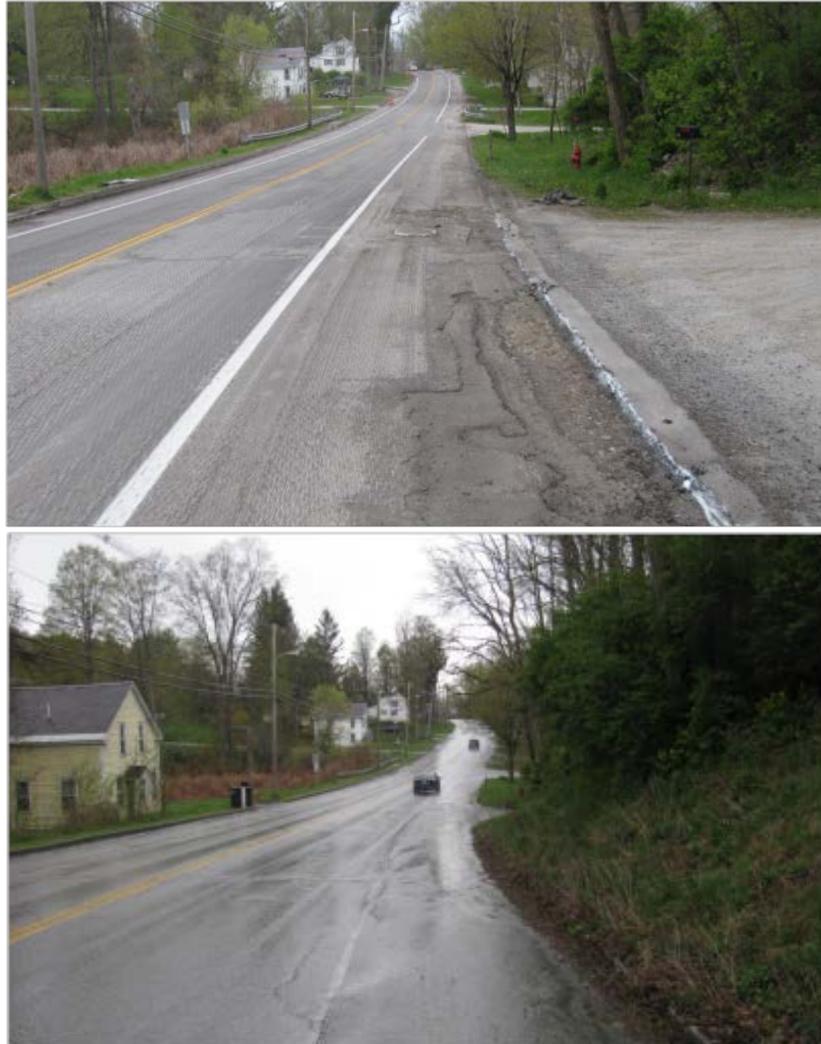
Figure 4. General view of pavement condition in two areas of the project before rehabilitation on U.S. 4A near Castleton. Condition of the other segments was similar. (Photos courtesy of Chris Thomas, Peckham Construction.)

All of these roadway segments were very rough in localized areas with transverse and longitudinal cracks and other surface disintegration distresses. Figure 4 shows a general view of the pavement before the rehabilitation project. In addition, there were localized areas with edge dropoffs that made the roadway less safe for the traveling public.

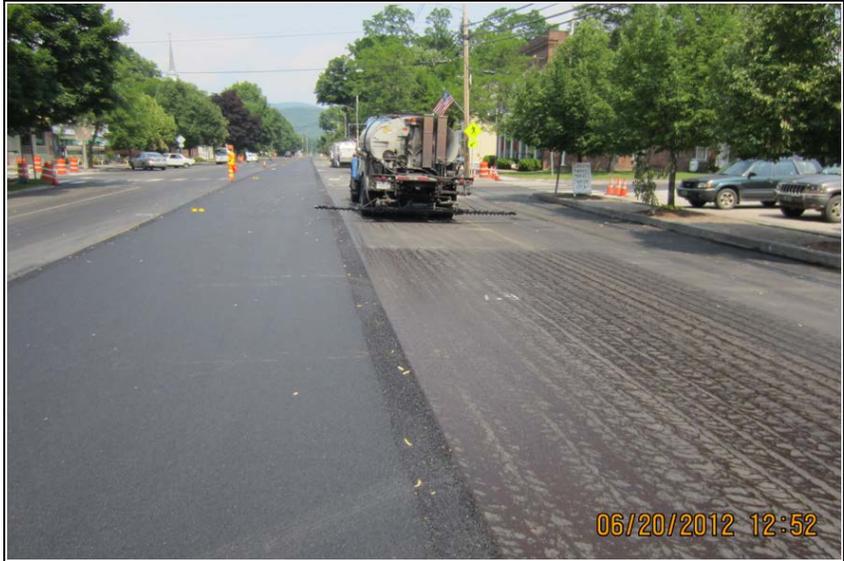
Figure 7. Tack coat (RS-1H emulsion) being applied to the surface of the leveling course before overlay placement.

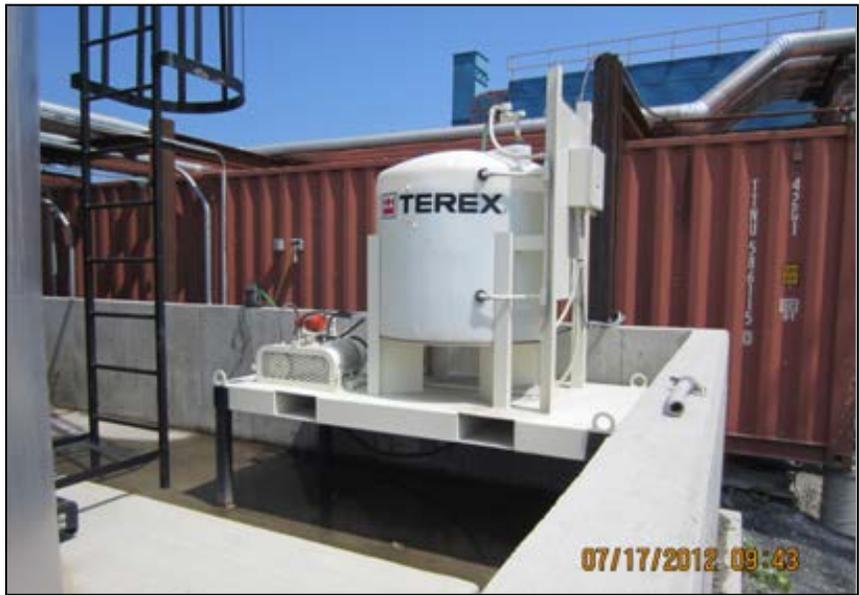
Figure 8. Terex foamer installed at the plant for producing foamed WMA.

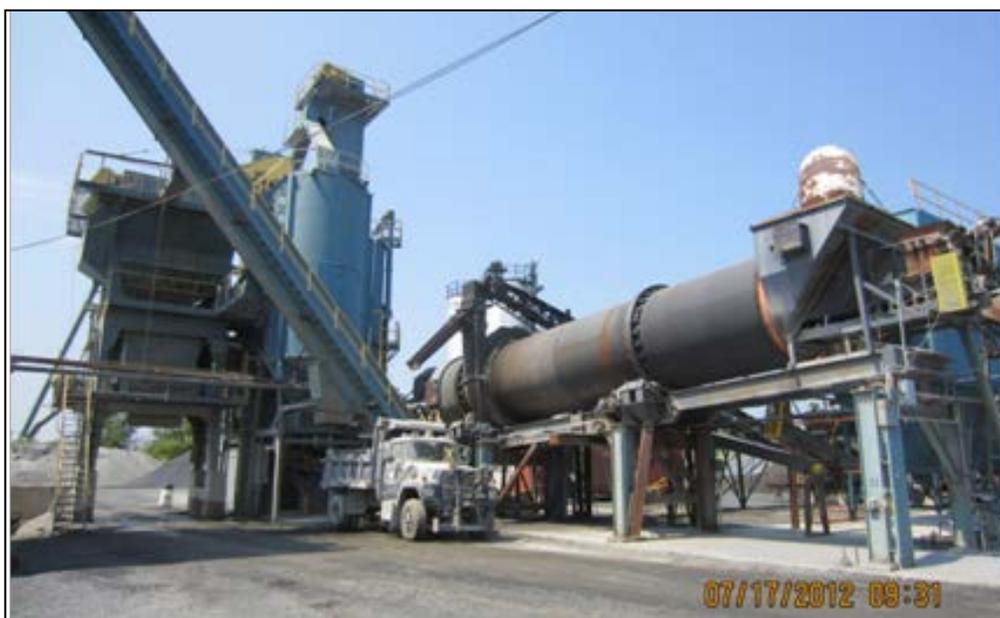
Figure 9. Peckham's drum mix plant in Hudson Falls, NY, used to produce WMA and HMA mixtures.

- The WMA foamed asphalt and organic wax technologies were used in specific locations of the project for comparison with HMA (see Table 1). All three mixtures were produced at Peckham's production facility in Hudson Falls, NY (see Figure 9). A drum mixer with a production capacity of 500 tons per hour was used to produce the mixtures. A #4 or #5 low-grade fuel was used as the burner fuel, but was preheated before combustion.
- The HMA and WMA mixtures were delivered to the project site using two types of delivery trucks (see Figure 10). End dump trucks were used more commonly and "flow boys" or horizontal discharge trucks were used infrequently.

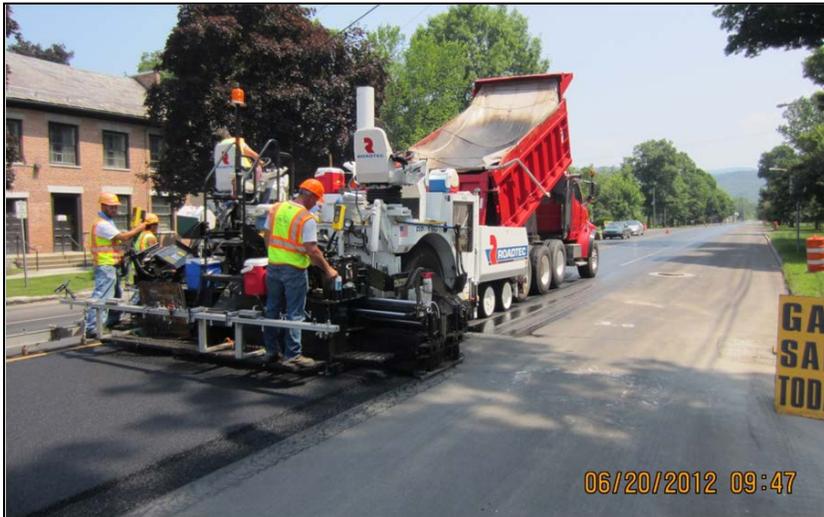
10a. Typical end dump truck used to deliver the HMA and WMA mixtures to the paver. The end dump trucks were used more frequently by the contractor.

- A ROADTEC RR190 paver was used to place the HMA and WMA mixtures along all three roadway segments (see Figures 10a and Figure 11). The contractor's paving crew had to overcome issues with overhanging trees and power lines when paving along U.S. 4A in Castleton (see Figure 12). The paving crew was able to unload and place the WMA mixture without incident.

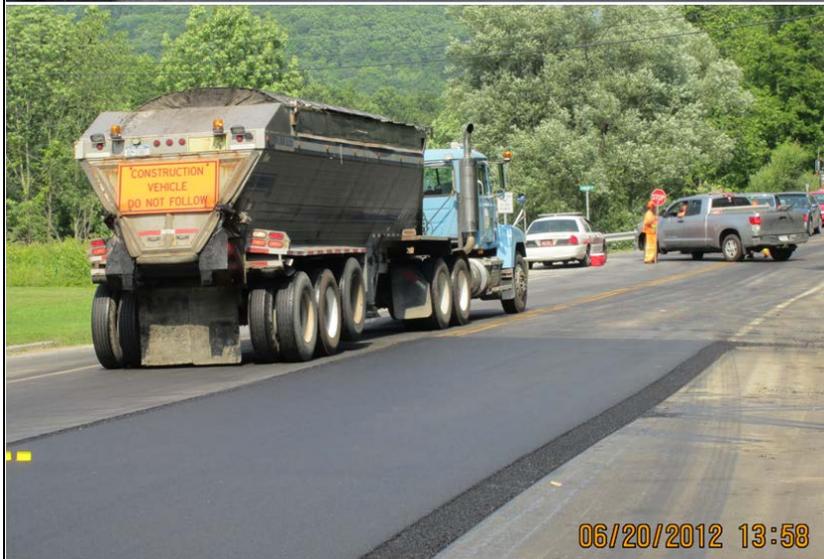
10b. Horizontal discharge trucks or flow boys were also used to deliver the HMA and WMA mixtures to the paver. This type of truck was used less frequently on this project.

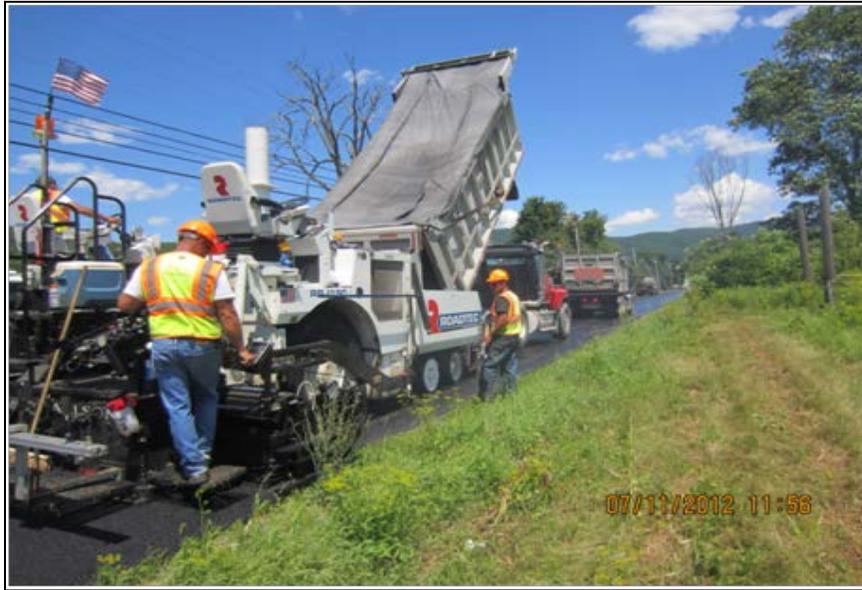
Figure 11. Paver used to place the HMA and WMA mixtures along all three roadway segments.

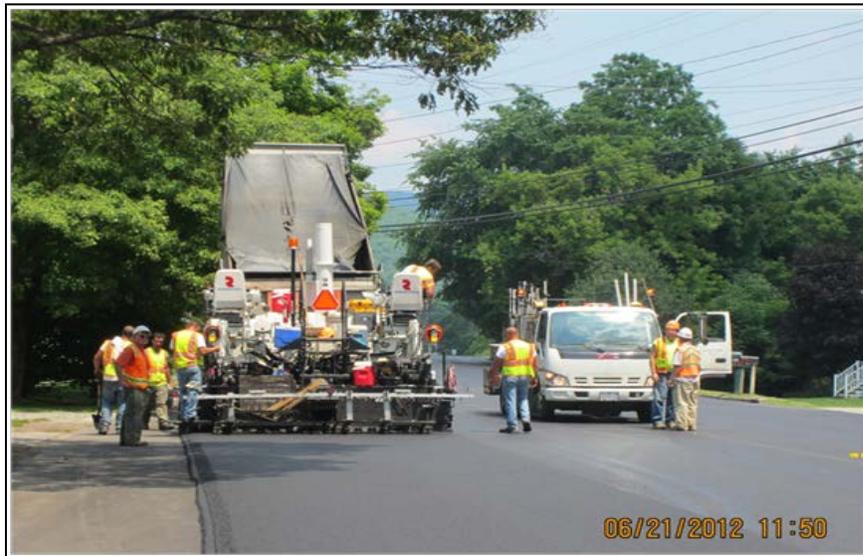
Figure 12. Overhanging trees and power lines along U.S. 4A in Castleton.

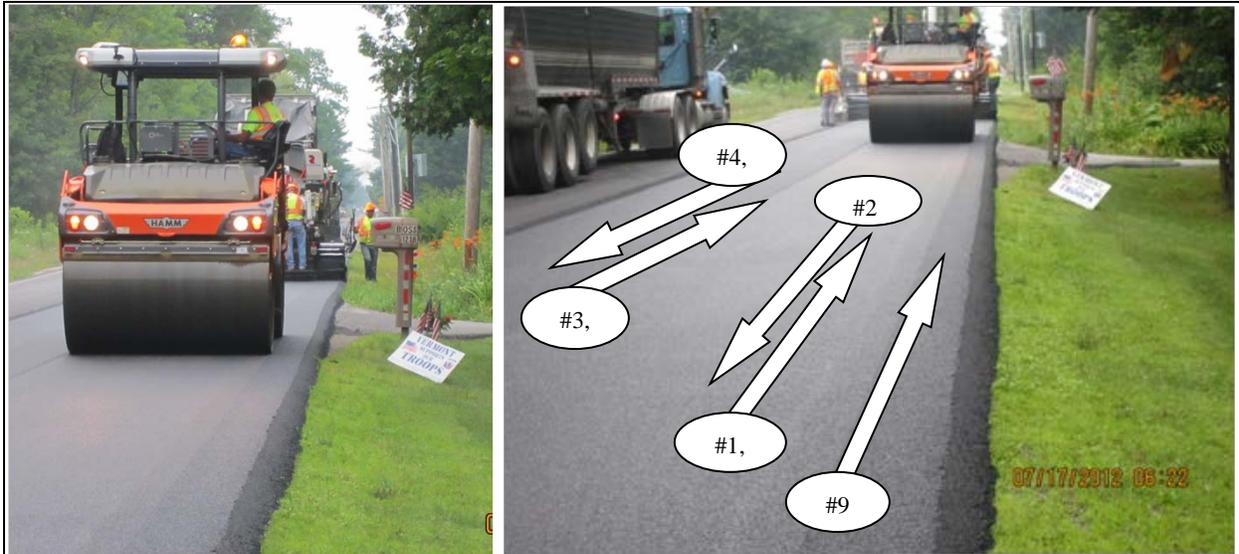
Roller passes 1, 2, 7, and 8 are where the edge of the roller is about 18 inches from the mat's outside edge. Roller passes 3, 4, 5, and 6 are where the edge of the roller is about 6 inches over the inside edge of the mat. Roller pass 9 is where the edge of the roller is about 6 inches over the outside edge of the mat.

Figure 13. HAMM IC roller and pattern (primary or breakdown roller) used to compact the WMA and HMA mixtures.

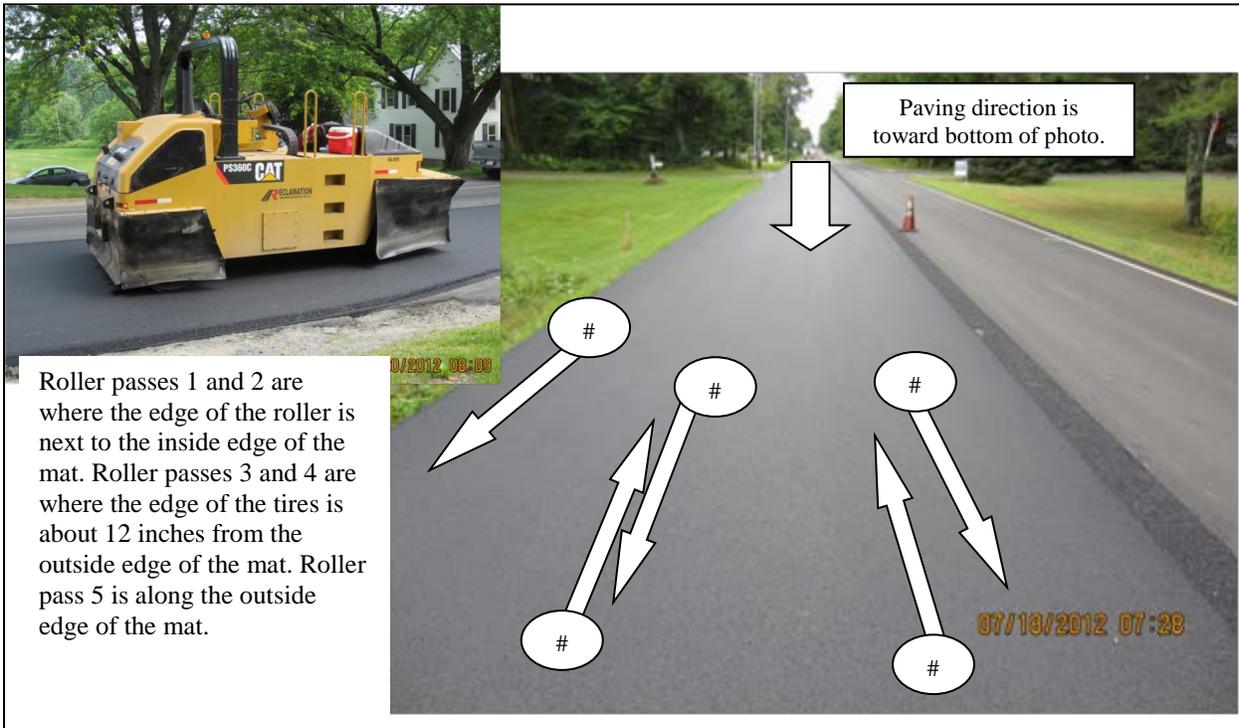
Roller passes 1 and 2 are where the edge of the roller is next to the inside edge of the mat. Roller passes 3 and 4 are where the edge of the tires is about 12 inches from the outside edge of the mat. Roller pass 5 is along the outside edge of the mat.

Figure 14. Caterpillar rubber-tired roller and pattern used for intermediate rolling of the WMA and HMA mixtures.

- Caterpillar rubber-tired roller—The rolling pattern for the intermediate roller consisted of five passes across the mat, as shown in Figure 14.
- HAMM oscillatory roller—The rolling pattern for the finish roller consisted of a minimum of five passes across the mat, as shown in Figure 15. The number of passes varied, depending on the density readings being measured with a nuclear density gauge to ensure the target mat density was met. Passes 1 and 3 were generally in the oscillating mode, while passes 2, 4, and 5 were in the static position. The mode and number of passes, however, depended on the results of the density readings taken behind the rubber-tired roller.

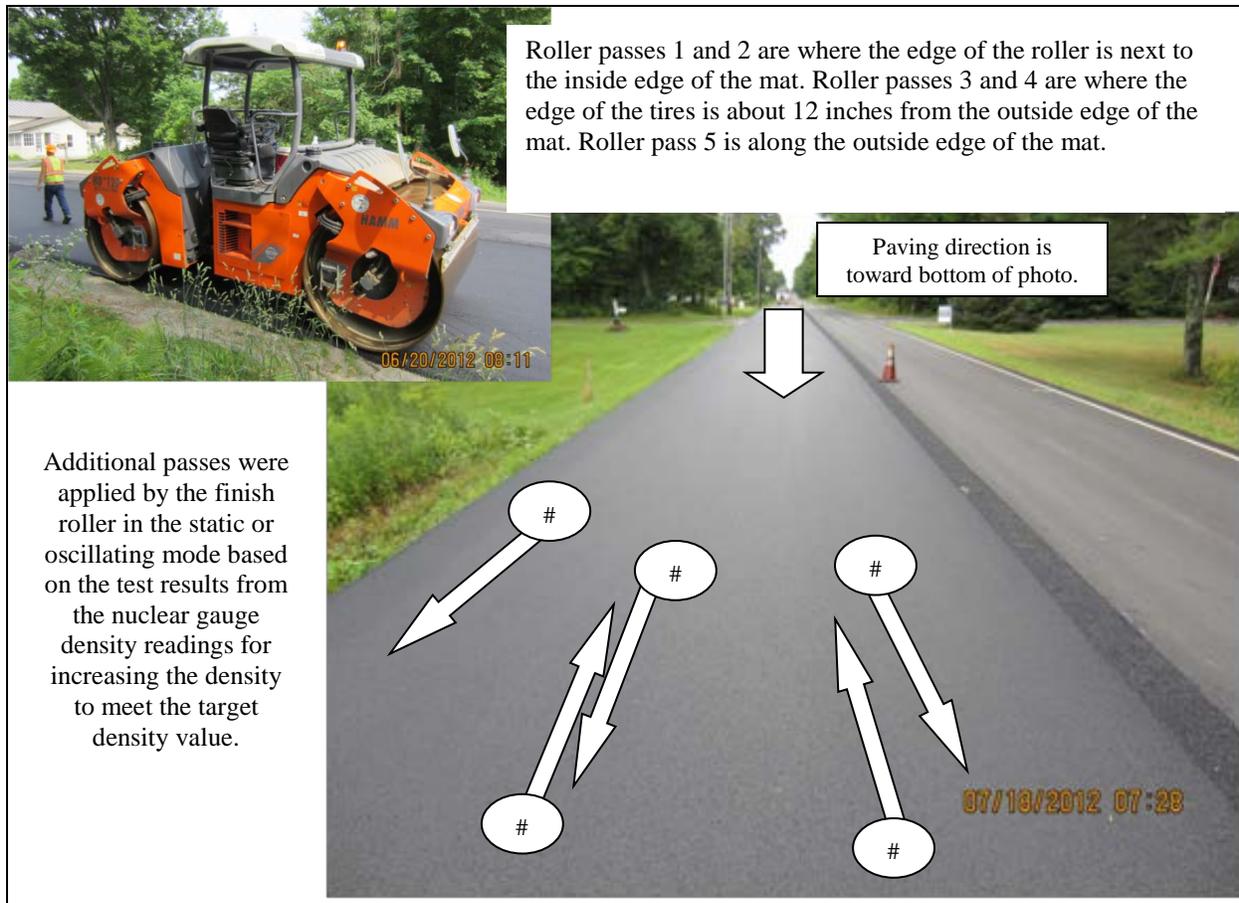
Figure 15. HAMM oscillatory double steel drum roller and pattern used for finish rolling of the WMA and HMA mixtures.

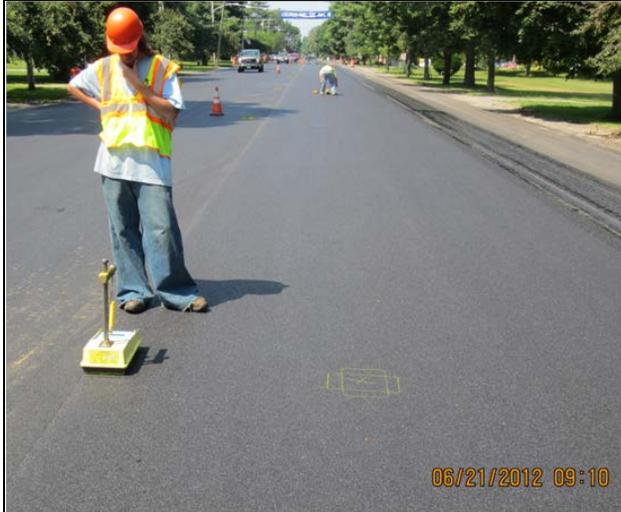
16a. Troxler nuclear density gauge used to monitor the mat density during the rolling operation.

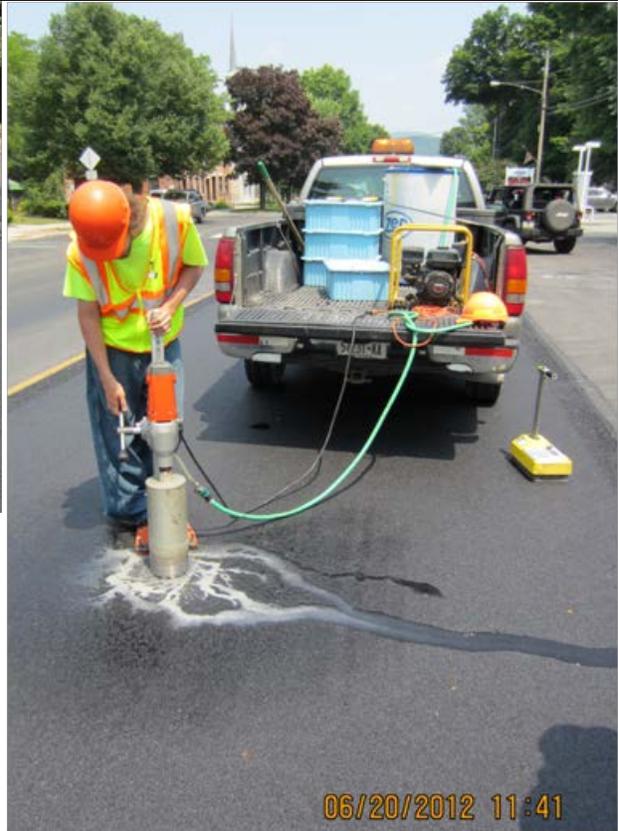
16b. Drilling cores in the WMA mat for acceptance.

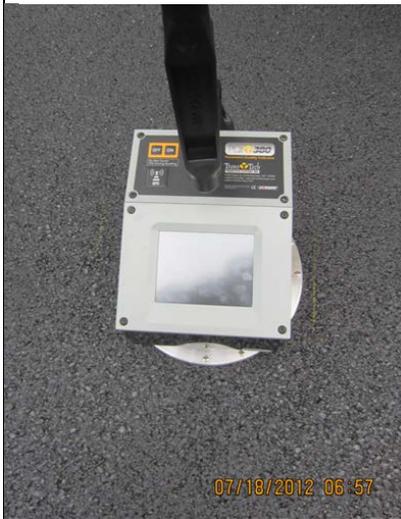
16c. Transtec's PQI nonnuclear density gauge used for QC purposes on a limited basis during the compaction operation.

The contractor used a nonnuclear density gauge for a limited time to monitor the compaction operation along the segment of VT 30 (see Figure Figure 16c). The contractor's QC team also measured the mat density to determine the longitudinal and transverse density profiles in limited areas at the request of VTrans and FHWA. These results are discussed in the next section. Densities were also measured at periodic locations along and next to the longitudinal construction joint.

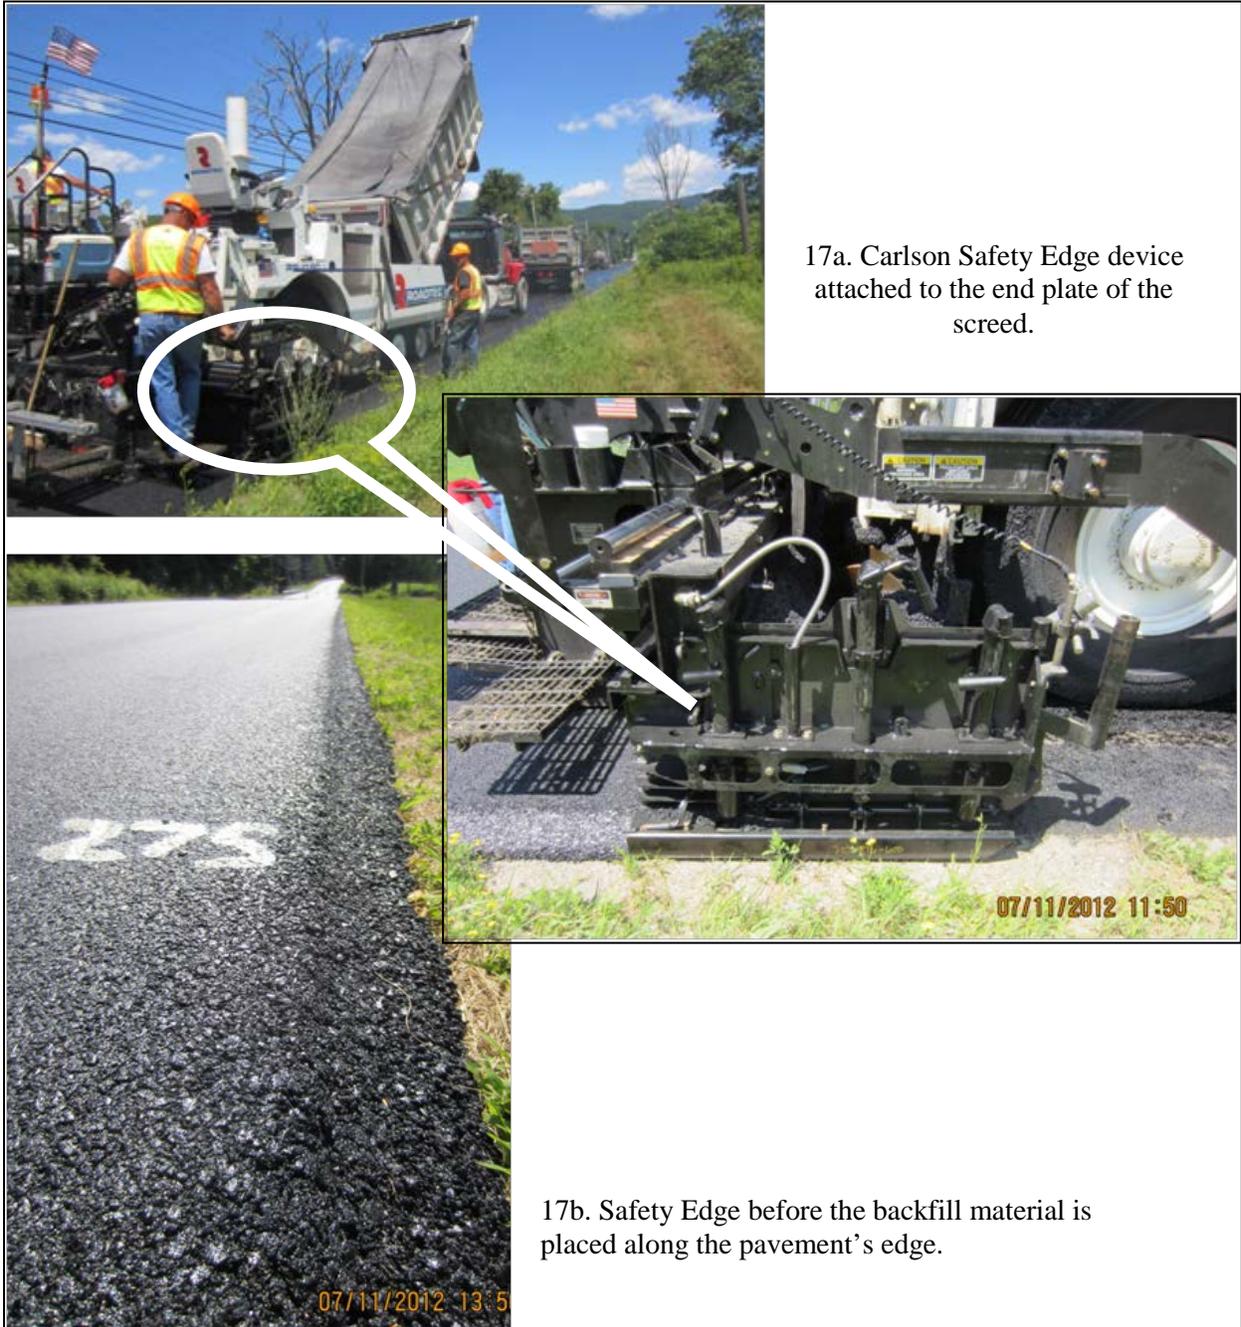
Figure 17. Safety edge placed by the Carlson device.

The Safety Edge is another strategy that is relatively new in Vermont (see Figure 17). The key benefit of the Safety Edge is that it allows vehicles driving off the pavement surface at highway speeds to safely return to the travel lane, reducing roadway departure crashes. It also reduces the amount of edge raveling and cracking that occurs along the pavement's edge, reducing future maintenance costs.

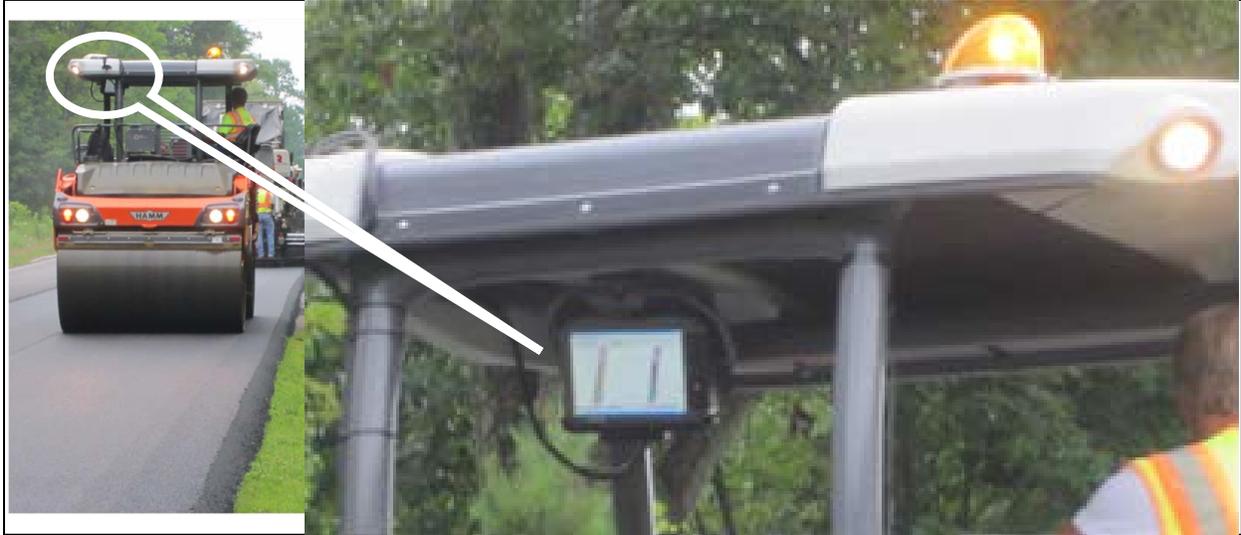
Figure 18. Display screen on the HAMM IC roller for monitoring coverage and other parameters.

because of inconsistent or no overlap between adjacent passes (see Figure 18). The other important benefit is determining the optimum number of passes over a specific point for maximizing mat density while preventing overcompaction. It is well known and reported that increasing the mat density and/or reducing its variability results in longer pavement or overlay service life and lower maintenance costs.

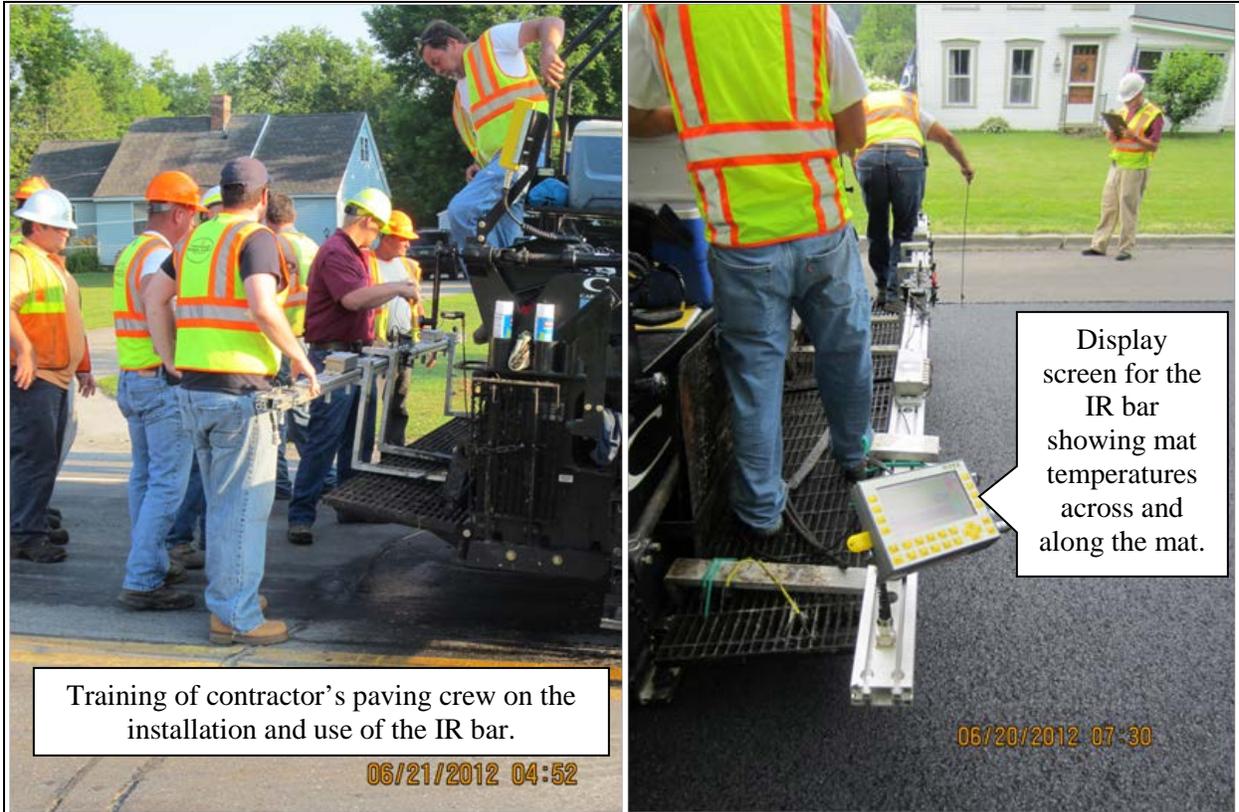
Figure 19. IR bar being installed and used to monitor mat temperatures directly behind the paver.

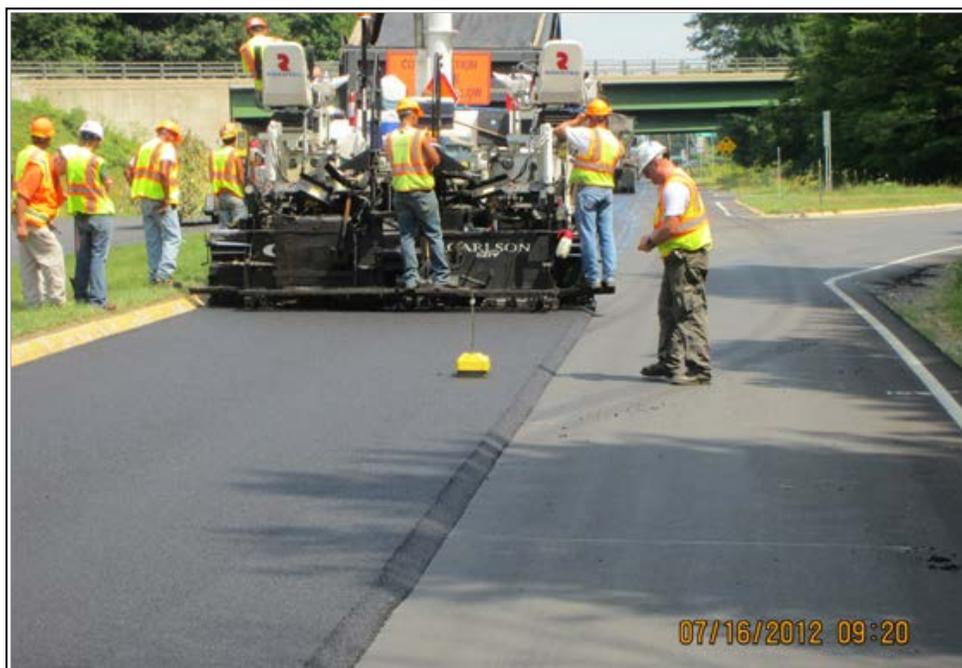
Figure 20. QC personnel taking density readings in the control strip with a nuclear density gauge.

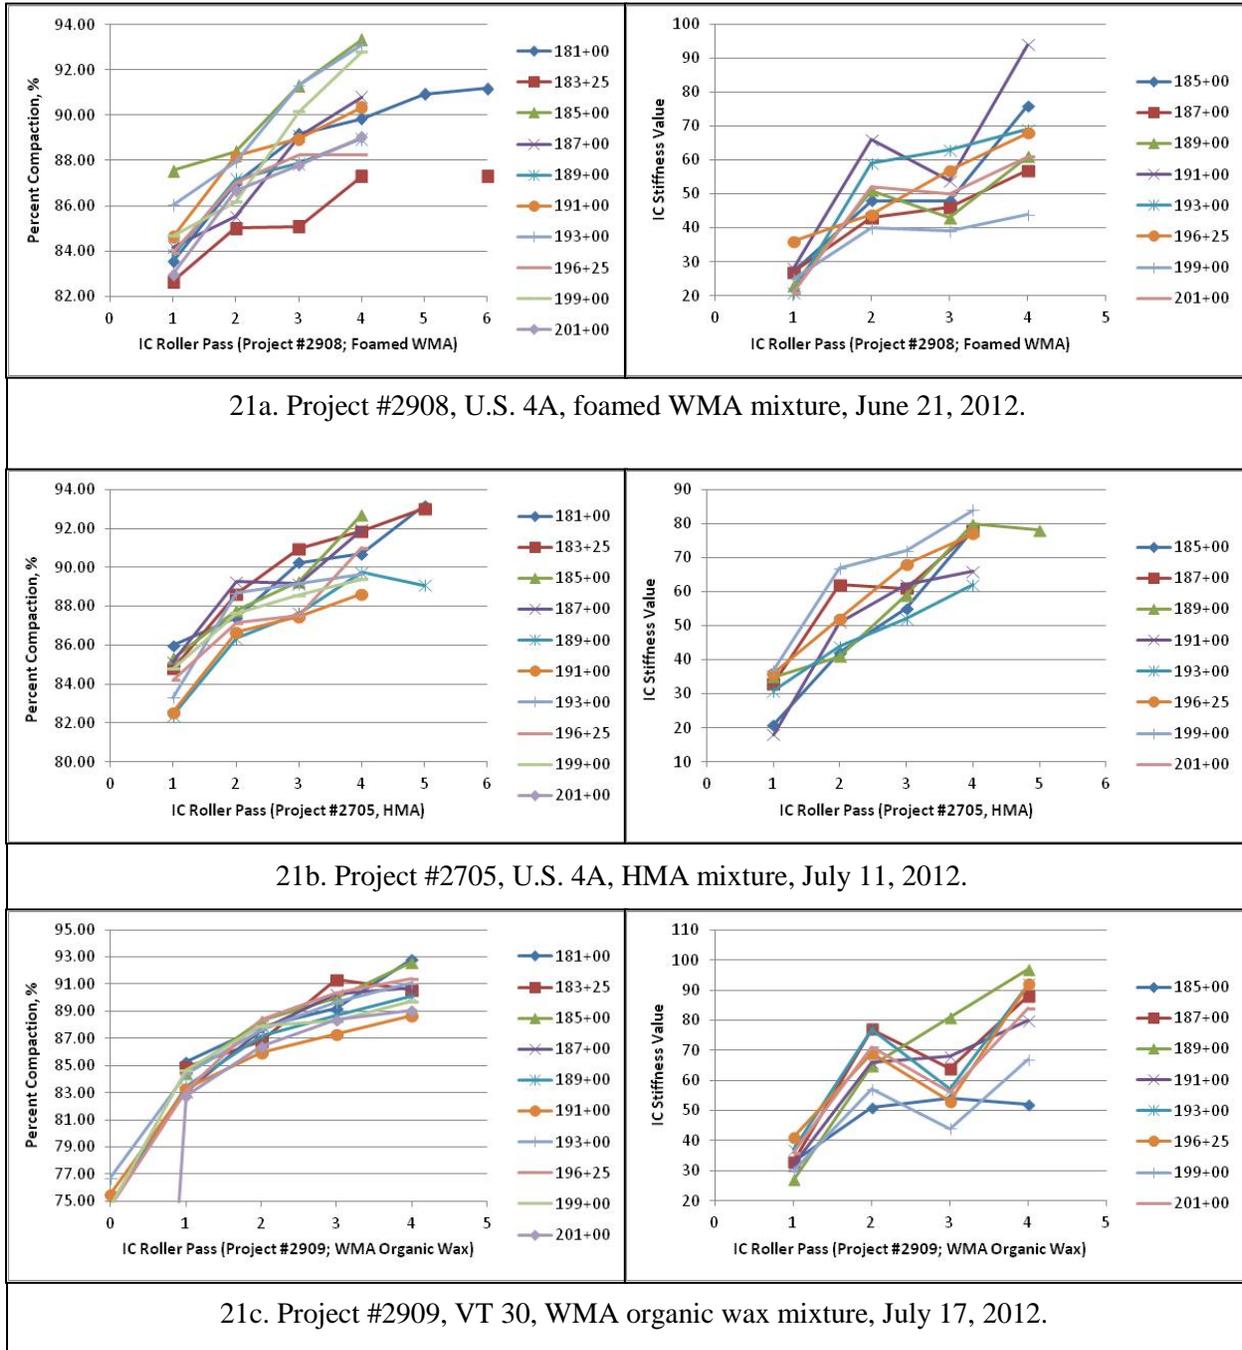
Figure 21. Density and IC stiffness growth curves for the WMA and HMA mixtures.

stiffness value increase with the number of passes. In the interest of time, more than four passes of the roller were used only at selected stations. The mat density and IC stiffness value are still increasing after four passes at most of the stations, but start to level off and decrease at five or six passes of the IC roller. After four passes, there is a much smaller increase in density. Thus, the contractor decided to use a minimum of four passes of the IC roller in setting the rolling pattern. The additional compaction effort for increasing the mat density was applied by the intermediate (Caterpillar rubber-tired) and finish (HAMM double-drum oscillatory) rollers.

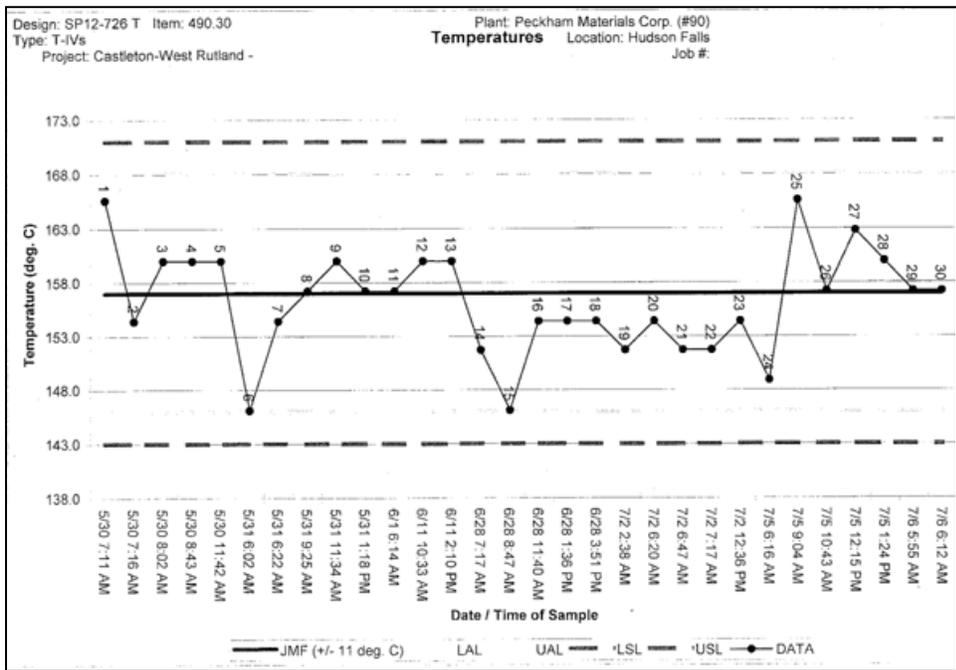
23a. HMA mixture temperature QC chart.

Mat temperature is probably the most important parameter for being able to properly compact WMA and HMA mixtures. Figure 23 includes an example of the production facility's control charts for WMA and HMA mixtures. The target production temperature at discharge was about 315 °F for HMA and 270 °F for WMA. The WMA temperature at discharge was later reduced to 260 °F because of a mixture pickup issue with the rubber-tired roller. The discharge temperature for the WMA mixtures generally varied between 255 to 265 °F when the test or control strips were completed.

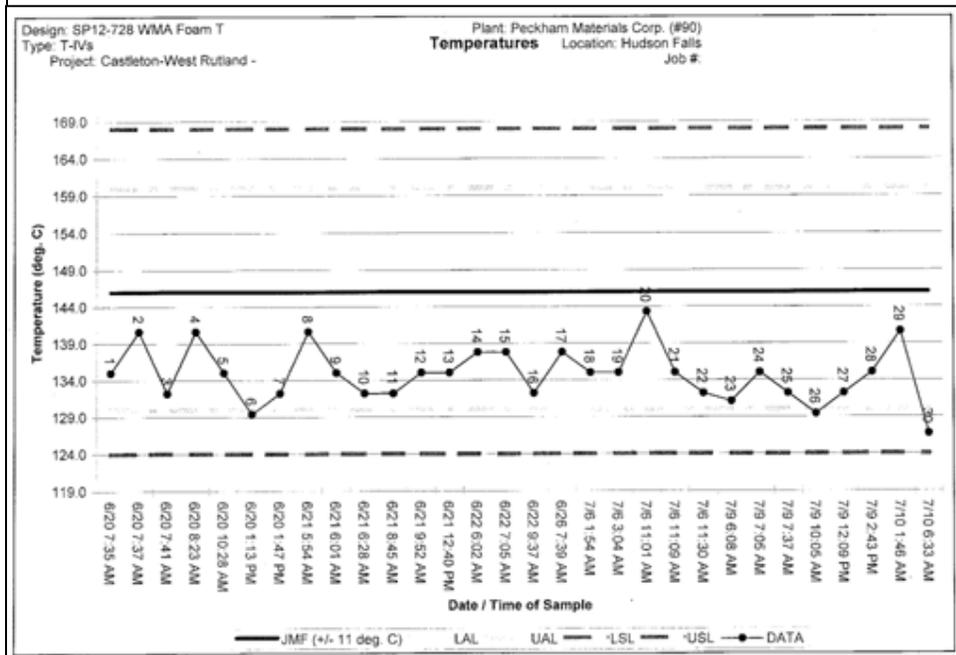
23b. WMA mixture (foamed) temperature QC chart.

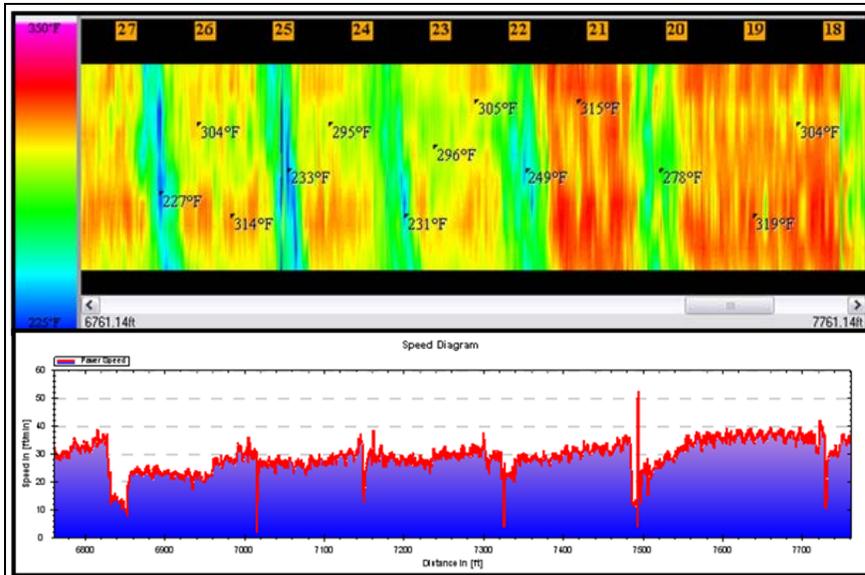
24a. Temperature profile near the beginning of construction, when many cold spots were observed in profiles and an inadequate number of trucks was available.

Figure 24. Temperature profiles and images from the IR bar.

The IR bar was used to monitor mat temperatures across and along the mat. The IR bar showed a high percentage of significant temperature differentials (cold spots) at the beginning of the project or when it was first installed and used on the project. Significant temperature differentials are defined as temperature profiles with more than 50 °F differentials. Table 3 summarizes the temperatures measured by the IR bar at the beginning of the project. Figure 24a shows an example of the IR bar temperature profile during this time. The high percentage of temperature differentials was caused by an insufficient number of trucks delivering mix to the paver, which meant the paver stopped and started many times. The contractor added trucks to resolve this issue. Figure 24b shows a more consistent mat temperature profile when an adequate number of trucks supplied mix to keep the paver moving down the roadway, not stopping and starting between truck loads.

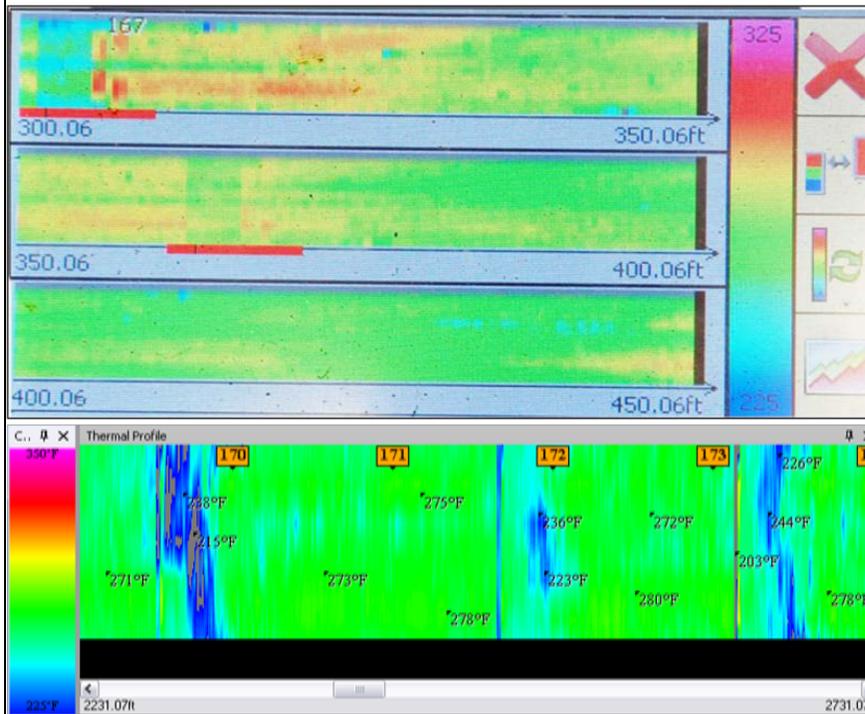
24b. Temperature profile with an adequate number of trucks and fewer cold spots observed in data.

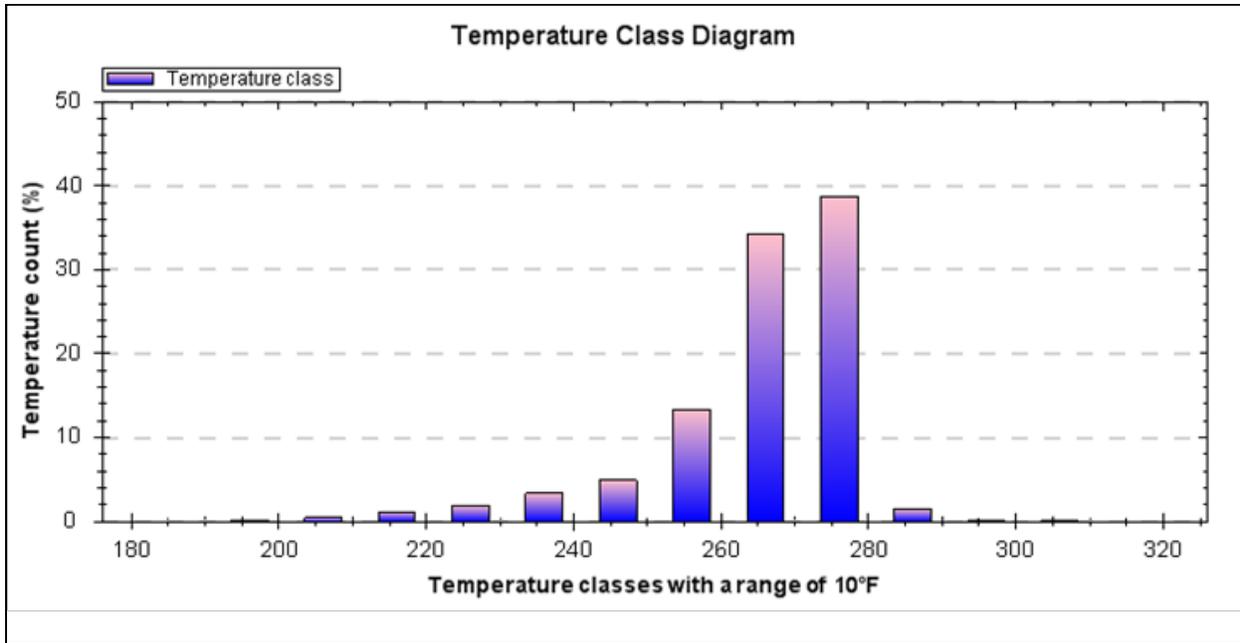
Figure 25. Histogram of mat temperatures (WMA foamed mixture) measured by the IR bar.

Figure 25 is a histogram of the mat temperatures measured by the IR bar behind the paver. As shown, it is skewed toward lower temperatures because of the cold spots from having an inadequate number of trucks at the beginning of the project. (The IR bar was not used throughout the project; it was used at the beginning, during the open house, and periodically during the test or control strips.)
