Vermont Demonstration Project:  
Warm-Mix Asphalt  
Overlay and Rehabilitation  
of U.S. 4A and VT 30

Final Report  
June 2013

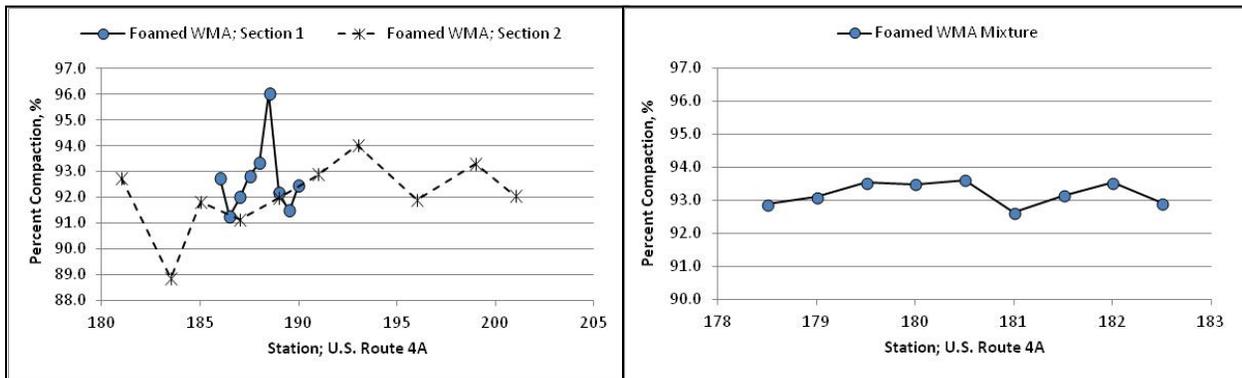
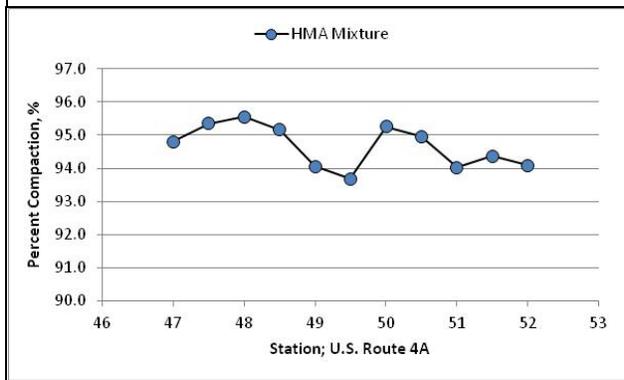
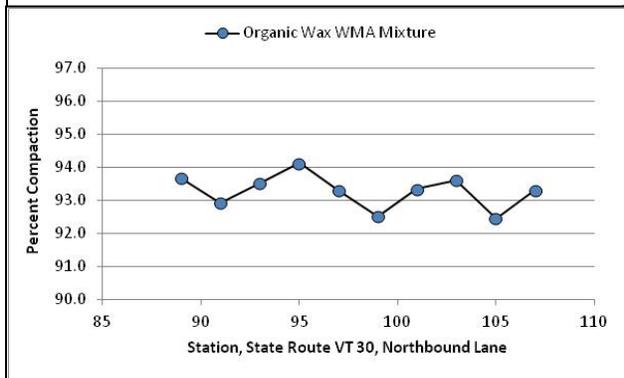
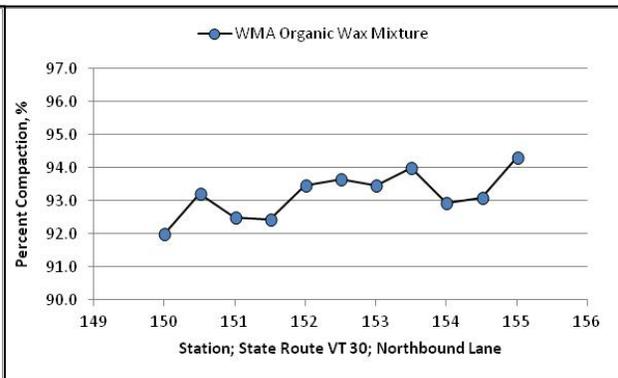
26a. Project #2908, U.S. 4A, foamed WMA mixture, June 21, 2012.

26b. Project #2705, U.S. 4A, HMA mixture, July 11, 2012.

26c. Project #2909, VT 30, WMA organic wax mixture, July 17, 2012.

Figure 26. Longitudinal density profiles of the mat.

Mat densities were measured with a nuclear density gauge along and across the mat in each roadway segment after rolling was complete. Figure 26 is a graphical illustration of the longitudinal density profiles, and Figure 27 shows the transverse density profiles. Table 4 summarizes the mat densities. For the most part, the data and profiles exhibit low variability or change in density along and across the mat, with the exception of the readings taken next to the mat's edge, which is expected.

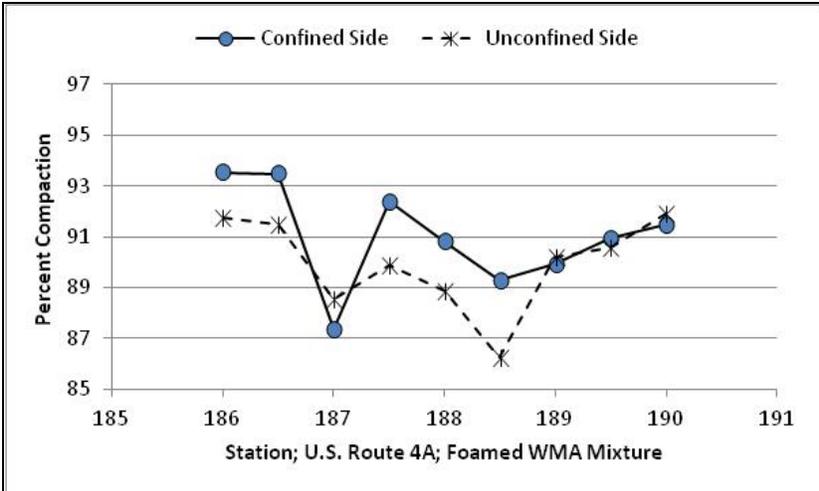
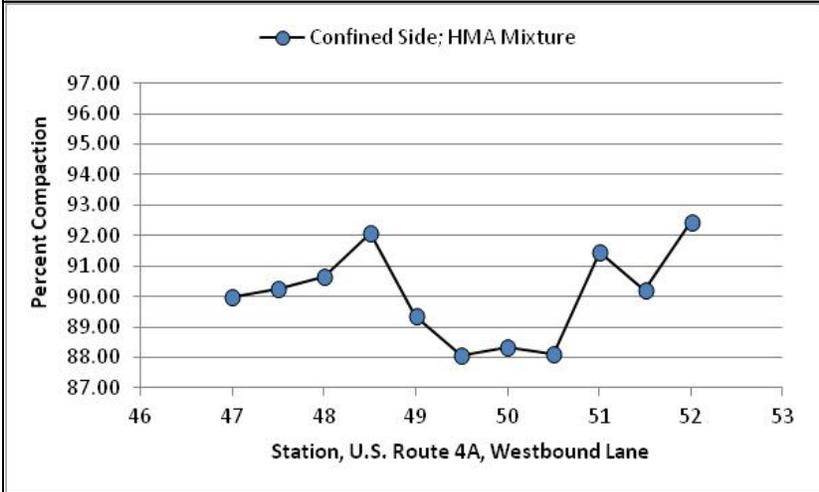
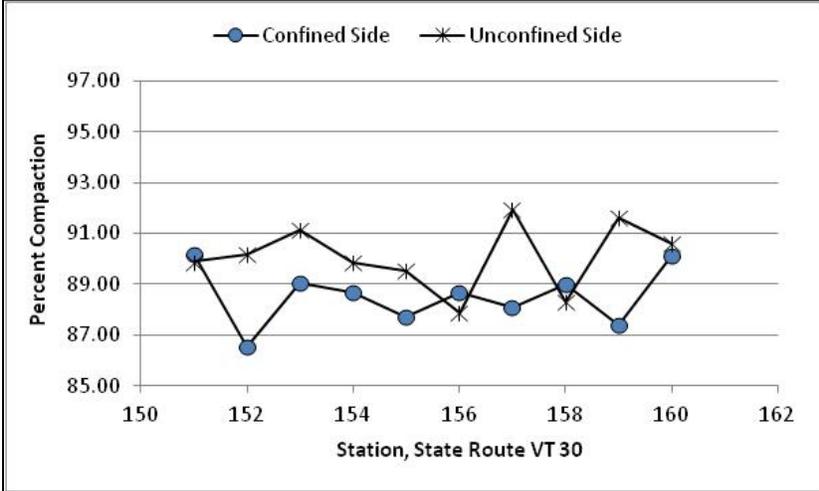
28a. Project #2908, U.S. 4A, foamed WMA mixture, June 21, 2012, density profile along longitudinal joint.

28b. Project #2705, U.S. 4A, HMA mixture, July 11, 2012.

28c. Project #2909, VT 30, WMA organic wax mixture, July 17, 2012.

Figure 28. Density profiles along the longitudinal construction joint.

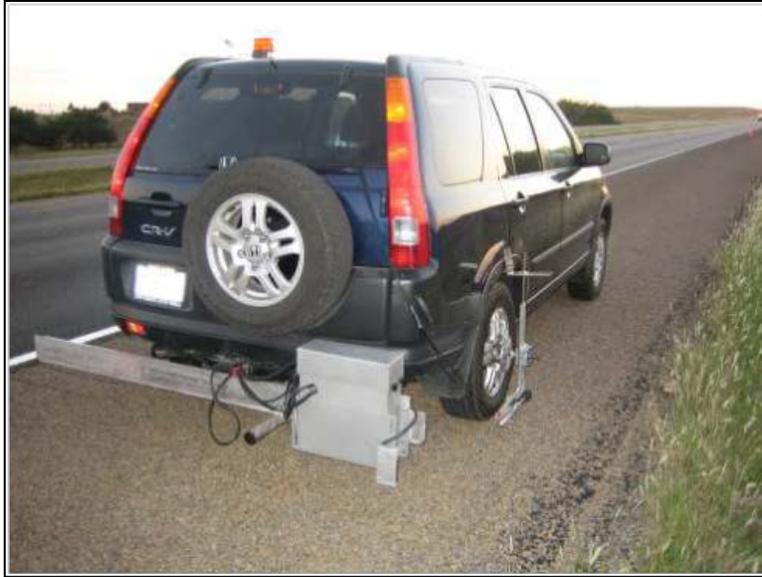
Figure 30. High-speed inertial profiler mounted behind the test vehicle.

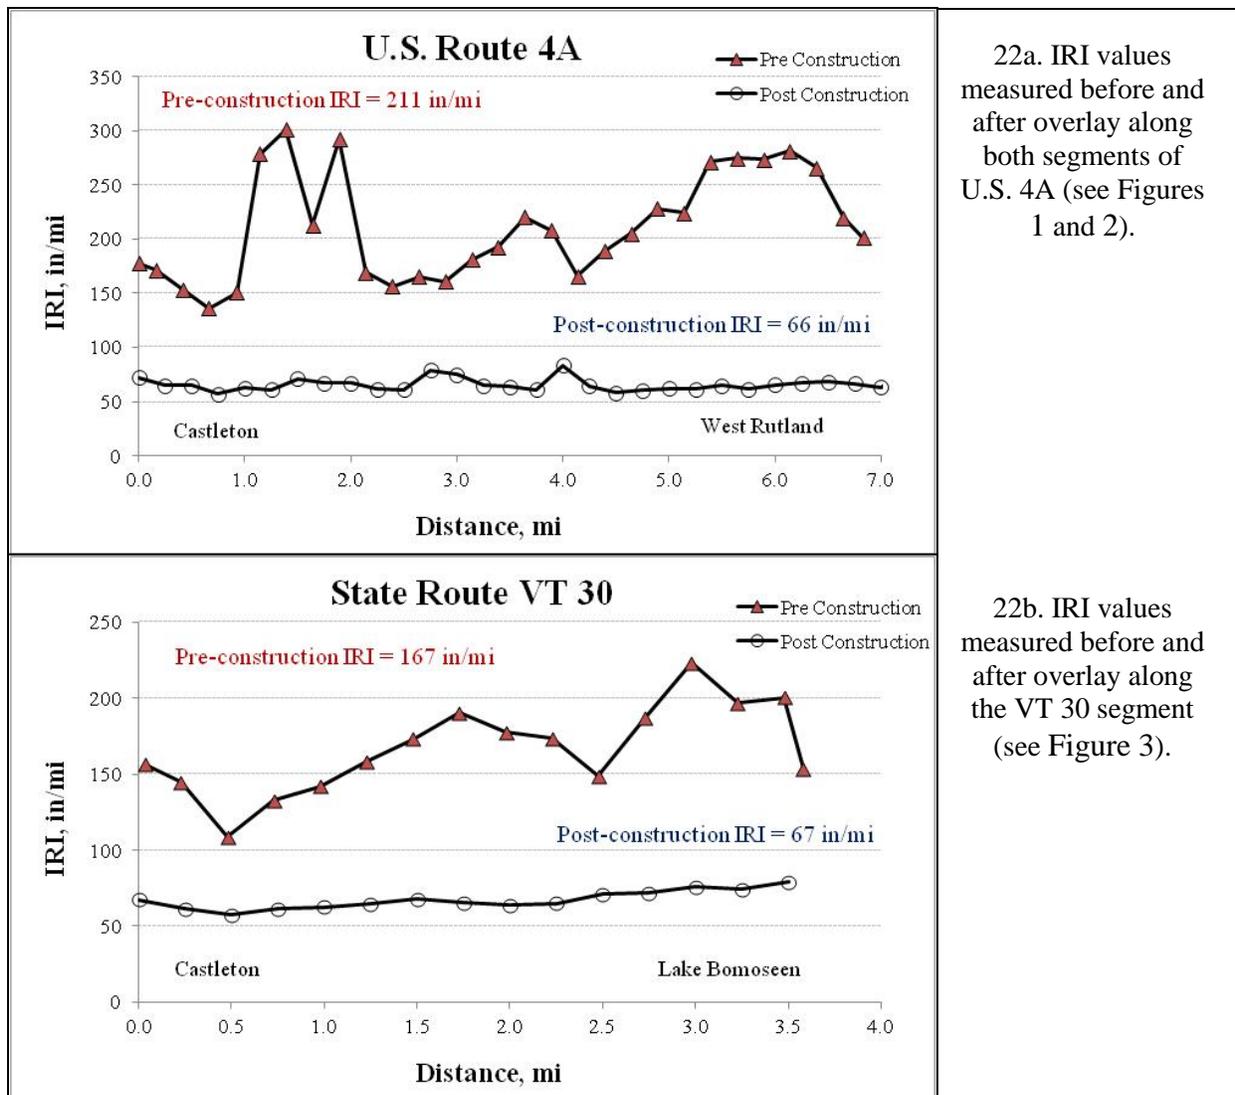
Figure 31. IRI values measured before and after the rehabilitation project.

3. The WMA mixture with the foaming technology was used on U.S. 4A, and the WMA organic wax mixture was used on VT 30 (see Table 2). Shortly after paving was initiated beyond the compaction test strip for each WMA technology, it was observed that the rubber-tired roller was picking up the fines or mastic from the surface. Larger pieces of the mastic started falling off the tires in some areas (see Figure 32). The contractor's roller and QC personnel removed many of the larger pieces before the HAMM finish roller. Pickup was more predominate with the organic wax. To remedy this situation, the plant production temperatures were slightly lowered and the pneumatic roller operator delayed his rolling, which reduced the problem of mixture pickup by the rubber tires. The plant temperatures slightly increased over time and mixture pickup returned, which is believed to have caused some of the increase in IRI values toward the north end of VT 30 (see Figure 31b).

As stated previously, the rehabilitation project resulted in a significant reduction in roughness (see Figure 31) for U.S. 4A and VT 30. Reduced roughness will make the roadway safer and result in less vehicle damage.

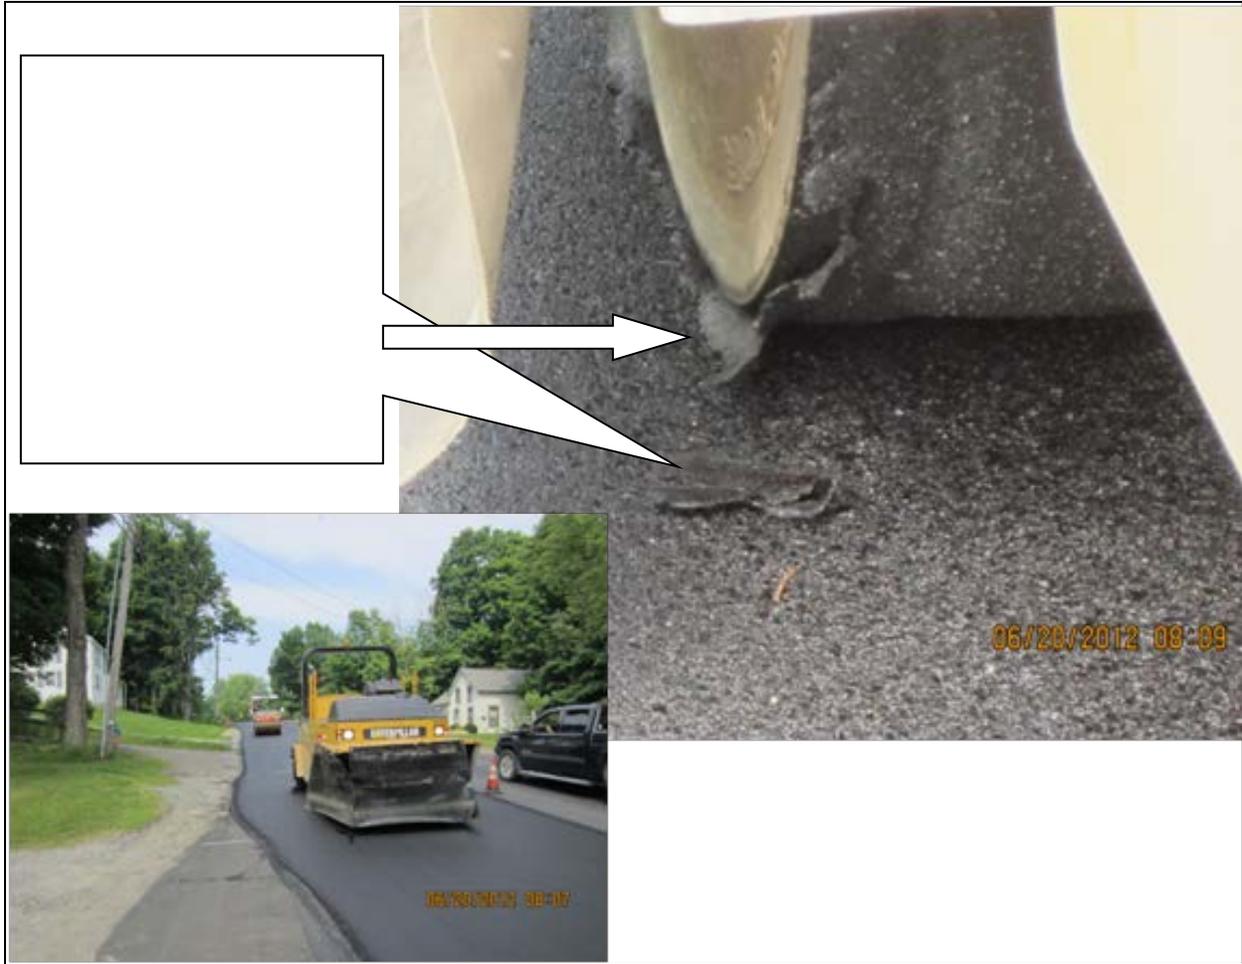
Figure 32. Rubber tires picking up the mastic from the WMA surface.

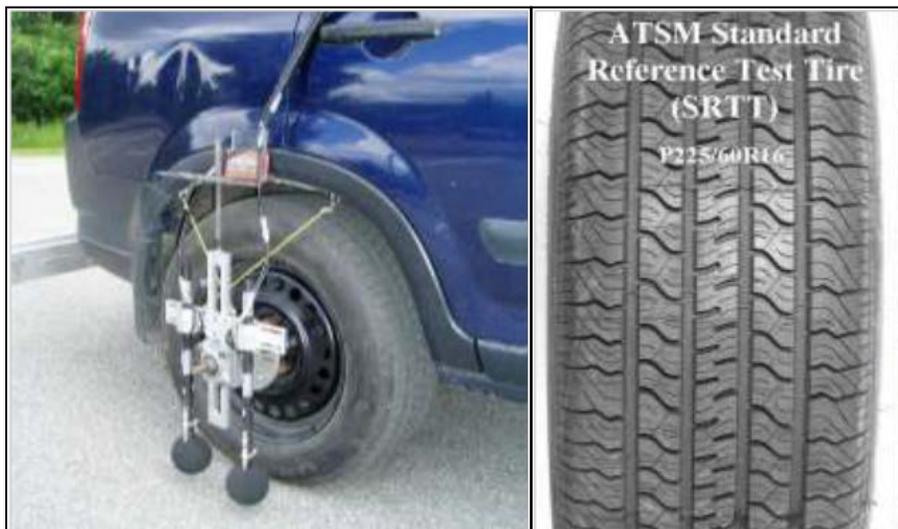
Figure 33. OBSI dual probe system and the SRTT.

VTrans has not used the OBSI test method on any past projects. This method, however, was used to collect tire-pavement SI measurements on the existing and overlaid pavement along all three roadway segments. OBSI values were measured at highway speed.

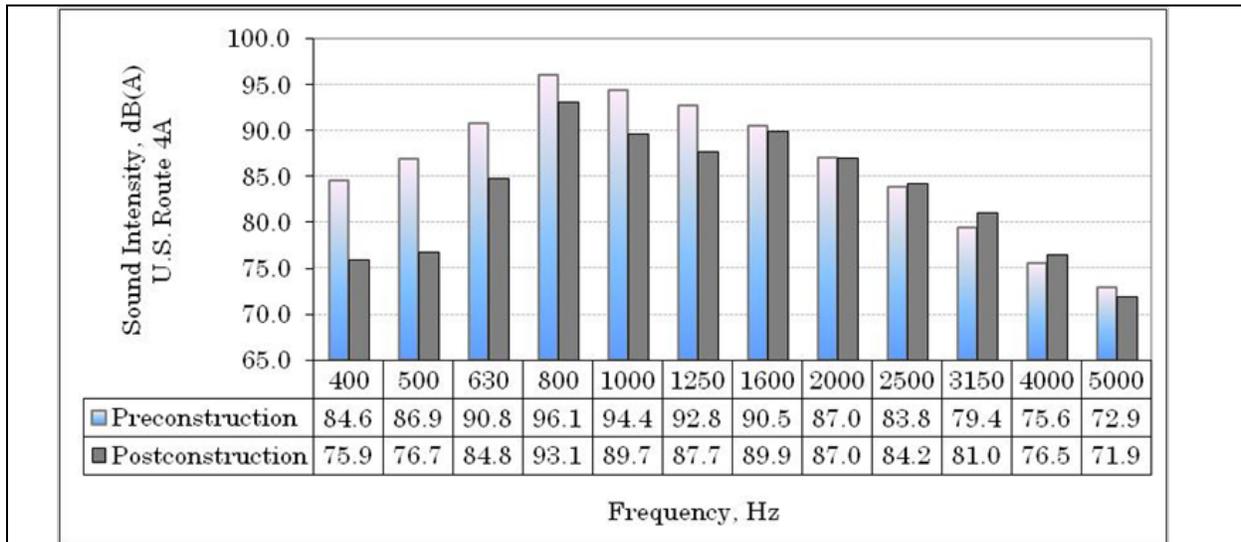
34a. SI values measured before and after overlay along both segments of U.S. 4A (see Figures Figure 1 and Figure 2).

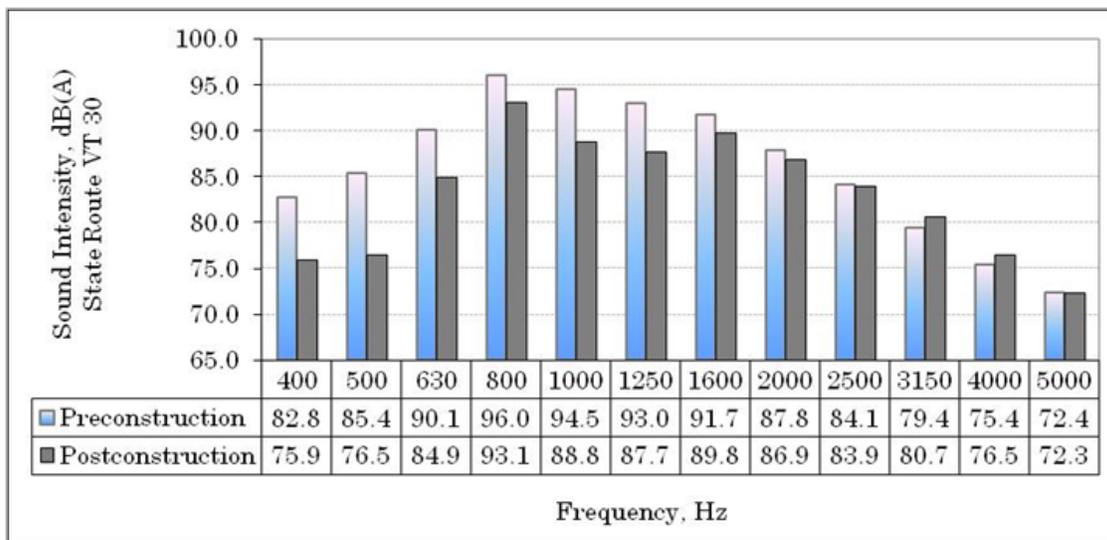
34b. SI values measured before and after overlay along VT 30 segment (see Figure 3).

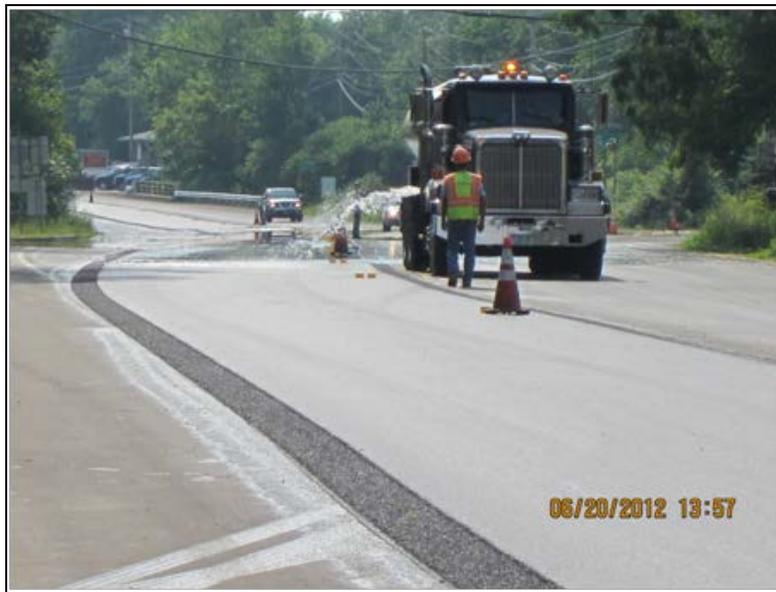
Figure 35. Recently placed WMA being artificially cooled with water to open the lane to traffic faster.

The air temperature was over 90 °F when paving through Castleton. The time needed for the mixture temperature to drop below 140 °F was more than an hour. The software program “CalCool” was used onsite to estimate this time; 69 minutes was determined for the WMA mixtures and onsite conditions. After waiting more than 50 minutes with a queue building on U.S. 4A, the contractor and agency personnel decided to artificially cool the mixture with water so the lane could be reopened to traffic and reduce the length of the construction zone (see Figure 35). The temperature of the existing surface was nearly 135 °F on a couple of afternoons.

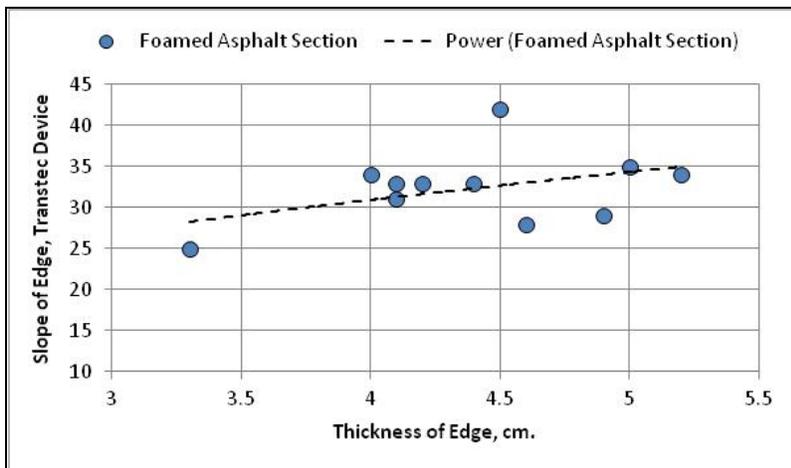
36c. Safety Edge placed with the Transtec device along U.S. 4A, foamed WMA, July 10, 2012.

As noted previously, a Safety Edge was added in appropriate segments of the roadway to reduce crashes in the future from vehicles departing the roadway at highway speeds when trying to recover or reenter the travel lane. The average slope of the Safety Edge is shown in Table 8 and was found to vary from about 32 to 37 degrees.

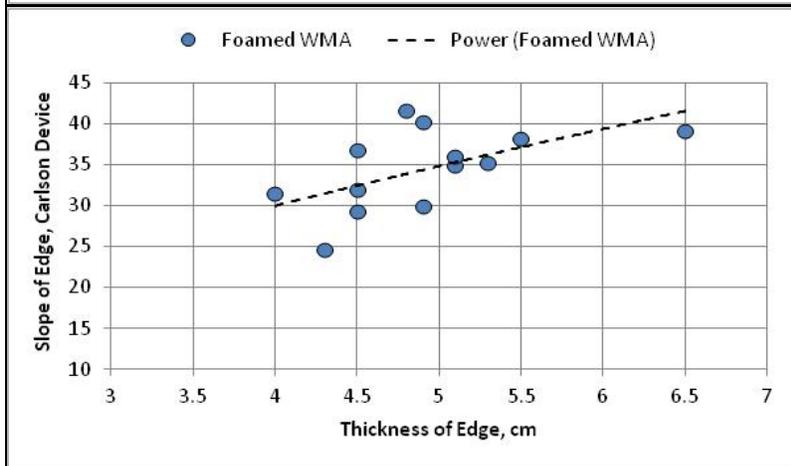
36b. Safety Edge placed with the Carlson device on U.S. 4A, foamed WMA, July 12, 2012.

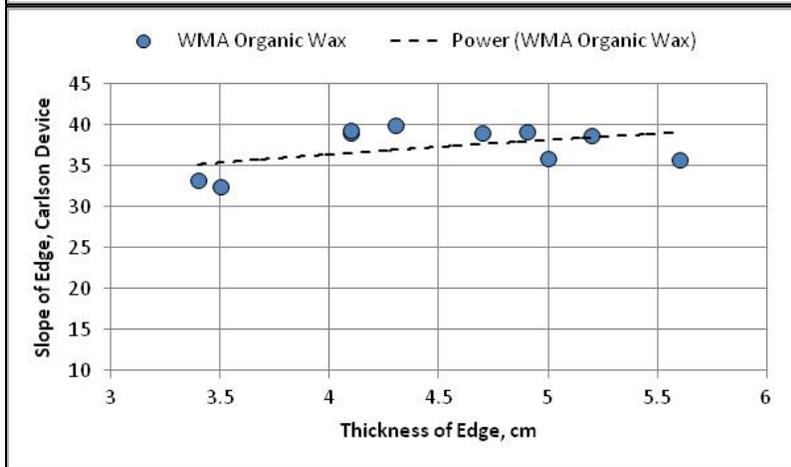
36c. Safety Edge placed with the Carlson device on VT 30, WMA organic wax, July 17, 2012.

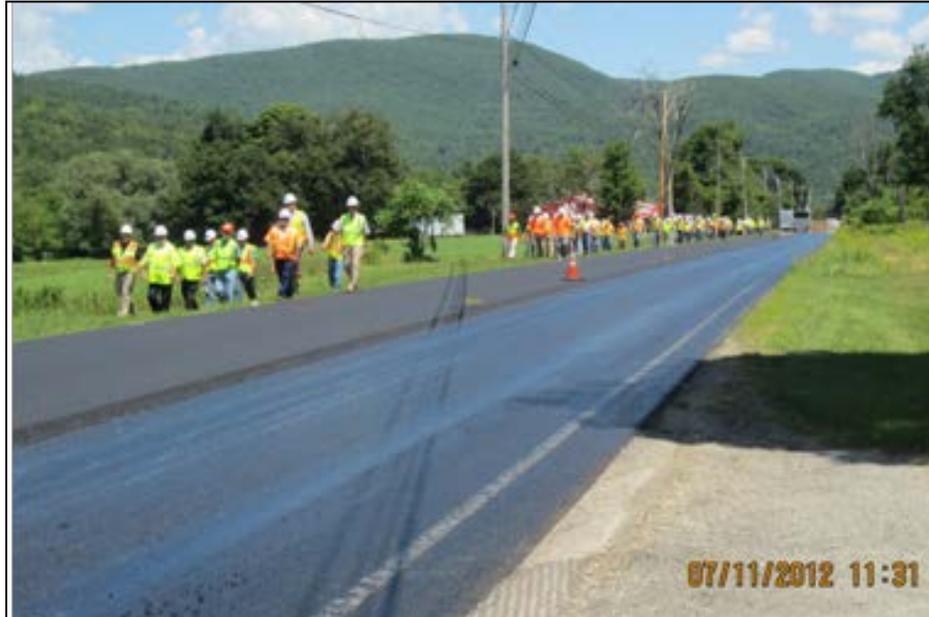
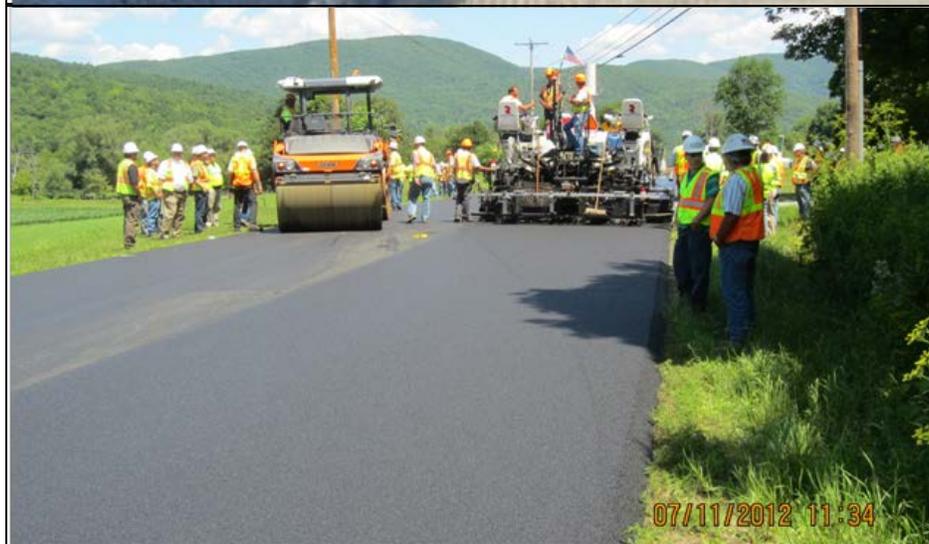
Figure 38. Field visit to showcase the paving and compaction operations along U.S. 4A.

The workshop concluded with a panel question-and-answer session, followed by a visit to the project site (see Figure 38).

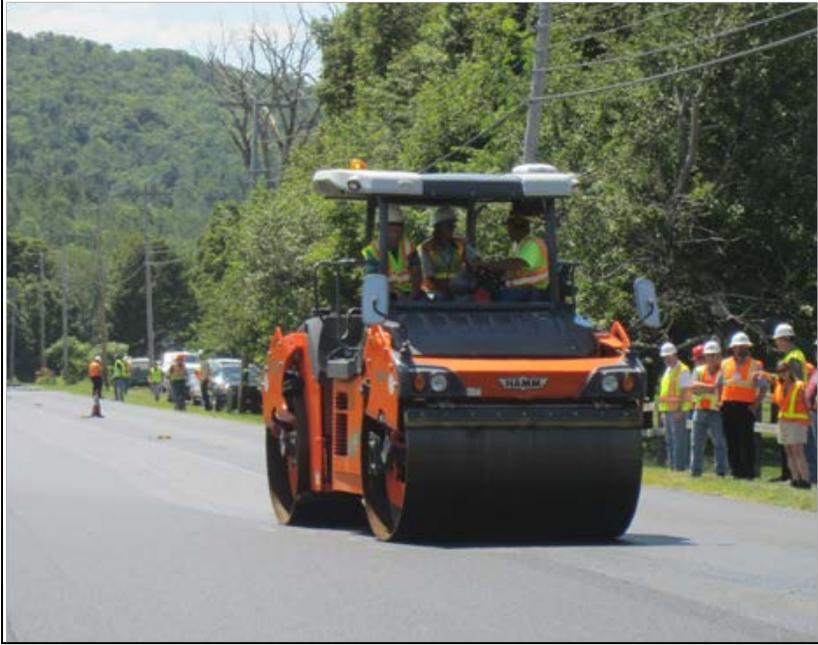
Figure 39. Participants on the IC roller to view real-time data on display screen.

1. The HAMM IC roller (see Figure 39). This technology was of the most interest to many of the participants, who were able to ride with the roller operator to view the display screen while the roller was in operation.
2. WMA foamed mixture being delivered to and placed by the paver. Most of the questions about the WMA mixtures were addressed during the workshop question-and-answer period.
3. The paver with the Carlson Safety Edge device attached to the end plate of the screed (see Figure 40). Participants viewed geometry of the Safety Edge and adjustments that can be made to the Safety Edge during the paving operation.

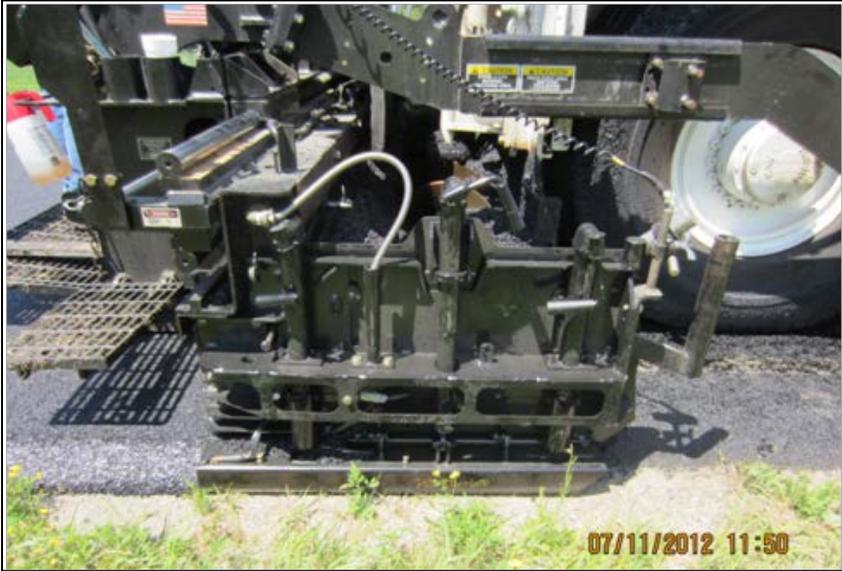
Figure 40. Closeup of Carlson Safety Edge device attached to the end plate of the screed.

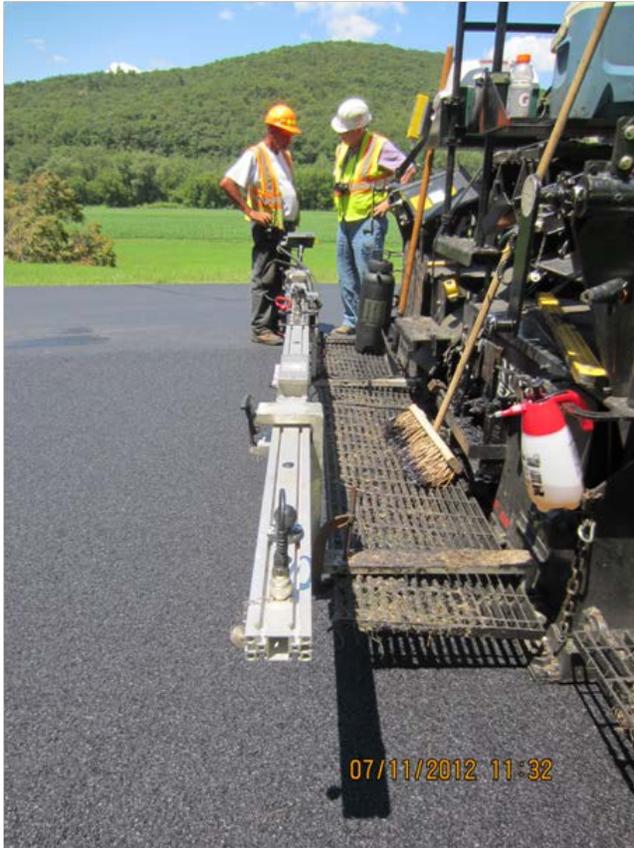
Figure 41. Participants viewing the mat surface temperatures displayed on the screen of the IR bar attached to the platform behind the screed.

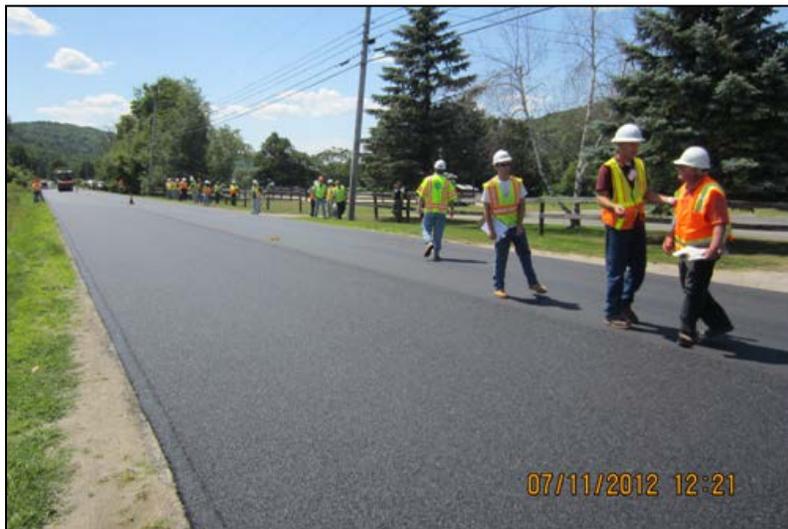
Figure 42. Participants and construction team members inspecting the longitudinal construction joint.

4. The IR bar attached to the back of the screed and used to monitor temperatures across the entire mat and along the roadway (see Figure 41). Participants viewed the display screen as the paver moved down the roadway.
5. Longitudinal construction joint. Participants were also interested in the details and equipment used to place and compact the longitudinal construction joint (see Figure 42).
