Evaluation of Bridge Abutments, Retaining Walls, and Barrier Walls along the Post Road Ext. near Providence, Rhode Island

Petrographic Evaluation

ASR Development and Deployment Program
Field Application and Demonstration Projects

U.S. Department of Transportation
Federal Highway Administration

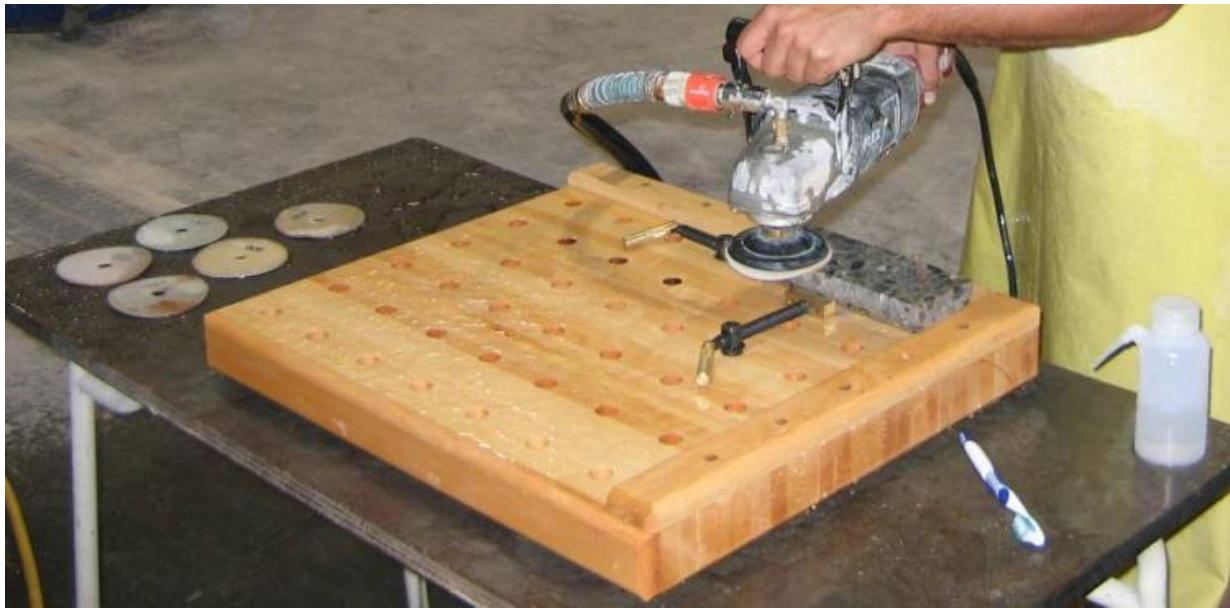
Figure 1 : Polishing process of the concrete specimens for the Damage Rating Index.

The portable hand-polishing device (Figure 1) uses a series of diamond-coated rubber disks to ensure progressive polishing from coarser to finer sizes (i.e. from disks no. 50 (coarse), 100, 400, 800, 1500 to 3000 (very fine)). The polished sections are then photographed and a grid is drawn on the section, which includes a minimum of 200 grid squares, 1 cm by 1 cm (0.4 by 0.4 in) in size (Figure 2). Each grid square is then examined under the stereomicroscope to determine the *Damage Rating Index* (DRI) (Figure 3).

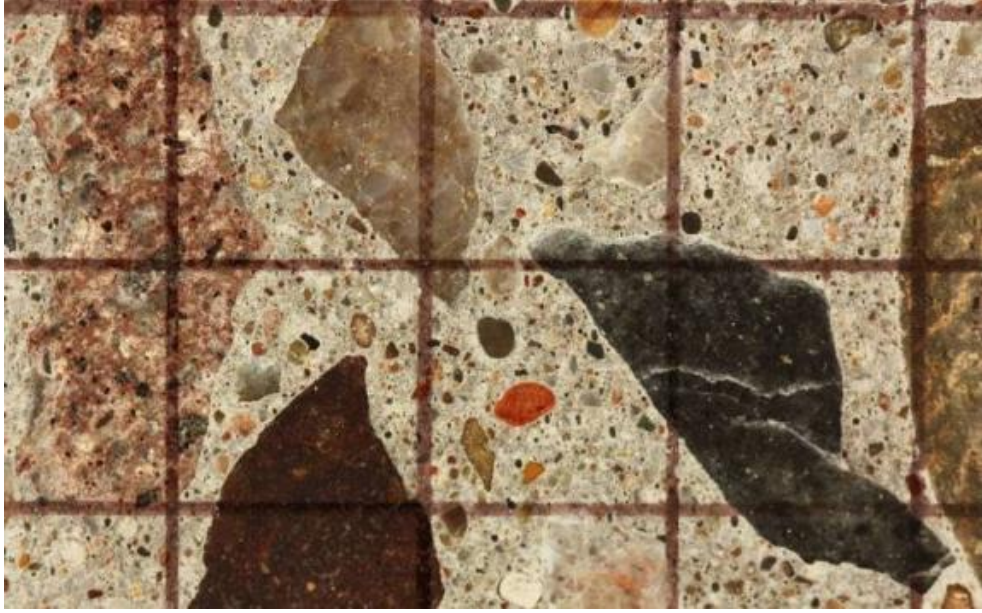
Figure 2 : One cm by one cm grid drawn at the surface of the polished concrete section for petrographic examination using the DRI method.

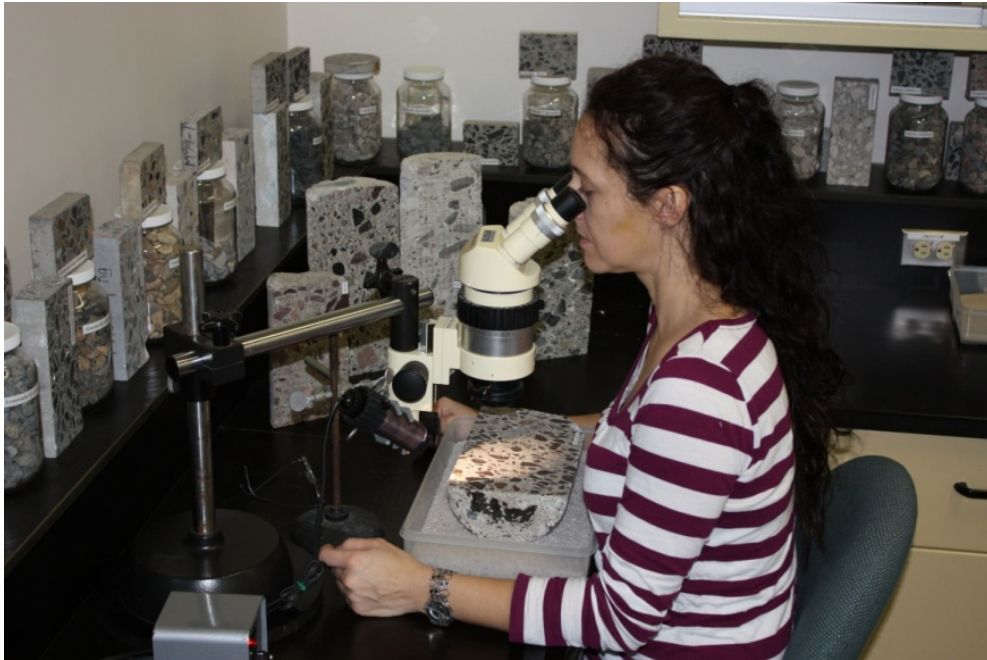
Figure 3 : Examination of the polished concrete section under the stereomicroscope for the determination of the Damage Rating Index.

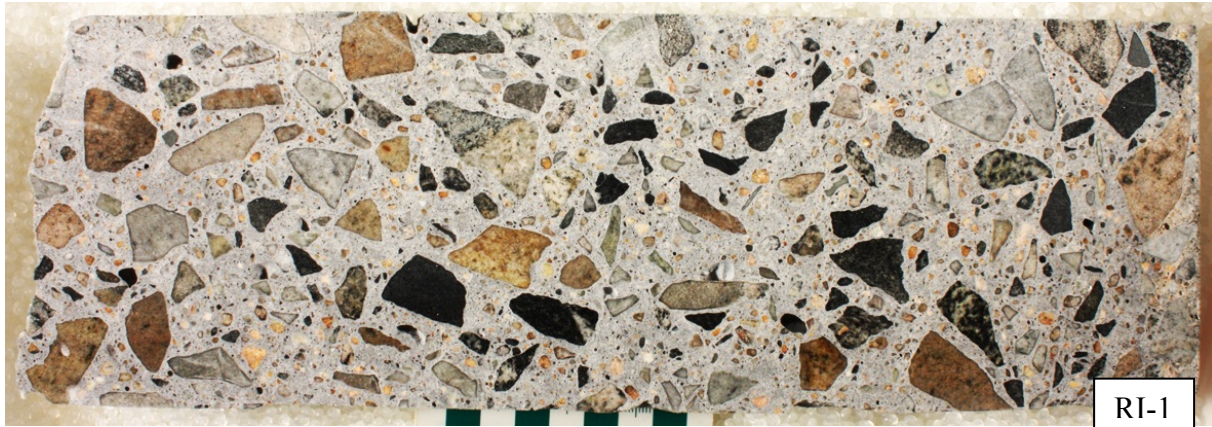
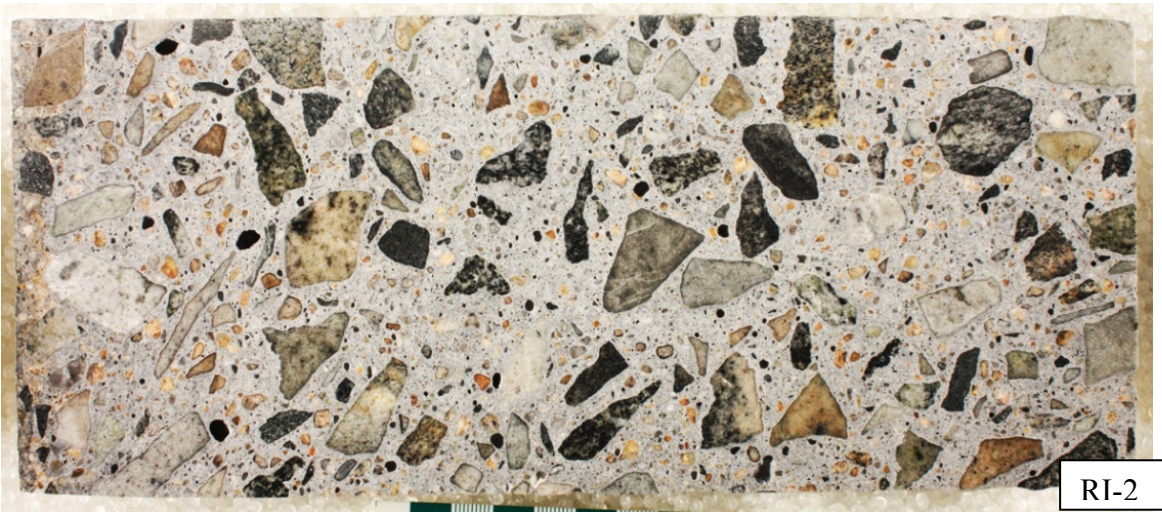
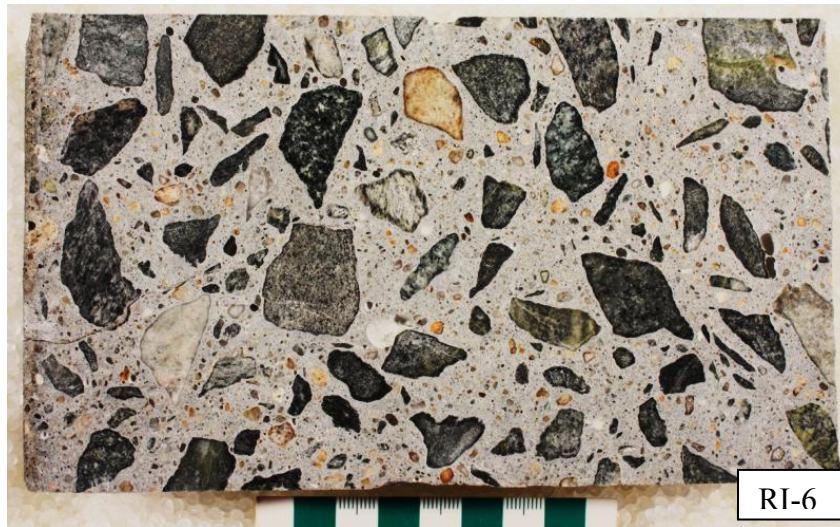
Figure 5 : Polished concrete sections from Rhode Island DOT.

Figure 5 (cont'd): Polished concrete sections from Rhode Island DOT (cont'd).

As illustrated in Figures 5 and 6, with Damage Rating Indices ranging from 129 to 546, the polished concrete sections of the Rhode Island DOT cores show low to moderate degree of deterioration/damage due to ASR. Details of the DRIs and micrographs of the polished sections can be seen in the Appendix B, Figures B1 to B14.

As illustrated in Figures 5 and 6, the polished concrete sections RI-1 and RI-2 show limited signs of damage/deterioration. Damage Rating Indices of 129 and 157 were obtained for those cores, respectively, thus indicating a low degree of damage due to ASR. Details of the DRIs and micrographs of the above polished sections can be seen in the Appendix B, Figures B.1 to B.4.

As illustrated in Figures 5 and 6, the polished concrete sections RI-5 and RI-6, show noticeable but limited signs of deterioration. With Damage Rating Indices of 230 and 296, those two cores indeed show low to mild degrees of deterioration/damage due to ASR. Details of the DRIs and micrographs of the polished sections can be seen in the Appendix B, Figures B11 to B14.

With Damage Rating Indices ranging from 285 to 546, the polished concrete sections RI-3 and RI-4 show moderate to high degree of deterioration/damage due to ASR (Figures 5 and 6). Details of the DRIs and micrographs of the polished sections can be seen in the Appendix B, Figures B5 to B10.

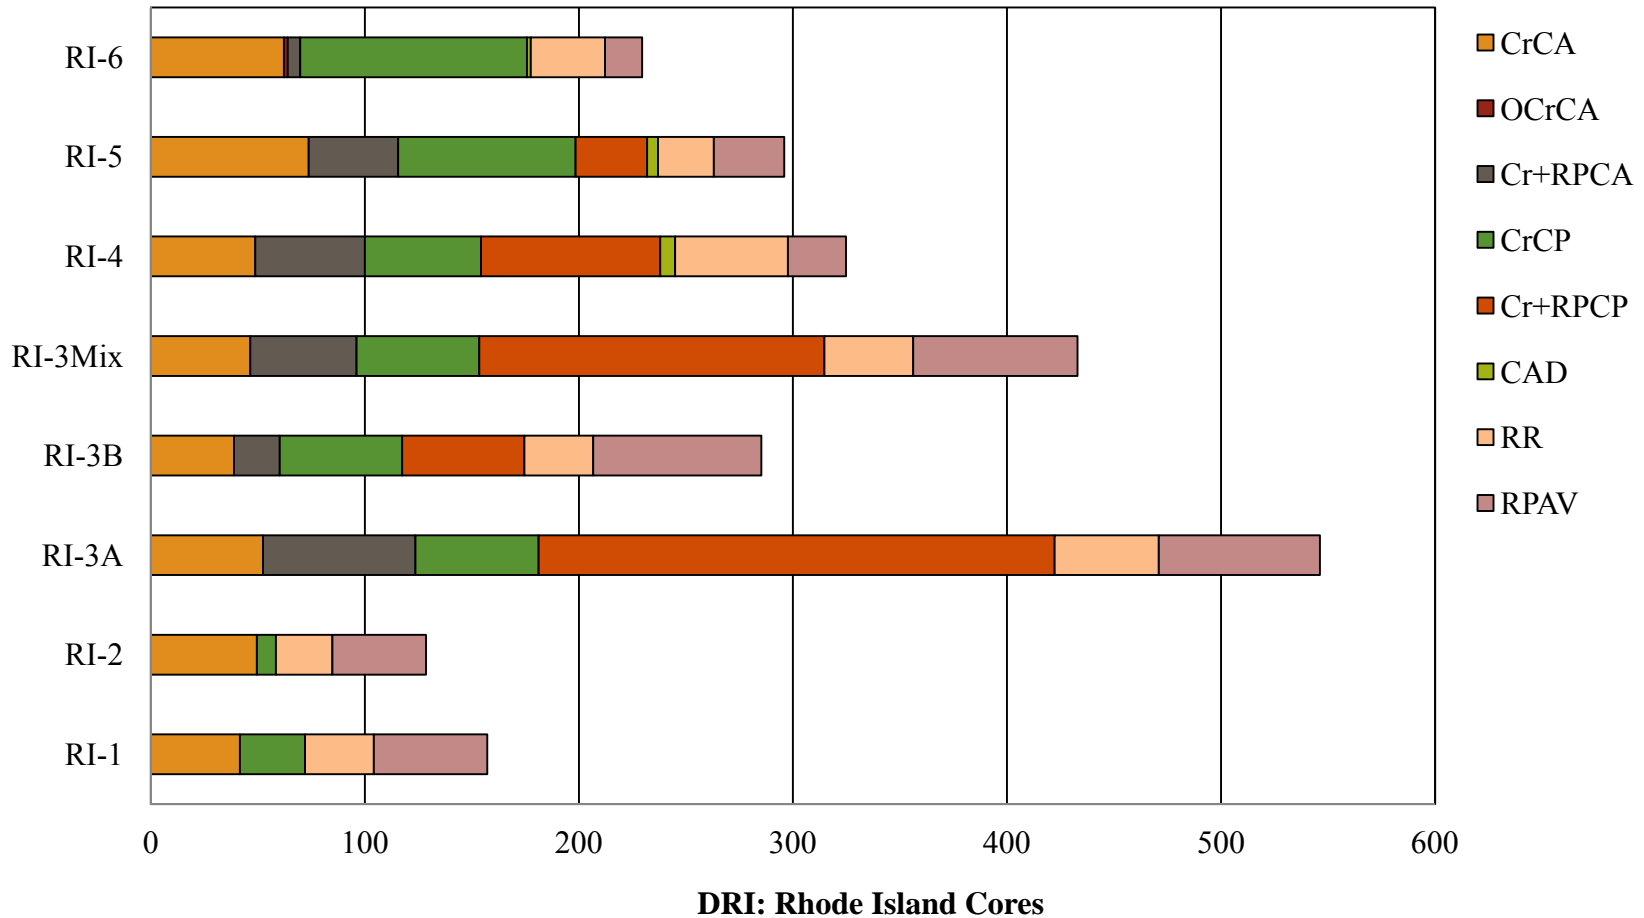
Figure 6 : Results of the Damage Rating Index (DRI) for the Rhode Island DOT cores.

As indicated in Table 4 and Figure 6, the highest contributor to the DRI for this set of cores is *Cracks in the cement paste, with or without reaction product (CrCP, CrCP+RP)* (7 to 55%). Widths of cracks in the cement paste vary from 0.05 to 0.1 mm. Those cracks are not always filled with ASR products and show some signs of carbonation (i.e. for those cracks penetrating from the surface of the cores).

Globally, *cracks in the aggregate particles, with or without reaction product (CrCA, OCrCA, CrCA+RP)*, represent the second most important petrographic sign of damage in the Rhode Island DOT cores (22 to 39%). Air voids in the cement paste are frequently lined or even filled with secondary products (*RPAV*), either ettringite (mainly) or alkali-silica gel. Dark (reaction) rims are observed around a fair number of coarse aggregate particles, and are present in most of the cores examined. The presence of reactions products in voids, as well as reaction rims, are however not indications of “damage” in the concrete.

The aggregate materials in the cores RI-1 and RI-2 show a variety of petrographic types/compositions (quartzitic sandstone/quartzite, granitic gneiss). As indicated in Table 4 and Figure 6, the highest contributors to the DRI for this set of cores are *Cracks in the aggregate particles (CrCA)* (26-39% of the DRI), *Air voids lined of filled with reaction product (RPAV)* (34% of the DRI), and *Reaction Rims (RR)* (20% of the DRI). This means that more than 50% of the DRI values for those two cores correspond to petrographic features (RPAV and RR) that are not a direct indication of “damage”.

The aggregate material observed in the above two cores show a variety of petrographic compositions/types (quartzitic sandstone/quartzite, granitic gneiss, schist), as for the first set of cores (RI-1 and RI-2). As indicated in Table 4 and Figure 6, the highest contributors to the DRI for this set of cores are *Cracks in the cement paste with or without reaction product (CrCP – CrCP+RP)* (40 to 55% of the DRI), *Cracks in the aggregate particles with or without reaction product (CrCA – CrCA+RP)* (22 to 23% of the DRI) and *Air voids lined or filled with reaction product (RPAV)* (8 to 28% of the DRI). Widths of the cracks in the cement paste vary from 0.05 to 0.1 mm, with typical opening of 0.1 mm.

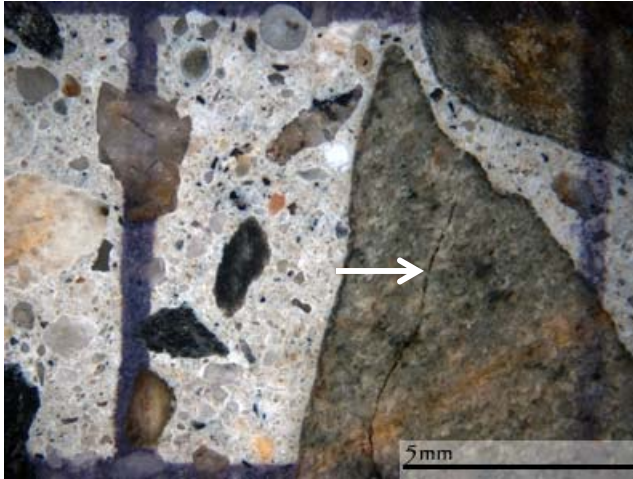
Figure 7 : Example of the petrographic features identified in the Rhode Island concrete cores. A-B: Crack in coarse aggregate particles; C-D: Cracks with reaction product in coarse aggregate particles; E-F: Cracks in the cement paste.

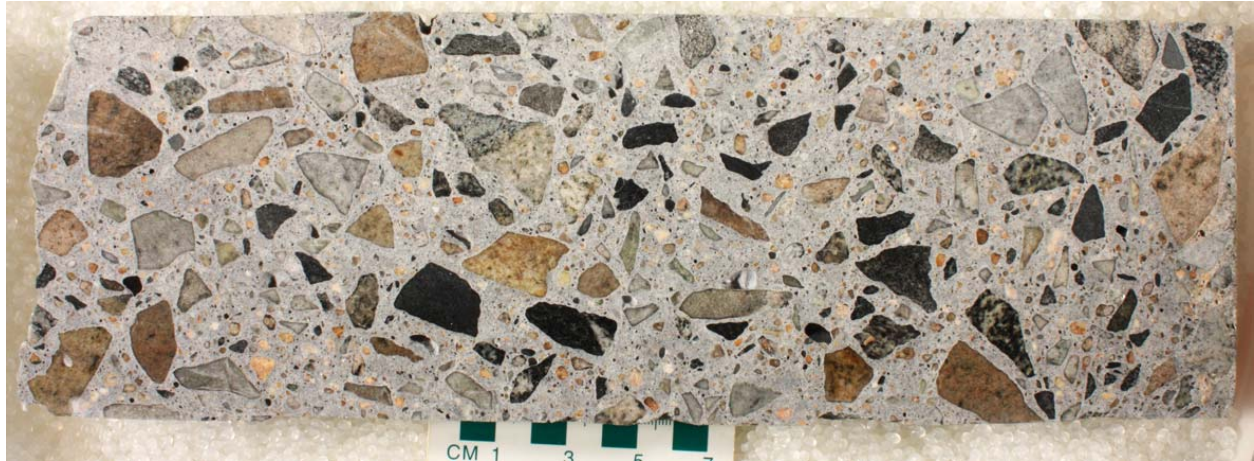
Sample	Feature	Cracks in the aggregate particles			Crack in the cement paste		Other features			DRI Total
		CrCA	OCrCA	Cr+RPCA	CrCP	Cr+RPCP	CAD	RR	RPAV	
RI-1	DRI	42	0	0	30	0	0	32	53	157
	% of the DRI	26	0	0	19	0	0	20	34	100

Figure B. 1 : Polished core section RI-1 and DRI results

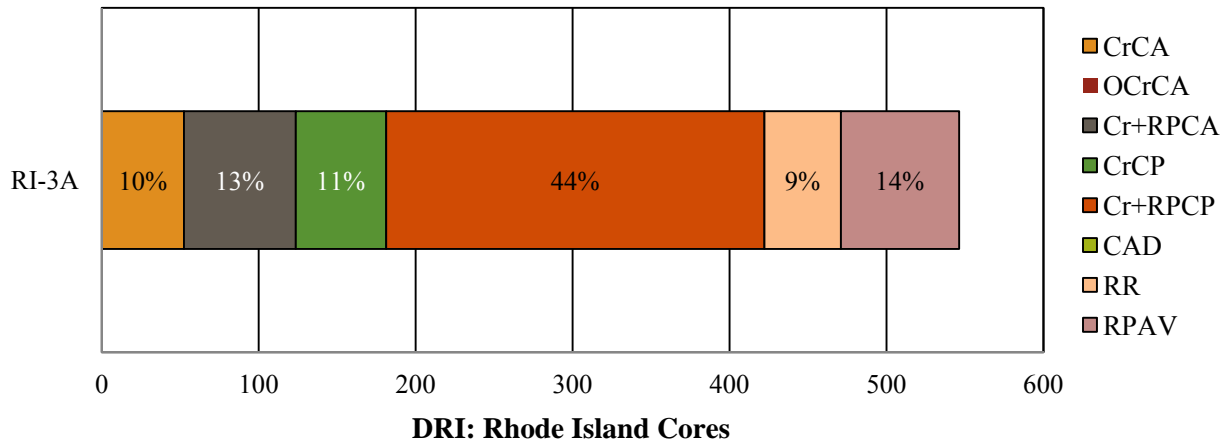
Sample	Feature	Cracks in the aggregate particles			Crack in the cement paste		Other features			DRI
		CrCA	OCrCA	Cr+RPCA	CrCP	Cr+RPCP	CAD	RR	RPAV	Total
RI-3A	DRI	52	0	71	58	241	0	49	75	546
	% of the DRI	10	0	13	11	44	0	9	14	100

Figure B. 5 : Polished core section RI-3A and DRI results

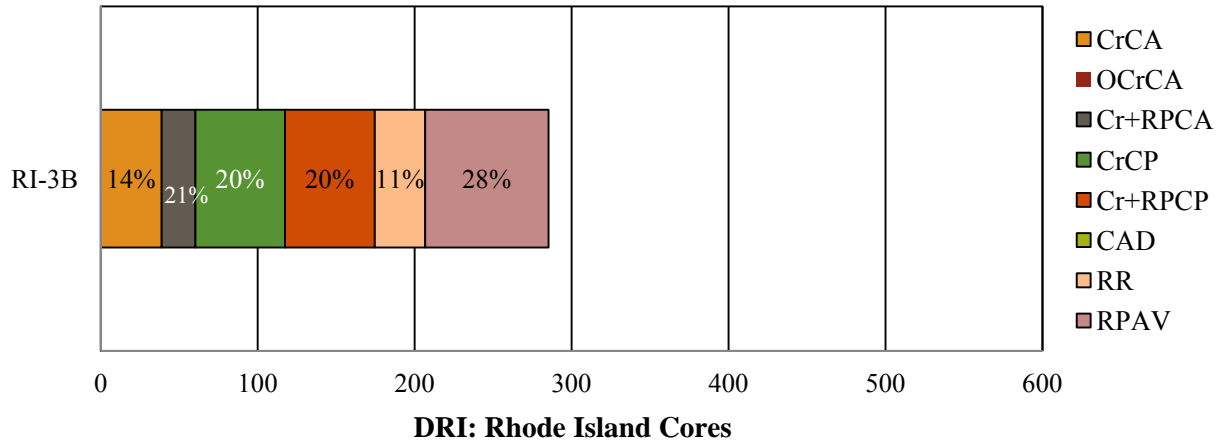
Sample	Feature	Cracks in the aggregate particles			Crack in the cement paste		Other features			DRI
		CrCA	OCrCA	Cr+RPCA	CrCP	Cr+RPCP	CAD	RR	RPAV	Total
RI-3B	DRI	39	0	21	57	57	0	32	79	285
	% of the DRI	14	0	8	20	20	0	11	28	100

Figure B. 7 : Polished core section RI-3B and DRI results

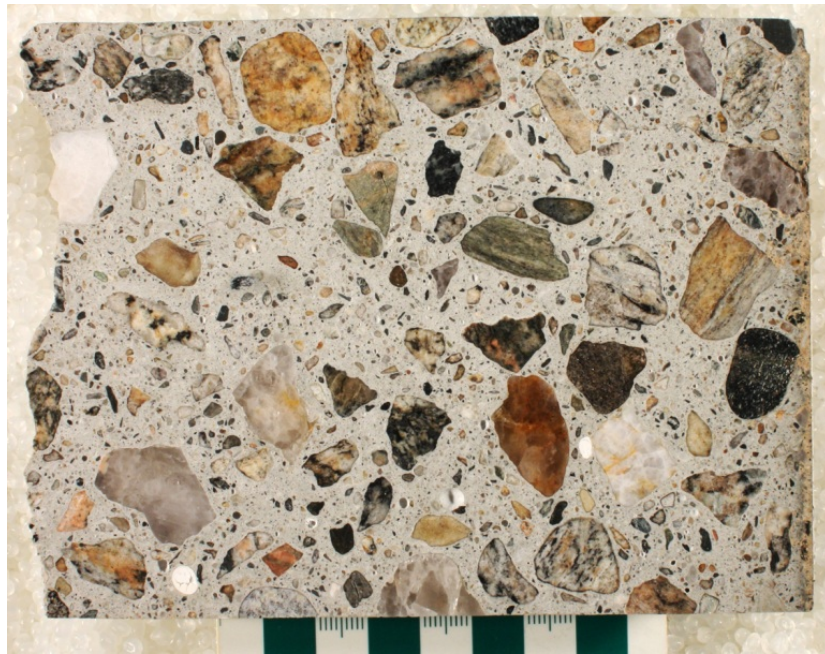
Sample	Feature	Cracks in the aggregate particles			Crack in the cement paste		Other features			DRI
		CrCA	OCrCA	Cr+RPCA	CrCP	Cr+RPCP	CAD	RR	RPAV	Total
RI-4	DRI	49	0	51	54	84	7	53	27	325
	% of the DRI	15	0	16	17	26	2	16	8	100

Figure B. 9 : Polished core section RI-4 and DRI results

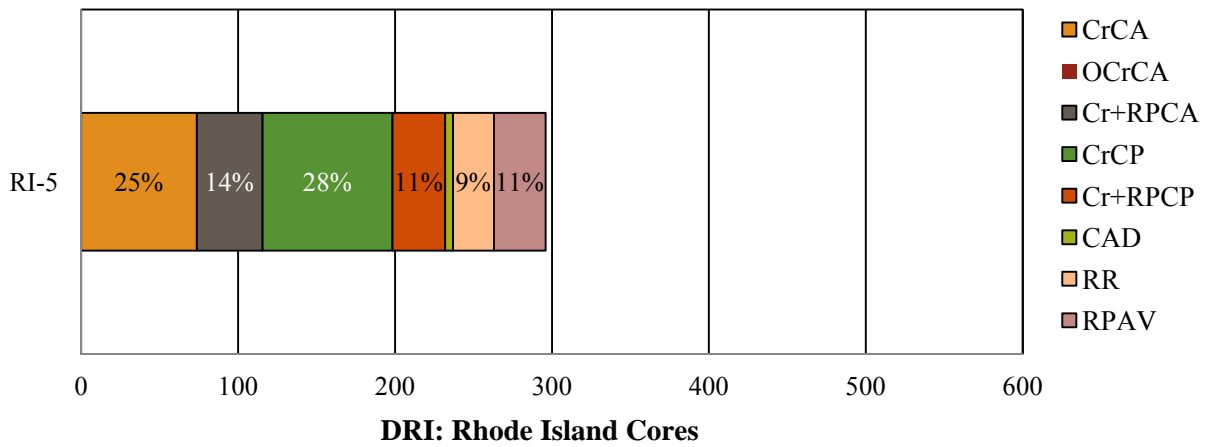
Sample	Feature	Cracks in the aggregate particles			Crack in the cement paste		Other features			DRI Total
		CrCA	OCrCA	Cr+RPCA	CrCP	Cr+RPCP	CAD	RR	RPAV	
RI-5	DRI	74	0	42	83	33	5	26	33	296
	% of the DRI	25	0	14	28	11	2	9	11	100

Figure B. 11 : Polished core section RI-5 and DRI results

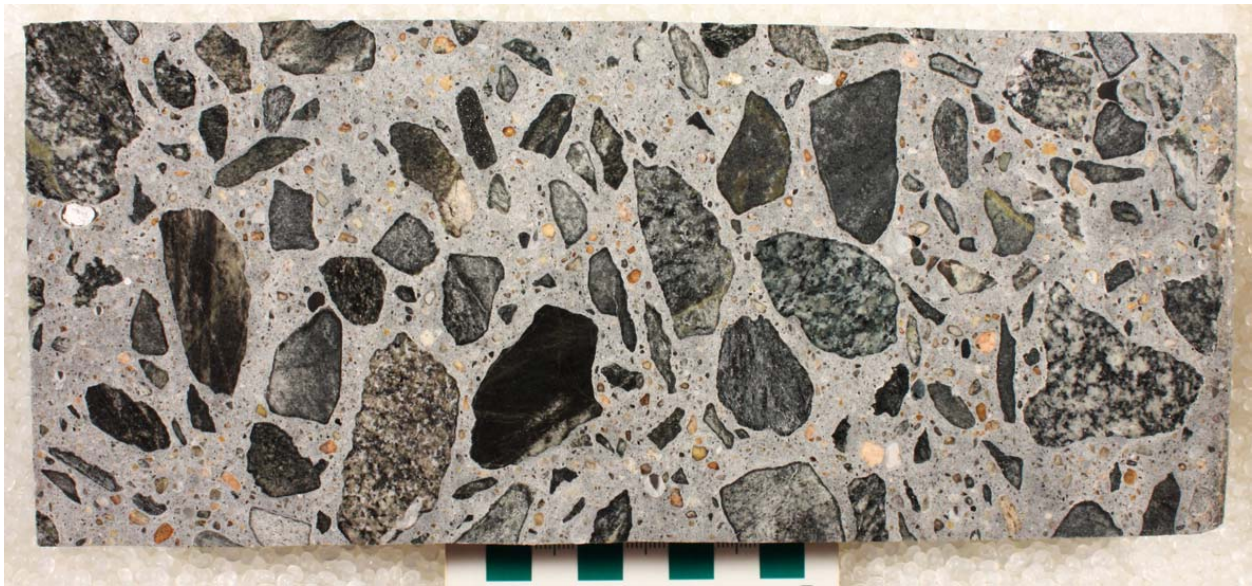
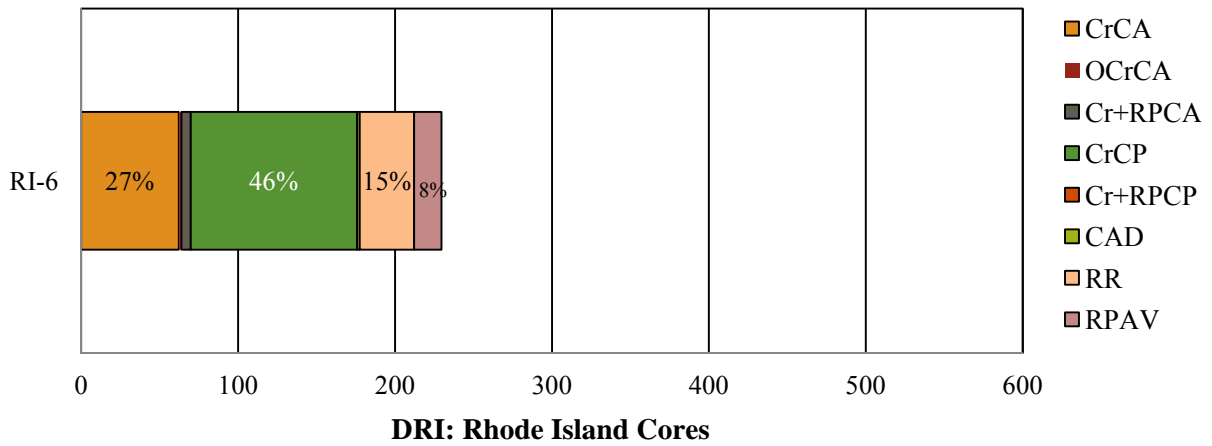
Sample	Feature	Cracks in the aggregate particles			Crack in the cement paste		Other features			DRI Total
		CrCA	OCrCA	Cr+RPCA	CrCP	Cr+RPCP	CAD	RR	RPAV	
RI-6	DRI	62	2	6	106	0	2	35	17	230
	% of the DRI	27	1	3	46	0	1	15	8	100

Figure B. 13 : Polished core section RI-6 and DRI results
