FHWA Workshop

Alkali-Aggregate Reaction

Session 08: Mitigation Measures Applied to ASR-Affected Structures

*Report on the Diagnosis, Prognosis, and Mitigation of
Alkali-Silica Reaction (ASR) in Transportation Structures
(Fournier et al. 2010)*

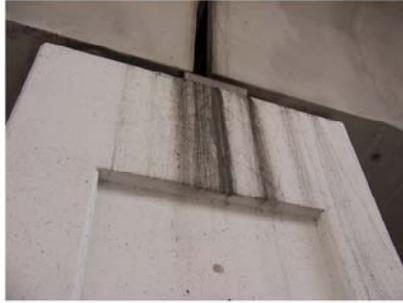
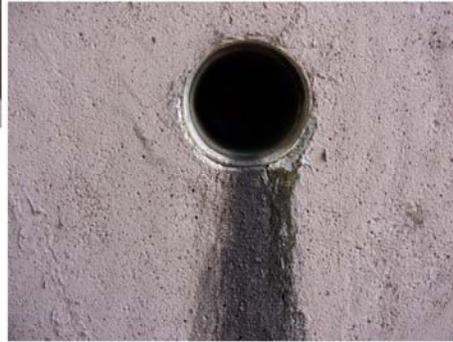
The case for improved drainage....

Improving the drainage of water away from ASR-affected structures is a simple, yet effective, method of reducing the internal relative humidity in concrete.

This slide shows a large reinforced concrete column that contained an internal drain pipe taking water from the deck above, through the column, to drainage pipes below the footings. However, upon examination, this drain pipe was clogged – simply unclogging the drainage pipe and restoring adequate drainage helped to reduce the availability of water to this ASR-affected column.

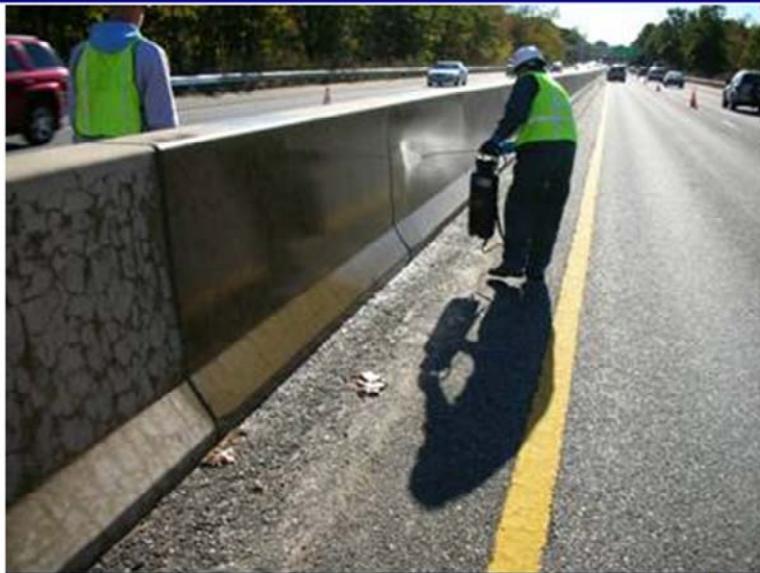
Applying silane to highway barriers near Boston

This photo shows the topical application of silane to highway barriers in Leominster, MA.

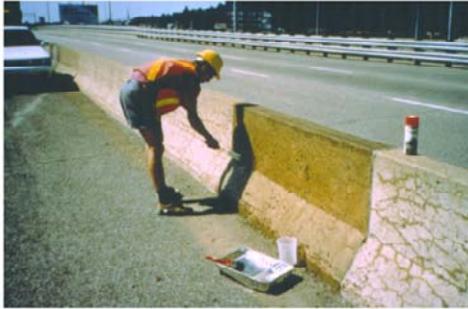
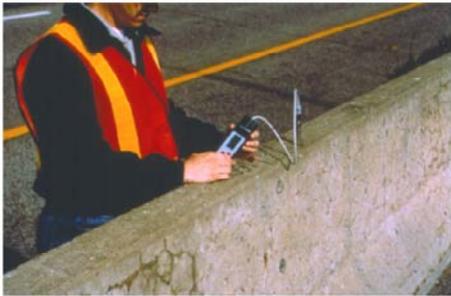
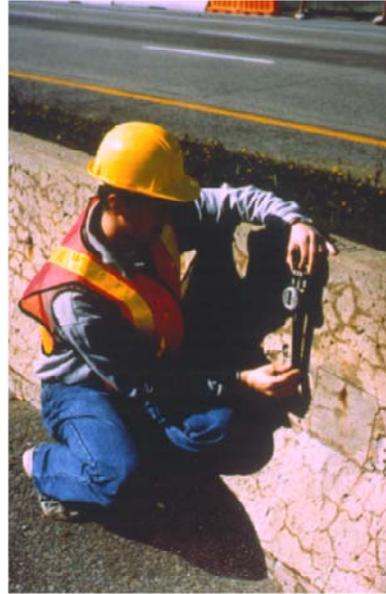
Use of Sealers (Quebec City)

The highway barriers near Quebec City that were treated with silanes (and other products) were monitored for long-term expansion, crack development, and internal relative humidity.

This graph shows that the application of silane to the highway barriers near Quebec City resulted in a lowering of the internal relative humidity.

The barriers treated with silane exhibit internal relative humidity values below 70 percent six years after treatment.

The control barriers still exhibit relative humidities above 80 percent, which is above the humidity level needed to sustain ASR-induced expansion.

Along with the reduced internal humidity came a reduction in the long-term expansion of the silane-treated barriers. In fact, after six years, the treated barriers had actually exhibited shrinkage, whereas the untreated barriers continued to expand during the monitoring period.

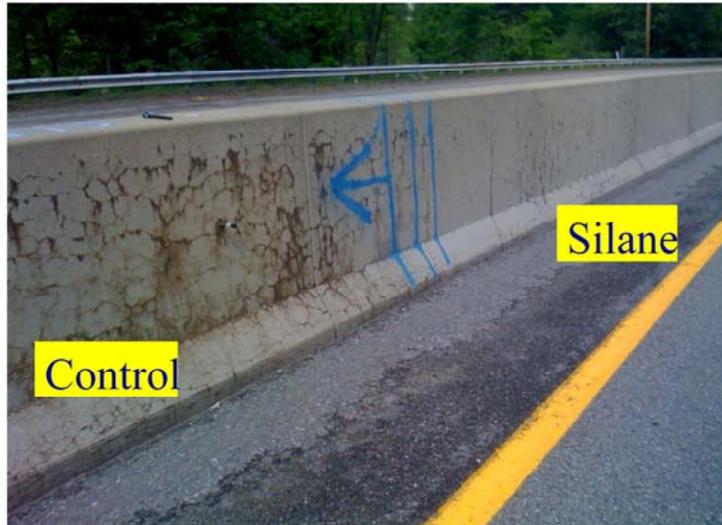
USA experience (FHWA trial in Massachusetts)

Coming back to the application of silanes under the FHWA project in Massachusetts, one can see that there is once again an obvious difference in the visual appearance of silane-treated and untreated barriers four years after treatment. Long-term monitoring has confirmed that the internal relative humidity has been reduced significantly for the silane-treated barriers.

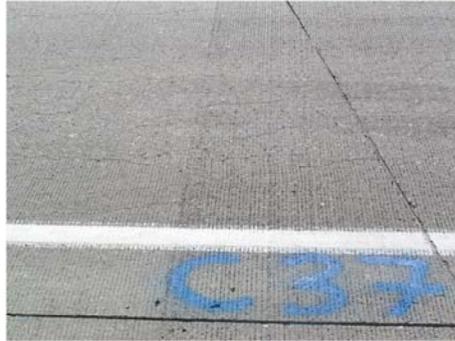
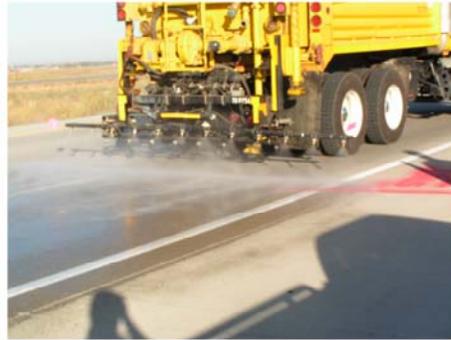
Field Studies – I94, Idaho

- 5-km section of I94 treated in Sept 2004 – 0.24 L/m² (6 gal/1000 ft²)
- Approx. 2/3 pavement area treated a second time in May 2005
- Approx. 1/3 pavement area treated a third time in Oct 2005
- Low, moderate & high severity of ASR

In 2004, a large field trial was performed on ASR-affected pavements in Idaho (I94 in Mountain Home, ID). This study included the topical application of lithium nitrate, with various sections receiving different numbers of lithium applications (once, two or three topical applications). The trial also included various levels of ASR-induced damage within the test section (labeled as low, moderate, and high severity of ASR).

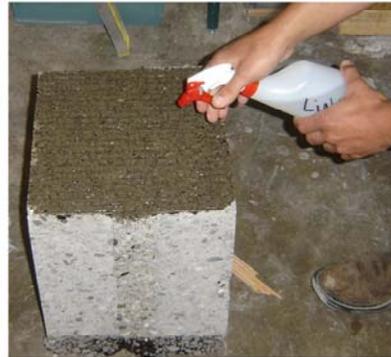
Beams at University of Texas in Austin

- 15 beams placed on exposure sited
- Control, lithium treatment similar to I94 & continuous ponding
- 1 beam from each of the panels cut into three 1 x 1 ft x full depth sections and surface treated with 0.24 L/m² (6 gallons/1000 ft³)
- Various pre- & post-treatments with water
- Cores extracted for lithium profiling

To complement the field trial in Idaho, the FHWA research team was able to procure full-depth beams from within the ASR field trial section. These beams were then cut into sections measuring 1 ft x 1 ft x full depth. Lithium nitrate was then applied to various beams, with concrete ranging from low to moderate to highly damaged, and with various numbers of lithium application. In total, nine beams were treated and then the concentration of lithium as a function of depth was determined for each beam, as shown on the next slide.

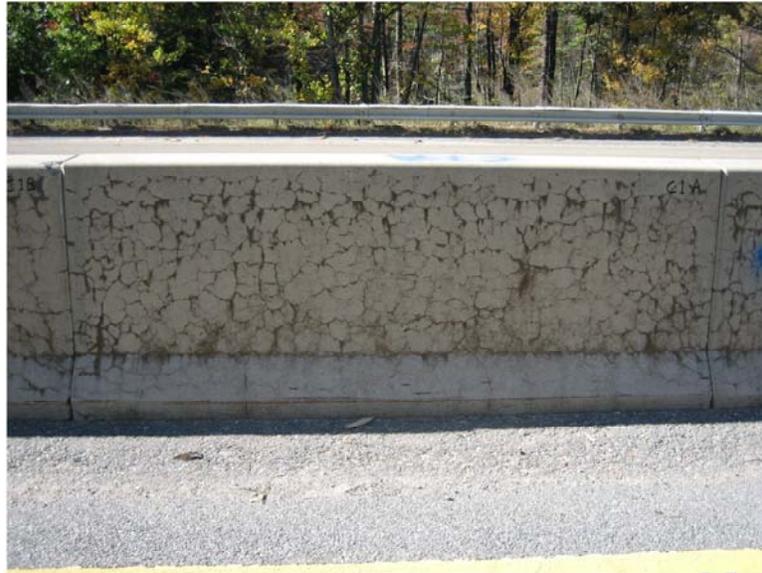
Field Studies – Barrier Wall, Leominster, MA

After completing the Idaho field trial, the FHWA research team initiated a comprehensive field trial on highway barriers in Leominster, MA. This trial included the application of lithium nitrate (topical and vacuum), and the topical application of various silane-based products. Following are the results of applying lithium nitrate to these barrier walls, with discussion first on topical application and then on lithium applied via vacuum.

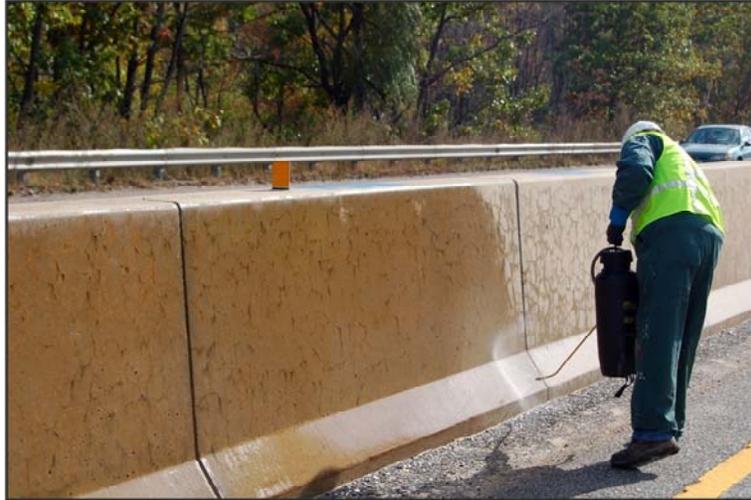
Topical application of lithium nitrate

This photograph shows FHWA researchers applying a 30% lithium nitrate solution topically to the barriers in Leominster, MA.

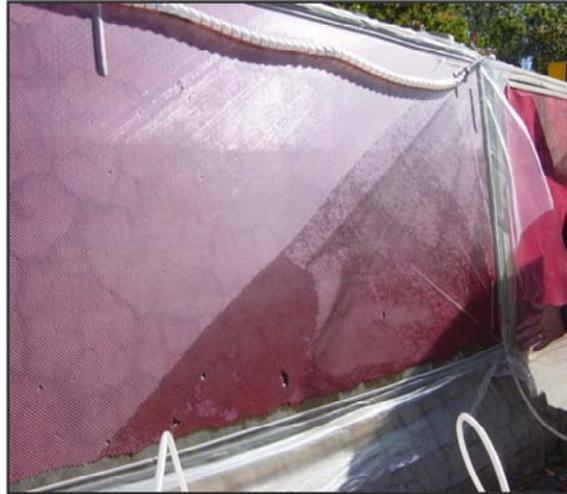
Vacuum Treatment

Because only minimal depths of penetration were observed in previous field trials when lithium was applied topically, it was decided to try more aggressive means of driving lithium into concrete. A contractor who has years of experience in vacuum impregnating concrete with various products (mainly epoxy-based) was hired to attempt to drive lithium into these test barriers using a vacuum impregnation process. The photograph above shows the vacuum impregnation process. Different sections were treated with different levels of vacuum impregnation, ranging from holding a vacuum for only a few minutes to several hours.

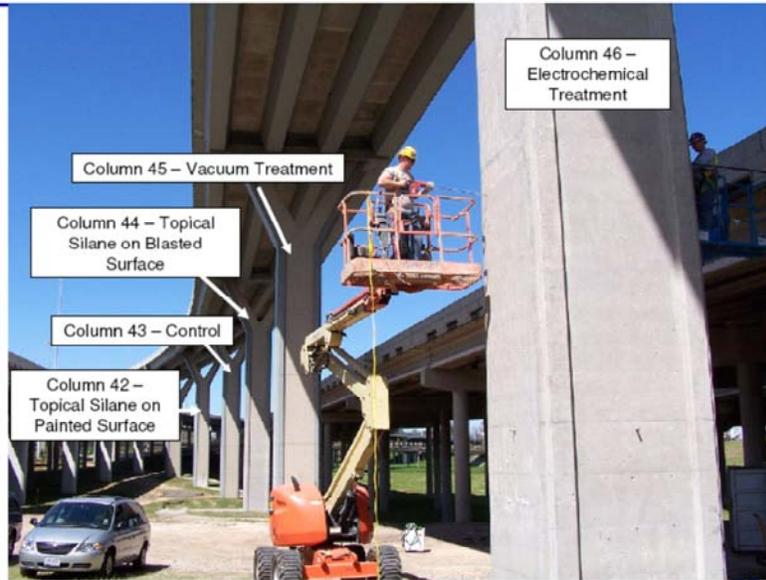
Houston columns – field trial

This graph shows the results of the vacuum application of lithium nitrate to an ASR-affected column in Houston, TX. The contractor hired for this field trial had previous experience with vacuum impregnation for repair applications, including the application of lithium nitrate to ASR-affected concrete.

For the first time, significant lithium concentrations were observed beyond the near-surface region. Lithium concentrations well above the threshold lithium content (0.01 percent by mass) were detected all the way down to the surface of the steel.

However, what is concerning is that the creation of OH ions at the surface of the rebar, due to the electrochemical treatment, appears to be causing the sodium and potassium, already present in the concrete pore solution, to migrate to the rebar surface. This could potentially worsen the ASR potential at the rebar surface as the higher alkali contents may exacerbate ASR-induced expansion and cracking.

This table summarizes the depth of lithium penetration measured on various cores extracted from FHWA field trials in recent years. The data that were the most promising were for the electrochemical treatment of the Houston columns – lithium was found to be in concentrations well above the threshold 50 mm from the treated surface. Although this is quite encouraging, it still remains to be seen if the migration of sodium and potassium, originally from the concrete pore solution, to the surface of the rebar will potentially worsen ASR at the rebar/concrete interface.

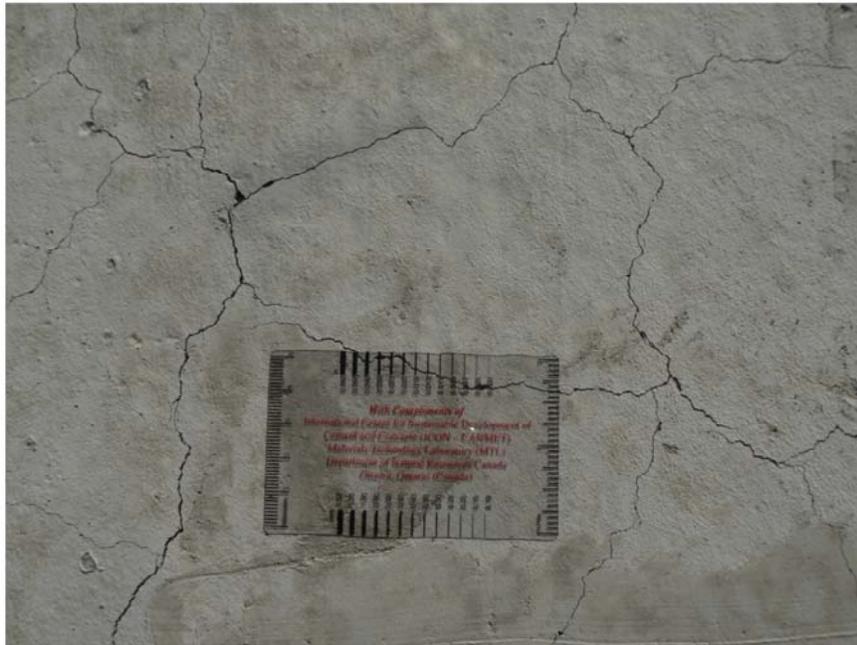
Jobe control

As a follow-up to the field trials, the FHWA-funded researchers cast a series of outdoor exposure blocks, containing a highly-reactive sand from El Paso. Three blocks were cast in total – one served as a control, one was sprayed once a week with lithium nitrate (for a total of 32 weeks), and one block was ponded continuously with lithium nitrate for 32 weeks. Expansion and cracking were then monitored for each of the blocks.

This slide shows the cracking observed on the control block – this block was never treated with lithium and serves as a point of reference for the slides that follow.

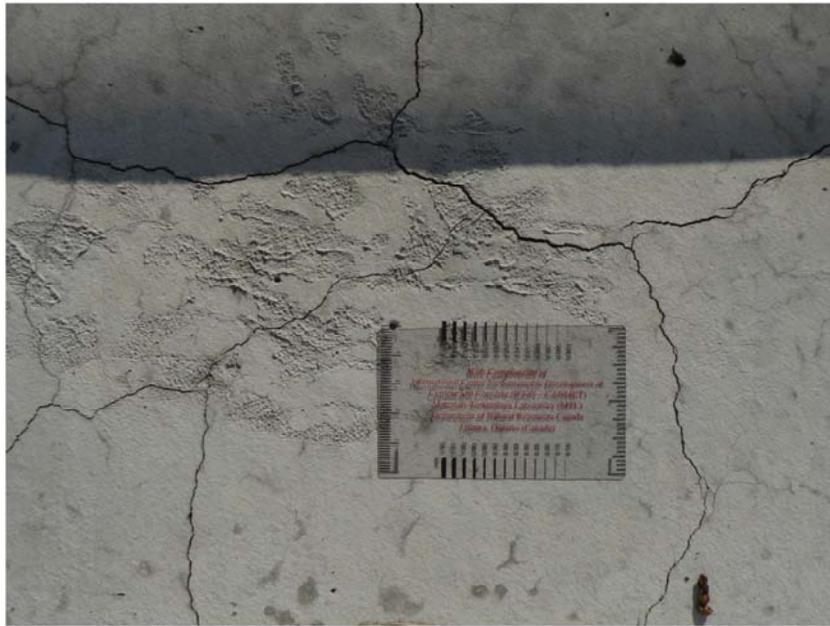
Jobe (ponded with lithium for 8 months)

Following up on this last slide, the block shown in this photograph is the block that was continuously ponded for 32 weeks with lithium nitrate solution. The cracking shown in this photo is comparable to the photo shown on the last slide of the control block.

It is quite interesting that even with continuous ponding for eight months with lithium nitrate solution, there was no visible benefit in terms of reduced cracking. Expansion data are provided later in this presentation.

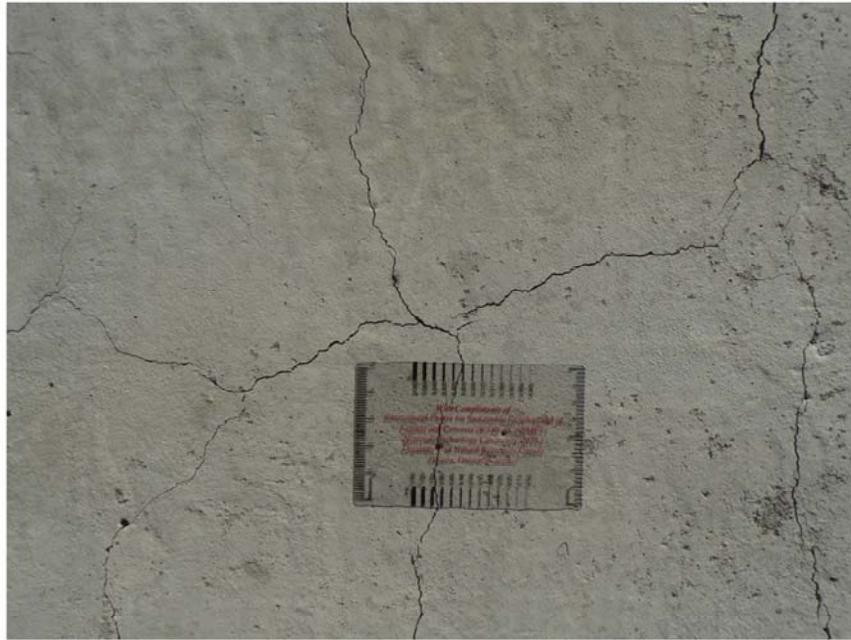
**Jobe (sprayed every week for 32 weeks –
4 gallons per 1000 sq. ft each treatment)**

This photo shows the top surface of the exposure block that was treated 32 times with lithium nitrate solution, over the course of eight months. There was very little, if any, difference between the cracking observed for this block and the control block.

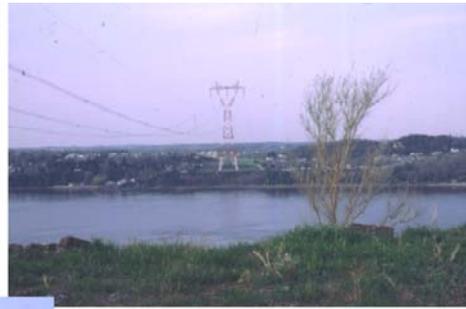
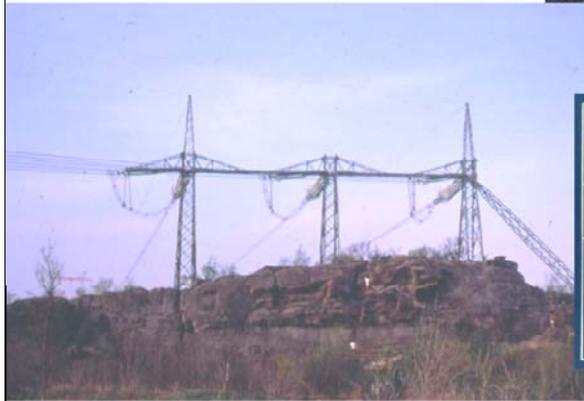
Hydro-Québec Transmission Tower Footings

The application of external restraint to ASR-affected structures is demonstrated in this slide and a couple that follow.

These slides describe work done by Hydro-Quebec in which various tower footings were repaired by removing the ASR-affected concrete, installing additional rebar, and casting a new, high-performance concrete around the original footing.

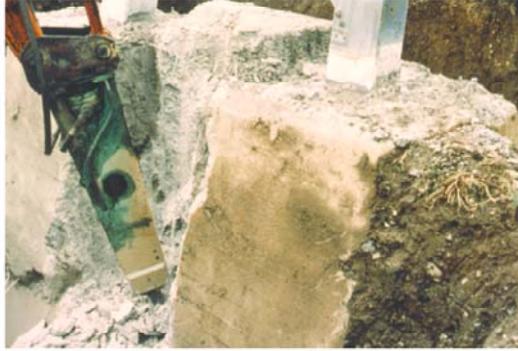
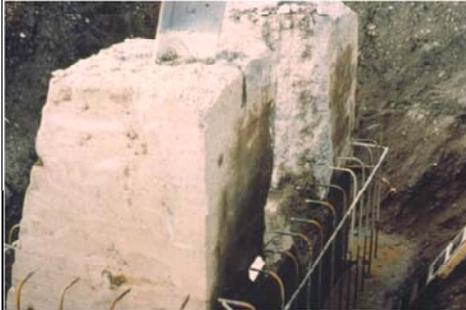
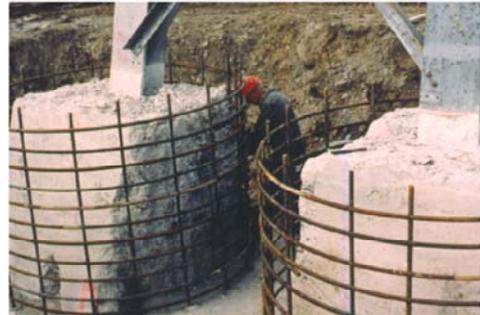
Management Actions

- Encapsulation with silica fume concrete
- Post-tensioning
- Other foundations: impermeable membrane

These photos show the removal of the damaged concrete and the placement of the rebar cage (around original footing).

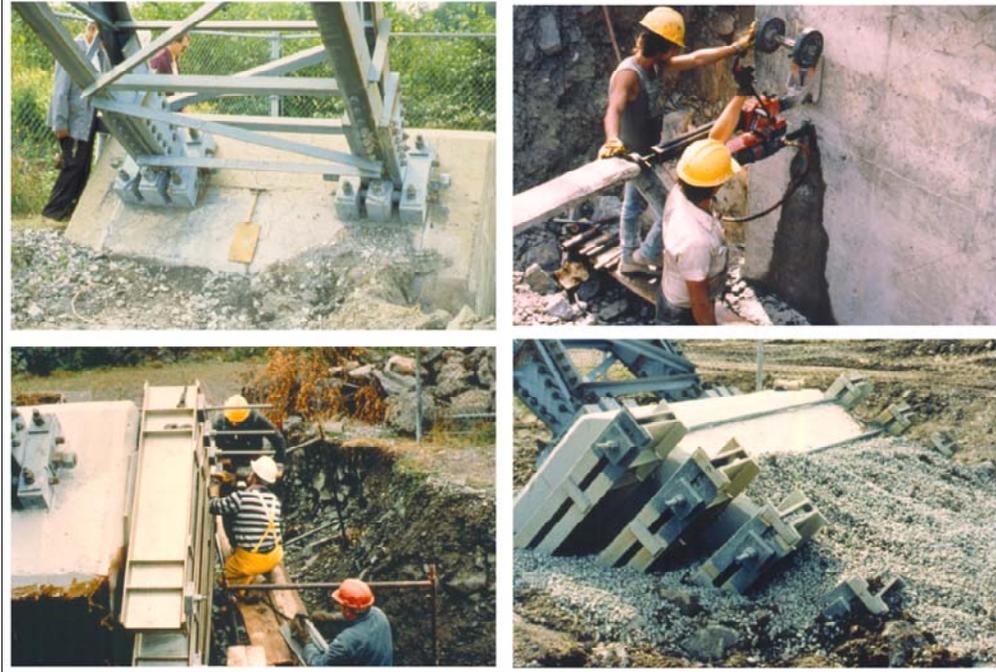
Post-Tensioning

Some of the damaged footings were also post-tensioned, as part of the repair regime. This post-tensioning was passed through the original footing and anchored and tensioned to provide active restraint.

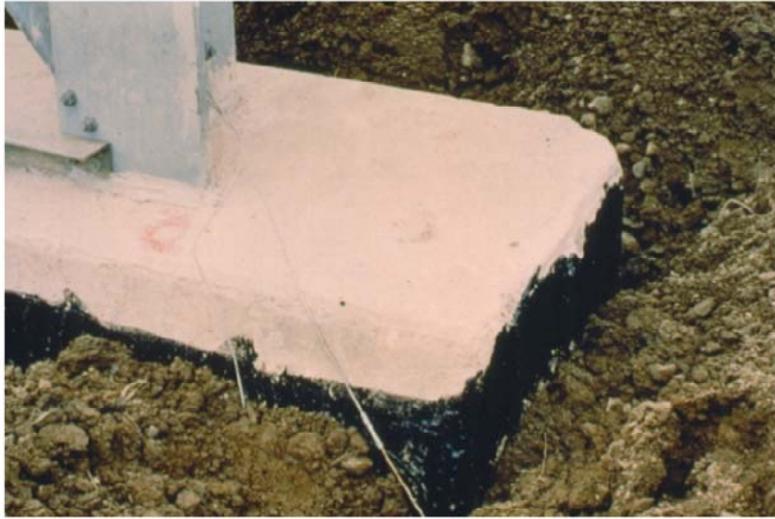
Membrane

Other footings from the same field trial were enveloped with a water-proofing membrane, with the overall objective of decreasing the availability of water to the ASR-affected concrete.

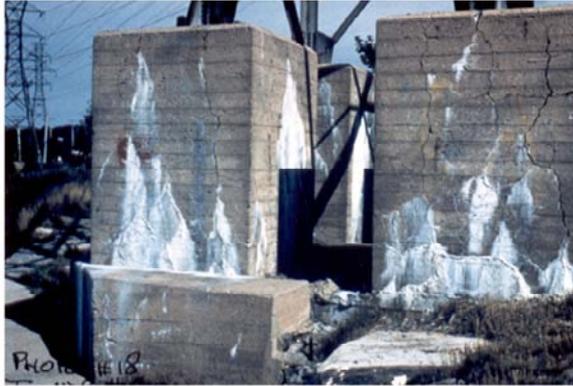
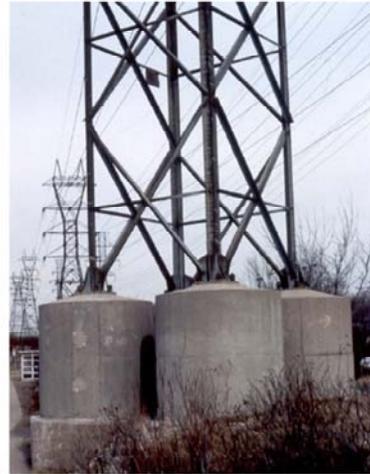
These are the before (left) and after (right) photographs of the repair of the ASR-affected footings using reinforced concrete encapsulation (around the original footing, after damaged concrete was removed).

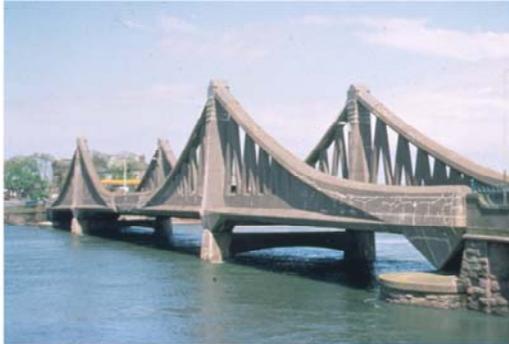
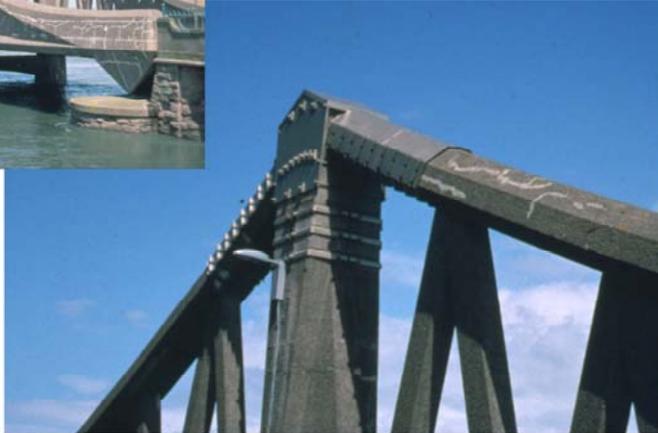
Application of physical restraint against expansion - strengthening with steel plates and drilled-through bolts - *Bridge affected by ASR in Scotland*

These photographs show another case study where external, physical restraint was applied to attempt to mitigate the effects of ASR damage in this arch bridge in Scotland.

In this case, as one can see in the photo on the right, steel plates and drilled-through bolts were used to physically restrain expansion near the top of the bridge.

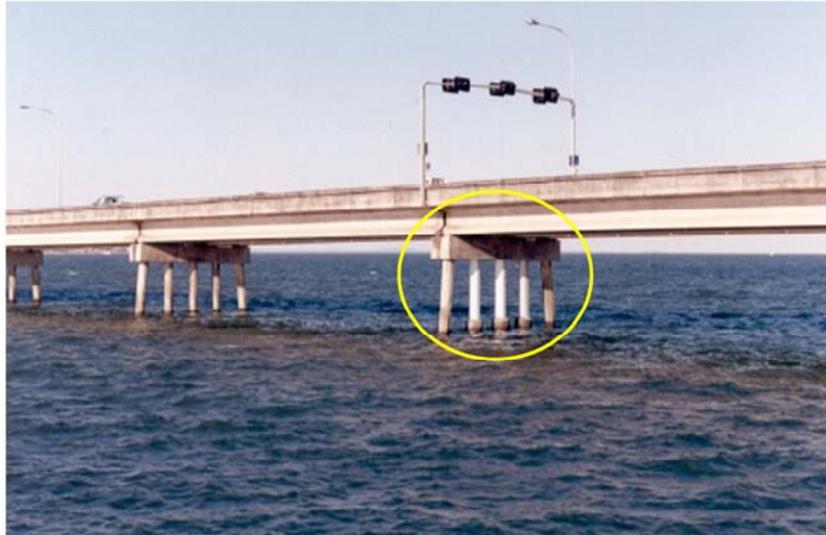
Bridge structure affected by ASR in Brisbane, Australia. The piles were wrapped with composite materials. The piles selected to be repaired by this method were those in which the ASR process was almost completed. It was also selected to try to minimize further deterioration due to corrosion (exposure to marine environment)

This photograph shows a bridge in Australia in which the columns were suffering from ASR-induced expansion and cracking. Cracking was particularly of concern as the bridge is in a very aggressive environment, especially with regard for corrosion of the reinforcing steel.

FRP wraps were used for the columns as shown in the highlighted portion of this photo and the next slide.

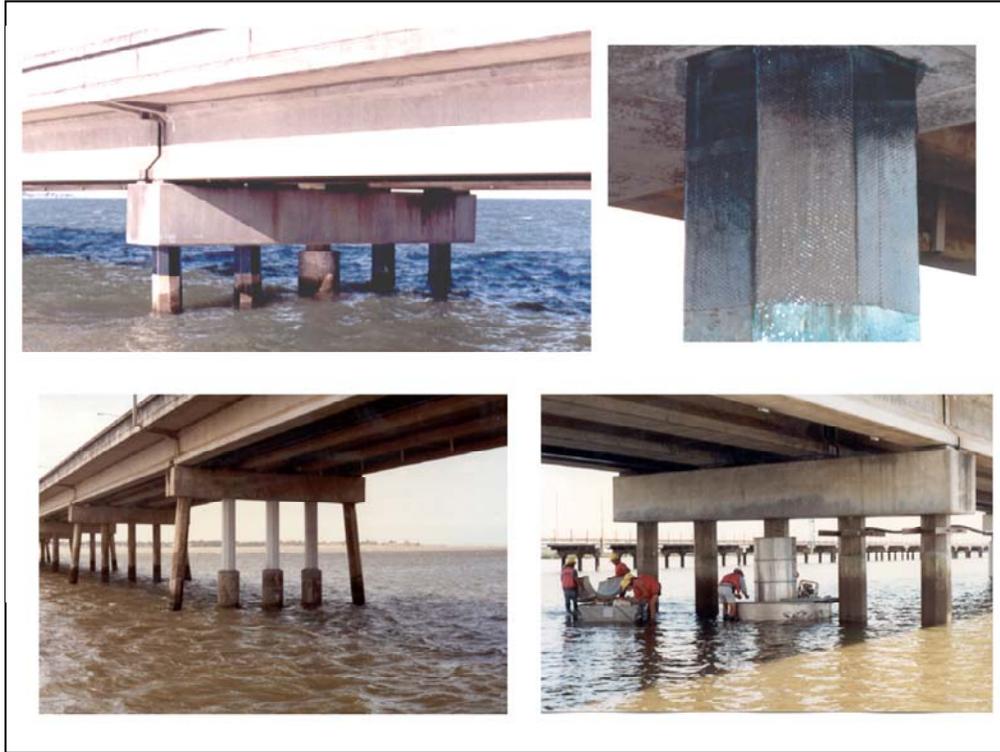
This slide shows the application of FRP wraps as a form of external restraint to ASR-affected columns. Again, this example is from a bridge in Australia.

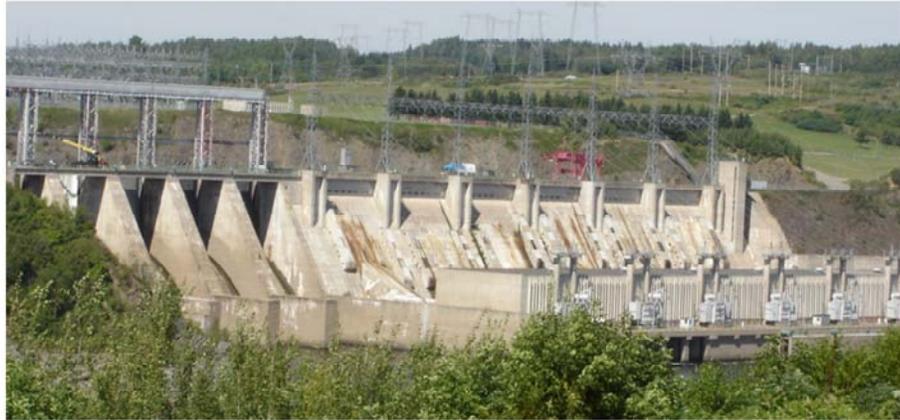
Repair – Relieving Stress

Aggregate passed ASTM C 227 – “non-reactive”

- Remediation due to ASR costs ~ \$6M per year
- Approx 18 inches of concrete removed from the intake structure
- Dam grown in height by approximately 7 inches

Another interesting technology that has been used in the Maқтаquac Dam is the use of stress relief in the form of “slot cutting.” What is done is a diamond wire is drawn through the entire cross section of the concrete dam, removing material as it goes through. The removal of this concrete helps to relieve the pressure that was accumulating, due to ASR-induced expansion. To date, about 18” of the dam has been removed in order to keep this dam in operation. This does nothing to address the root cause of ASR, but rather it just tries to lessen the impact of ASR on the operation and safety of this dam.

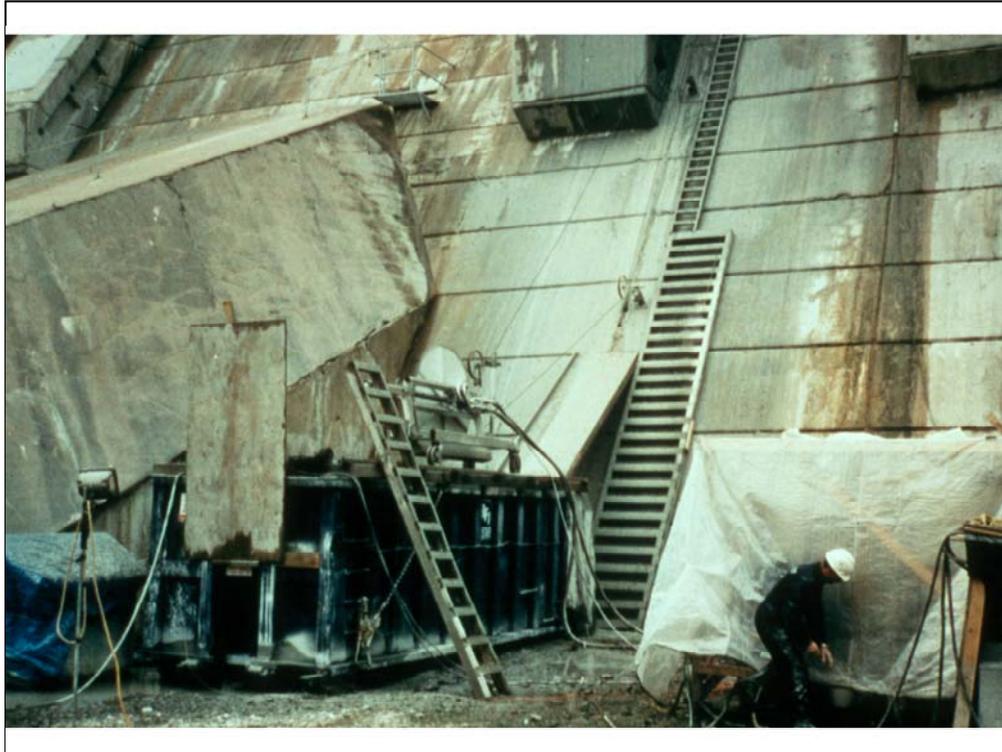
This photograph shows the equipment used for “slot cutting.” The procedure itself is not fancy, but it is effective.

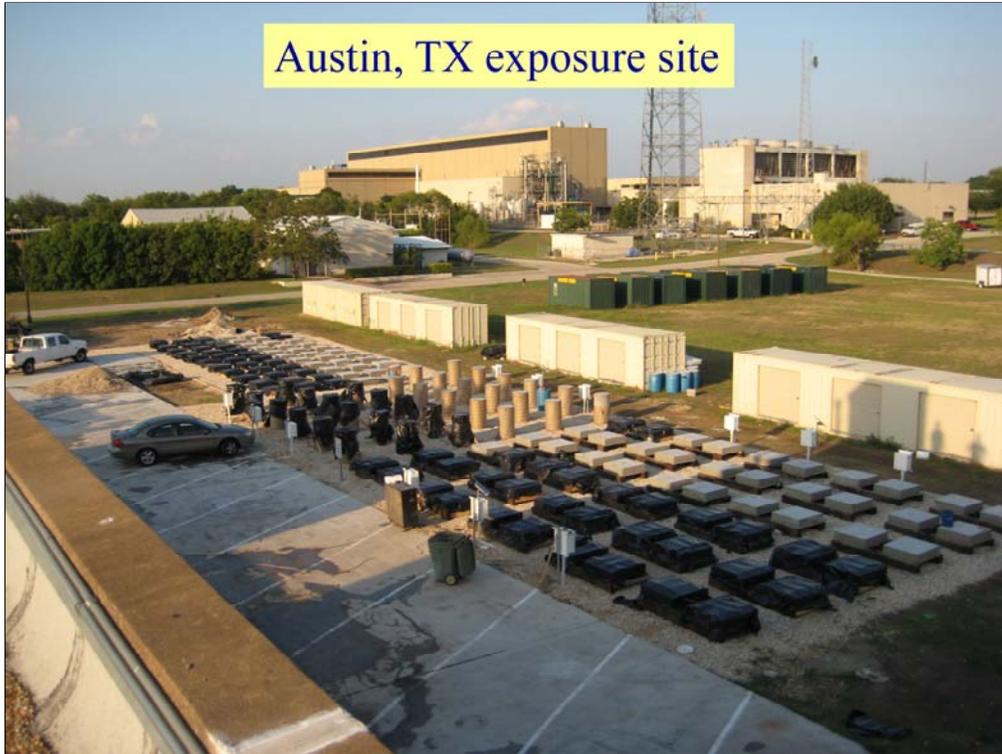
In addition to the field trials on existing structures, the FHWA research team has developed two outdoor exposure sites aimed at evaluating local aggregates and preventive measures – these studies are being performed in conjunction with state highway agencies in Hawaii and Massachusetts.
