TechBrief

NOVEMBER 2011 | FHWA-HIF-12-007

Jointed Full-Depth Repair of Continuously Reinforced Concrete Pavements

This TechBrief describes both conventional methods and an alternative method for making full-depth repairs in continuously reinforced concrete pavements. The alternative method, which does not utilize continuous longitudinal reinforcement in the repair area, is suitable for repairing a single lane (or two of three adjacent lanes), and results in repair areas that have performed well after several years.

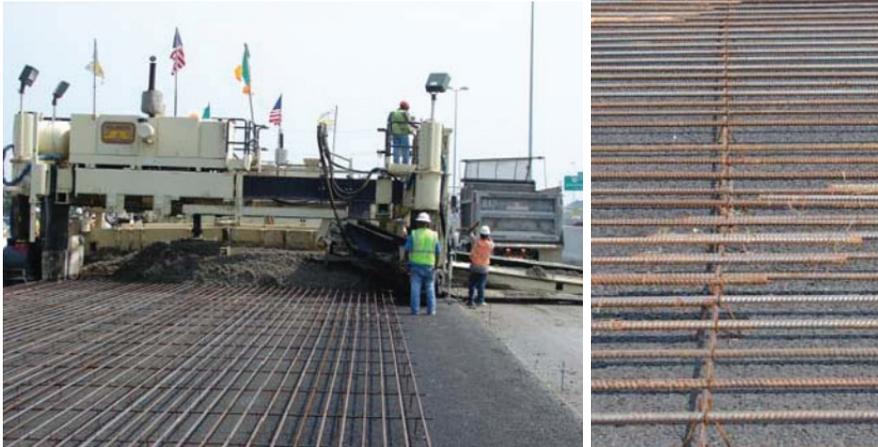
Figure 1. Steel reinforcement in CRC pavement (staggered laps of longitudinal bars shown on right).

A CRC pavement is a concrete pavement with continuous longitudinal steel reinforcement and no regularly spaced contraction or expansion joints. The only transverse joints used are non-active construction joints placed at the end of a day's paving. The continuous joint-free length of CRC pavement can extend to several miles, with breaks provided only at structures. CRC pavements develop a transverse cracking pattern with cracks generally spaced at about 2 to 6 ft (0.6 to 1.8 m). The cracking pattern is affected by the ambient weather condition at the time of construction, the amount of steel reinforcement, and concrete strength. The steel reinforcement, as shown in figure 1, induces the closely spaced cracking and then holds the cracks tightly closed. The higher the amount of steel used, the more closely spaced the cracks will be. Most of the cracks develop shortly after concrete placement; however, additional cracking may continue to develop over several years as a result of continued drying shrinkage of concrete, temperature variations, and traffic loading.

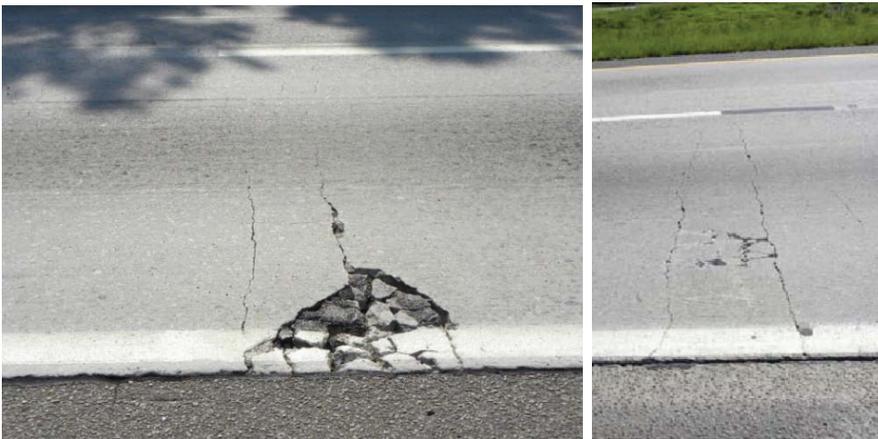
Figure 2. Punchout distress in CRC pavement.

CRC pavement as their primary concrete pavement alternative. When designed and constructed well, CRC pavements can provide a service life of 40-plus years with minimal maintenance. The maintenance that is needed in older CRC pavements is related to the development of punchout distress (figure 2), severely distressed/spalled cracks, and steel rupture. These distresses impact ride quality and safety. A common corrective action for these distress types is FDR. The repairs must be performed correctly; otherwise the likelihood of their early failure will be high.

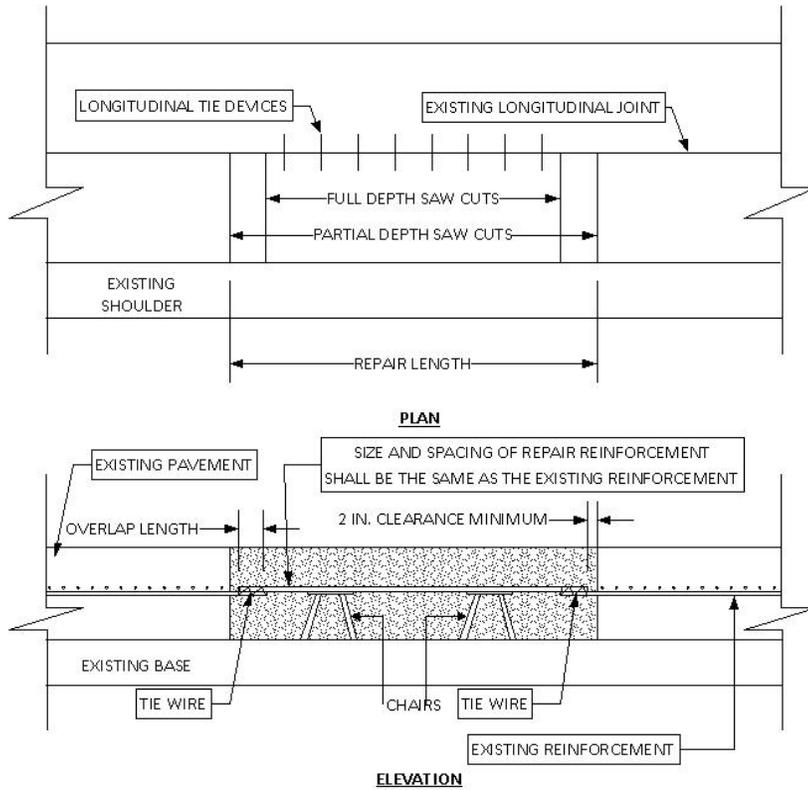
Figure 3. Schematic of conventional CRC pavement FDR.

Many agencies have developed standard techniques for performing FDR of CRC pavements. Most of the techniques are based on maintaining the continuity of the longitudinal steel within the patch area, as illustrated in figure 3. The steps involved in such FDRs are as follows:

1. Identify the repair boundary—most agencies require the repair to be full-lane width and at least 6 ft (1.8 m) in length.

2. Remove the damaged concrete.

- a. Sawcut along the repair area perimeter—full depth along the longitudinal edges and partial depth about 2 to 3 in. (50 to 75 mm) along the transverse edges, avoiding the longitudinal steel bars.

- b. Remove the interior damaged concrete by making a full-depth sawcut about 20 in.

(0.5 m) from each transverse repair edge and lifting out the interior concrete. The breakout method for the interior concrete removal is not recommended as this method can damage the existing base.

- c. Remove the remaining concrete along the transverse edges by jack-hammering. This operation should result in about 20 in. (0.5 m) of longitudinal steel exposed at each transverse end to allow sufficient lap length for tying with new steel in the repair area. The recommended lap length for tying the longitudinal steel ranges from 25 to 30 times the steel diameter. Figure 4 shows the prepared area with exposed longitudinal steel bars.

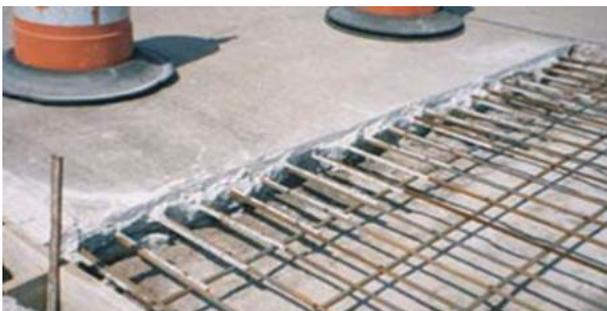
Figure 4. Prepared repair area with exposed longitudinal steel bars.

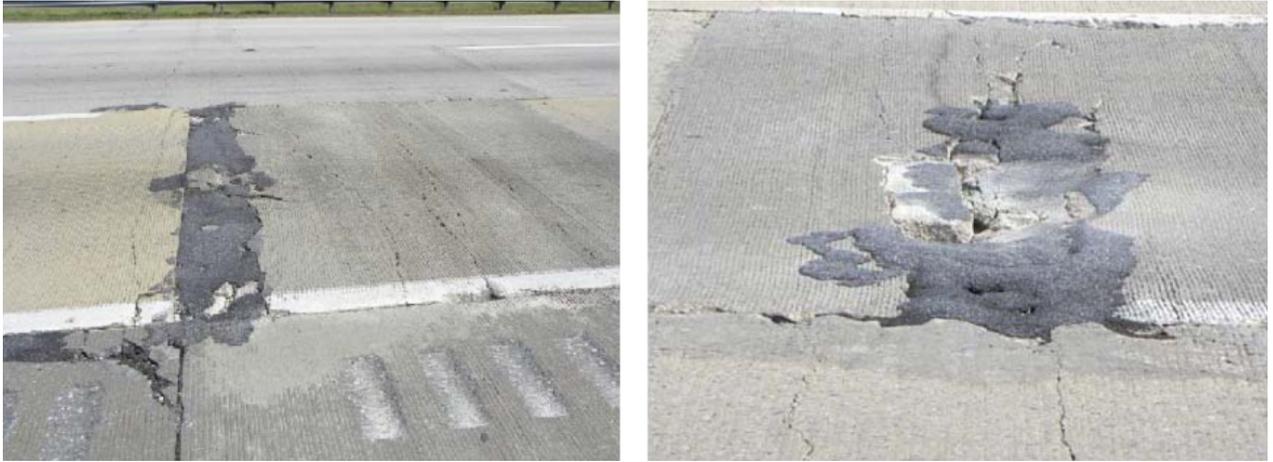
Figure 5. Failed FDRs on CRC pavements.

The conventional FDR method as described above has shown mixed levels of performance, especially when repairs were performed under short lane-closure requirements. Many FDRs have failed within 1 to 5 years, creating a need to keep extending the repair area with subsequent repairs. Typical examples of failed conventional FDR of CRC pavements are shown in figure 5.

Failures have typically been due to the following:

1. Inability to adequately restore the base under the exposed steel after concrete removal.

2. Poor quality concrete—the time required to jackhammer the end concrete area limits the time available to properly place and finish the repair concrete.

3. Poor steel lapping practices.

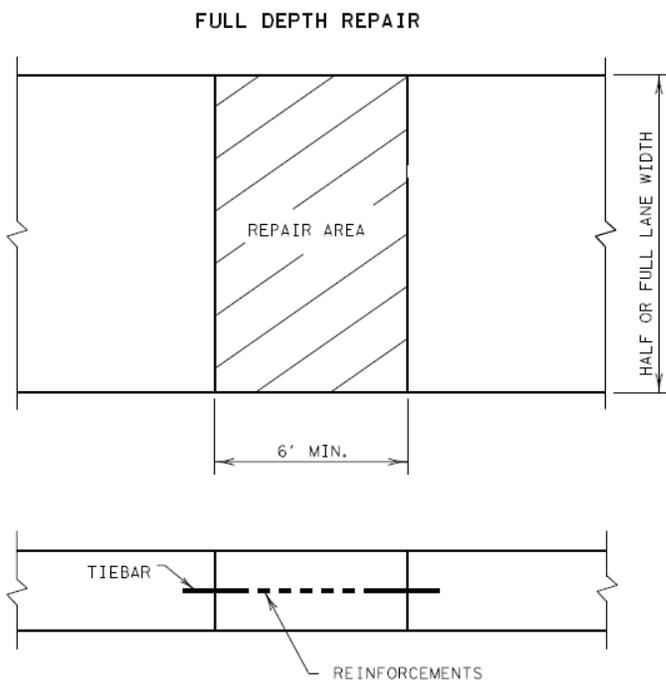
Figure 6. Plan and cross section of the Texas FDR of CRC pavements.

To address some of the shortcomings of the conventional FDR technique, several Texas DOT districts have modified the technique as follows (Texas DOT):

1. Perform a full-depth sawcut along the transverse edges of the repair area.

2. Remove all damaged concrete using the lift-out method, minimizing any hand removal of the concrete.

3. Drill holes in the transverse sawcut faces for installing tie bars.

4. Install tie bars in the drilled holes and epoxy-grout the bars.

5. Connect the tie bars with the repair area longitudinal bars corresponding to the tie bar spacing.

6. Follow through with concrete placement, finishing, and curing, as with the conventional technique.

The Texas method, illustrated in figure 6, shortens the time for preparing the repair area and allows for restoration of the base within the entire repair area. However, the performance of this alternate FDR method has also been mixed, primar-

ily because the tie bars across the full-depth sawcut transverse edges of the repair area do not provide adequate load transfer under heavy truck loading.

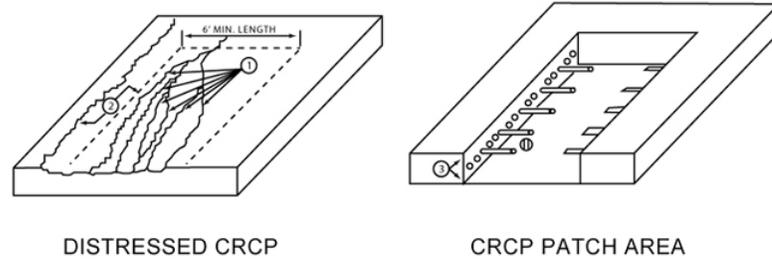
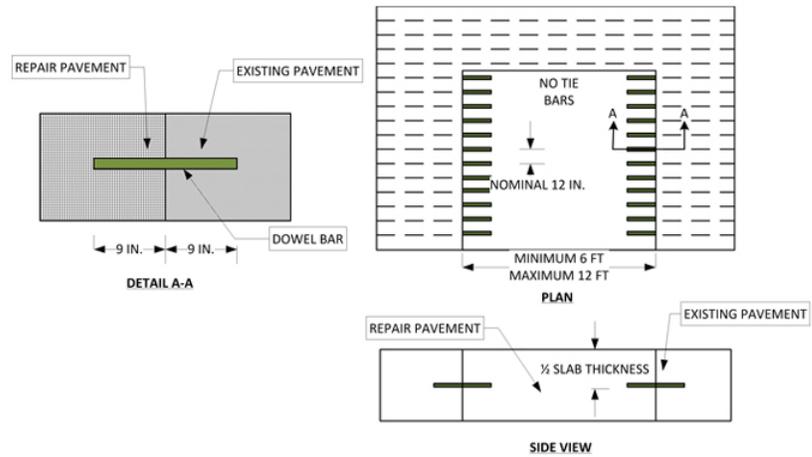
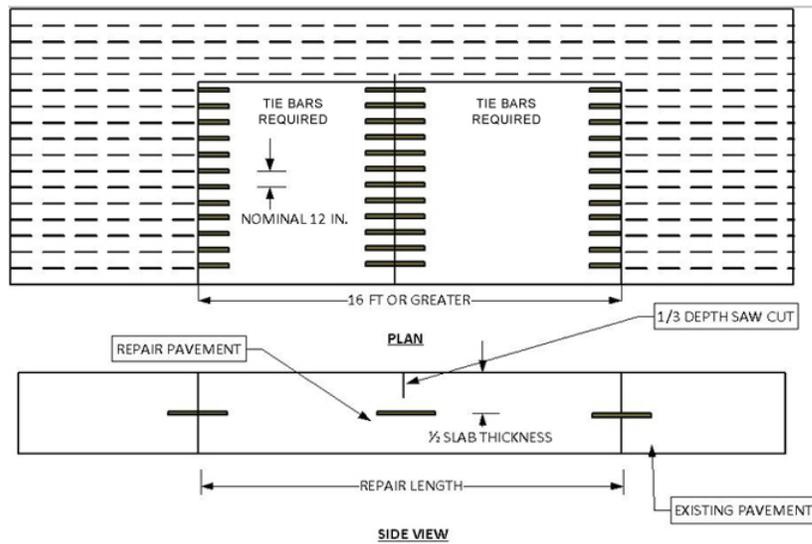
PATCH LENGTHS 6 FT TO 12 FT

PATCH LENGTHS 16 FT OR GREATER

Figure 7. Details of the South Carolina jointed FDR of CRC pavement.

1. Repairs are full-lane width and in a single lane, typically in the outside lane of a two-lane, one-direction roadway. However, a few repairs have been carried out in two lanes of a three-lane roadway (sections of I-77).

2. The repair area perimeter cuts are made full depth.

3. Longitudinal steel continuity is not maintained in the repair area. In fact, longitudinal steel is not used in the repair area.

4. Similar to the conventional FDRs described above, tie bars are not used along the centerline longitudinal joint for patches less than 16 ft (4.9 m) in length. For longer patches, longitudinal tie bars are spaced nominally at 30-in. (760-mm) intervals, but the spacing may be varied to avoid existing cracking in the adjacent lane and to be at least 15 in. (400 mm) away from the transverse joints at each end of the repair area.

5. Dowel bars are placed at mid-depth at a nominal spacing of 12 in. (300 mm) starting and ending about 12 in. from the corners of the repair area. The dowel bar spacing is adjusted to miss any longitudinal steel in the existing pavement.

6. Intermediate transverse joints are required for repair lengths greater than 16 ft (4.9 m). Dowel baskets are used at these intermediate joints, with dowels spaced at 12 in. (300 mm). The intermediate joints are sawed to a depth of one-third the depth of the repair area and sealed.

The details of the South Carolina DOT method are shown in figure 7.

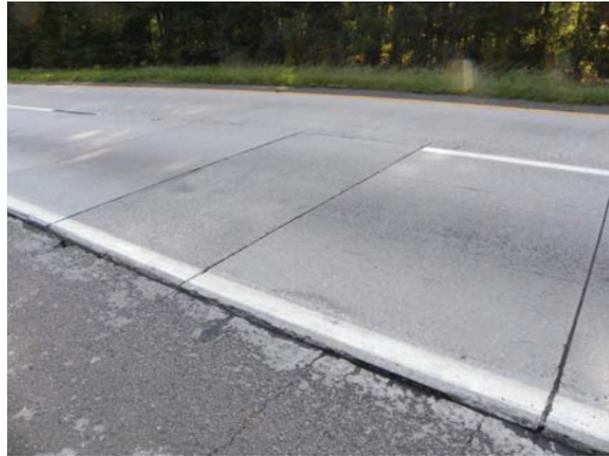
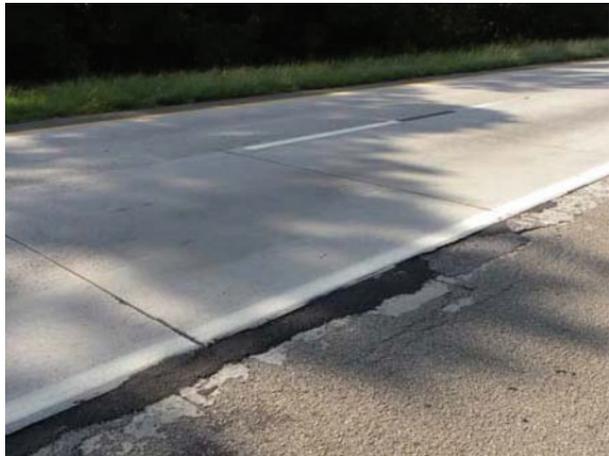
Figure 8. Views of the I-95 jointed FDRs.

Overall, the jointed FDRs are performing well, based on a windshield survey performed during August 2010, as shown in figure 8. The CRC pavement still had a bare concrete surface. The overall ride was good, including over the FDR areas. The repair areas included single panel repairs (up to a length of about 18 ft [5.5 m]) as well as multiple panel repairs with intermediate joints at 15-ft (4.57 m) spacing, incorporating dowel baskets. One repair area was more than 250 ft (76.2 m) long with 18 panels—each of 16 panels was 15 ft (4.6 m) long and two panels at one end were each 9 ft (2.7 m) long. The repair area joints were in good condition and sealed. There was no noticeable faulting at the repair area joints. There did not appear to be any adverse effect on the cracking in the inside CRC lane. The inside lane cracks within the outside lane repair areas appeared to be tight. A few of the repair panels exhibited single transverse mid-panel cracking. The cracking was about 0.04 to 0.08 in. (1 to 2 mm) wide as observed from the shoulder. Some repair panels were observed to exhibit mid-panel longitudinal cracking, as shown in figure 9. The repair panel cracking at these few isolated areas was reportedly due to poor base/subbase condition at these locations.

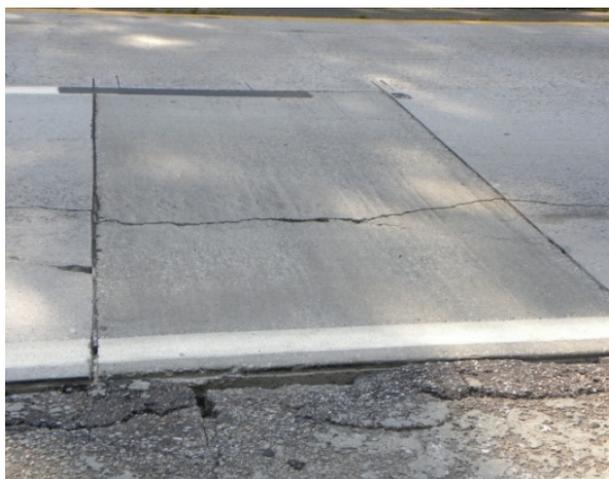
Figure 9. Longitudinal cracking at a jointed FDR location.
